Los Angeles County
Metropolitan Transportation Authority

Subject: Safety Recommendation R-10-25 in the investigation of the June 22, 2009
Washington Metropolitan Area Transit Authority accident

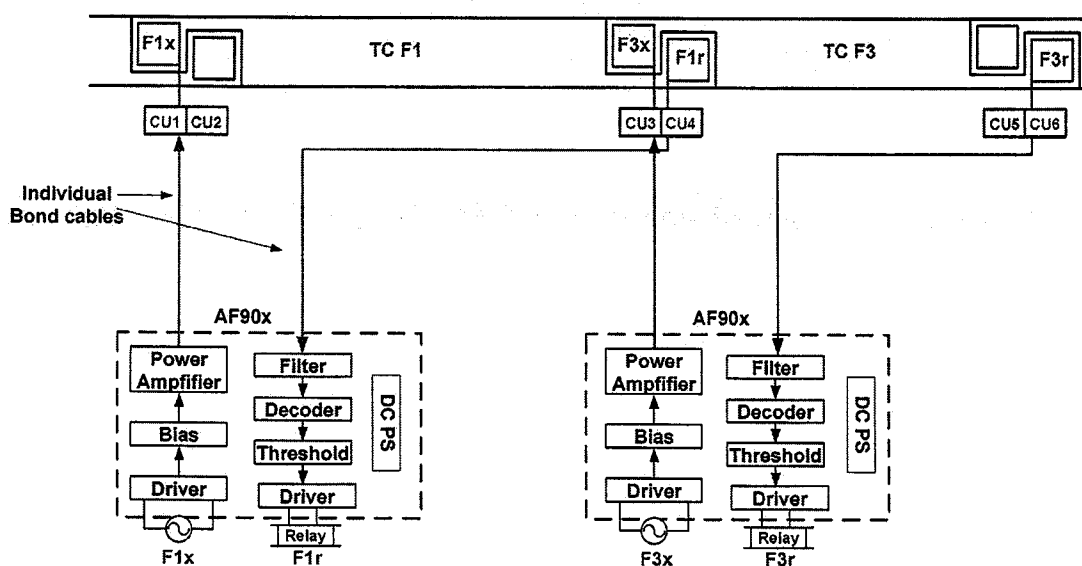
As indicated in the NTSB Safety recommendation, in the Alstom track circuit at WMATA, a large signal transmitter source was directly paralleled to the receiver input. As shown in the diagram below, the AF 90x design does not have a transmitter paralleled to a receiver. Thus the failure mode experienced at WMATA cannot occur .
