THE CONTINUING CHALLENGE

THE NORTHRIDGE EARTHQUAKE OF JANUARY 17, 1994

Report to the Director,
California Department of Transportation

by the
Seismic Advisory Board

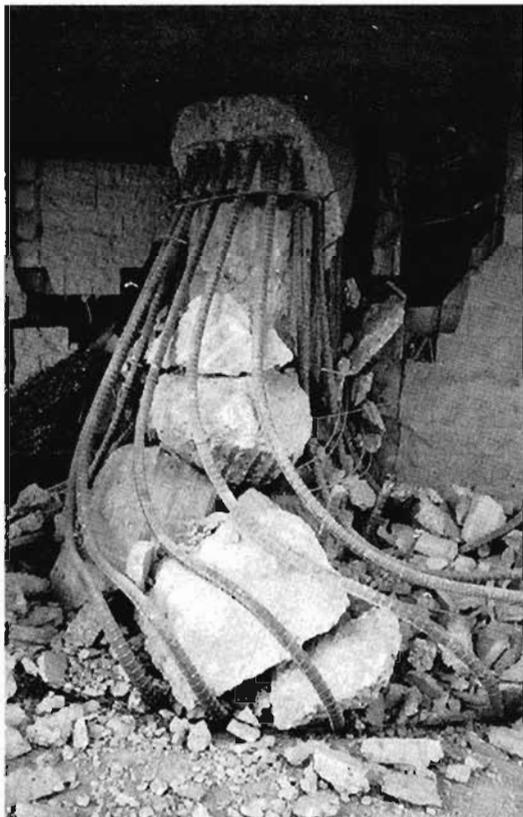
Retrofit designs for both of the collapsed I-10 structures were complete at the time of the Northridge earthquake. However, retrofit implementation reportedly was compounded by legal problems concerning the leased airspace under the La Cienega and Venice structures, reemphasizing the fact that time is of essence in the seismic retrofit program.

Figure 4-3. Brittle column failure at I-10, La Cienega and Venice. Northridge earthquake. (photo: F. Seible)

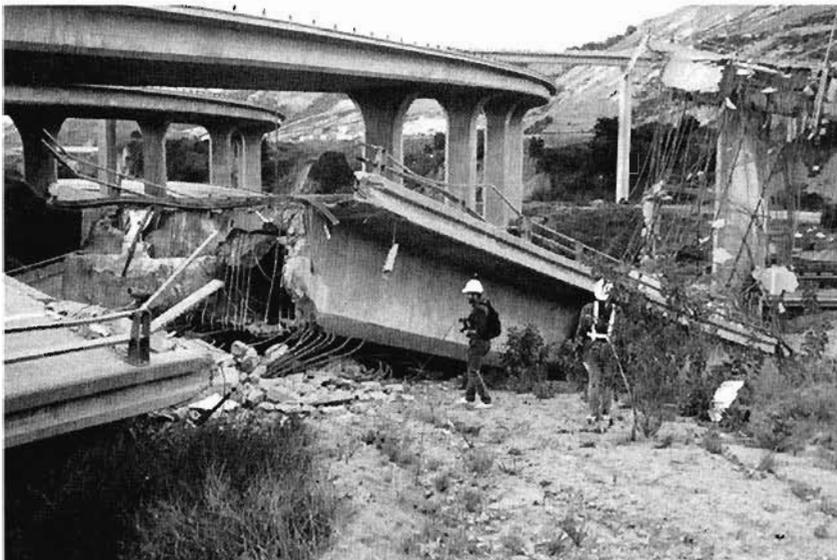
Figure 4-4. SR-14/I-5 North Connector Overcrossing, Northridge earthquake. (photo: F. Seible)

During the Northridge earthquake, the two bridge failures at the I-5/SR-14 Interchange (Figures 4-4 through 4-6) can be attributed to brittle shear failure of short or stiff columns. These columns, proportionally to their stiffnesses, attracted more seismic force than their more flexible adjacent bents and did not have the necessary deformation capacity due to the pre-1971 transverse reinforcement detailing [Priestley, Seible and Uang, 1994]. In addition, the shear failure of the north connector of bent #2 was aided by

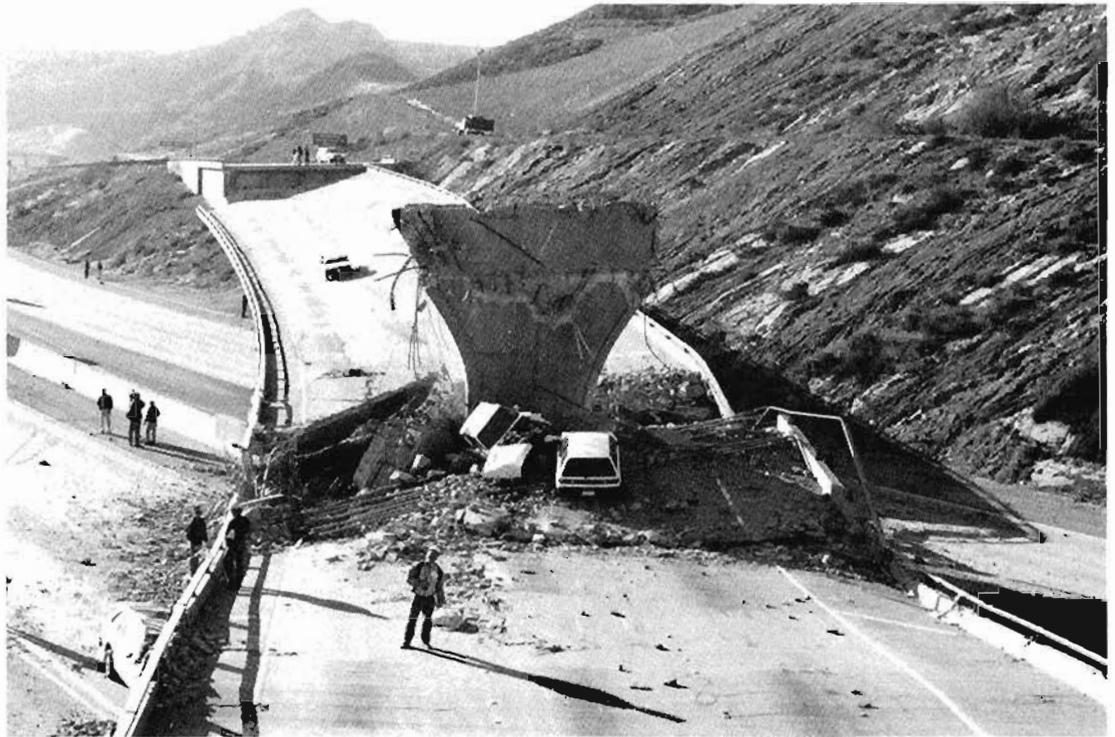
Figure 4-5. SR-14/I-5 South Connector Overhead, Northridge earthquake. (photo: F. Seible)
