Southern California Rapid Transit District  
Metro Rail Project

Analysis of  
Fireproofing Repairs  
to Main Shop Building  
Contract A112  
November 14, 1989

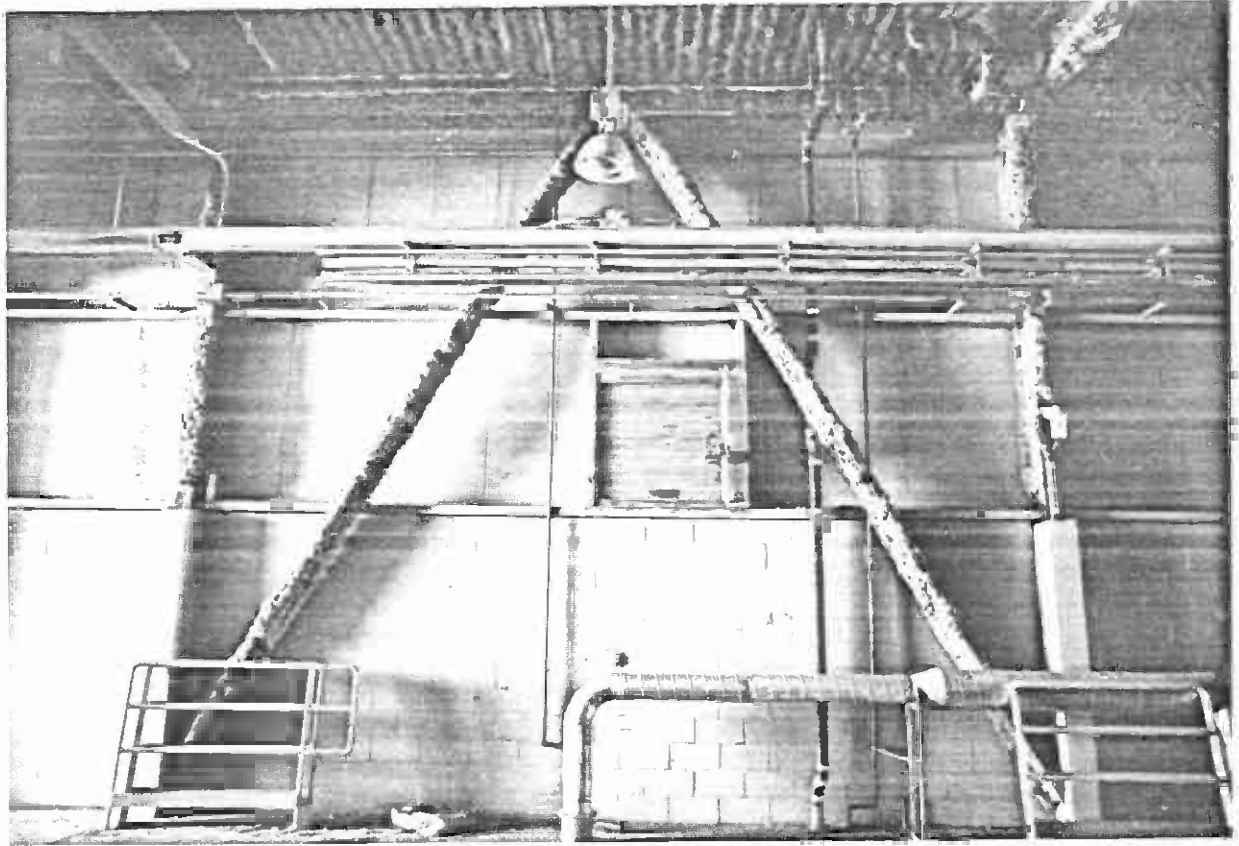
1

RM. 157- COLUMNS & K-BRACING AT GRIDLINE A-3 & A-4

rainwater leaders, and sprinkler system drain lines that occur on or near K-braces will have to be handled by enclosing or relocating the service to the new face of finish. (Repair Type III.) (Photos Nos. 1, 2, 3, 4.)

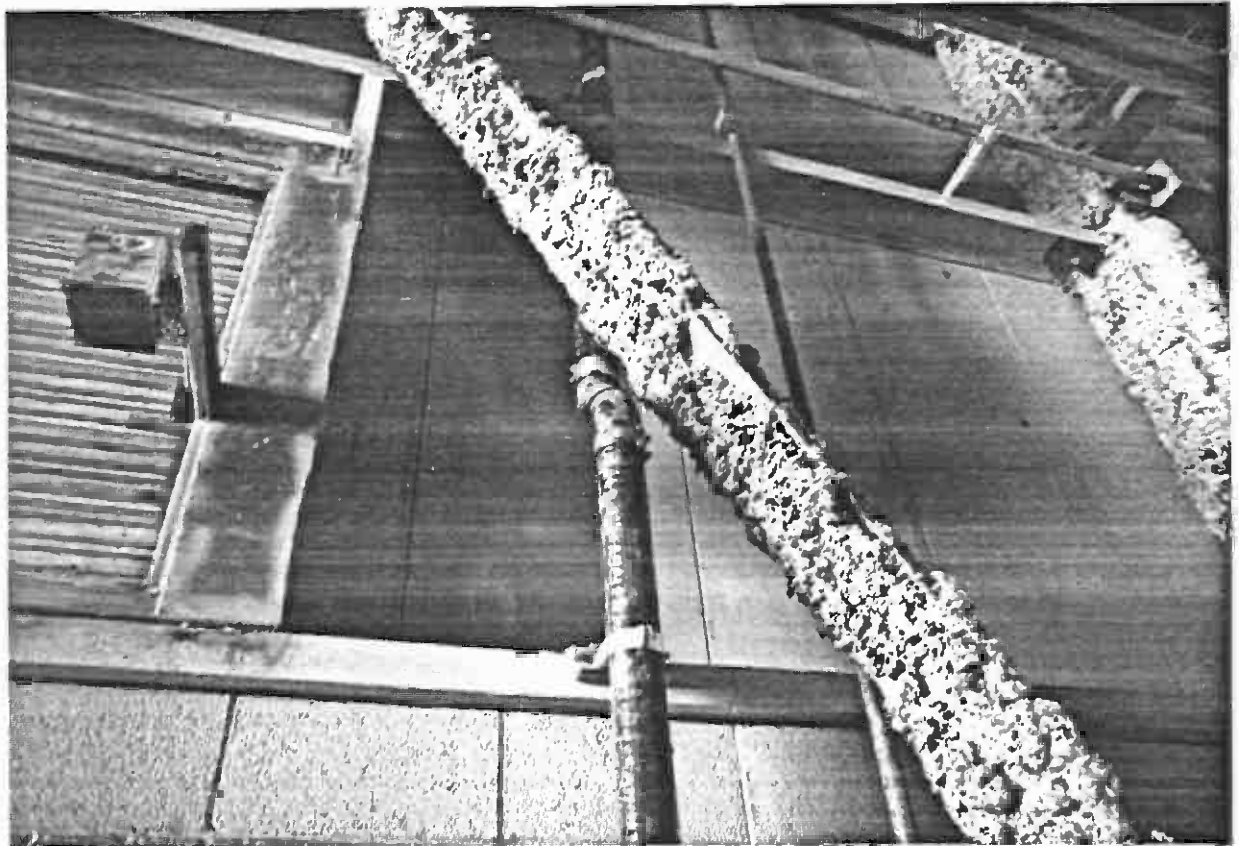
2

RM. 157- K-BRACING AT COLUMN A-4. ROOF DRAIN BEHIND K-BRACE.

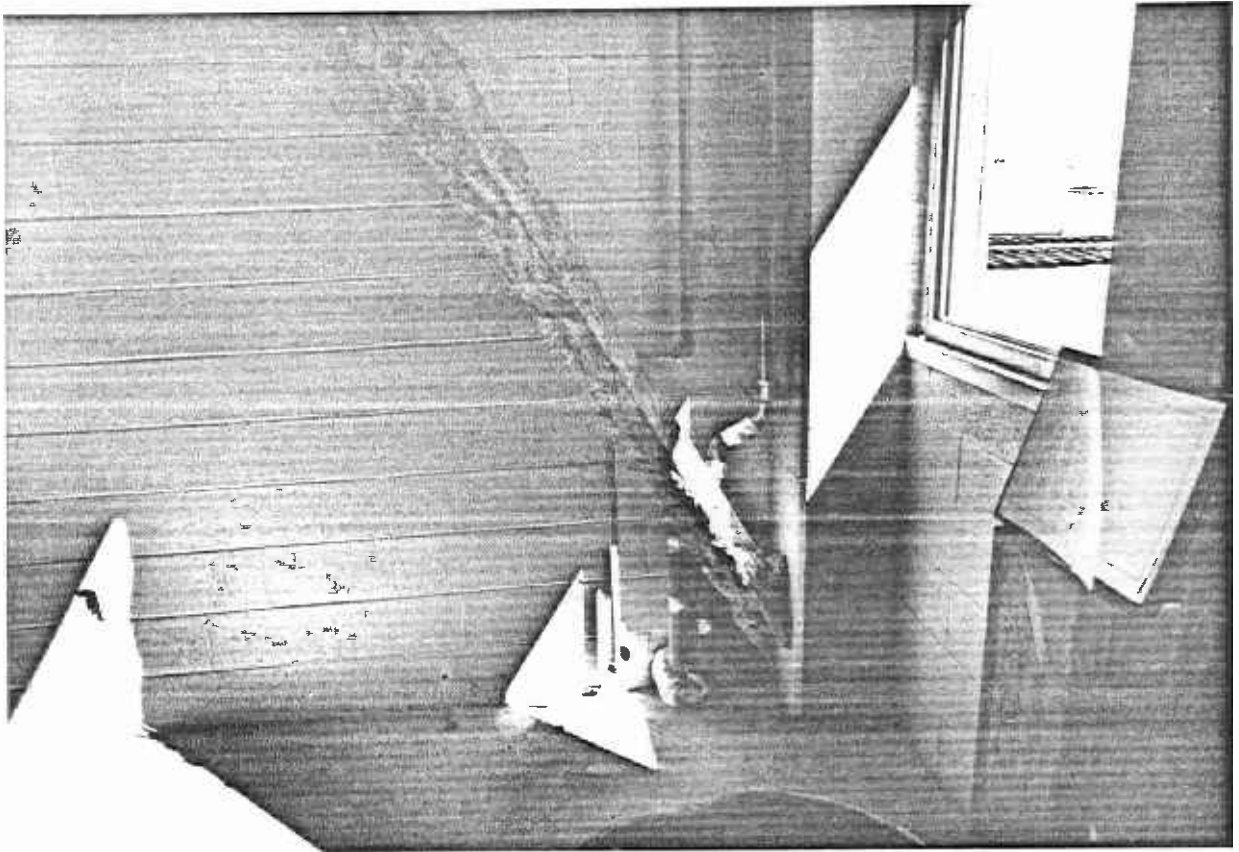
RM. 157- K-BRACING AT COLUMN A-10.

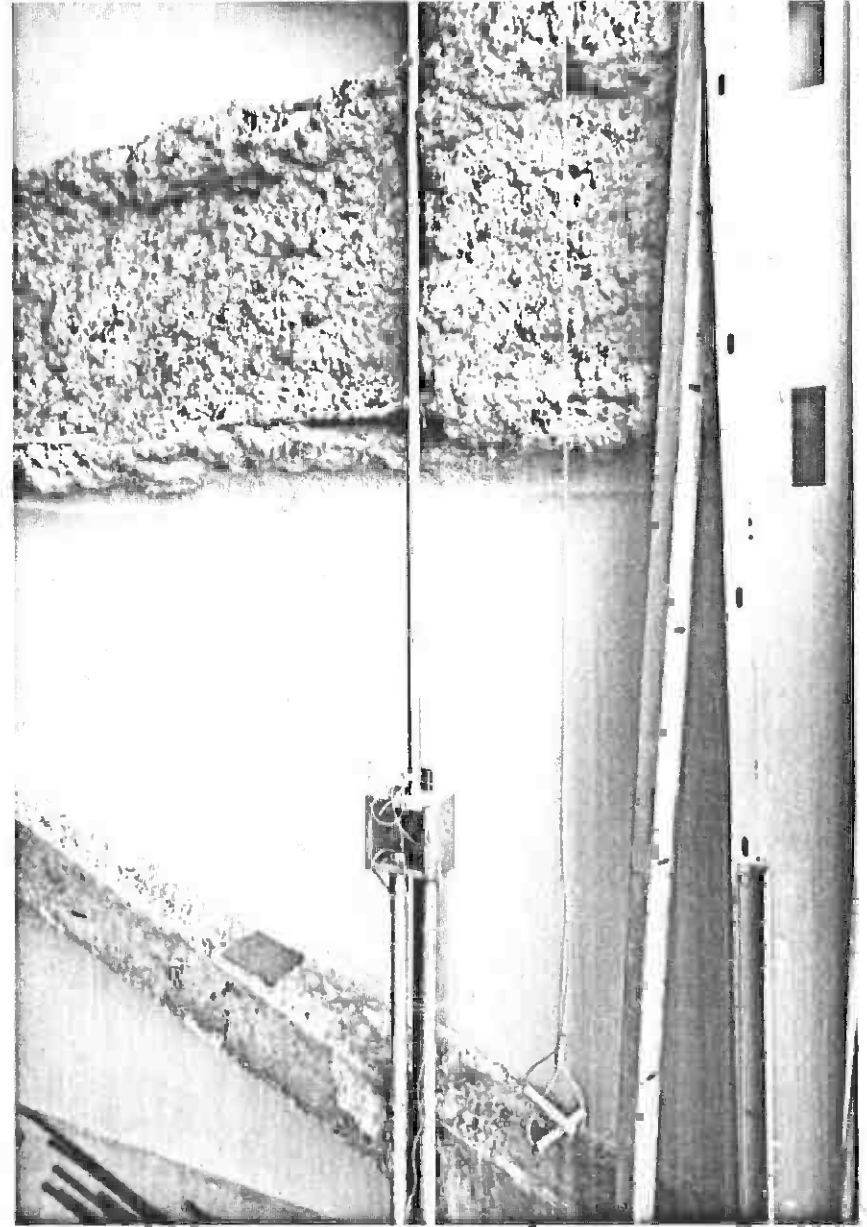
RM. 157- DOOR JAMB AT GRID A.7-1 ADJACENT TO BRACING. 4

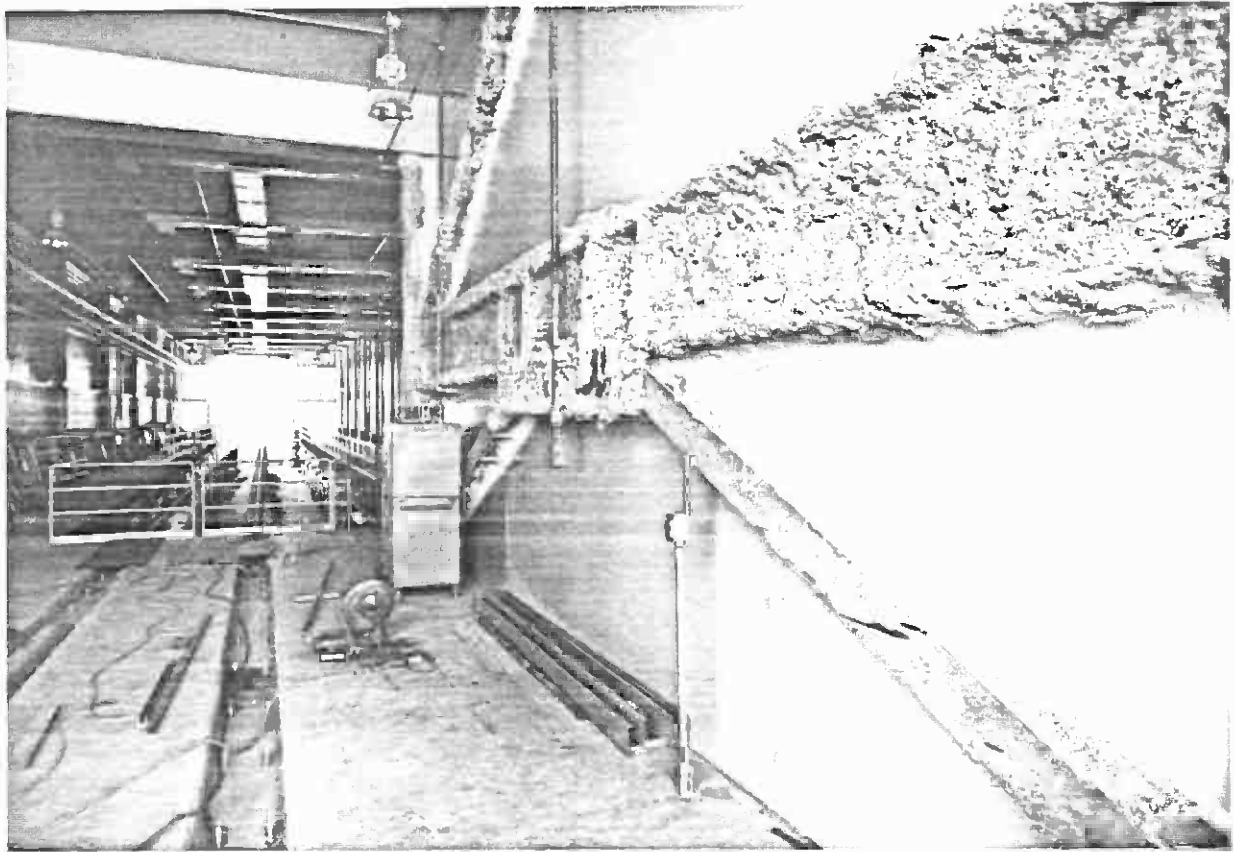
6

RM. 157- K-BRACING AT GRIDLINE A.7.

The columns and K-braces on gridline A.7 that project through the existing rated gypsum board wall finish shall have a new full height gypsum board wall constructed in front to enclose the fireproofing. Electrical services and sprinkler test lines shall be extended to the surface of the new wall. (Repair Type V.) (Photos Nos. 5, 6, 7, 8.)

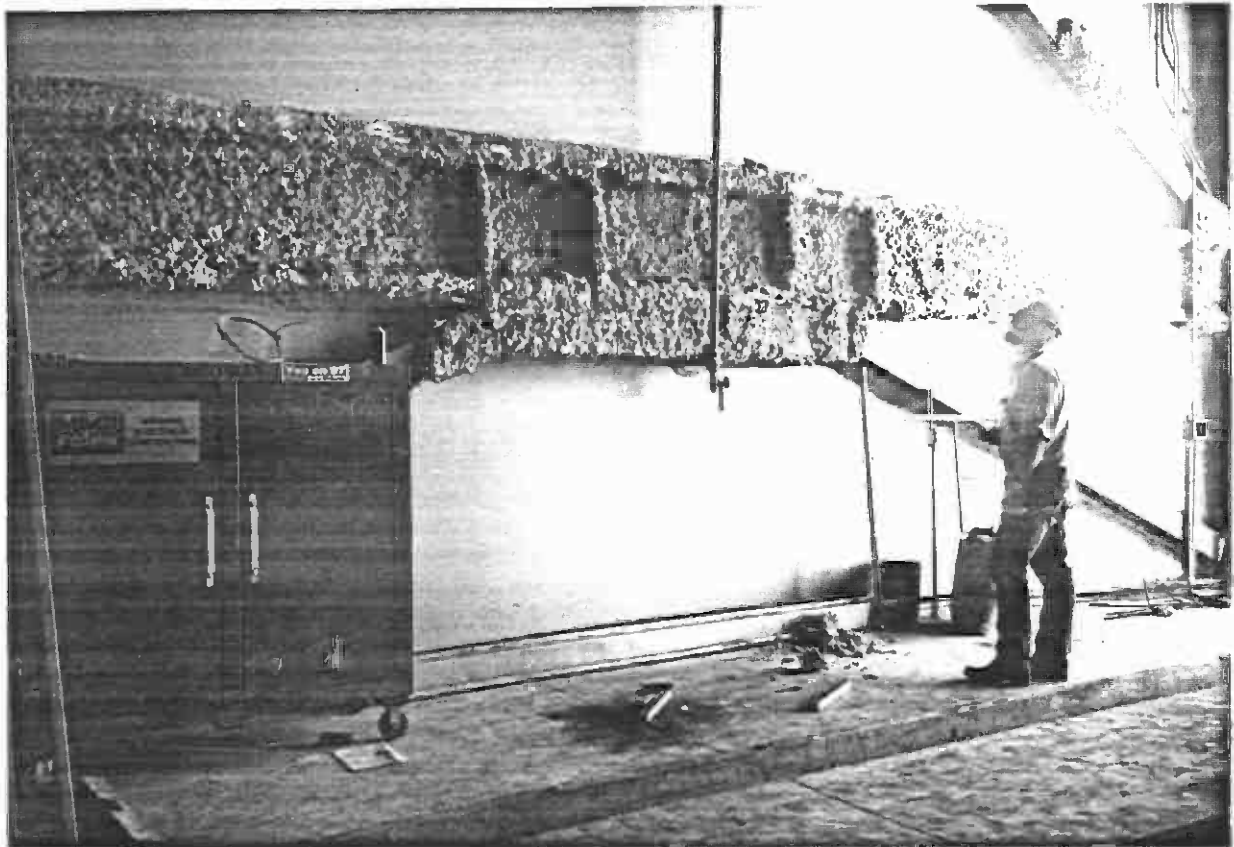
7

RM. 157- K-BRACING AT GRIDLINE A.7.

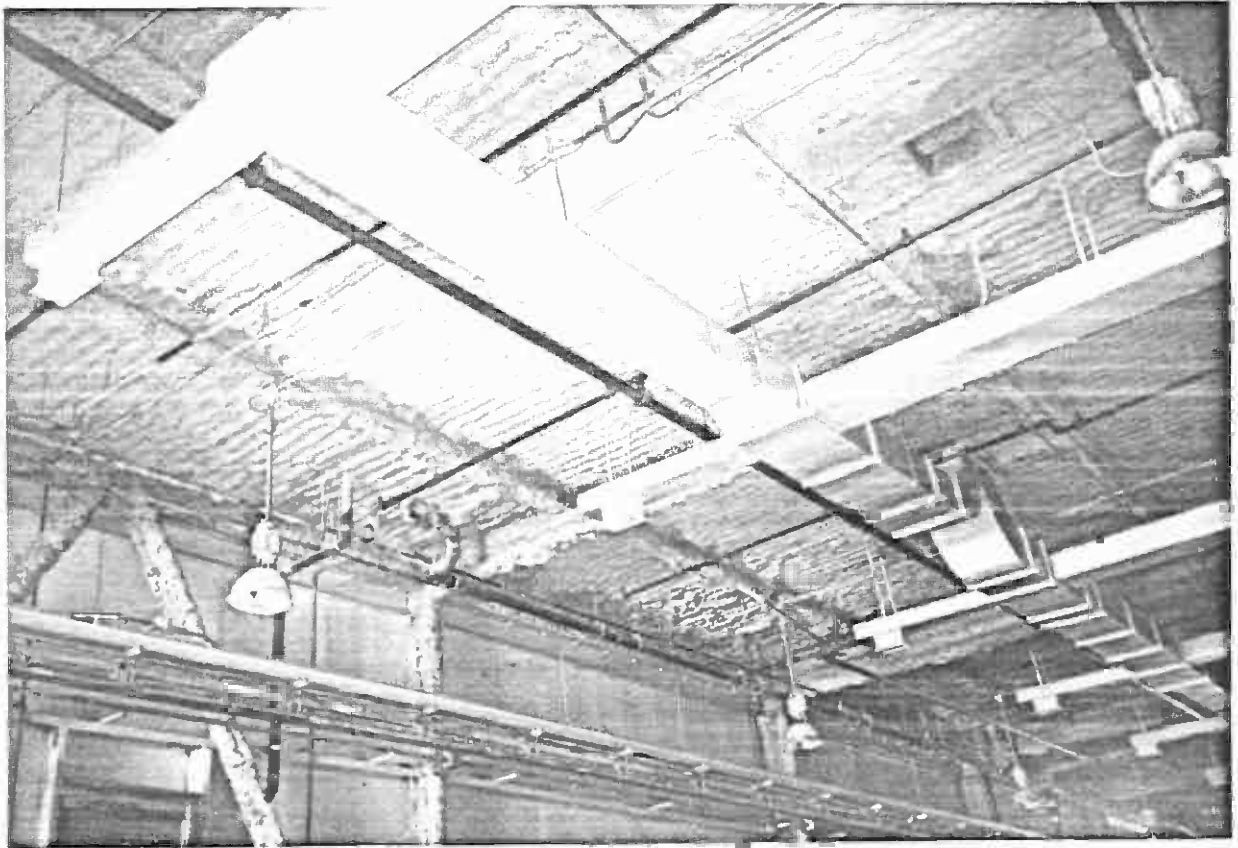
9

RM. 157- EXPOSED ROOF DECK.

All the existing fiber-type fireproofing on the roof trusses, bottom chord diagonal bracing, purlins, and roof deck between gridlines 2.7 and 10, must be sprayed with a sealer compatible with the mineral fiber-type fireproofing. (Photos Nos. 9, 10.)

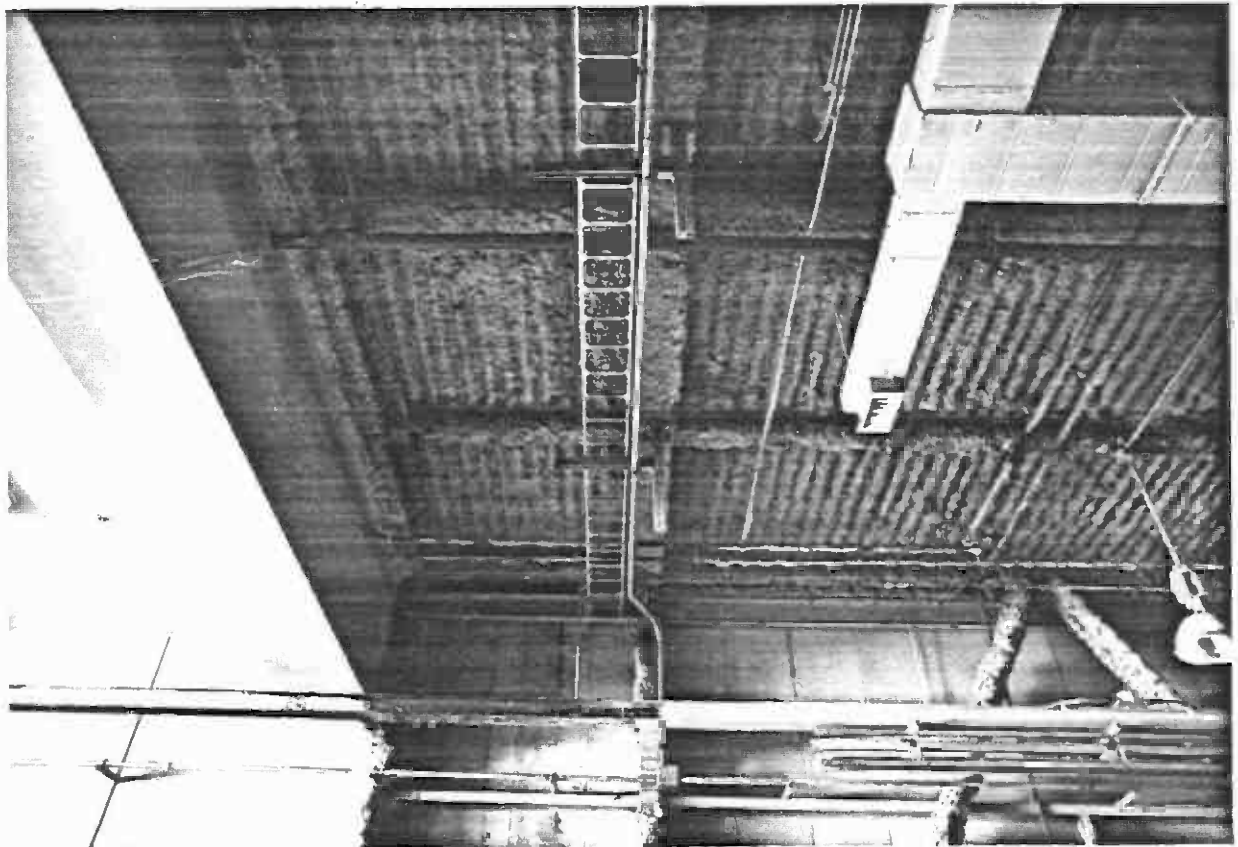
10

RM. 157- EXPOSED ROOF DECK

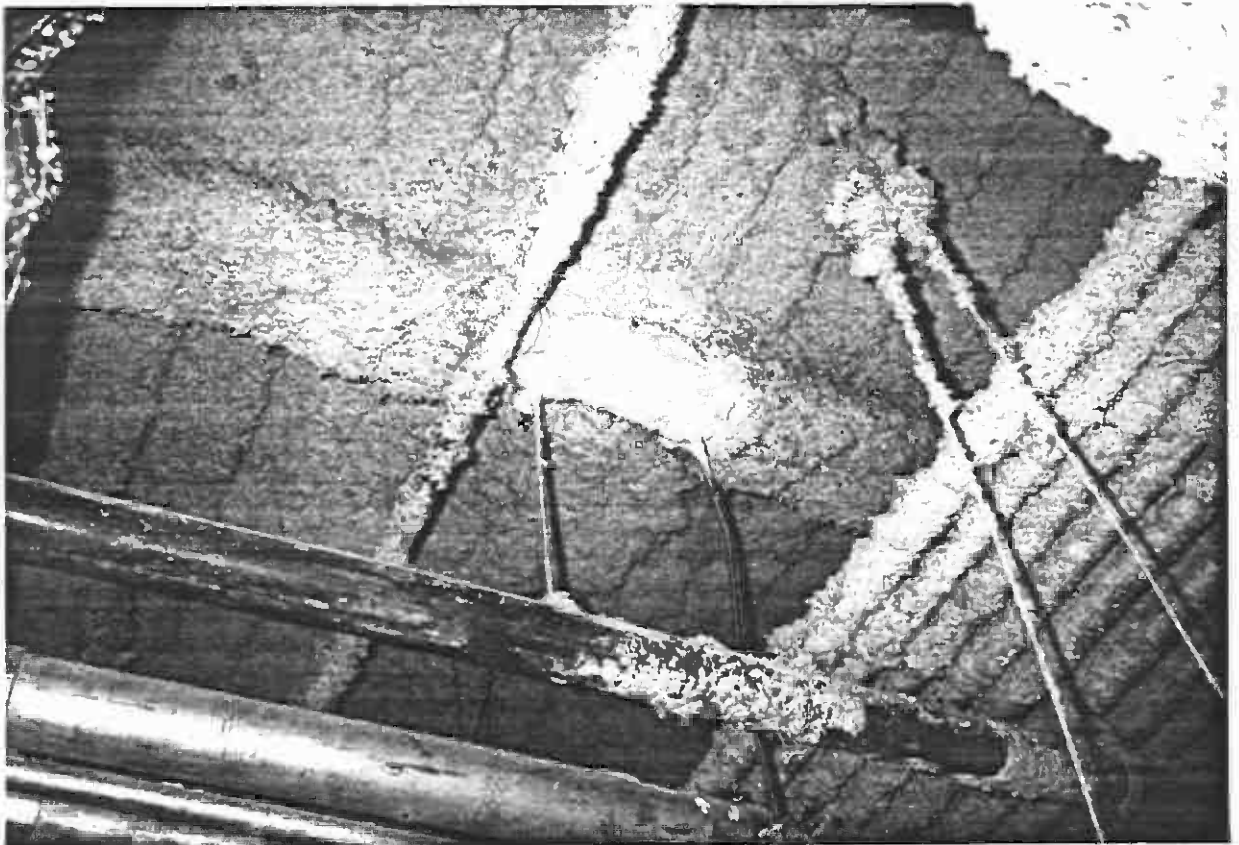
12

All rooms have gypsum board walls that enclose the perimeter columns and K-braces so there is no exposed fireproofing at these locations. Room 249 has free-standing columns on gridline F.6 that have exposed fireproofing above the 12'-0" high gypsum board furring. With the exception of Communications Equipment Room No. 249, these rooms have suspended acoustical ceilings below the fireproofed steel roof deck and beams. The fireproofing on the roof deck and beams in Room 249 is exfoliating.

RM. 249- ROOF DECK FIREPROOFING PATCHED WITH MONOKOTE.

The freestanding columns in Room 249 must be protected by a gypsum board finish on steel studs. The roof deck and beams in Room 249 must be sprayed with a sealer to eliminate exfoliation.

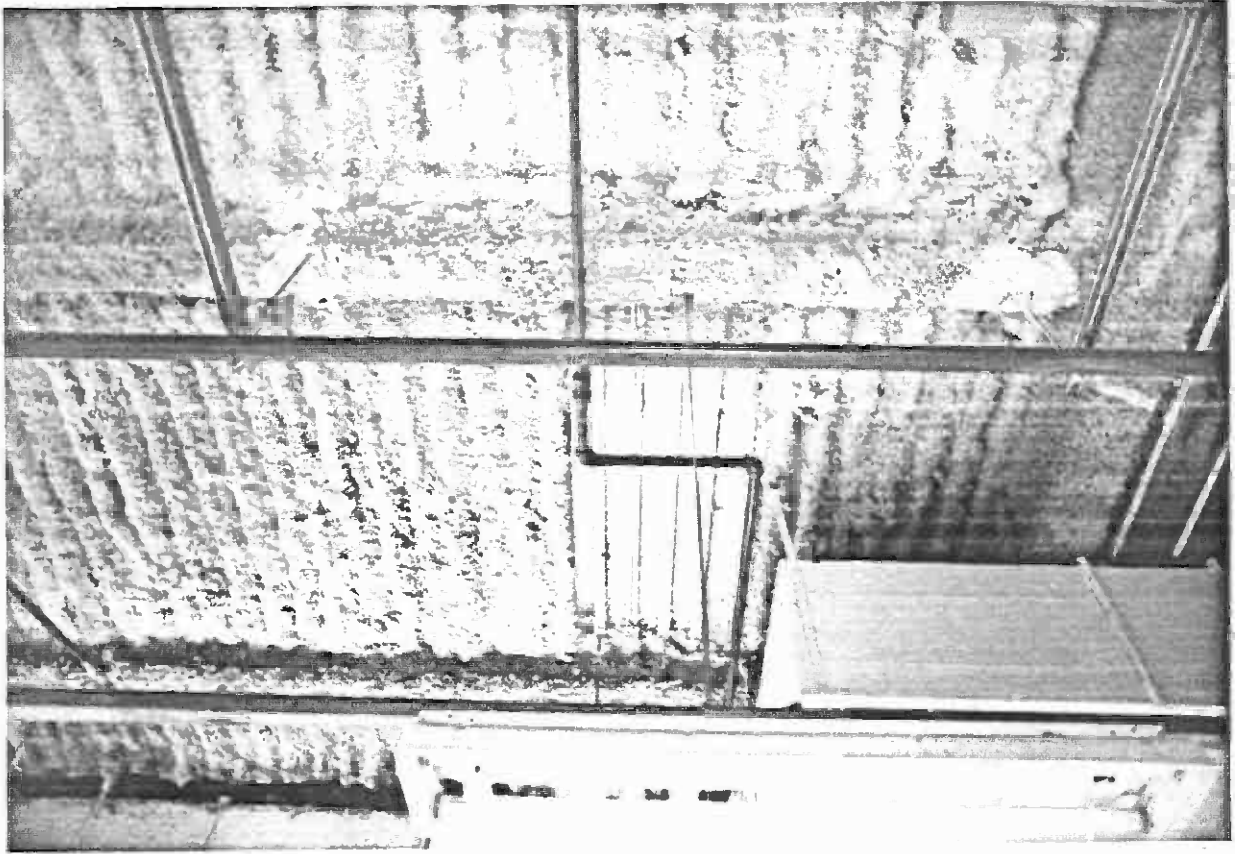
13

RM. 249- EXPOSED ROOF DECK W/ FIREPROOFING MISSING.

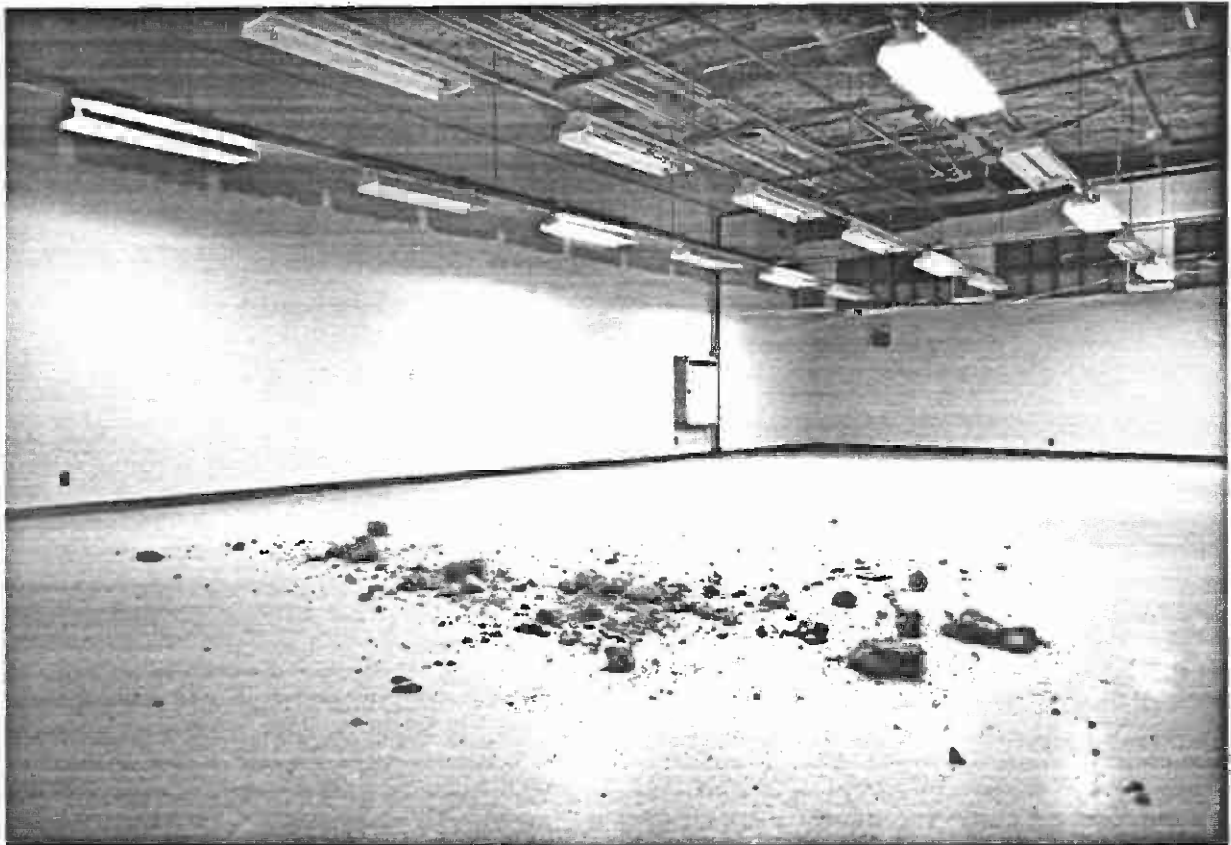
14

RM. 249- FIREPROOFING ON FLOOR.

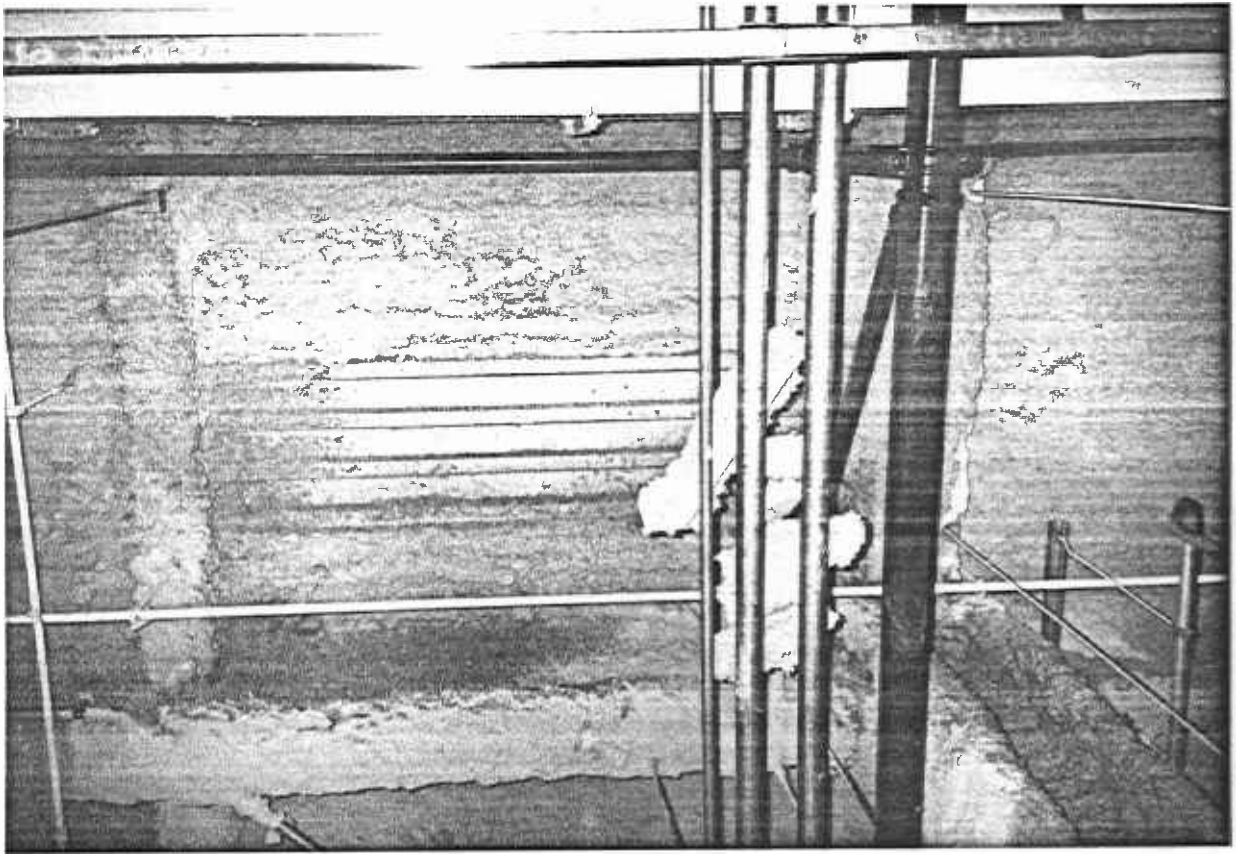
RM. 249-- EXPOSED ROOF DECK W/ FIREPROOFING MISSING.

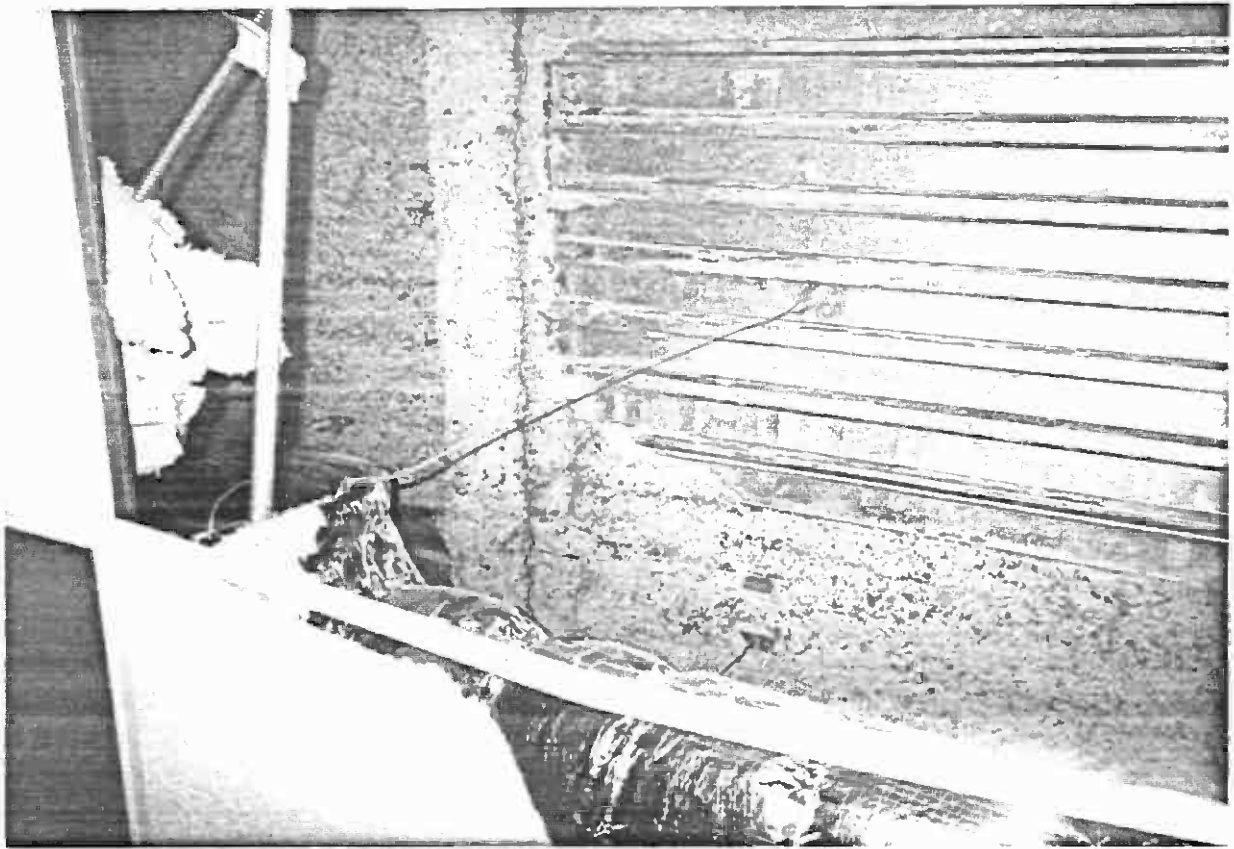
RM. 401- DECK W/ FIREPROOFING MISSING ABOVE SUSPENDED CEILING.

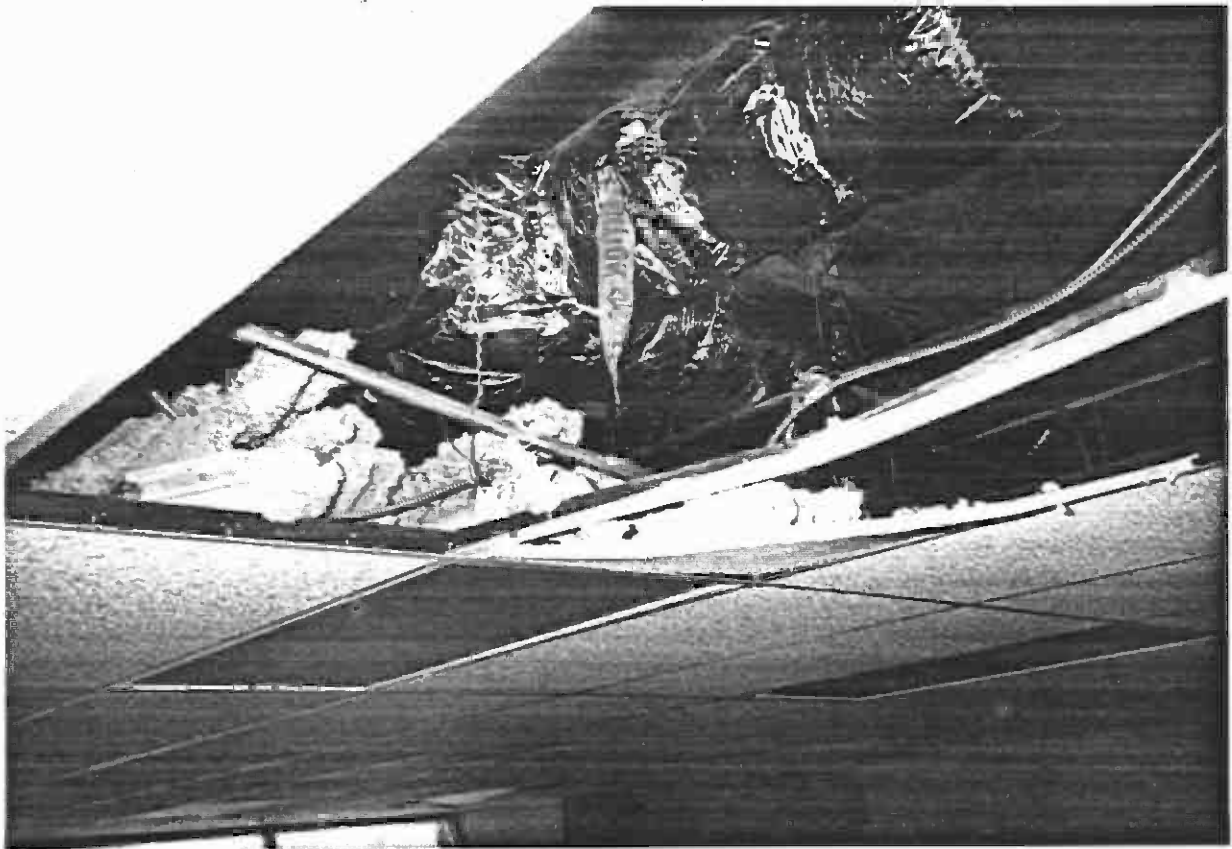
RM. 401- SUSPENDED ACOUSTICAL CEILING DAMAGE

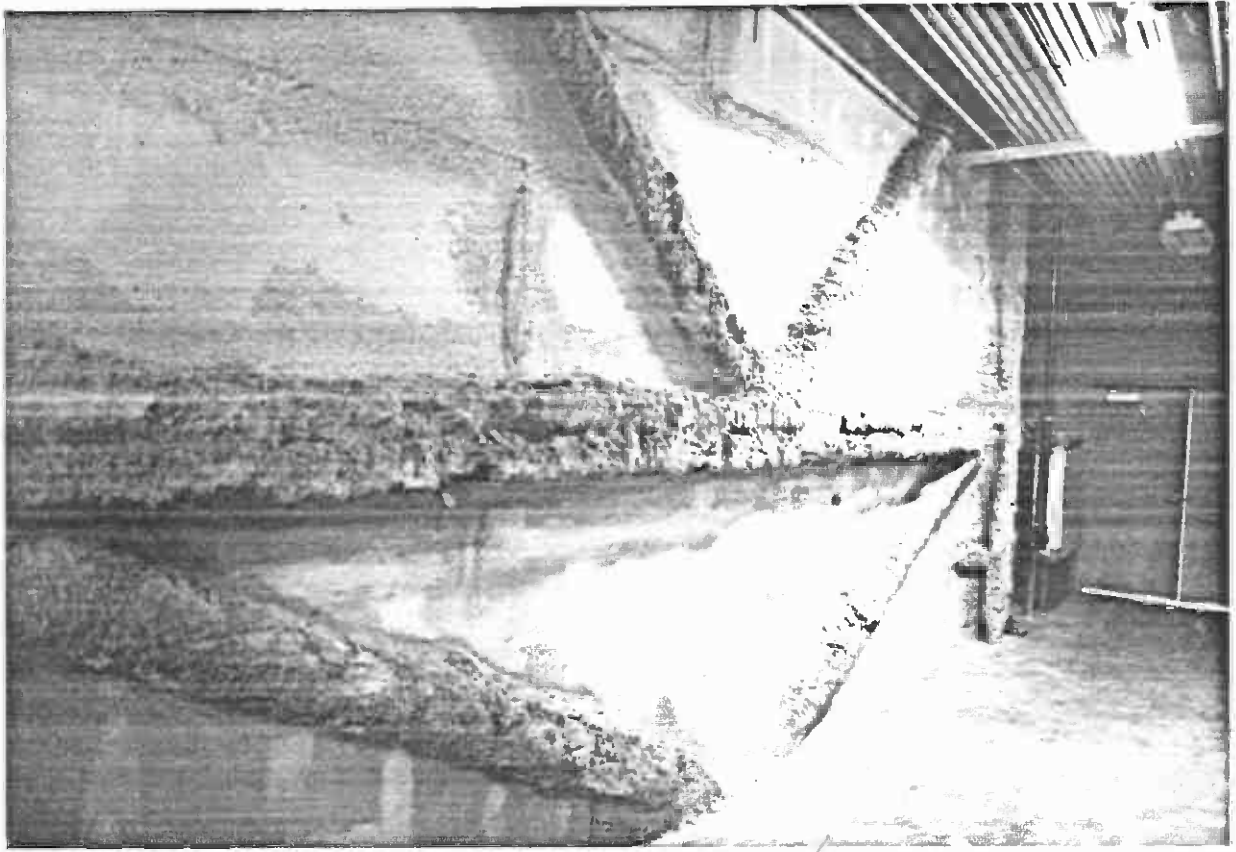
21

RM 276- K-BRACING AT COL D-13.

The exposed K-braces must be covered by a new, full height gypsum board wall and existing electrical outlets must be extended to the new finish surface. The existing fireproofing on the steel roof deck and supporting beams must be sprayed with a sealer compatible with the mineral fiber-type fireproofing. (Repair Type V.) (Photos Nos. 21, 22, 23.)

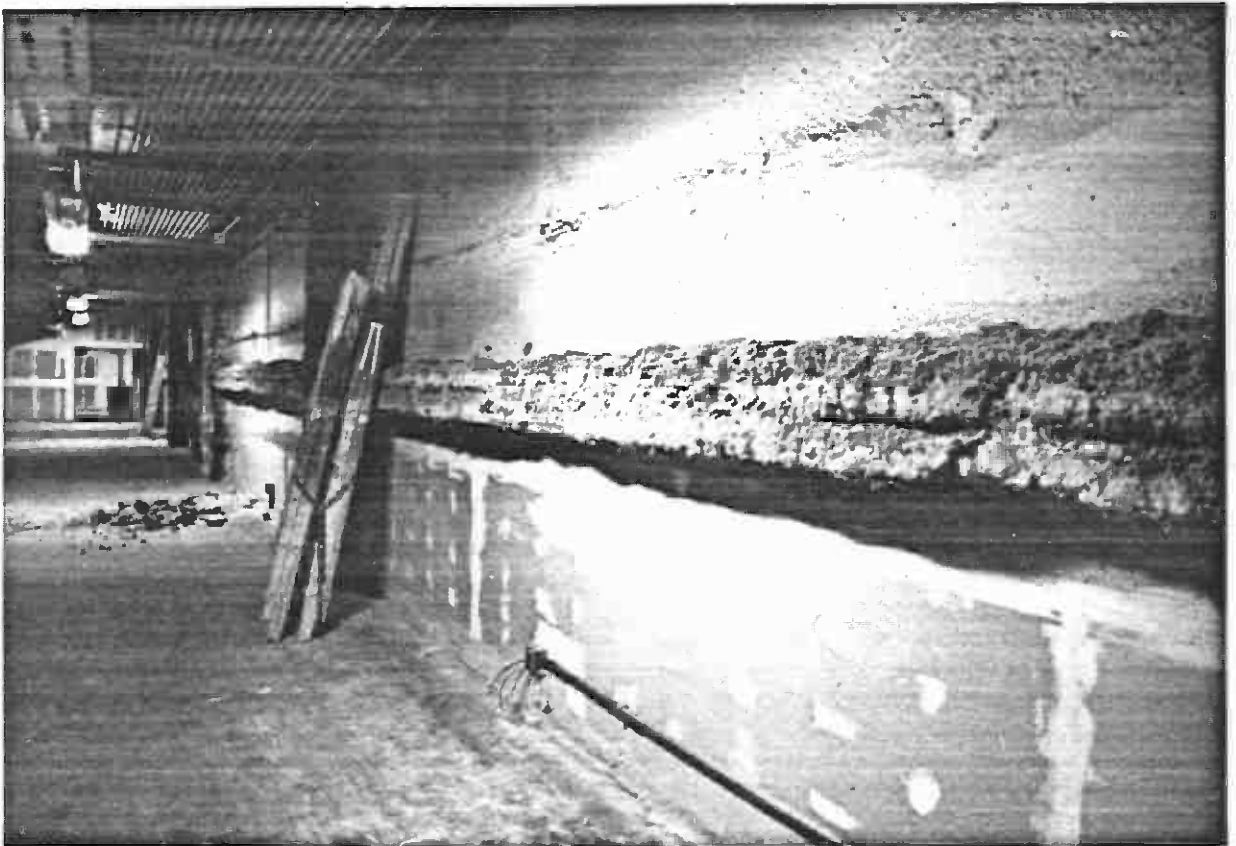
22

RM 276- WEST WALL

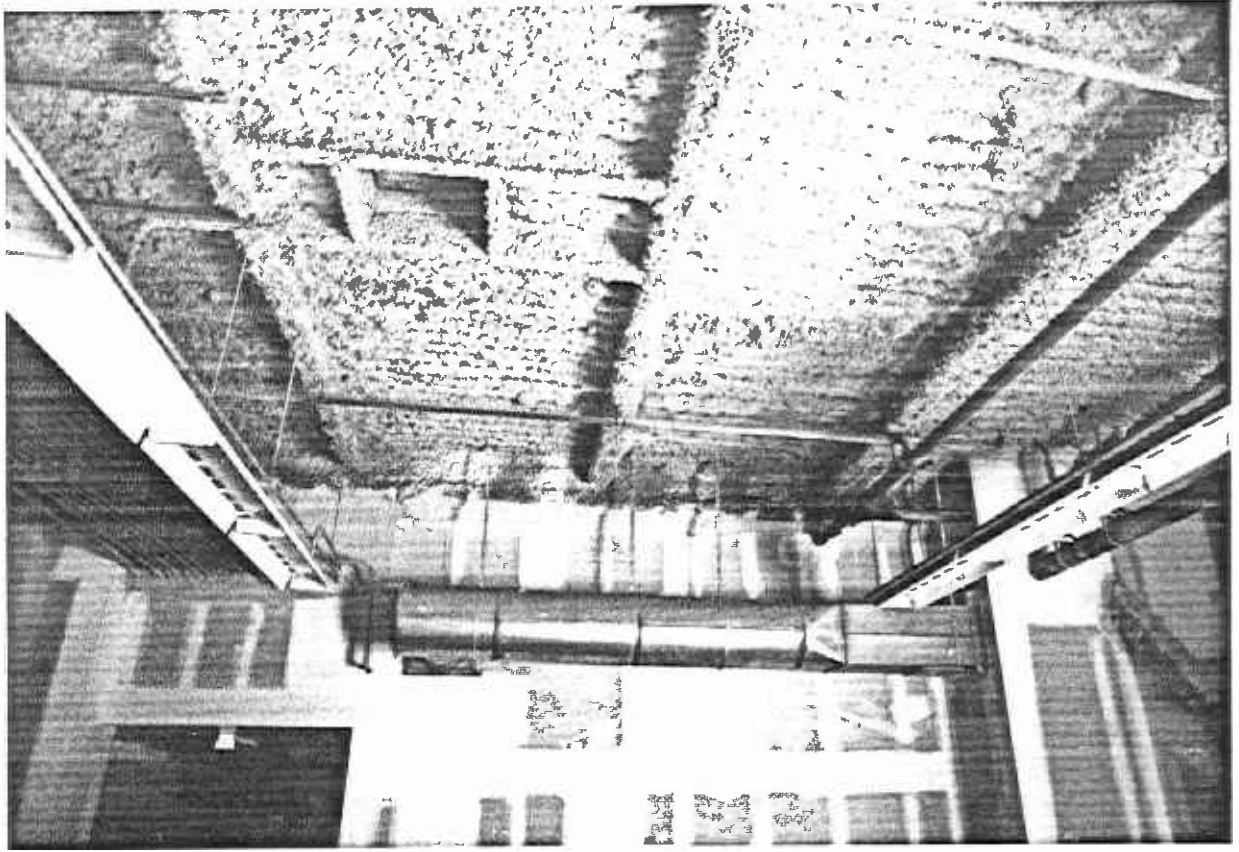
RM. 278- EXPOSED ROOF DECK

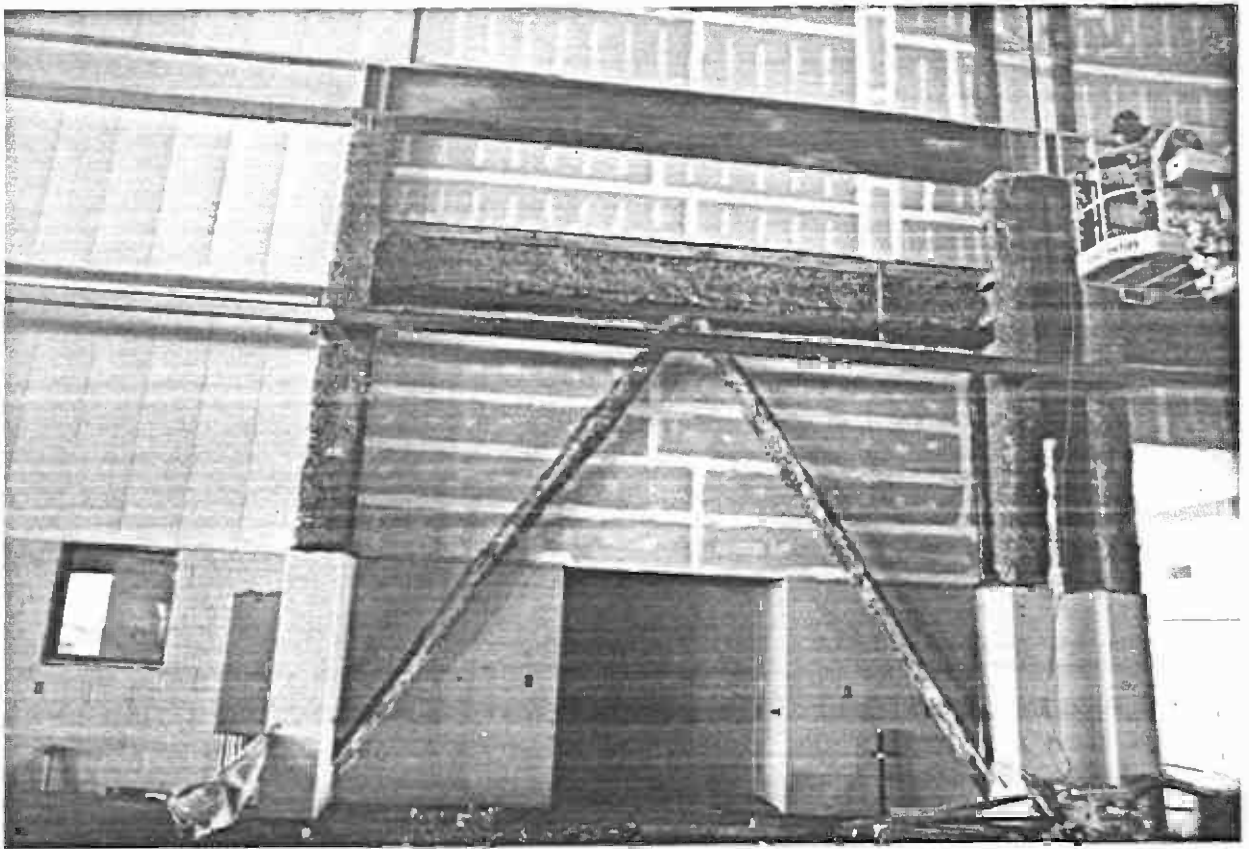
28

RM. 124- COLS. D-11, D-11.9 & D-121 W/ K-BRACING

The K-braces on gridlines D and F in the Heavy Repair Shop shall receive the gypsum board finish extending to 8'0" above finish floor. (Repair Type III. Photos Nos. 24, 25, 26, 27, 28, 29, 30, and 31.)

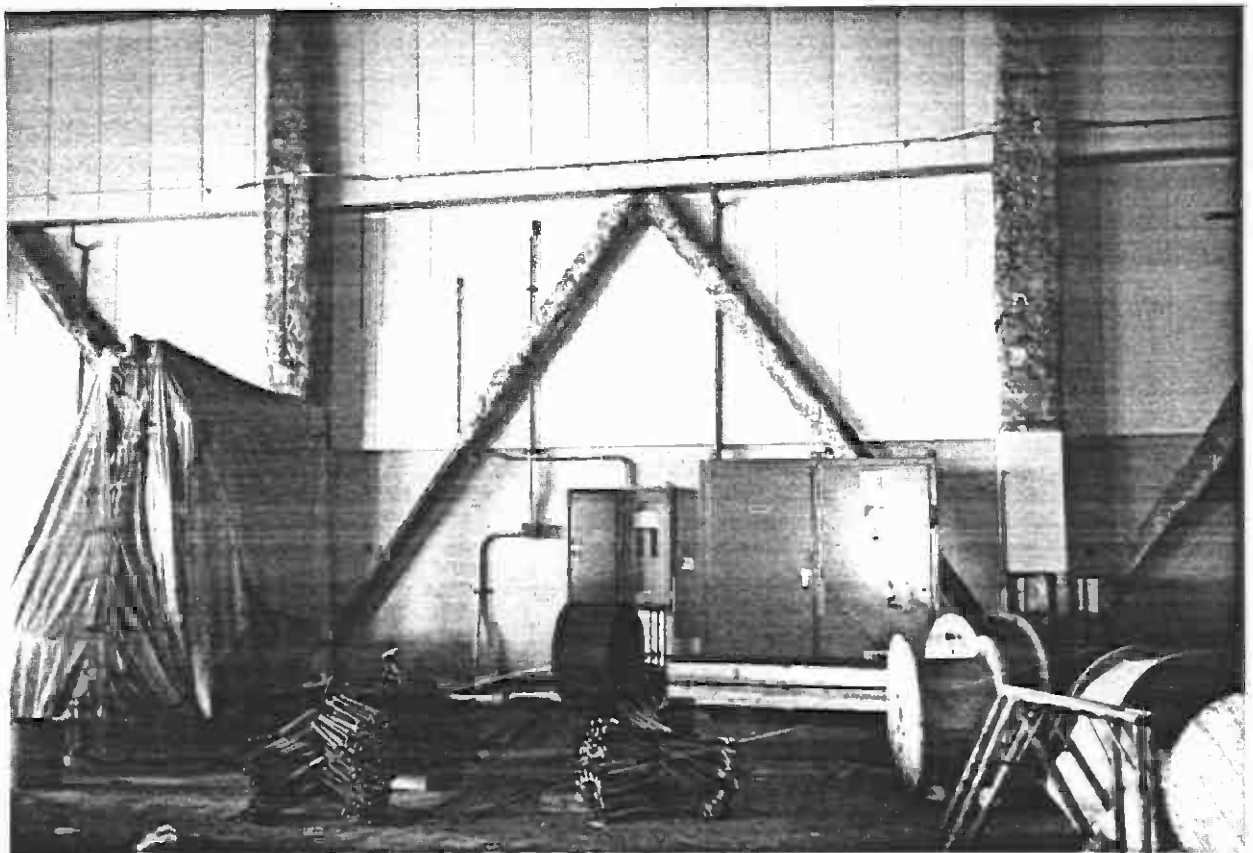
29

RM. 124- COLS. F-17 & F-18 W/ K-BRACING

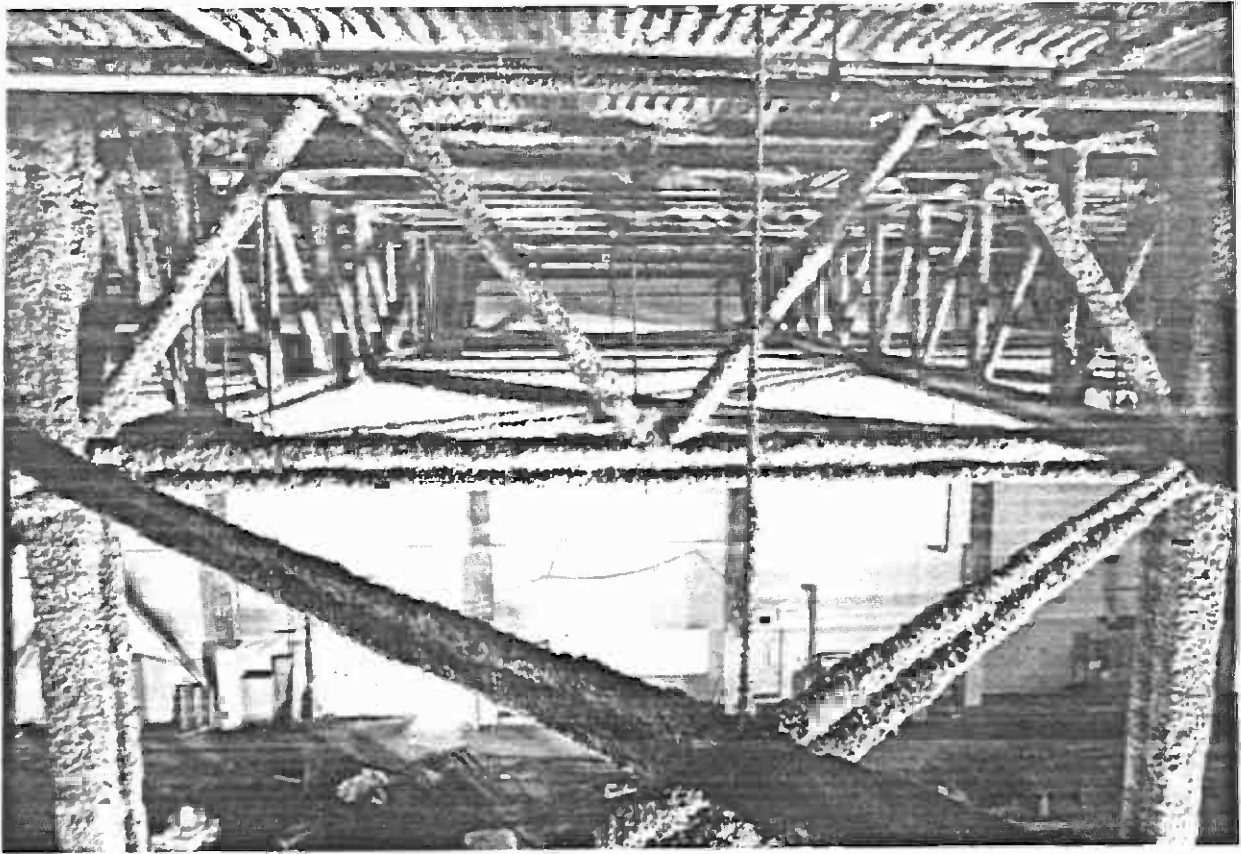
37

RM. 124- ROOF TRUSSES.

The roof deck does not require fireproofing by code because of the height above finish floor, but the trusses, bottom chord bracing and purlins do. The existing fireproofing must be sprayed with a compatible sealer. (Photos Nos. 35, 36, 37, 38, 39, 40, 41.)

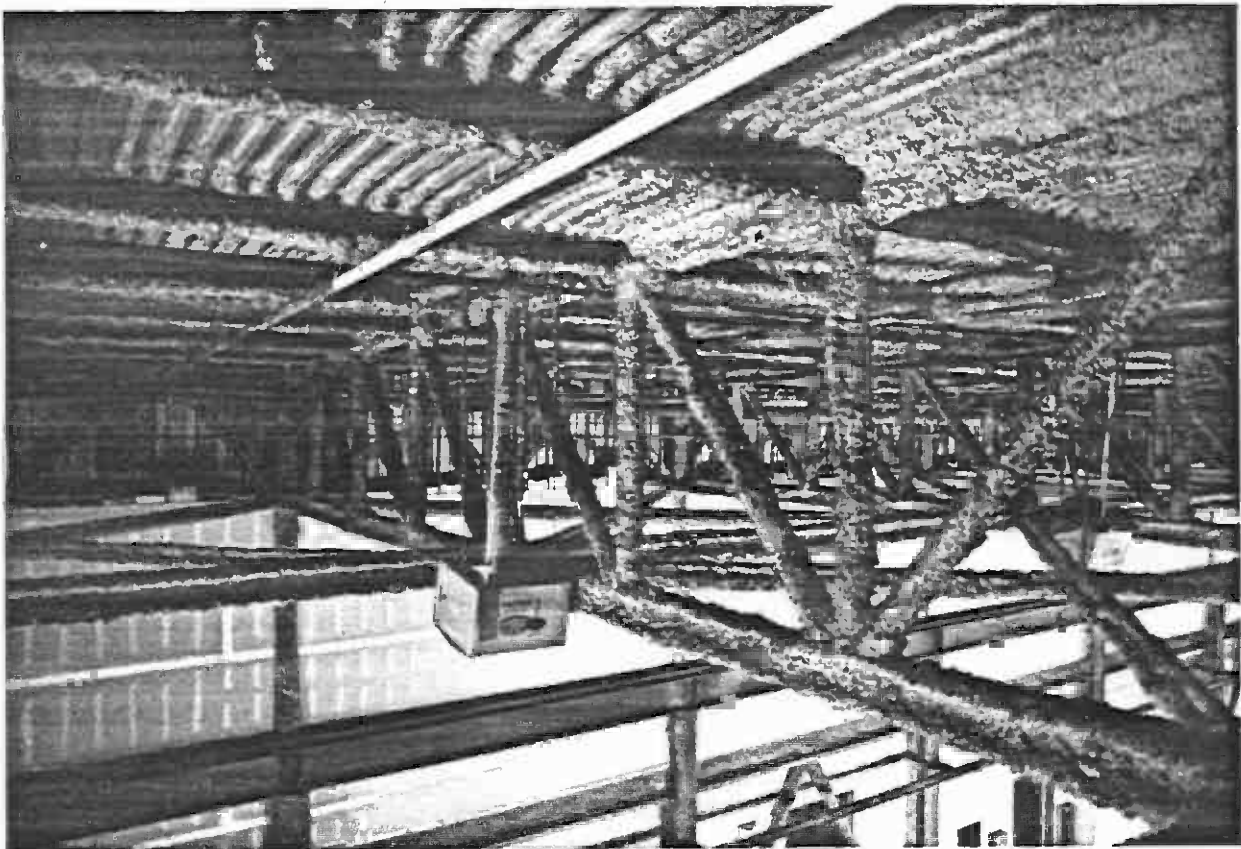
38

RM. 124- ROOF TRUSSES.
