Southern California Rapid Transit District  
Metro Rail Project

Analysis of  
Fireproofing Repairs  
to Main Shop Building  
Contract A112  
November 14, 1989

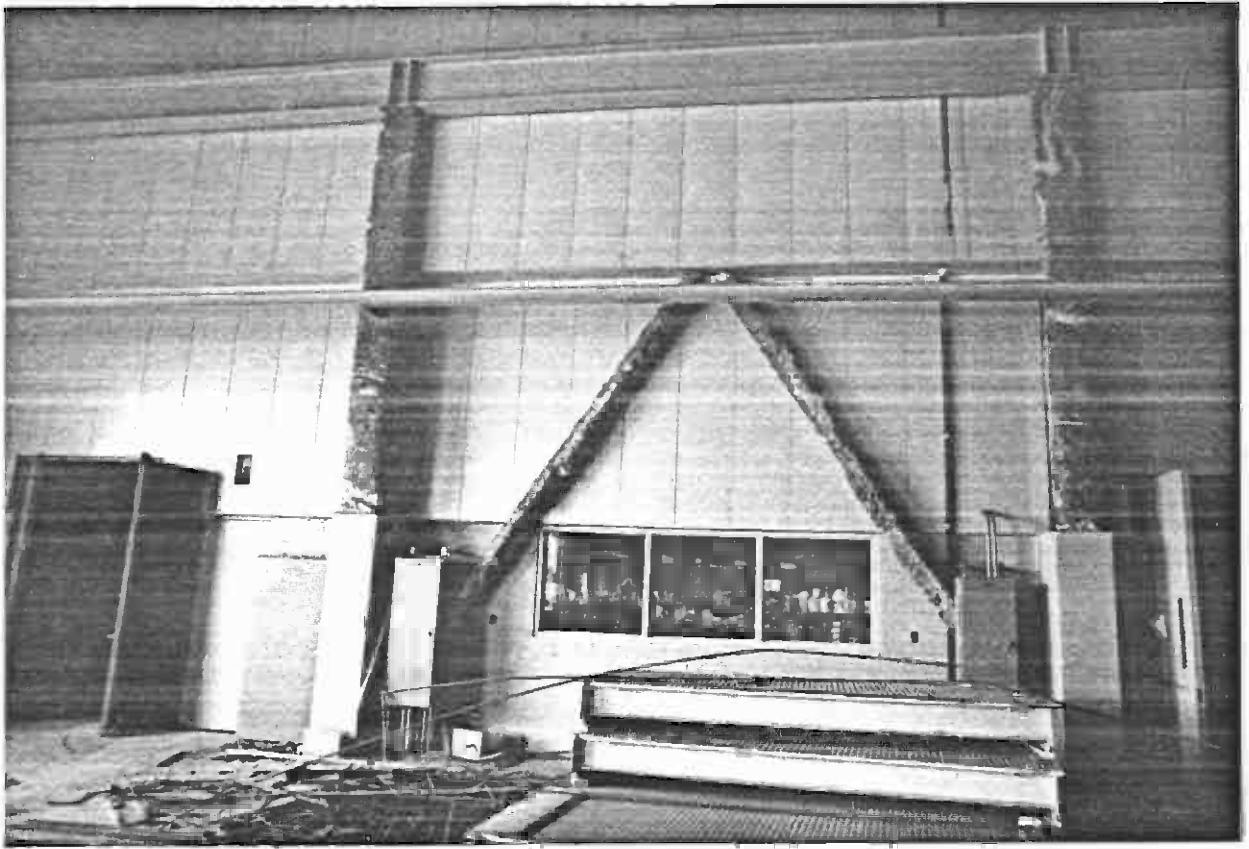
42

RM. 124- COLS. & K-BRACING AT GRIDLINE D-6 & D-7.

In Service/Inspection the K-braces on gridlines B and C must receive a new gypsum board finish, extending to 8'-0" above finish floor. Miscellaneous conduits, surface mounted light fixtures, rain water leaders and sprinkler system check valves occurring on or near K-Braces will have to be handled by enclosing or relocating the service to the new face of finish. (Repair Type III.) (Photos Nos. 42, 43, 44, 45, 46, 47, 48.)

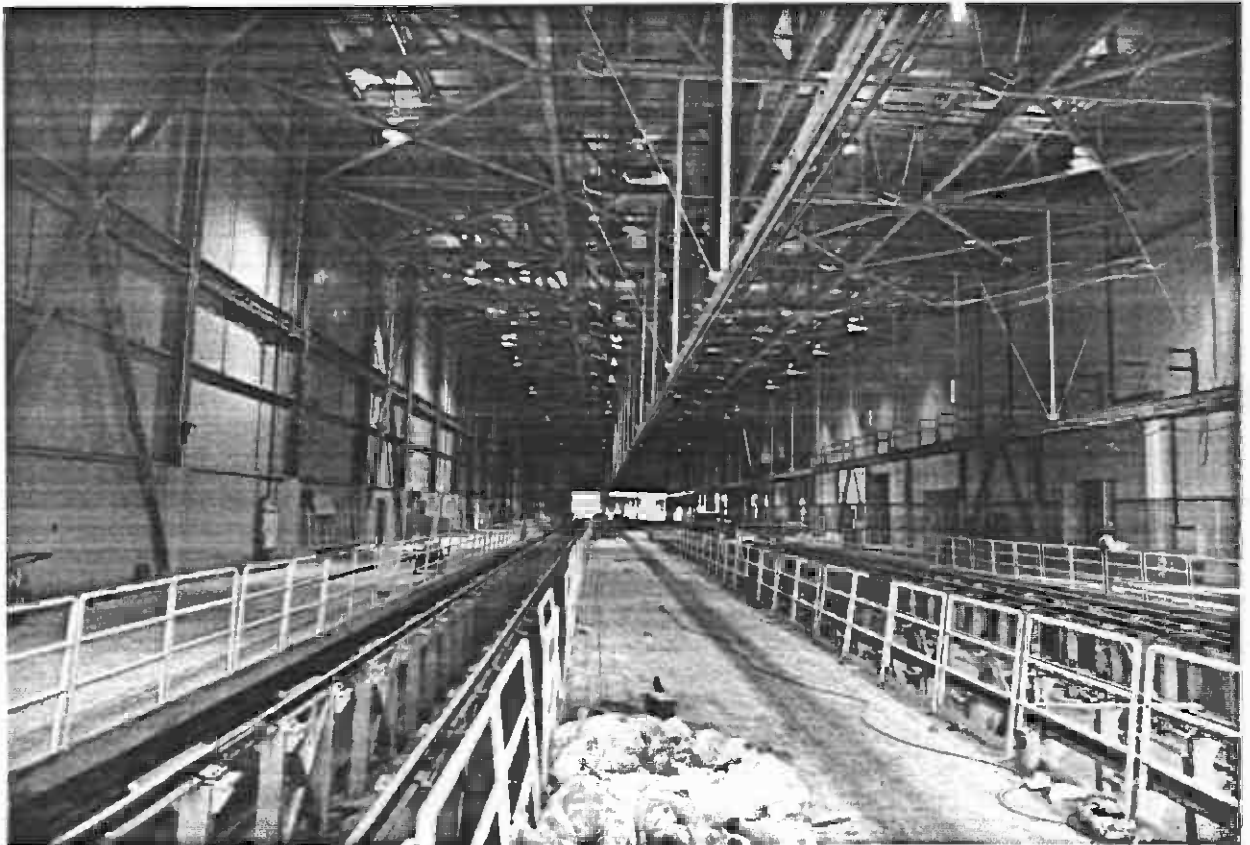
43

RM. 156

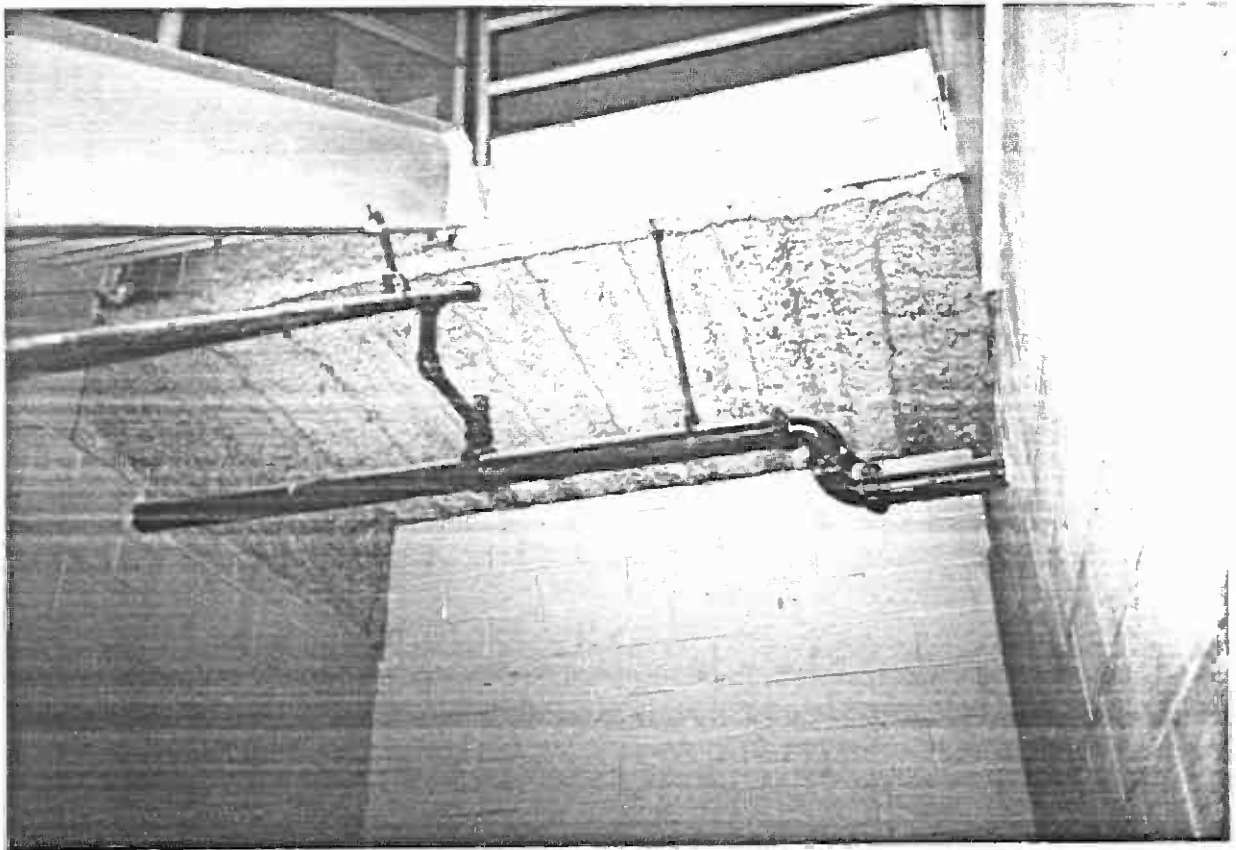
52

RM. 154- STAIR NO. 4- EXP. FIREPROOFING UNDER LANDING.

Install a gypsum board finish ceiling to the underside of floor landings. Extend fire sprinklers to the new face of finish. Where the framing is exposed at the floor openings in the stairwell, provide gypsum board finish on metal furring to protect fireproofing. (Photos Nos. 51, 52, 53.)

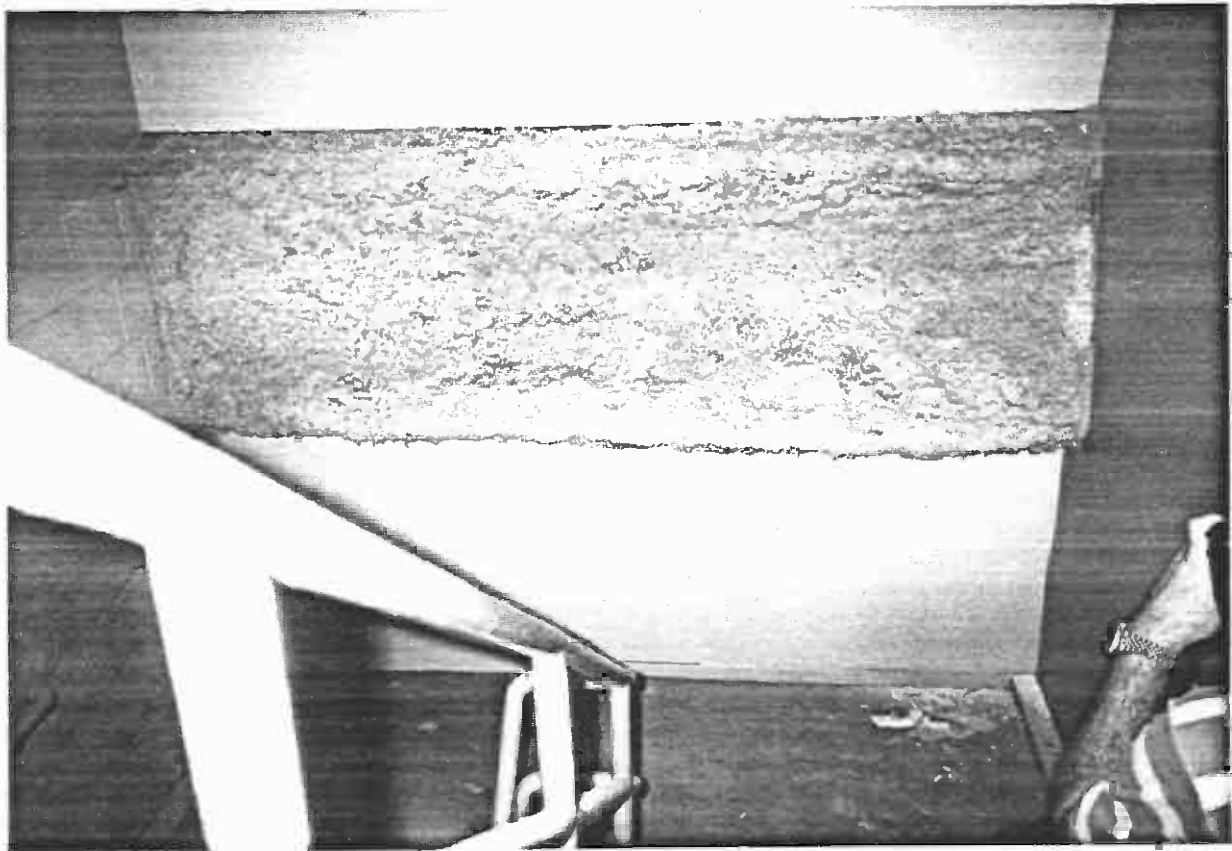
53

RM. 136- STAIR NO. 3- FIREPROOFING ON EXP. FRAMING

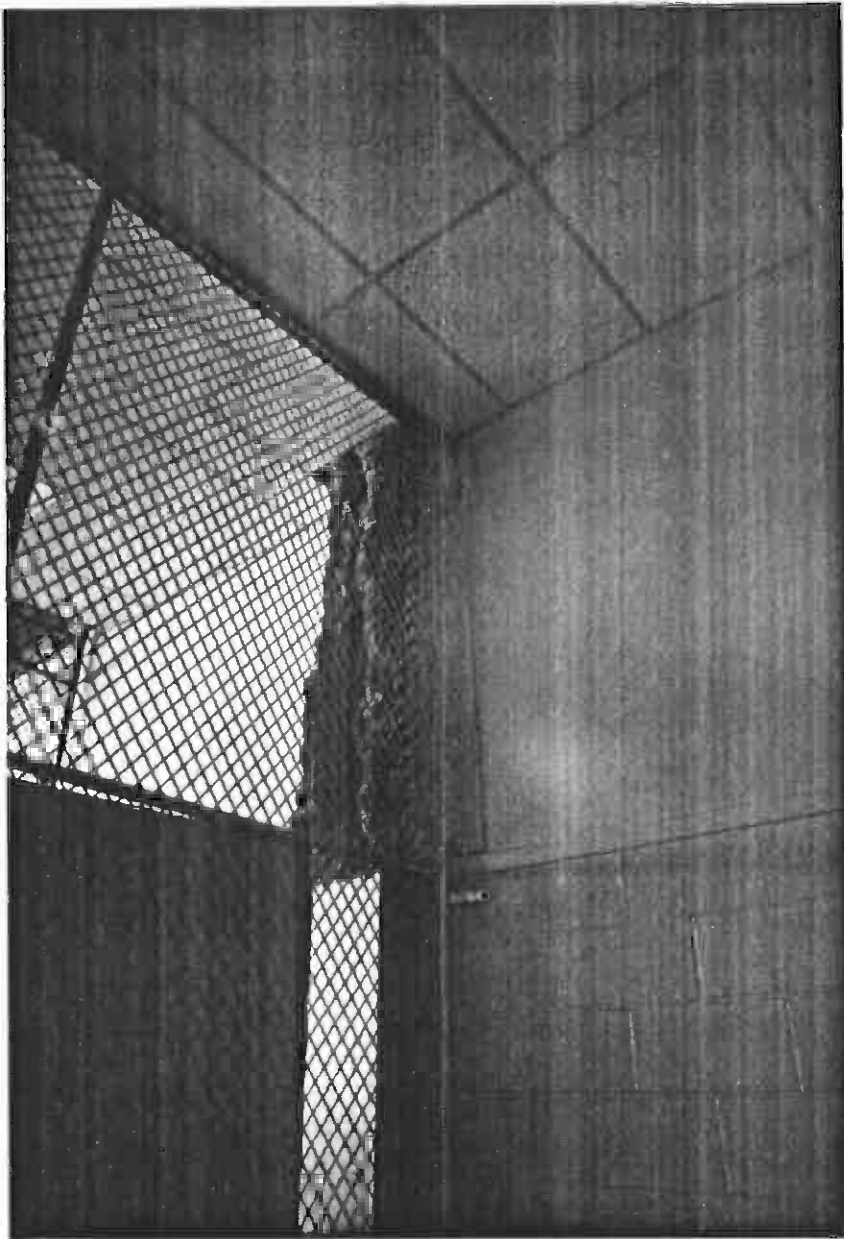
58

RM. 134- COL F.6-14 BEHIND PARTITION

above concrete encasements to steel deck above. (Repair Type IV.) (Photos Nos. 54, 55, 56, 57, 58, 65, 66, 67, 68, 69, 70, 71.)

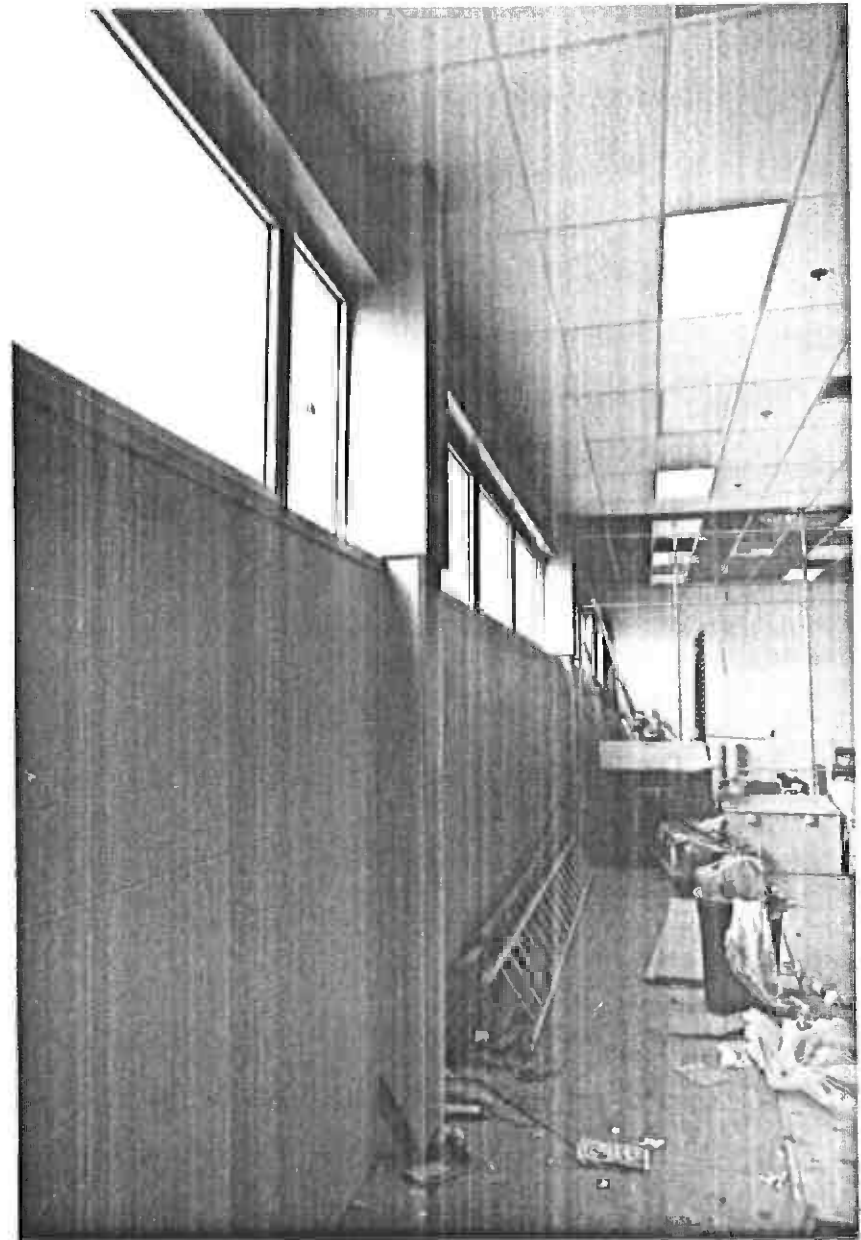
59

RM. 134- CQL G-16.

There are columns and K-bracing along gridline G in Systemwide Stores with exposed mineral fiber-type fireproofing that have been touched up with a cementitious-type fireproofing. Provide gypsum board finish on metal stud furring for columns from top of concrete encasement to steel deck above. At the K-braces provide the same gypsum board finish from finish floor to steel deck. Where columns and K-braces span across windows, the gypsum board finish shall enclose all four sides. (Repair Type II.) (Photos Nos. 59, 60, 61, 62, 63, 64.)

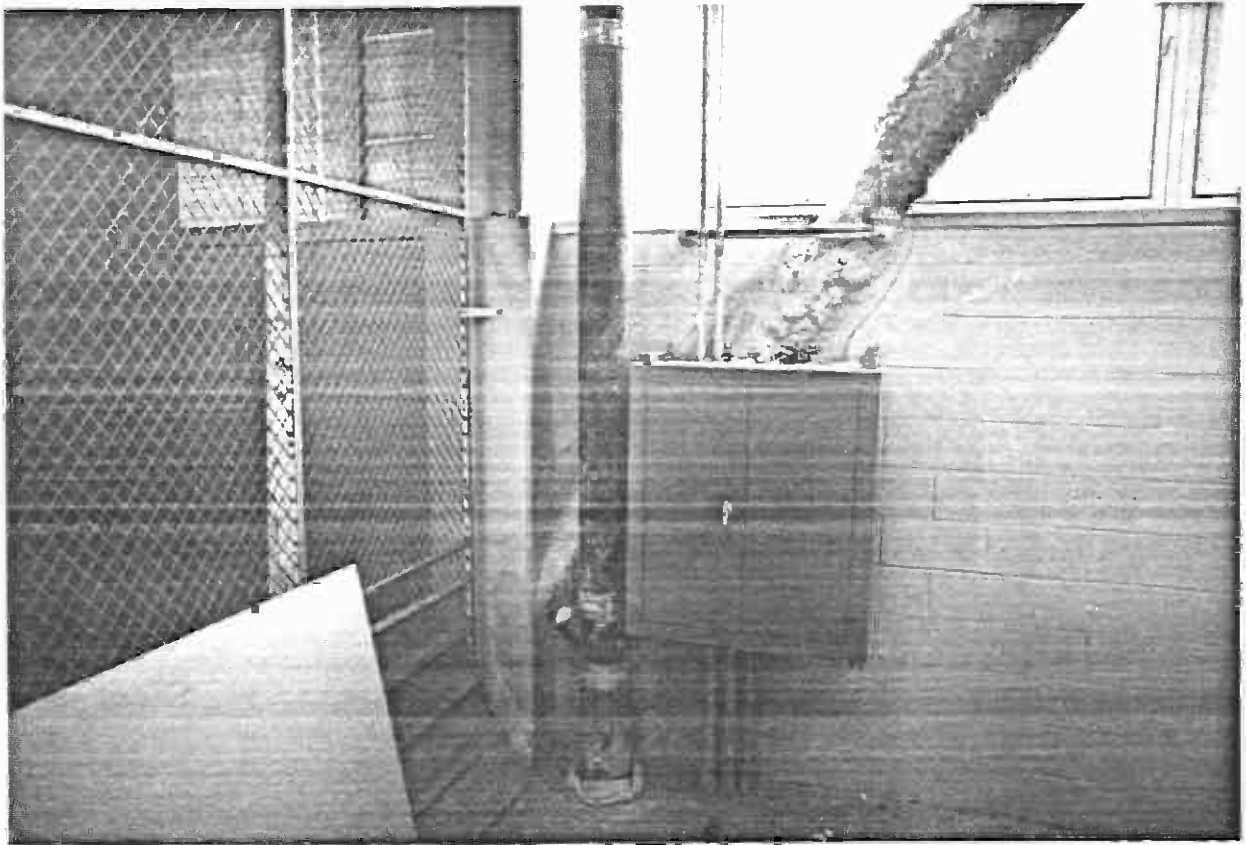
62

RM. 134- COL G-18 K-BRACING BEHIND BOX & DRAIN LINE

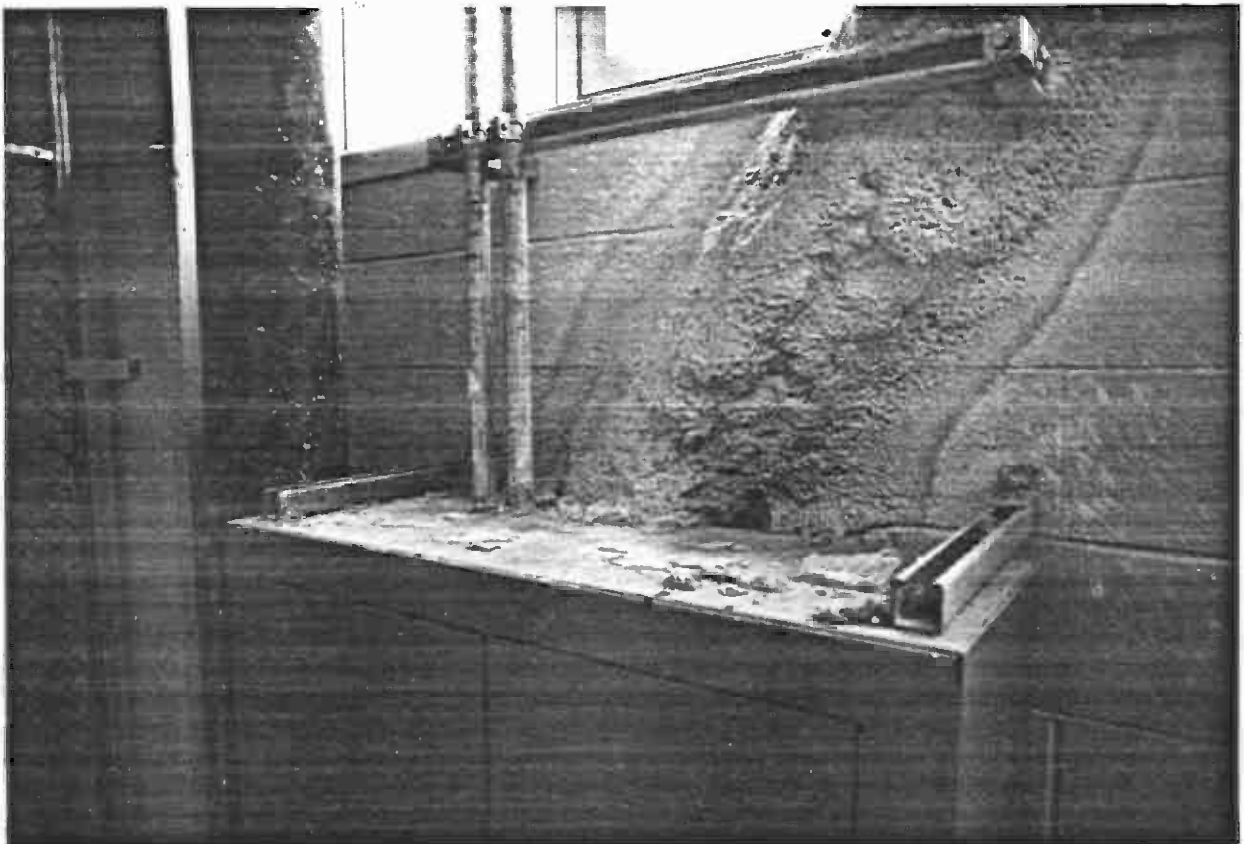
63

RM. 134- COL G-18 K-BRACING AT ELEC. PANEL BOX

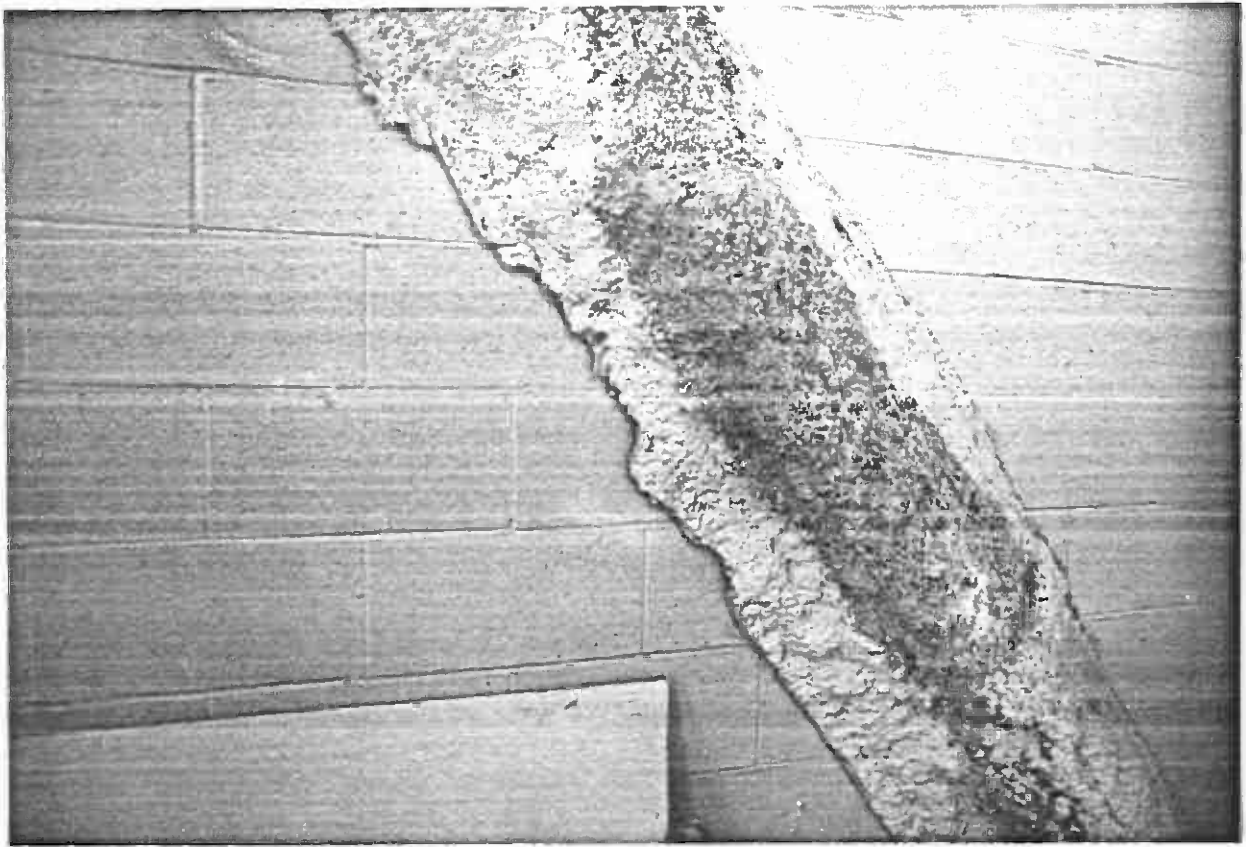
64

RM. 134- K-BRACING AT G-18 W/ MONOKOTE PATCHING

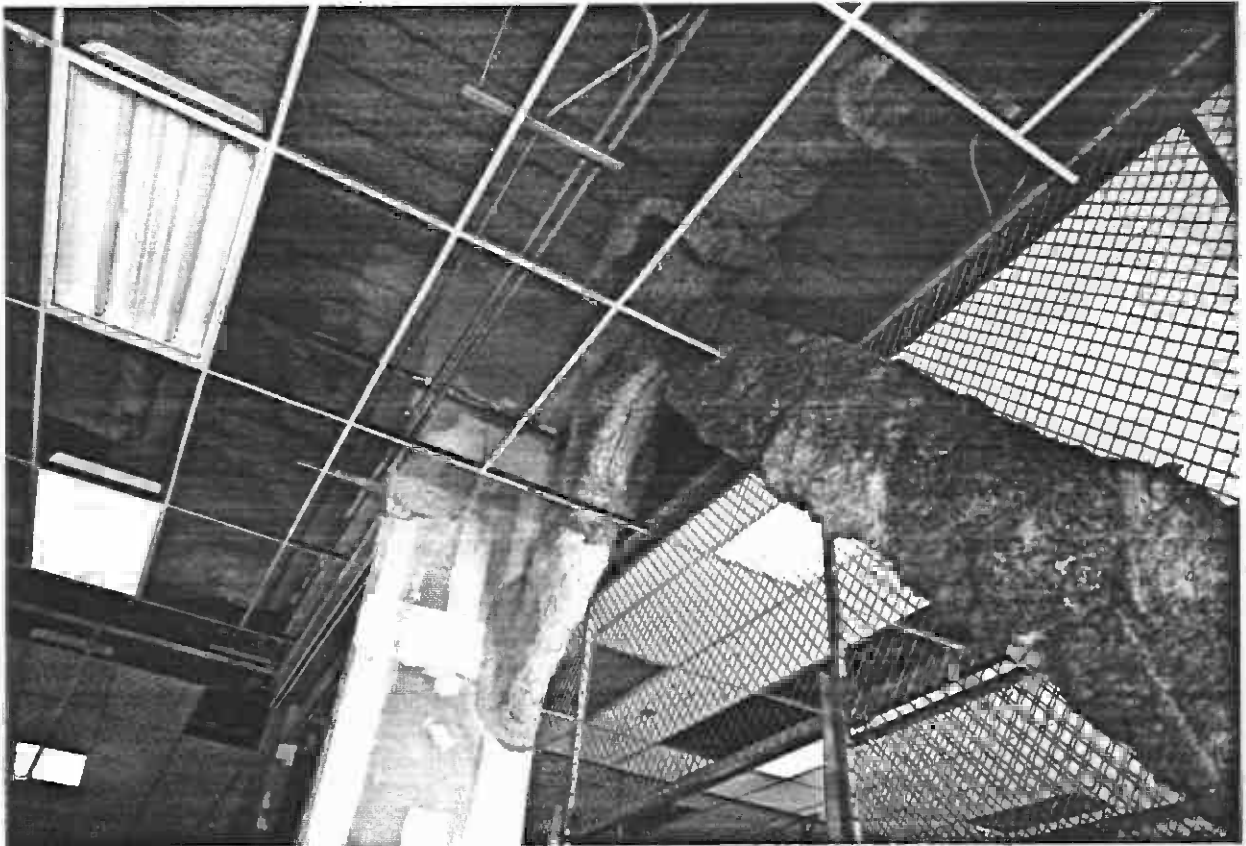
65

RM. 134- COL & K-BRACING AT F.6-19.

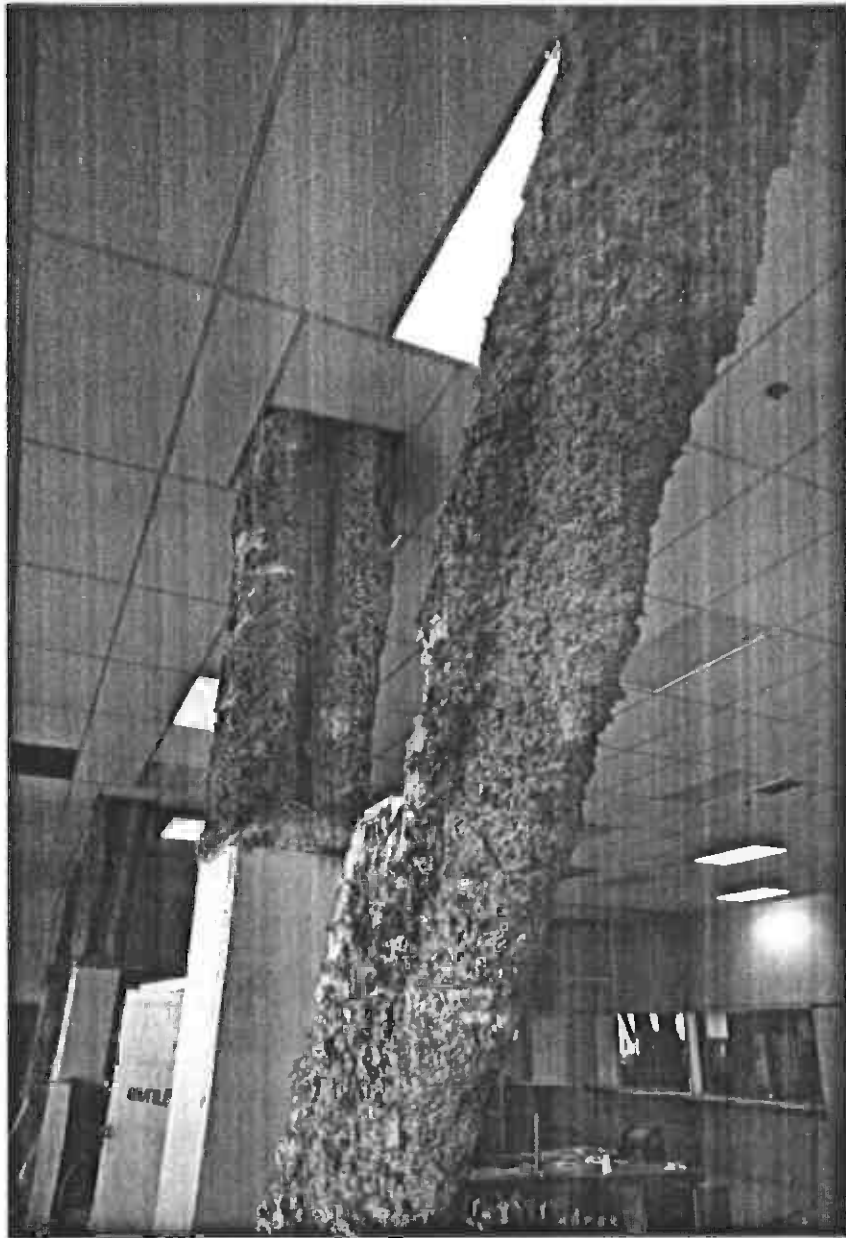
70

RM. 134- COL F.6-16 W/ BRACING

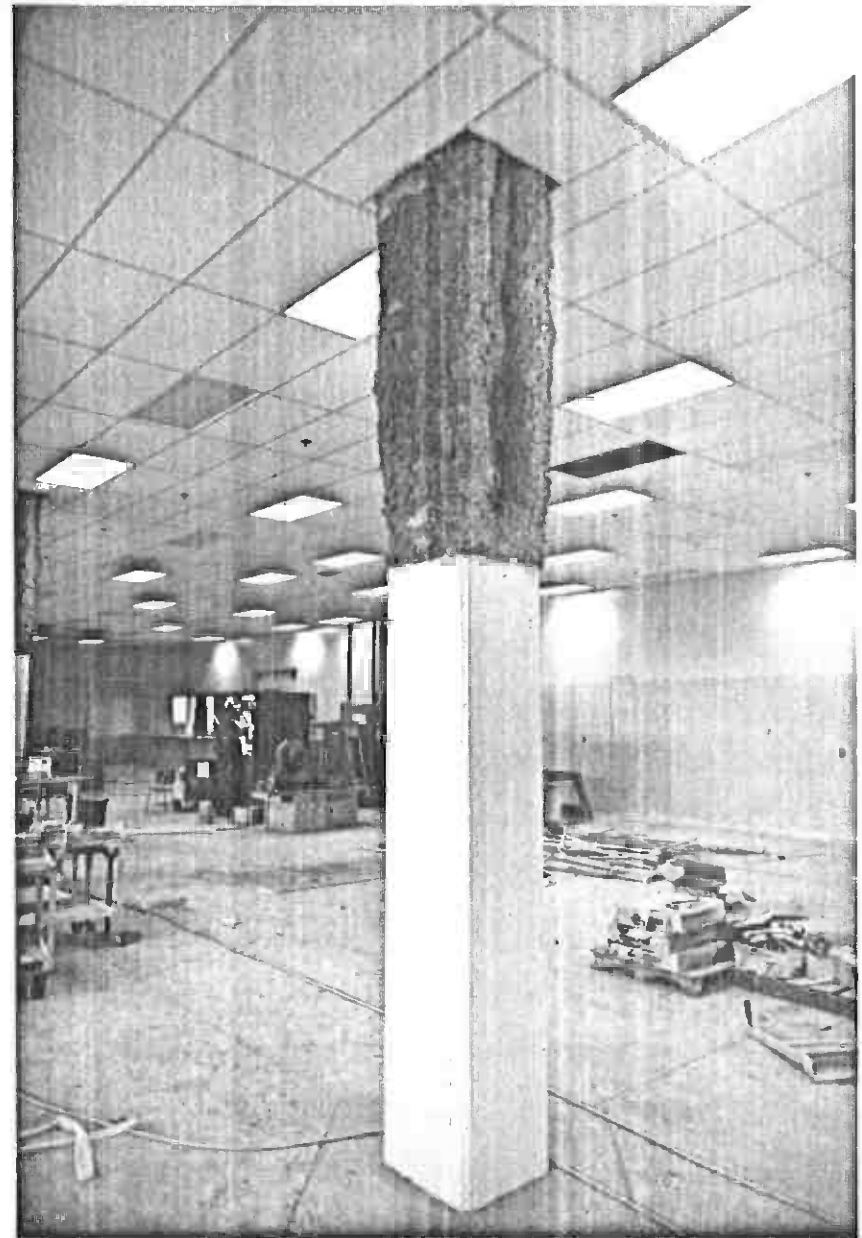
71

RM. 134- COL F.6-18
