<b>Date</b>	March 3, 2011
<b>To</b>	Greg Angelo – Director of Real Property Management and Development
<b>From</b>	Chip Hazen – ADA Compliance Officer
<b>Subject</b>	ADA Evaluation of Union Station

On February 28, 2011, I completed a quick walk through of Union Station. Observed were the common general public areas such as the tunnels to the track platforms, rest room lobby area, Amtrak lobby area, the two outside patios, and the parking lot. From the observations, the ADA issues fall in three categories: safety, physical accommodations, and signage.

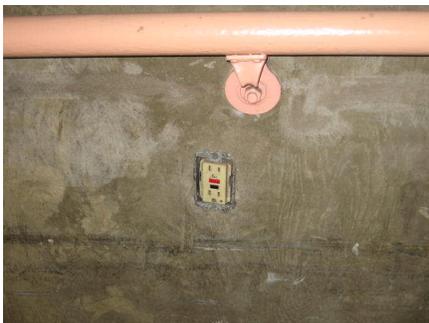
On the ramp leading to Tracks 11 and 12, the cover for the electrical outlet is missing. This could pose a safety hazard for persons with vision impairments, riders in wheelchairs, and small kids.

No cover on electrical outlet on ramp serving Tracks 11 and 12.

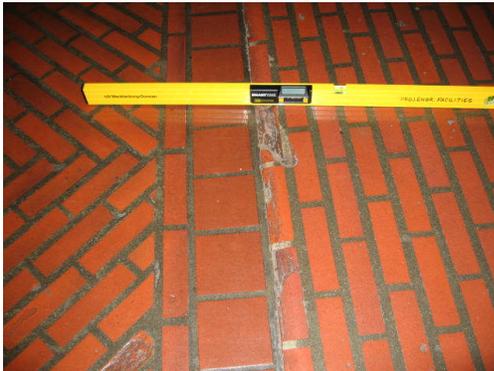
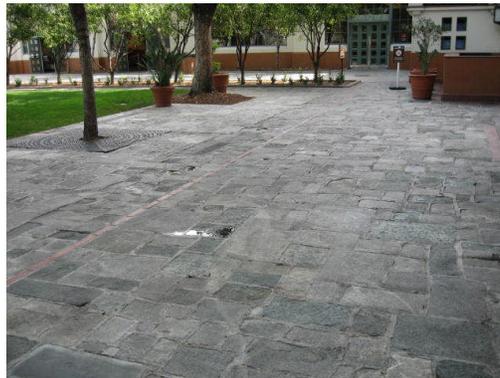
Various locations of the floors have cracks and are missing material. The outside patio on the north side of the Station has an uneven surface, which makes it difficult for a wheelchair to roll over and poses a tripping hazard for a person with vision impairments. Many of these tripping hazards are deeper than the one-half inch allowable under the ADAAG requirements. Many have been patched over the past six months with some of the patches coming loose.

Tripping hazard on the south side walkway    Uneven floor in the patio

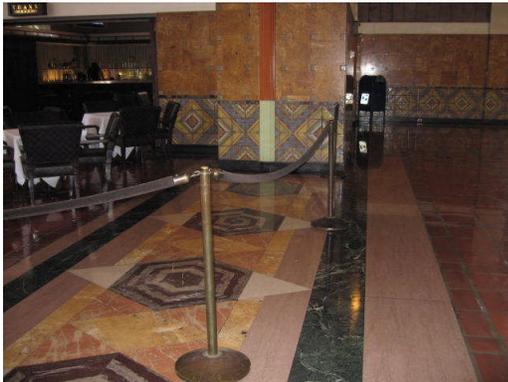
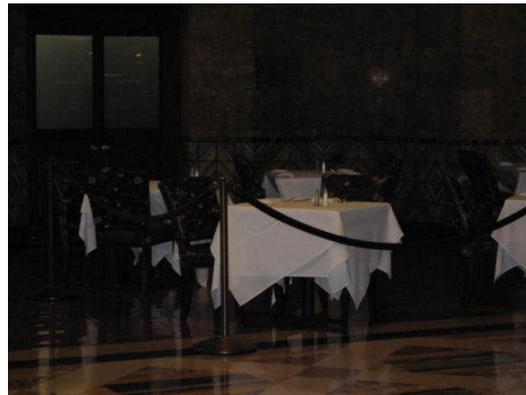
The restaurant, Taxis, uses a temporary barrier to outline its service area. ADAAG requires that two straps be provided with the lower strap at or below 27". This allows a cane to hit the strap instead of the individual hitting the strap.

Barrier outlining the dining tables with only one strap instead of two, as required.

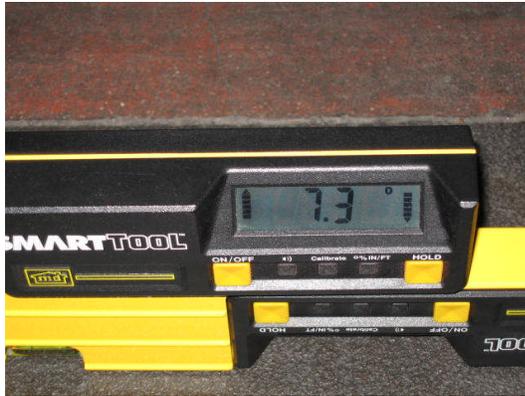
The ramps to the tracks on the north side of the tunnel have slopes ranging from 7.3% to 7.6%, which is within the ADA required slope maximum of 8.33%. However, there are no resting areas along the ramp (the ADAAG requires one every 30' to 40'), and the handrails do not comply with the ADAAG requirements.

North ramps are within the 8.33% slope.

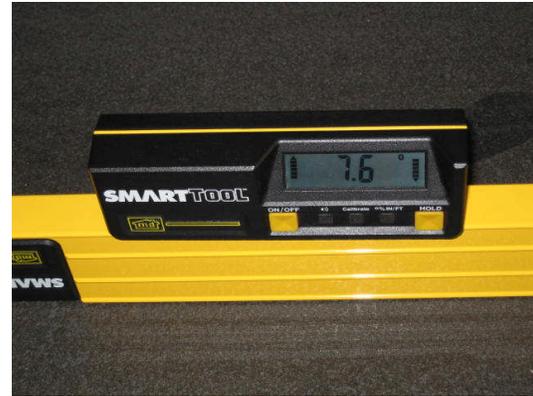
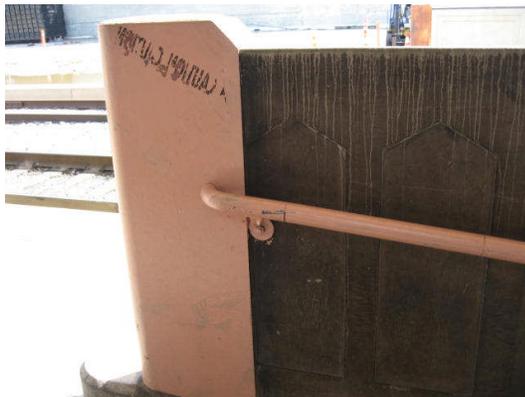
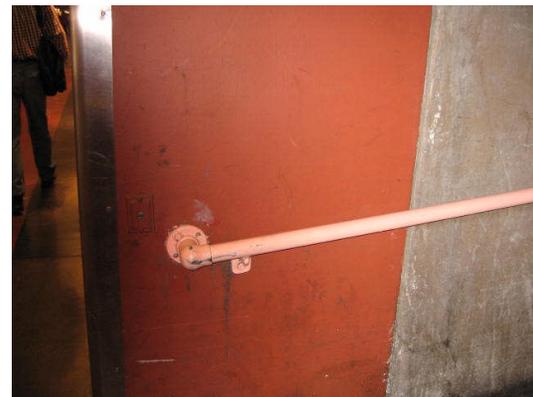
Handrails do not extend beyond the top of the ramp and does not extend at the bottom of the ramp.

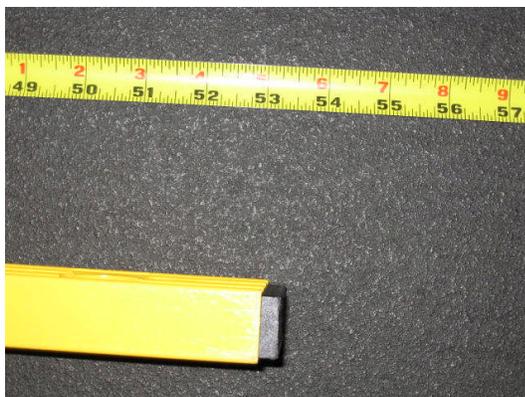
Ramps on the south side of the tunnel are within the ADAAG requirements for slope percentage ranging from 4.6% to 6.1%. However, the hand rails at the top of the ramp do not extend a minimum of one foot beyond the end of the ramp and the length of the landings are 53" instead of the required 60".

Measurement indicating that the resting landing is less than the required 60".

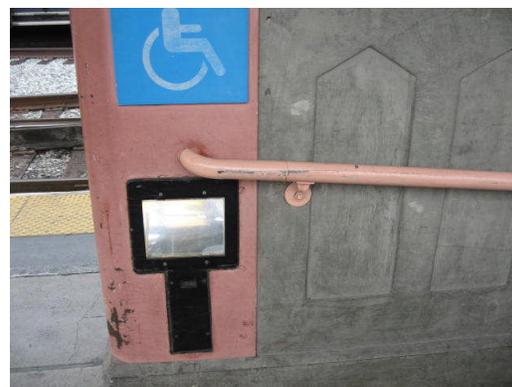
Handrails are required to extend a minimum of twelve inches (12") past the end of the slope and parallel with the ground.

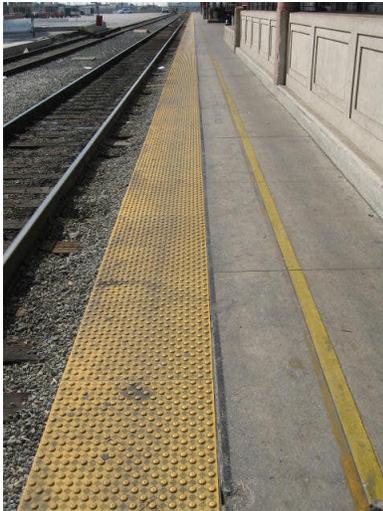
All of the platforms have a similar width. Some platforms have islands with equipment in the middle; but, all platforms have the minimum travel pathway of 36" (as required by the FTA Rules and Regulations) along the edge of the platform that is free of obstacles. The platform used by Amtrak, Tracks 11 and 12, have truncated domes all the way to the edge of the platform as required; however, the truncated domes are not maintained. All are dirty and the yellow domes could blend into the edge of the platform for persons with vision impairments.

Truncated domes in places do not offer the required 70% contrast between the domes and the edge of the platform.

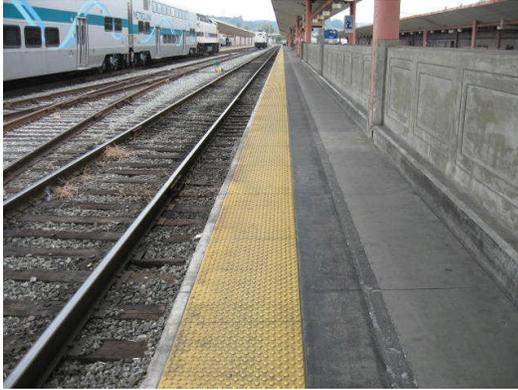
The other platforms, which are used by Metrolink, have a two inch gap between the truncated domes and the edge of the platform. The ADA requires the following:

810.5.2 Detectable Warnings. Platform boarding edges not protected by platform screens or guards shall have detectable warnings complying with 705 along the full length of the public use area of the platform.

705.2 Platform Edges. Detectable warning surfaces at platform boarding edges shall be 24 inches (610 mm) wide and shall extend the full length of the public use areas of the platform.

Platform with 2” gap between the truncated domes and the “edge” of the platform.

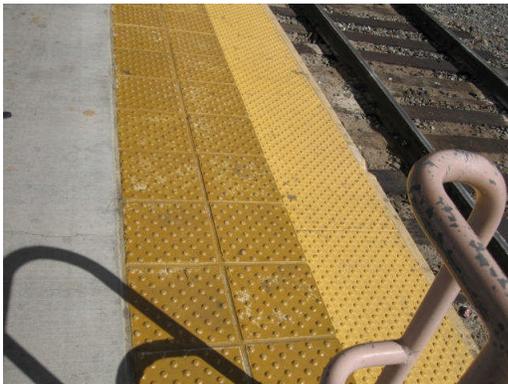
The color of the truncated domes is a State of California requirement. The color that all California transportation agencies must conform to is Federal Color No. 33538 of Standard No. 595B. The high platform loading area uses a different color truncated dome than is the standard. The contrast between the two colors can be seen in the following pictures.

Color difference

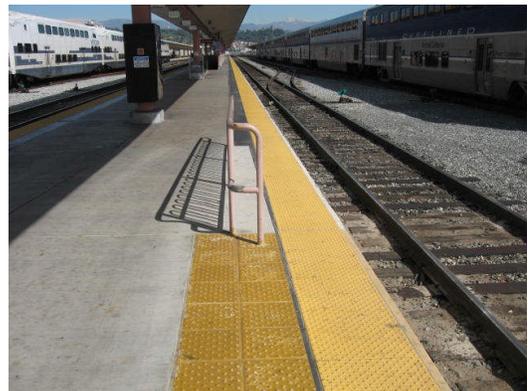
Different perspective showing the color difference

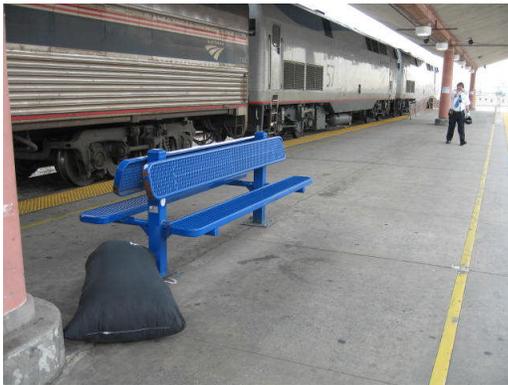
None of the benches on the platform that serves Tracks 11 and 12 or the seating inside of the Union Station waiting area complies with the ADA requirement for benches. Five percent of seating, if it is provided, must meet the ADA requirements. Since seating is provided, at least one seat on the platform and two or three seats in the waiting area must meet the ADA requirements. The requirement is as follows:

Bench on platform that does not meet the ADAAG requirements.

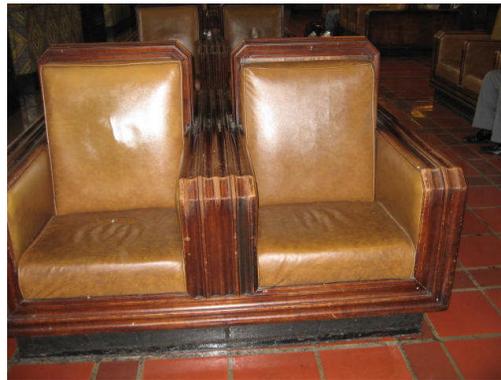
Seats in Union Station that do not meet the ADAAG requirements.

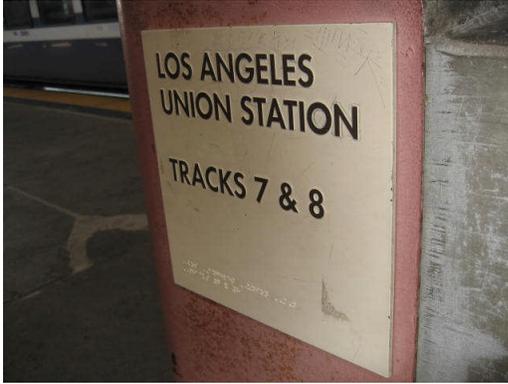
Signage is a major issue at Union Station. Since the signs were installed in the 90's, the requirements have changed, but the signs have not been changed. The picture below meets the tactile requirement for signs, but the Braille is to be 3/8" under the letters. The sign is also too low for someone to read the Braille. The sign is required to be at 60" to the top of the highest tactile letter, this sign is below waist high level.

Platform sign at the top of the ramp with Braille too far below the sign and the sign posted too low.

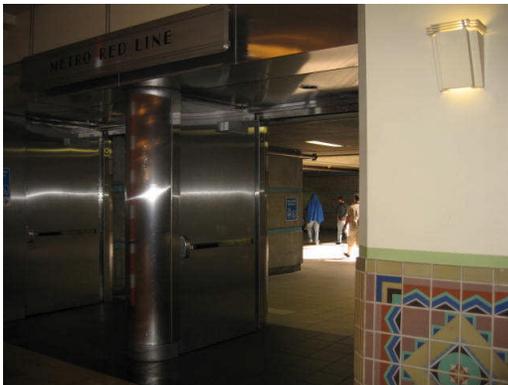
Another signage issue is Metro's lack of a Braille/Tactile station identification sign at the entrance to the Subway. Metro has attempted to install a sign at this entrance, but the owners have rejected all requests stating that there was no sign in the 1930's; therefore, a sign cannot be put at this location.

Lack of signage on the right side of the entrance to Subway.

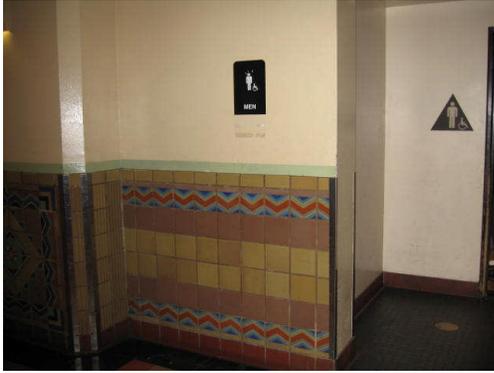
Signage at rest rooms are higher than allowable. The rest room sign was recently installed following renovation of the rest rooms. The sign is two inches higher than allowed under the ADAAG requirements.

The inside sign is compliant, but the outside sign is two inches higher than allowed.

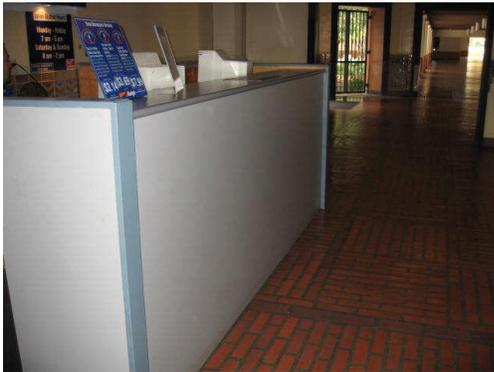
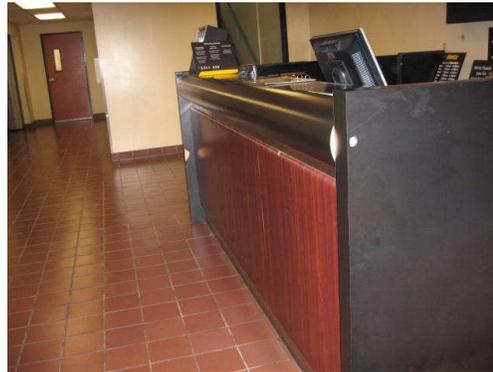
The counters at the car rental booths are too high for someone in a wheelchair. The required height for the counter is 36" with space under the counter for the legs of a person who uses a wheelchair.

Counters are too high at the car rental booths.

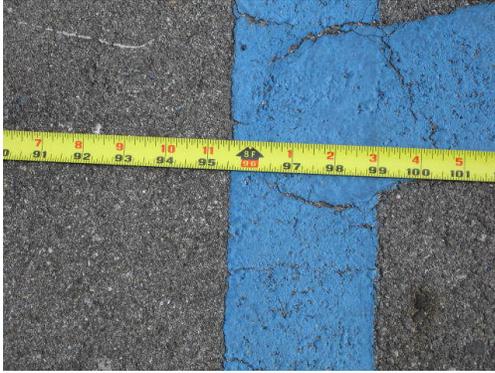
The parking lot has three disabled spaces with one space designated for vans, as required by both state and federal standards. However, one of the parking stalls (number 49) is 8' wide, both state and federal requirements call for the space to be 9' wide. Additionally, a warning rail was installed, but the curb on the ramp could be a tripping hazard for someone crossing the roadway at this non-designated location. Lastly, the sidewalk is required to be concrete, not asphalt. Asphalt does not allow groves that are required as a warning to persons with vision impairments and can be slippery when wet. Concrete requires a certain level of slip resistant that cannot be maintained in asphalt. Lastly, the sidewalk from vehicles to the facility has many obstacles, which can be seen in the pictures on the next page.

Parking stall is 8' wide; 9' is required

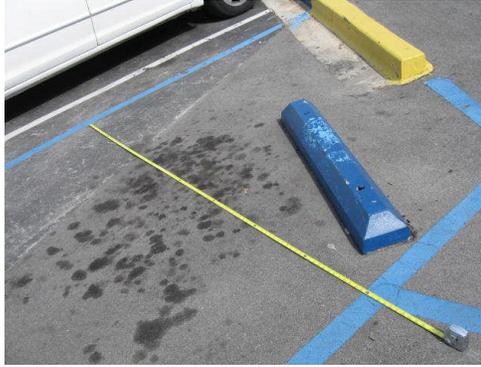
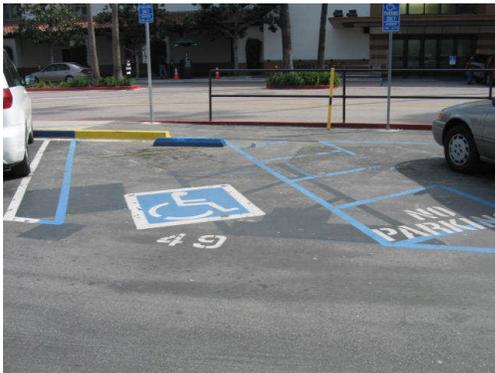
Space 49 is 8' wide.

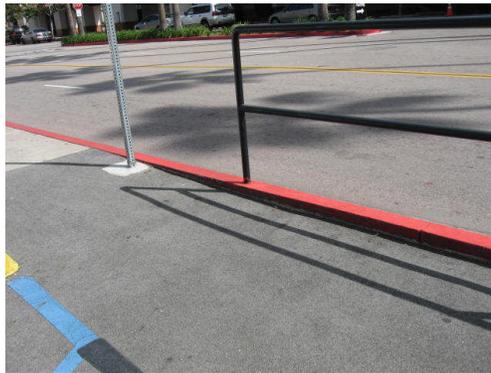
The ramp to the parking spaces does not meet the ADAAG requirements for a stable surface.

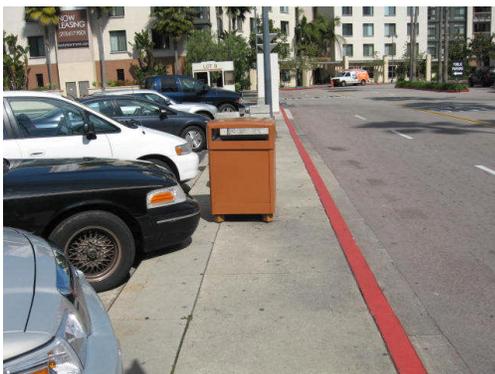
Sidewalk is blocked by trash cans and other obstacles.

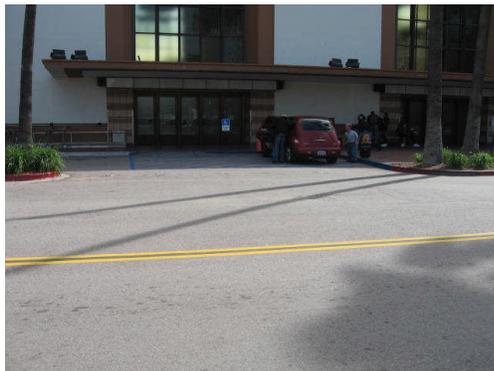
In 2003 the Federal Transit Administration made a finding that Union Station provided designated drop-off locations for the general public but not for persons with disabilities, as required by both state and federal accessibility requirements. Therefore, Union Station developed an area for dropping off persons with disabilities; however, that area does not conform to the ADA specifications, which are as follows:

Long shot of disabled drop-off zone

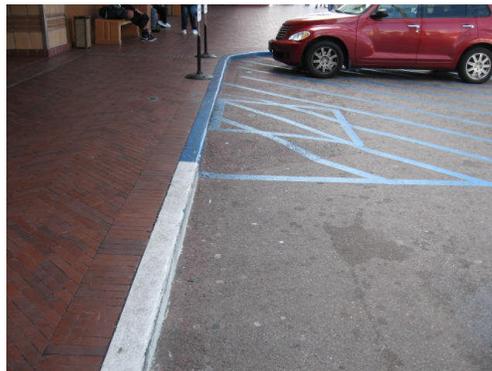
The ramp must be made of concrete, cannot be part of the loading zone, and ramp is not long enough, and there is no space for parallel parking

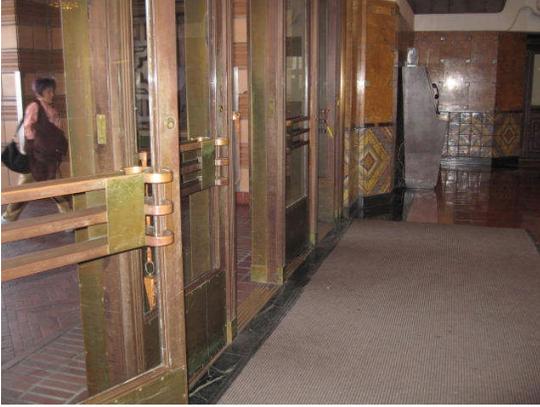
Doors leading into the Station are too heavy. The pressure to open the doors cannot exceed 5 pounds, as required. These doors require more than 20 pounds of pressure to open from the outside and more pressure from the inside.

Doors are currently blocked open, except when the blocks are removed as is the case for two of the four doors shown in this picture.
