## PROPERTY CONDITION ASSESSMENT

# PROJECT SANTA FE LOS ANGELES UNION STATION

800 North Alameda Street  
Los Angeles, California

Draft: November 12, 2010

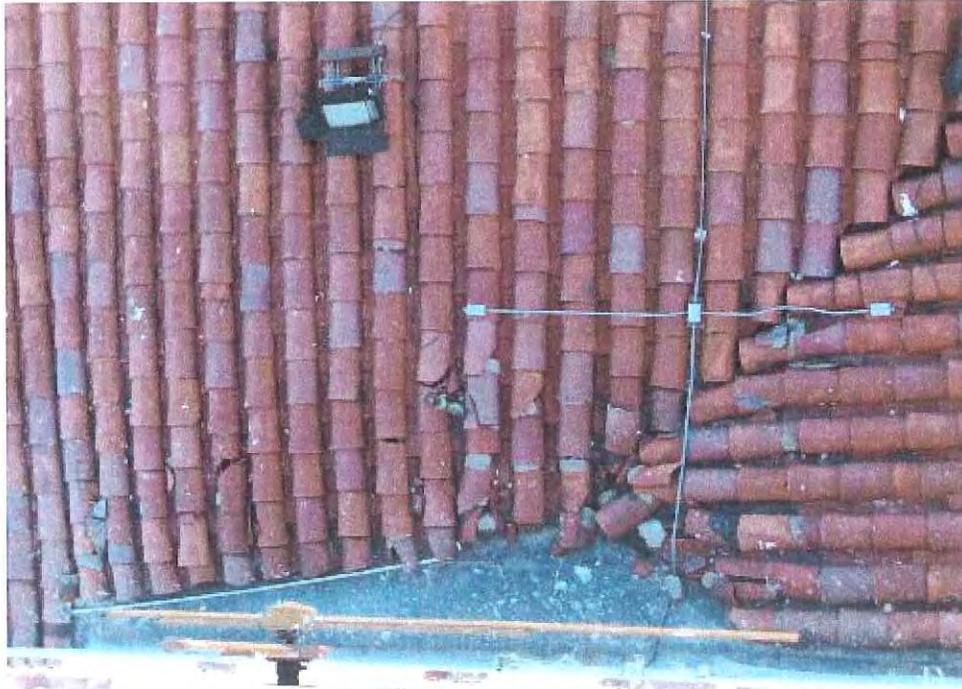
Photo #2 – Typical broken tile at base of North side of clock tower.

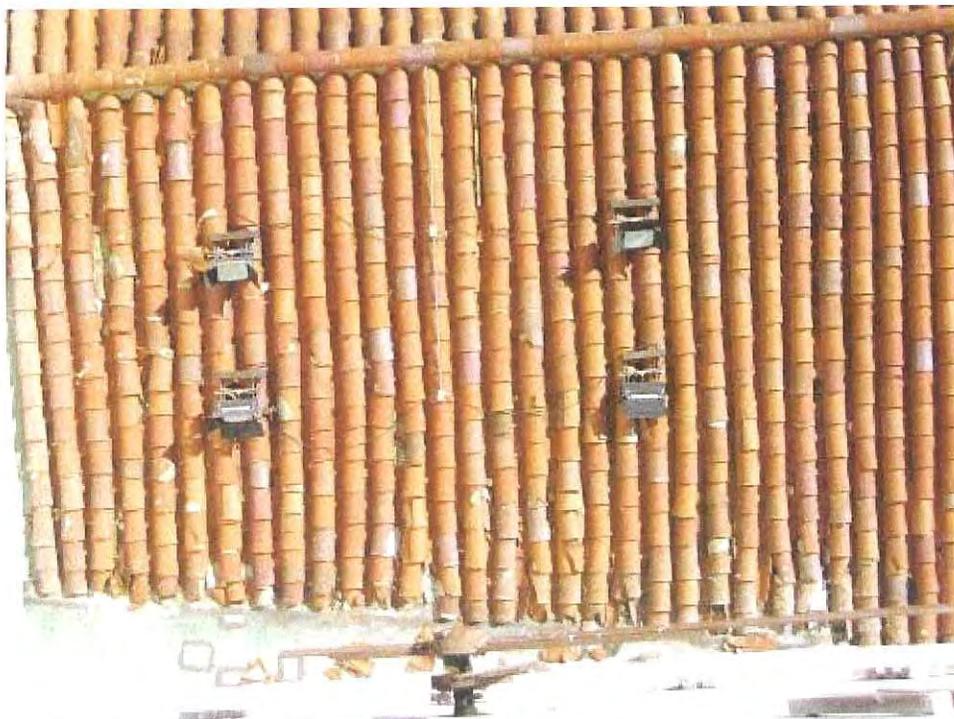
Photo #4 – Typical broken tile at base of East side of clock tower.

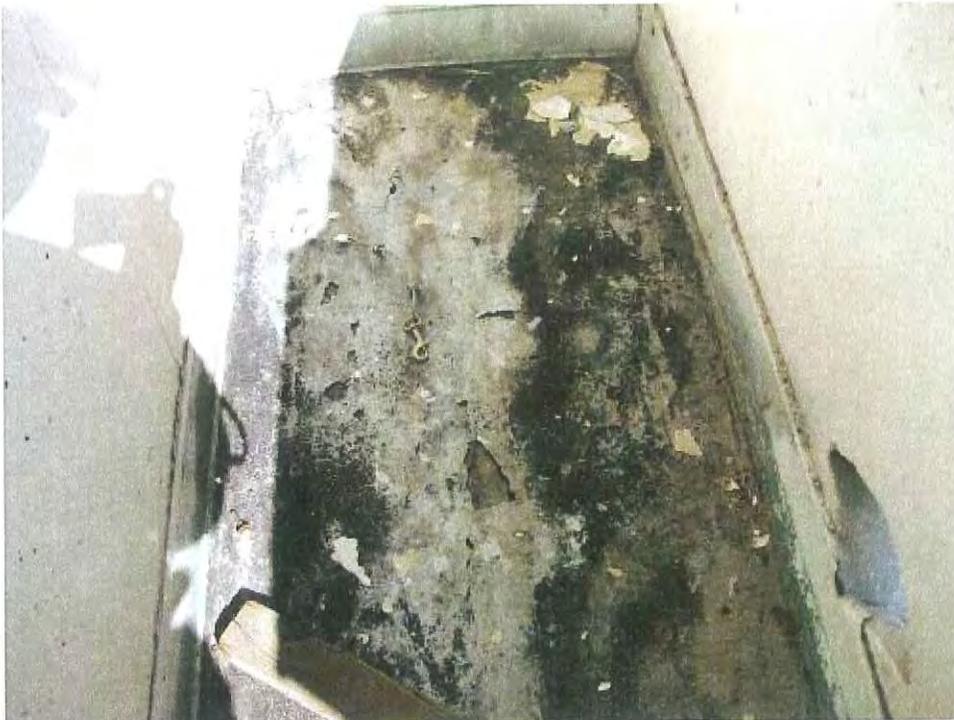
Photo #5 – Deteriorated roofing at East clock tower well.

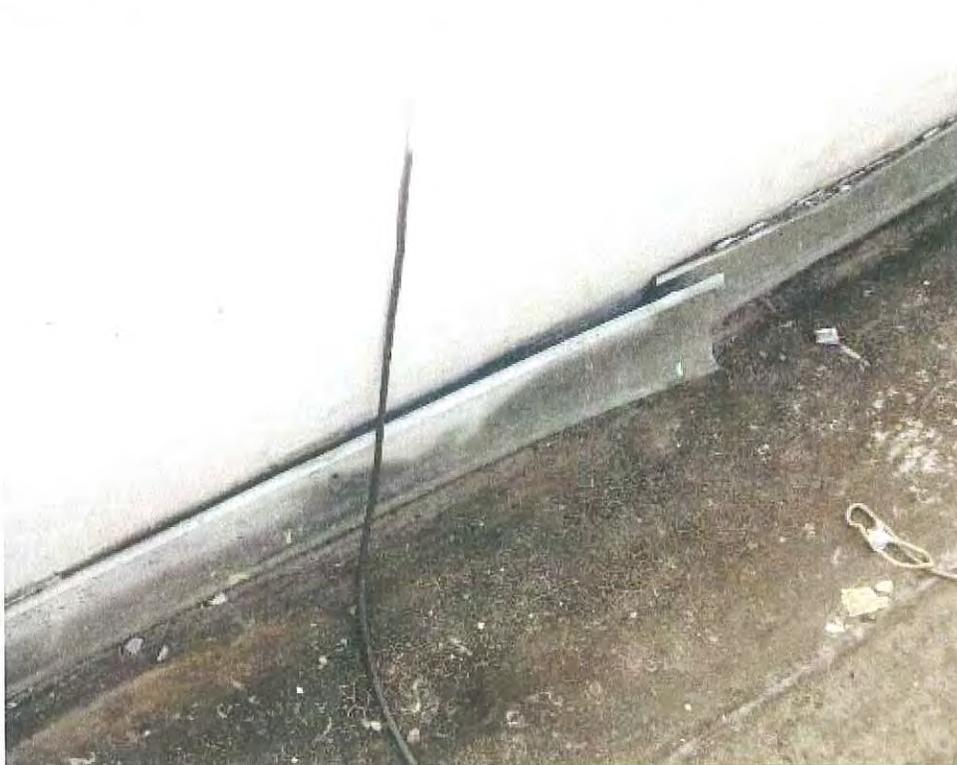
Photo #6 – Loose counterflashing at South clock tower well.

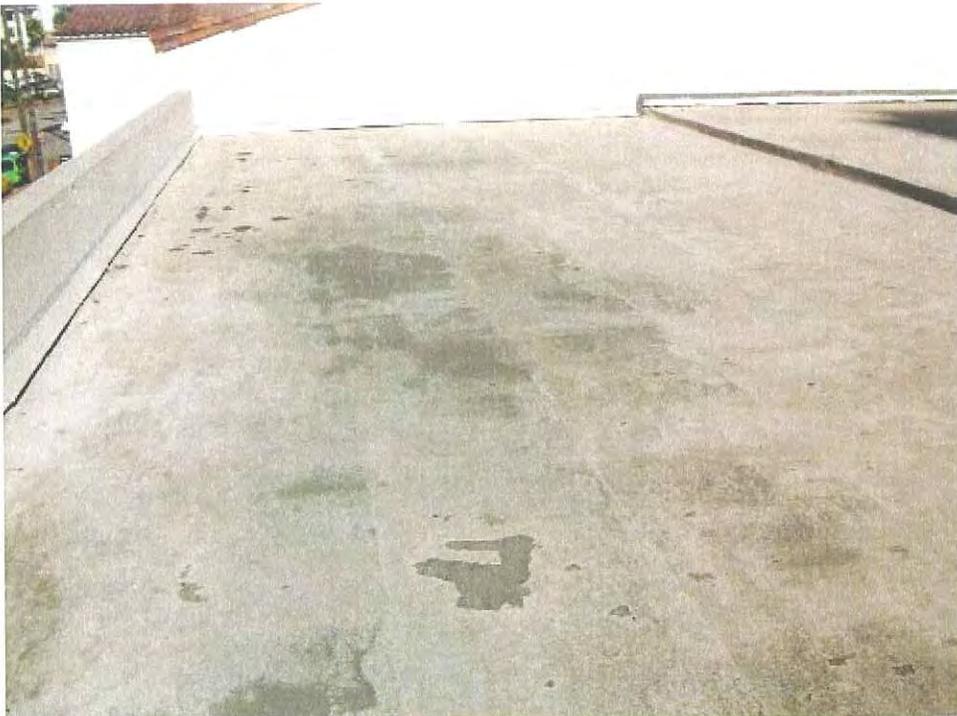
Photo #7 - General overview of South built-up roof leak area.

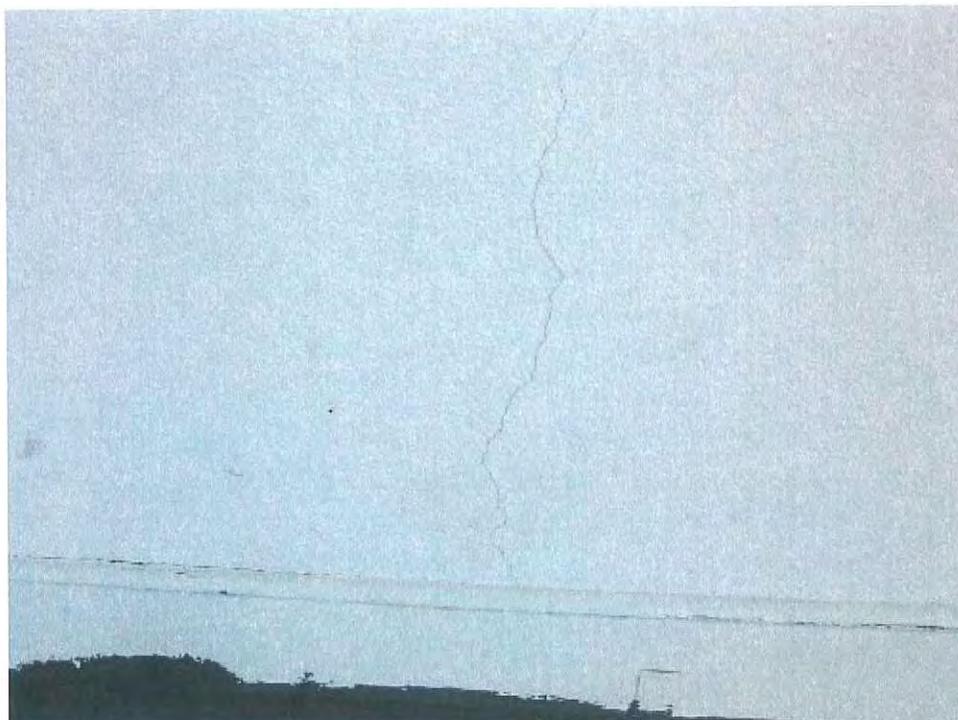
Photo #3 – Typical crack in stucco at inside wall above counterflashing.

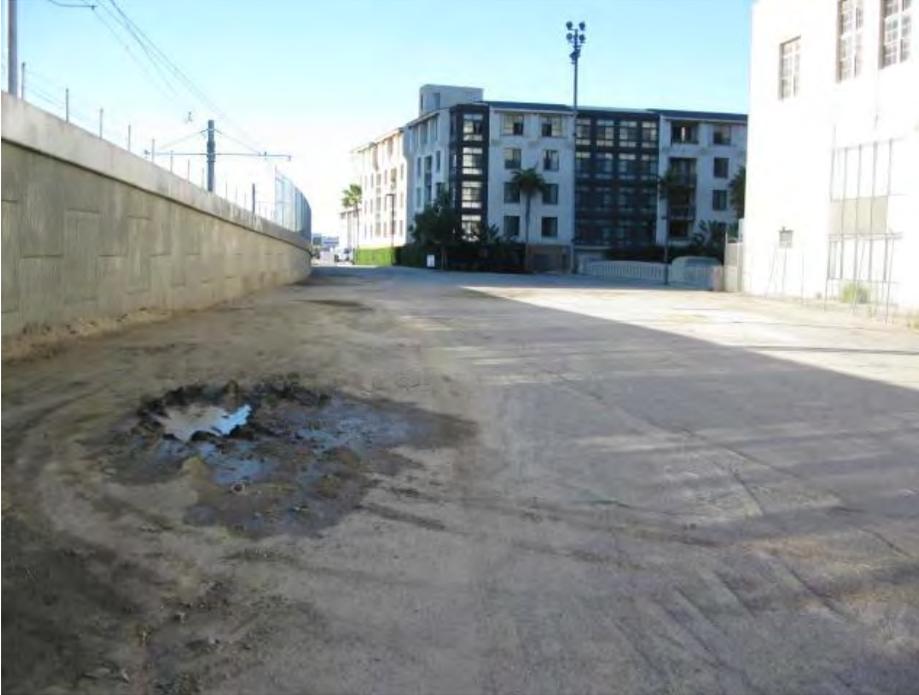
Photograph #11

**Condition:** The asphalt paving appeared in good to fair condition with minor cracking and alligating observed throughout. Lot G was noted to be in poor condition. Parking stall striping appeared faded in select areas. Resealing of the asphalt and stall restriping is recommended early in the term and then generally every five years thereafter.

Overall view of Lot G; Note the deteriorated condition of the paving.

Paving and striping of Lot G is recommended. Sidewalks are generally in good condition with select areas showing signs of disrepair. These areas should be restored. It should be noted that any brick or natural stone restoration should take the historical aspect of this property into consideration.

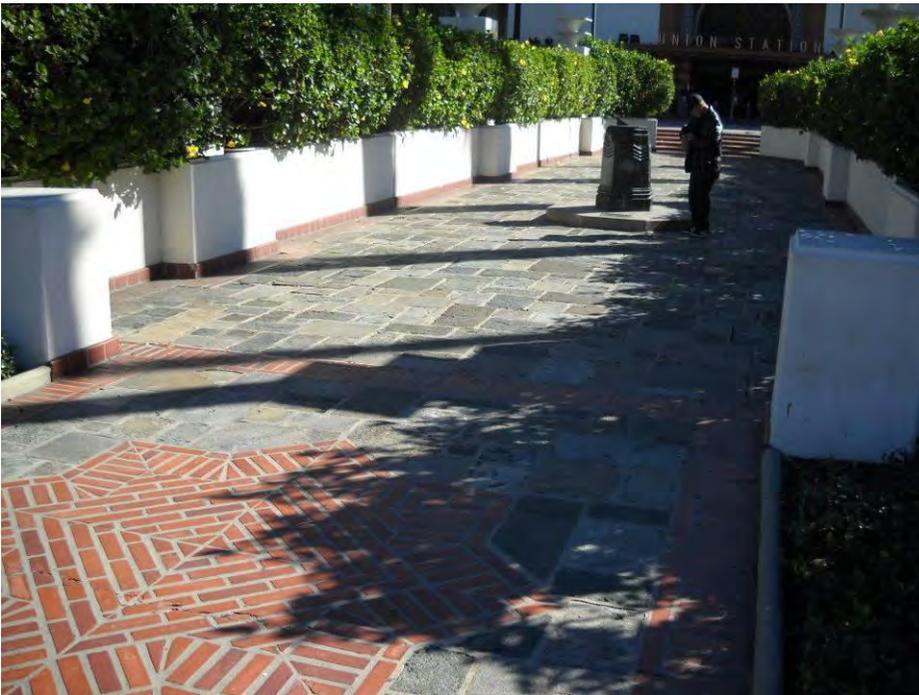
Photograph #12

View of the Sun Dial Plaza. Note the damaged pavers.

Management reported that there is a stock pile of special pavers stored on site. Decorative pavers can also be custom made for paved areas on an as-needed basis. Strategic areas are accentuated by marble and limestone in layers. Broken and damaged marble inlay should be replaced as needed.

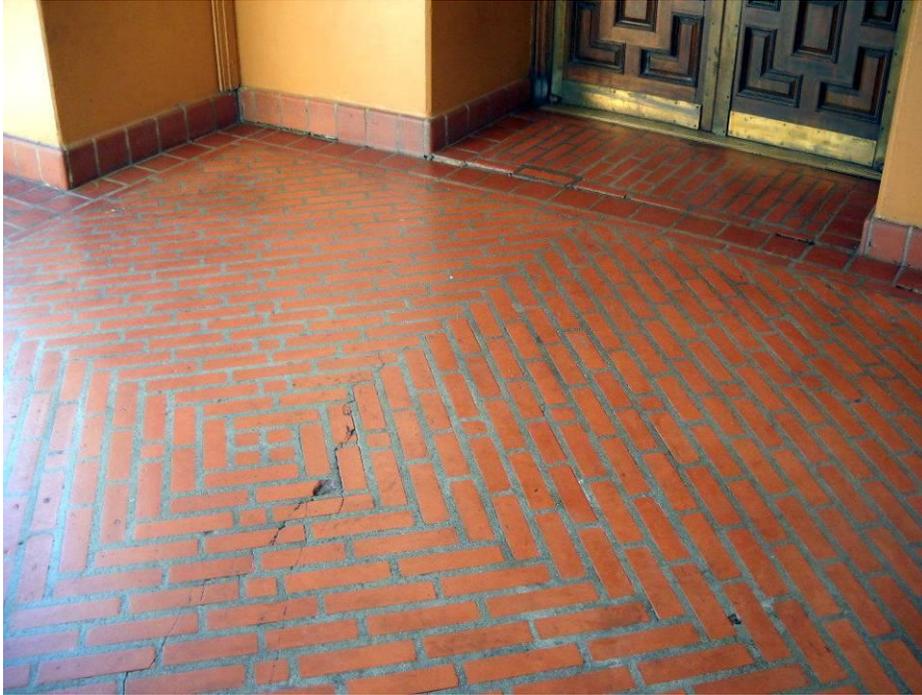
Photograph #15

Damaged pavers  
and trip hazard at  
the side entries.

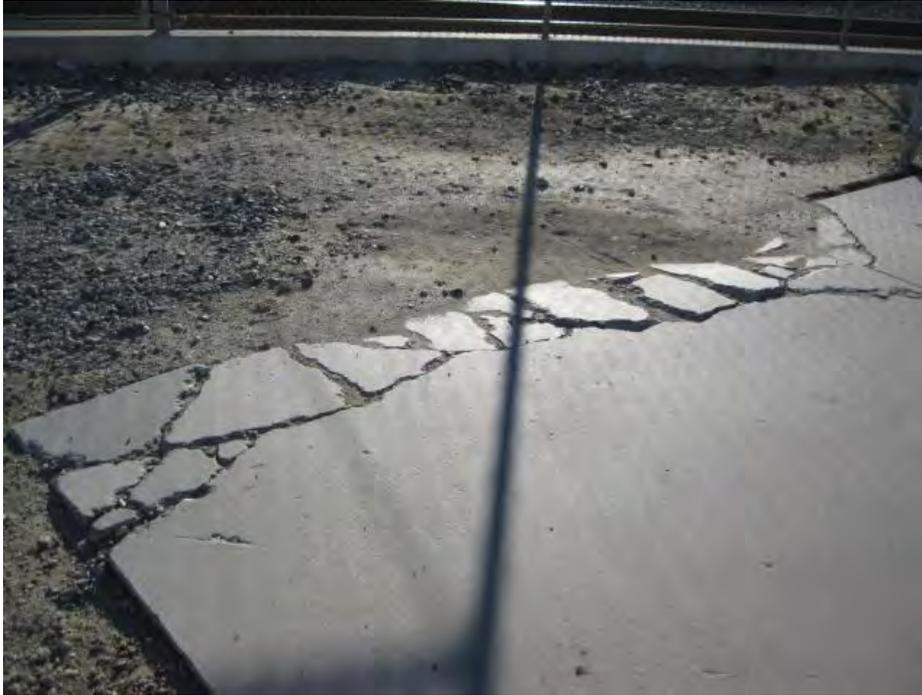
Photograph #17

View of the  
damaged concrete  
paving.

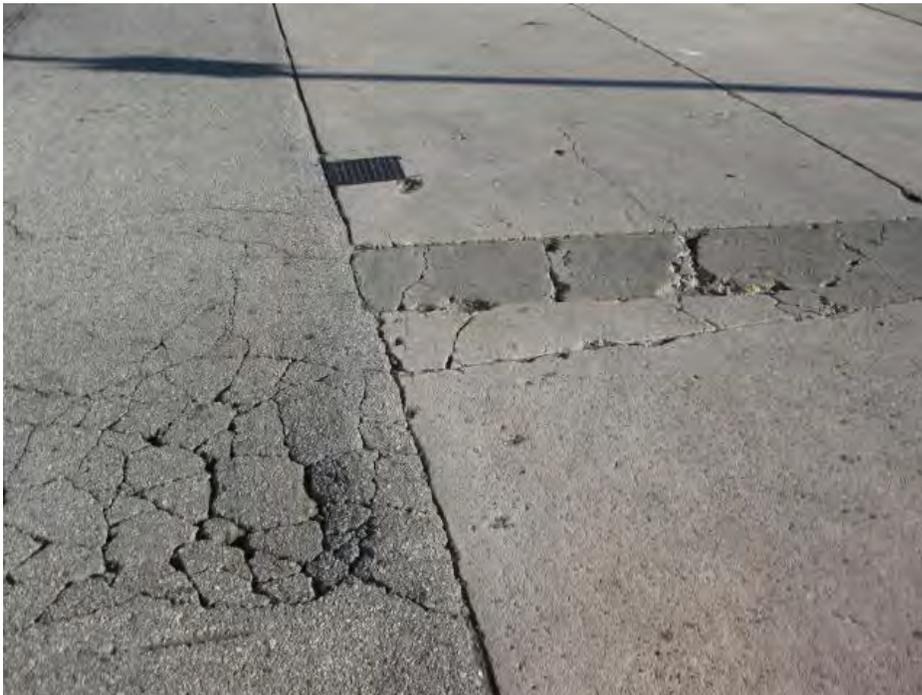
Photograph #18

View of the  
damaged asphalt  
paving.

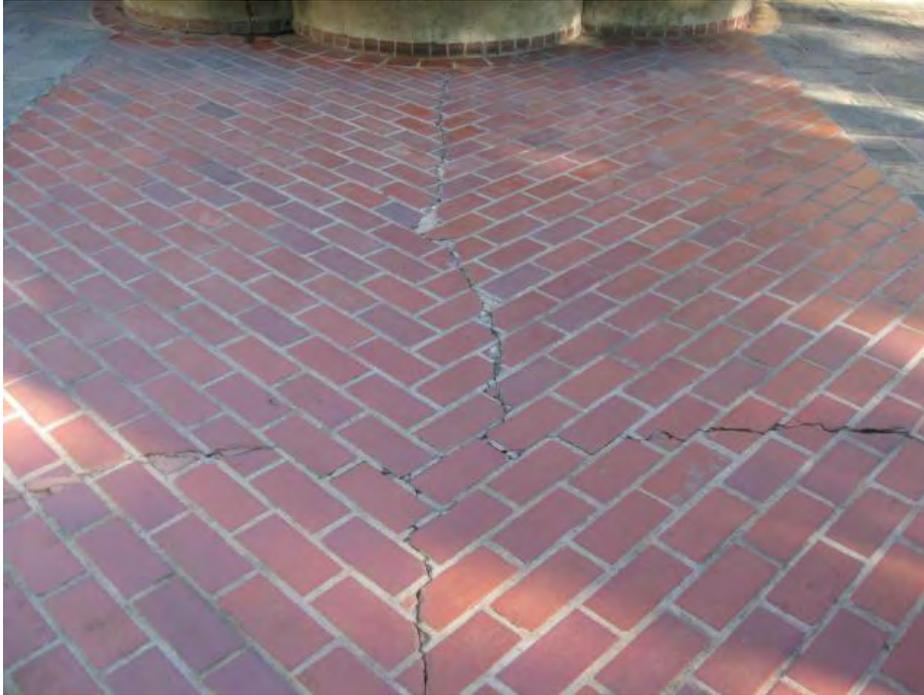
Photograph #19

View of damaged  
brick pavers.

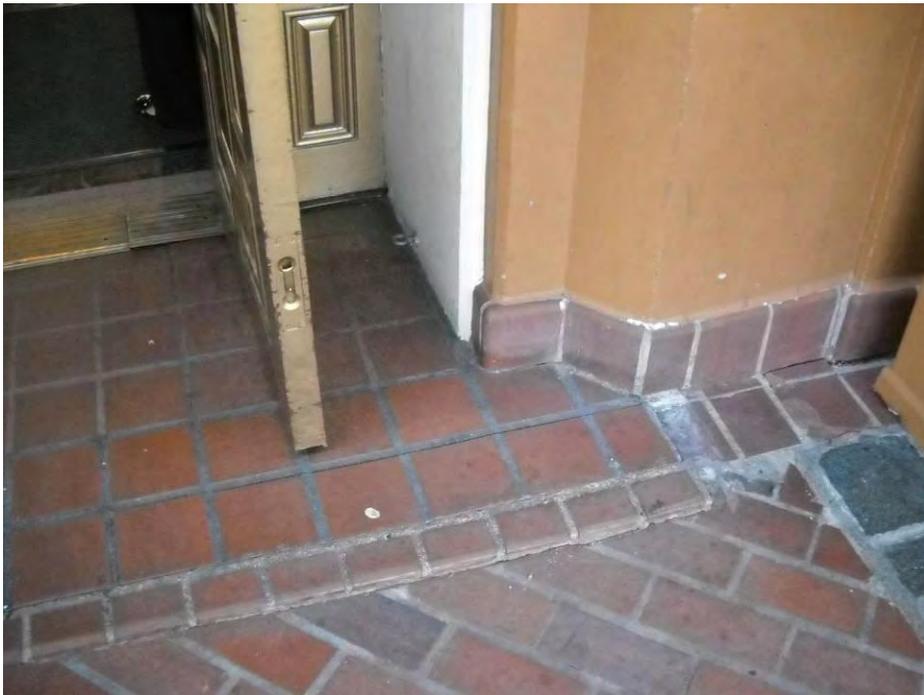
Photograph #20

Damaged pavers,  
trip hazard at the  
courtyard entries.

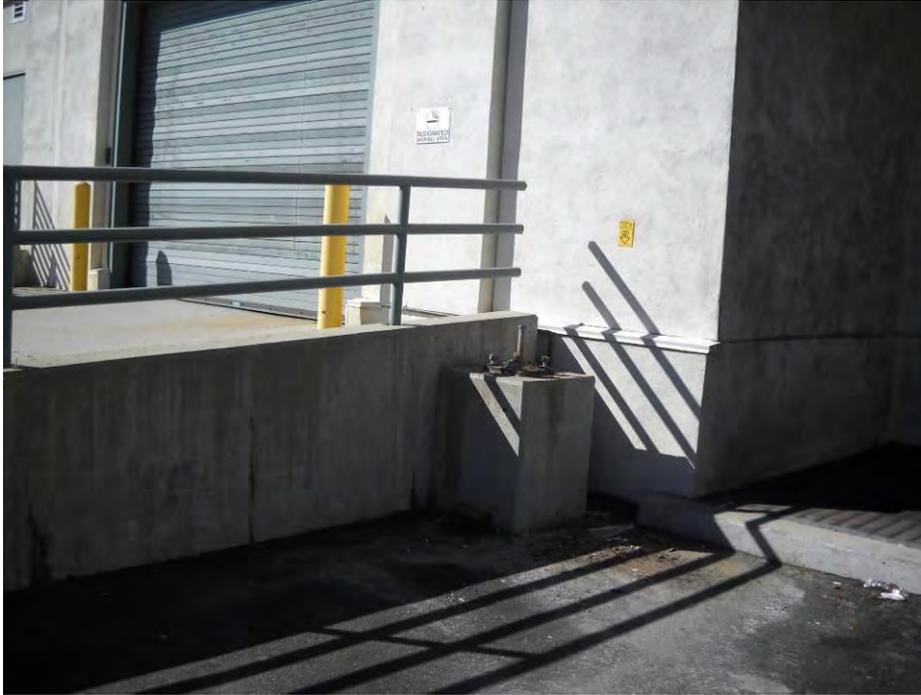
Photograph #21

Missing or damaged site lighting should be replaced.

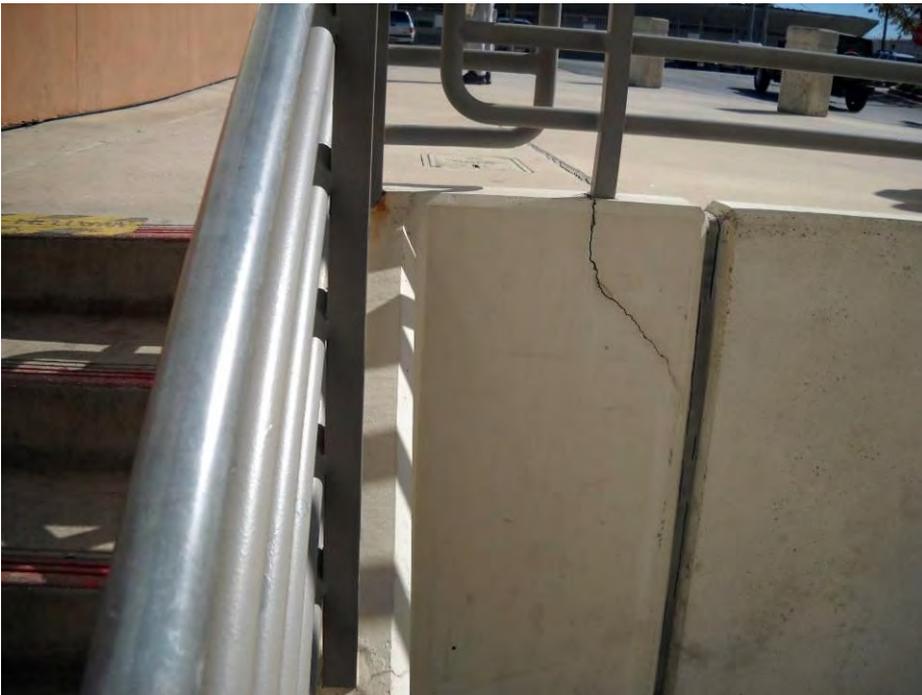
Photograph #24

Condition: No significant issues were noted or reported; however, cracks and damaged retaining walls on the south side of terminal and high-curbs on the north side were noted which should be repaired and painted.

Cracked and damaged retaining wall is on the south side of the terminal.

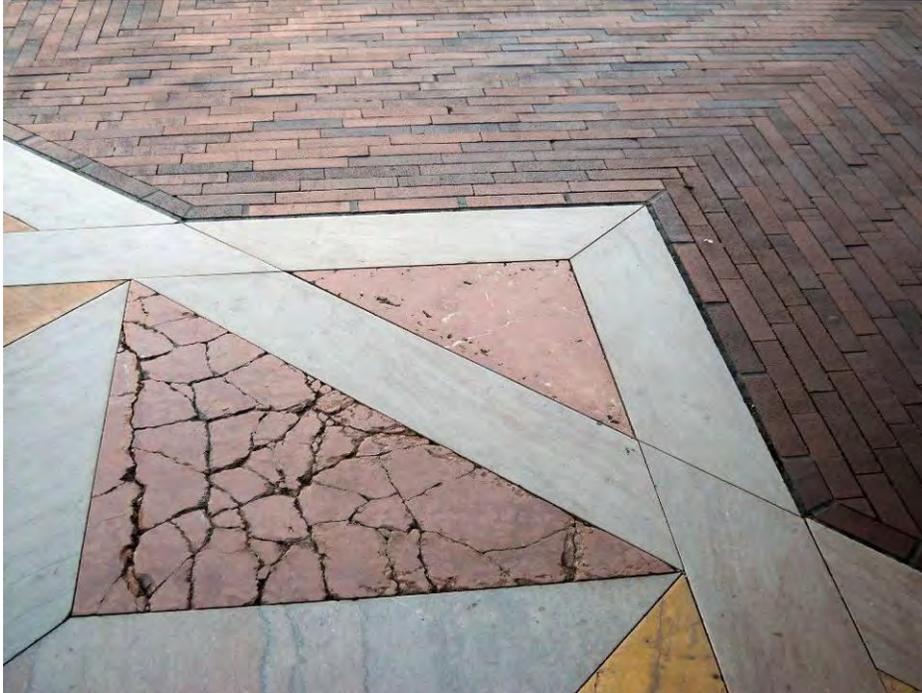
Photograph #25

Damaged marble inlays at the front entrance.

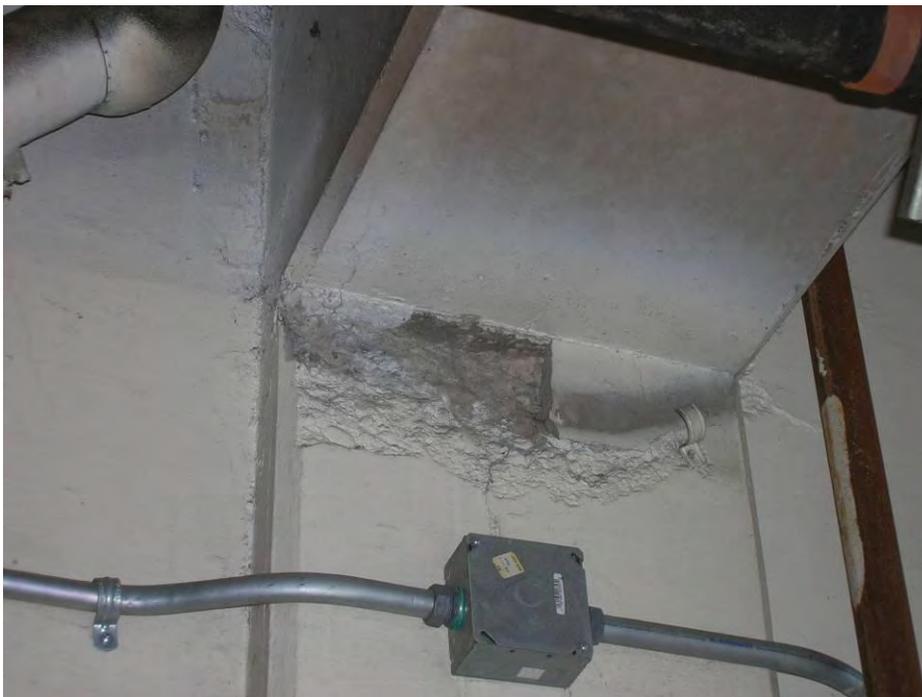
Photograph #26

Damage to concrete framing at parking garage under Waiting Hall.

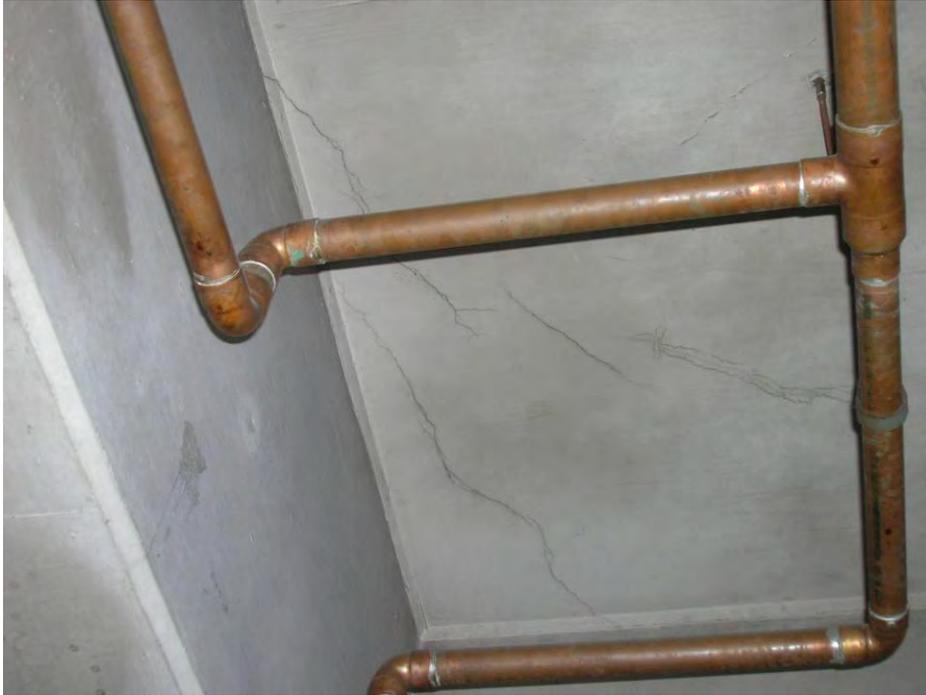
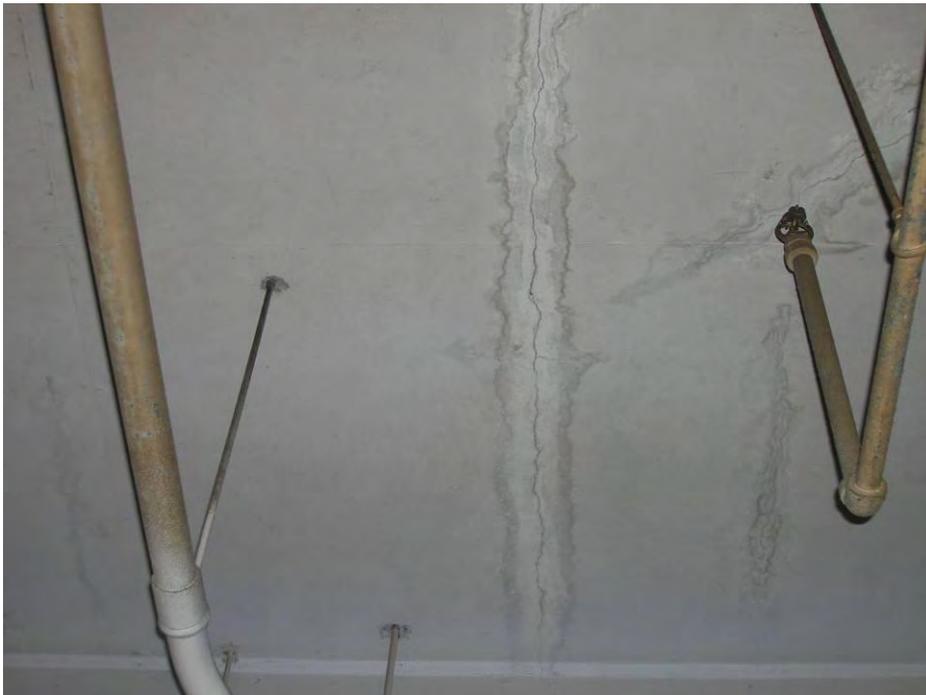
In the parking garage, the underside of the ground floor slab could be observed. This slab was observed to be cracked in numerous locations. Cracking in the walls was also observed. Repair of the cracking is recommended.

Cracking at underside of concrete slab as seen from parking garage.

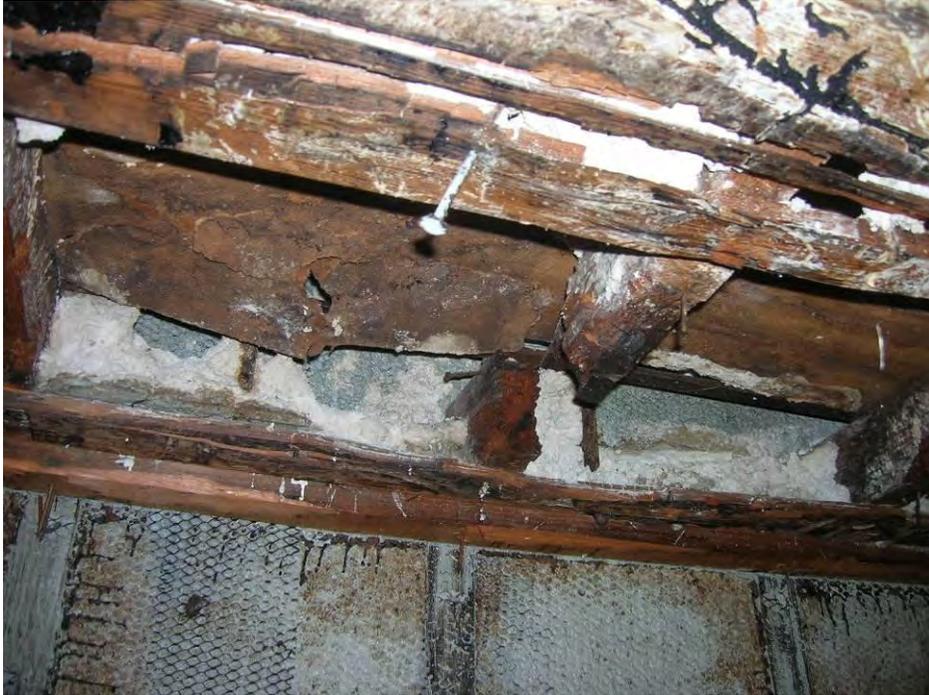
Photograph #29

Damage to wood framing at underside of restaurant.

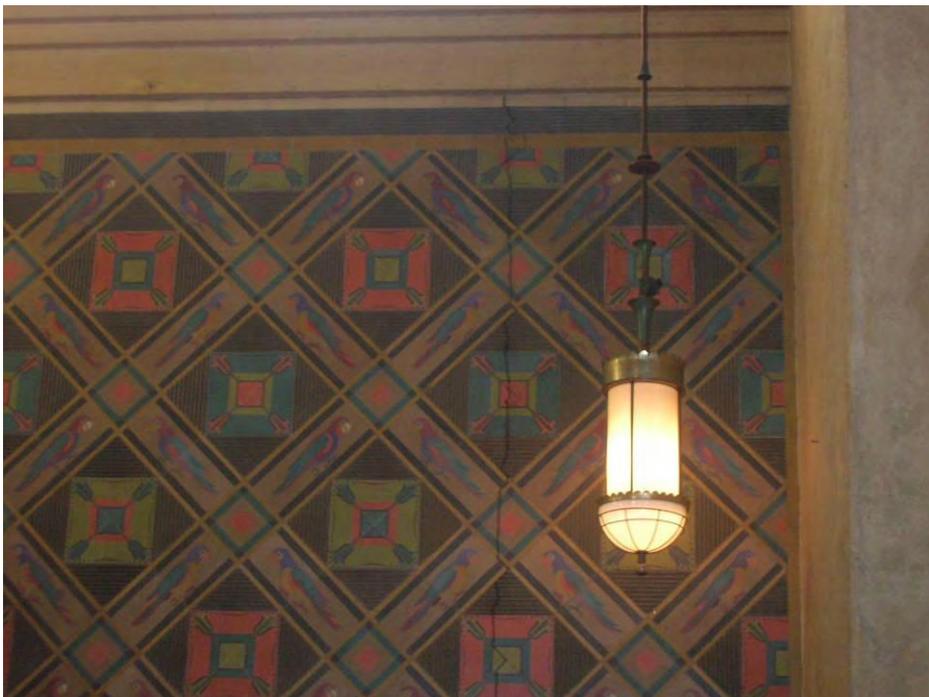
Photograph #30

Damage to concrete wall in restaurant space; reportedly damage from 1994 Northridge Earthquake.

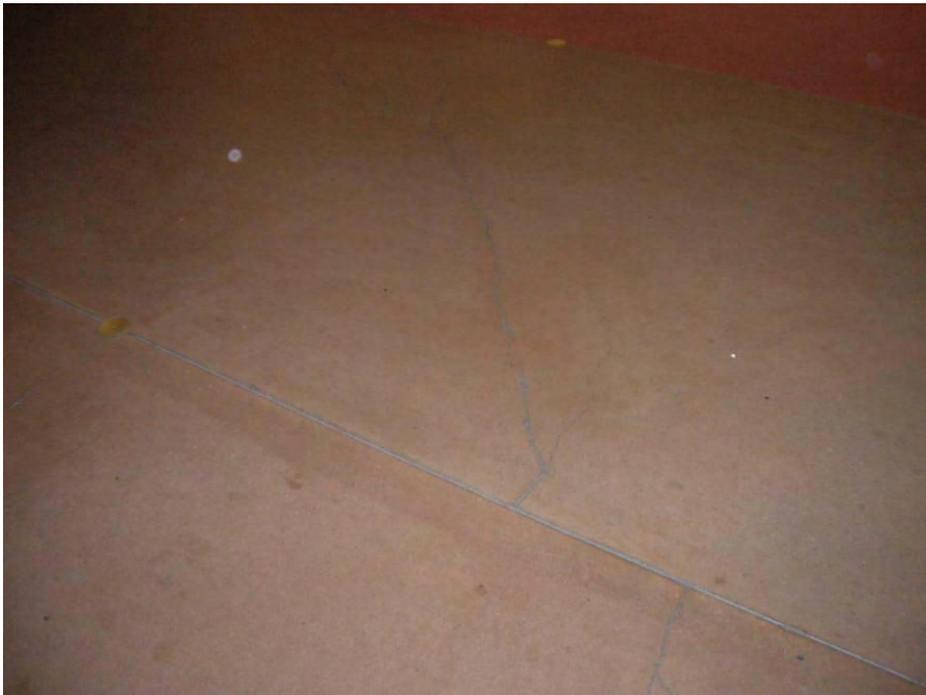
Photograph #38

Cracking in the  
slab-on-grade at the  
tunnel.

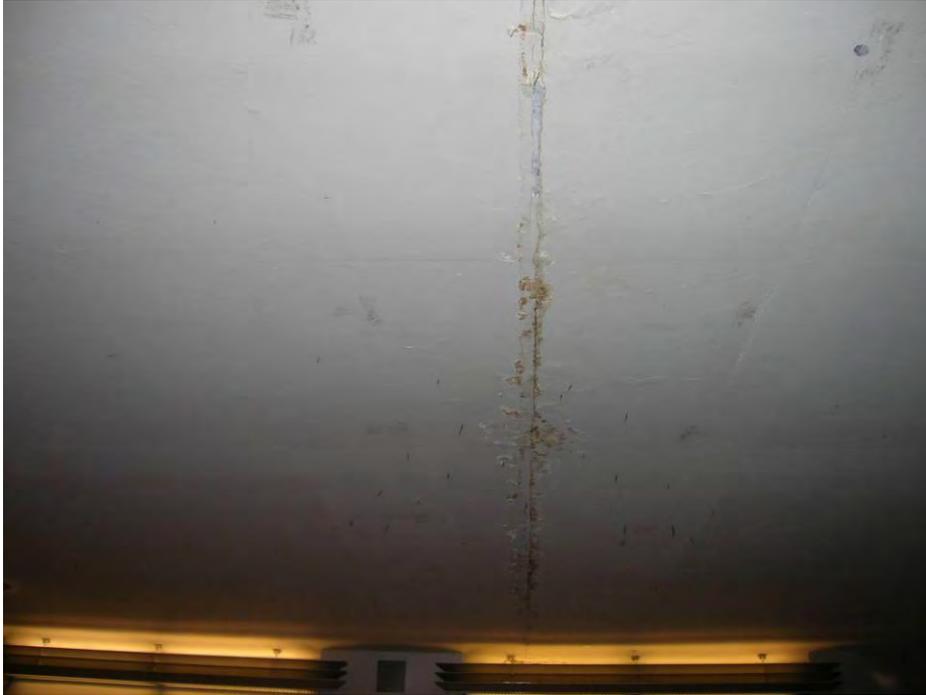
Photograph #39

Evidence of water intrusion was observed from the underside of the tunnel. The property periodically implements repairs to stop the water intrusion. Property management reportedly has attempted to address these issues from the top side of the slab, but has been unsuccessful. Implementing repairs from the top side would impact railroad operations, which should be coordinated with operators. The wood-framed ceilings at the areas below the former Fred Harvey restaurant was noted with disintegration and rot and should be replaced.

Evidence of water intrusion at tunnel structure beneath railroad tracks.

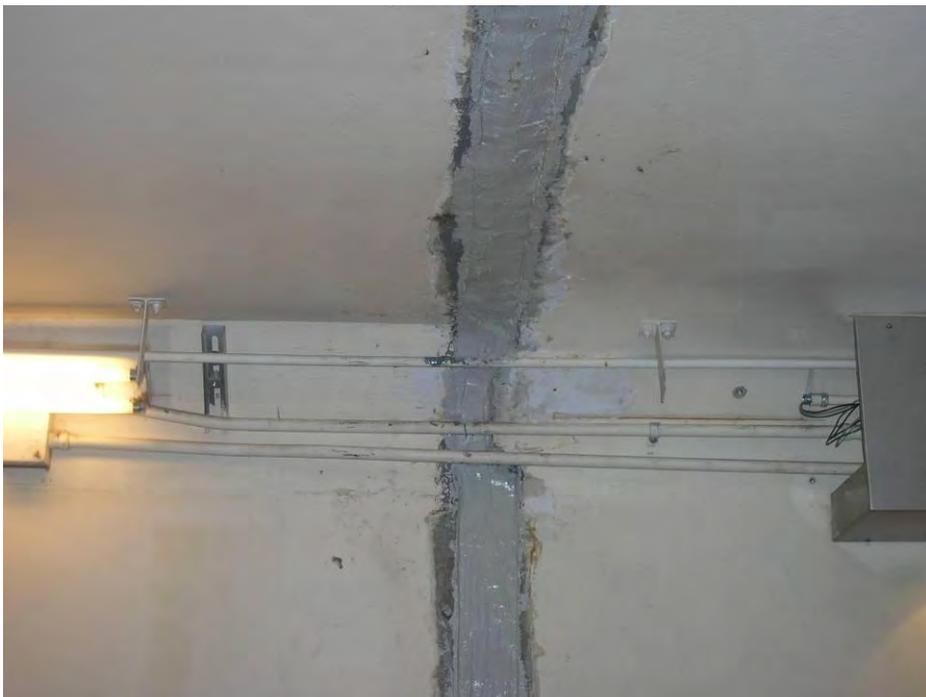
Photograph #40

Evidence of repairs to water intrusion at the tunnel beneath the railroad tracks.

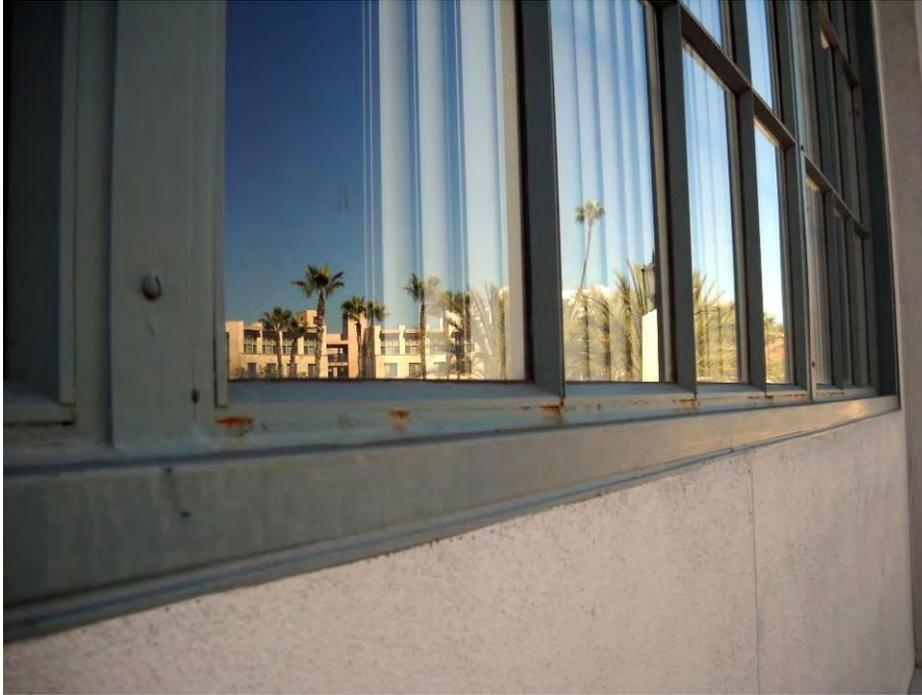
Photograph #49

Rust and stained wall at the Amtrak steel windows.

Painting of the exterior concrete and stucco surfaces should be anticipated within the term. Windows were noted with rust at the frame. Repair and repainting of windows should occur at the same time and maintained. The wood beams and eave lines should be maintained and painted. The decorative glazed tile and terra cotta were noted with chipped and broken sections, which require replacement and maintenance. It should be noted that the original building is listed as historic, and all the tile and refurbishment should be consistent with historic preservation guidelines. Exterior doors to the main station appear to be original, decorative, wood doors and continuous maintenance and repair should be anticipated throughout the term.

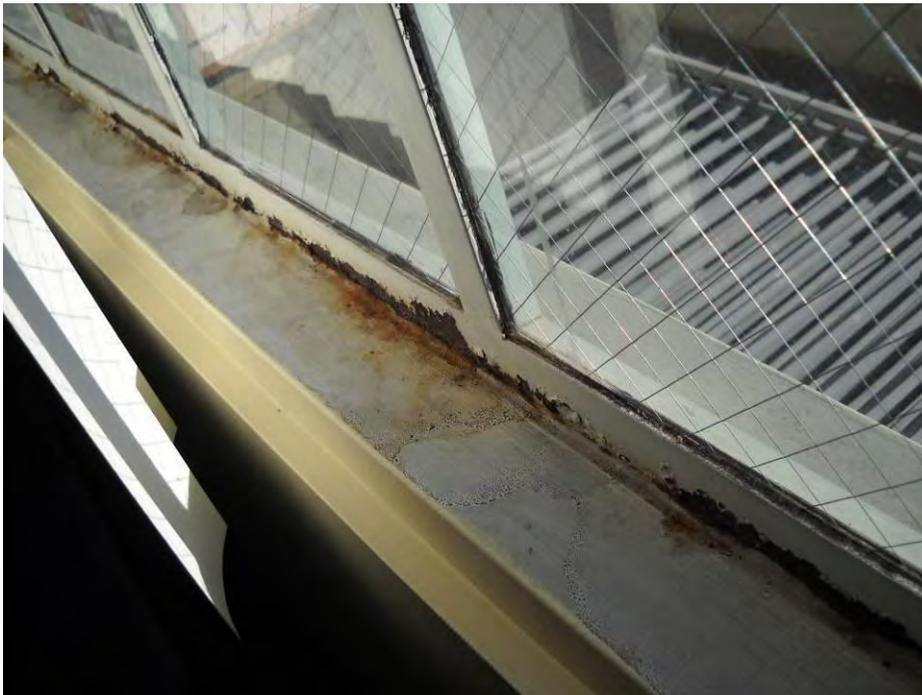
Photograph #50

Excessive rust at the older steel windows.

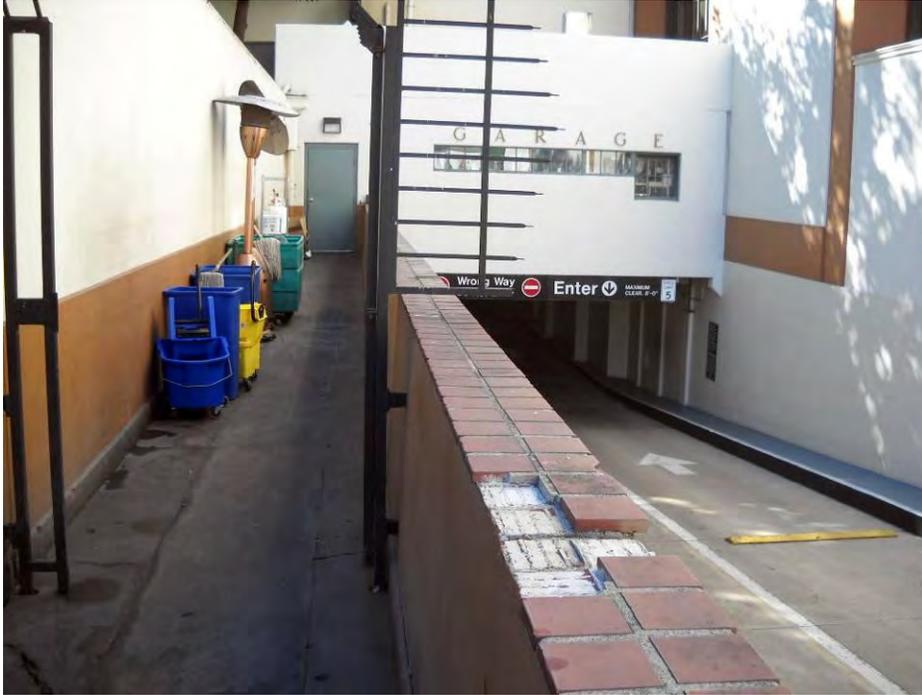
Photograph #51

Damaged wall cap  
tile noted  
throughout.

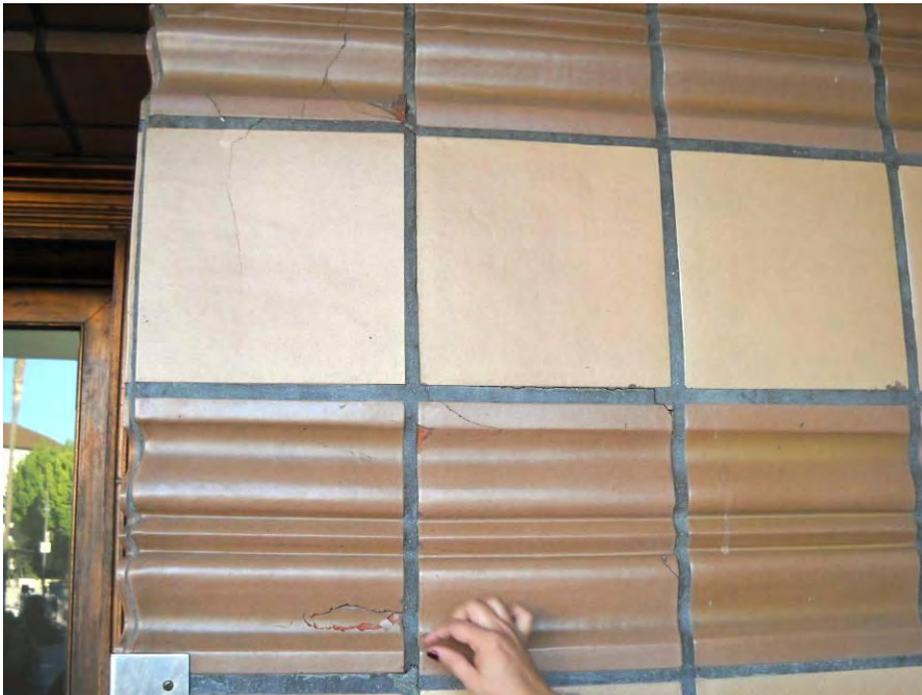
Photograph #52

Cracked and  
damaged terra cotta  
tiles at the front.

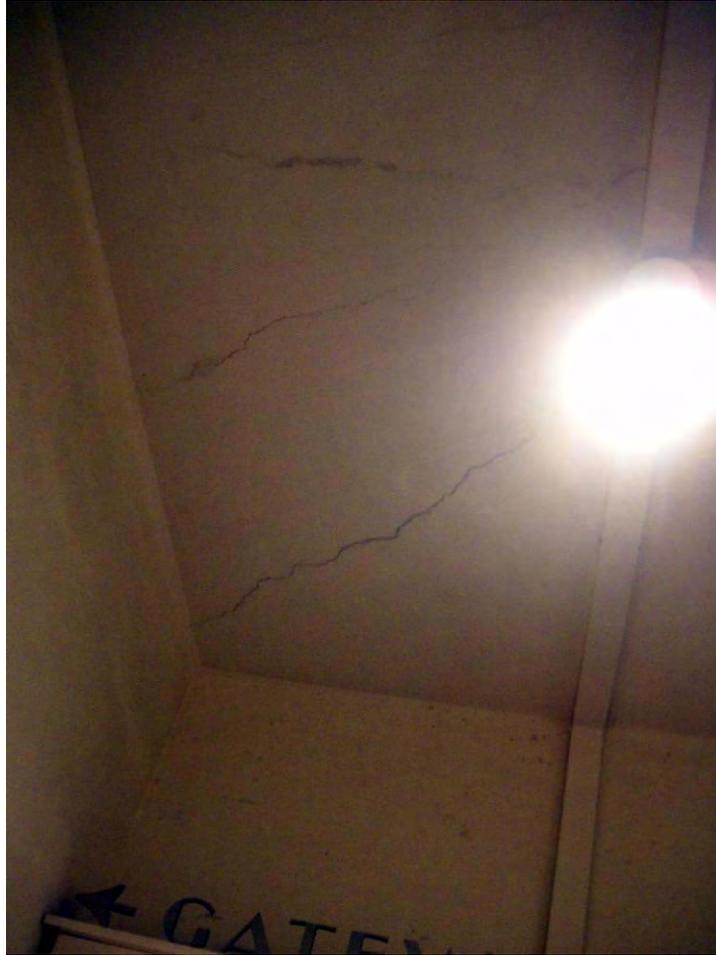
Photograph #61

Concrete cracking  
at the tunnel  
ceiling.

Repair work on the tunnel ceilings and walls is underway inside the main tunnel. Once the repair work is complete, all walls and ceilings should be painted and damaged tile should be repaired and replaced. The concrete walls and ceilings of the subterranean parking were noted with spalling, cracking, and in overall worn condition. All surfaces should be scheduled for painting after all damaged and cracked areas are repaired. Reapplication of the traffic coating at the tunnel floor should be anticipated.

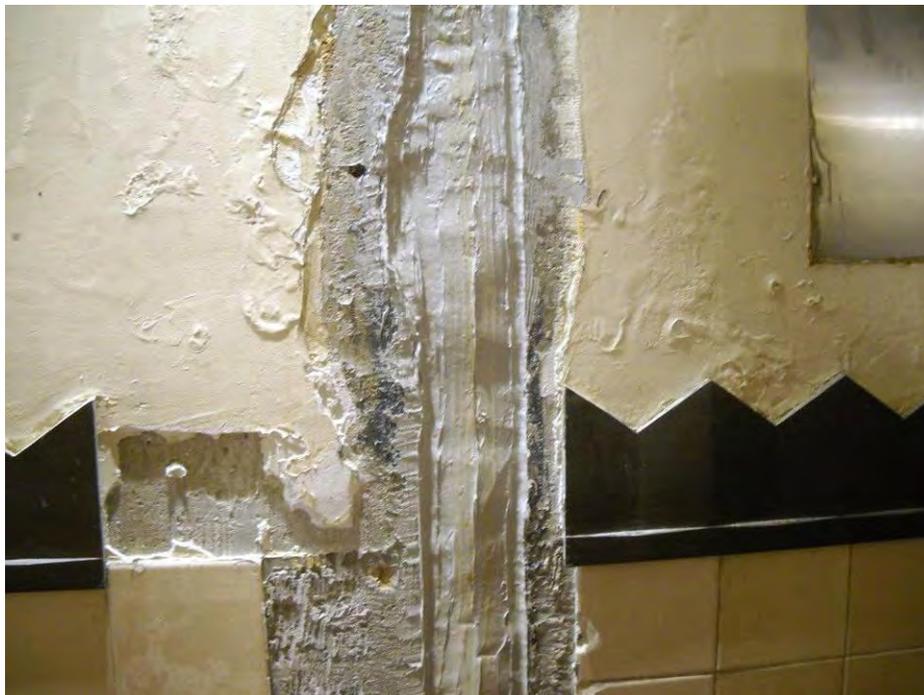
Photograph #62

Repair work of the  
expansion joints in  
the tunnel is in  
progress.

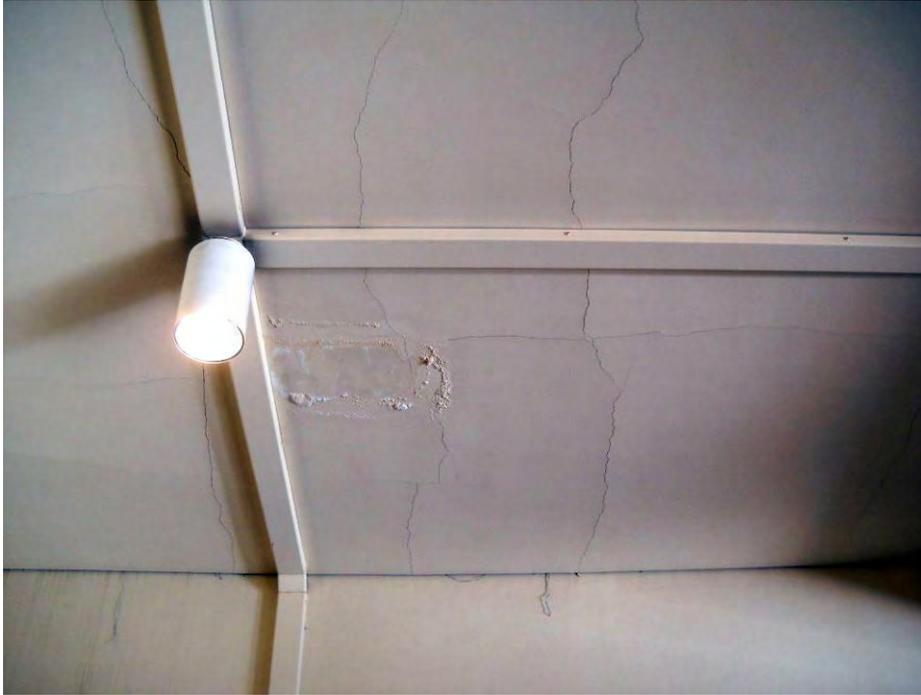
Photograph #63

Concrete cracking and signs of water intrusion into the tunnel.

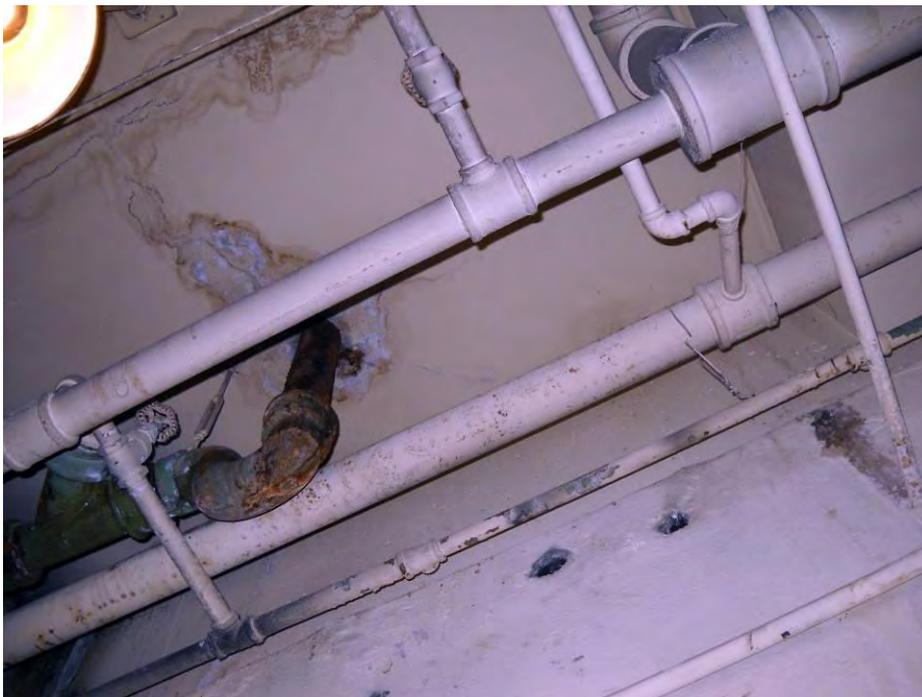
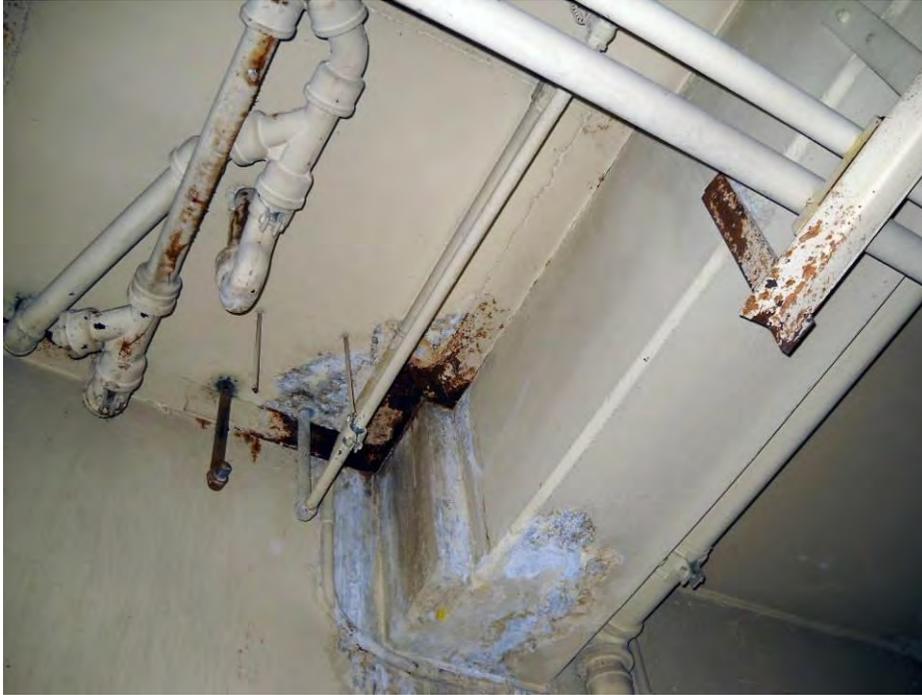
Water stains and rust at the areas below the Fred Harvey Restaurant.
