## PROPERTY CONDITION ASSESSMENT

# PROJECT SANTA FE LOS ANGELES UNION STATION

800 North Alameda Street  
Los Angeles, California

Draft: November 12, 2010

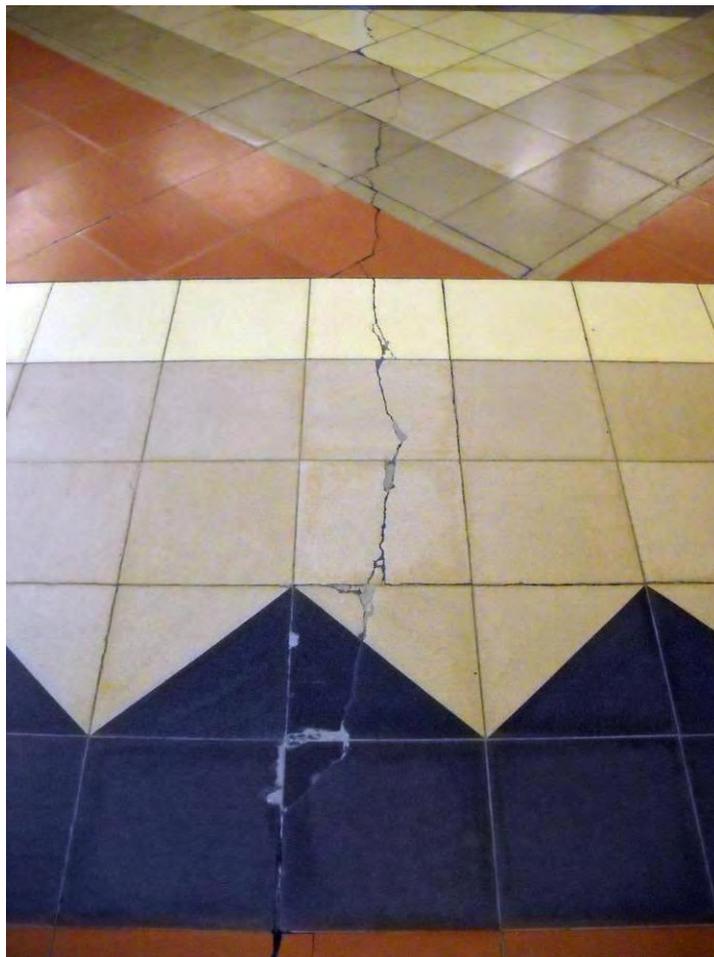
Photograph #74

Cracked and damaged concrete pavers at the ticketing area.

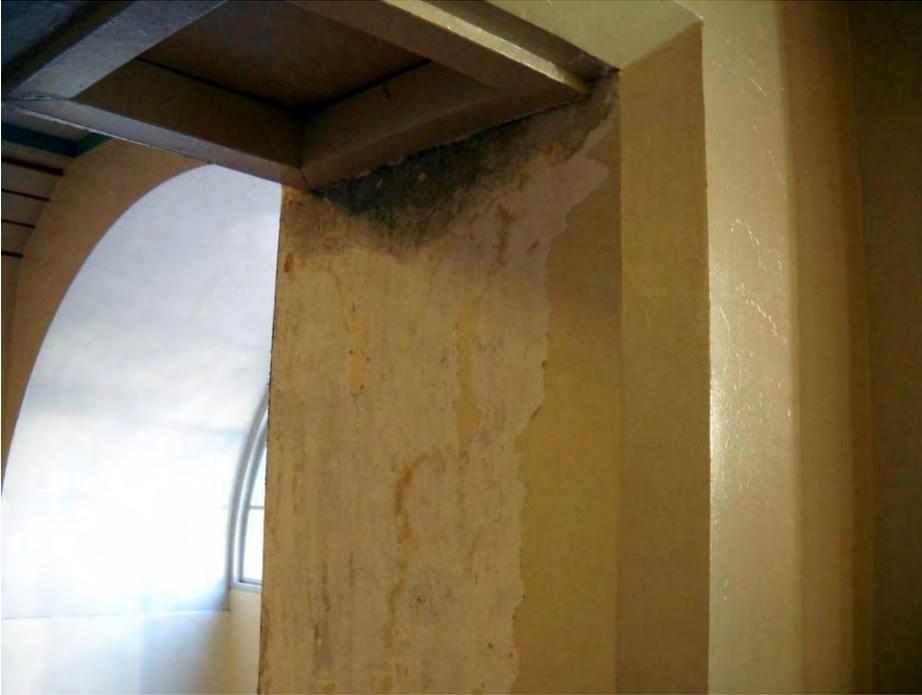
Photograph #75

Signs of water intrusion into the interior of the ticketing area.

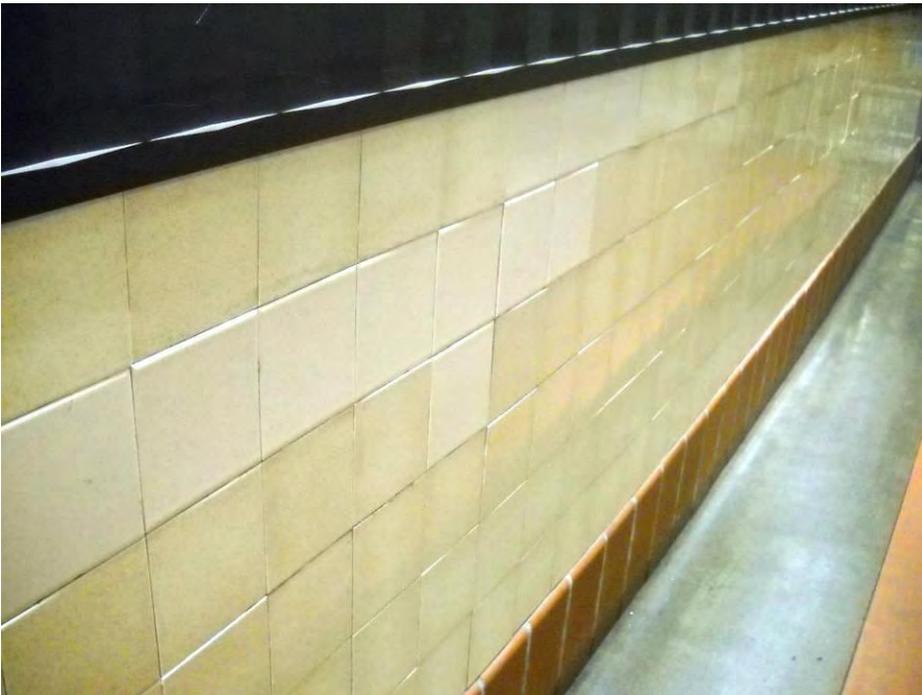
Photograph #76

Tile wainscoting repair and replacement.

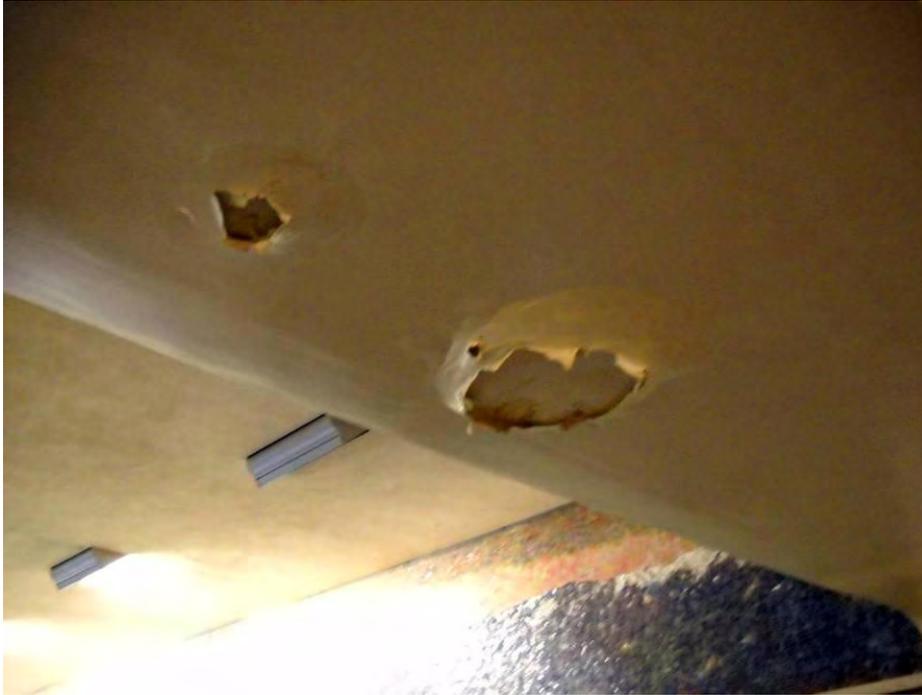
Photograph #77

Damage and signs of water intrusion into the tunnel.

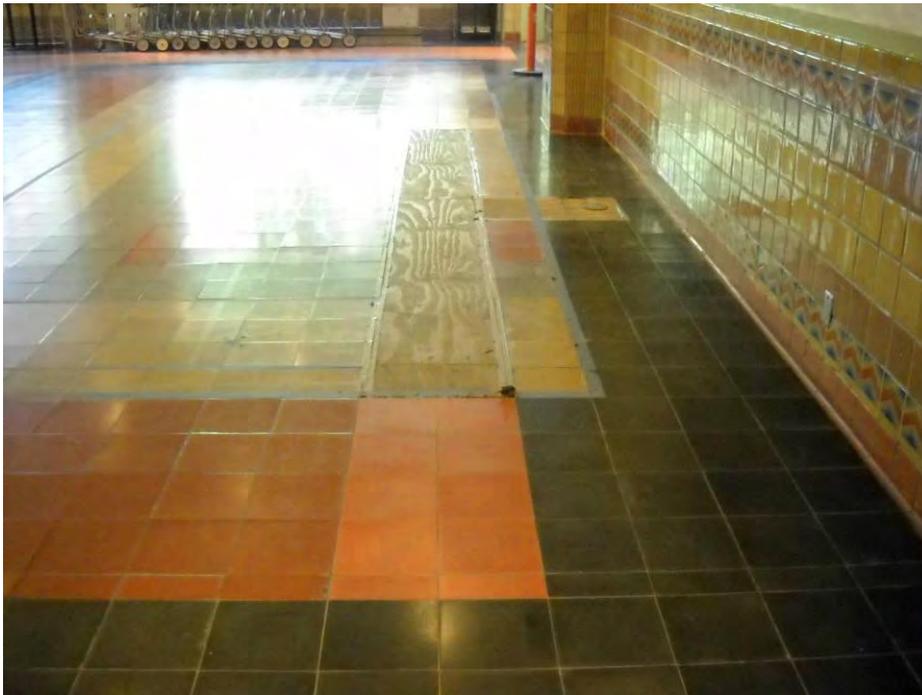
Photograph #78

Damaged concrete pavers have been removed and are temporarily covered by plywood. Note the color variation of the tiles.

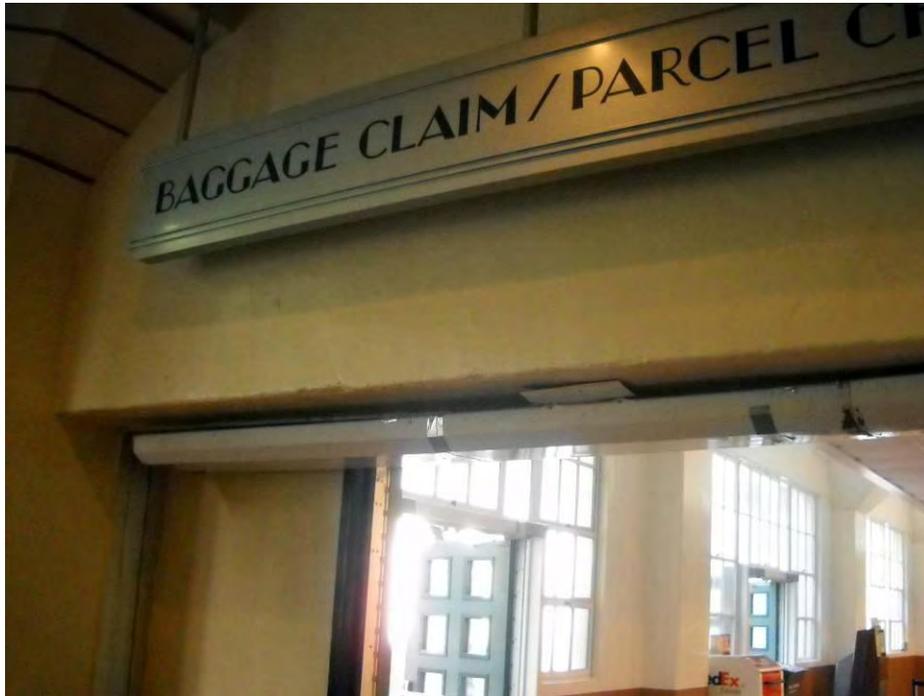
Photograph #79

Water intrusion and temporary repair at the baggage claim area.

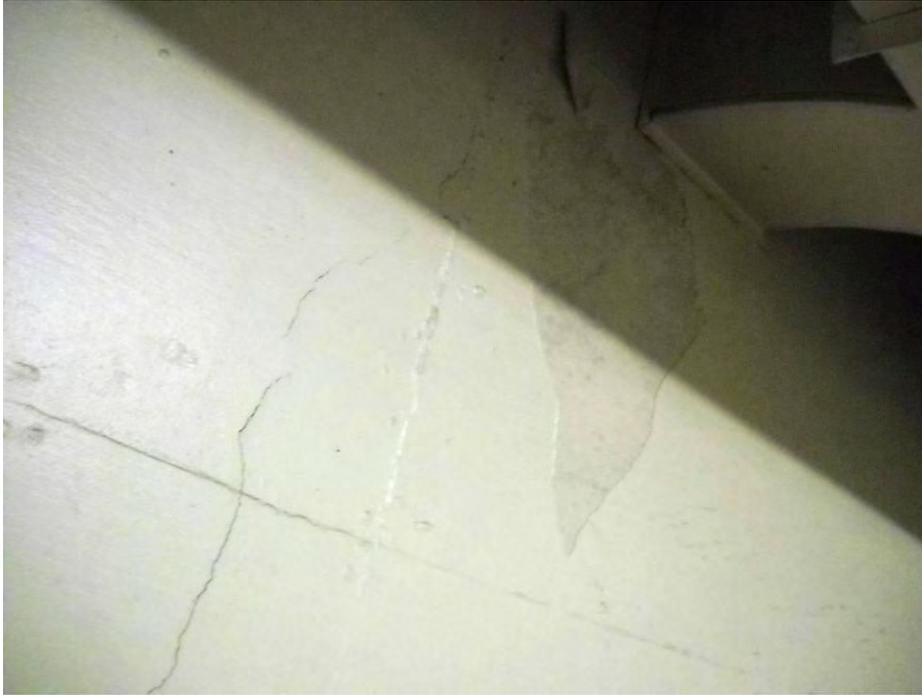
Photograph #81

Stained, cracked, and peeling paint at the subterranean garage area.

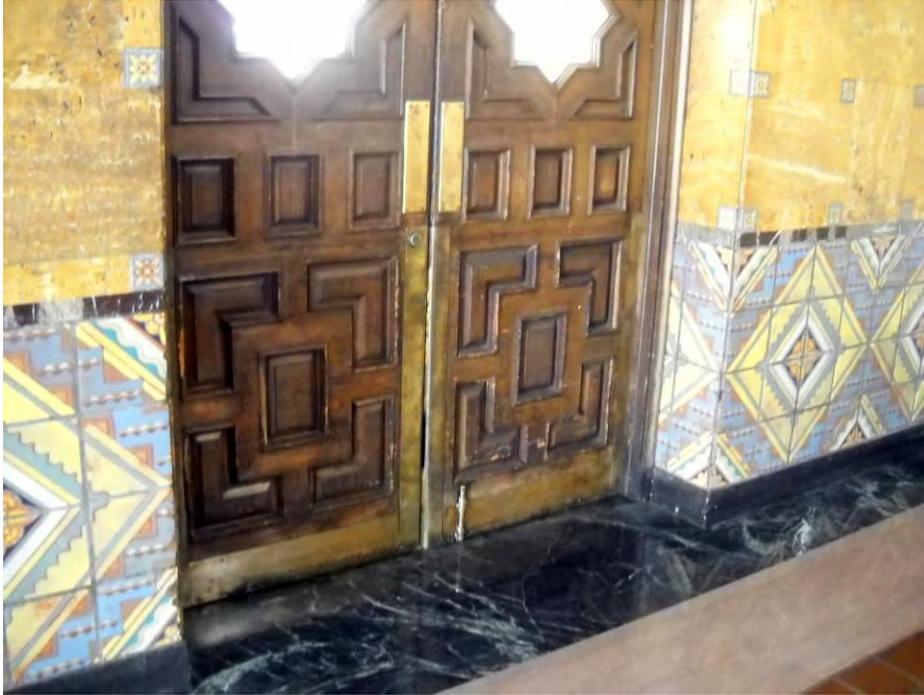
Photograph #91

Wood interior doors will require re-finishing and repair work.

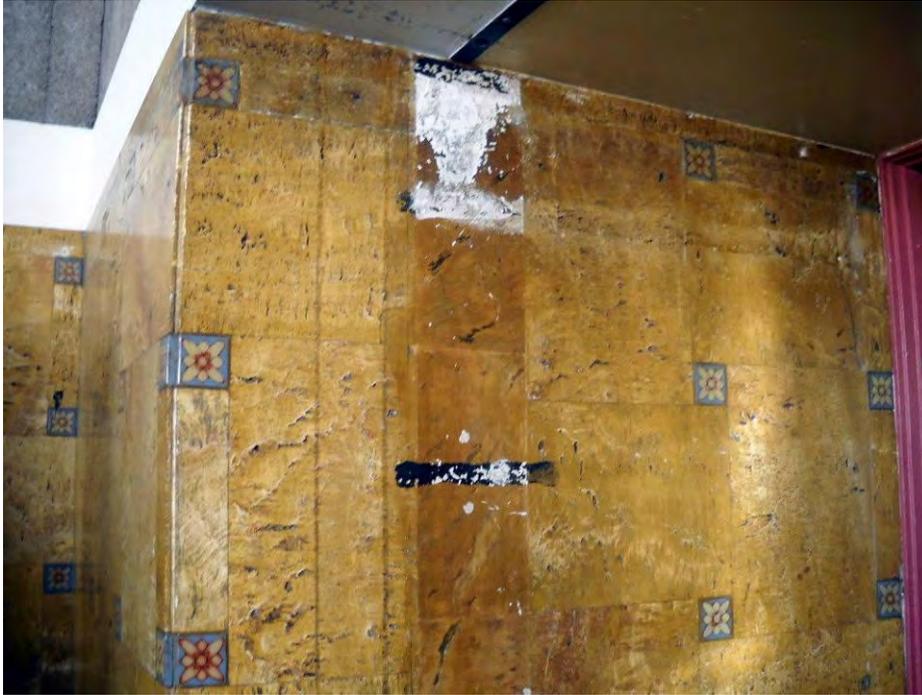
Photograph #93

Damaged decorative tiles will require restoration.

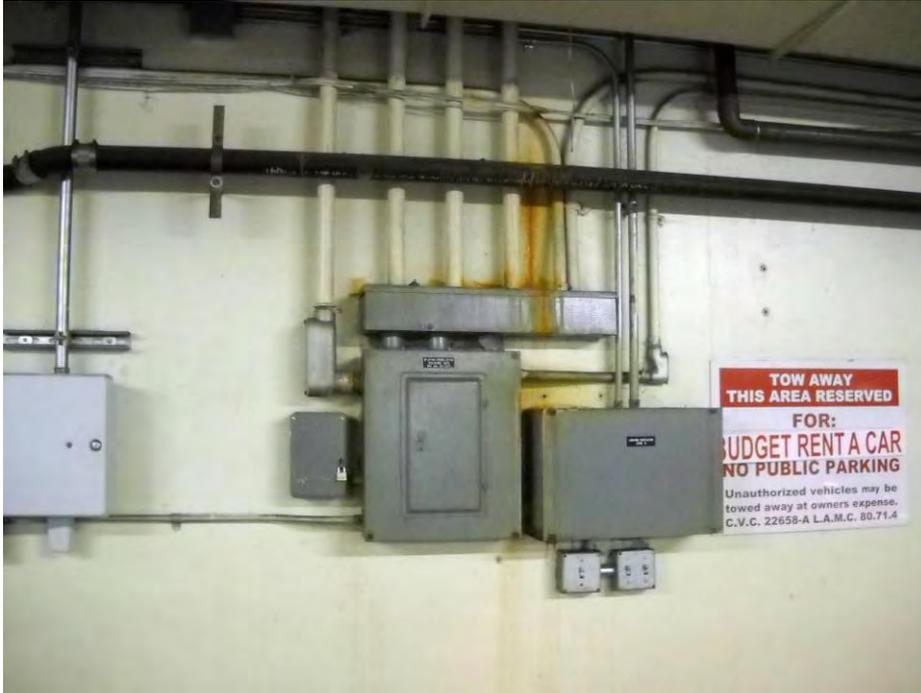
Photograph #109

Water stains at the electrical boxes in the garage area.

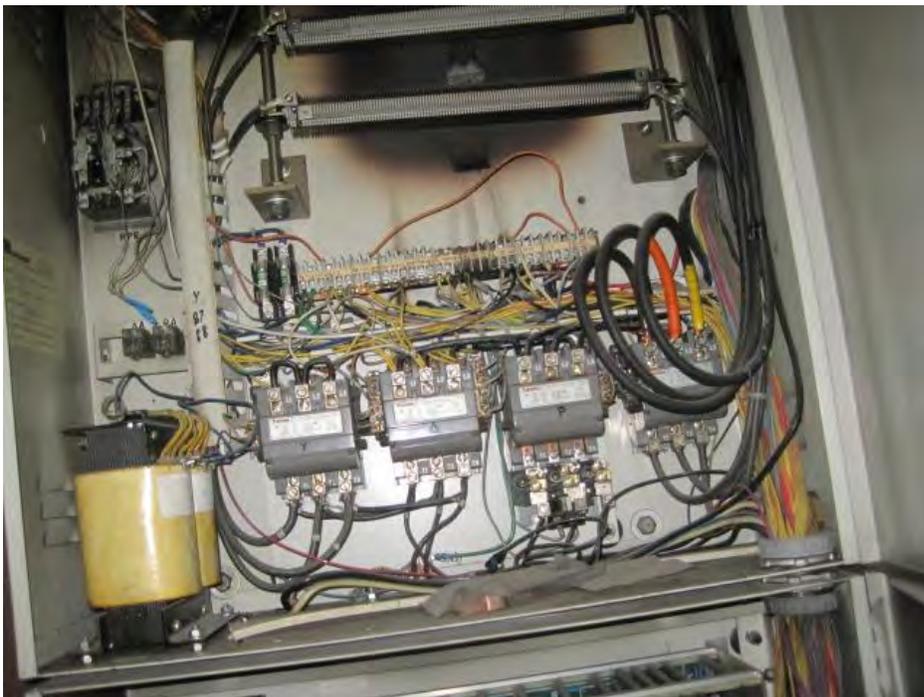
Photograph #130

Relay motor starter at Elevator 2. Note, burn mark.

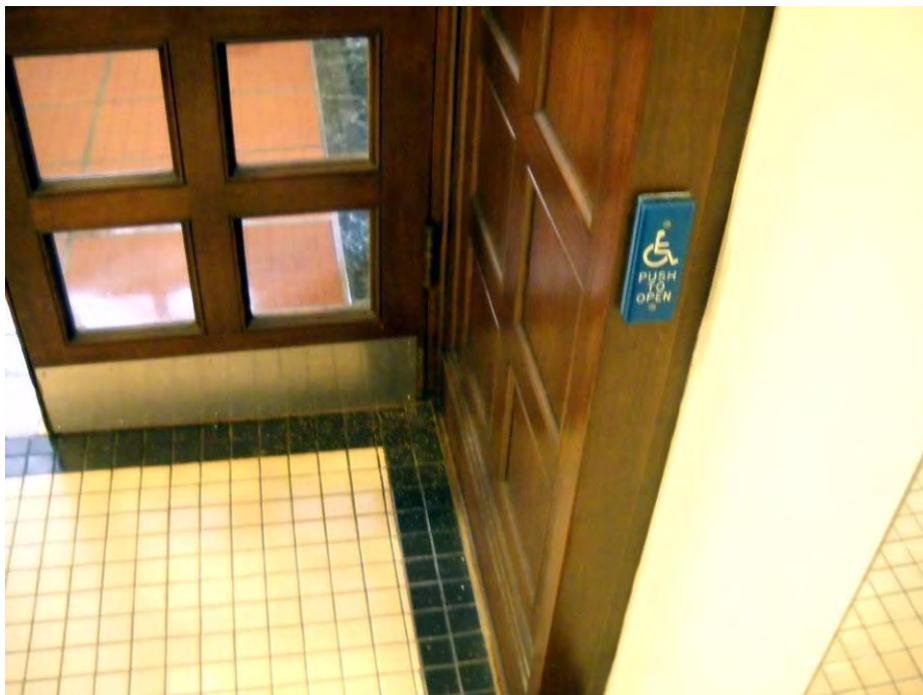
Photograph #148

Inoperational door opener should be repaired.

Based on the number of available parking spaces, one additional disabled-accessible parking space is required. The automatic door openers in the main concourse toilet rooms should be repaired for proper performance. Compliant handrails should be installed inside Elevators 1 and 3. Elevators 2 and 3 should be upgraded with compliant car operating panels, and compliant hall lanterns. Elevators 1 and 3 should be upgraded with hall-entrance Braille.
