Detectable Warnings: Testing and Performance Evaluation at Transit Systems

Final Report
November 1994

1. AGENCY USE ONLY (Leave blank)	2. REPORT DATE November 1994	3. REPORT TYPE AND DATES COVERED Final Report July 1993 - June 1994	
4. TITLE AND SUBTITLE Detectable Warnings: Testing and Performance Evaluation at Transit Stations		5. FUNDING NUMBERS U5041/TT548

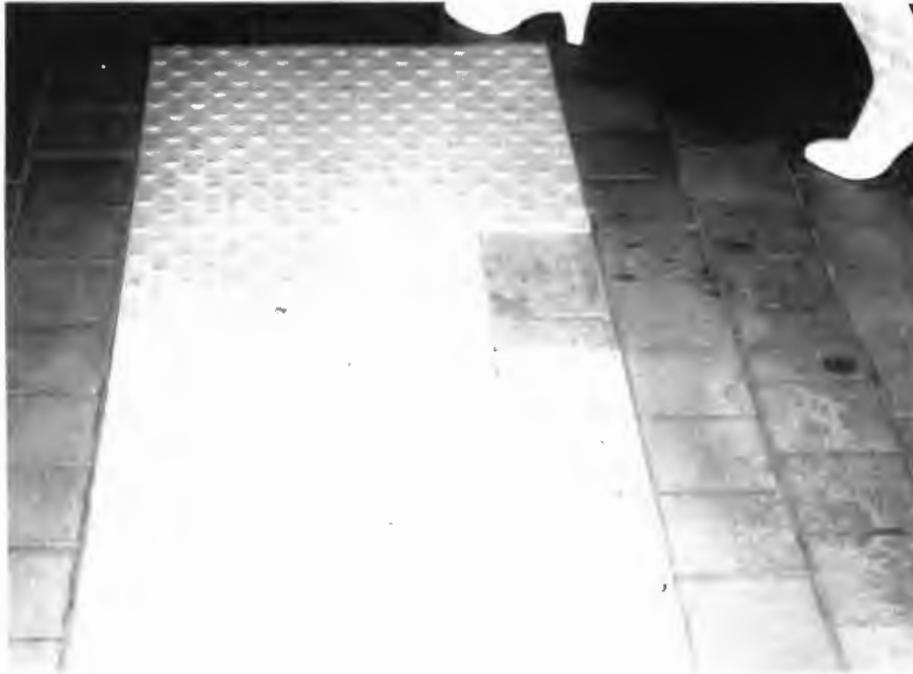
Figure 3-2
Rehau: Access Tactile Tile
Installation at MBTA South Station Illustrating Missing Tile
(Photo Taken after 78 Exposure Days)

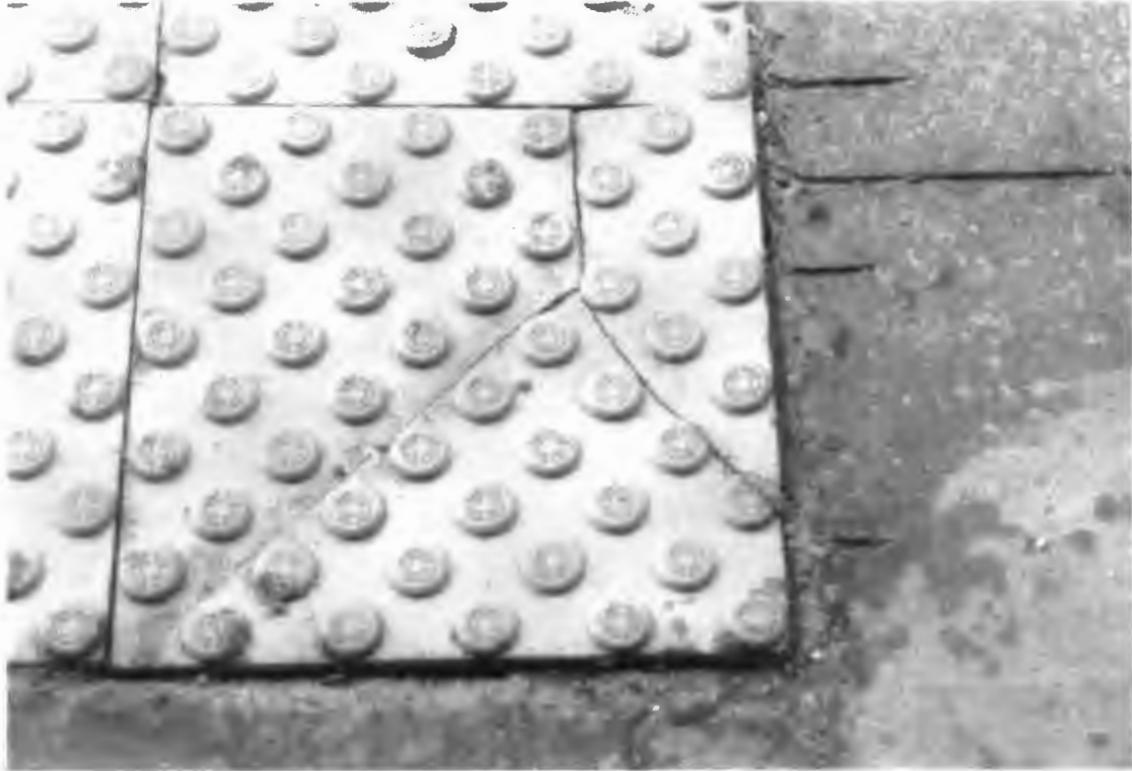
Figure 3-3 shows a portion of the installation of Transpo's Step-Safe at Orient Heights. One tile has cracked and is no longer bonded to the platform.

Figure 3-3
Transpo Industries: Step-Safe
Installation at MBTA Orient Heights Station Illustrating Cracked Tile
(Photo Taken after 167 Exposure Days)

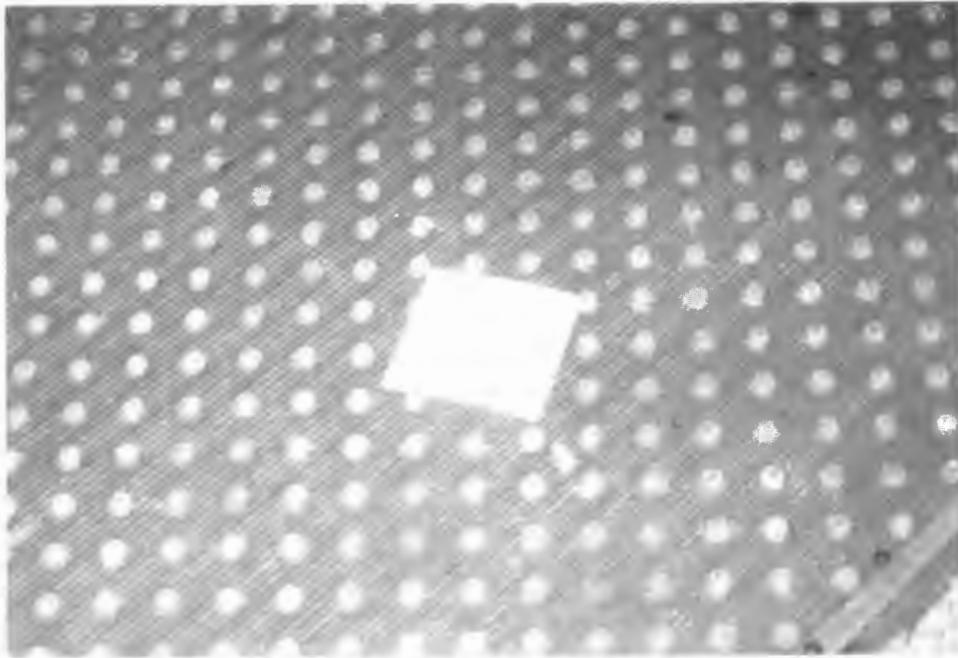
Figure 3-4
ADA Consultants: Alert Mat
Installation at GCRTA Brookpark Station Illustrating Change From Original Color
(Sample Piece in Center of Photo)
(Photo Taken After 201 Exposure Days)

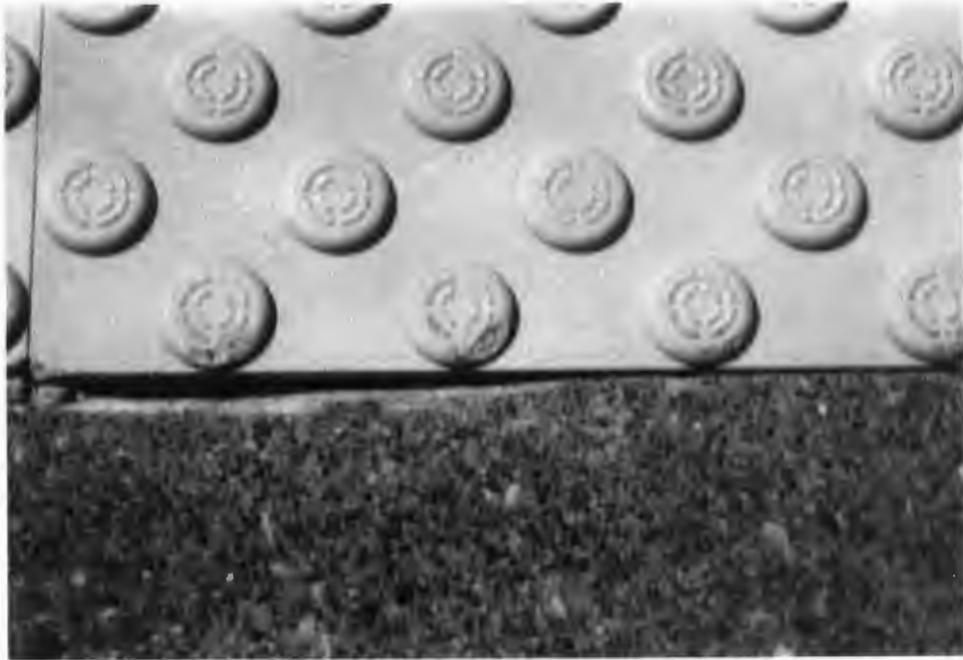
Figure 3-5
Transpo Industries: Step-Safe
Installation at GCRTA Triskett Street Station Illustrating Chipped Domes
(Photo Taken After 200 Exposure Days)

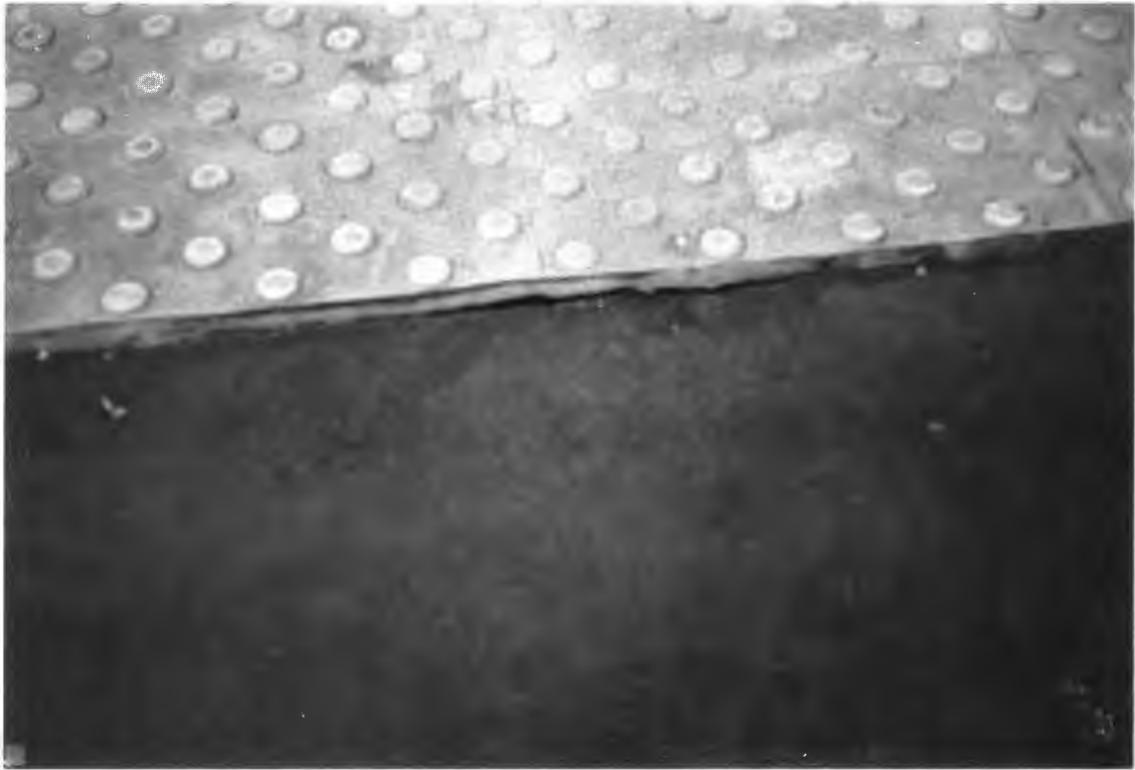
Selected results include the display of a portion of Rehau's Access Tactile Tile installation at 8th Street (see Figure 3-6). The caulking at the bottom edge has begun to loosen from both the tile and the platform surface.

Figure 3-6
Rehau: Access Tactile Tile
Installation at SEPTA 8th Street Station Illustrating
Lifting Tiles and Loose Caulking
(Photo Taken After 113 Exposure Days)

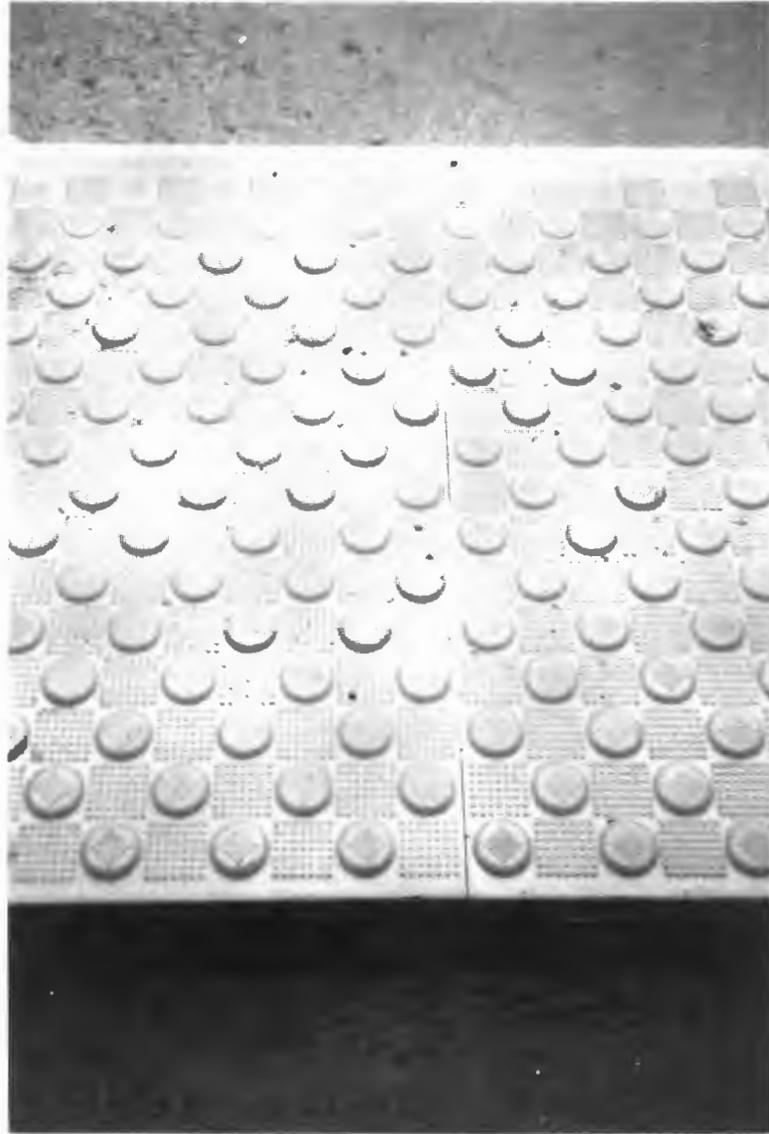
Figure 3-7
Engineered Plastics: Armor-Tile
Installation at SEPTA Bethayres Station Illustrating
Small Accumulation of Dirt and Sand
(Photo Taken After 87 Exposure Days)

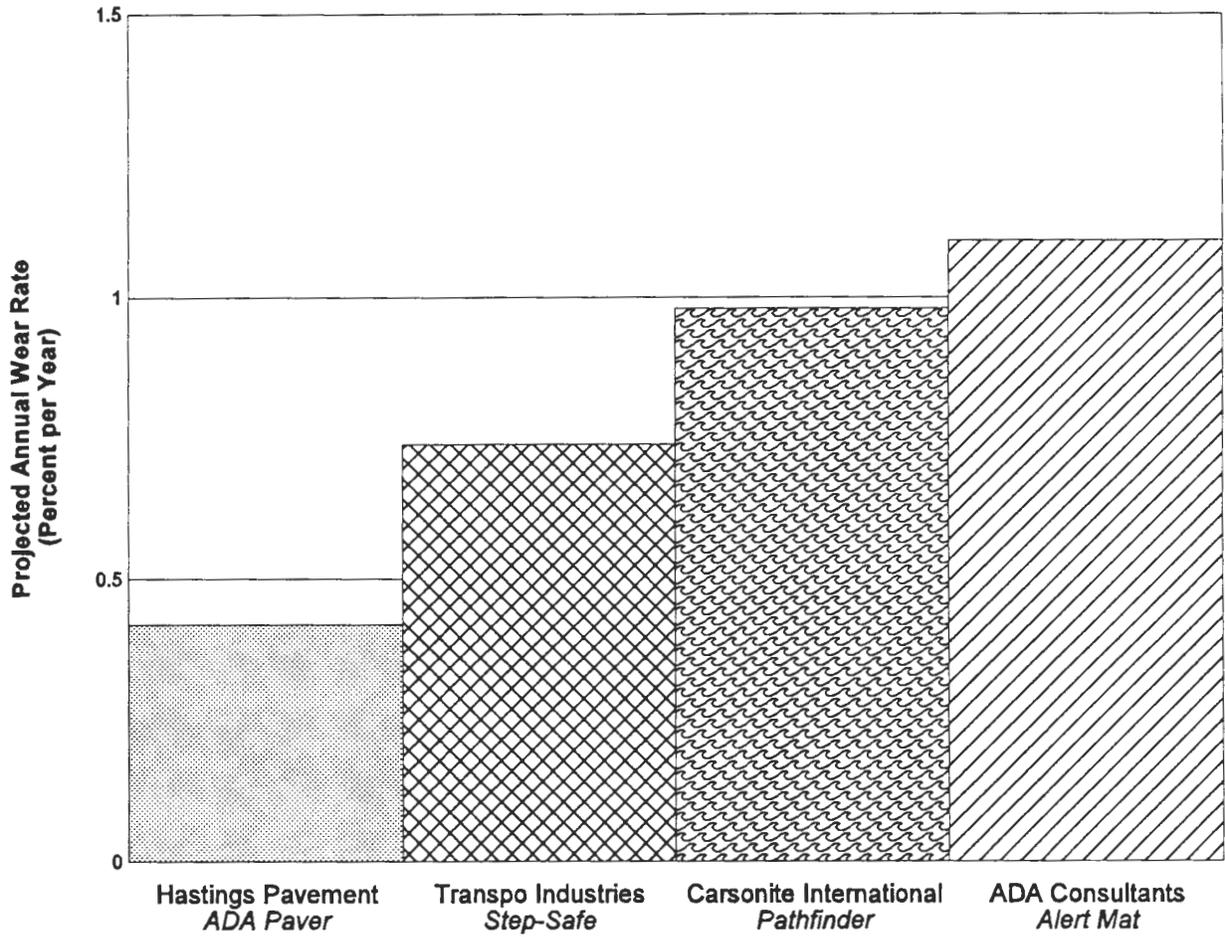
Figure 3-9
Projected Annual Wear Rate of Detectable Warning Materials at Platform Edge for
Low Passenger Volume Station at GCRTA (Brookpark)

Source: Measurements of Dome Height Wear for Approximately 7 Months at Interior Test Section at Brookpark Station.

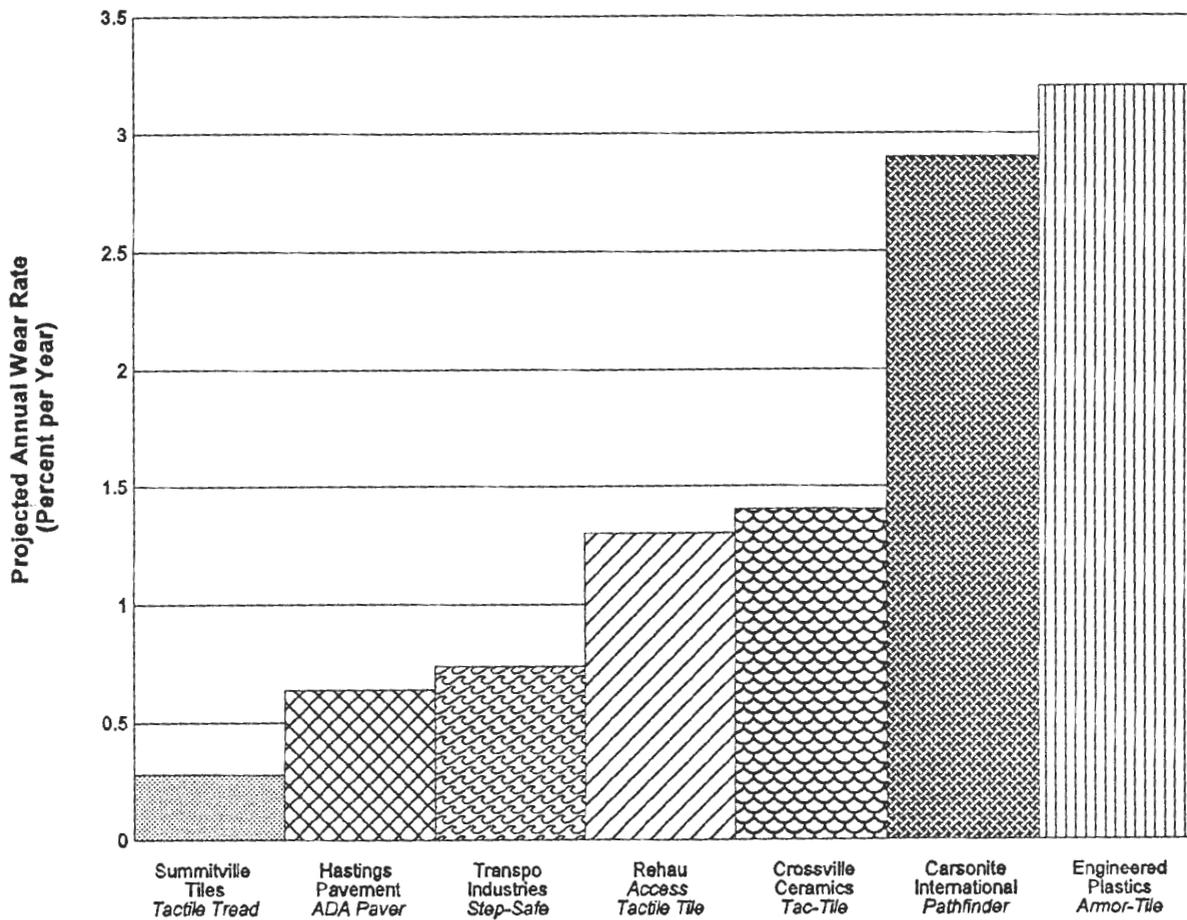
Figure 3-10 presents similar information on projected annual wear rates for the seven detectable warning materials installed at the MBTA South Station site. This station is a high passenger volume station with an estimated 16,275 passengers per day, approximately 25 times greater than that of the Brookpark station. In this case, the projected annual percentage wear rate ranges from a low of 0.28 percent to a high of 3.2 percent. The highest wear rate would result in a 32% average reduction in dome height over a period of 10 years, assuming that the rate remained constant over that period.

Figure 3-10
Projected Annual Wear Rate of Detectable Warning Materials at Platform Edge for High Passenger Volume Station at MBTA (South Station)

Source: Measurements of Dome Height Wear for Approximately 2.5 Months at Interior Test Section at South Station.
