REDLANDS PASSENGER RAIL PROJECT
Preliminary Geotechnical Evaluation
San Bernardino, San Bernardino County, California
December 2011

Subject: Preliminary Geotechnical Evaluation for SANBAG Redlands Passenger Rail
Project, San Bernardino County, California

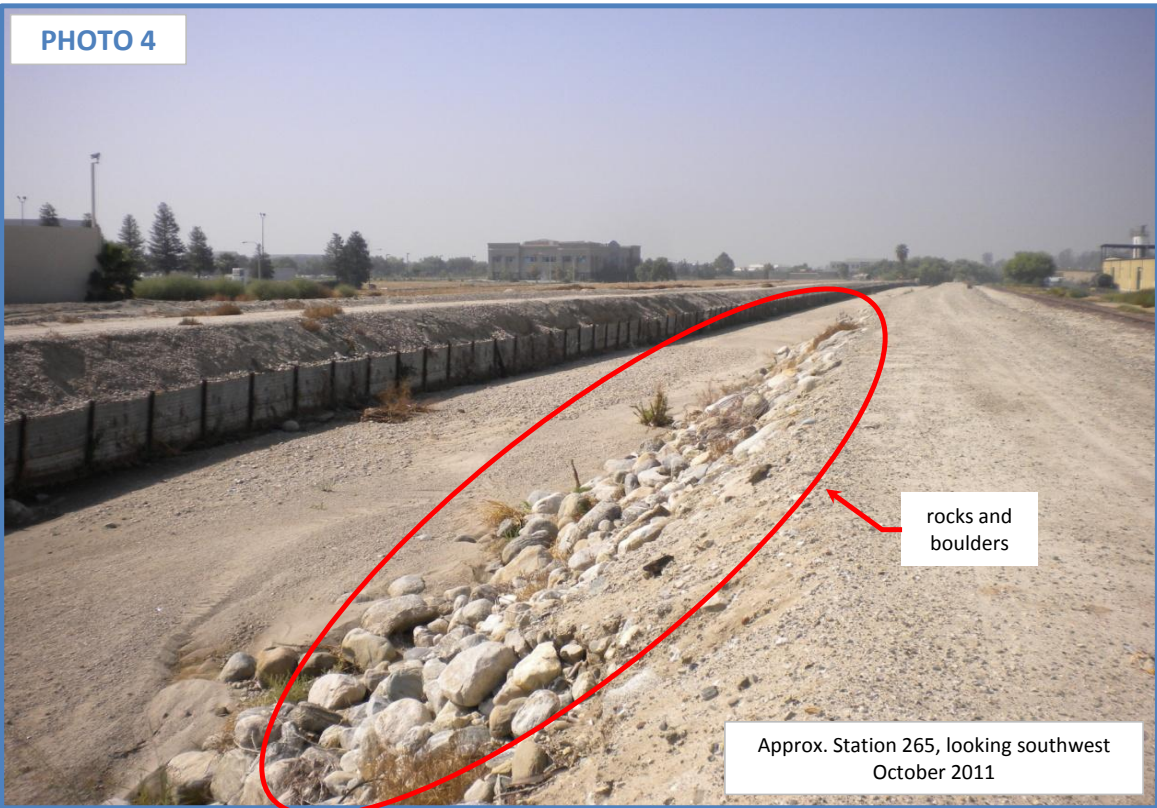
PHOTO 4

Station Nos	Photo Nos.	Existing Conditions
236+00 to 263+00	1 and 2	Slope face covered with trees, bushes and occasionally rocks
263+00 to 263+70	2 and 3	Concrete drop structure, approximately 11 feet in height
263+70 to 267+00	4	Rocks and boulders on slope face
267+00 to 269+00	5 and 6	Approximately 3 to 4 feet high of retaining structure at bottom of slope with rocks and boulders at bottom of Creek. Minor localized surficial/erosion failure or loss of soils behind retaining structure.
269+00 to 269+80	5 and 6	Tippecanoe Avenue Crossing
269+80 to 281+00	7	Unprotected slope face with gravel and cobbles and occasional rocks and boulders
281+00 to 290+40	8 and 9	Several localized surficial/erosion failures observed during site visit in March, 2011. Exposed slope face included garbage mixed with soils. New fills were already placed over localized failure areas during site visit in October 2011.
290+40 to 291+40	10	Retaining structure at bottom of slope with rocks and boulder at bottom of Creek. Encountered refusal on the south side of existing track at shallow depth due to possibly rocks and boulders.

rocks and boulders

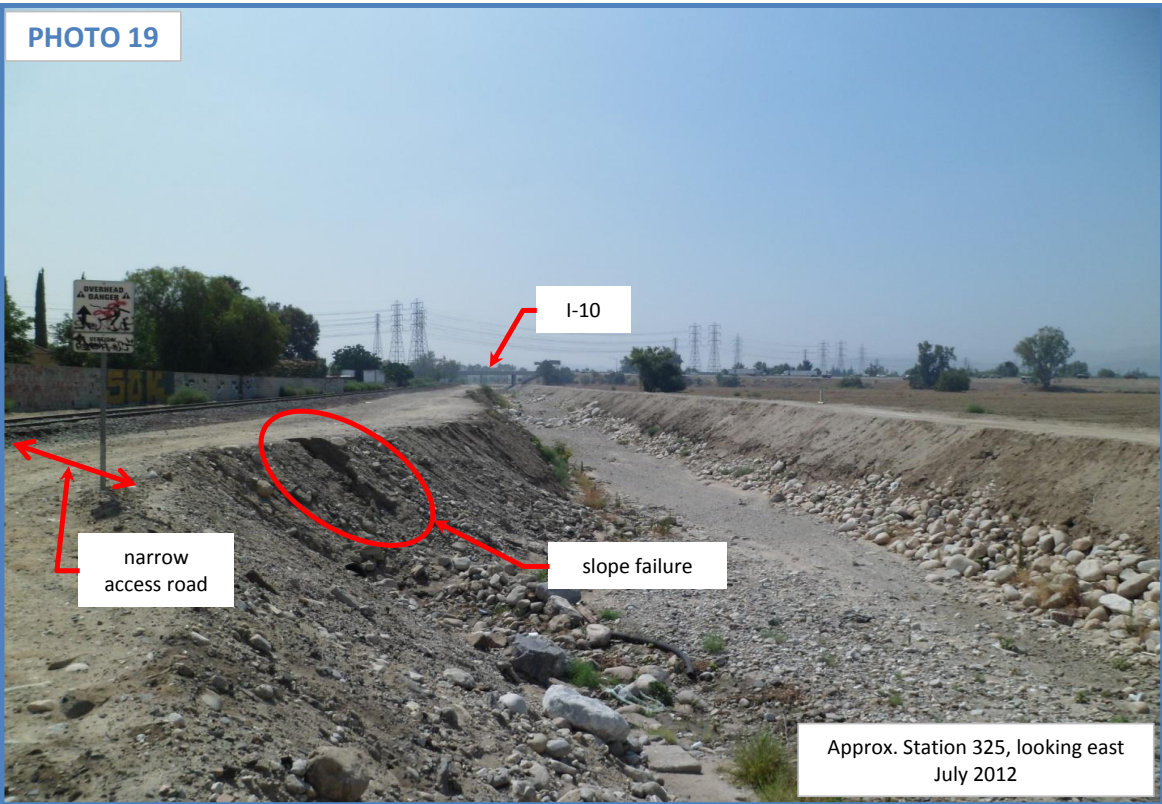
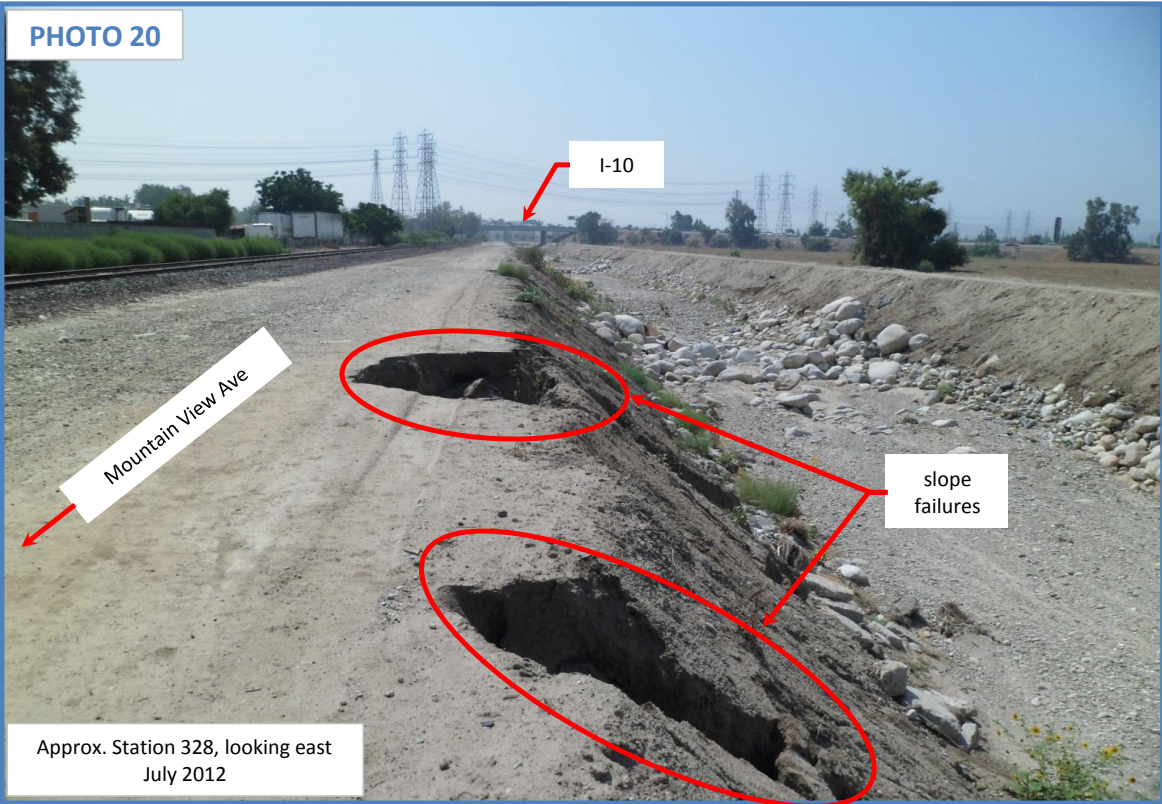
PHOTOS 19 AND 20
 MISSION ZANJA CREEK
 REDLANDS PASSENGER RAIL PROJECT
 COUNTY OF SAN BERNARDINO, CALIFORNIA

326+00	19	Narrow access road, possibly loose soils due to the drainage outlet to Creek. Local surficial failure observed
343+20 to 347+40	23 and 24	I-10 overcrossing with slope face covered with rock and cement grouting
347+40 to 364+00	25 and 26	Unprotected slope face with occasional rocks and boulders. Observed signs of new fills placed on access road and slope face along existing railroad track.

Also the existing slopes between Station Nos approximately 261+00 and 369+00 should be mitigated to minimize surficial/erosion failures. The artificial debris (garbage mixed with soils) observed within areas between Station Nos approximately 281+00 and 290+40 should be completely removed and replaced with compacted fill. An additional field exploration should be performed to verify our preliminary findings and recommendations within the above-named portion of the alignment.
