Middle-of-the-Night Inspiration Solves Engine Overheating Problem

- Road calls dropped from 10 a week to 3 a month

By RICH MORALLO

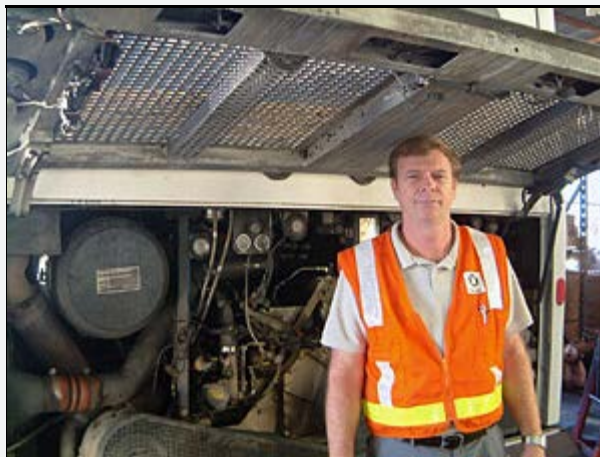
The delicate wiring connection is located deep on the left side of the engine. The fan clutch wiring is typically clipped to an iron bar and is connected with other wires at its location.

Tom Whitman's mystery: Why and how was the wiring that runs the cooling fans inside bus engine compartments breaking?

Glove-wearing attendants were accidentally pulling the cooling fan wires – which are located adjacent to the engine oil dipstick – out of their sockets when they checked the engine oil.

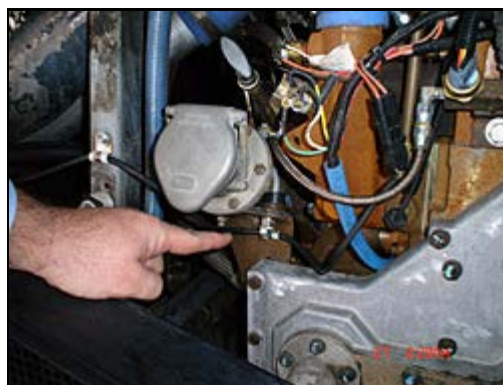
The wiring for the engine cooling fan is now tucked away from the engine oil dipstick to avoid accidental disconnection.

As the buses came through for inspection, he had his mechanics reroute the wiring around the engine oil dipstick to avoid damaging the wiring.
