CRENSHAW/LAX PHOTOGRAPHIC UPDATE

October 30, 2020

Crenshaw/LAX Transit Project

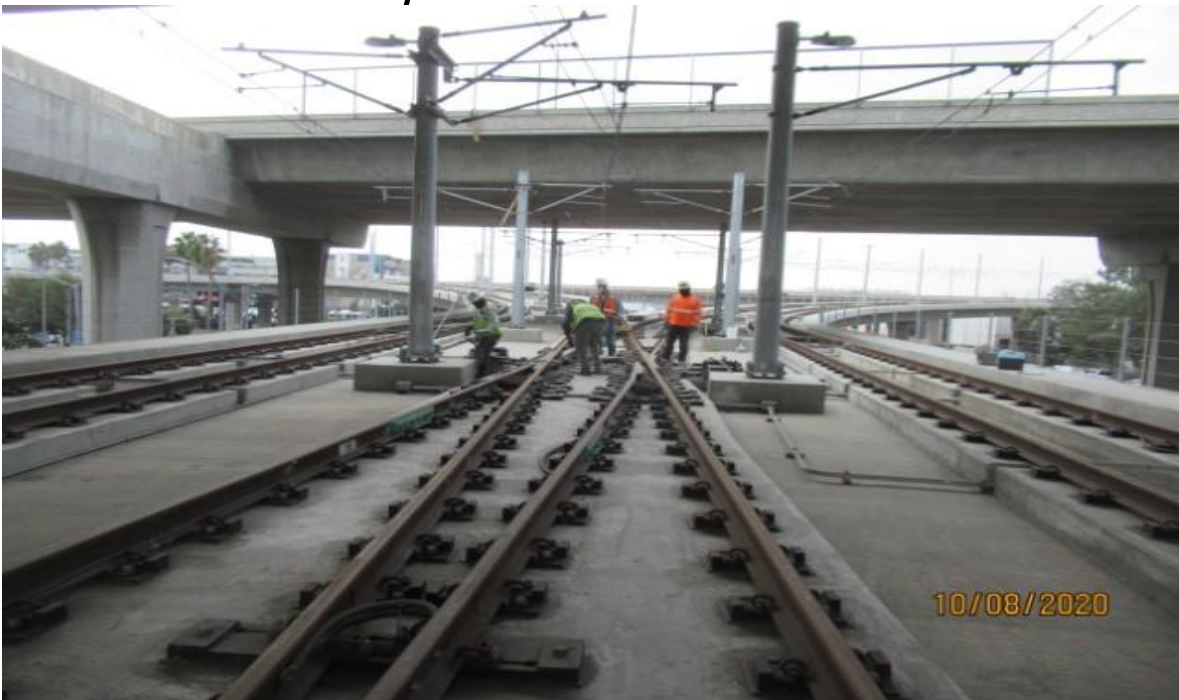
Guideway- WSCC/LKC personal at GL Wye for MPF repair work on plinth (looking south)
Rework

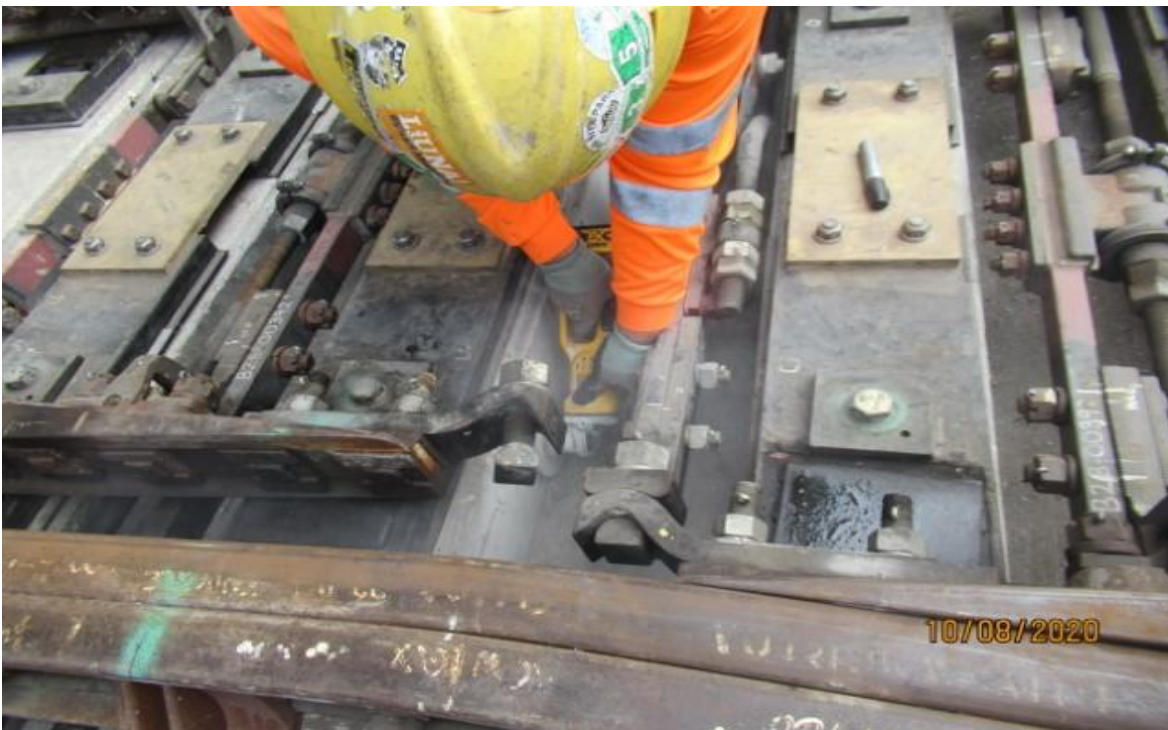
Guideway- WSCC using hand grinder to shave down switch machine plinth, to clear point
protector rod at GL Wye Rework

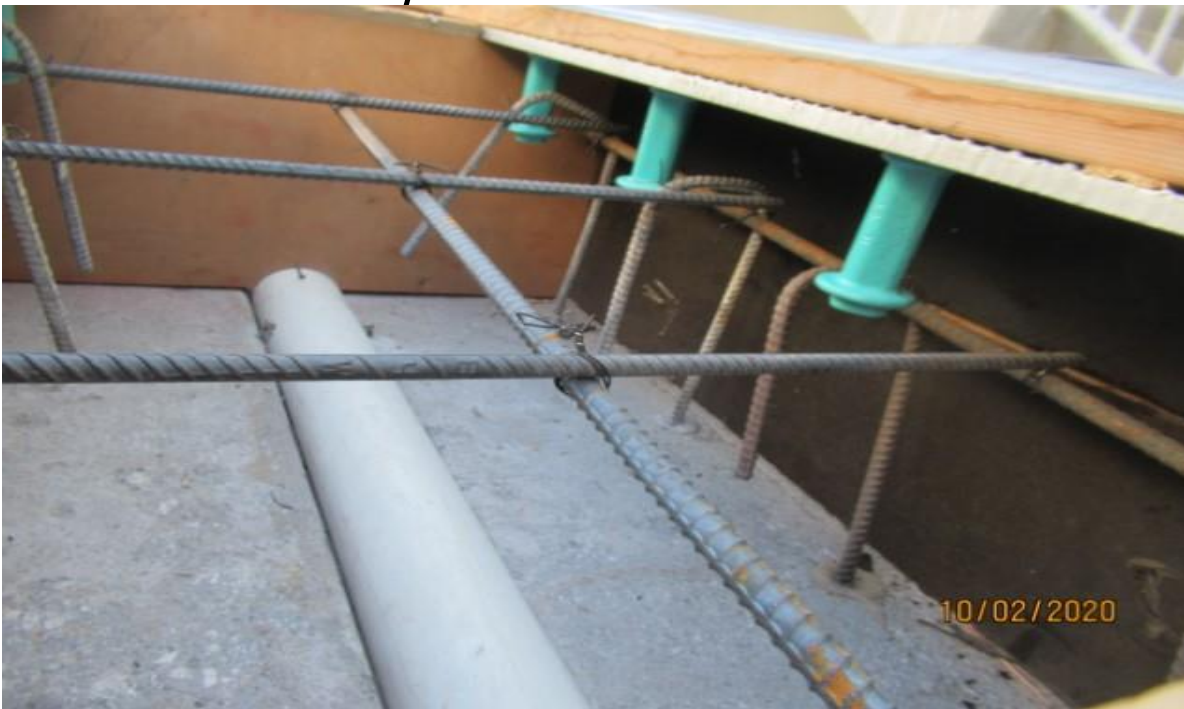
UG1- Emergency walkway crossing foundation showing adequate stirrup & elongated reinforced rebar prior to placing concrete into foundation UG1 NB track STA 56+50 Rework

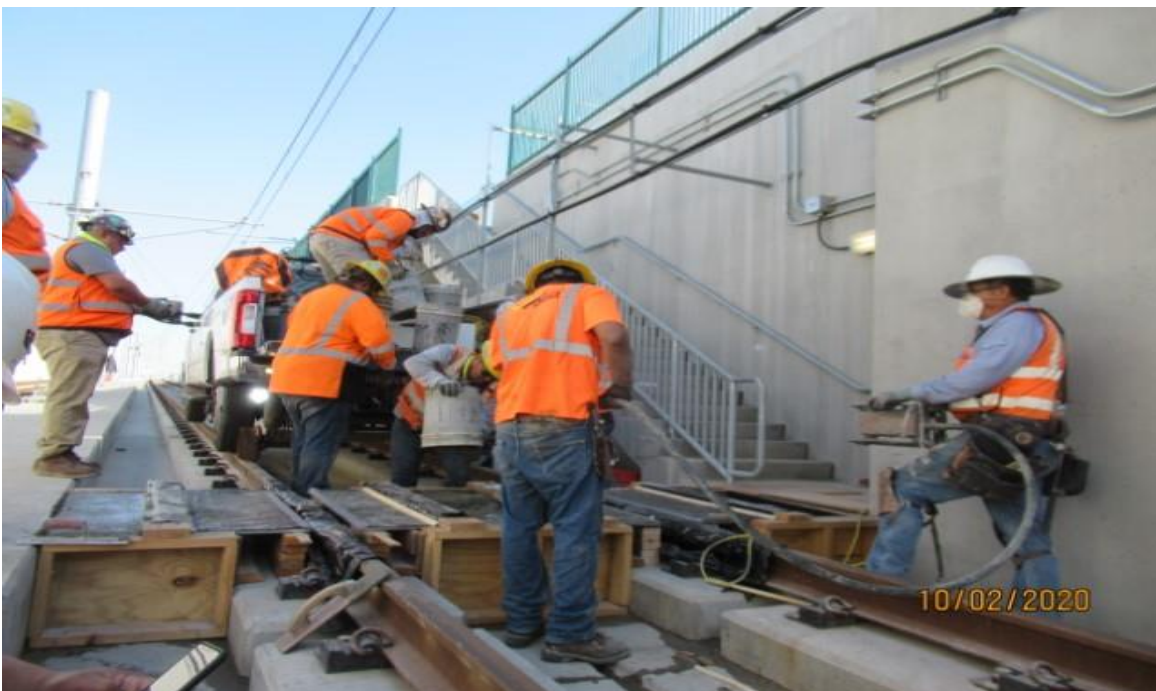
UG1- WSCC placing concrete for newly re-located Emergency Walkway Crossing foundations UG1 NB track STA 56+50 (looking northeast) Rework

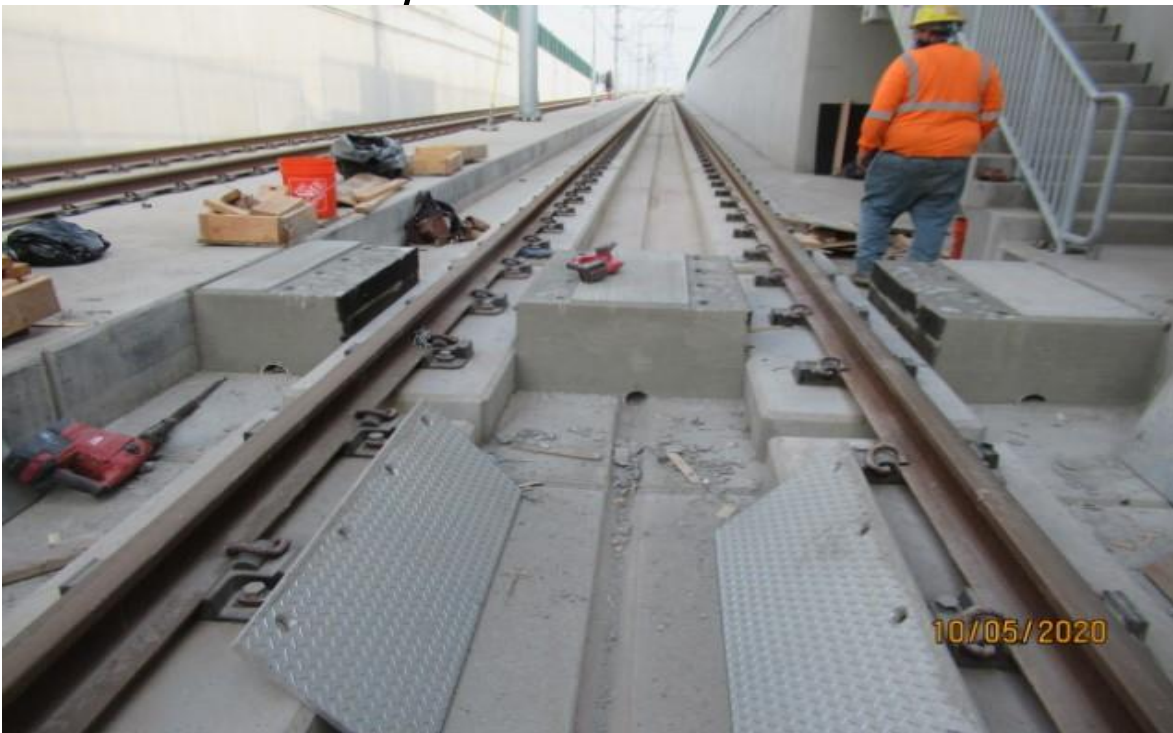
UG1- UG1 NB track STA 56+50 WSCC preparing to bush & butter top of Emergency Walkway Crossing foundations (looking north) Rework.

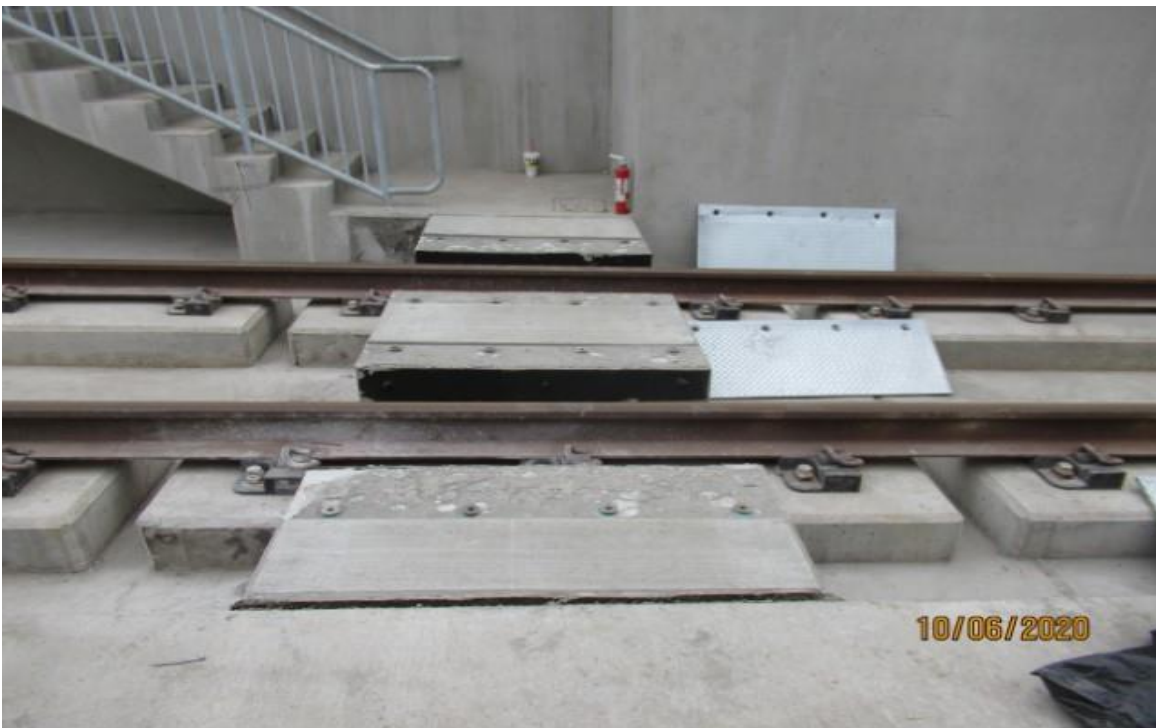
UG1- UG1 NB track STA 56+50 Emergency Walkway Crossing foundation on-going repair work for re-location on crossing (looking east) Rework.

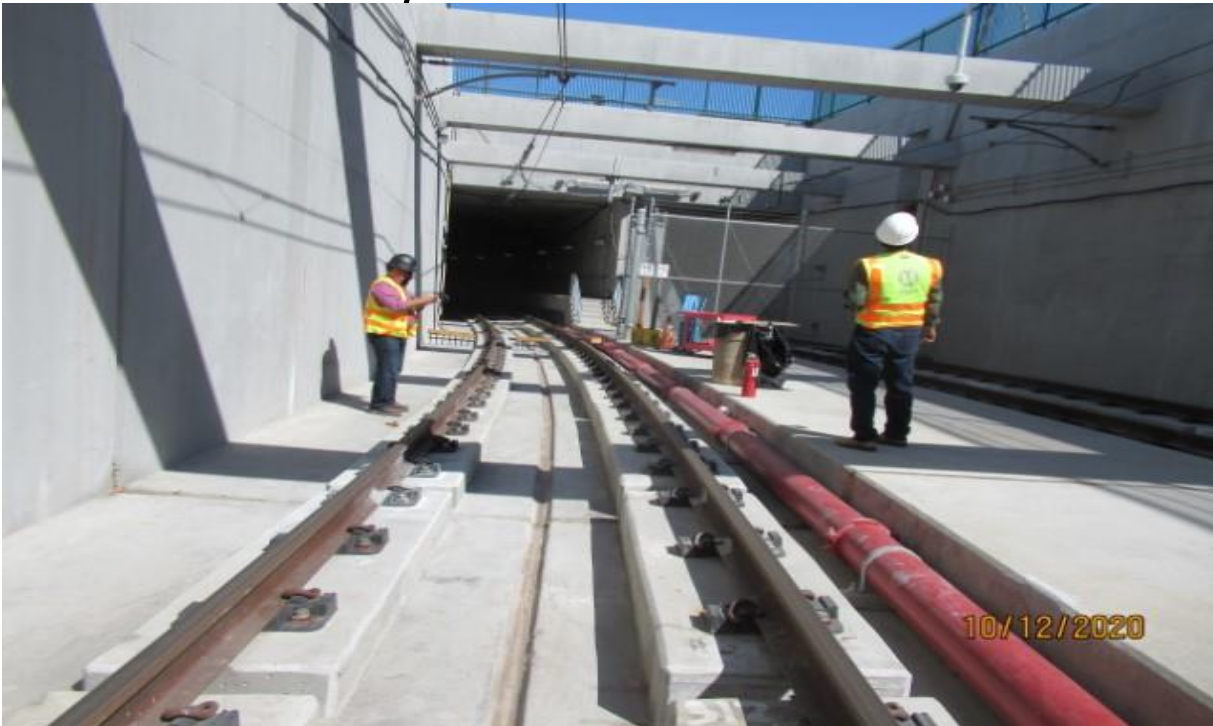
UG1- Field walk with Metro CM team at UG1 south portal SB track STA 281+90 to evaluate cut & cover wall (looking north)

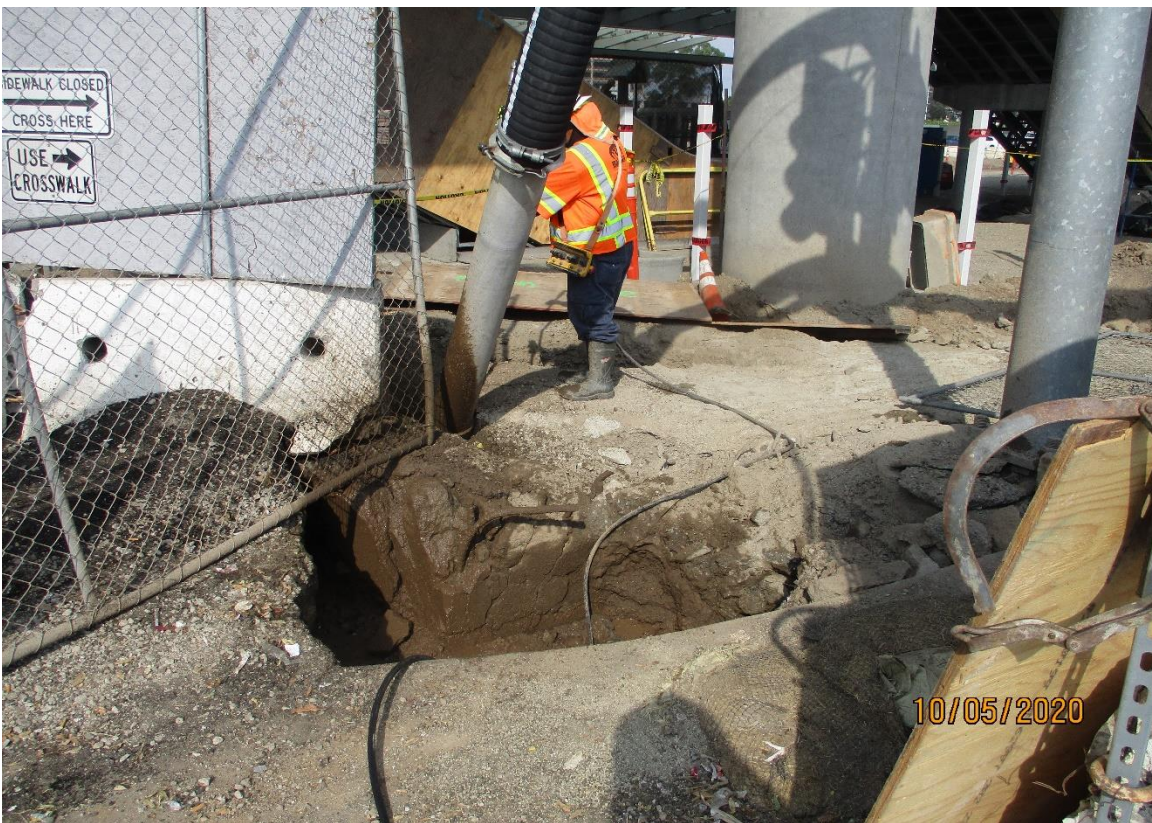
AVIATION/CENTURY- Daylighting a foundation in conflict with the traffic signal conduit on the NEC of Century and Aviation.

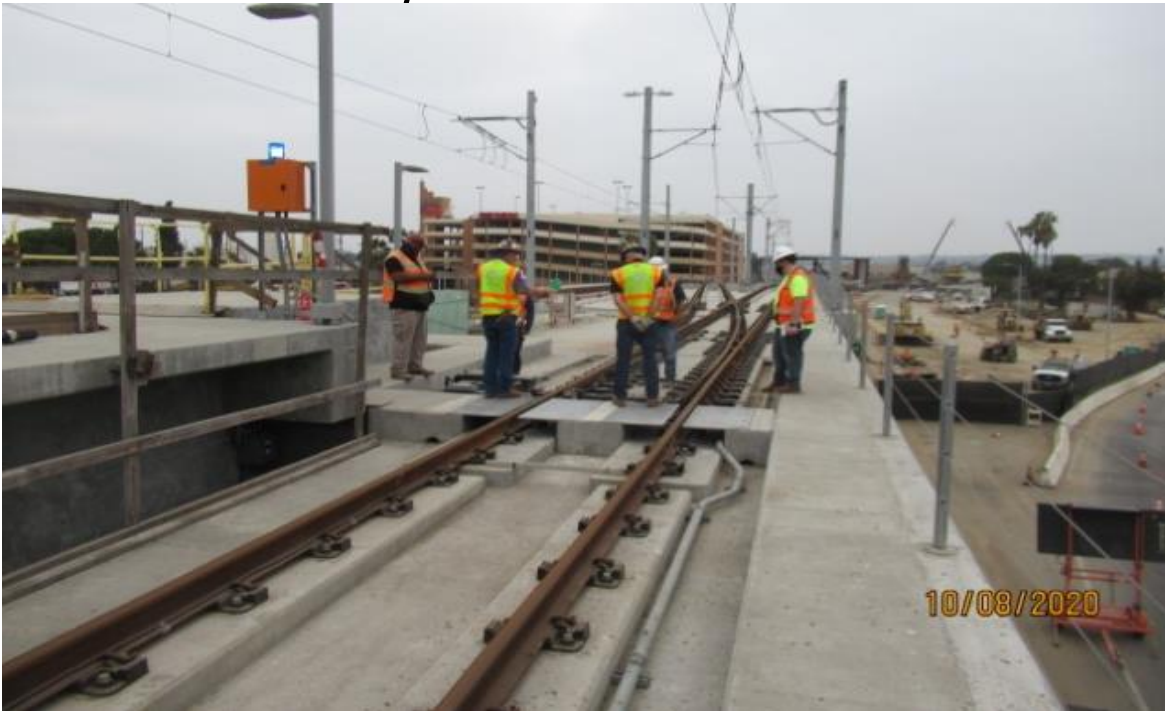
AVIATION/CENTURY- WSCC & Metro CM field walk on Century/Aviation OP NB track at 10K1LHXO.

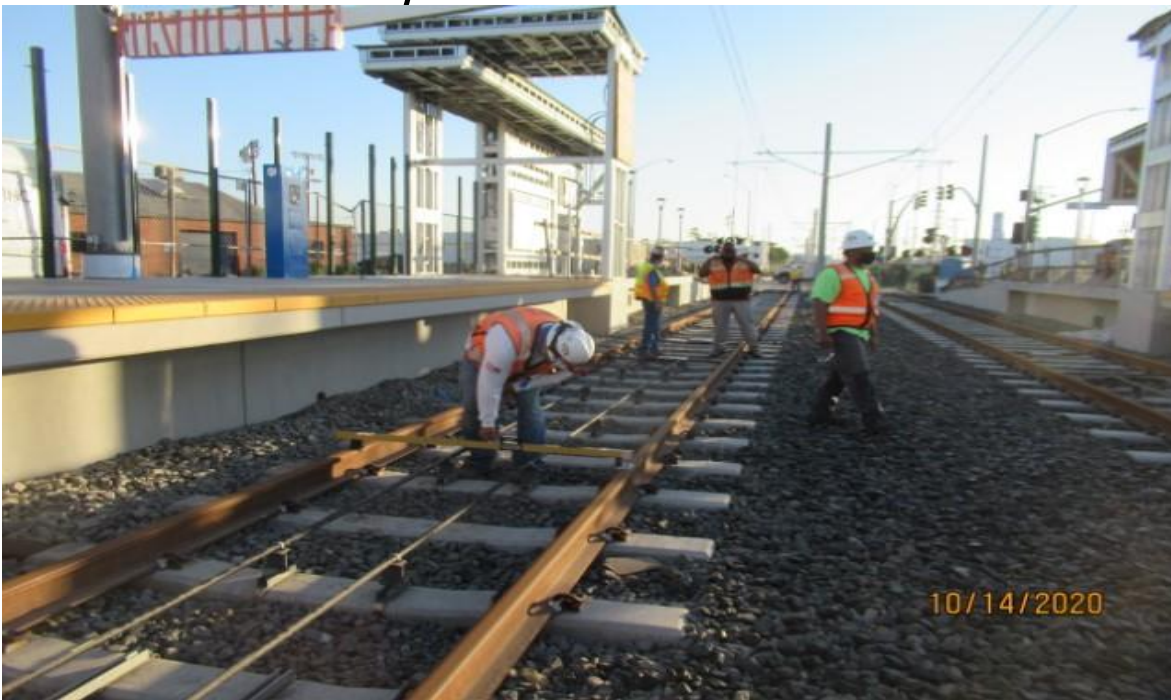
Hindry – Field walk with WSCC & Metro CM personal at Hindry station, evaluating track & overall guideway condition (looking north)

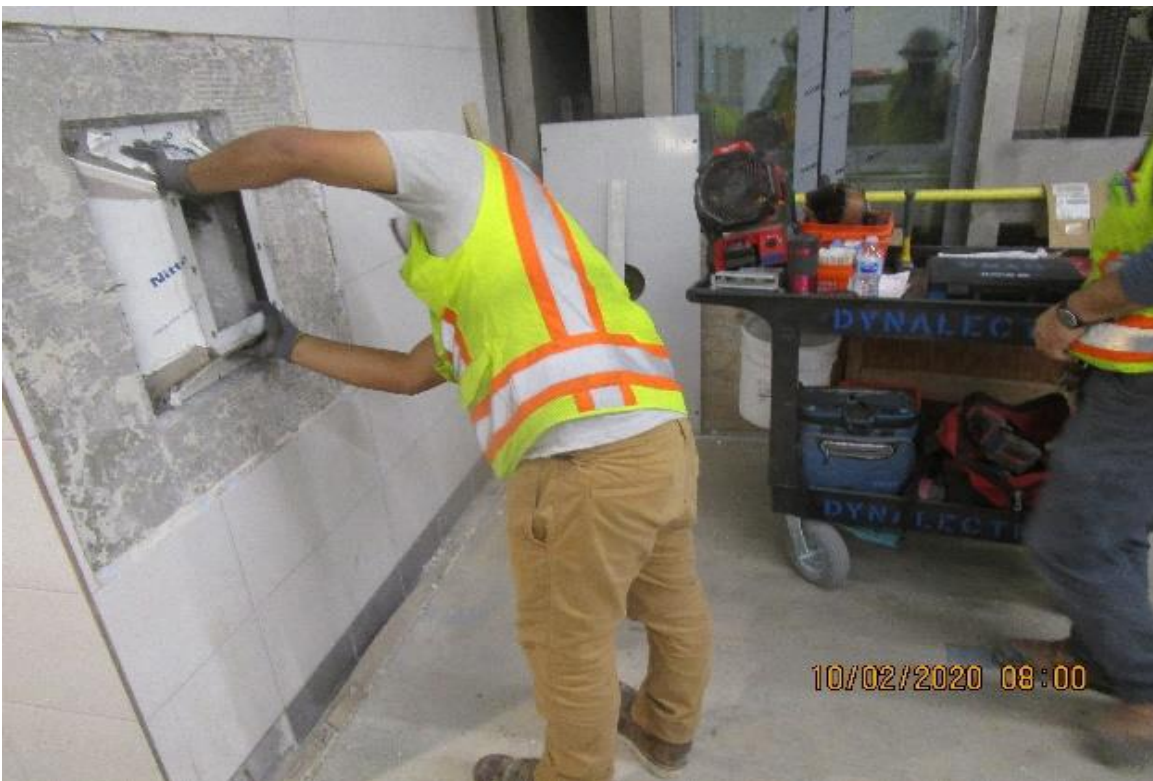
Crenshaw/Vernon – Vernon, Free Area C129, MTEL-17 Resume rework & rough in stainless steel shroud (No Metro Approval)

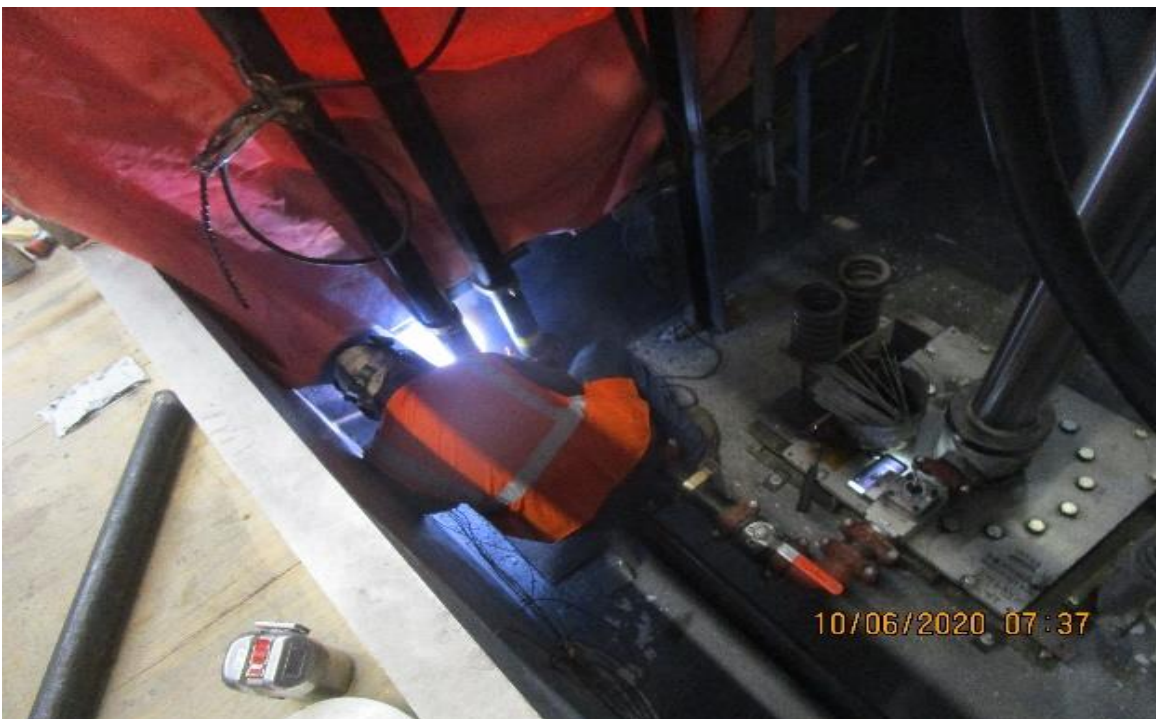
Crenshaw/Vernon – Vernon Platform, Elevator 1 & 2 pit, 3" hydraulic fluid feed lines, welding of leaking piping connections

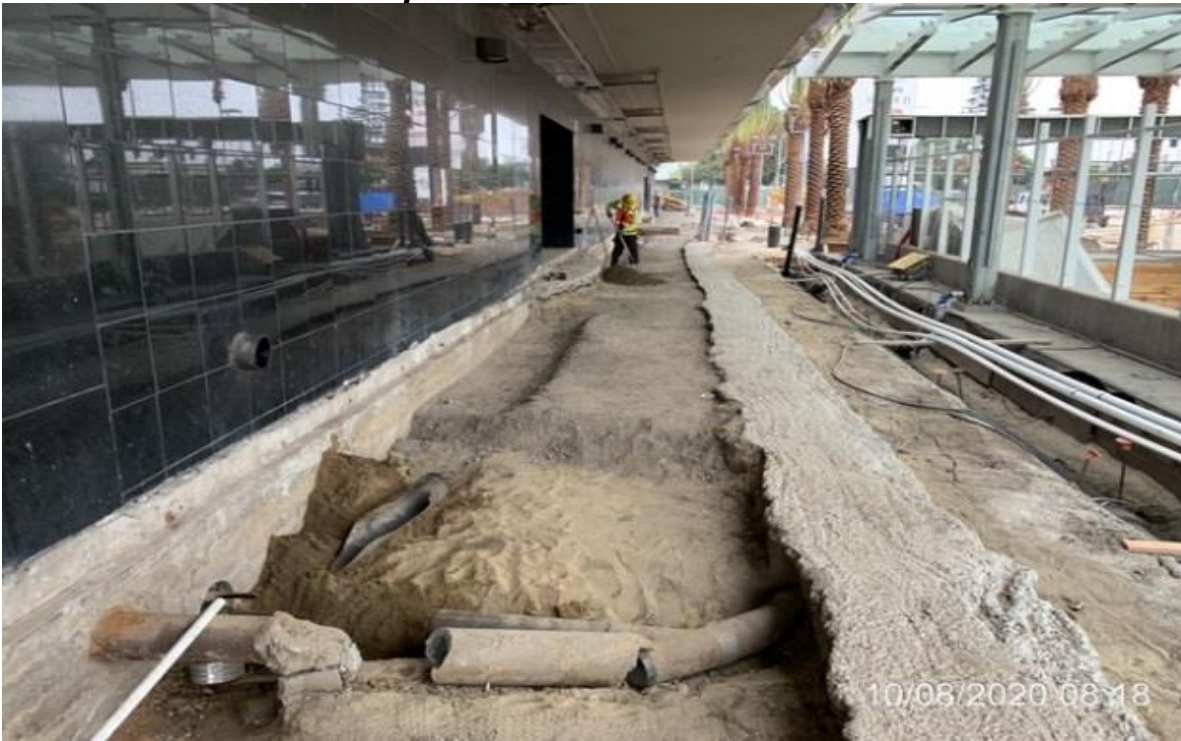
MLK STATION – WSCC crew hand digging to expose damaged drain pipes for repair.

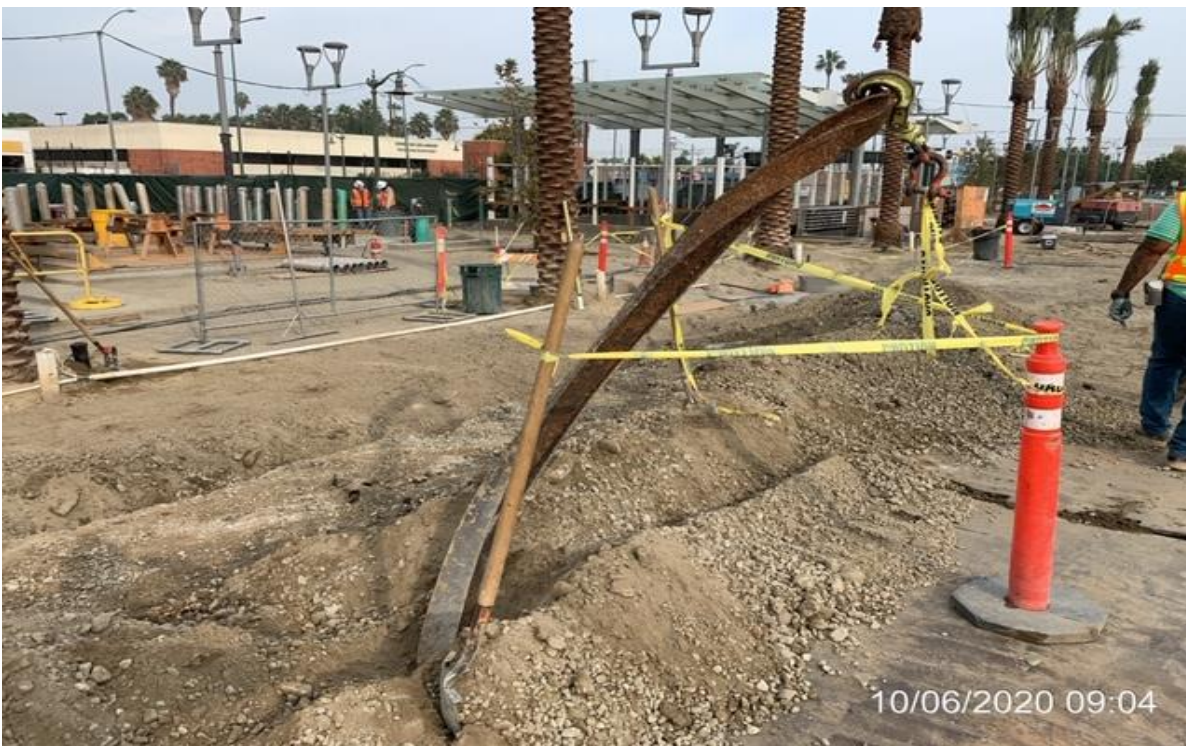
EXPO STATION– Large metal piece observed protruding from yard needs removal.

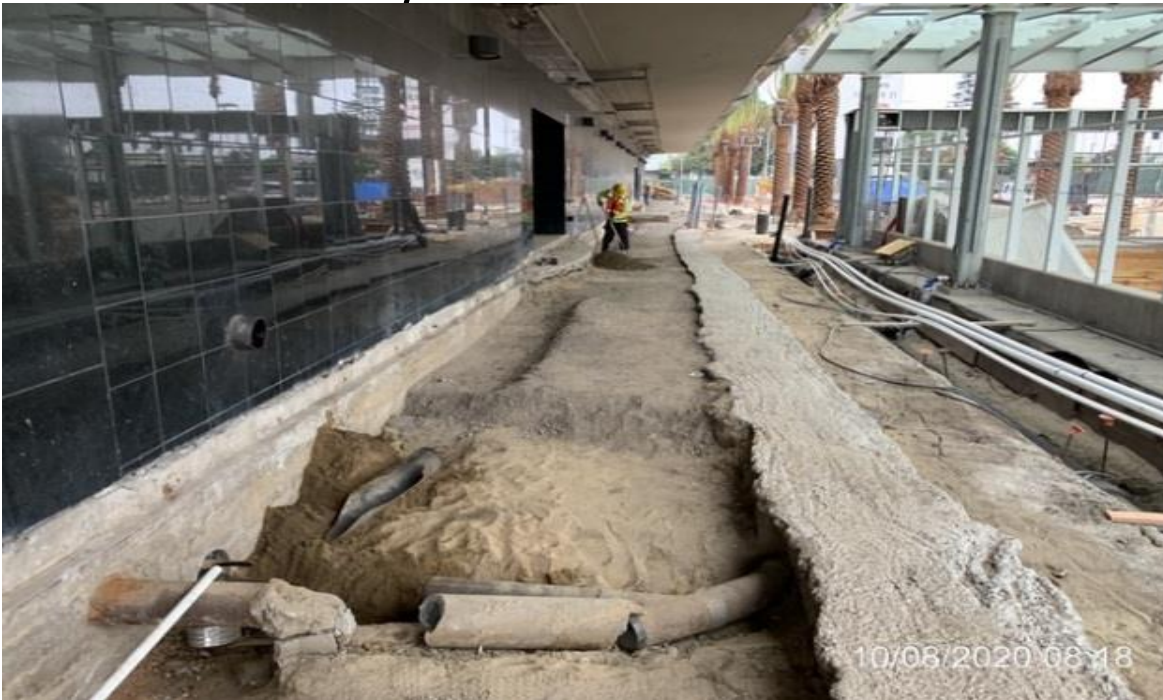
EXPO STATION SITE – WSCC crew hand digging to expose damaged drain pipes for repair.
