# CRENSHAW/LAX PHOTOGRAPHIC UPDATE

Dec 30, 2020

## Crenshaw/LAX Transit Project

Overview of trackwork progress issues for 11/30/2020 – 12/15/2020  
(Please note the attached Trackwork Progress Tracking Report)

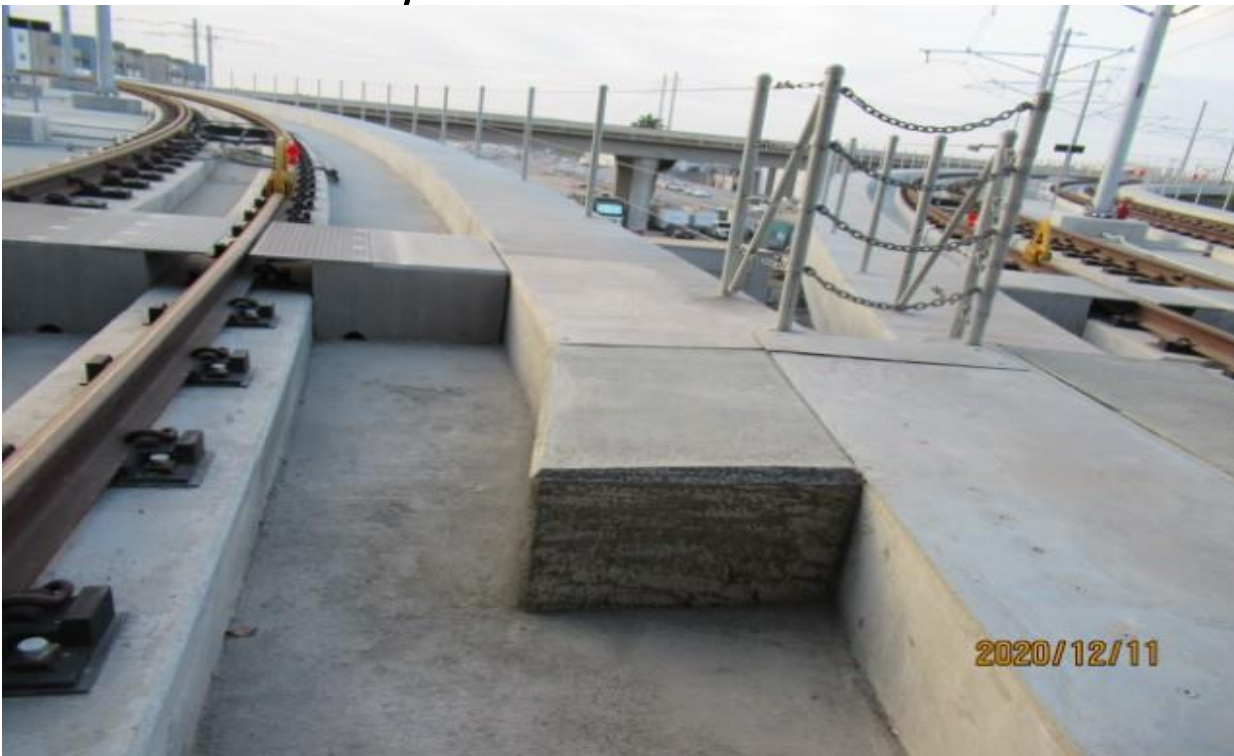
AVIATION/CENTURY - East leg of Wye WSCC placed extension on Emergency Walkway.

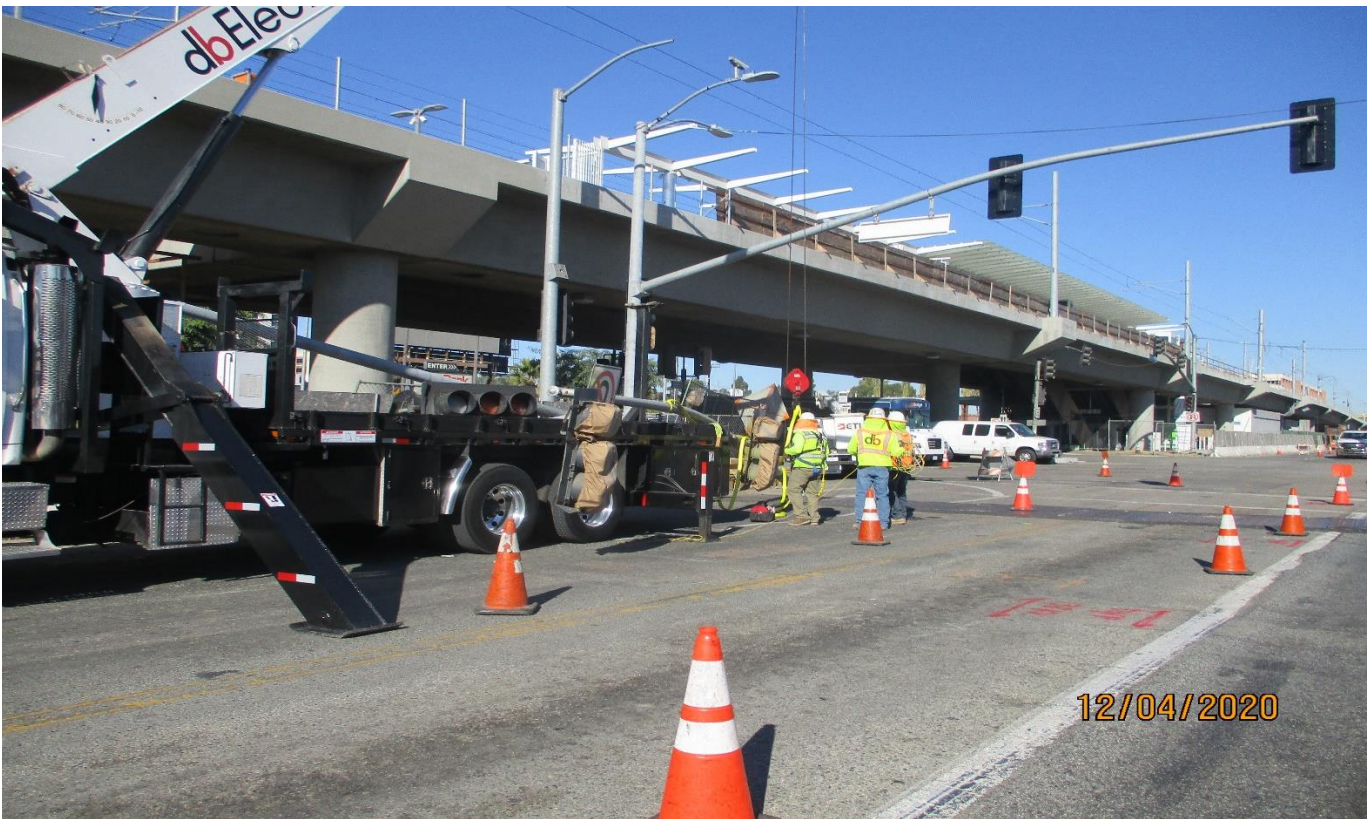
AVIATION/CENTURY- Traffic signal pole removal at Aviation and Century.

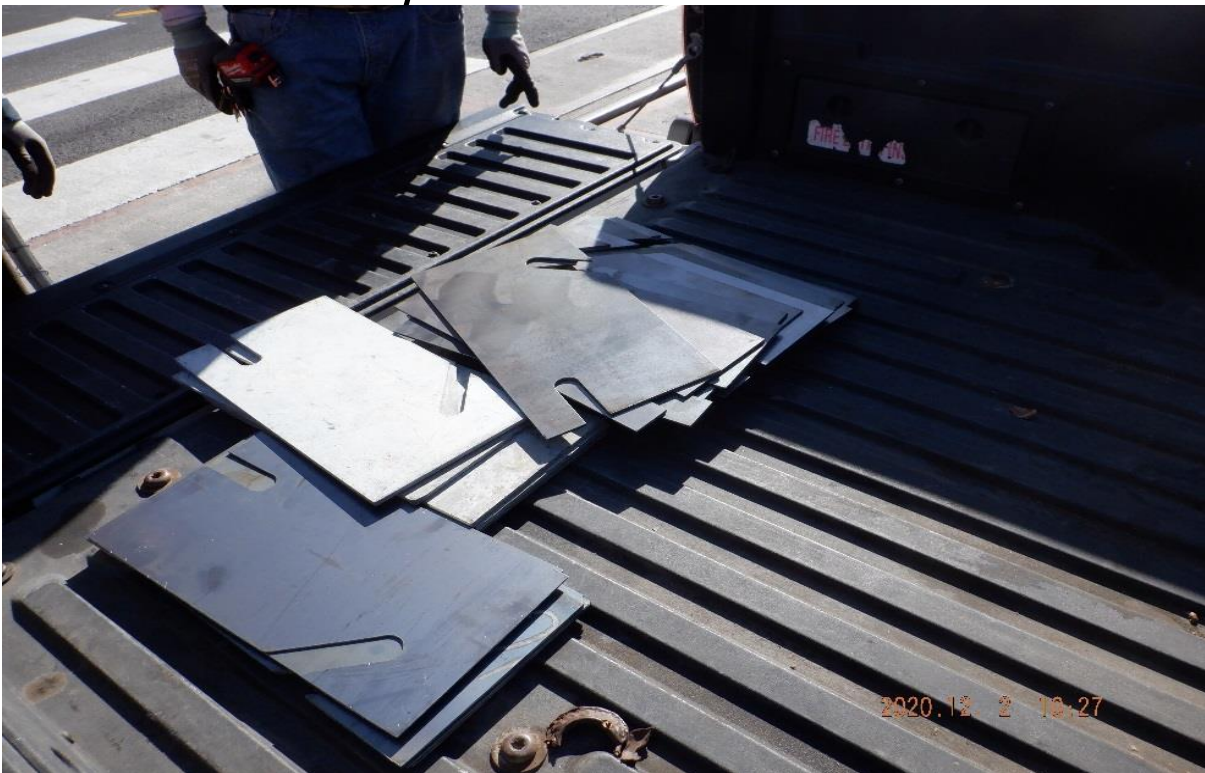
UG4 – STA 364+00 TK#4/NB – shim material delivered in UG4 does not look to be galvanized steel nor stainless steel (left & right pile)

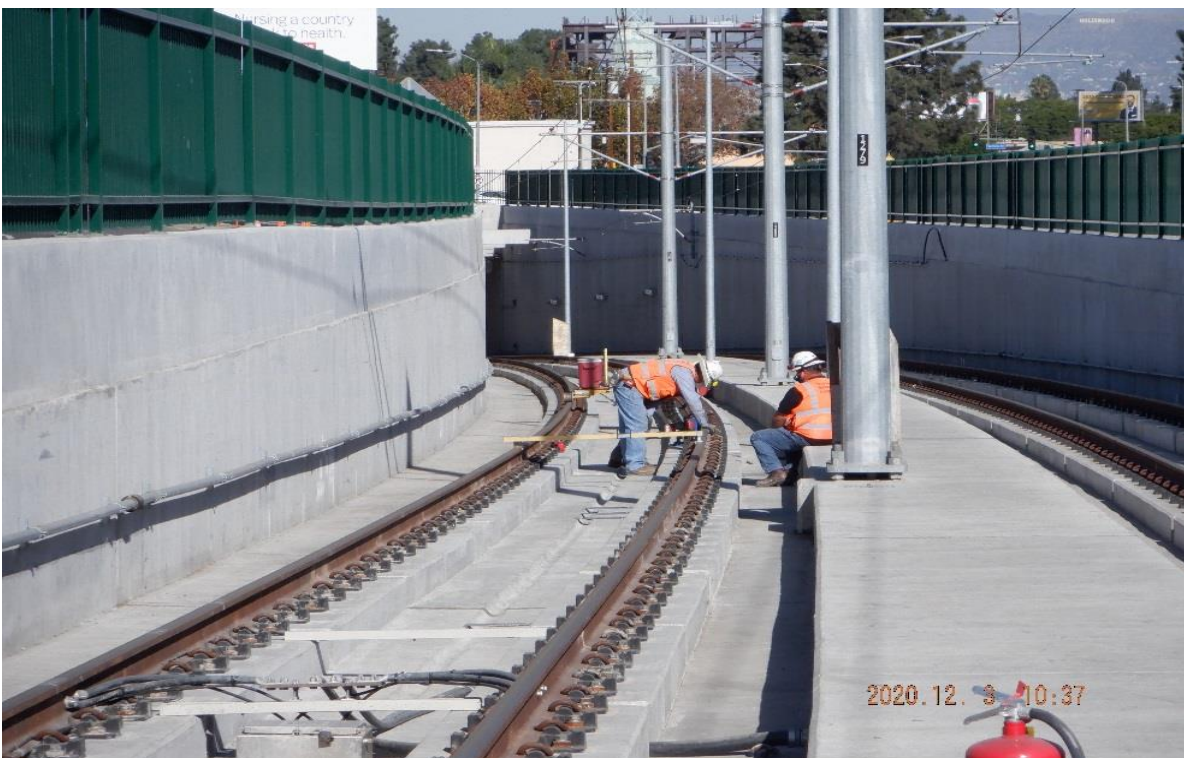
UG4 – STA 365+20 TK#3/SB looking north – shimming curve SB-33 of UG4 south portal.
