August 1, 2019

Crenshaw/LAX Transit Project

Segment A

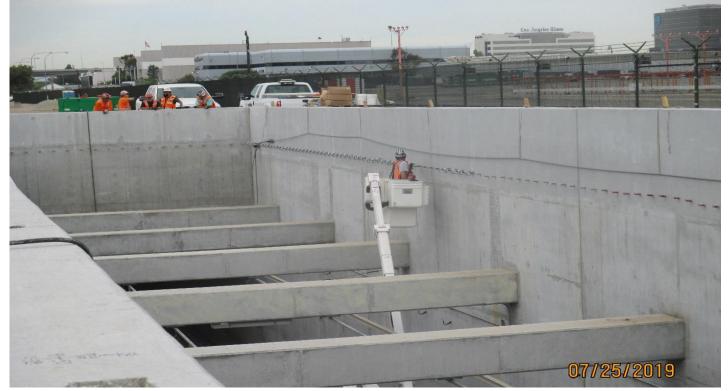
UG1- Cable barrier installation.

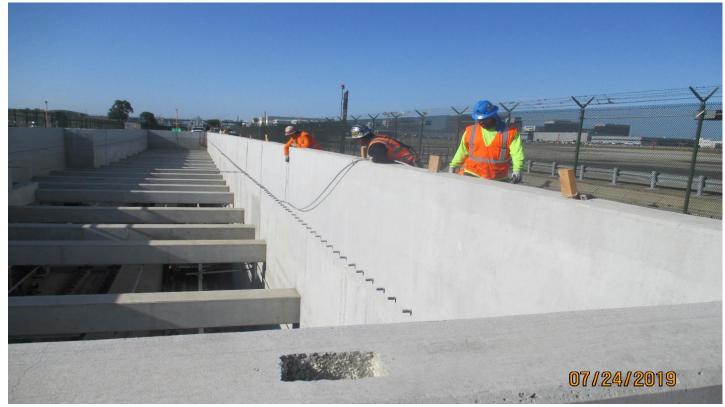
UG1- Cable safety barrier installation.

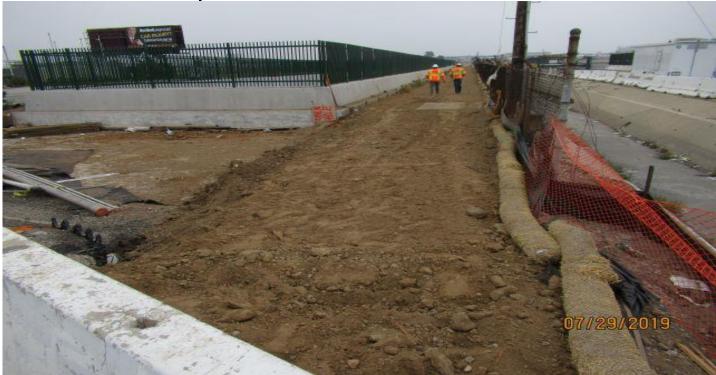
UG-1- 104th street south side no changes for UG1 Jet Fan conduit install.

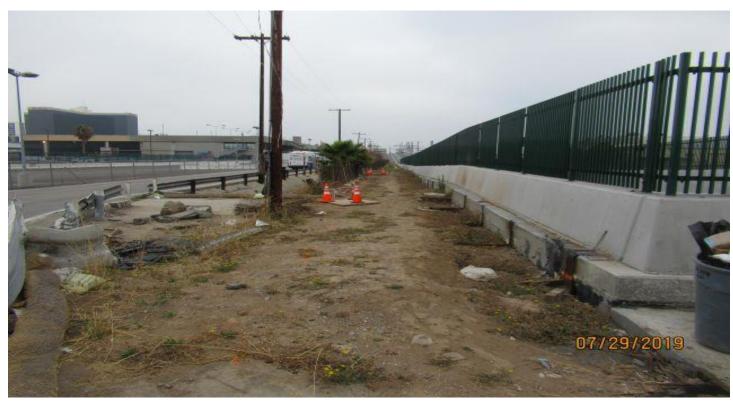
UG-1- 104th street north side no changes for UG1 Jet Fan conduit install.

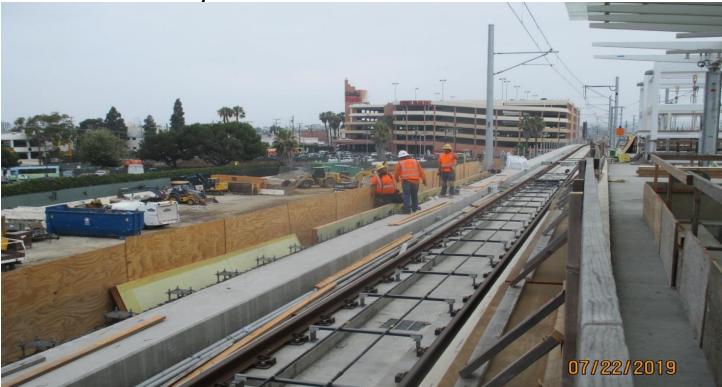
AVIATION/CENTURY- Reinstalling the galvanized fence anchor bolts at the Aviation Station

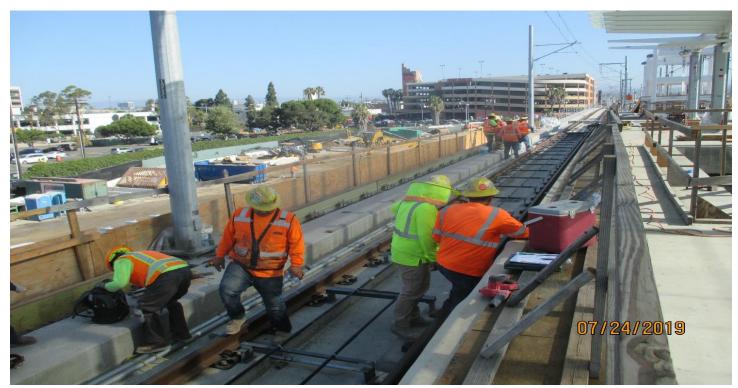
AVIATION/CENTURY- Galvanized fence anchor bolt replacement at the Aviation Station.

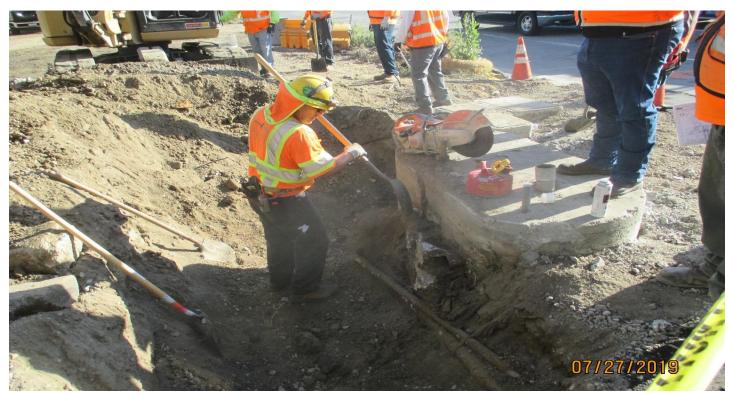
AVIATION/CENTURY- Existing foundation to be removed at the NW corner of Aviation.

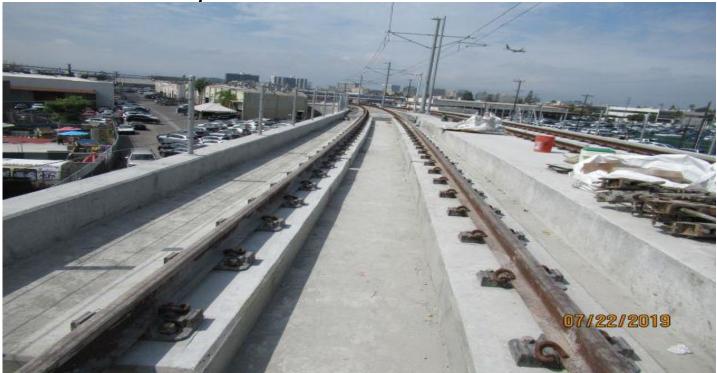
MANCHESTER BRIDGE- SB track at Manchester Bridge DF replacement work.

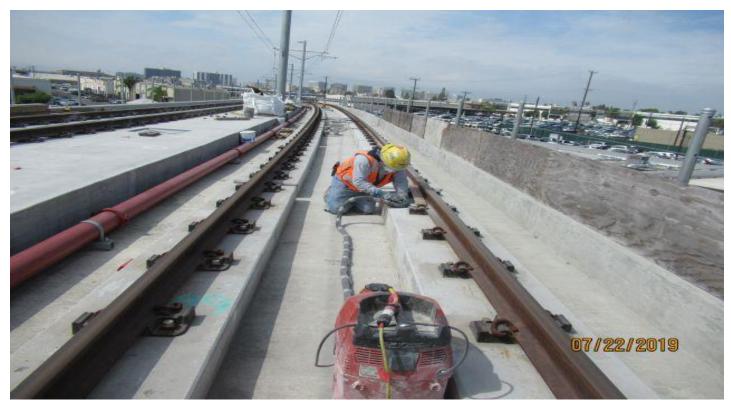
MANCHESTER BRIDGE- NB track WSCC finisher hand grinding plinths for 0" plane.

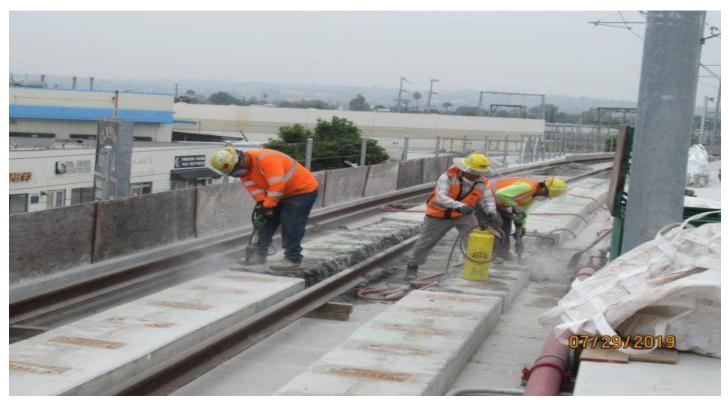
MANCHESTER BRIDGE- WSCC demoing out DF plinths that don't conform to Metro tollarances on Manchester Bridge SB track ..
