December 1, 2019

Crenshaw/LAX Transit Project

Segment A

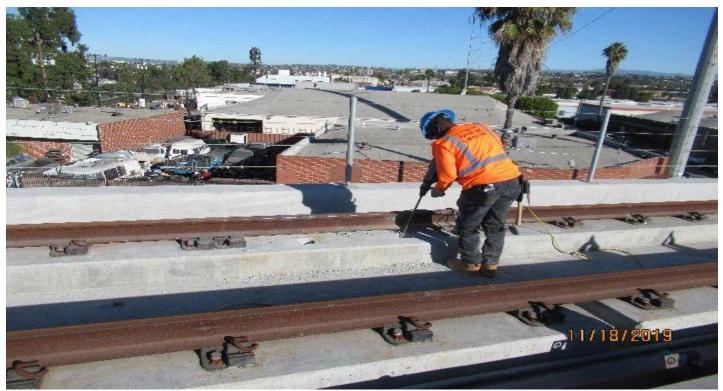
GUIDEWAY AT 405- WSCC chipping out concrete around insert hole on SB #3 track 405 fwy OP.

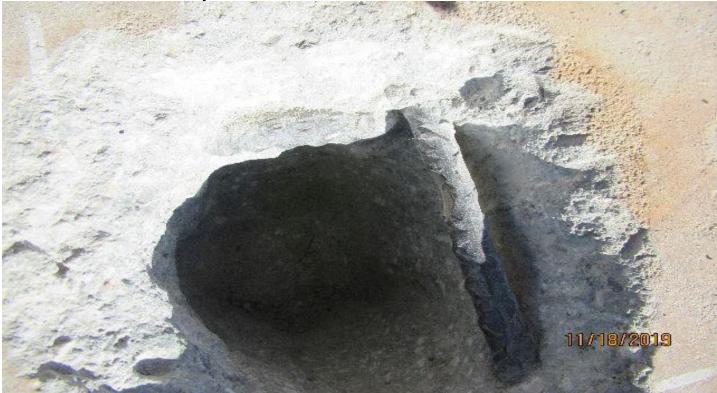
GUIDEWAY AT 405- Damaged strip rebar while coring insert on SB #3 track 405 fwy OP.

GUIDEWAY AT 405- WSCC preforming repair work on SB #3 track 405 fwy OP.

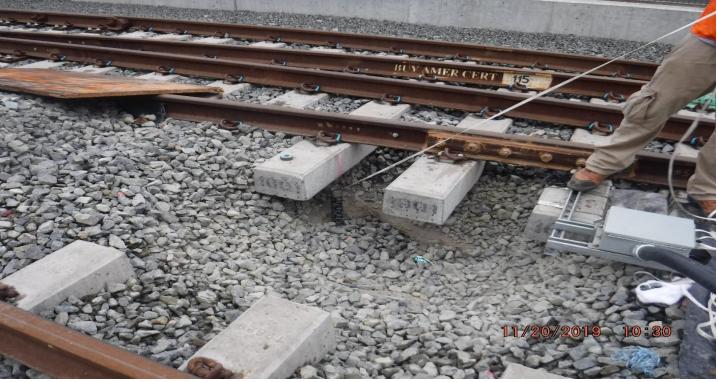
HIGH STREET - STA245+15_ Looking East_ Disturbed track ballast_ PUNCH LIST_S616.

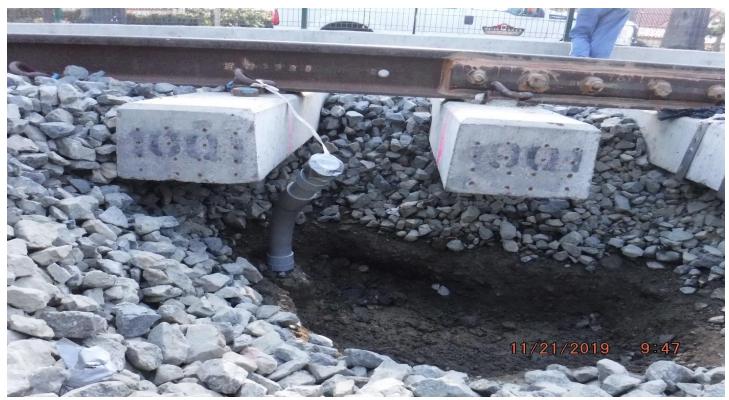
HIGH STREET - STA245+15_ Looking East_ Disturbed track ballast_ PUNCH LIST_S616.

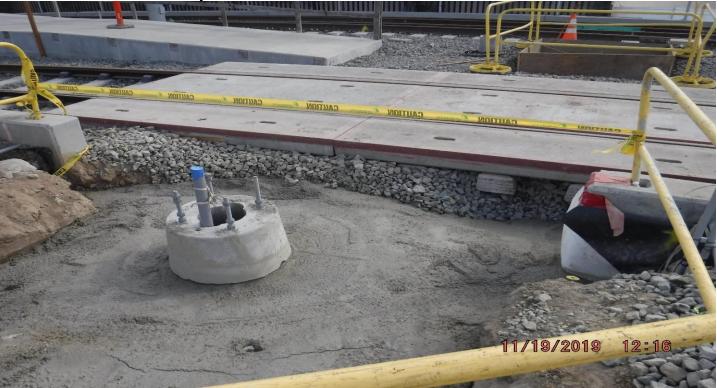
FLORENCE/WEST - STA262+74_ Looking East_ Disturbed track ballast_ Slurry pour.

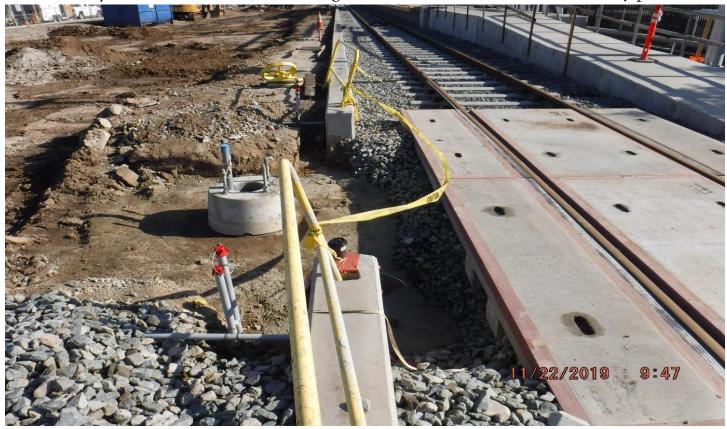
FLORENCE/WEST - STA262+74_ Looking North_ Disturbed track ballast.

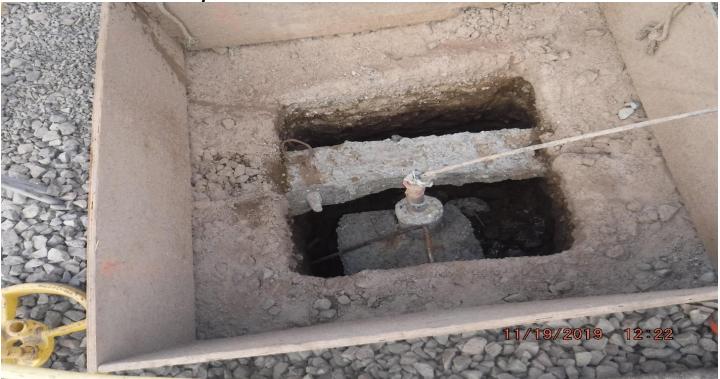
FLORENCE/WEST – STA262+74_ Looking Down_ Vacuum Excavation_ Disturbed track ballast.

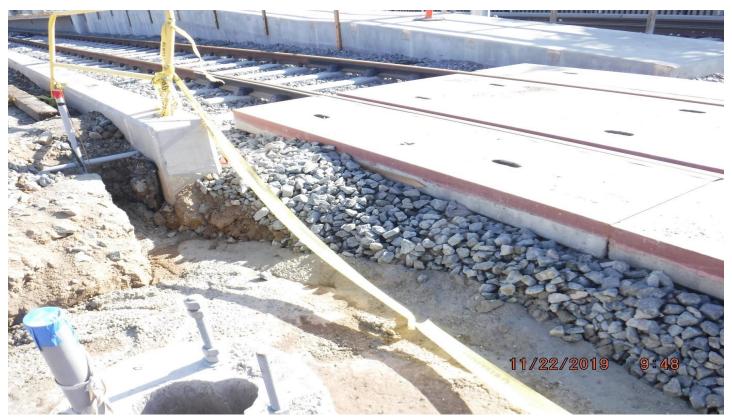
FLORENCE/WEST – STA262+68_ Looking North_ Disturbed track ballast.

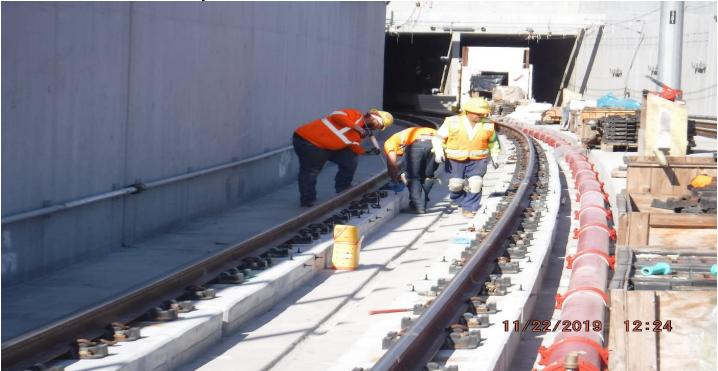
UG4- STA367+50_ Looking North_ SIKA crack injection investigation_ NCR-C-129_ UG4_ 48ST.
