CRENSHAW/LAX PHOTOGRAPHIC UPDATE

March 17, 2020

Crenshaw/LAX Transit Project

- 8.5 miles Light Rail
- 8 Stations
- \$2,058.0 Million
(Board approved revised LOP)

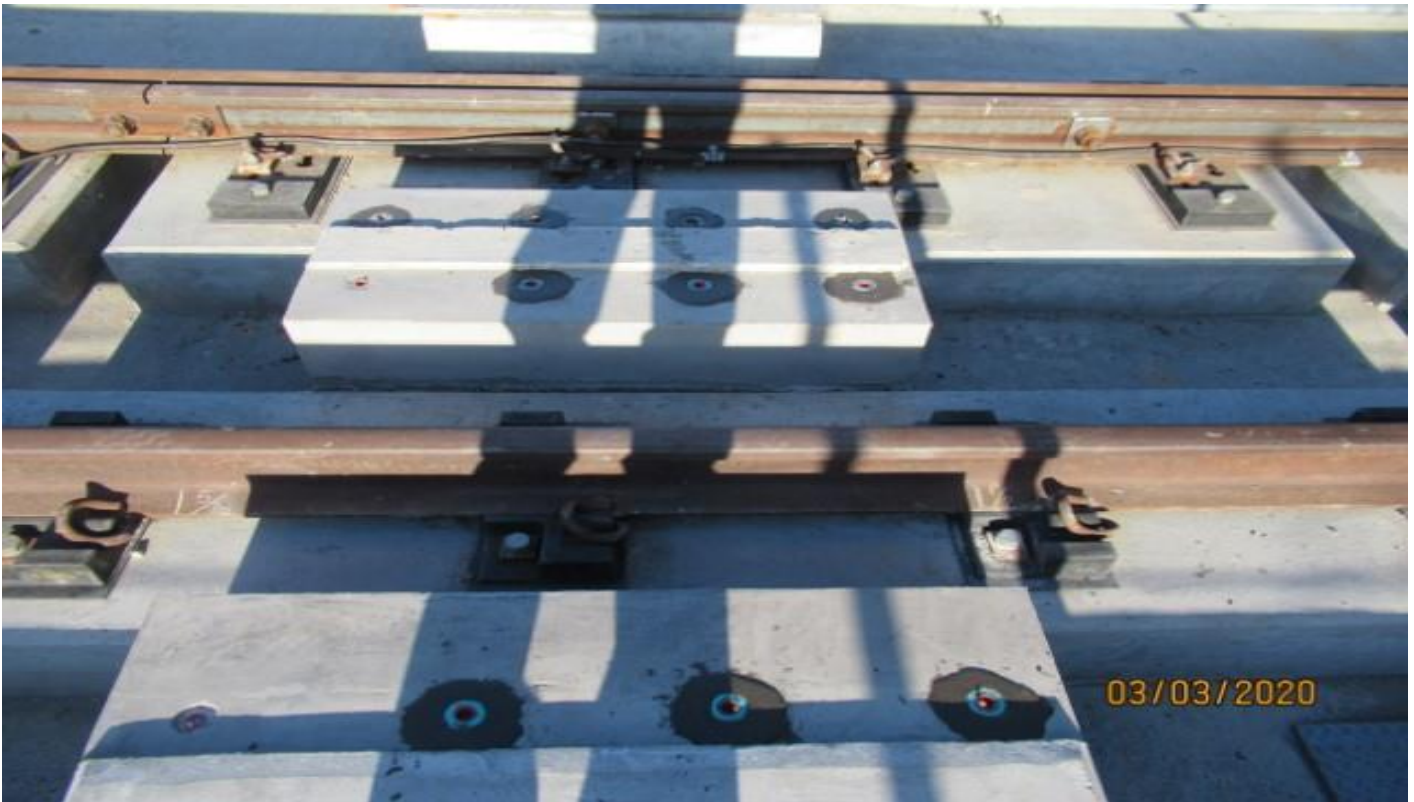
GUIDEWAY - East leg of wye crossing STA 12+66 incomplete work.

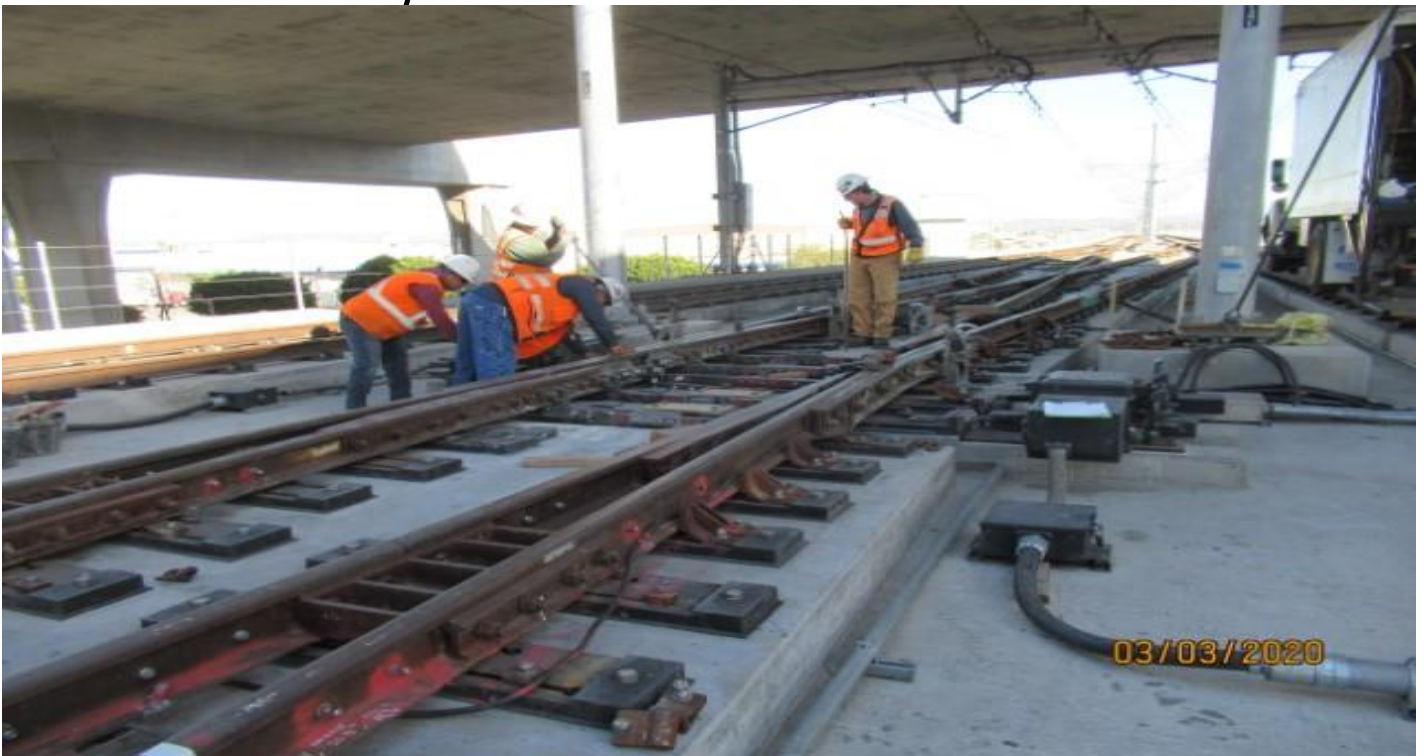
GUIDEWAY - HCC raising rails on MPF for repair work on concrete slab at GL Wye.

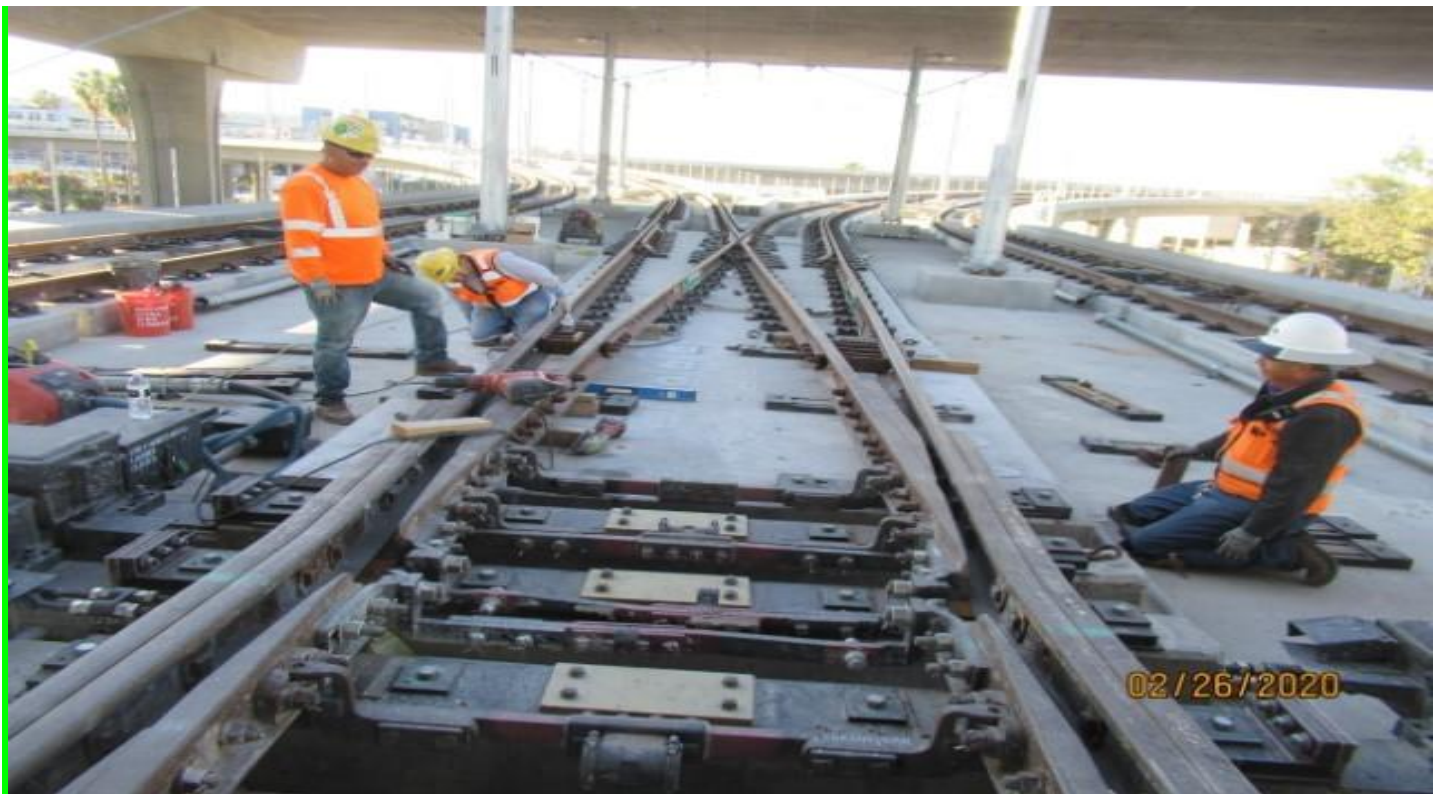
GUIDEWAY - WSCC preforming repair work on concrete slab for even surface under fasteners MPF STA 13+90 GL Wye.

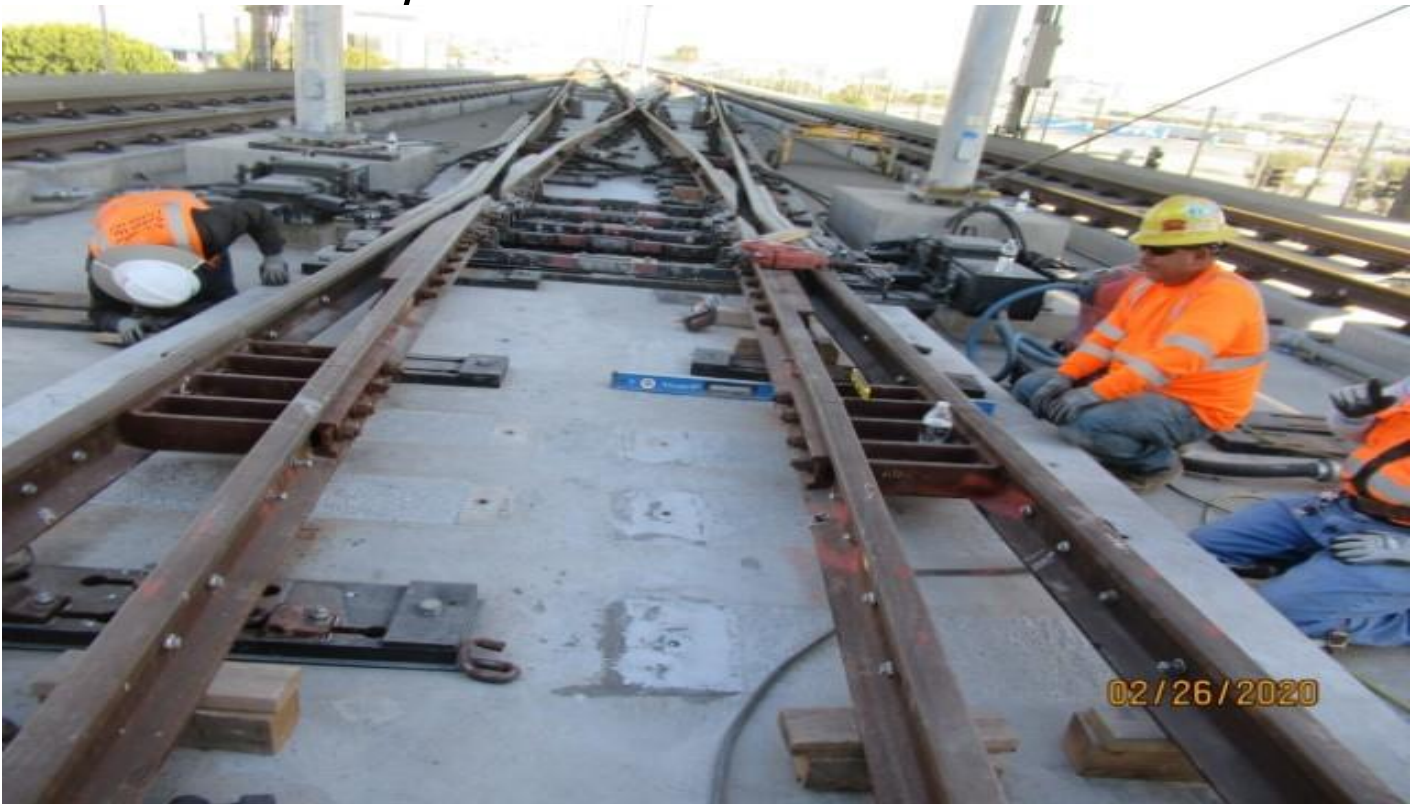
GUIDEWAY - WSCC checking plane on surface for concrete MPF at GL Wye STA 13+90 (looking north) Rework

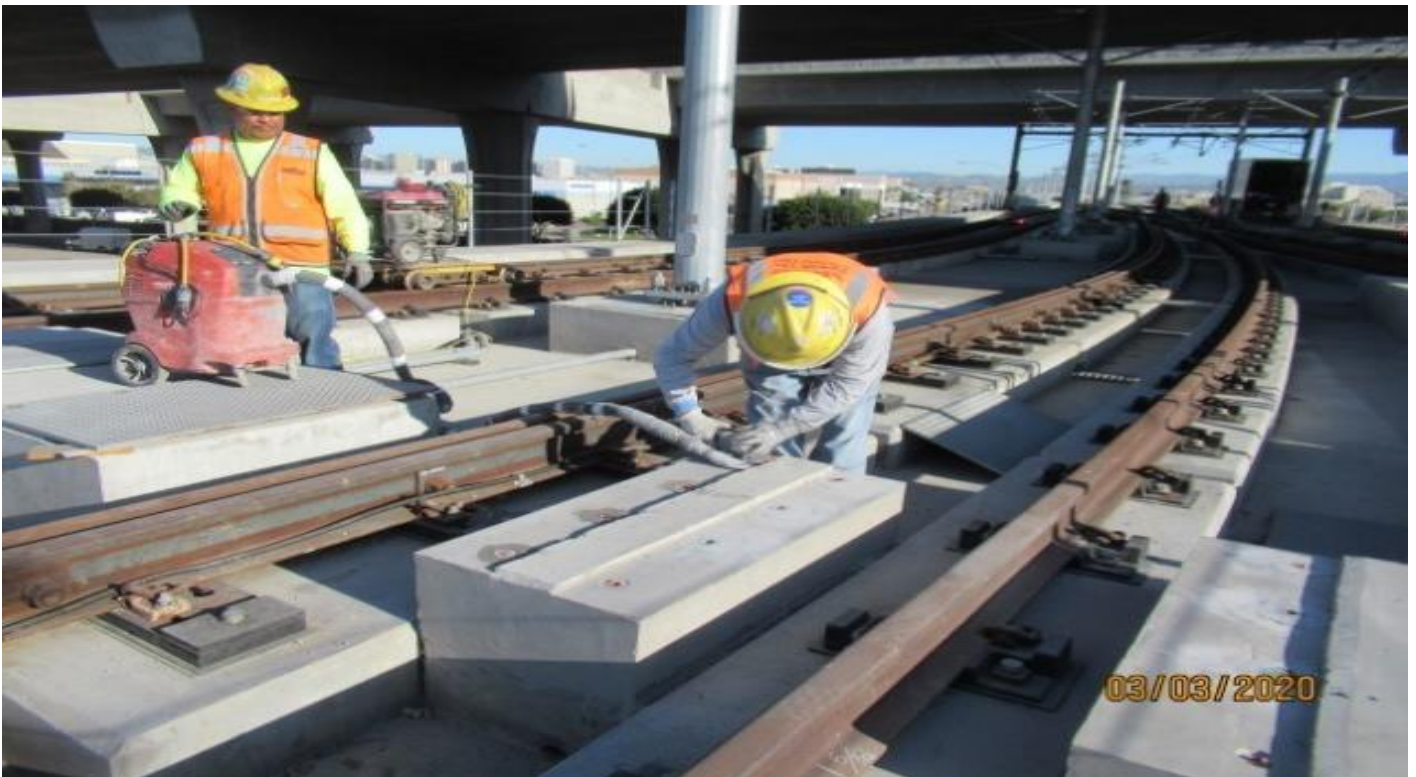
GUIDEWAY - WSCC hand grinding epoxy on concrete foundation for west leg of Wye STA 13+01

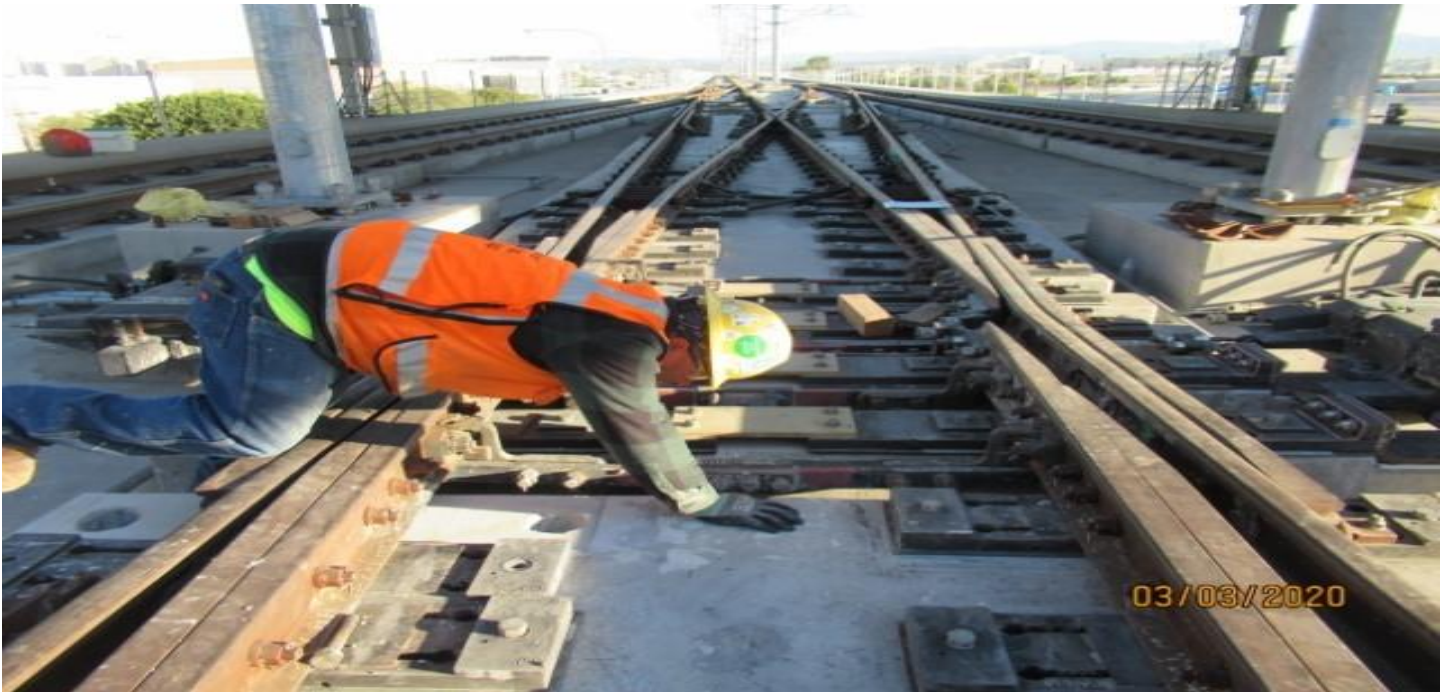
GUIDEWAY - WSCC Concrete foreman checking elevation differences between gauge & field side of slab on MPF at GL Wye STA 13+90

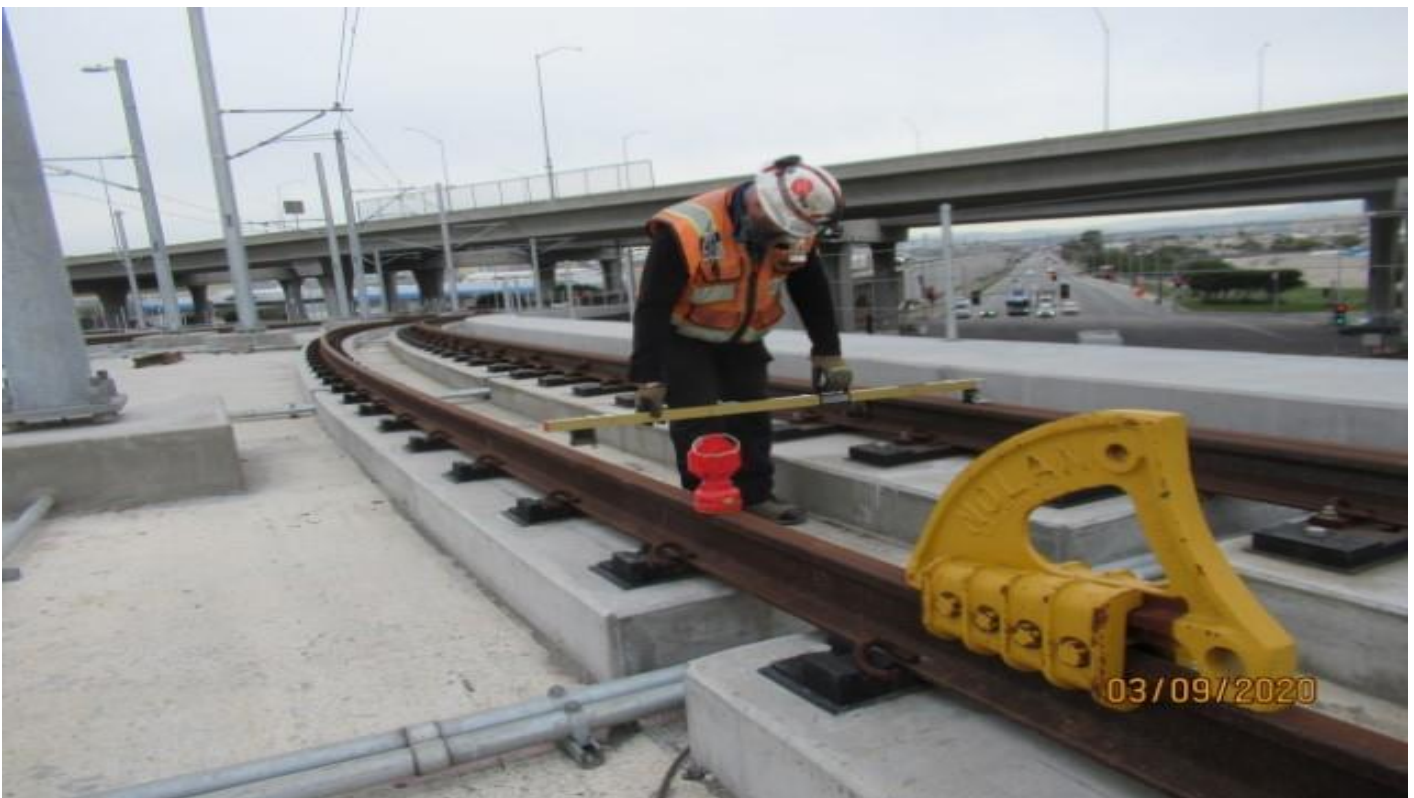
GUIDEWAY - WSCC QC track inspector verifying cross level & track gauge on NB1300 track GL Wye STA 10+75 .

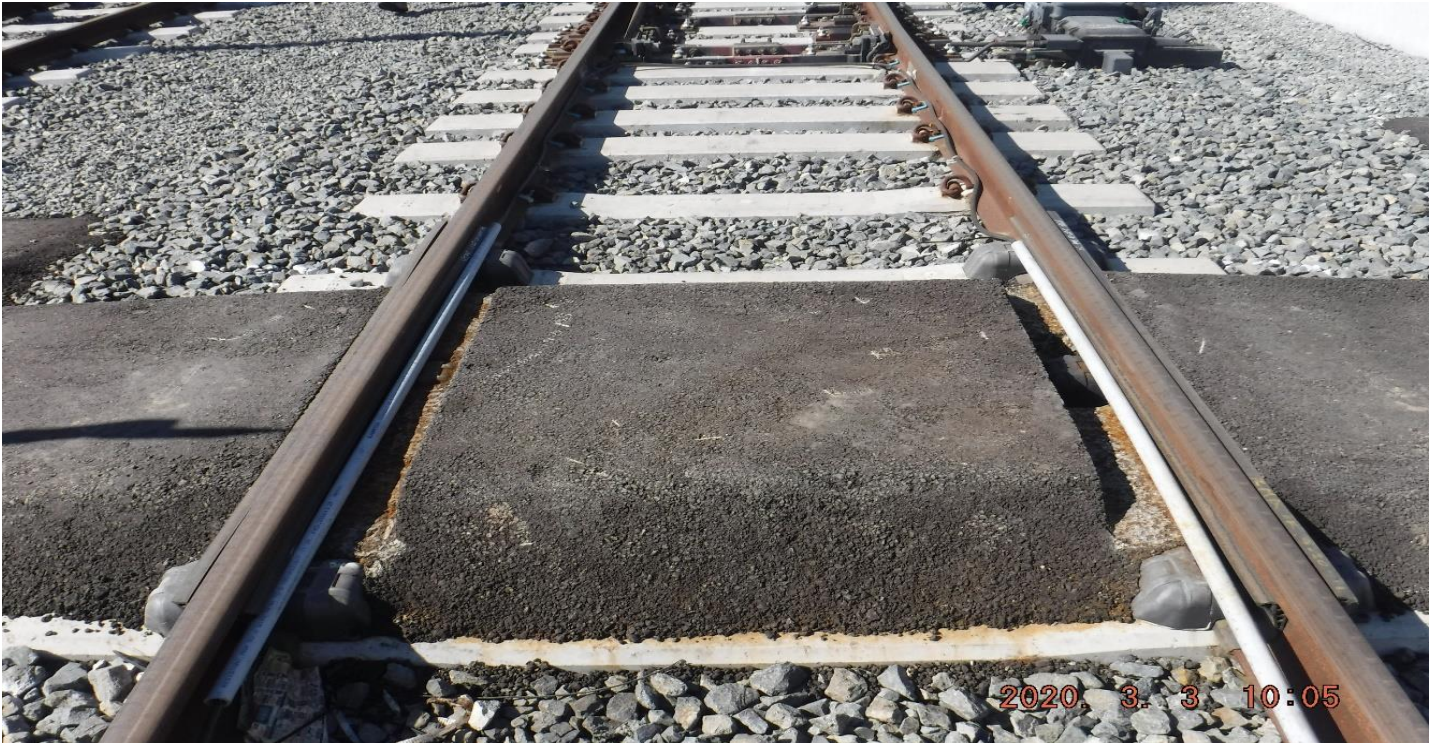
Florence/Ivy - STA255+50_ Looking South_ AC Xwalk before repair between rails_ High

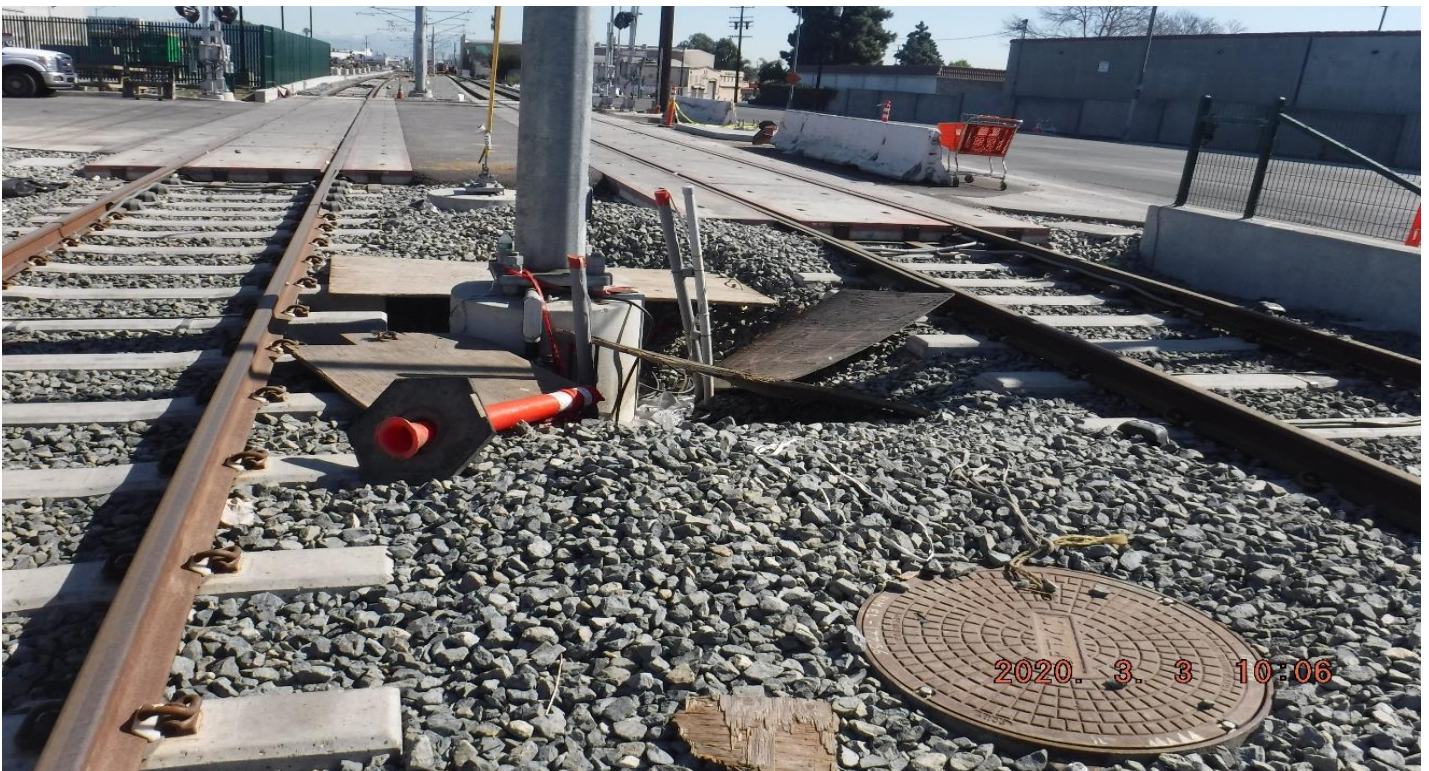
Florence/Ivy - STA256+10_ Looking North_ Disturbed track structure OCS#1212_ PUNCH LIST_ High.

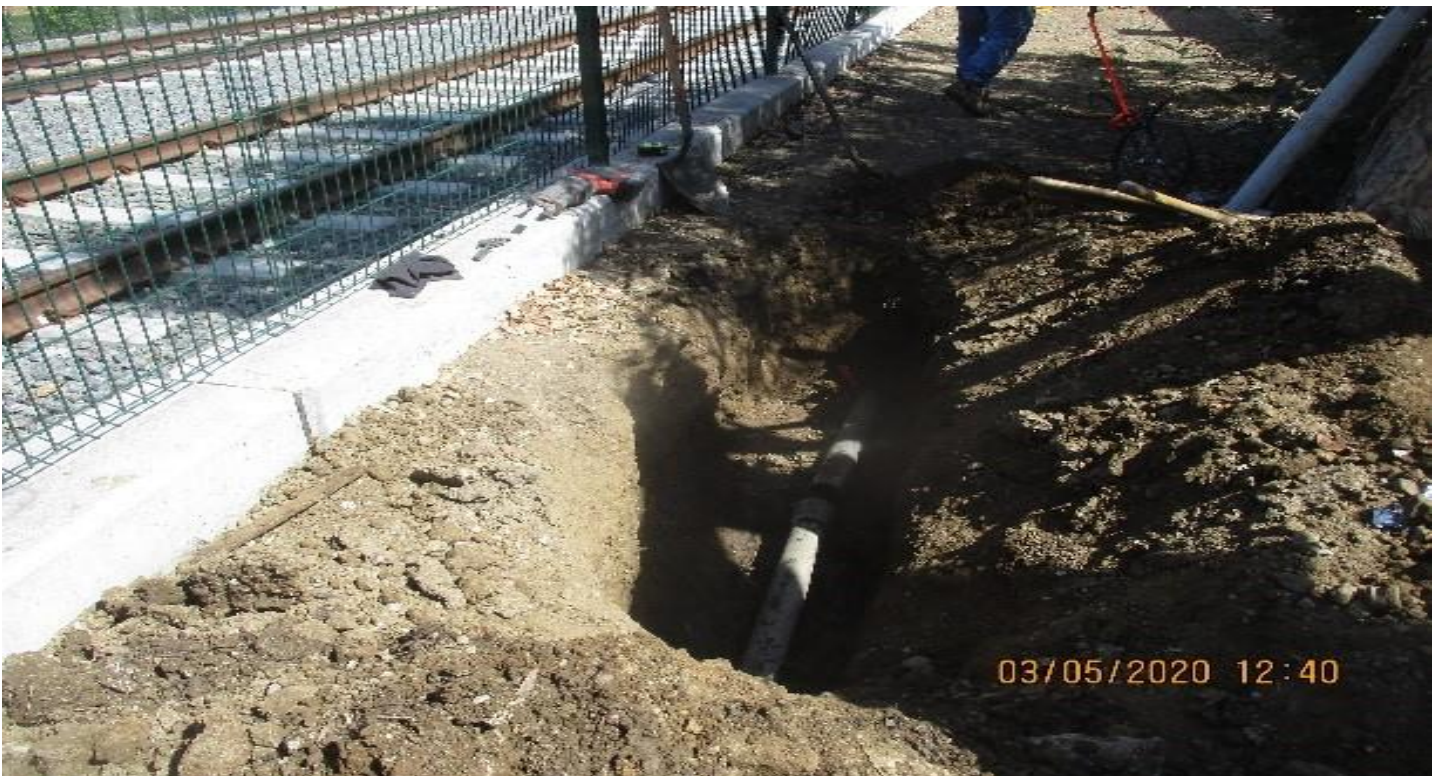
Florence/Ivy - Select Electric Repair damaged conduit between High and Prairie.

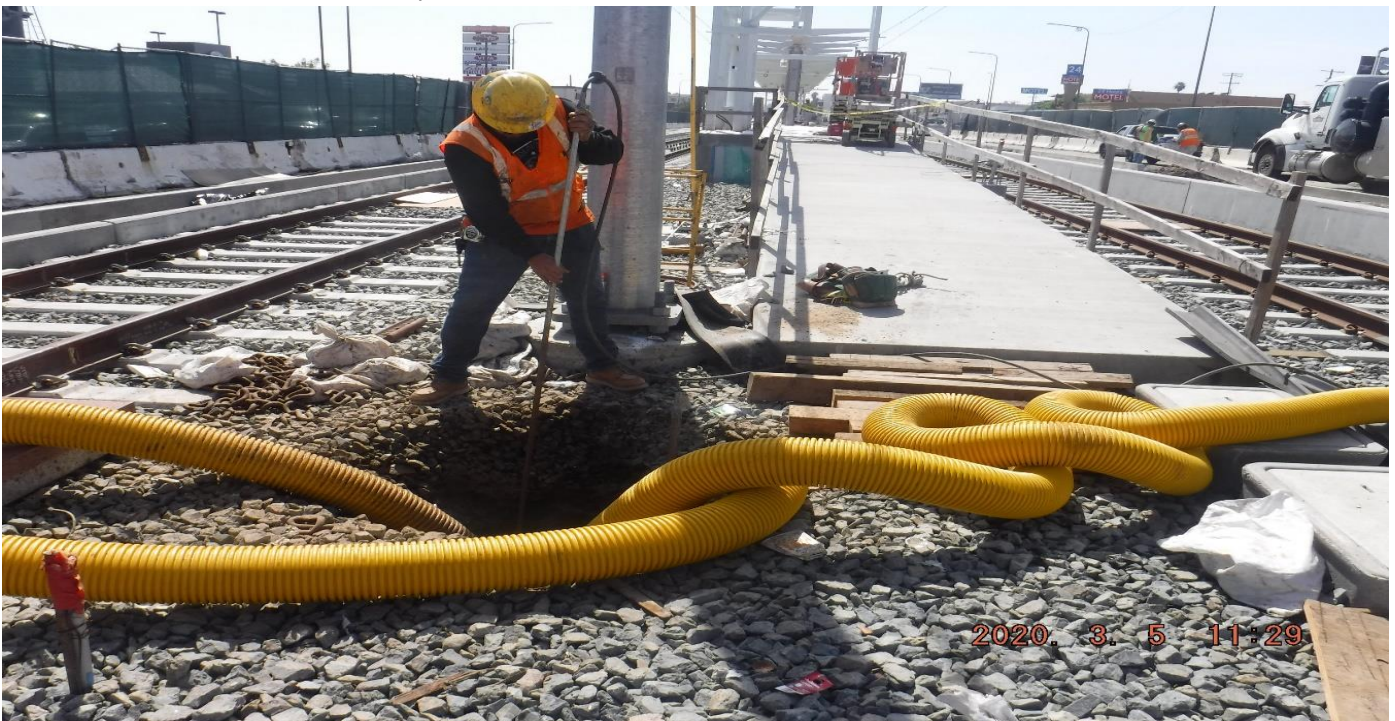
SLAUSON STA – STA323+10_ Looking South_ Vacuum excavation 4 camera pole foundation_ PUNCH LIST.

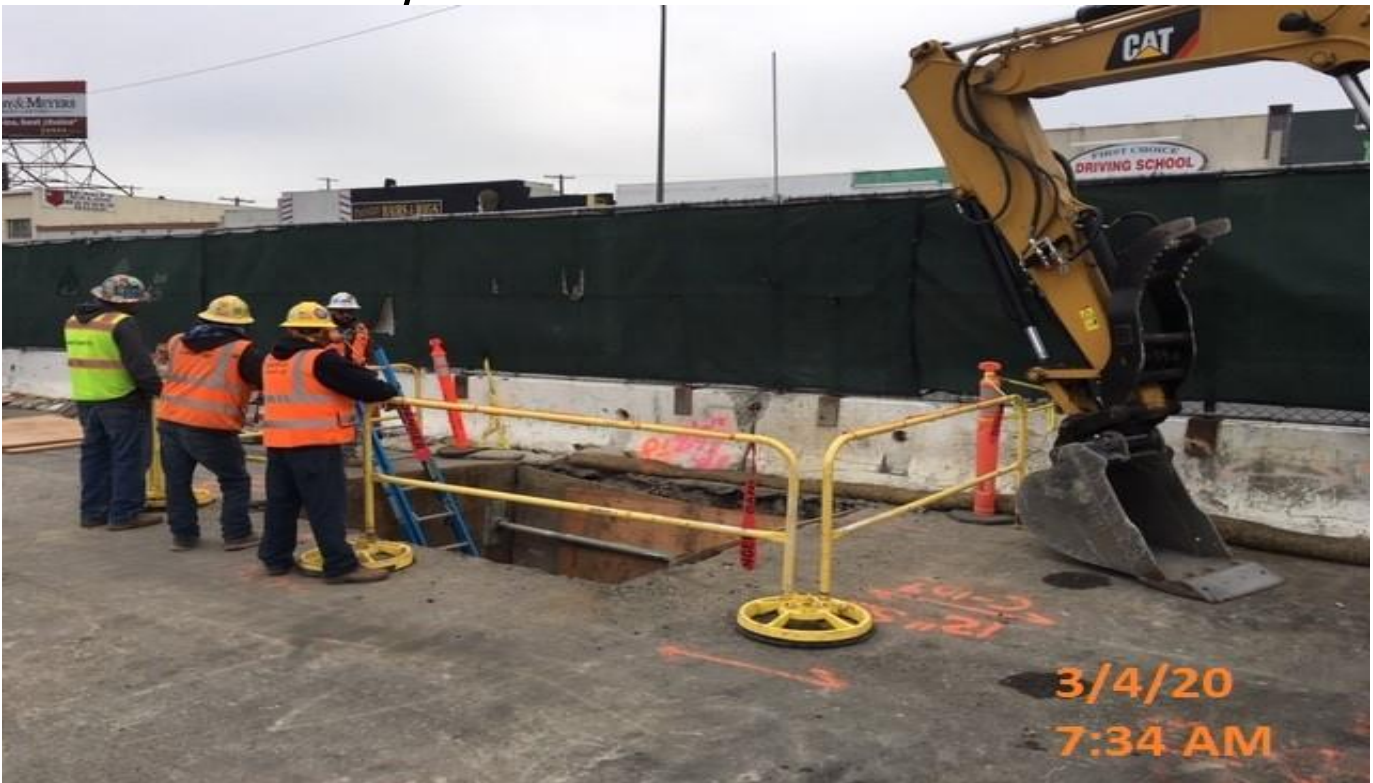
MLK STATION – WSCC crew and Norcal continue exploratory work on leak repair.

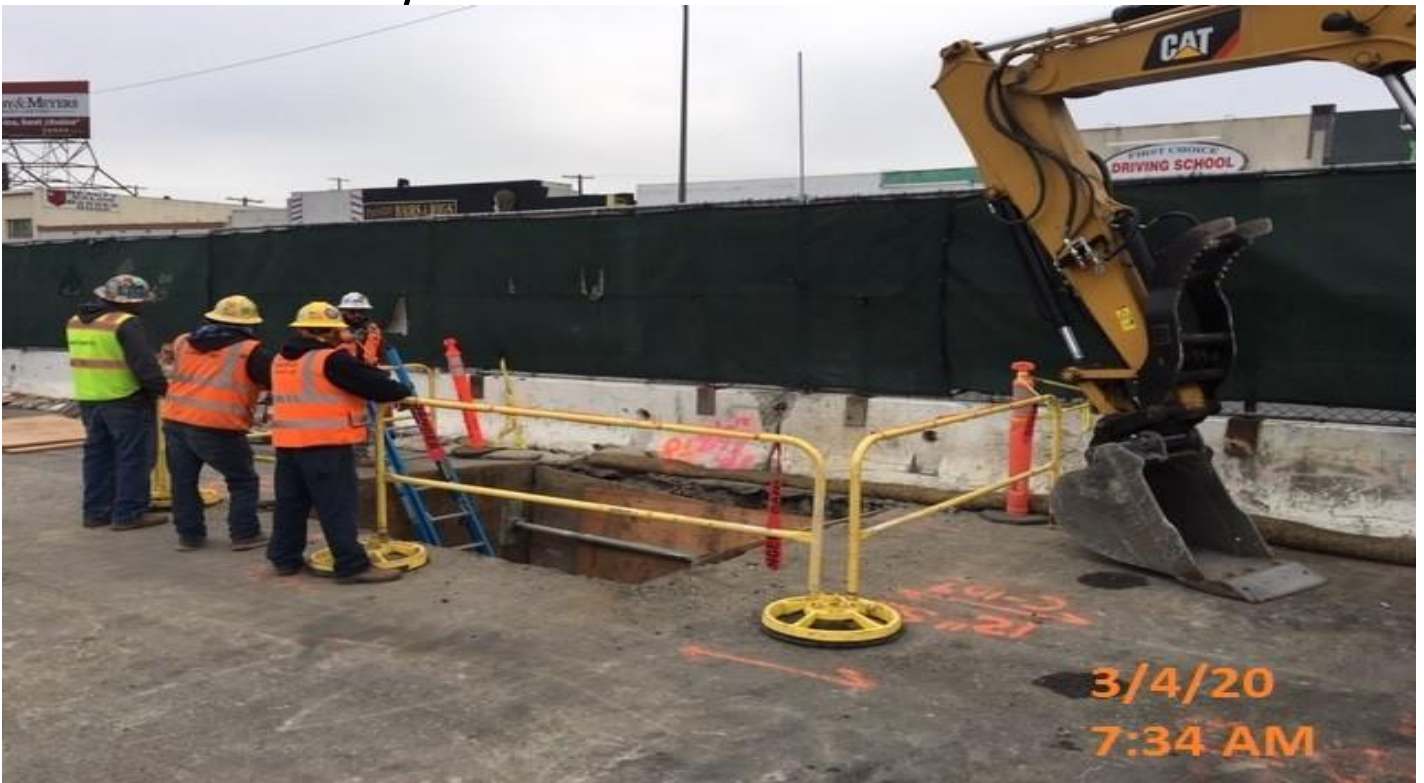
MLK STATION – WSCC crew and Norcal continue exploratory work on leak repair.

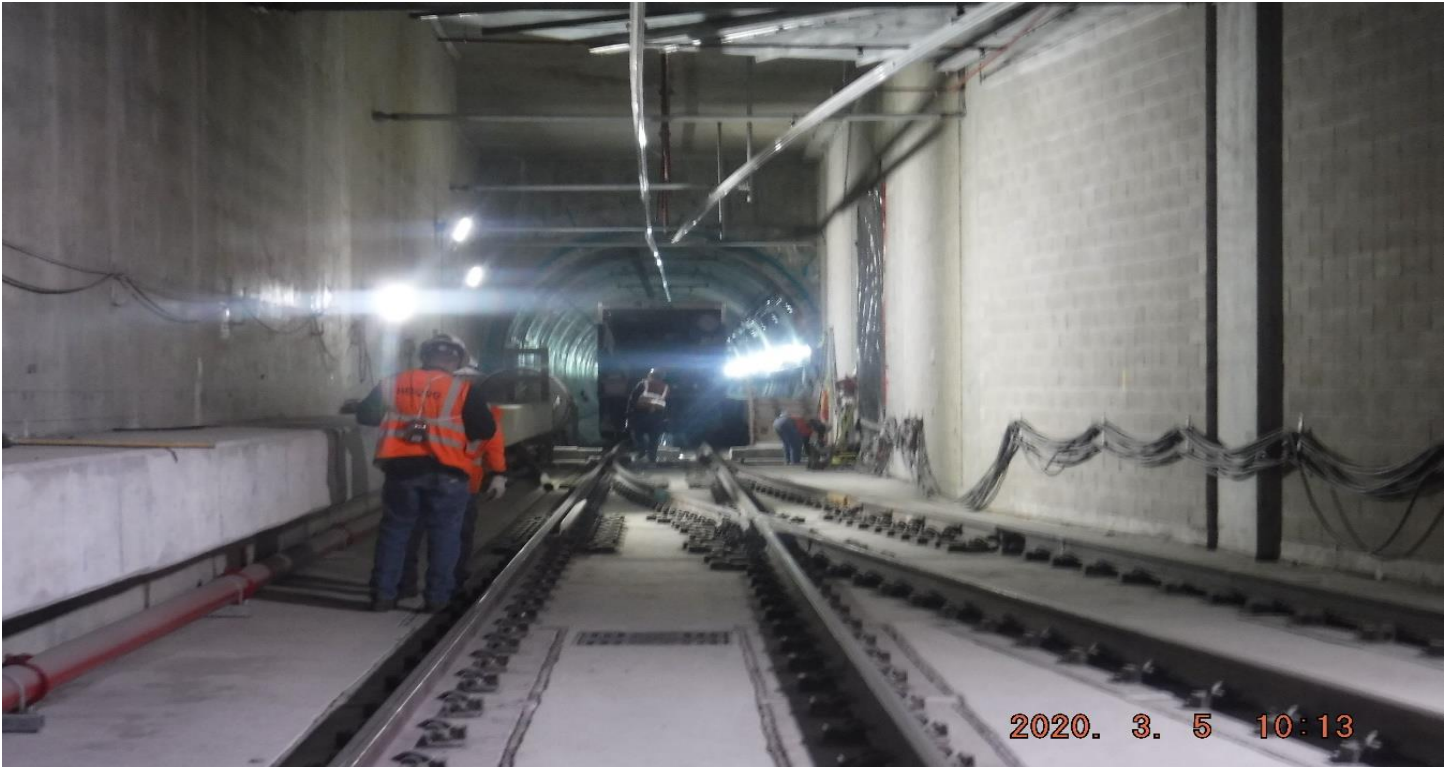
UG4 – STA442+00_ Looking South_ TK geometry adjustment_8W1_ UG4_ Expo.

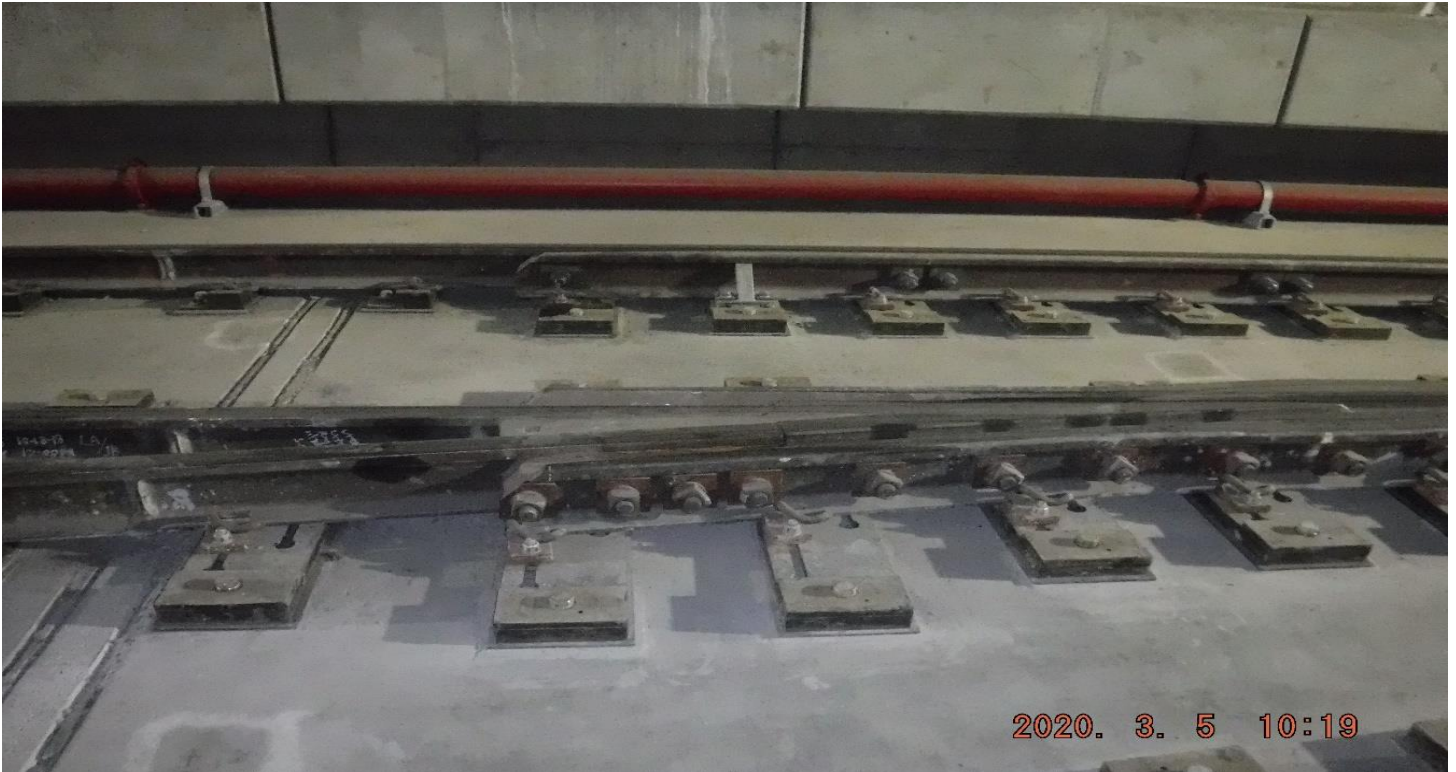
UG4 – STA443+70_TK3_ Looking West_ Installed guard rail brace_ 8W2_ UG4_ Expo.
