#### CRENSHAW/LAX PHOTOGRAPHIC UPDATE April 15, 2020

#### Crenshaw/LAX Transit Project

Overview of trackwork progress issues for 4/15 - 4/30(Please note the attached Trackwork Progress Tracking Report)

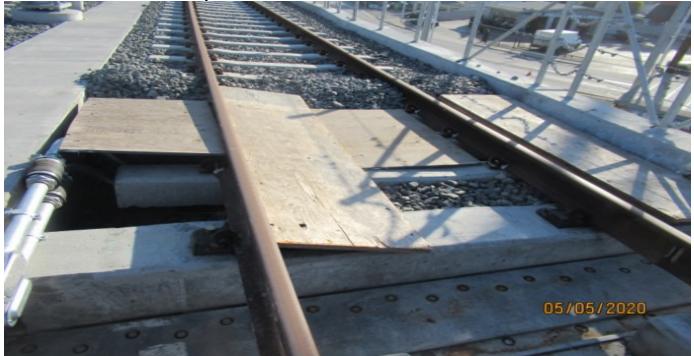
**Manchester Bridge** - Manchester Bridge NB #4 track STA 121+45 no condition changes for disturbed ballast on Metro's Punch list, item #250 in Segment A

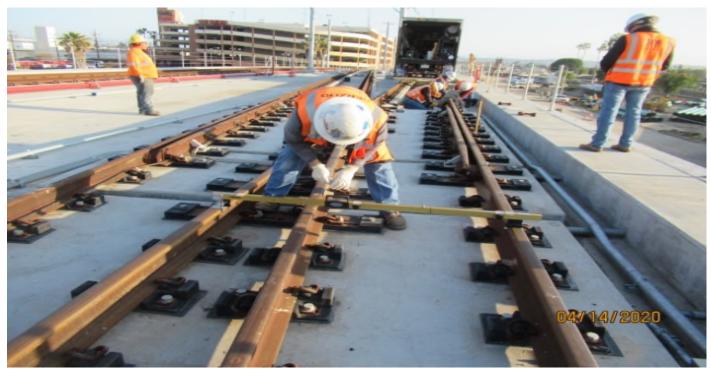
**Aviation/Century** – HCC, repairing cross levels on 10K1LH XO Century-Aviation Bridge NB # 4 track.

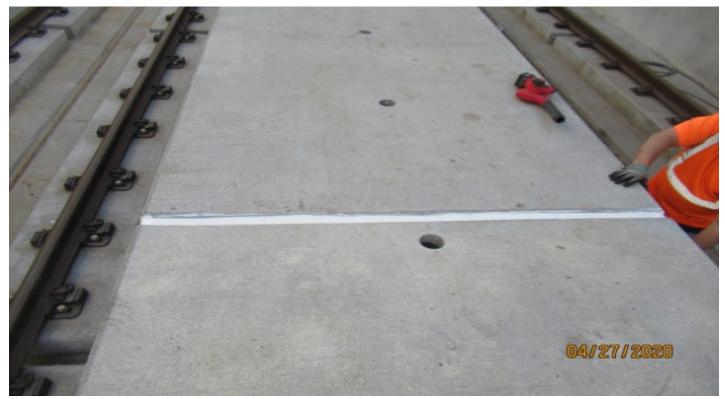
**UG1** – UG1 SB #3 track STA 49+78 emergency walkway on-going repair work (looking west) Rework

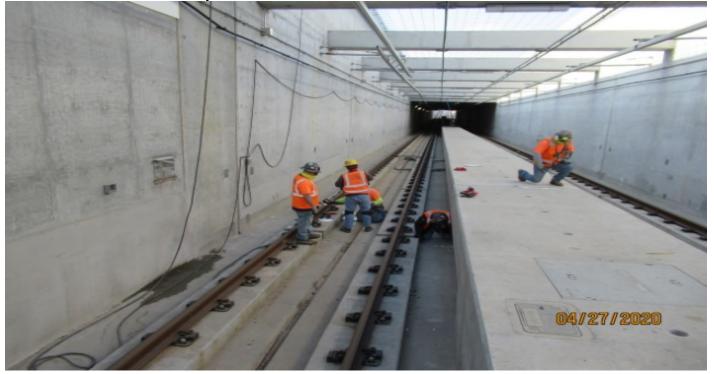
**UG1** – UG1 SB #3 track STA 49+78 emergency walkway on-going repair work (looking west) Rework

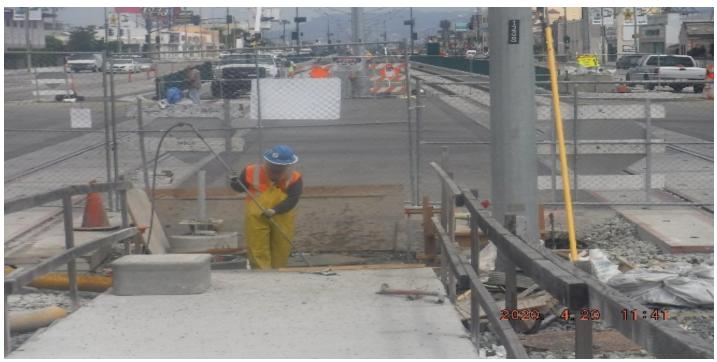
**Crenshaw / Slauson -** STA 323+00 TK#3/SB looking west – track structure disturbed (between tracks) north end of Slauson Station – PUNCH LIST

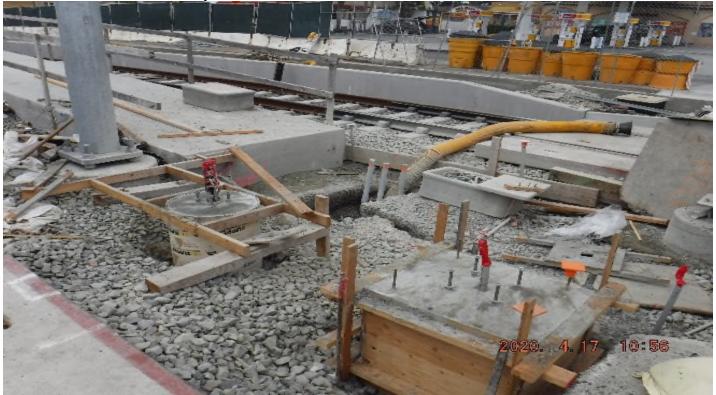
**Crenshaw / Slauson** - STA 323+00 TK#4/NB looking north – vacuum pole foundation excavation north end Slauson Station – PUNCH LIST

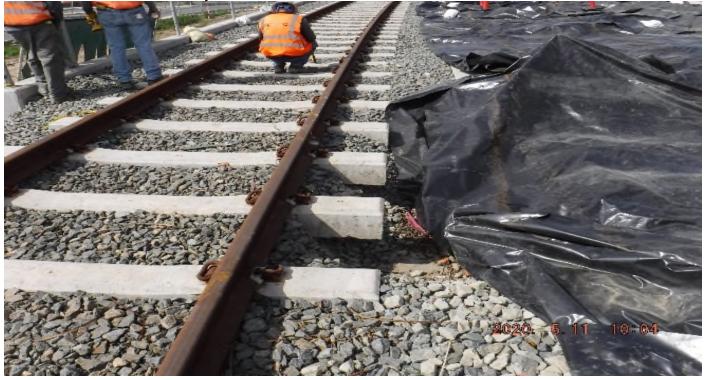
**Florence/Brea** - STA 205+50 TK#4,NB looking north – track geometry measurement south of La Brea Station

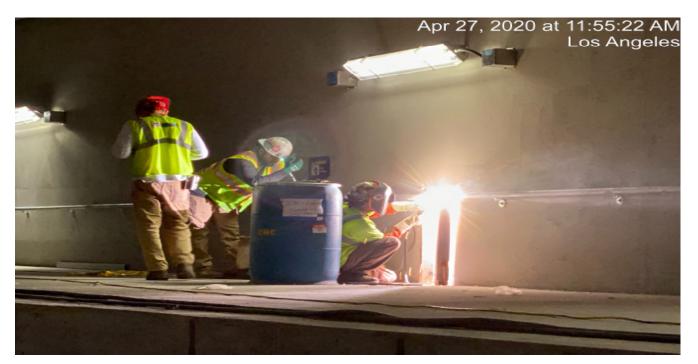
**UG4** – WSCC in UG4 NB #4 track STA 371+64, repair work on emergency walkway foundations.
