CRENSHAW/LAX PHOTOGRAPHIC UPDATE

June 12, 2020

Crenshaw/LAX Transit Project

Overview of trackwork progress issues for 05/15/2020 – 06/01/2020
(Please note the attached Trackwork Progress Tracking Report)

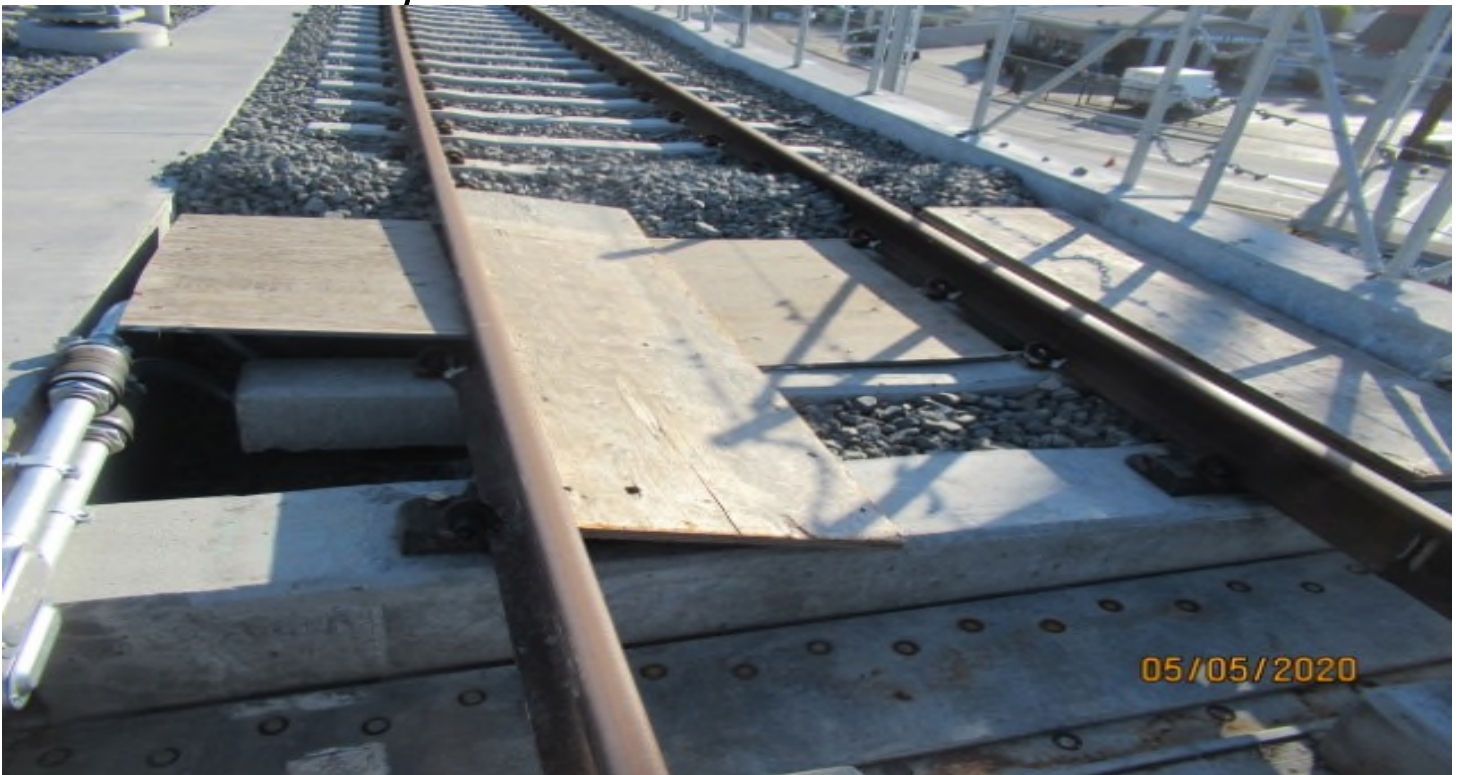
Manchester Bridge - Manchester Bridge NB #4 track STA 121+45 no condition changes for disturbed ballast . on Metro's Punch list, item #250 in Segment A.

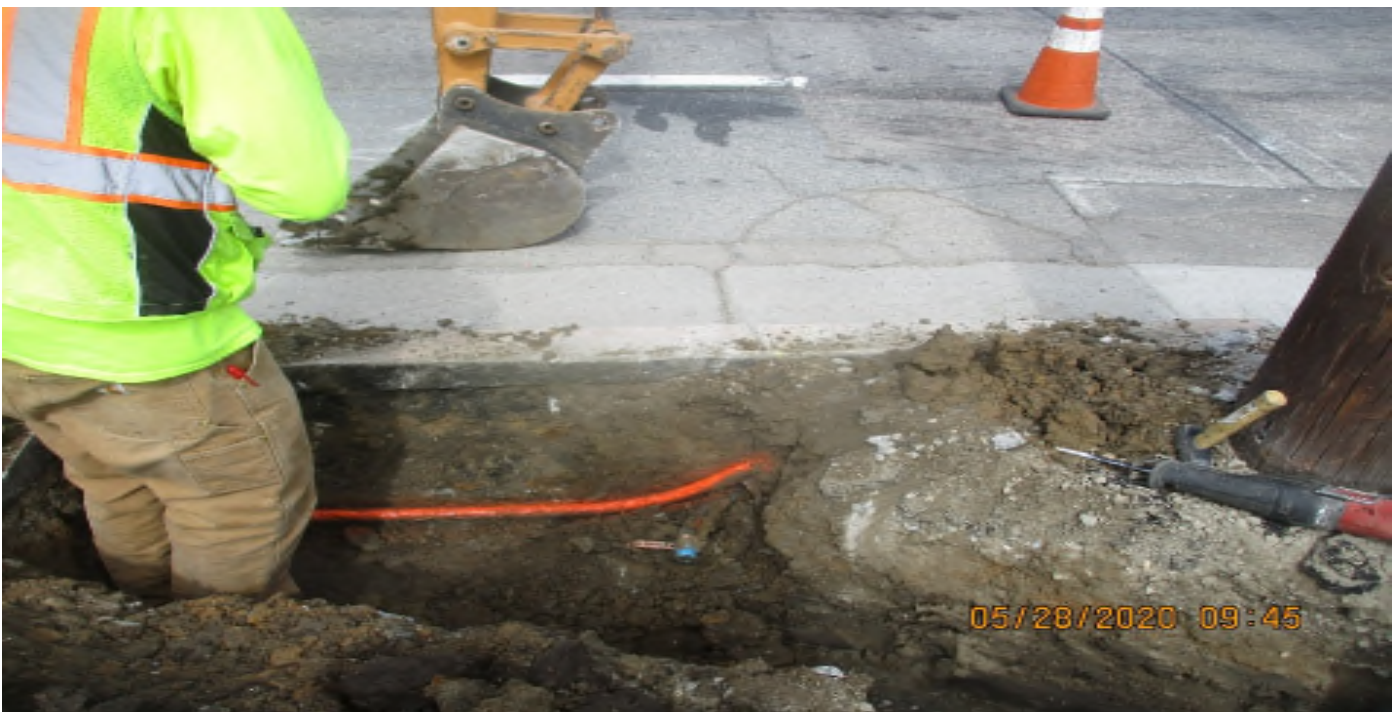
Aviation/Century - DB Electric Found and repaired incomplete conduit at 111th and Aviation.

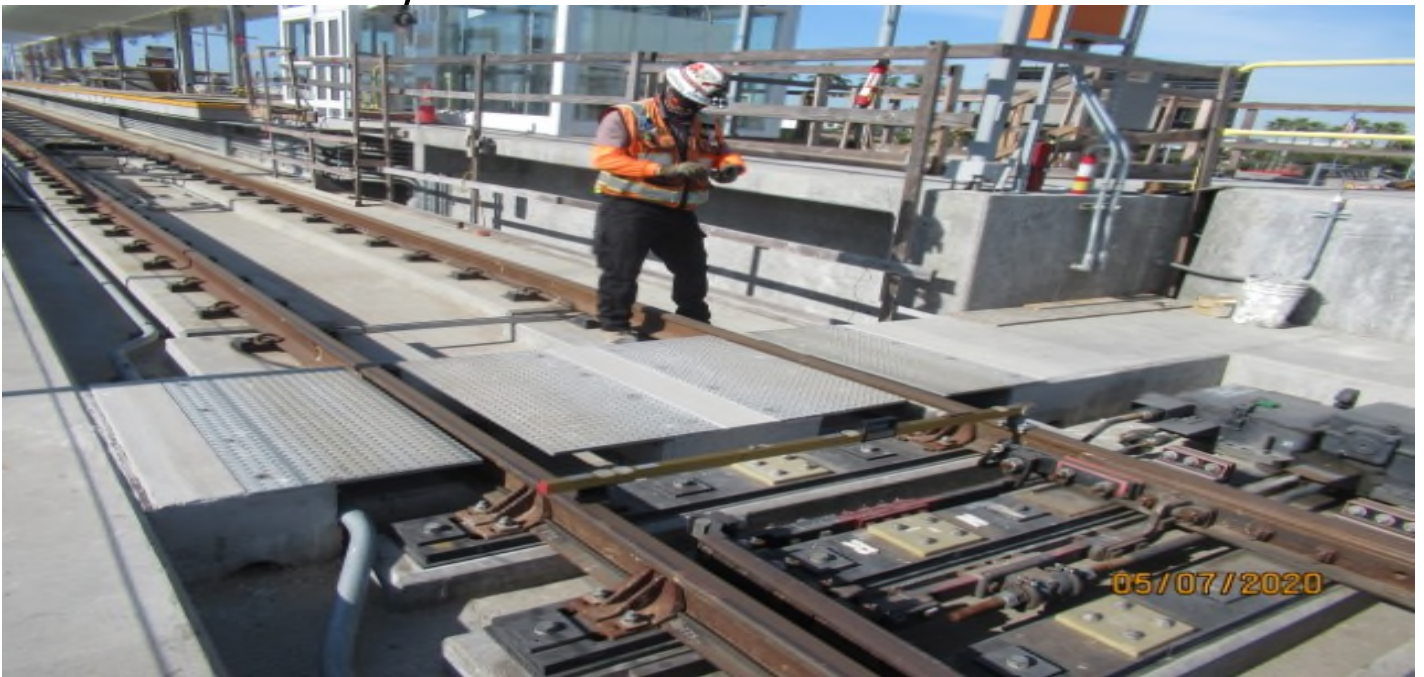
Aviation/Century – WSCC QC looking at condition of Emergency Walkway crossing on NB #4 track on Century/Aviation bridge (looking southwest)

- Punchlist walk with WSCC QC Inspector continues to review current completion status.
- Rework continues for emergency walkway insert plates due to miss-alignment.
- Disturbed ballast due to systems electrical conduit relocations continues to be repaired and re-dressed.
- Investigation of a possible repair process for plinth to invert gap continues in UG1.
- Replacement of damaged switch ties at TT #5EQLXO is completed.

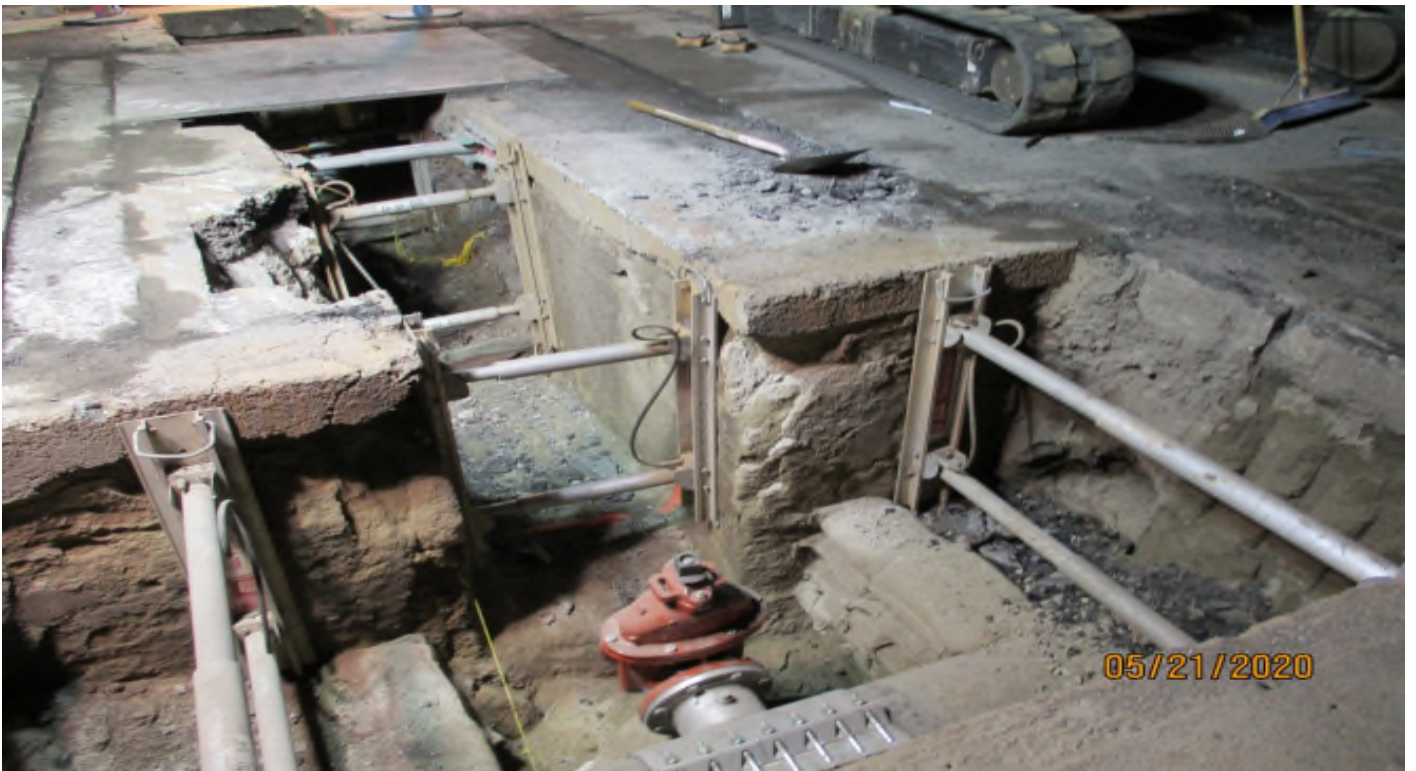
111th Street – Under mining of the fire line trench at 111th street.

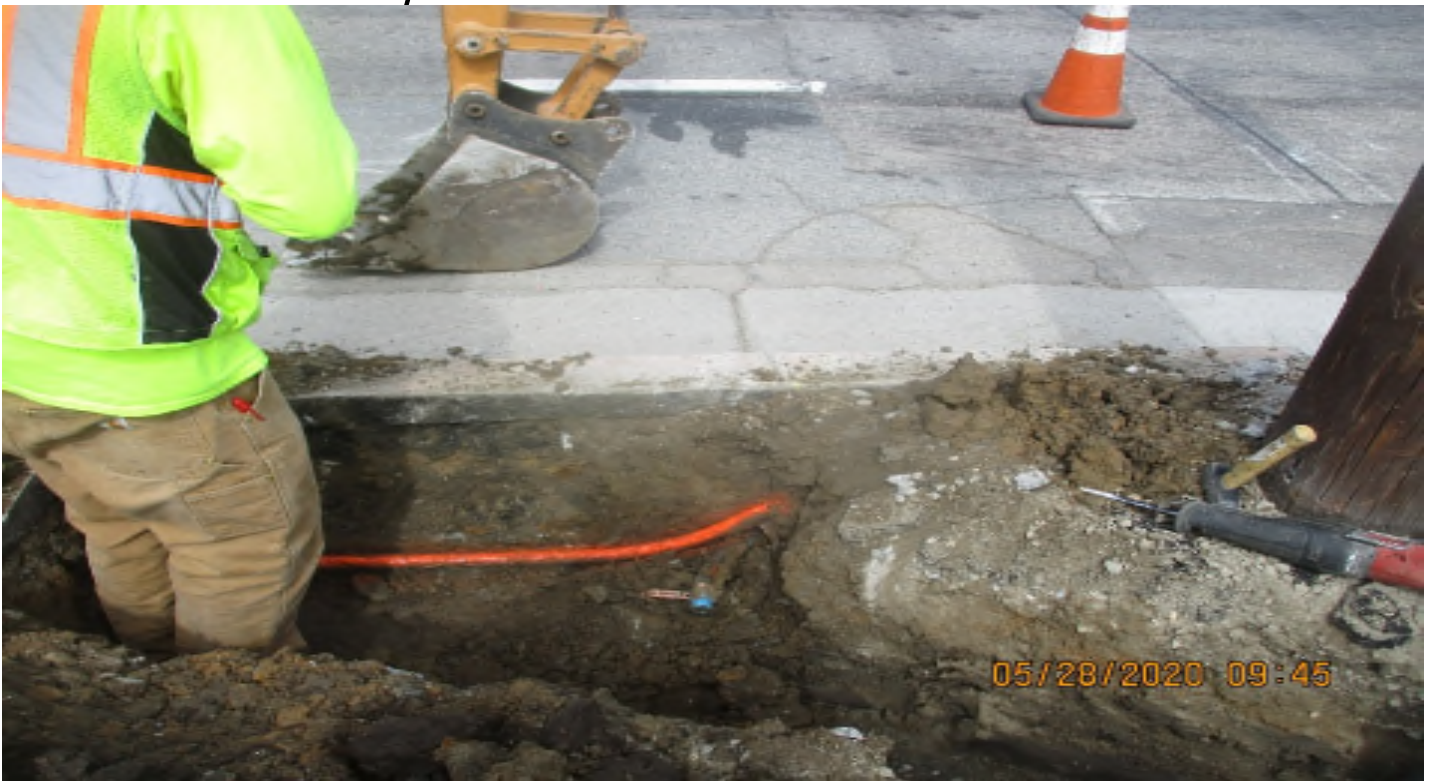
111th Street – DB Electric Found and repaired incomplete conduit at 111th and Aviation.

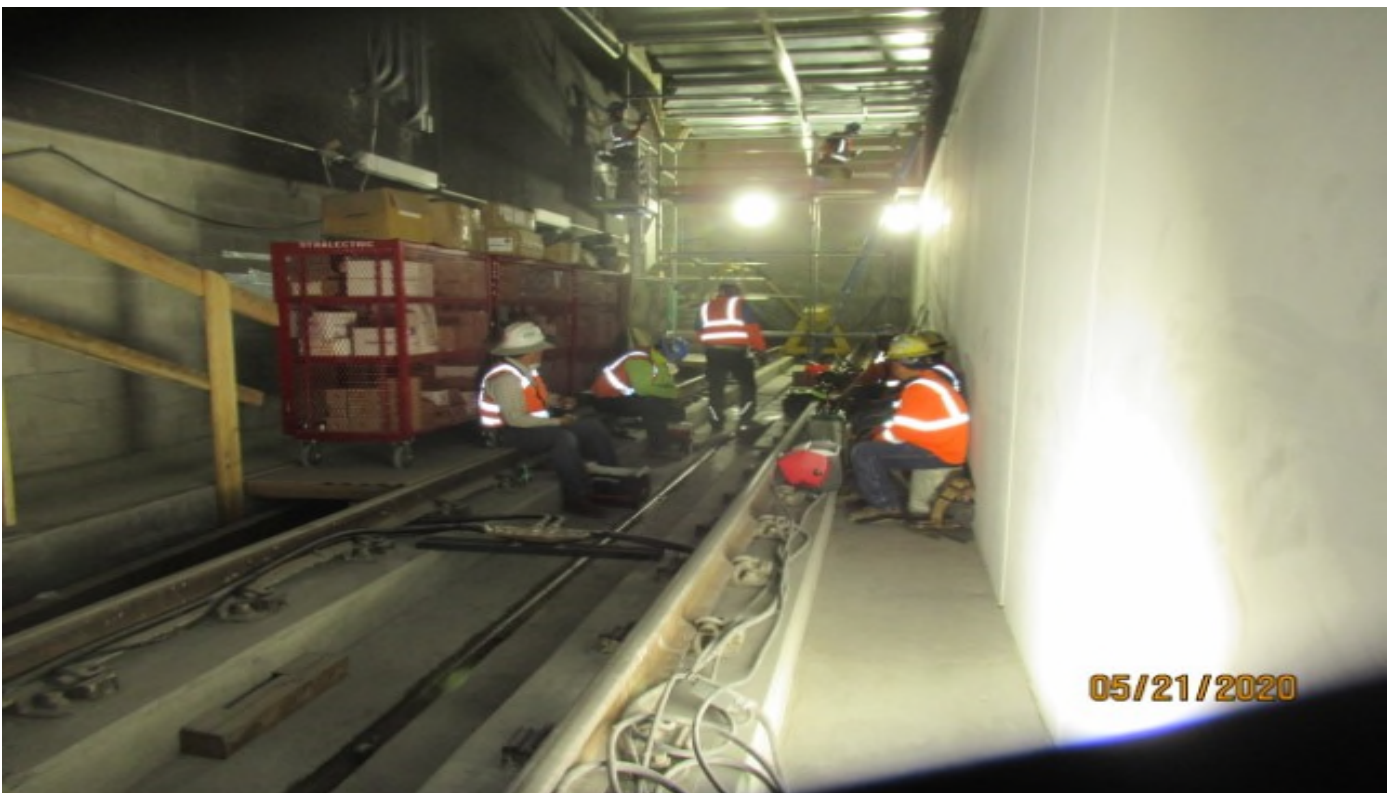
Crenshaw/Expo - WSCC repairing damaged plinths at Expo. Station NB #4 track STA 448+00 (looking north) Rework
