CRENSHAW/LAX PHOTOGRAPHIC UPDATE

July 7, 2020

Crenshaw/LAX Transit Project

Overview of trackwork progress issues for 06-22-2020 – July 7, 2020
(Please note the attached Trackwork Progress Tracking Report)

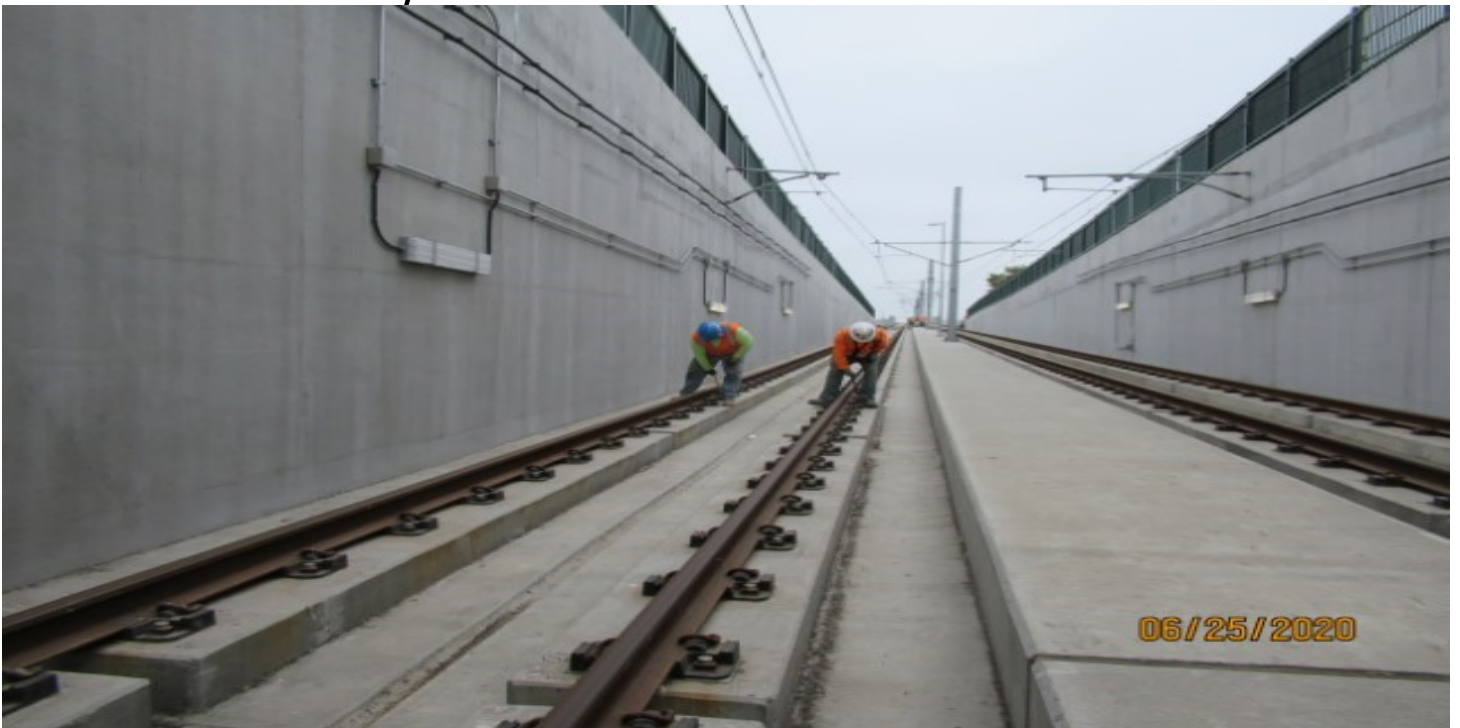
UG1- WSCC adjusting E-clips on NB #4 track UG1 south portal (looking south) Rework

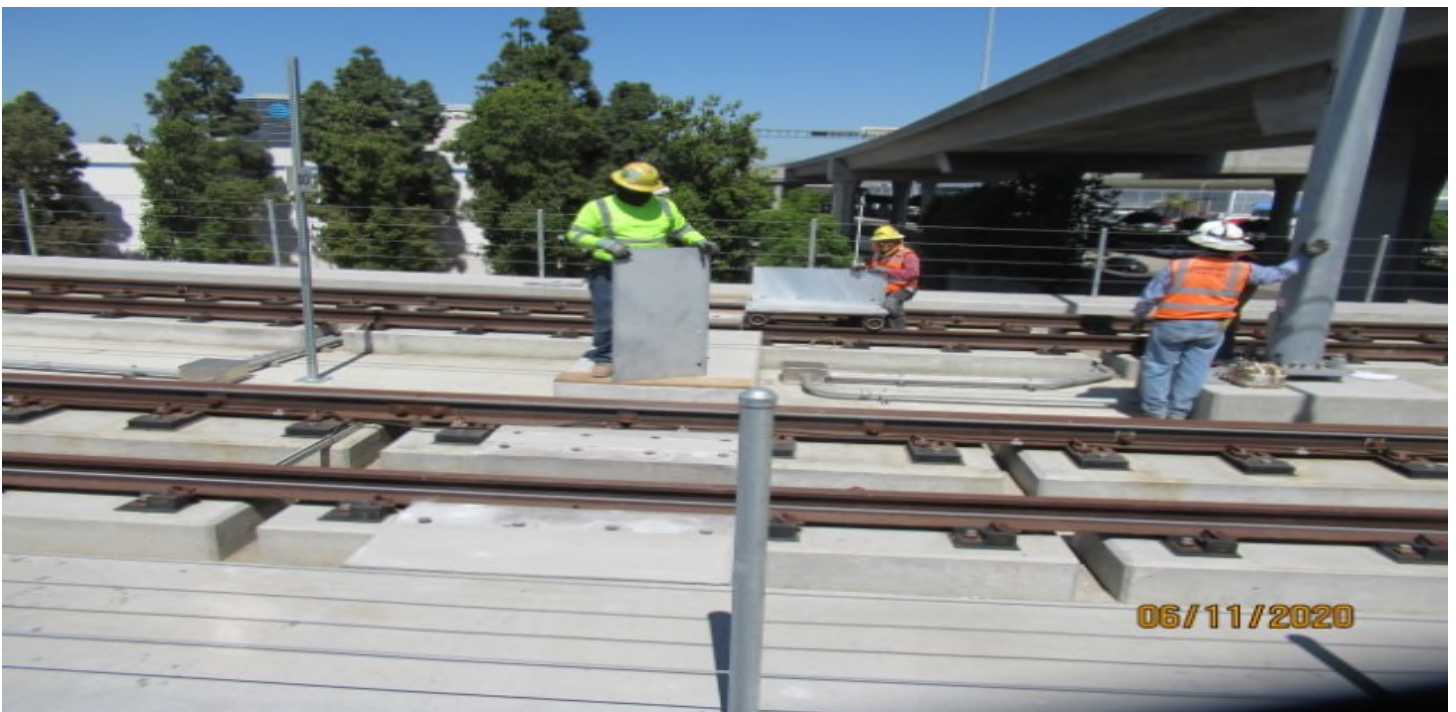
GREENLINE UNDERPASS- WSCC at west leg of GL Wye, installing repaired emergency walkway plates

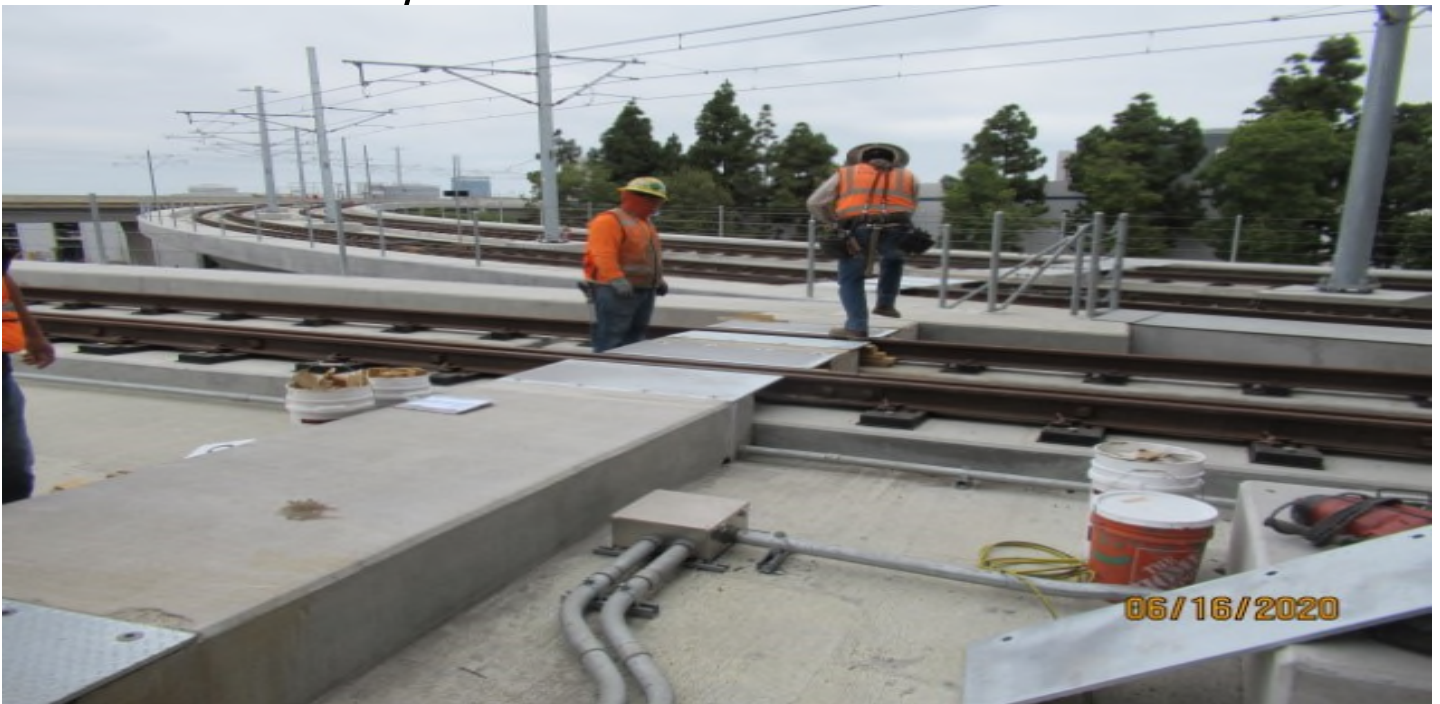
GREENLINE UNDERPASS- WSCC on east leg of Wye, repairing emergency walkway crossings (looking southwest) Rework

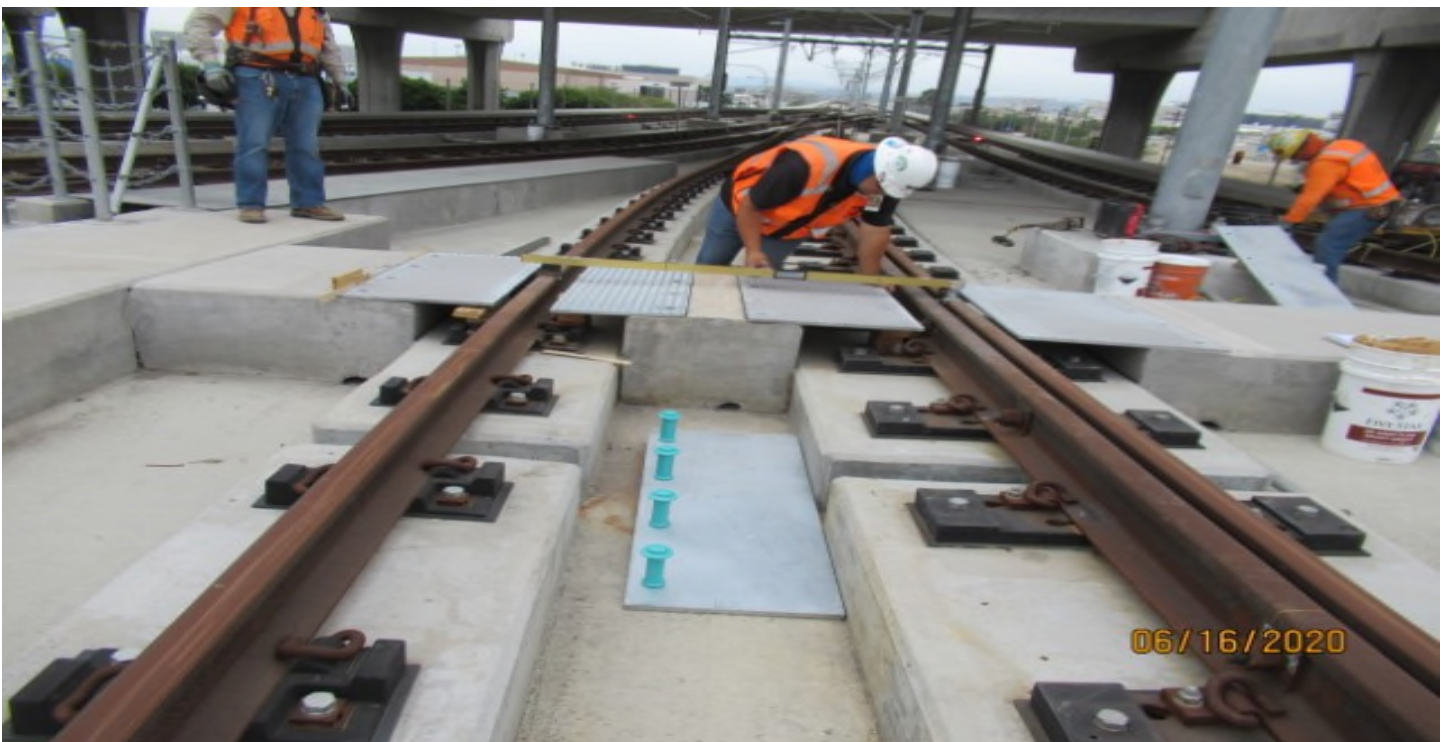
GREENLINE UNDERPASS- WSCC QC inspector checking cross level & track gauge where crossing plates will be re-installed GL Wye (looking north) Rework.
