CRENSHAW/LAX PHOTOGRAPHIC UPDATE

Feb 12, 2021

Crenshaw/LAX Transit Project

Overview of trackwork progress issues for 1/30/2021- 2/15/2021
(Please note the attached Trackwork Progress Tracking Report)

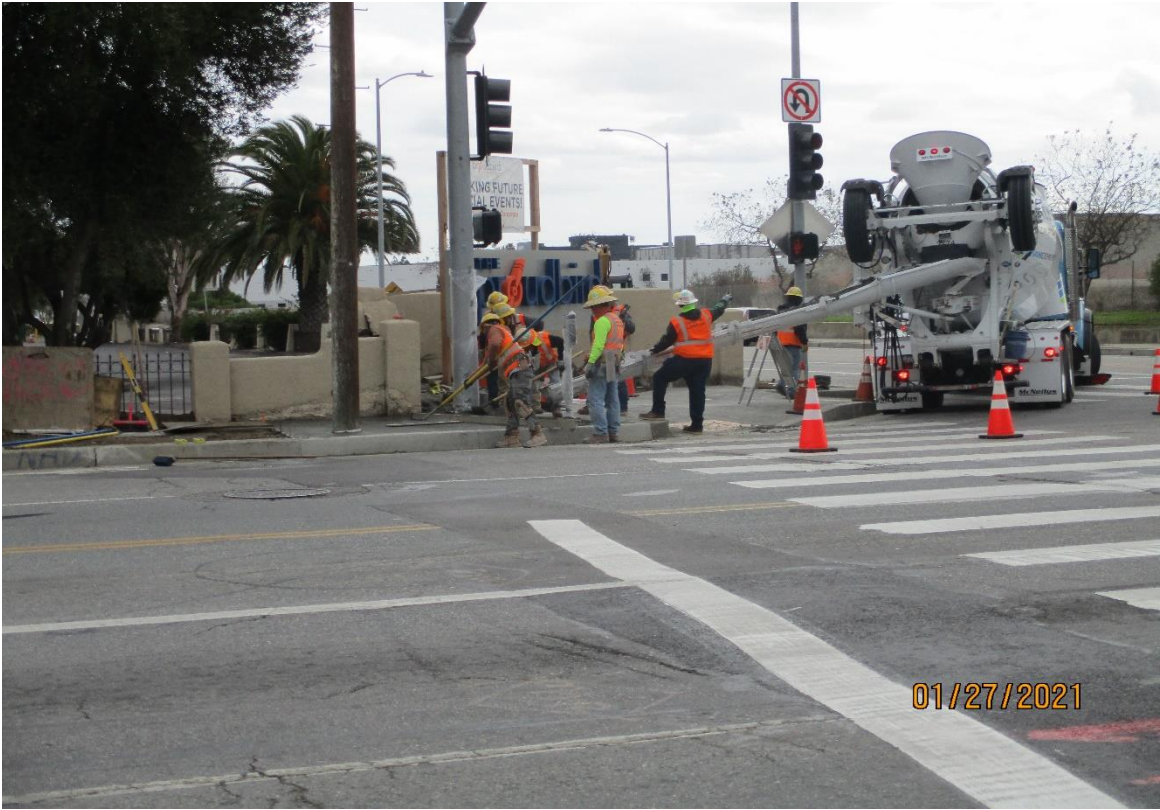
AVIATION/CENTURY- Placing sidewalk concrete at Aviation and 111th.

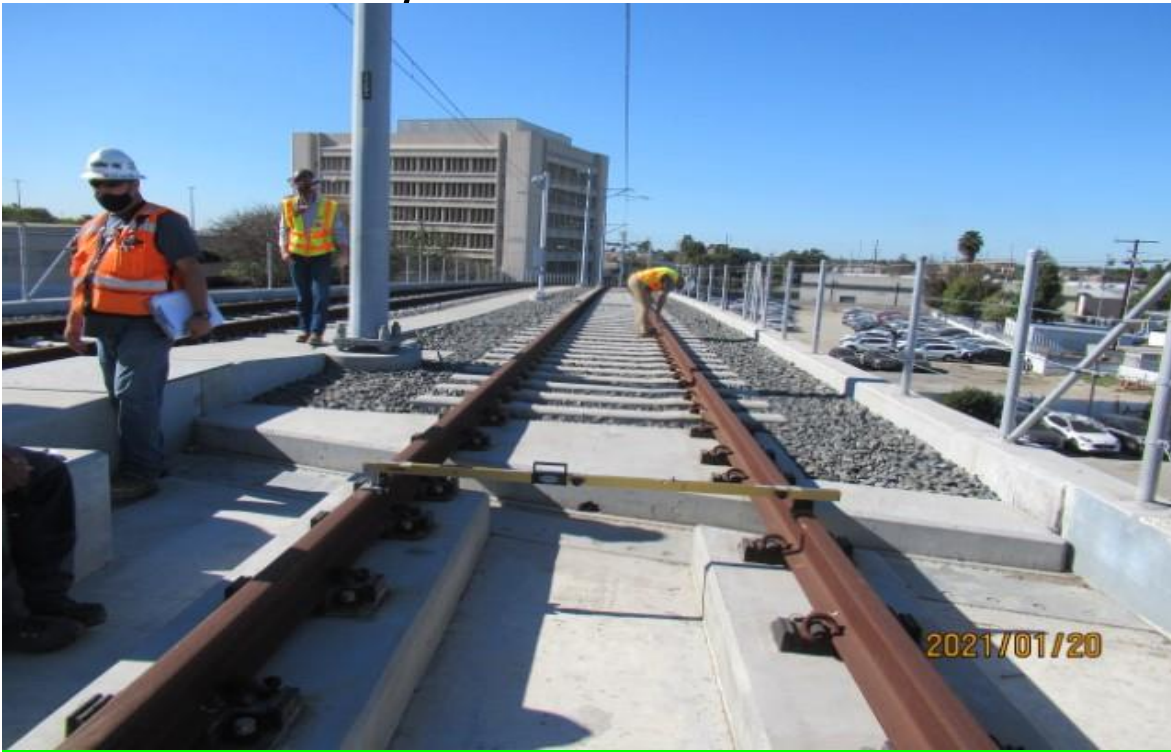
La Brea Station - Field site walk with WSCC QC & Metro CM team at La Brea OP SB track STA 202+00 checking track conditions on guideway (looking south)

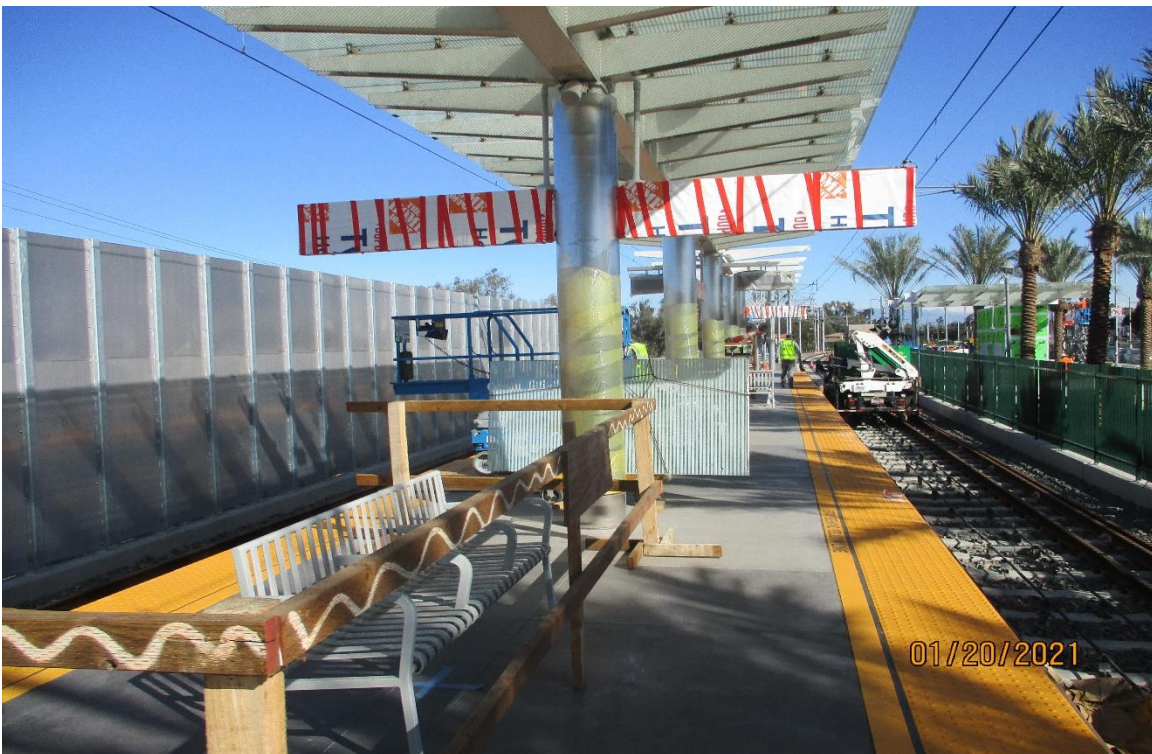
La Brea Station - Glass replacement for the La Brea Station platform canopy.

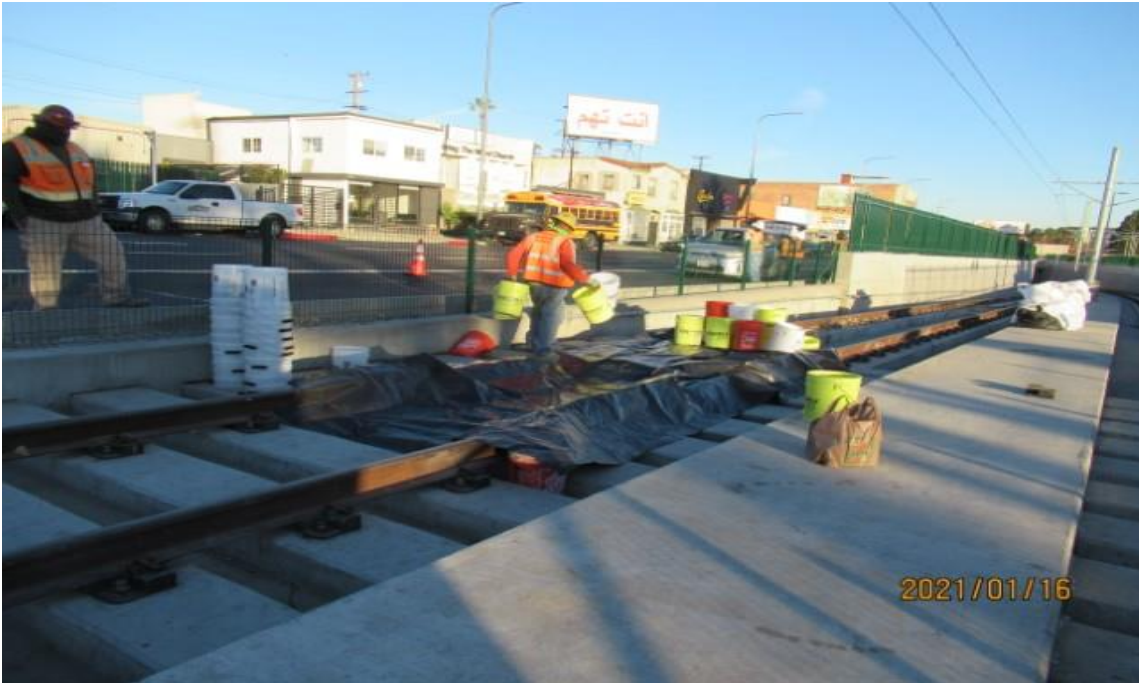
UG3 – WSCC at 48th Street preparing for concrete placement for plinth repair work on SB track (looking northwest) for BIM 360 issues log number 000294 rework

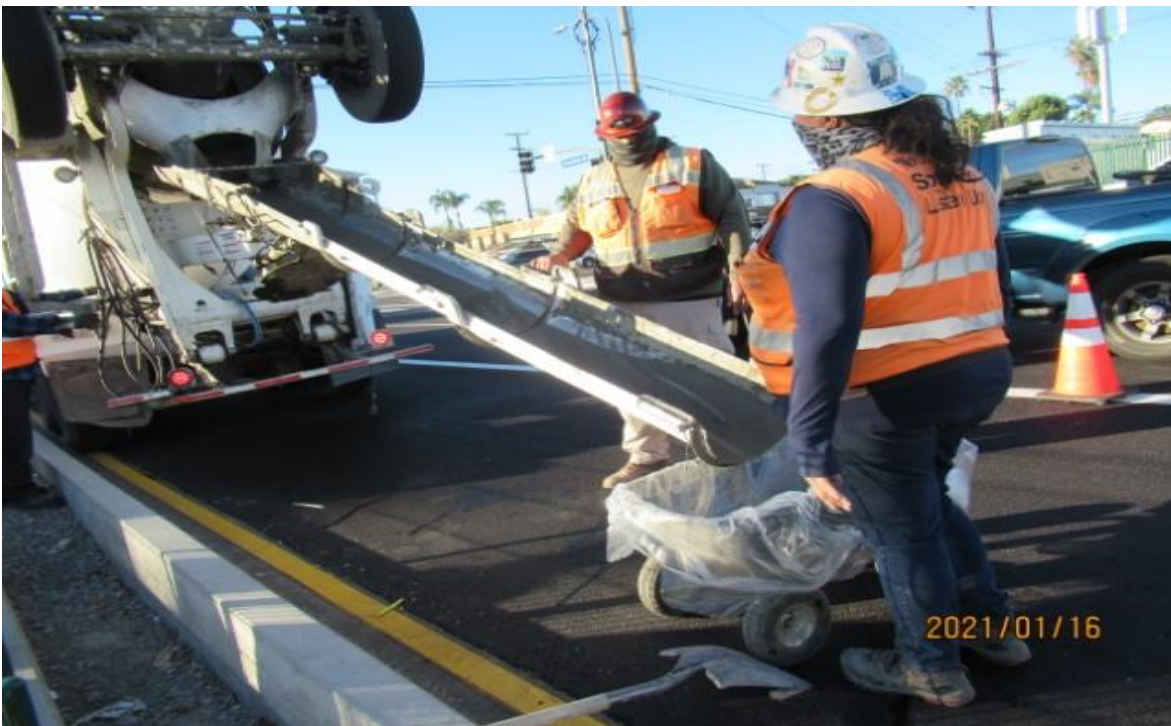
UG3 – RMA Concrete Inspector, collecting concrete samples for break test cylinders at 48th Street (looking southwest) for BIM 360 issues log number 000294 rework

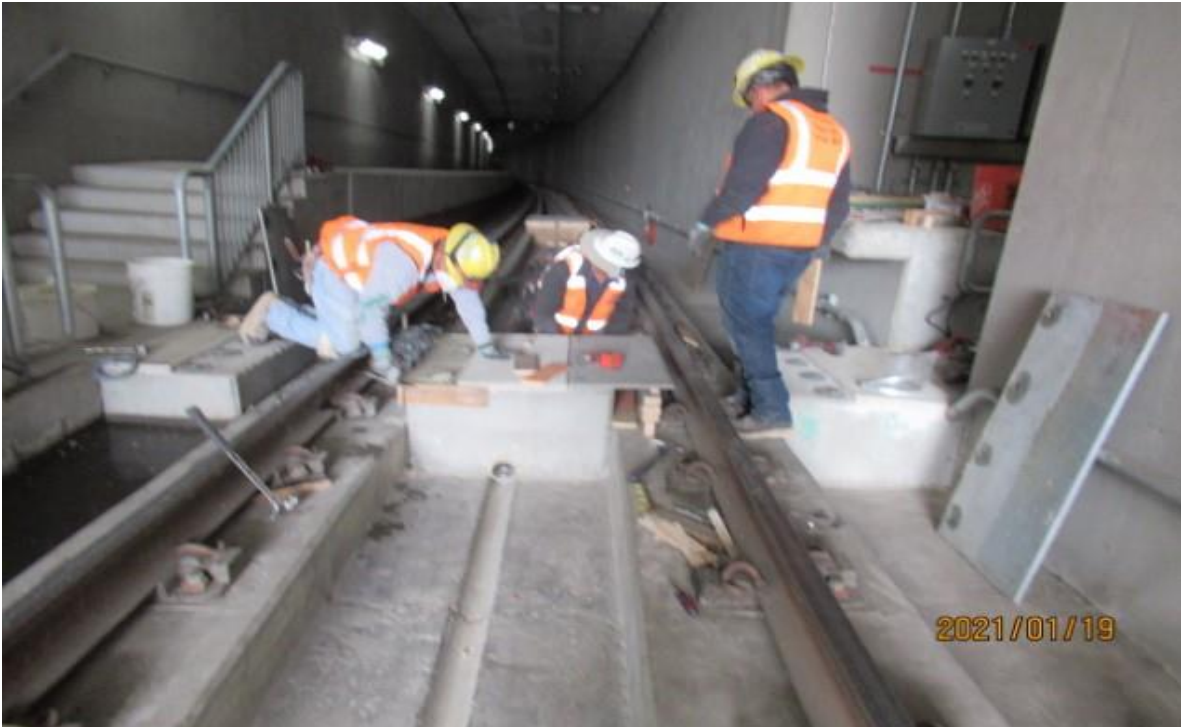
UG4 – WSCC in UG4 NB track STA 371+25 emergency walkway foundations, multiple tasks taking place (looking north) rework

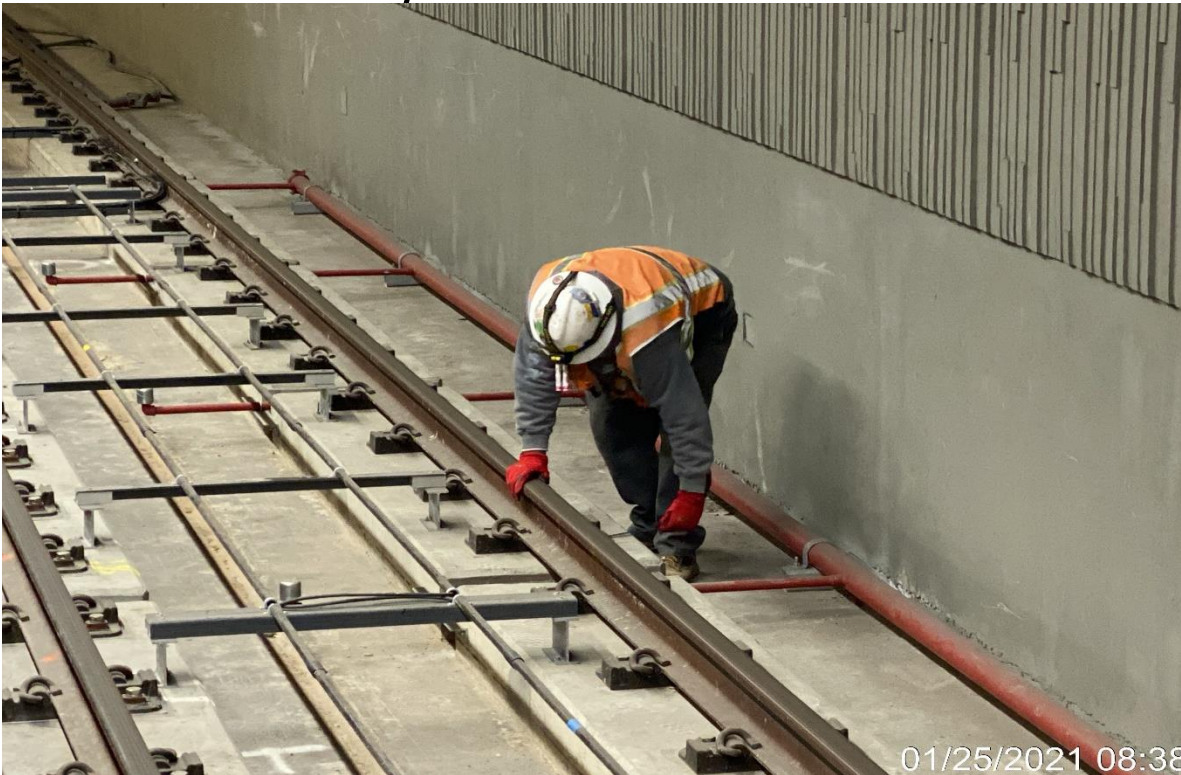
UG4 – RMA checking track fastener gaps at UG-4.

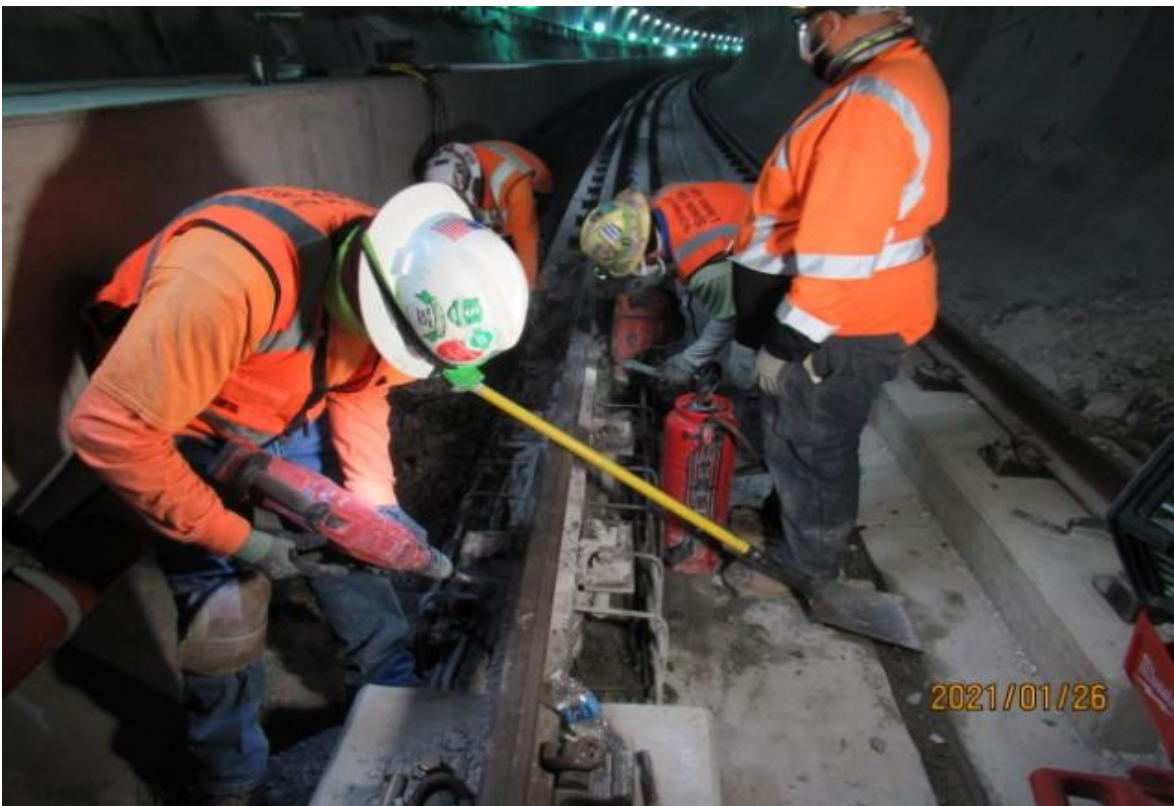
UG4 – WSCC using electrical jack hammers to control demo out plinth 160 in UG4 NB track (looking north) Rework

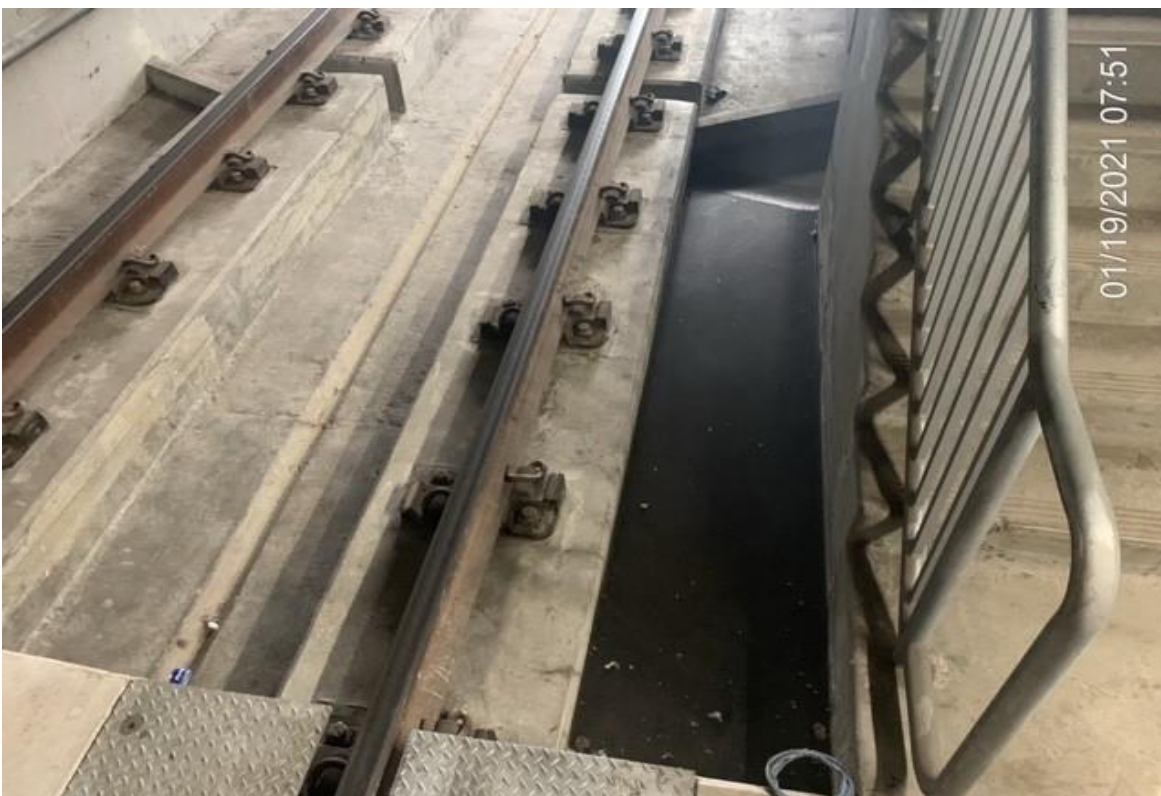
UG4 – Stagnant water condition at south portal NB track.

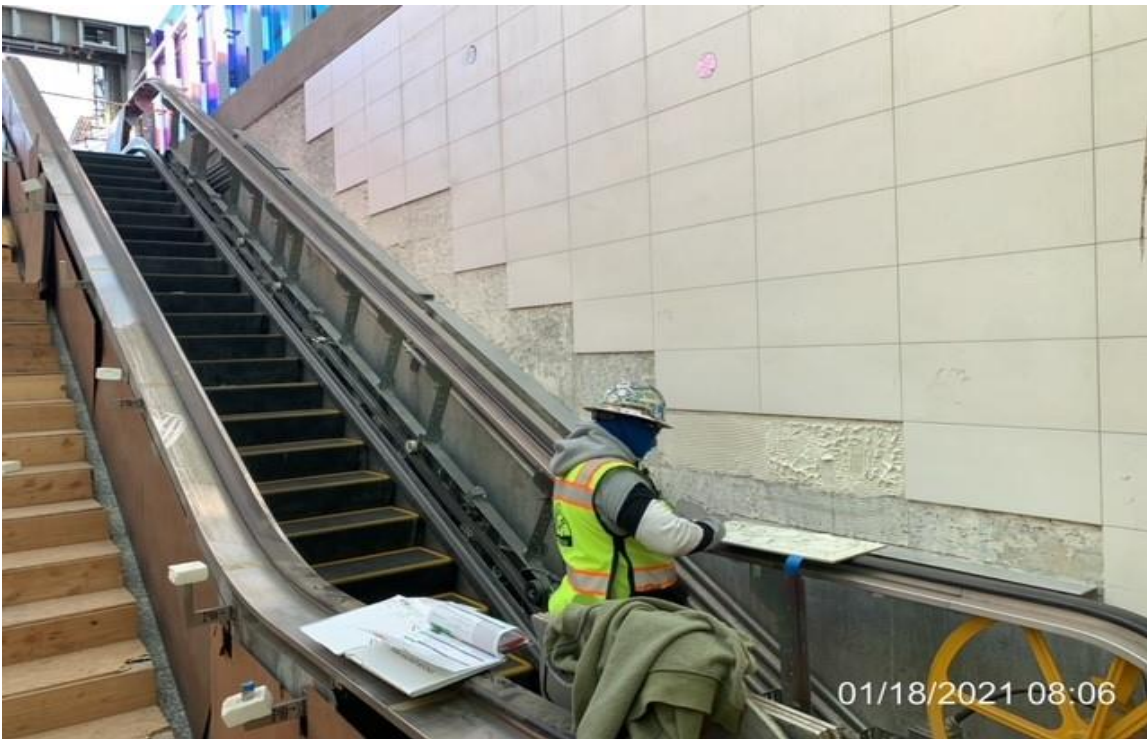
UG4 – Premier Tile & Marble installing missing tiles between escalator #1 and #2.

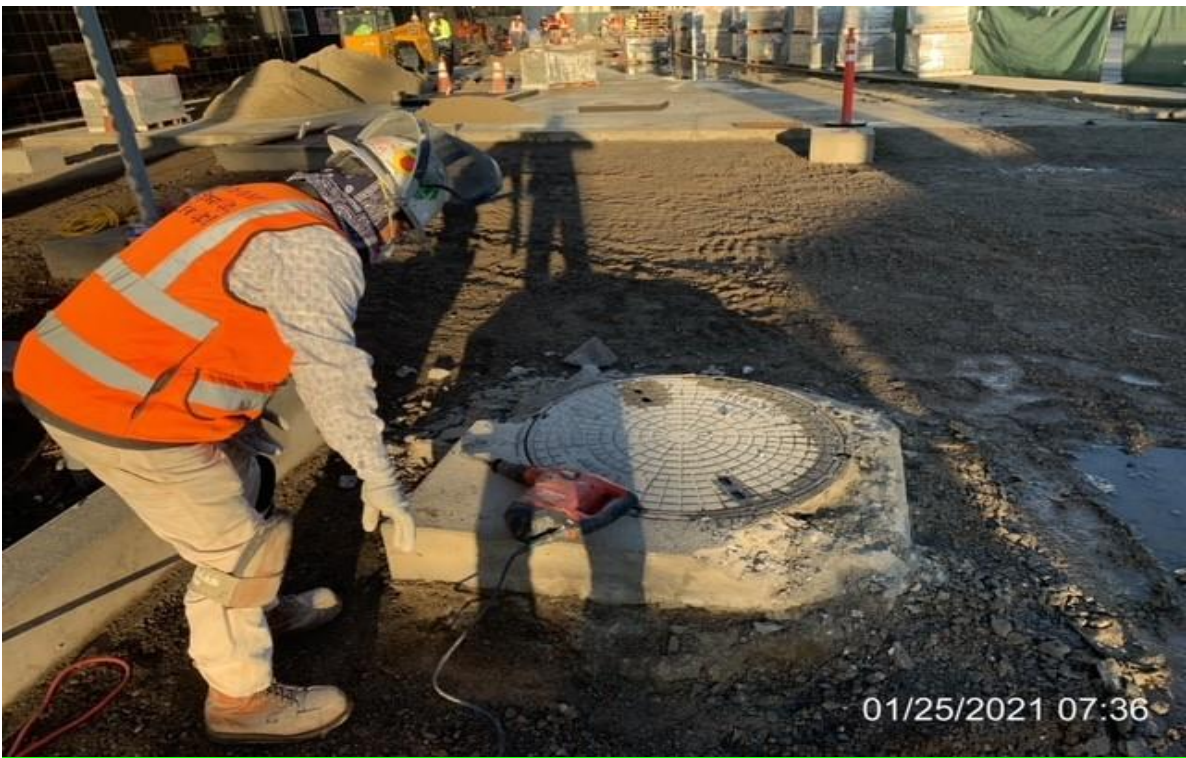
MLK STATION – WSCC finisher chipping out damaged manhole encasement

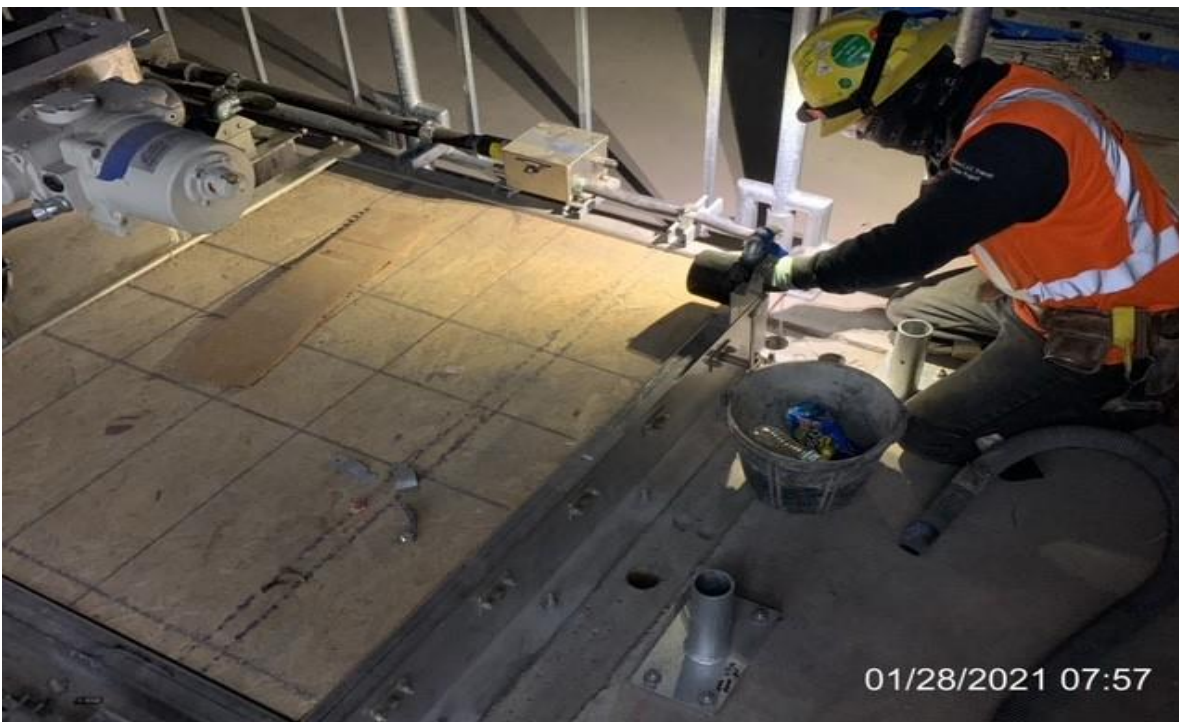
MLK STATION – WSCC finisher filling and patching holes not used for guardrail at north EVF room

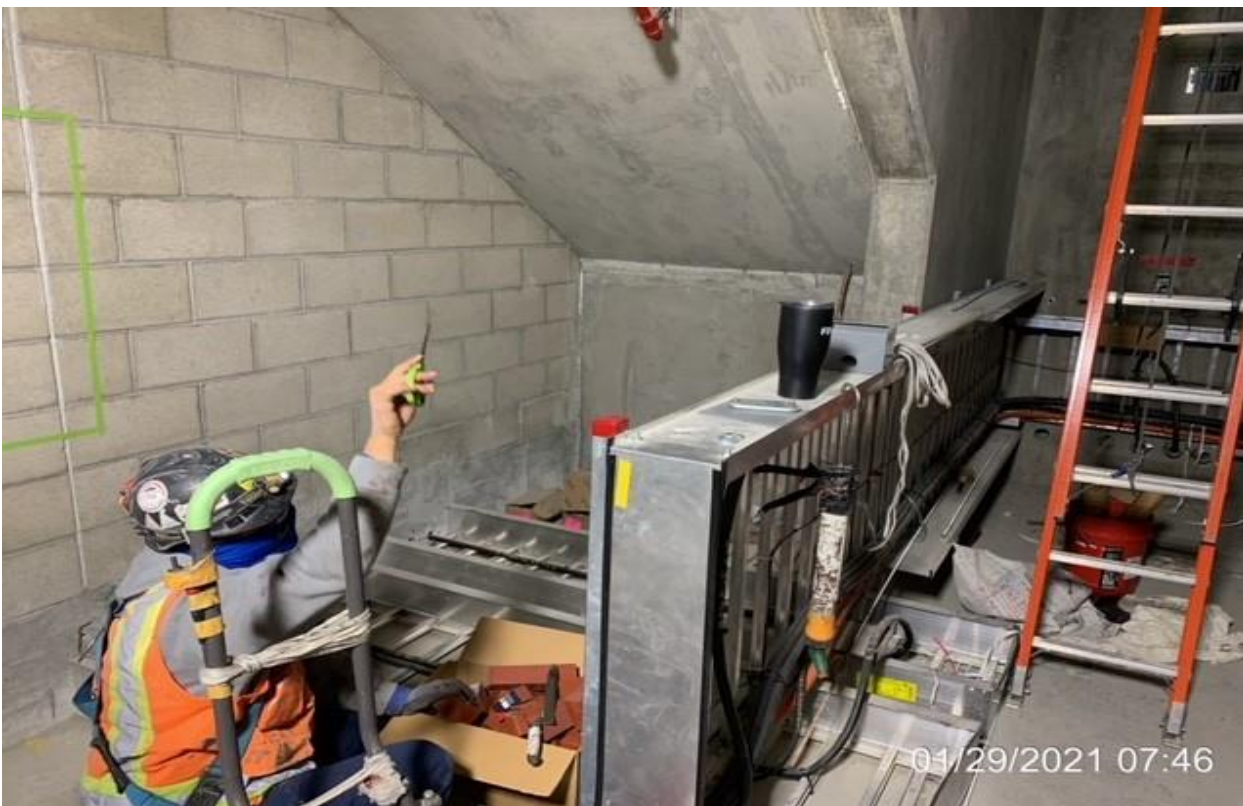
MLK STATION – Applied fire caulking to penetrations through the invert level.
