The Northridge Earthquake

Post Earthquake Investigation Report

California Department of Transportation - Division of Structures

17 January 1994

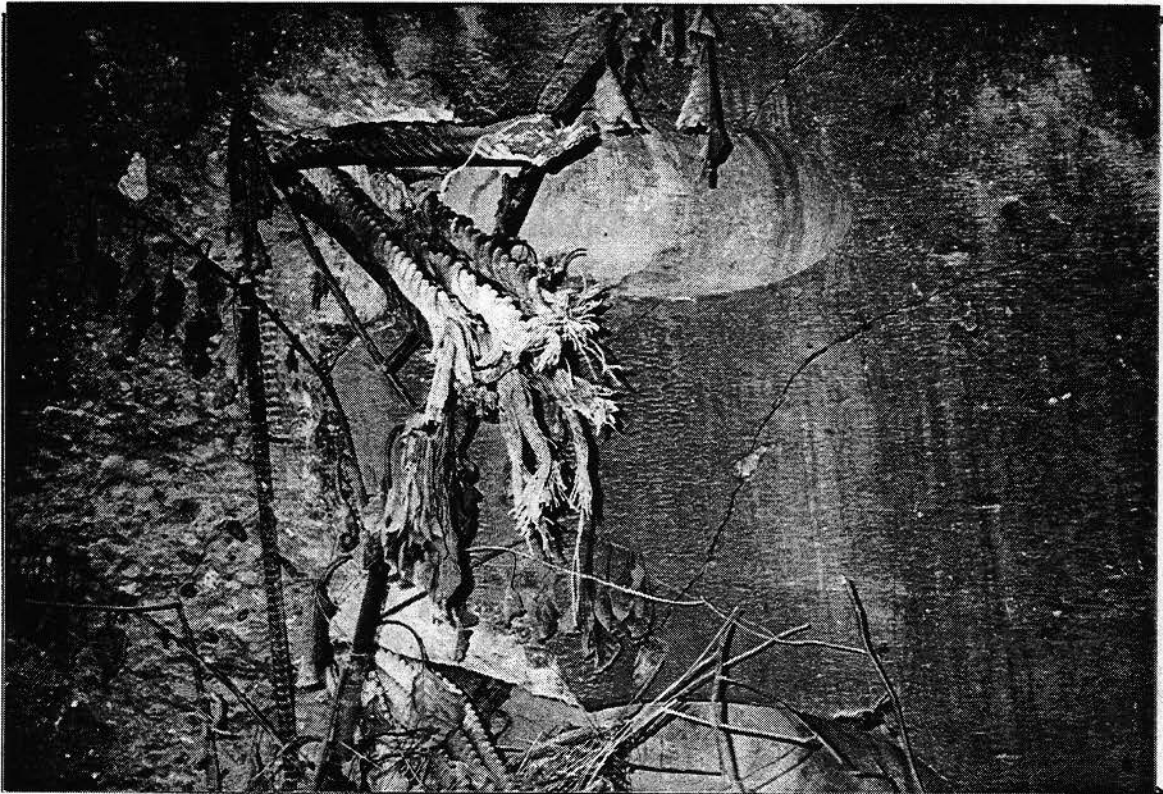
Gavin Canyon Bridge 53-1797R/L 7-LA-5-R47.83 3-12-MDK
The cable restrainer assembly was placed parallel to the centerline of the bridge and spalled the cored void in the hinge diaphragm when the superstructure rotated.

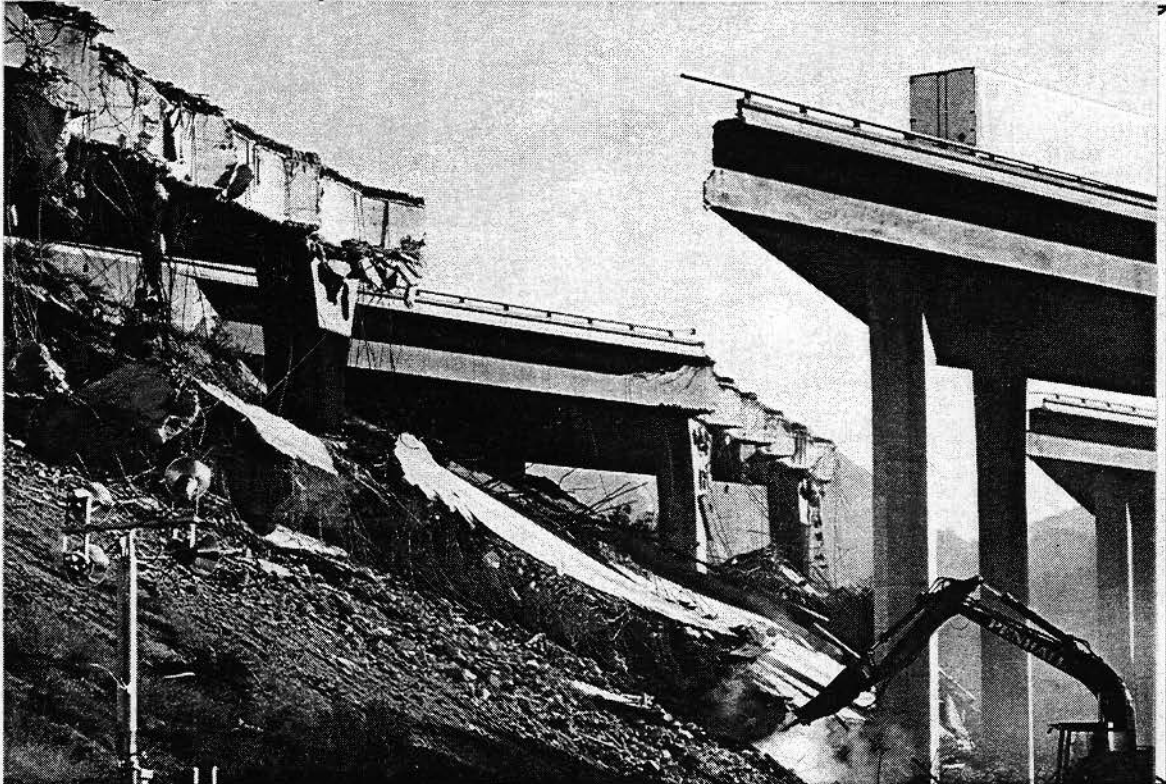
Gavin Canyon Bridge 53-1797R/L 7-LA-5-R47.83 3-2-JSM
Demolition in progress, span 4, southbound structure

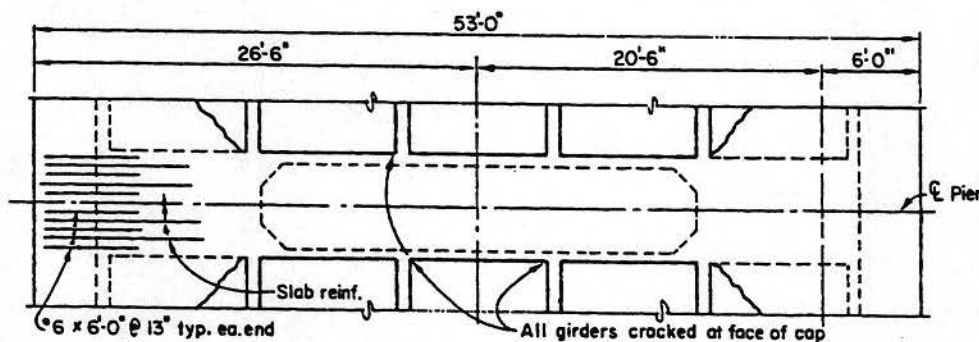
Drawing of damage at Pier 3 following 1971 San Fernando Earthquake.

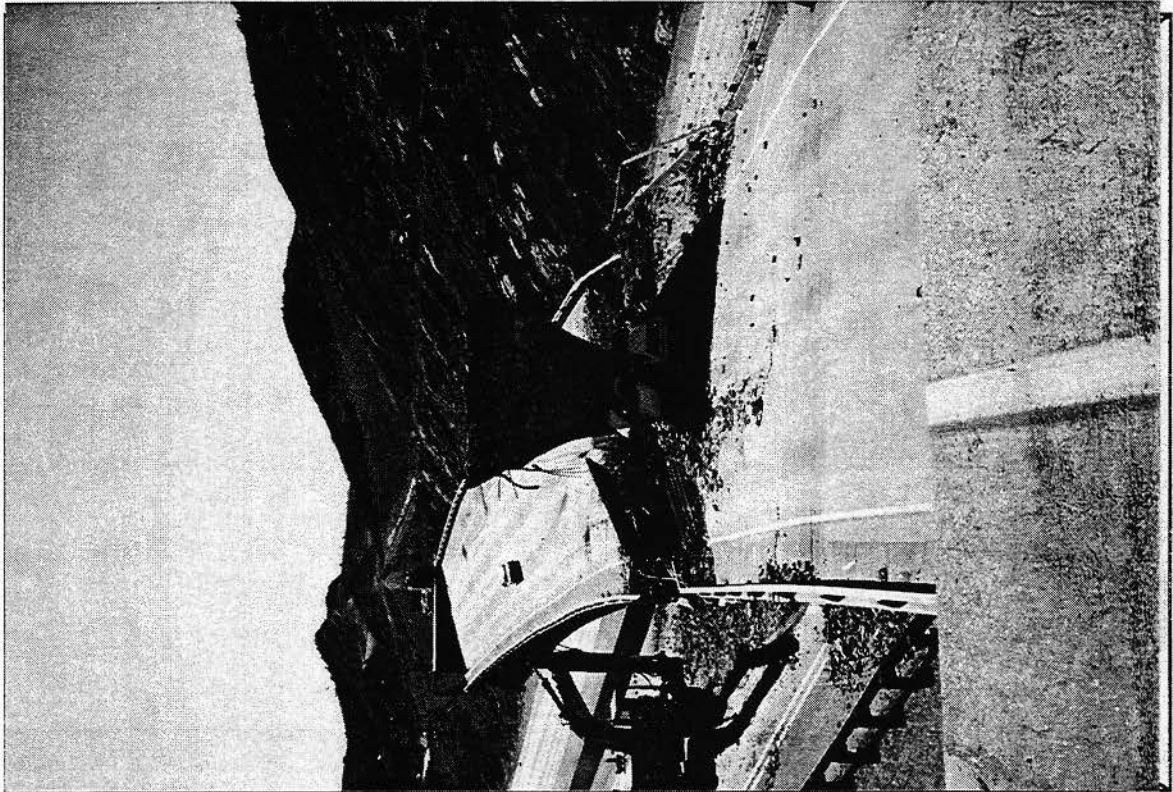
53-1960F

Pier 3 remained standing. Pier 3 did not have cracking on the transverse face, while some vertical cracking ($\approx 3/8$ " wide) was evident on the longitudinal face (looking in elevation). The superstructure on both sides of the pier was on the ground. The main bent cap reinforcement at pier 3 was also on the ground. The #18 bars appeared undamaged and all the concrete was cleaned from the bars. The #5 stirrups in the bent cap had been ripped from the bent cap. Furthermore, there was no longitudinal, mild steel through the bent cap. When the prestressing was over-stressed and failed, the superstructure had almost no negative moment capacity.

14/5 Conn. Sep. & OH
Looking S @ the standing pier 3

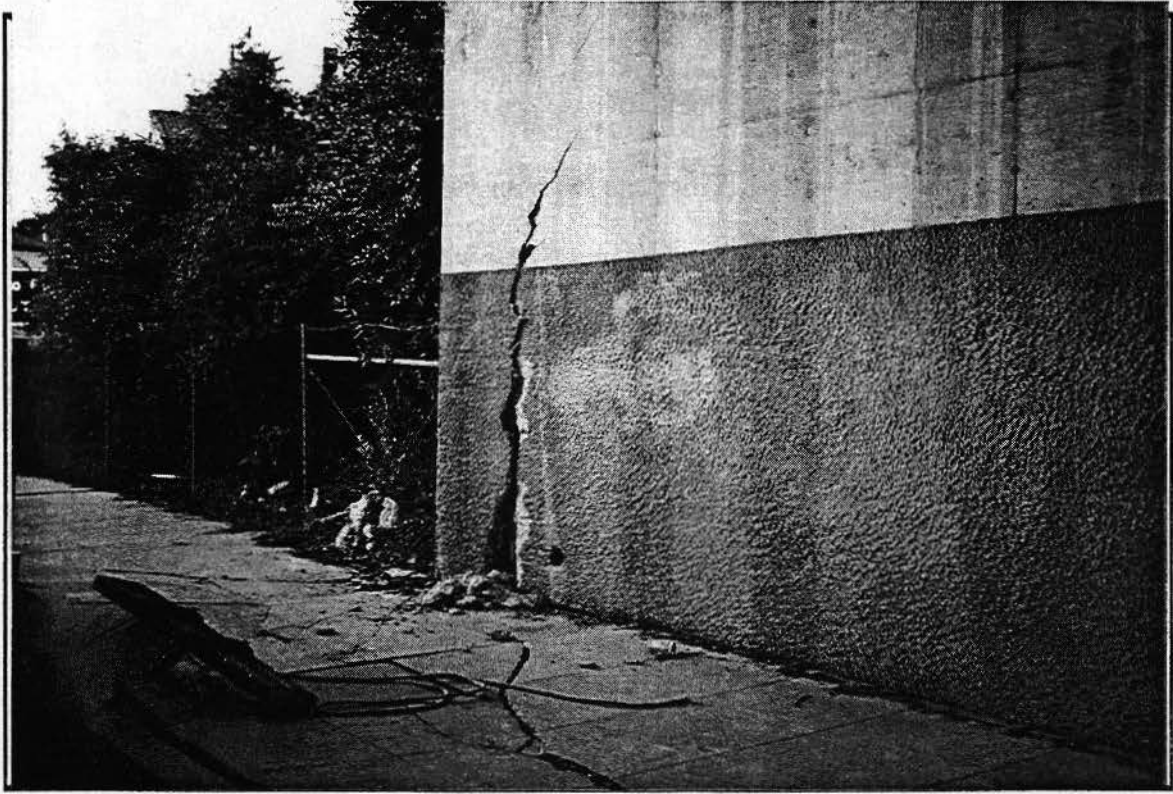
53-1506

Rinaldi Street Undercrossing
Crack in North Bin Wall.

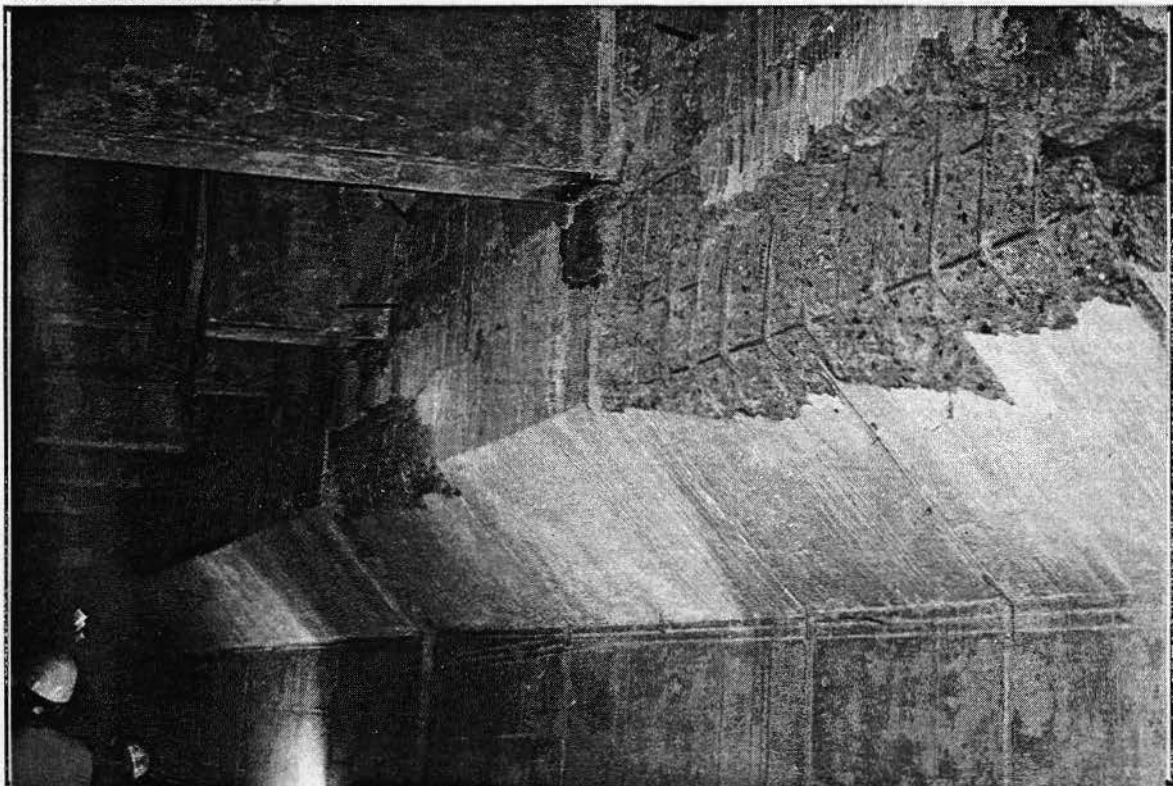
53-1506

The girders spanning the bin had cycled a longitudinal moment into the backwall, working it back and forth to form a flexural tension crack into the abutment backwall. This movement spalled off a compression region at the back and bottom of the backwall surface. There are signs of transverse motions of the bin girders doing more damage.

Rinaldi Street Undercrossing
Flexural Tension Cracks in Backwall.

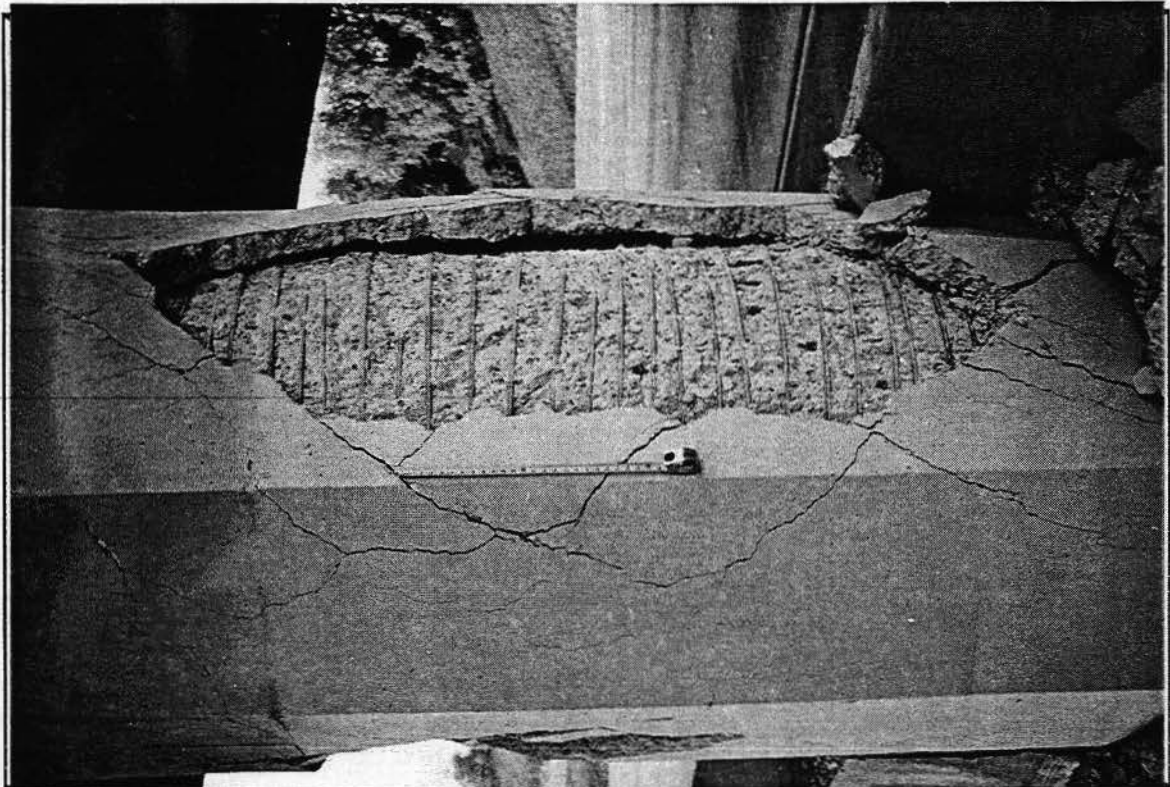
Although the column had massive spalling, the core of the column remained intact. This type of behavior can be expected to happen with only minor repair of the bridge necessary.

Ruffner Avenue OC 53-2396 7-LA-118-R8.05 16-11-TES
Bent 2, east column, looking northwest.

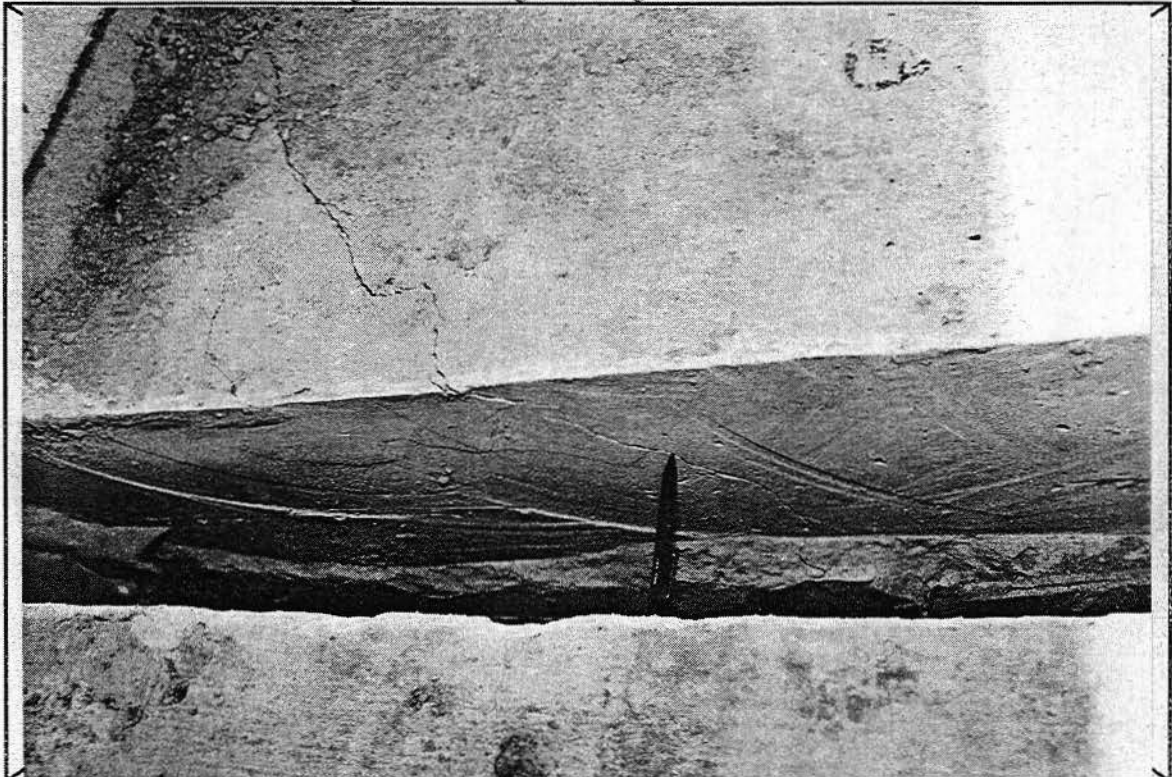
Southeast Connector O.C. 53-1637F 7-LA-10-R5.65 E-17-BKT
Cracks in Diaphragm (Span 7 Side) at Bent 7 Hinge, Looking West.

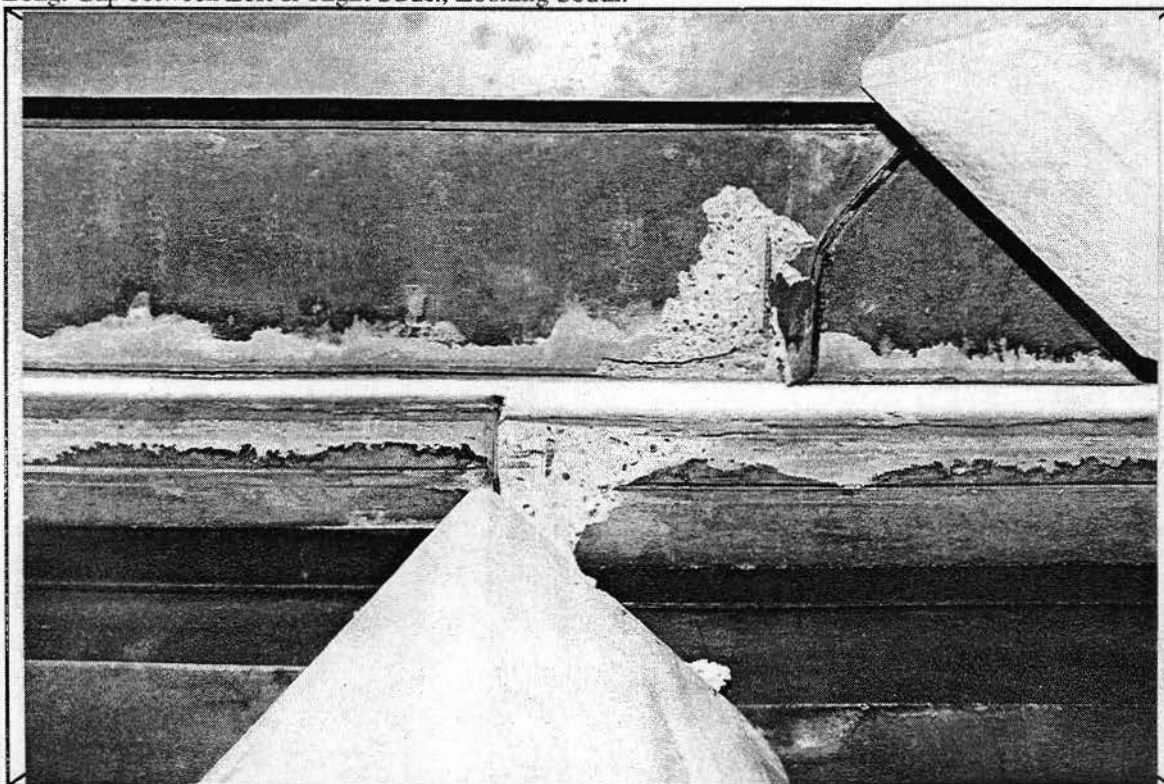
Las Las Virgenes Road OC 53-1442 7-LA-101-31.05 G-5-BKT
Spalling at longitudinal gap between structures near bent 4, looking up.

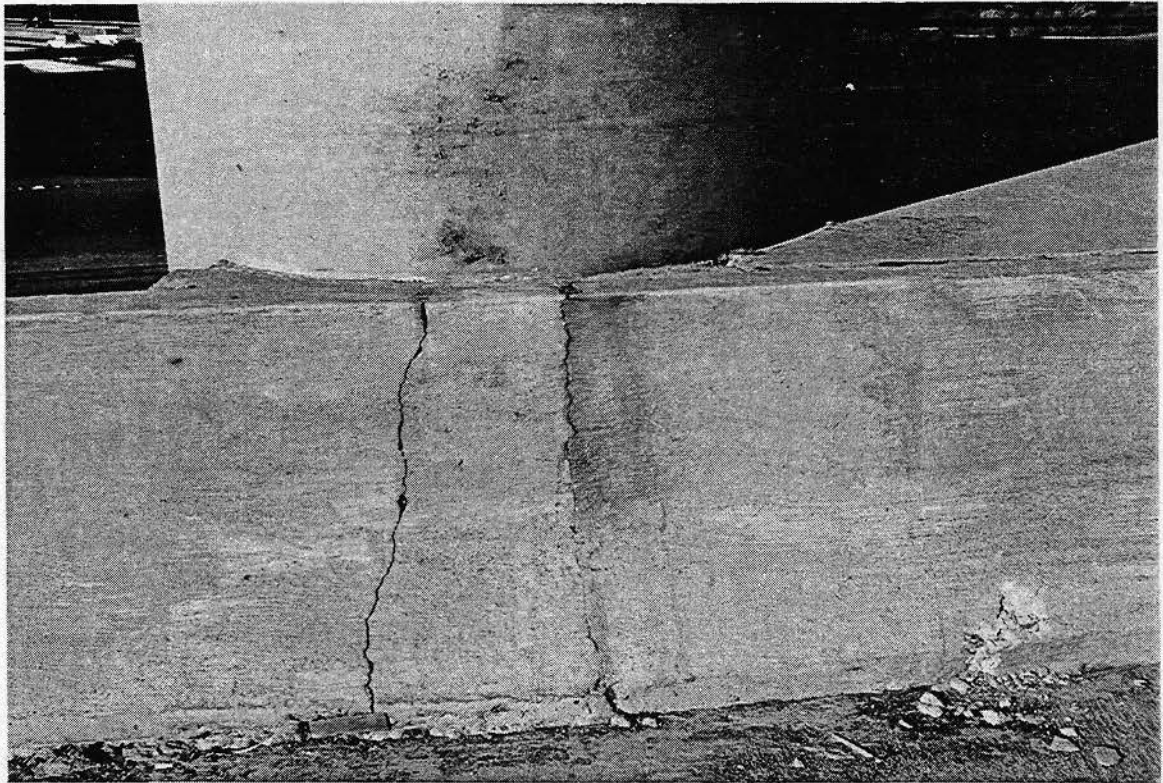
Cracked barrier rail next to bent 6 column.

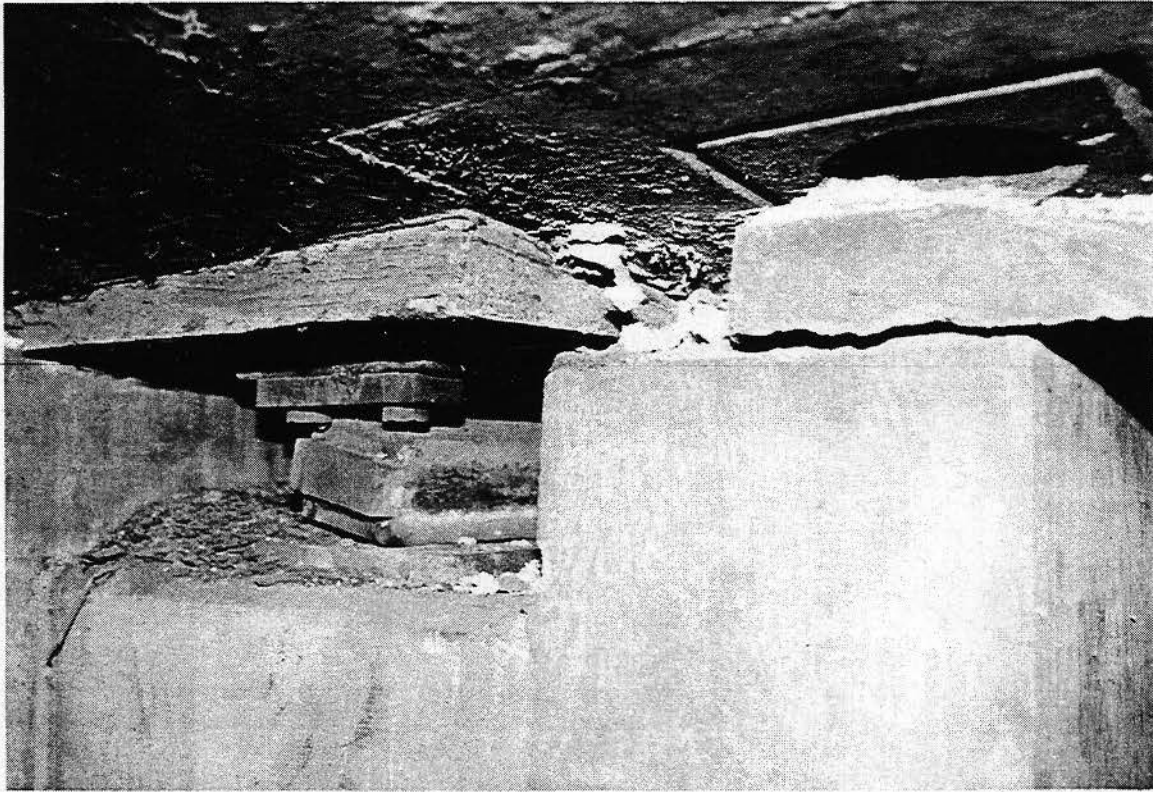
Tipped rocker bearing bar at abutment 11.

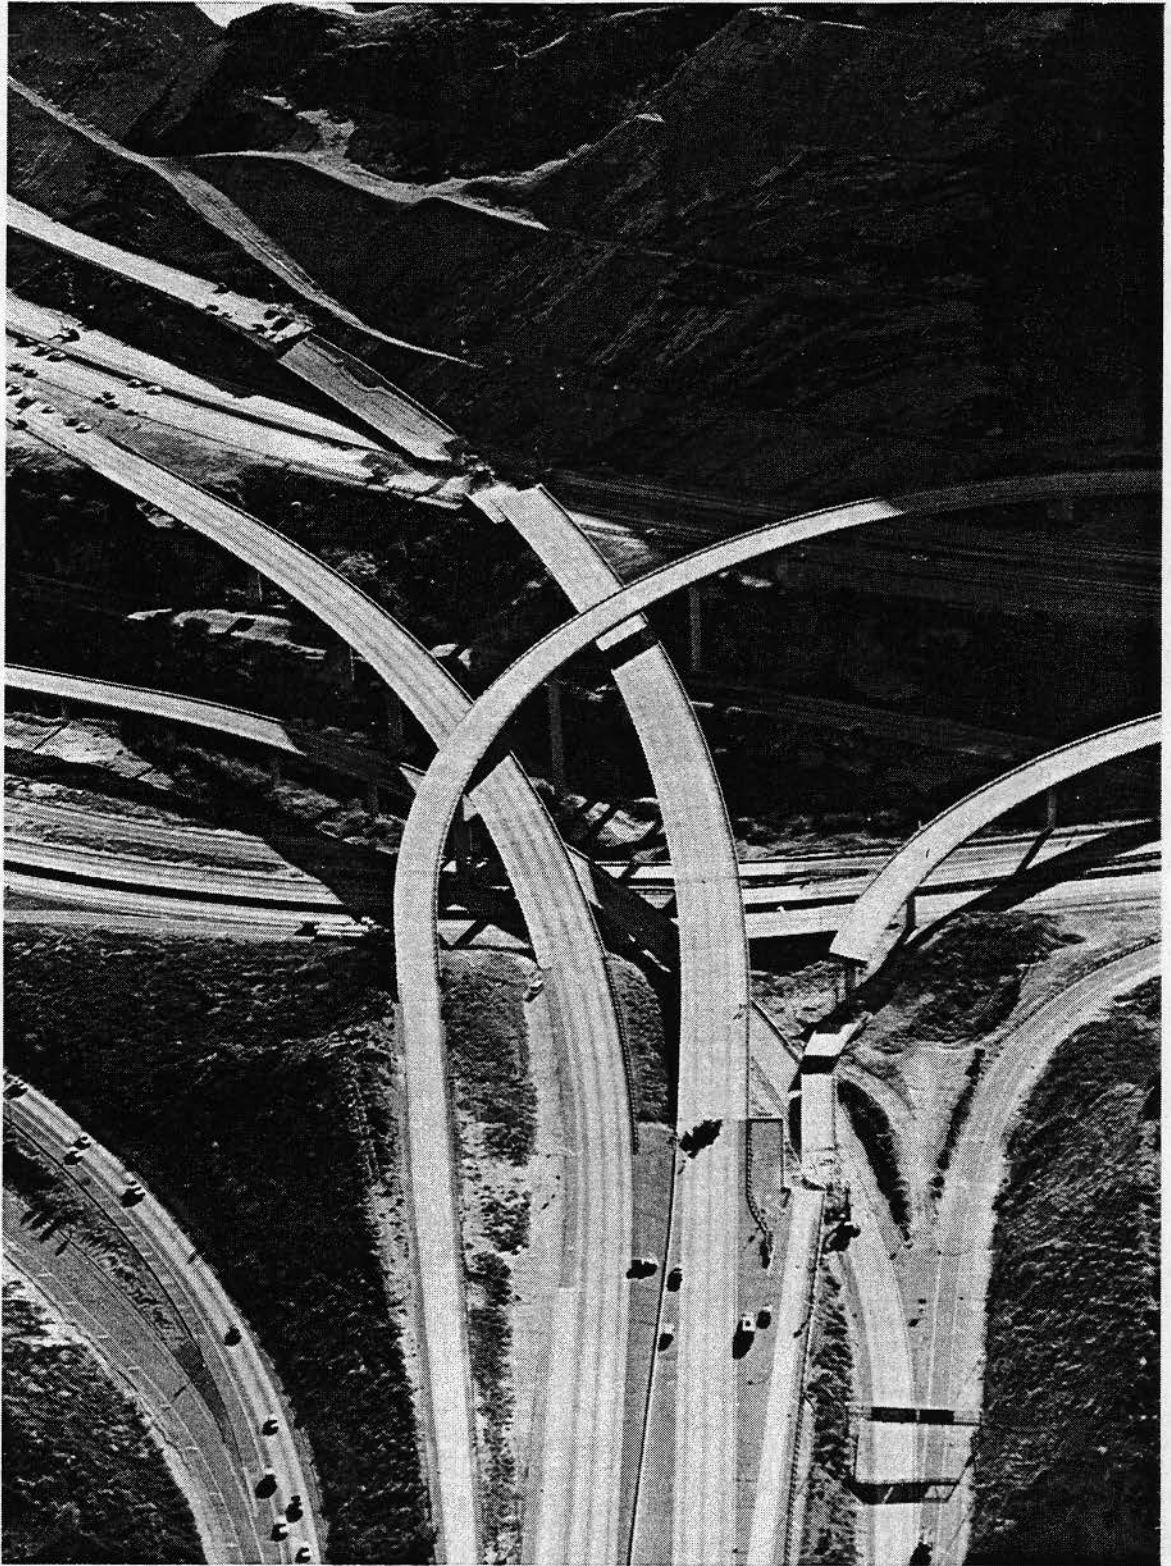
Route 14/Interstate 5 Interchange
Collapsed Connectors 53-1964F & 53-1960F

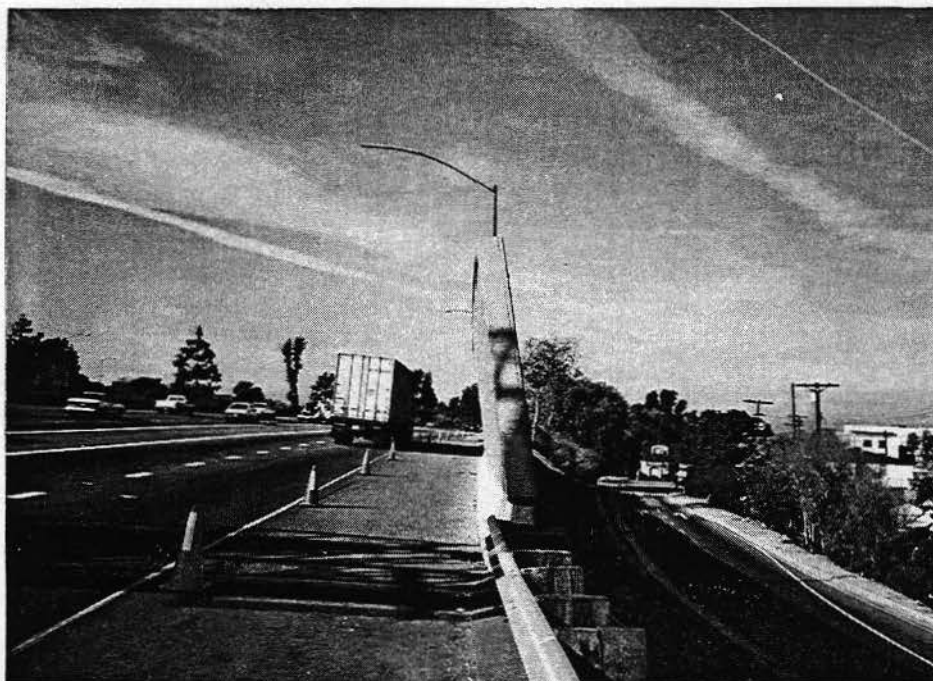
Damaged Soundwall on WB Route 101

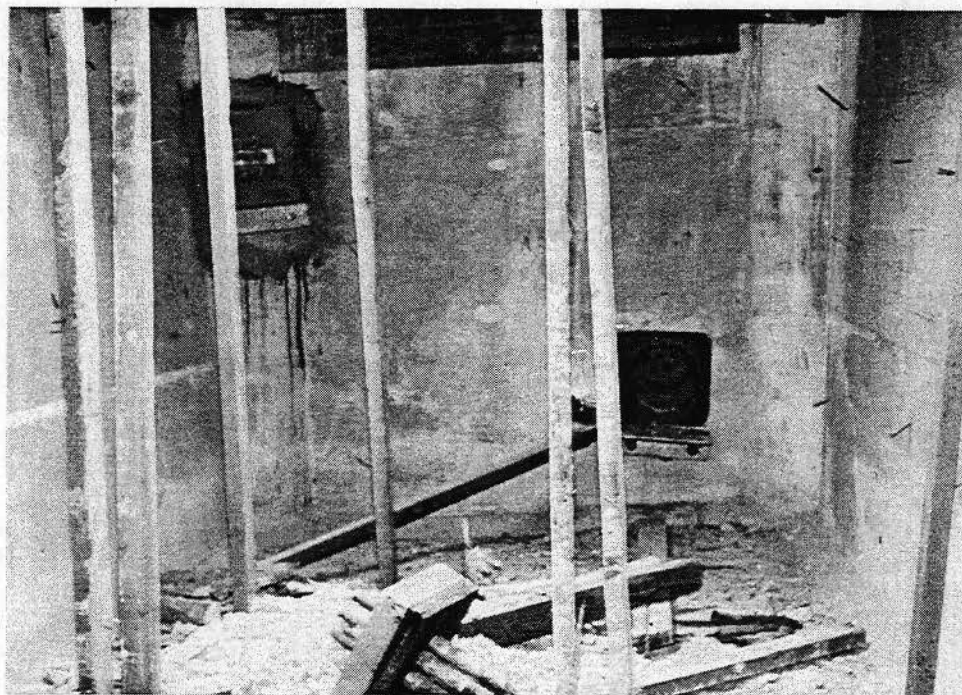
Inside cell, failed restrainer unit in foreground

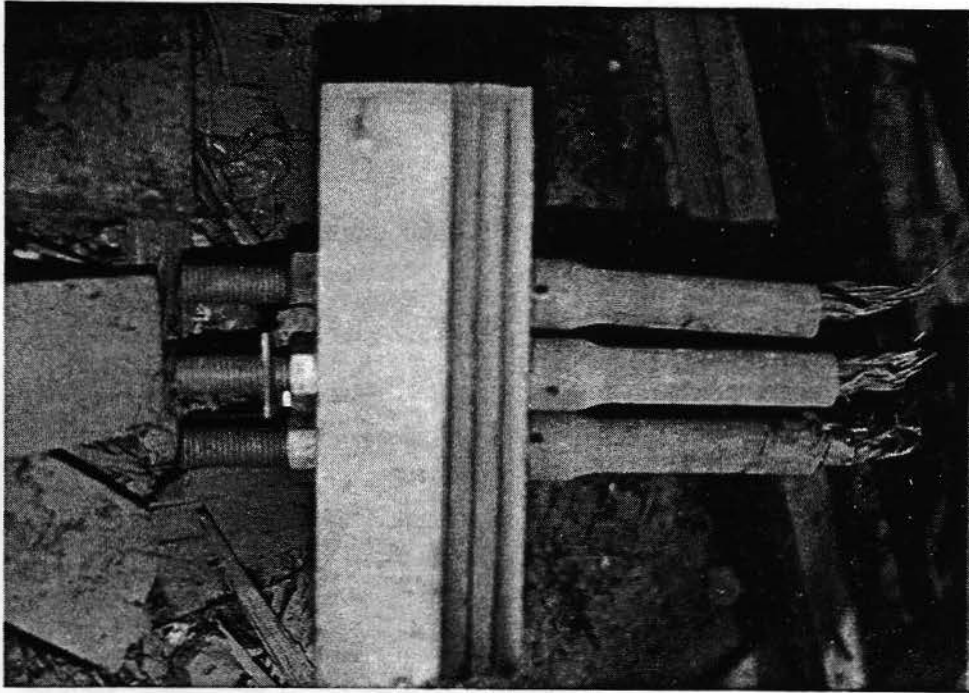
Close-up of failed restrainer cables.
