REDLANDS PASSENGER RAIL PROJECT
Preliminary Geotechnical Evaluation
San Bernardino, San Bernardino County, California
December 2011

Subject: Preliminary Geotechnical Evaluation for SANBAG Redlands Passenger Rail
Project, San Bernardino County, California

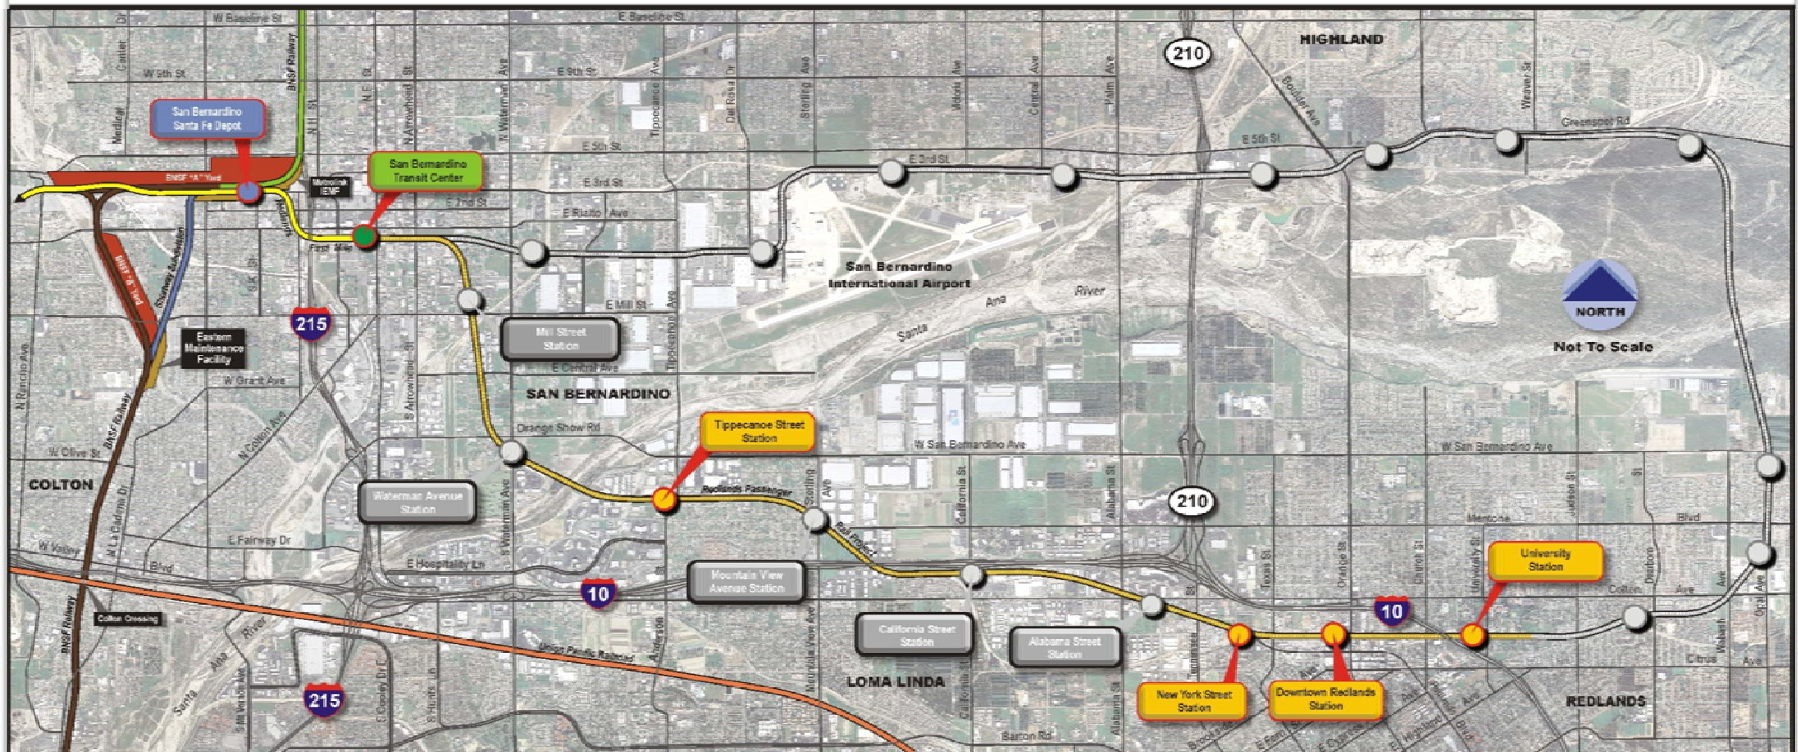
VICINITY MAP
 REDLANDS PASSENGER RAIL PROJECT
 COUNTY OF SAN BERNARDINO, CALIFORNIA

The proposed project consists of the development of a passenger rail service operating between the proposed E Street Station, located at the southwest corner of E Street and Rialto Avenue, and the University of Redlands, over a distance of approximately nine miles. The location of the proposed alignment is shown on Figure 1, Vicinity Map.

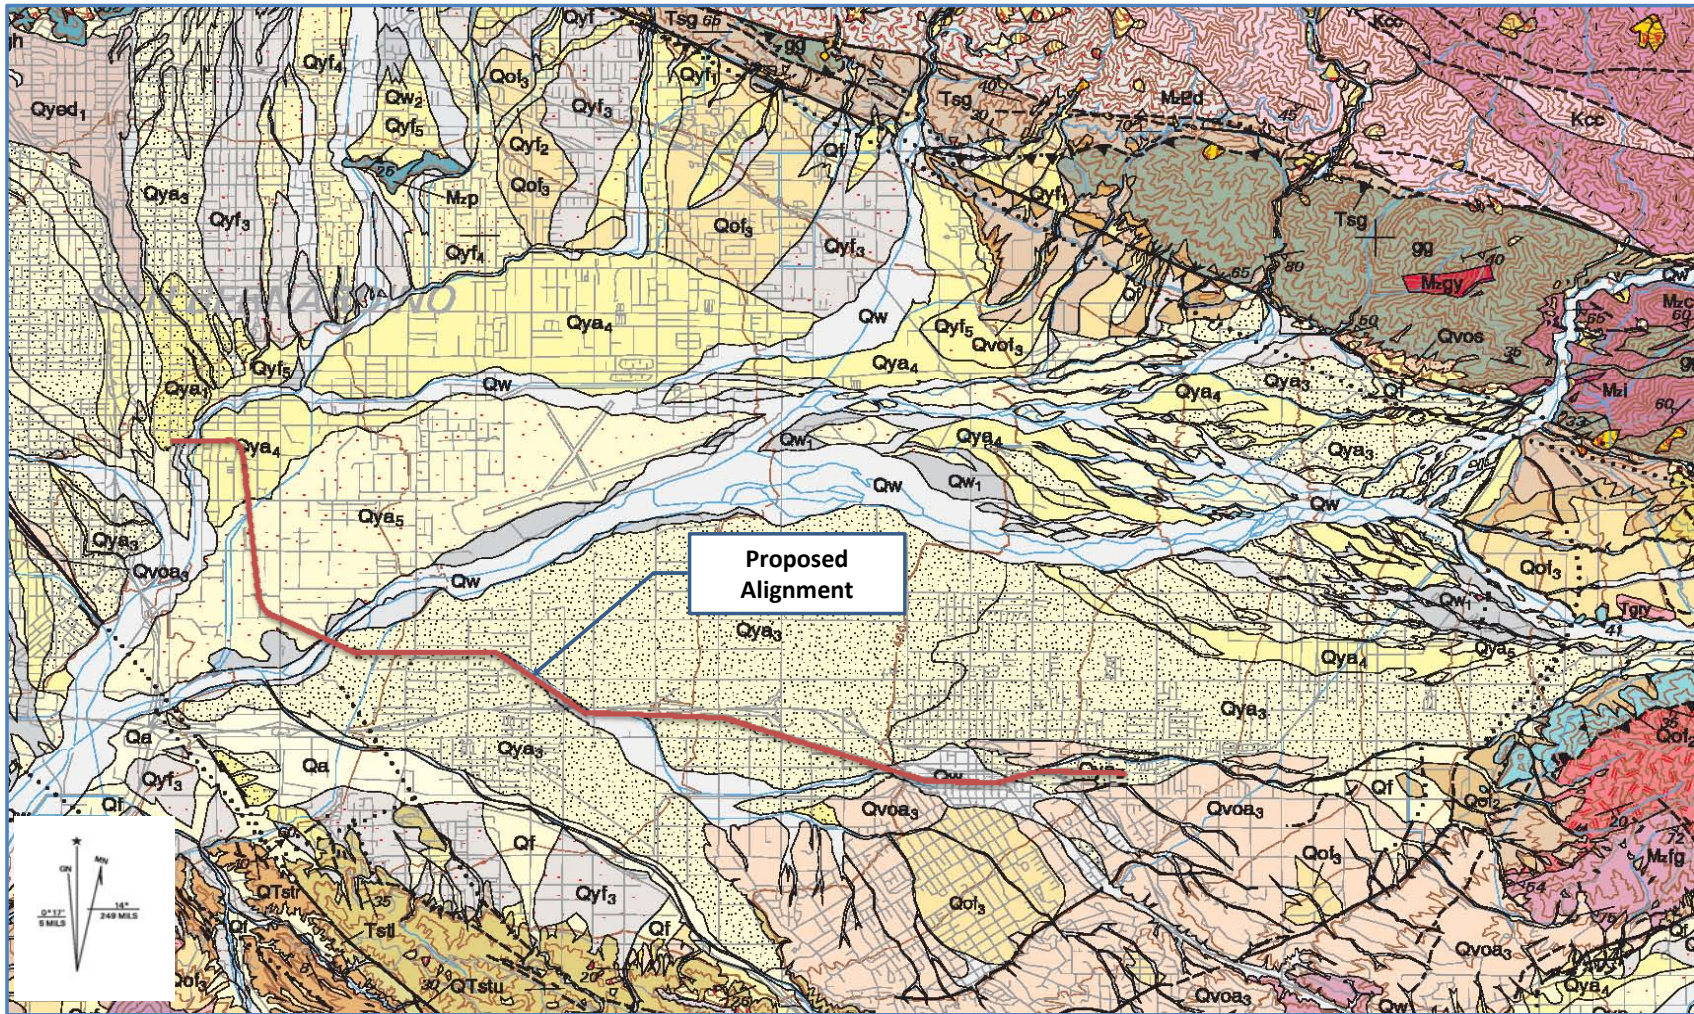
Figure 2

In general, the alignment is underlain by young alluvium valley deposits (designated Qya1, Qya3, Qya4, and Qya5, CGS, 2003). At the Santa Ana River and several creek crossings, the alignment is underlain by very young alluvial wash deposits (designated Qw, CGS, 2003). The alluvial soils are composed primarily of sand and gravel with some local finer and coarser deposits. A geologic map of the area is presented on Figure 2.

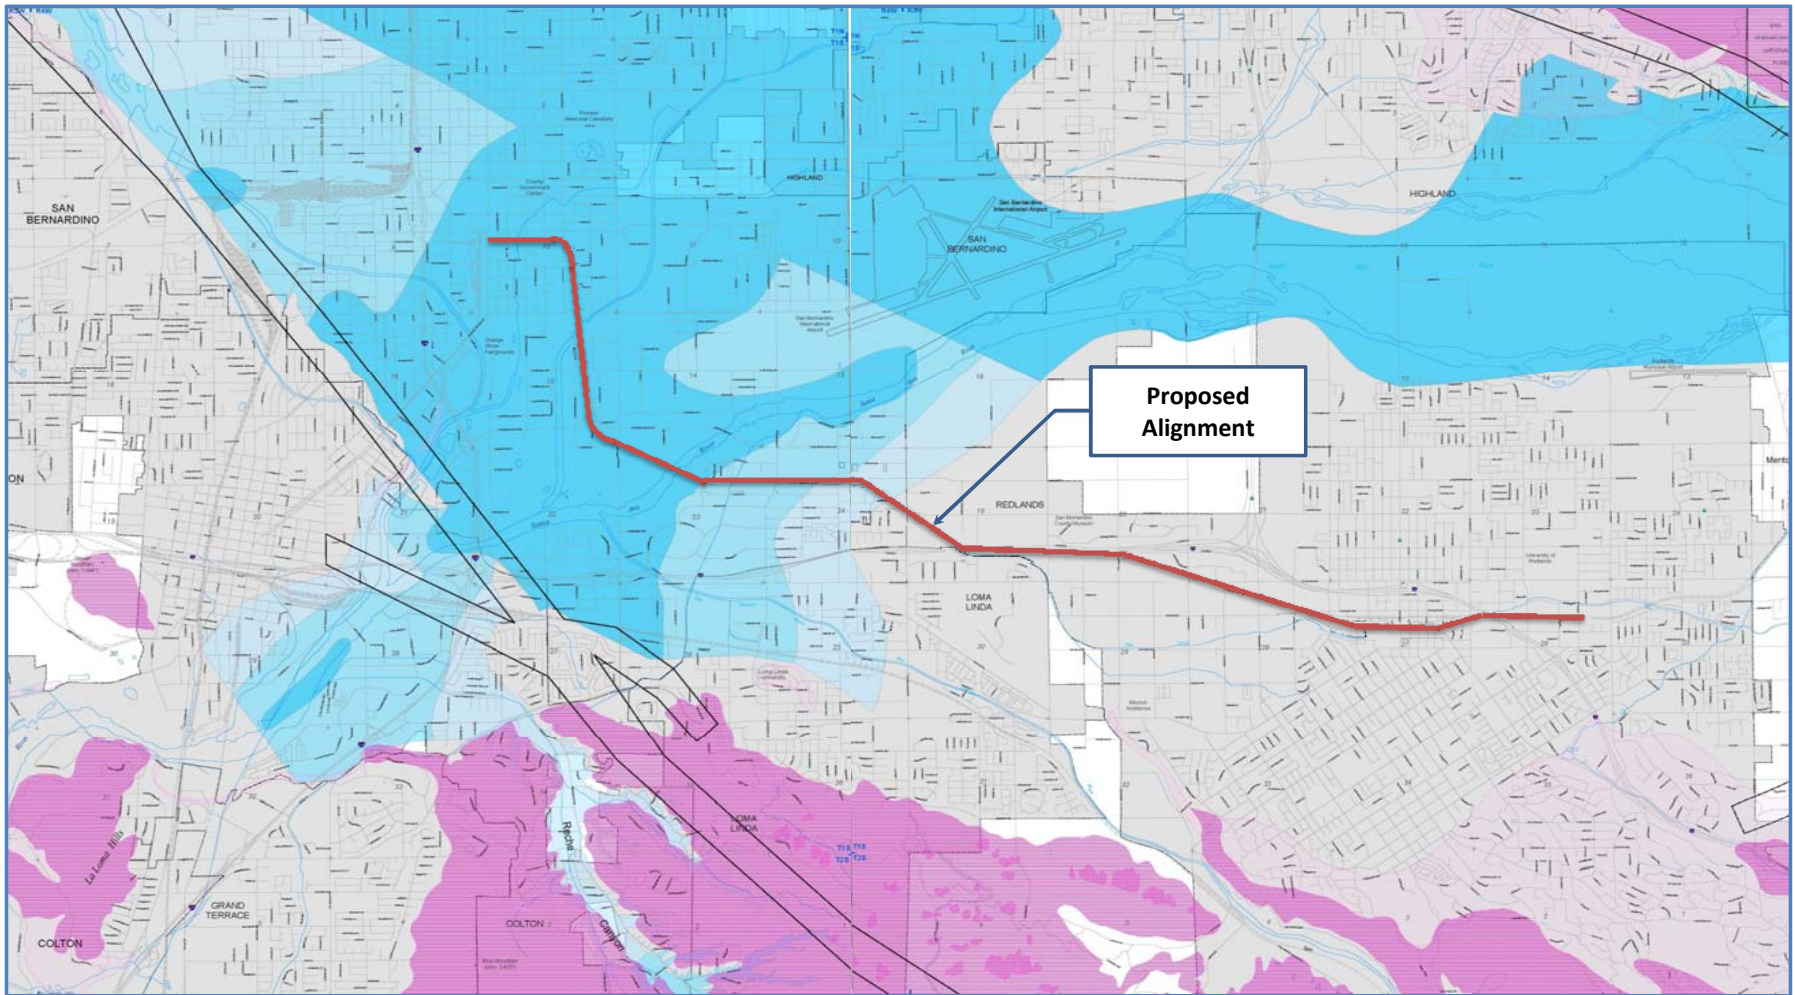
Figure 5

Based on the *San Bernardino County General Plan – Geology Hazard Overlays* (San Bernardino, 2009, see Figure 5), an approximate western half of the alignment up to the west side of Mountain View Avenue is located within an area designated as low to high susceptibility to liquefaction; (1) High susceptibility from E Street to approximately 2,500 feet west of Tippecanoe Avenue, (2) Medium susceptibility from approximately 2,500 feet west of Tippecanoe Avenue to approximately 1,500 feet east of Tippecanoe Avenue, and (3) Low susceptibility from approximately 1,500 feet east of Tippecanoe Avenue to the west side of Mountain View Avenue. The potential for surface manifestation of liquefaction in the form of sand boils and ground cracking may be anticipated. The remaining stretch of the alignment is not considered susceptible to liquefaction.

Marginally stable slopes, including existing landslides, may be subject to landsliding caused by seismic shaking. In most cases, this is limited to relatively shallow soil failures on steep slopes, especially where the soil is relatively thick and loose. The project area in general is not located in an area shown to be susceptible to seismically induced landslides by San Bernardino County (see Figure 5).

Mitigation Measure No 3: Future geotechnical exploration will need to be performed to evaluate the liquefaction potential, and the proposed structures constructed in areas susceptible to liquefaction should be supported on piles embedded below the liquefaction zones or on a mat foundation, if feasible. Alternatively, the liquefaction potential can be mitigated by ground improvements, such as stone columns or compaction grouting.

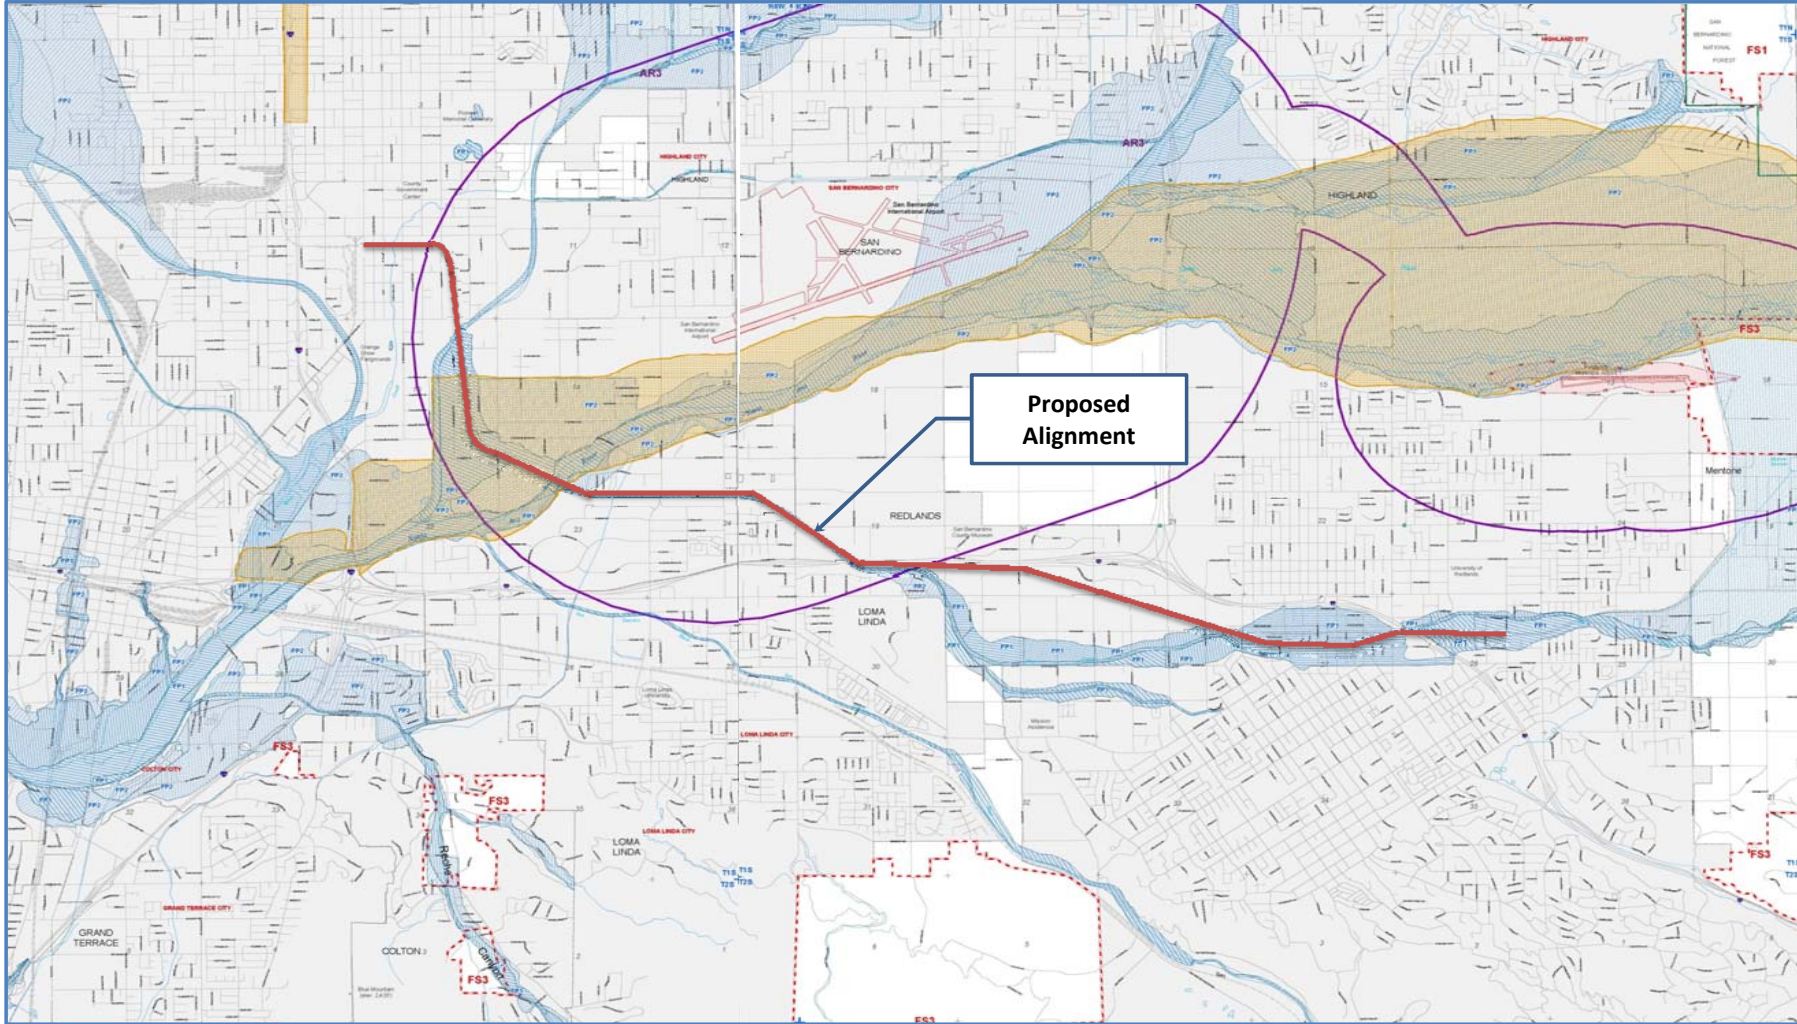
FLOOD HAZARD MAP
 REDLANDS PASSENGER RAIL PROJECT
 COUNTY OF SAN BERNARDINO, CALIFORNIA

Strong seismic ground motion can cause dams and levees to fail, resulting in damage to structures and properties located downstream. Based on the *San Bernardino County General Plan – Hazard Overlays* (San Bernardino, 2009, see Figure 6), the area along the alignment between Central Avenue (approximately Milepost 2.0) and east of the Santa Ana River (approximately Milepost 6.0) is located within an area designated as having a dam inundation hazard. The reservoirs retained at Big Bear Lake and Seven Oaks Dam are tributary to the Santa Ana River. If the Big Bear Lake Dam and/or the Seven Oaks Dam fails due to a strong earthquake, the above-named portion of the alignment is expected to experience significant flooding. The potential for seismically induced inundation due to failure of the Big Bear Lake Dam or the Seven Oaks Dam cannot be mitigated locally.

Based on the *San Bernardino County General Plan – Hazard Overlays* (San Bernardino, 2009, see Figure 6), the areas along the alignment between Twin Creek (also called Lower Warm Creek) and west of California Street and between the east side of New York Street and the eastern end of the alignment are located within an area designated as a 100-year flood plain. The potential for flooding at these locations is considered high.

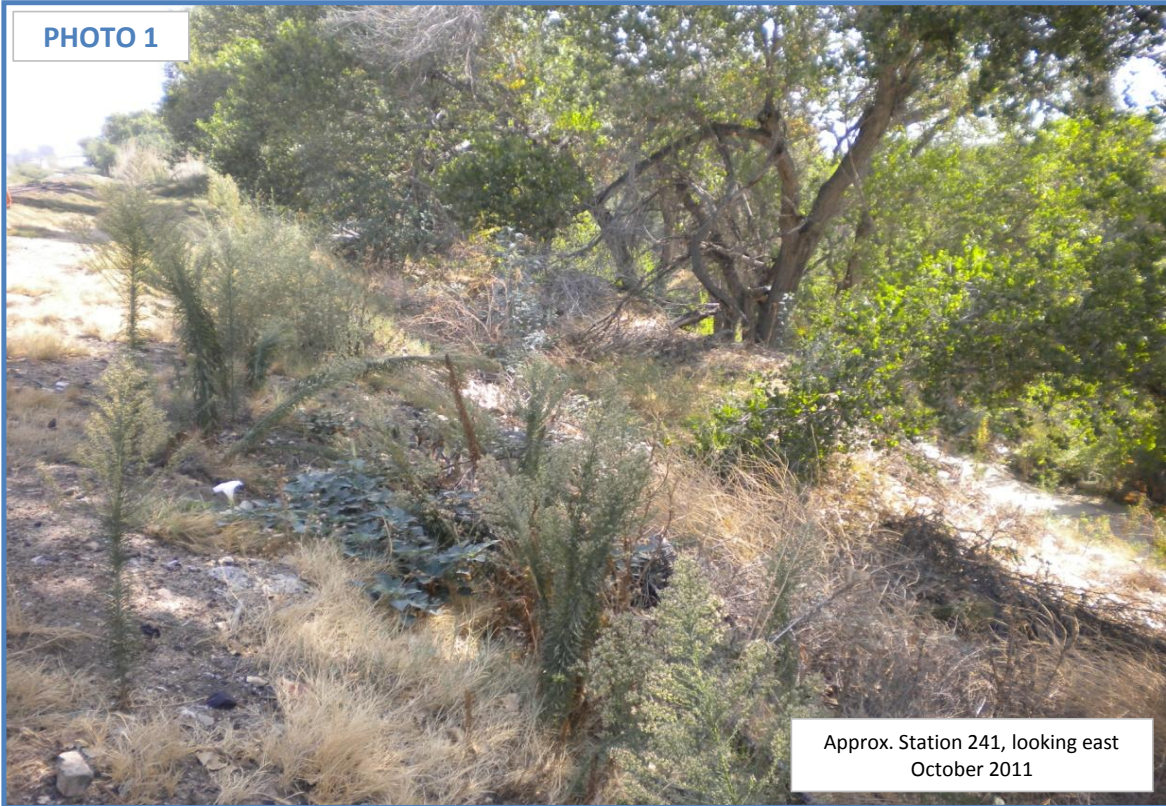
PHOTO 1

Station Nos	Photo Nos.	Existing Conditions
236+00 to 263+00	1 and 2	Slope face covered with trees, bushes and occasionally rocks
263+00 to 263+70	2 and 3	Concrete drop structure, approximately 11 feet in height
263+70 to 267+00	4	Rocks and boulders on slope face
267+00 to 269+00	5 and 6	Approximately 3 to 4 feet high of retaining structure at bottom of slope with rocks and boulders at bottom of Creek. Minor localized surficial/erosion failure or loss of soils behind retaining structure.
269+00 to 269+80	5 and 6	Tippecanoe Avenue Crossing
269+80 to 281+00	7	Unprotected slope face with gravel and cobbles and occasional rocks and boulders
281+00 to 290+40	8 and 9	Several localized surficial/erosion failures observed during site visit in March, 2011. Exposed slope face included garbage mixed with soils. New fills were already placed over localized failure areas during site visit in October 2011.
290+40 to 291+40	10	Retaining structure at bottom of slope with rocks and boulder at bottom of Creek. Encountered refusal on the south side of existing track at shallow depth due to possibly rocks and boulders.

Approx. Station 241, looking east
October 2011

Also the existing slopes between Station Nos approximately 261+00 and 369+00 should be mitigated to minimize surficial/erosion failures. The artificial debris (garbage mixed with soils) observed within areas between Station Nos approximately 281+00 and 290+40 should be completely removed and replaced with compacted fill. An additional field exploration should be performed to verify our preliminary findings and recommendations within the above-named portion of the alignment.

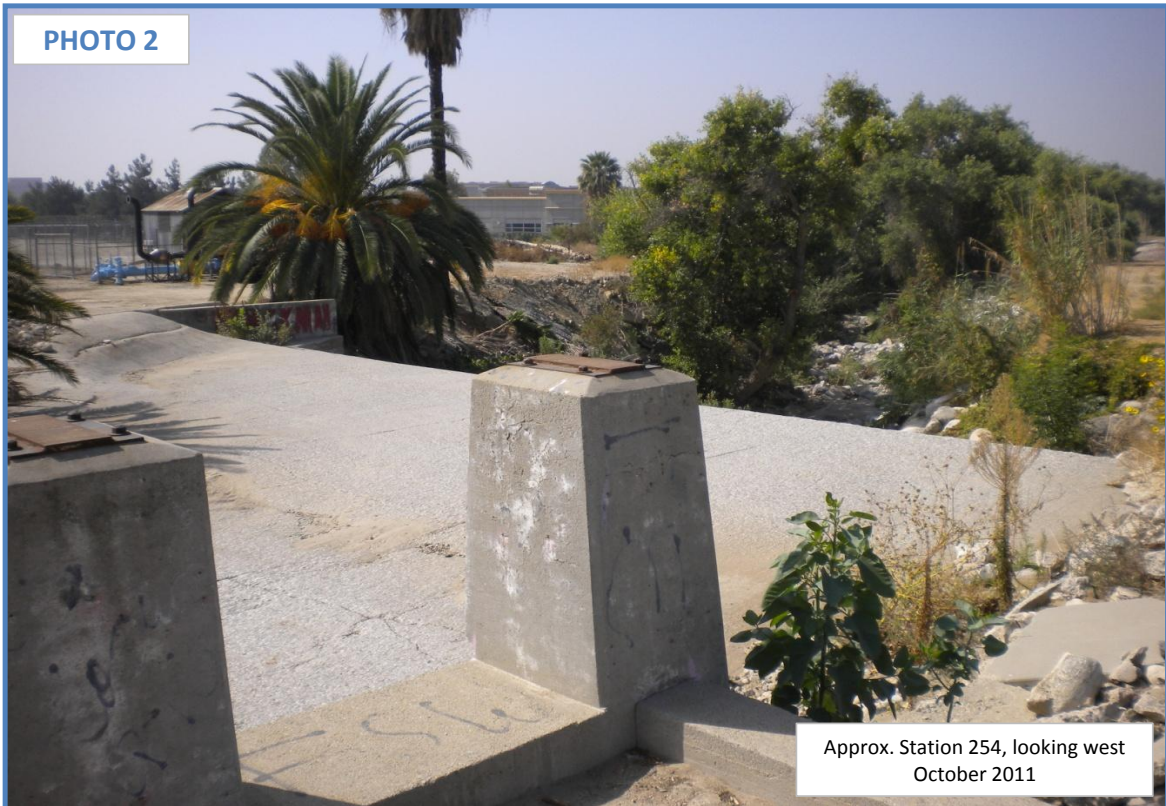
PHOTO 2

Approx. Station 254, looking west
October 2011

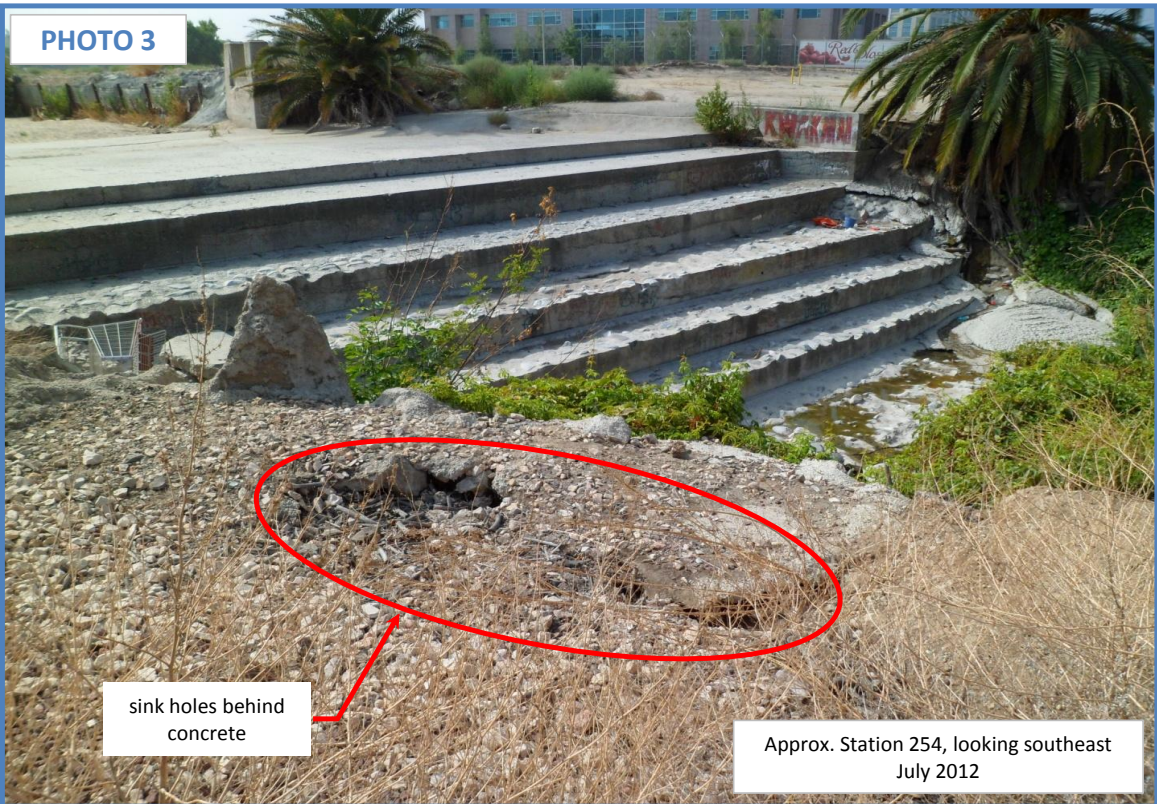
PHOTO 3

sink holes behind concrete

Approx. Station 254, looking southeast
July 2012

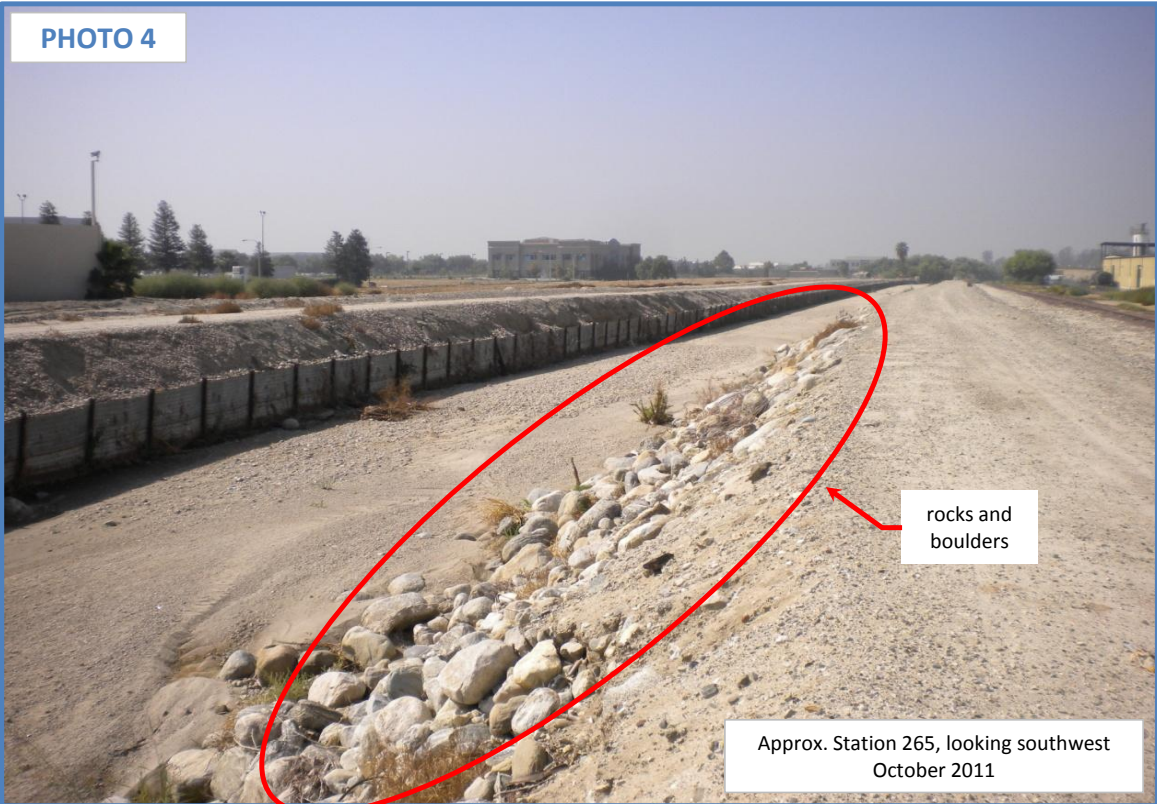
PHOTO 4

rocks and boulders

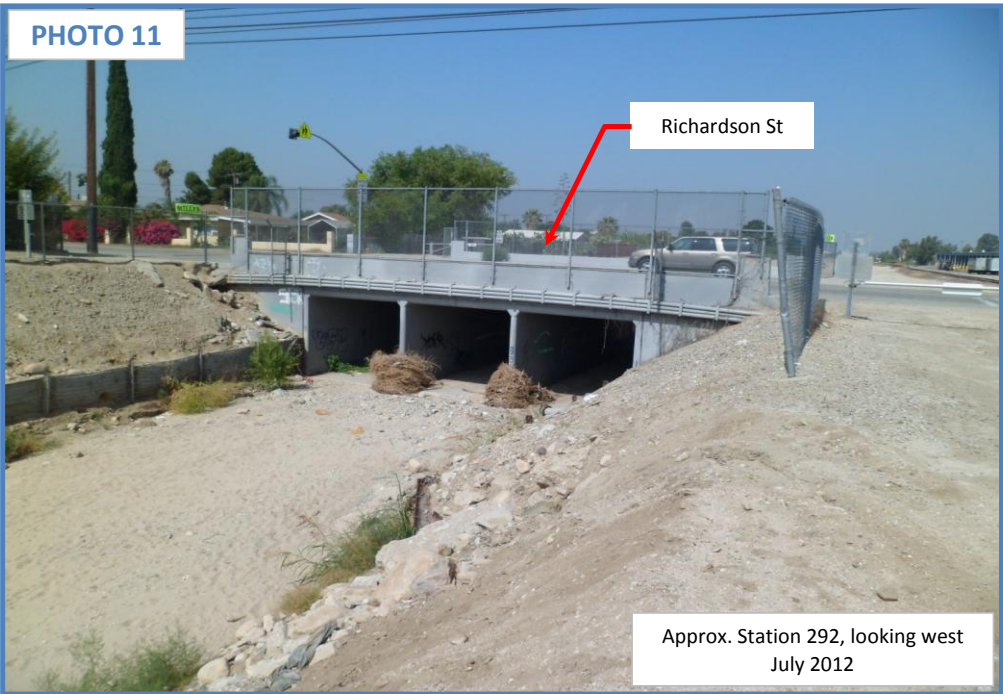
PHOTO 11

291+40 to 292+00	10 and 11	Richardson Street Crossing
292+00 to 320+20	12, 13 and 14	Unprotected slope face with occasional rocks, boulders, asphalt concrete and concrete debris. Several localized surficial/erosion failures were observed during site visits. New fills were already placed over localized failure areas during site visit in October 2011. Rocks and boulders were observed at bottom of Creek at several locations.
317+00 to 320+20	15 and 16	Loose concrete debris observed on slope face and exposed steel pipe on slope face. Indication of loose surficial soils
320+20 to 321+00	14	Mountain View Avenue Crossing
321+00 to 323+00	17 and 18	Two concrete panels, possibly part of wing wall for adjacent bridge, were placed on slope face.
323+00 to 343+20	19, 20, 21 and 22	Unprotected slope face with occasional rocks, boulders and concrete debris. Observed signs of new fills placed on access road and slope face along existing railroad track. Several local surficial failure observed

Richardson St

Approx. Station 292, looking west
July 2012

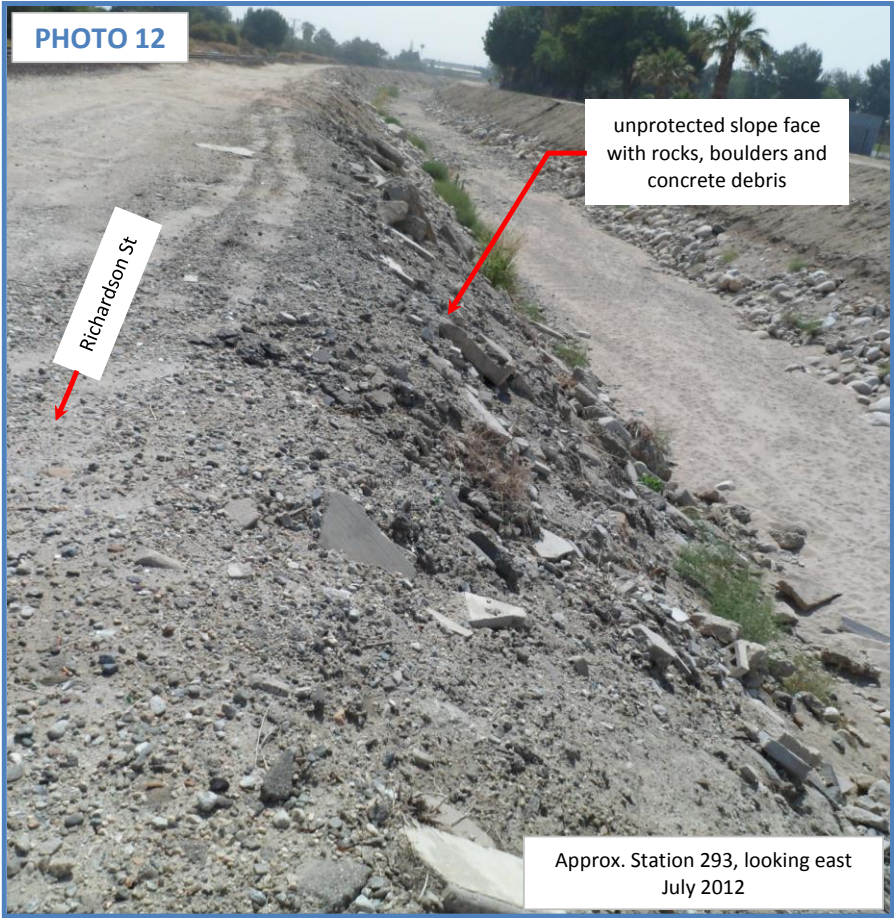
PHOTO 12

unprotected slope face
with rocks, boulders and
concrete debris

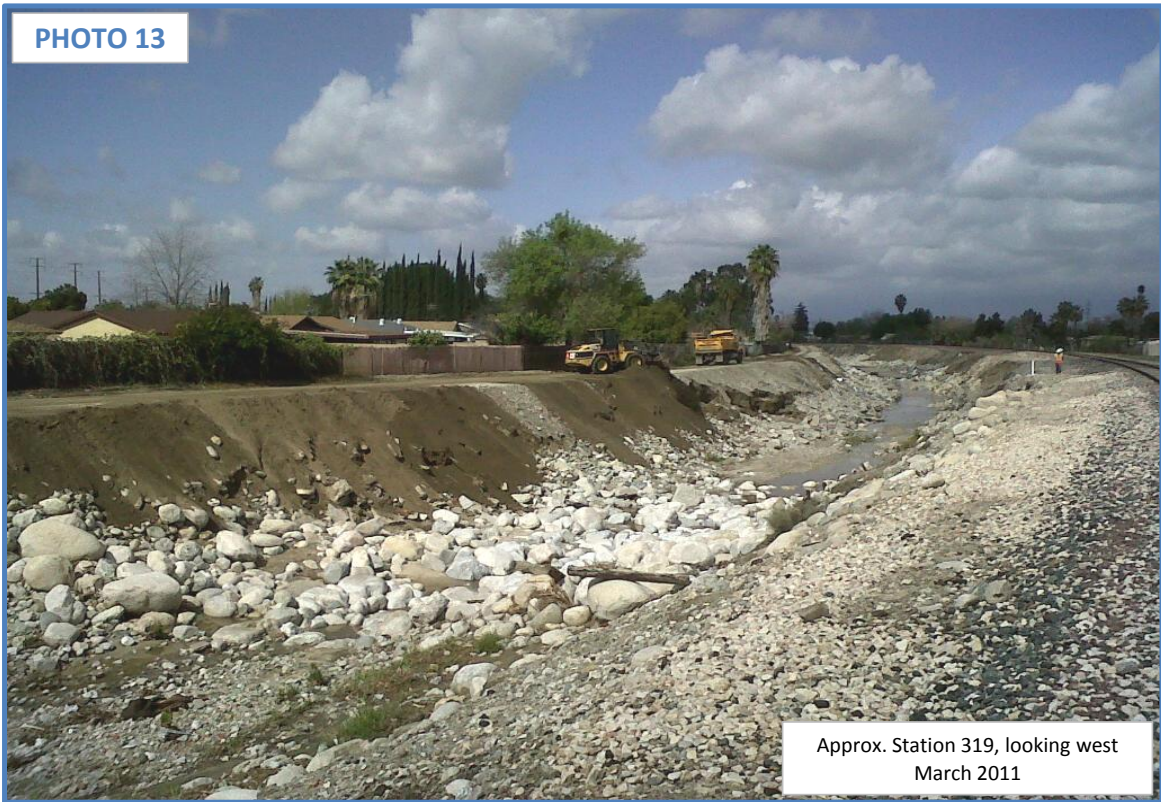
PHOTO 13

Approx. Station 319, looking west
March 2011

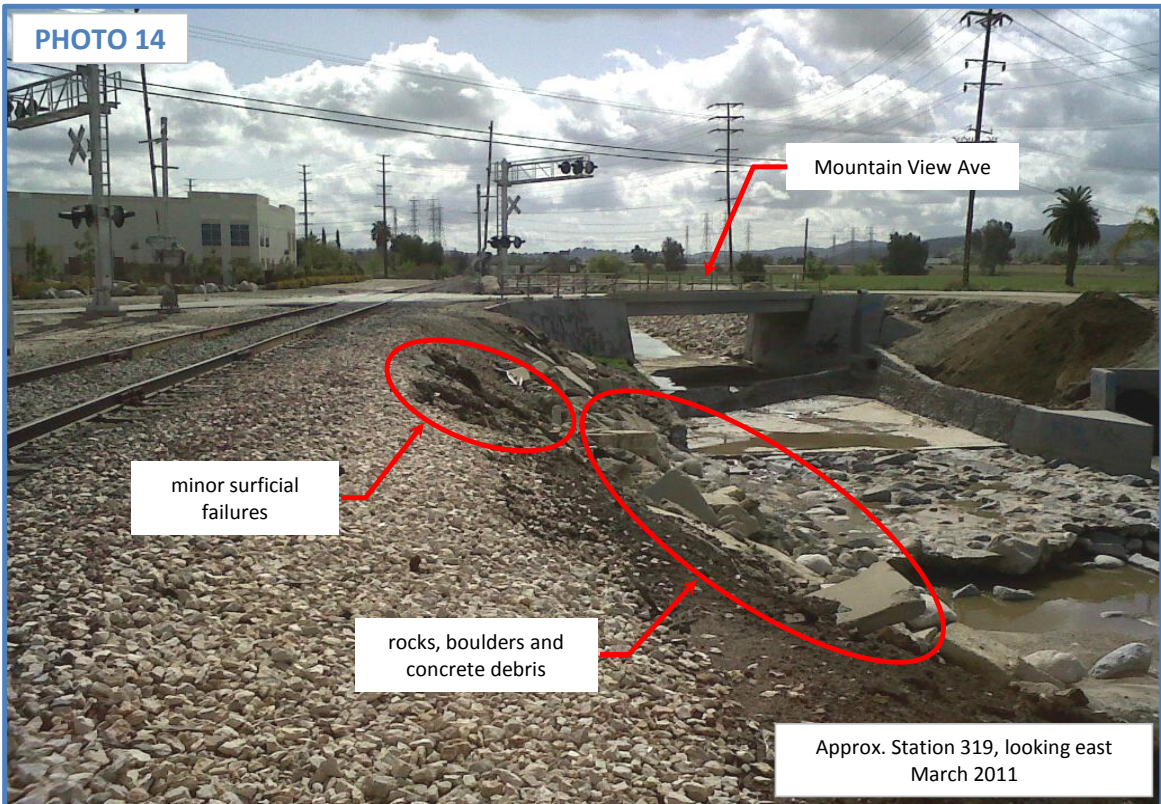
PHOTO 14

minor surficial
failures

rocks, boulders and
concrete debris
