BEST PRACTICES FOR BICYCLE TRAIL PAVEMENT CONSTRUCTION AND MAINTENANCE IN ILLINOIS

Research Report FHWA-ICT-12-009

**Developing Best Practices for Bicycle Trail
Pavement Construction and Maintenance in Illinois**

June 2012

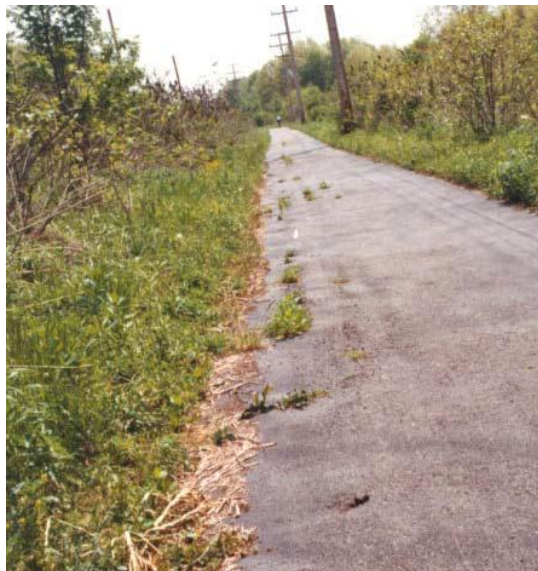
Pop-ups refer to small eruptions in the asphalt pavement surface, generally caused by weed growth. Weed growth can occur both underneath and within the pavement structure. An example of this distress can be seen in Figure 7.

Figure 7. Pop-ups through the HMA layer (ODOT).

The first step to preventing pop-ups and achieving a quality pavement is thorough grubbing to remove all vegetation from the projected trail site.

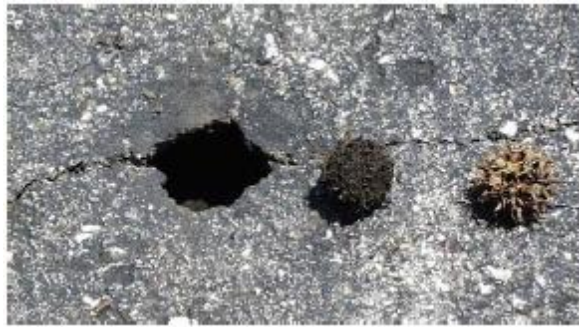
Pop-outs are generally caused by organic matter being deposited into haul vehicles during construction. An example of this distress can be seen in Figure 8.

Figure 8. Pop-out caused by sweetgum ball within the HMA layer (Luttrell et al. 2004).

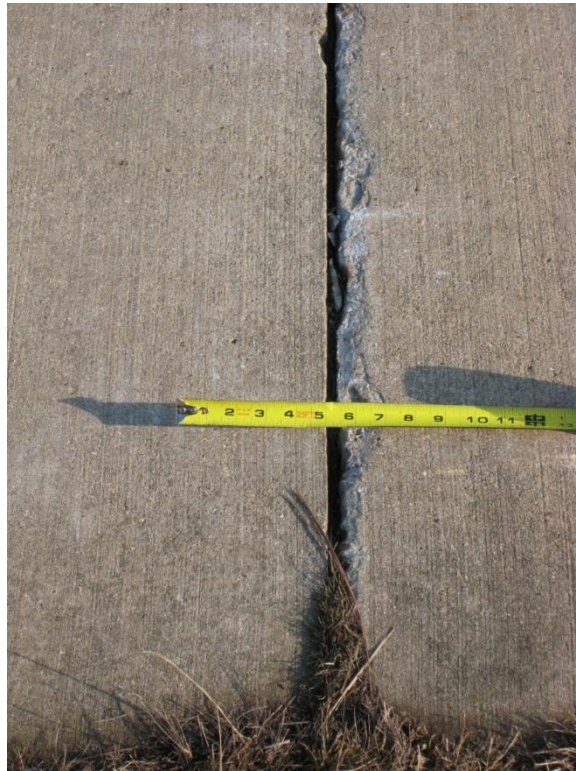
All three trails had instances of minor faulting. The majority of faults resulted in a grade difference between slabs of 0.5 inch or less, as shown in Figure D.2. These faults also led to increased spalls at the joint due to contact with snow removal equipment.

Figure D.2. Joint faulting leading to further deterioration.

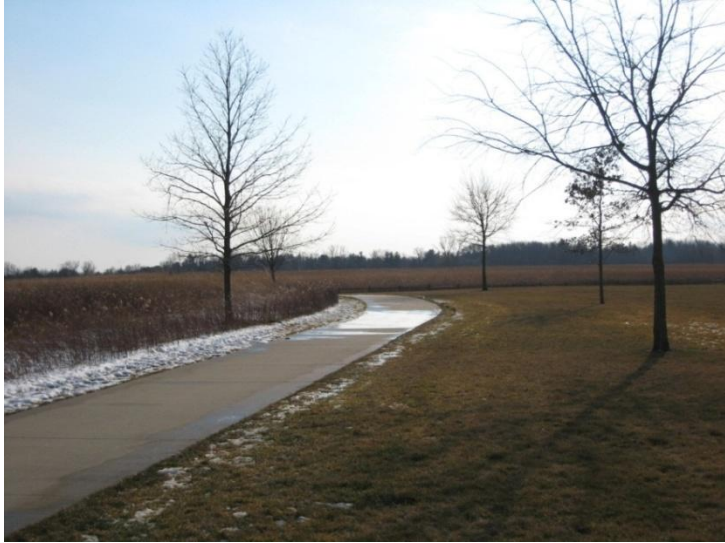
Figure D.3. Standoff between trees and trail.

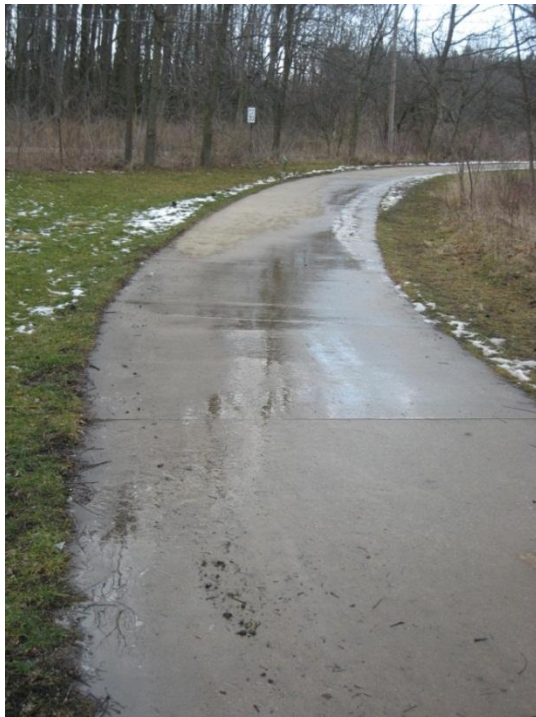
Figure D.4. Lack of trail drainage.

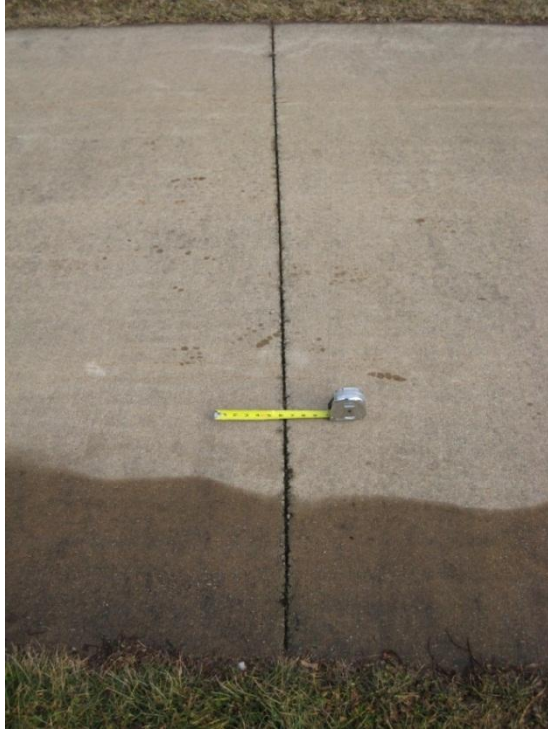
Some joint deterioration was also present on all three trails. As seen in Figure D.5, the contraction joints were sawcut after paving. The jagged edges of the sawcut suggest that the joints were sawed too early, as the paste had not had time to achieve proper strength and prevent small aggregate from being broken away from the concrete matrix. Evidence of organic growth from the contraction joints was also apparent. While some of the joint sealant had been replaced on expansion joints, much of it was in poor condition, as seen in Figure D.6. This is leading to incompressibles entering the joint, causing additional spalling and degradation.

Figure D.5. Small aggregate broken away from concrete matrix during sawcutting.

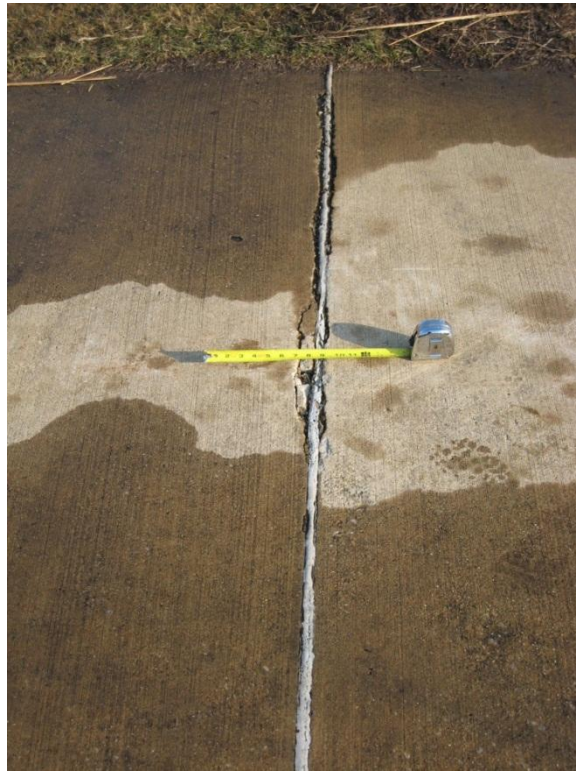
Figure D.6. Joint deterioration due to failing sealant.

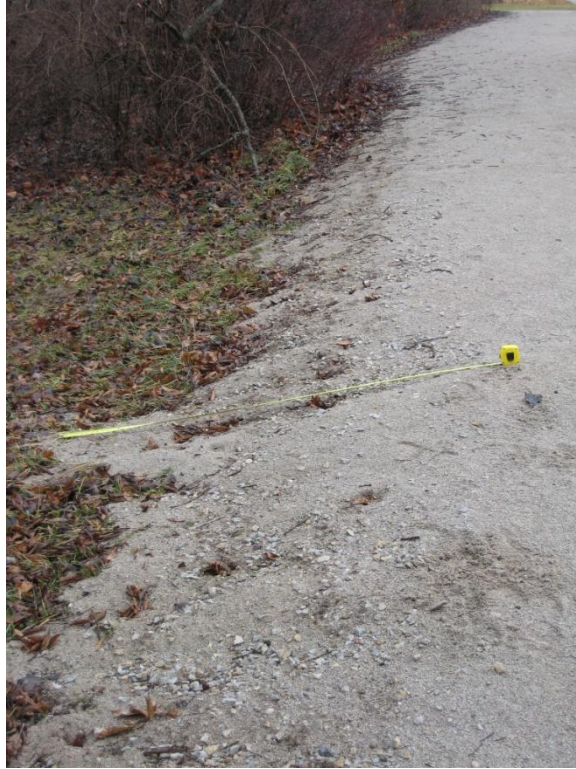
Figure D.8. Water displacement of the surface aggregate.

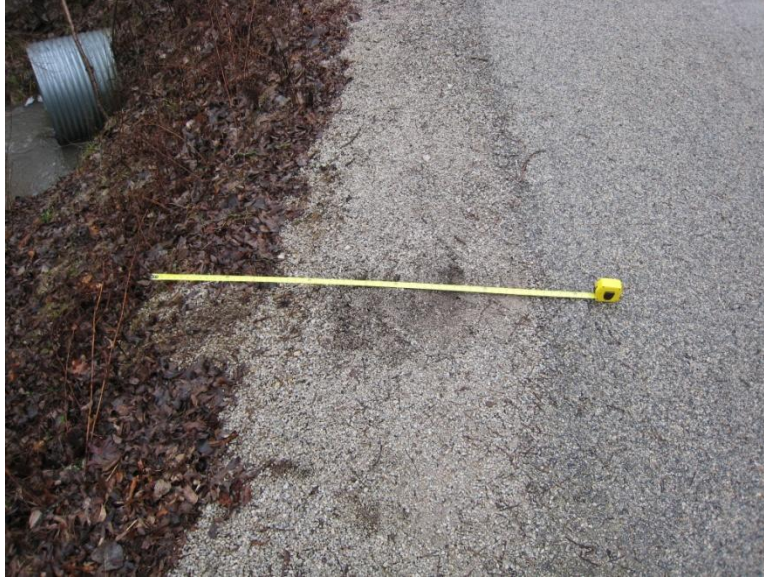
On the portions of the trail that were constructed with a bituminous surface treatment, the aggregate base extended beyond the edge of the treatment in many locations, as seen in Figure D.10. An extended base course width was not specifically called for in the plans. The additional aggregate base width, combined with low vehicular traffic, has led to good performance of the surface treatment. The only surface distresses present are a very few minor cracks in the bituminous surface treatment. As shown in Figure D.11, there are some grade variations (high spots and low spots) in the surface treatment, which can be expected with this material.

Figure D.10. Aggregate base extended beyond the edge of the surface treatment.

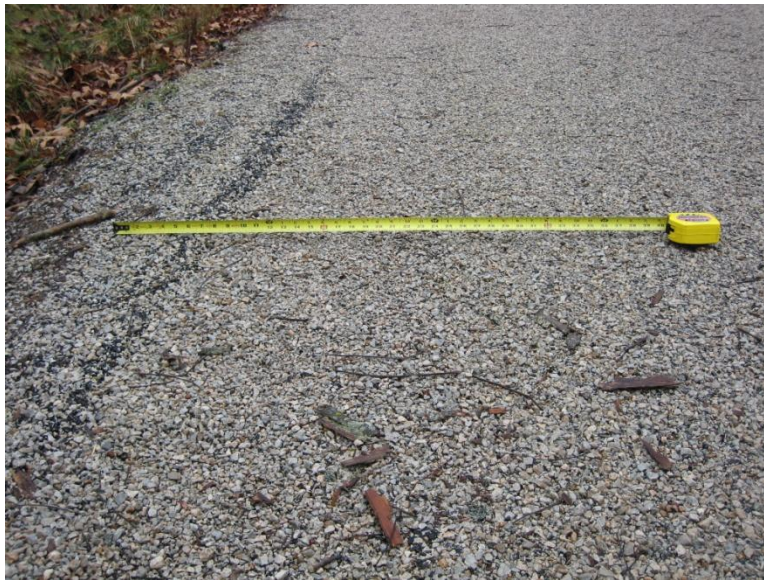
Figure D.11. Grade variation in the bituminous surface treatment.

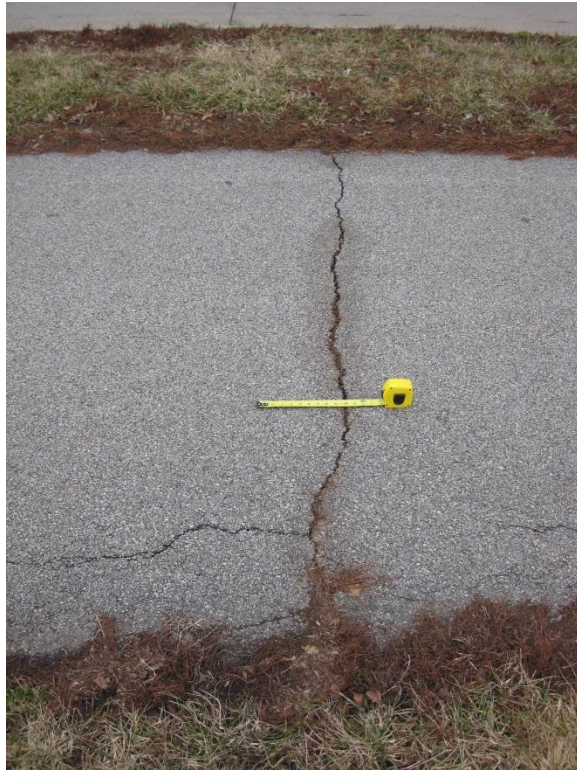
If 30% RAP was used in the asphalt for this trail, it would have increased the low-temperature rating of the PG 58-22 binder.

Figure D.13. Typical thermal crack.

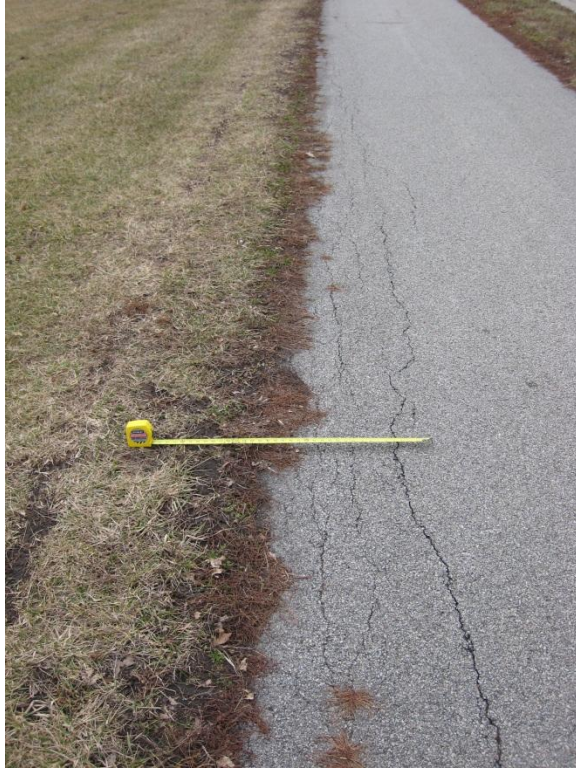
Figure D.14. Typical edge cracking on the east side of the trail.

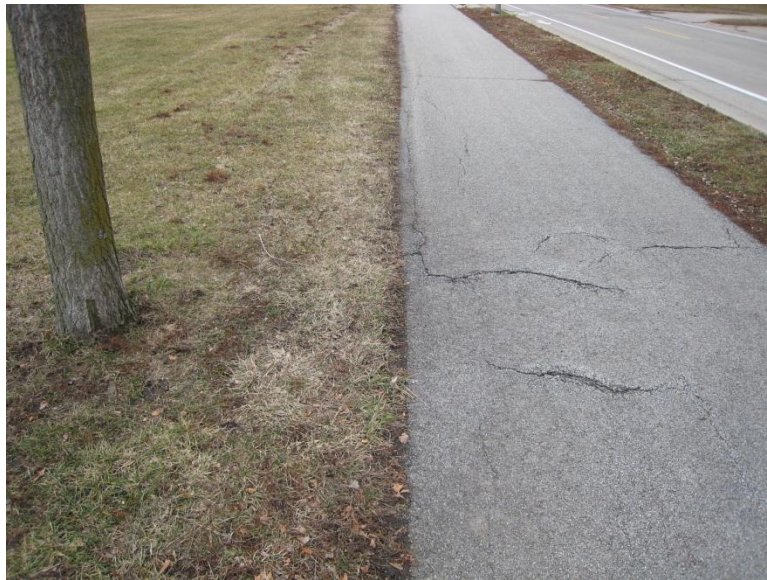
As seen in Figure D.15, there was a only short standoff between the trees lining the trail. This has caused several locations where roots have disrupted the asphalt surface. Installation of a root barrier or use of additional standoff would have helped to prevent this problem.

Figure D.15. Inadequate standoff and tree root infiltration.

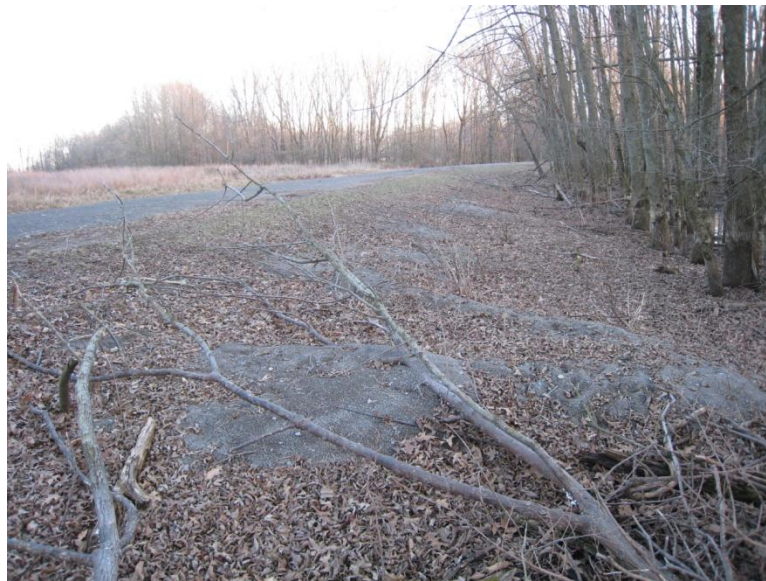
Figure D.19. Displacement of surface aggregate due to water.

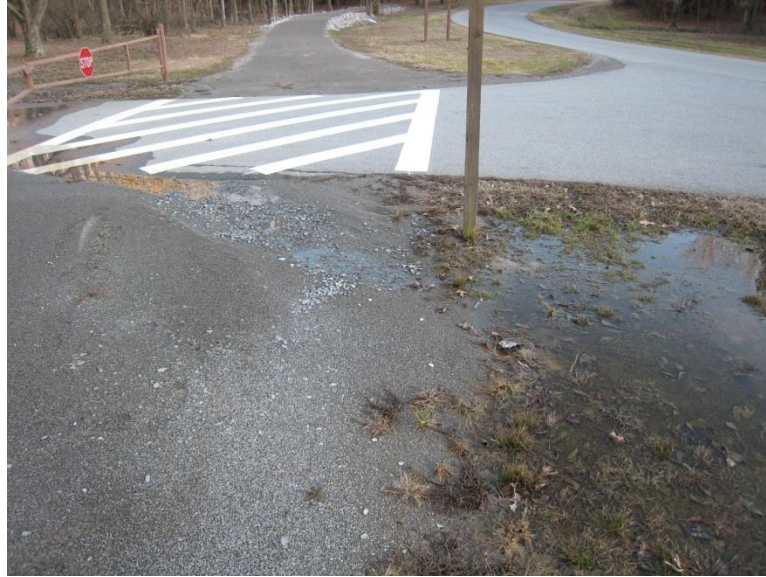
Figure D.20. Additional drainage elements needed in some locations.

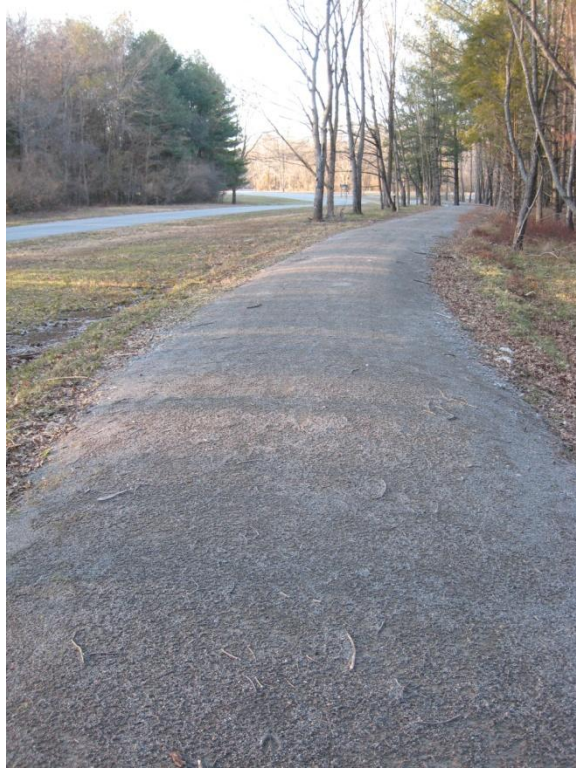
Figure D.22. Trail humping due to lack of shoulder material and no extension of aggregate base beyond aggregate surface.

have likely been prevented by extending both the compacted subgrade and aggregate base at least 12 inches on either side of the trail aggregate surface. Additionally, this extension of the base would help to prevent water from undercutting the pavement structure. Installing proper shoulders will also help to prevent humping, along with providing a safer environment for users.

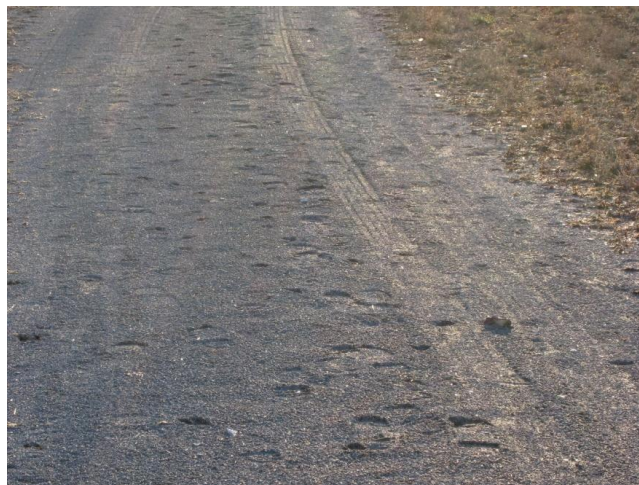
As shown in Figure D.23, the trail surface was quite soft. While freeze–thaw action is likely a cause, it also appeared that there was a low level of fines in the aggregate surface, thus cutting down on the self-cementing nature of the surface aggregate. Additionally, some of this softness could be caused by a relatively uniformly graded material. The TMA proposed would help alleviate both these issues by providing a well-graded aggregate blend with adequate fines content.

Figure D.23. Soft surface aggregate.

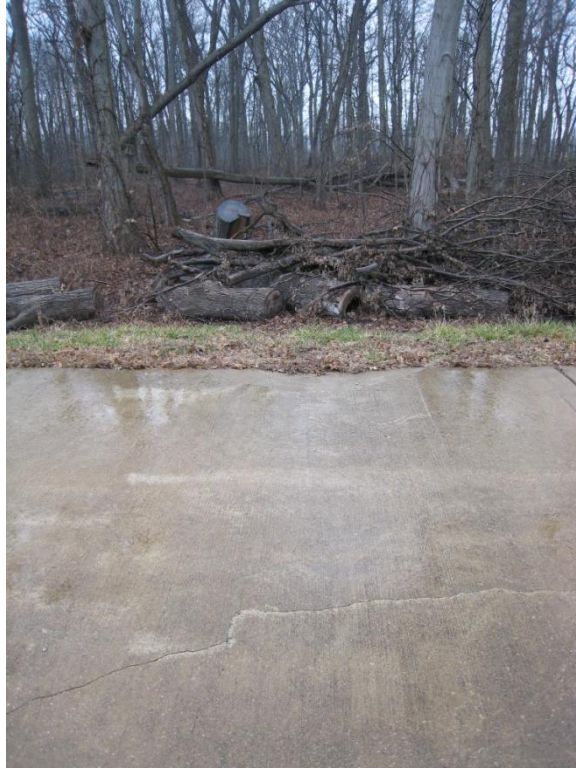
Figure D.25. Slab shattered by tree removal equipment.

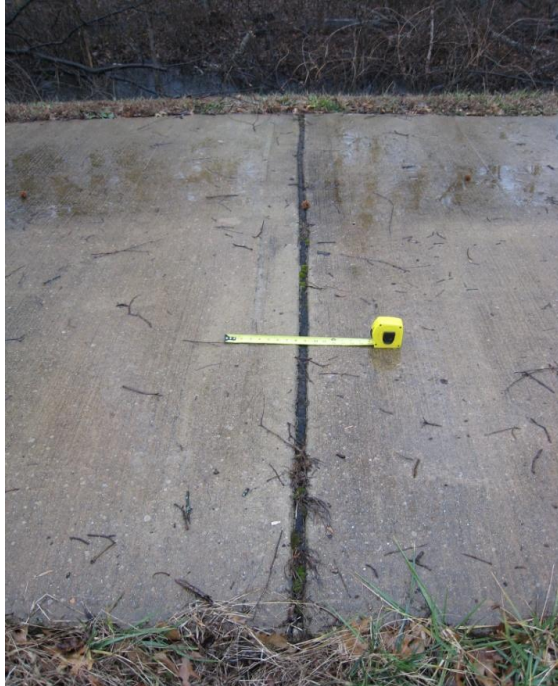
Figure D.27. Typical unsealed expansion joint.

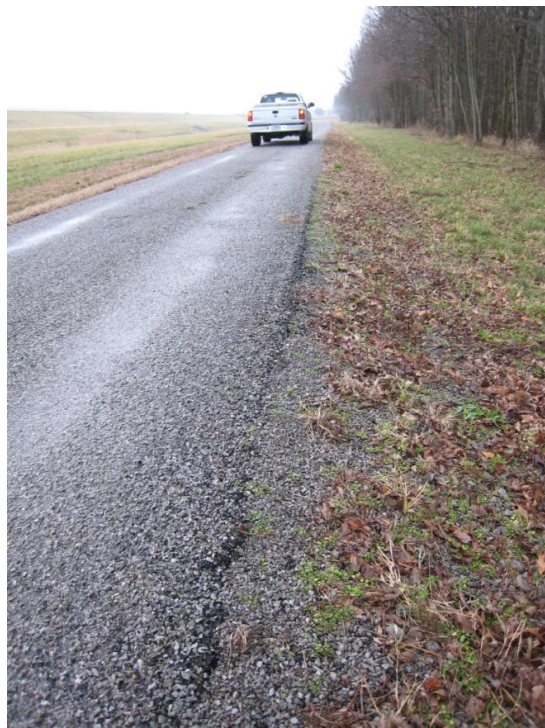
The bituminous surface treatment portion of the trail was in poorer condition. As seen in Figure D.28, rutting of the bituminous surface treatment had formed due to the regular vehicular traffic, and some breakdown of the bituminous surface was occurring at the edges. The trail also sustained some surface damage due to impressions from downed trees. Figure D.29 shows the damage caused by animal burrows under the bituminous treatment. As seen in this application, bituminous surface treatments are not considered to be a structural layer. A consideration of both the positives and negatives of the options should be undertaken before selecting it as a trail surface.

Figure D.28. Rutting and breakdown at the edge of the bituminous surface.

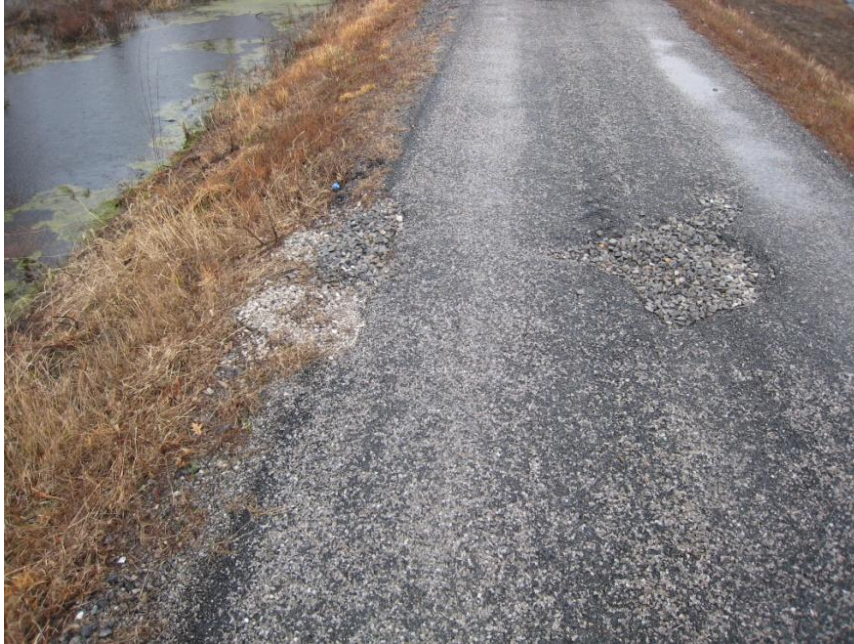
Figure D.29. Animal burrows causing surface collapses.

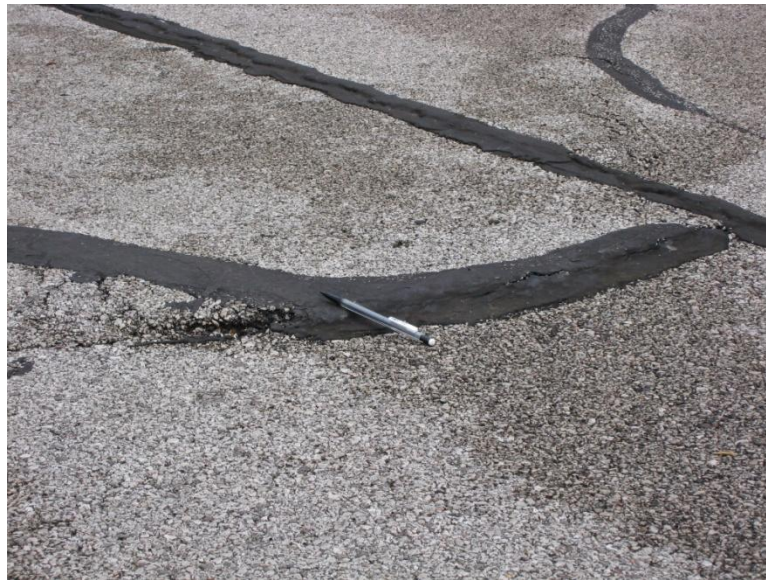
Figure D.31. Tree root infiltration.

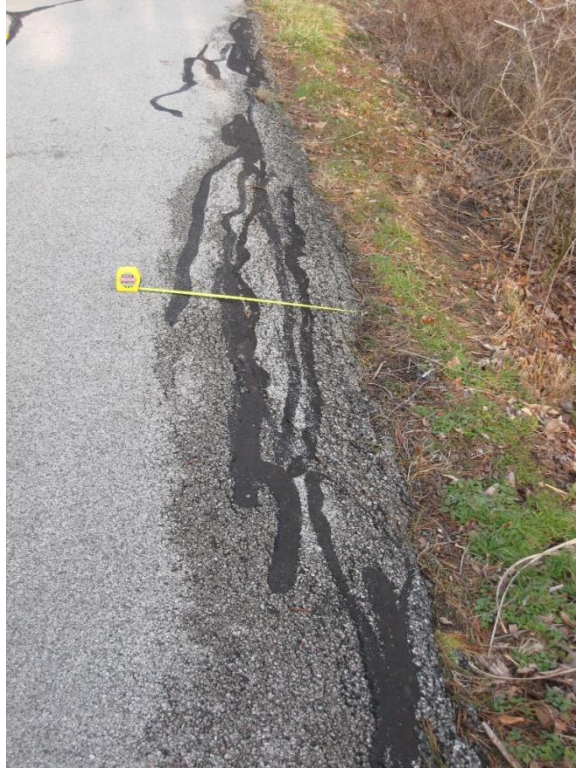
Figure D.32. Area of edge cracking and fall-off.

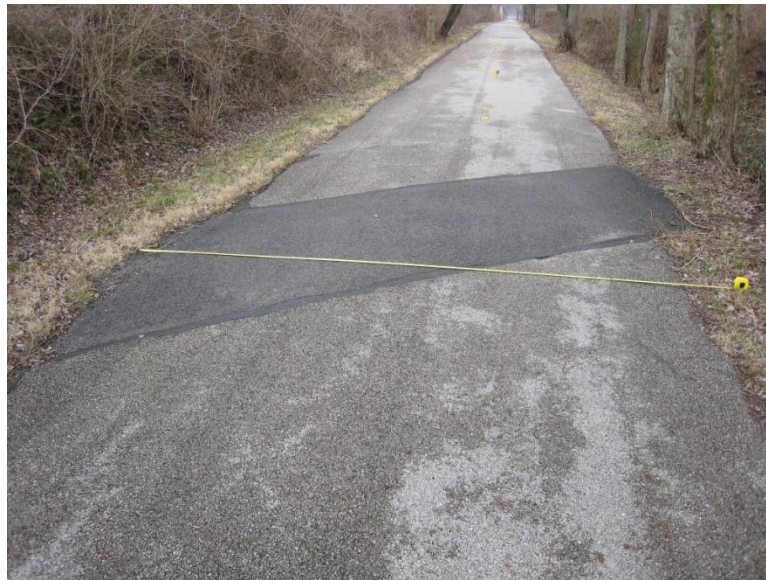
Figure D.33. Patch correcting tree root infiltration.

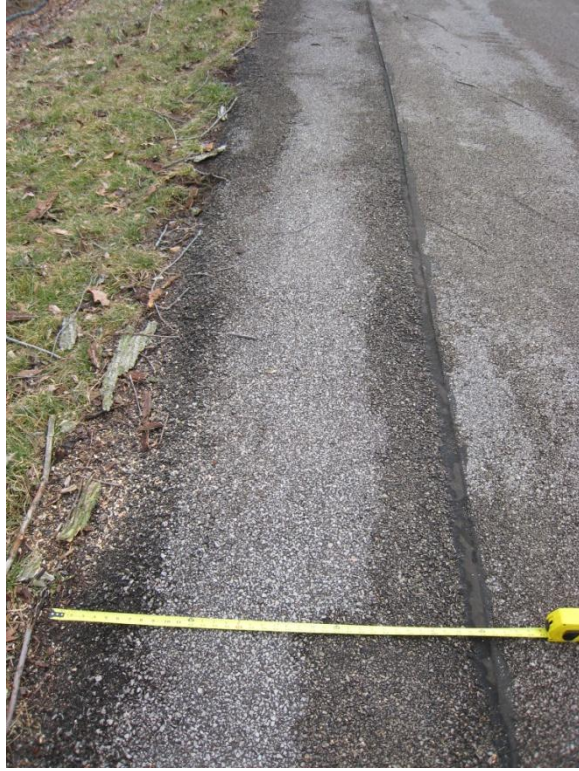
Figure D.34. Patch correcting edge cracking.

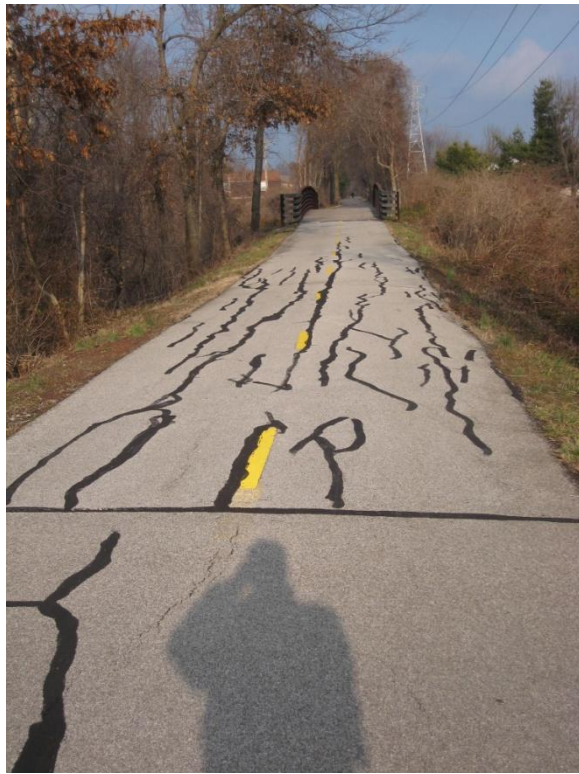
There was one location with significant longitudinal cracking. As shown in Figure D.35, this area was very localized and therefore is likely due to a lens of plastic soil. It should be noted that there was no thermal cracking present in the trail.

Figure D.35. Localized extreme longitudinal cracking.

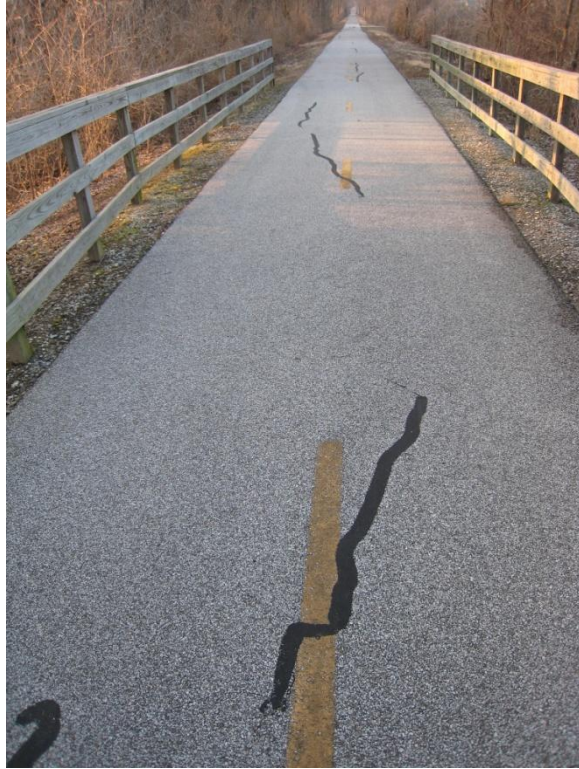
Figure D.39. Low-severity longitudinal cracking.

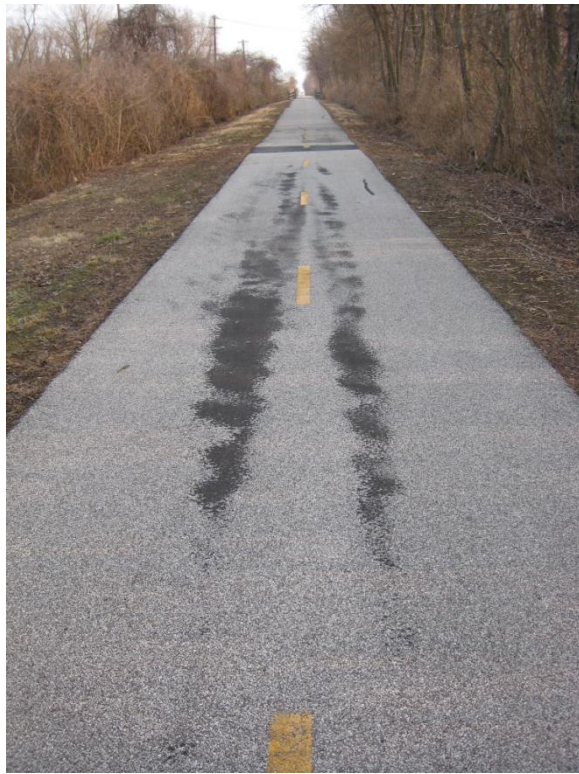
This trail was in outstanding condition. Like the Nature Trail, there were no thermal cracks present. As shown in Figure D.38, there was good vegetation clearance and pavement edge support. Some areas had low-severity longitudinal cracking, as shown in Figure D.39. One localized area of binder bleeding was observed, as shown in Figure D.40.

Figure D.40. Localized binder bleeding.

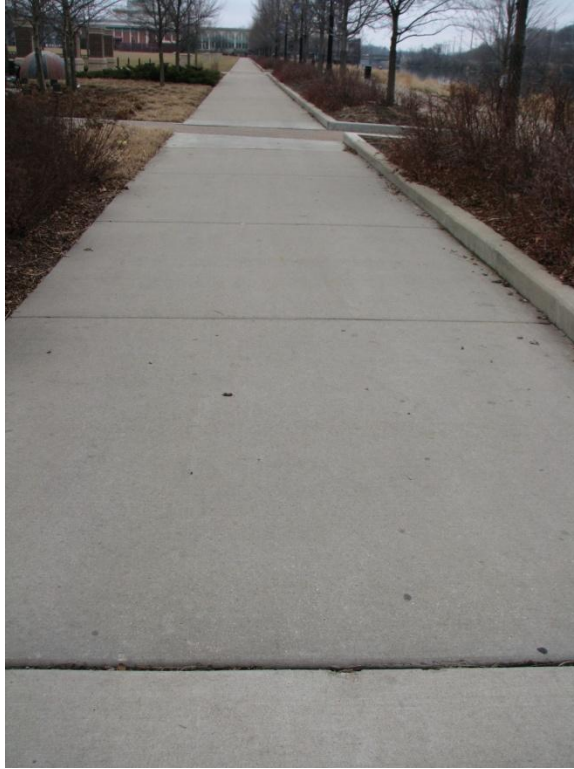
The PCC portion of the trail was also in good condition. Contraction joints were tooled. Some spalling was evident where the joints were tooled, likely due to overfinishing and snow removal equipment. Figure D.46 shows a typical PCC pavement section. Contraction joints were placed at 10-foot intervals. No expansion joints were installed in the pavement. No patching had occurred.

Figure D.46. Typical PCC pavement section with some joint spalling.
