METRO RED LINE, SEGMENT 2, CONTRACT B251

Investigation of Tunnel Collapse and Sinkhole

Wiss, Janney, Elstner Associates, Inc.

FINAL REPORT

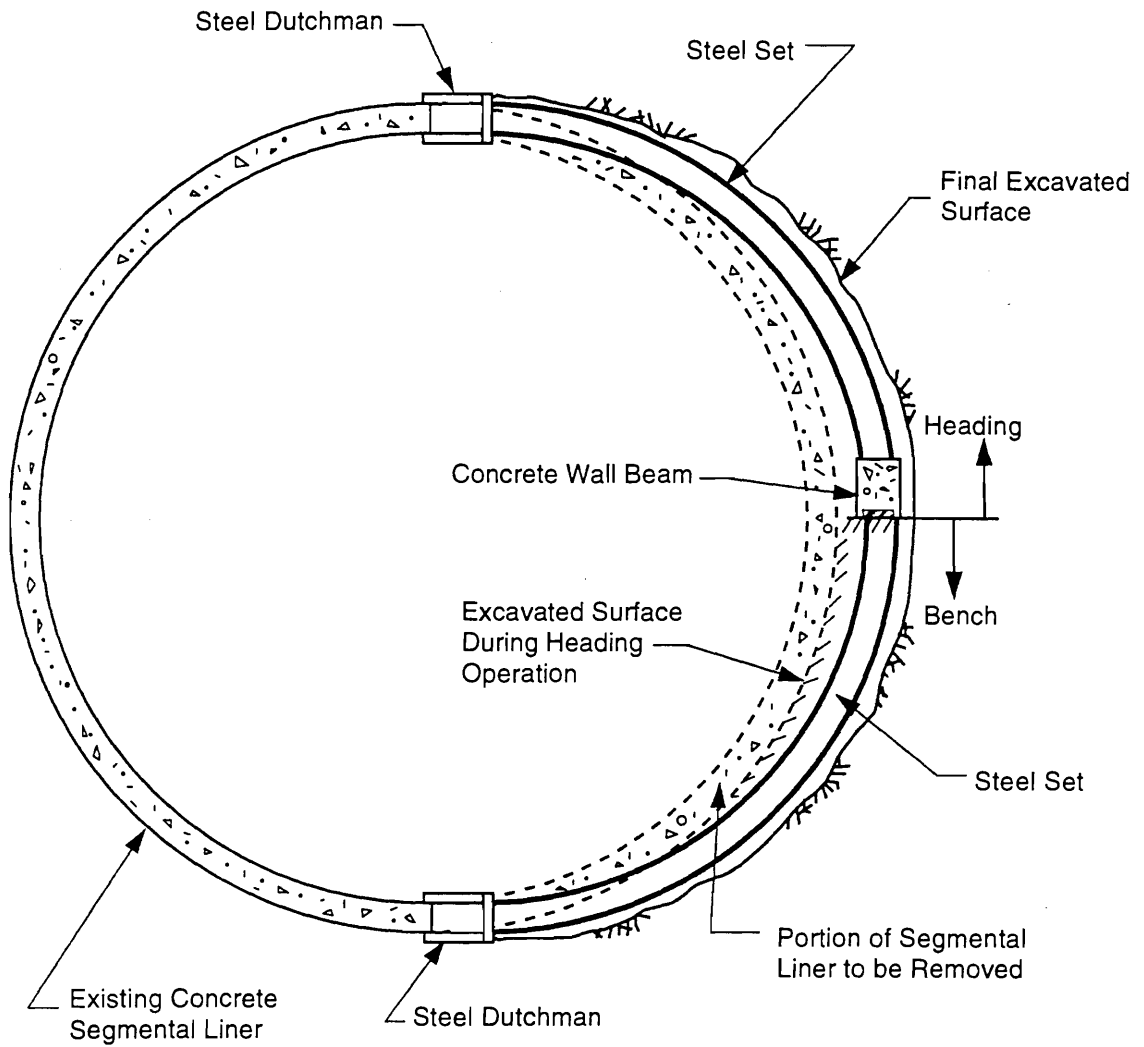
Figure 2.3 Temporary Support for Remined Area

The tunnel failure is due to a deficient design of the temporary support for the steel sets. This design deficiency became apparent when seepage within the Puente formation was encountered during remining. Minor variations from the approved remining procedure occurred which did not significantly affect the performance. Flow from the 10-in. water main did not contribute to the initial foot block failure, but damage would have been significantly reduced if the water main were shut off earlier.

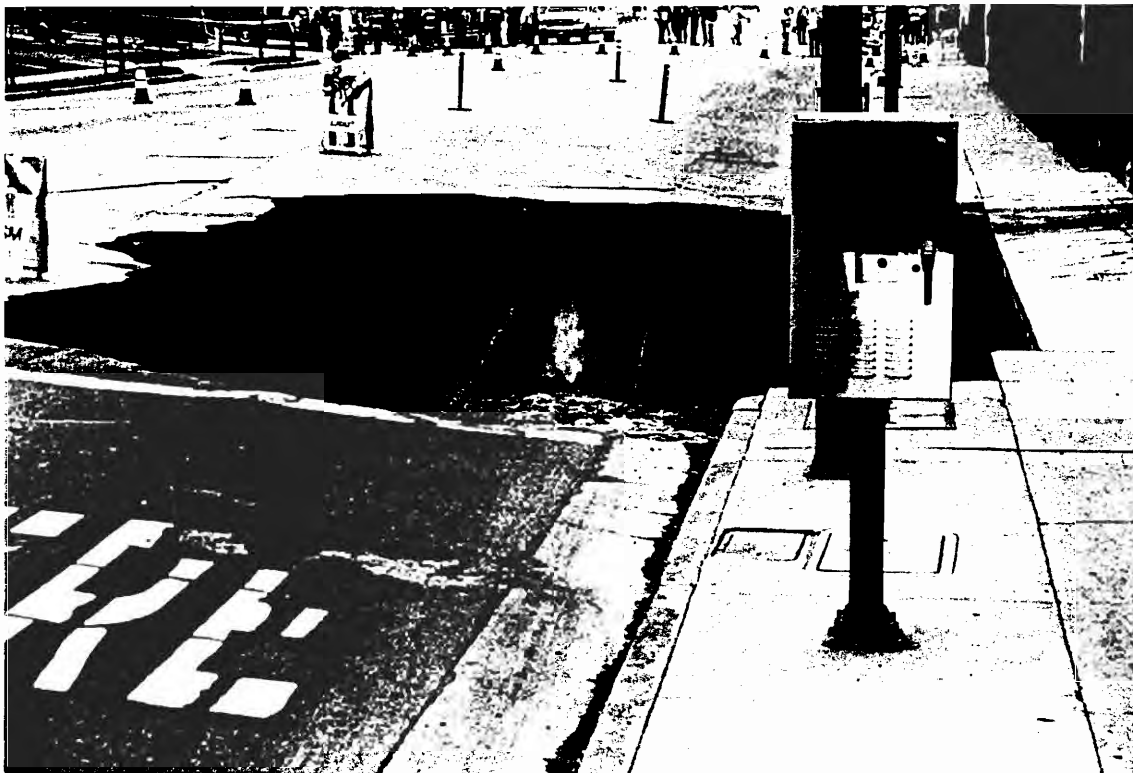
After this first collapse, water from the broken main filled the resulting sinkhole for at least 45 minutes until the main was shut off. A gas leak was reported by the Gas Company at about 8:00 a.m. The Los Angeles Fire Department directed the Gas Company to shut down the main gas line, which was done at 2:45 p.m. Until the gas line was shut off, SKK was not allowed to pump water out of the hole. At about 11:35 a.m., a second collapse of the remined area occurred which resulted in water and earth flowing eastward from the remined area through the Barnsdall Shaft and into the Vermont tunnels.

Fig. 2.4 - Water main pouring into sinkhole above tunnel collapse

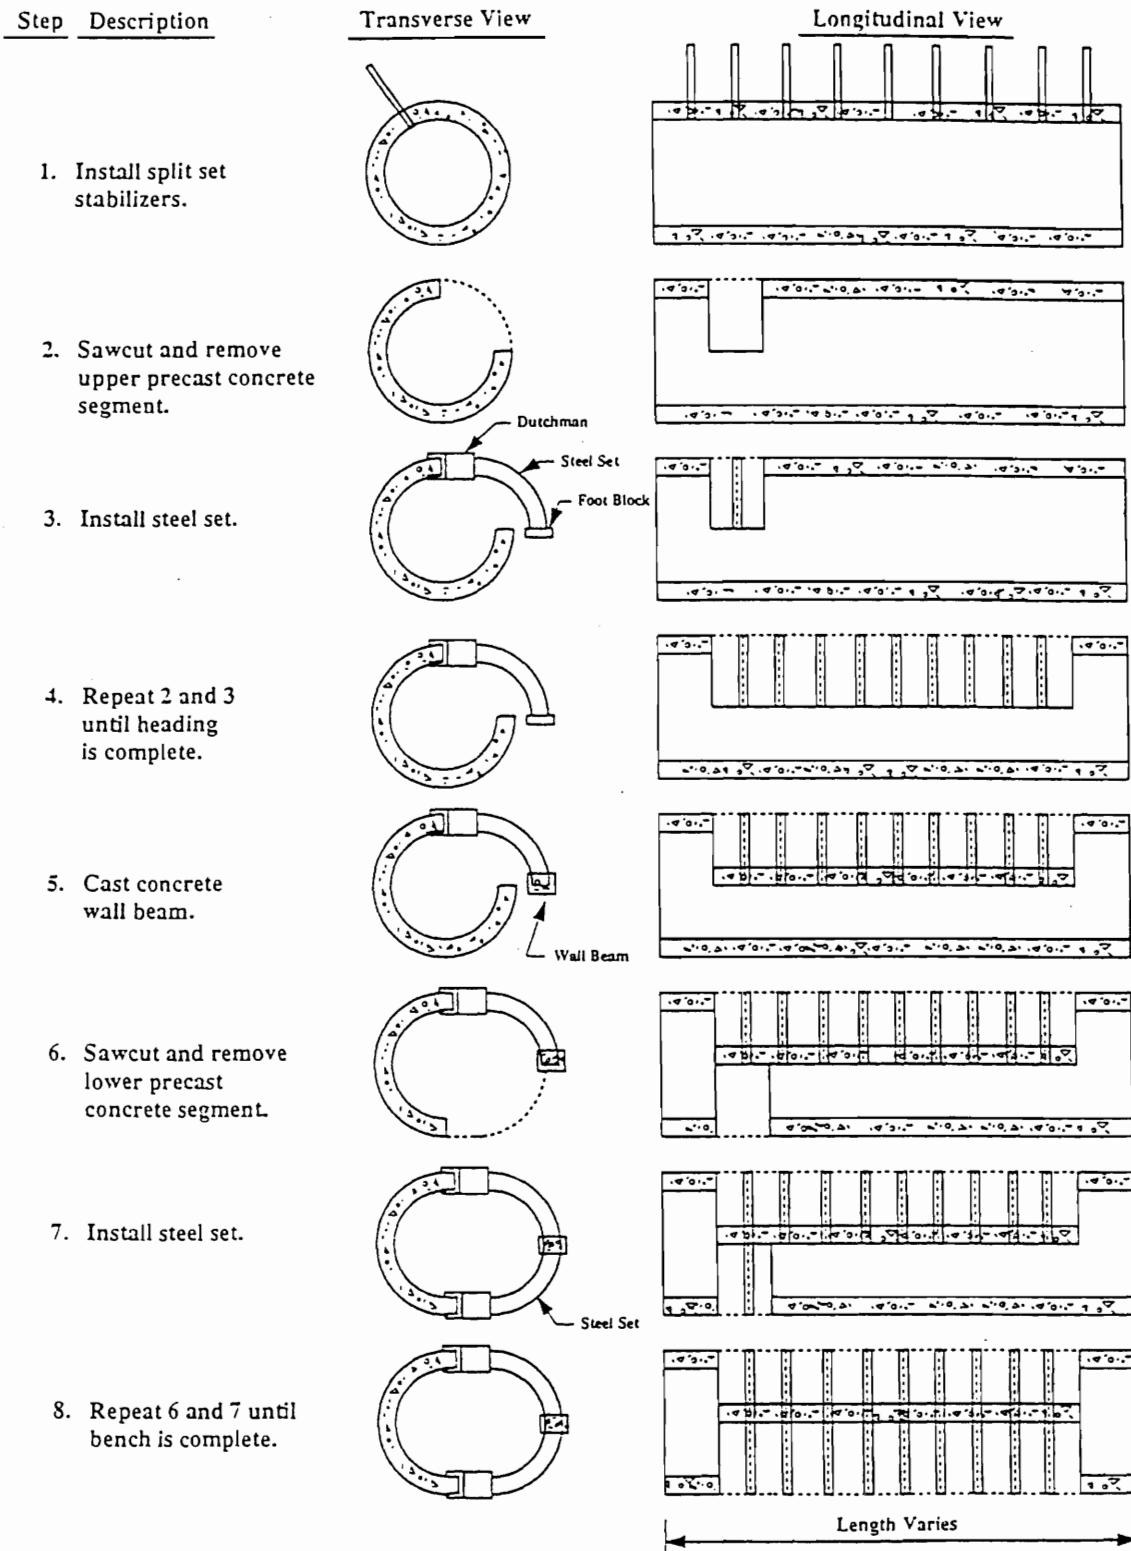
Fig. 3.1 Remining and Resupport Operations

No calculations were available for review by WJE which evaluated either the bearing capacity of the concrete wall beam or the bearing capacity of the foot blocks before the concrete beam was placed, steps 3 through 6 in Fig. 3.1. These temporary conditions were not considered in the calculations

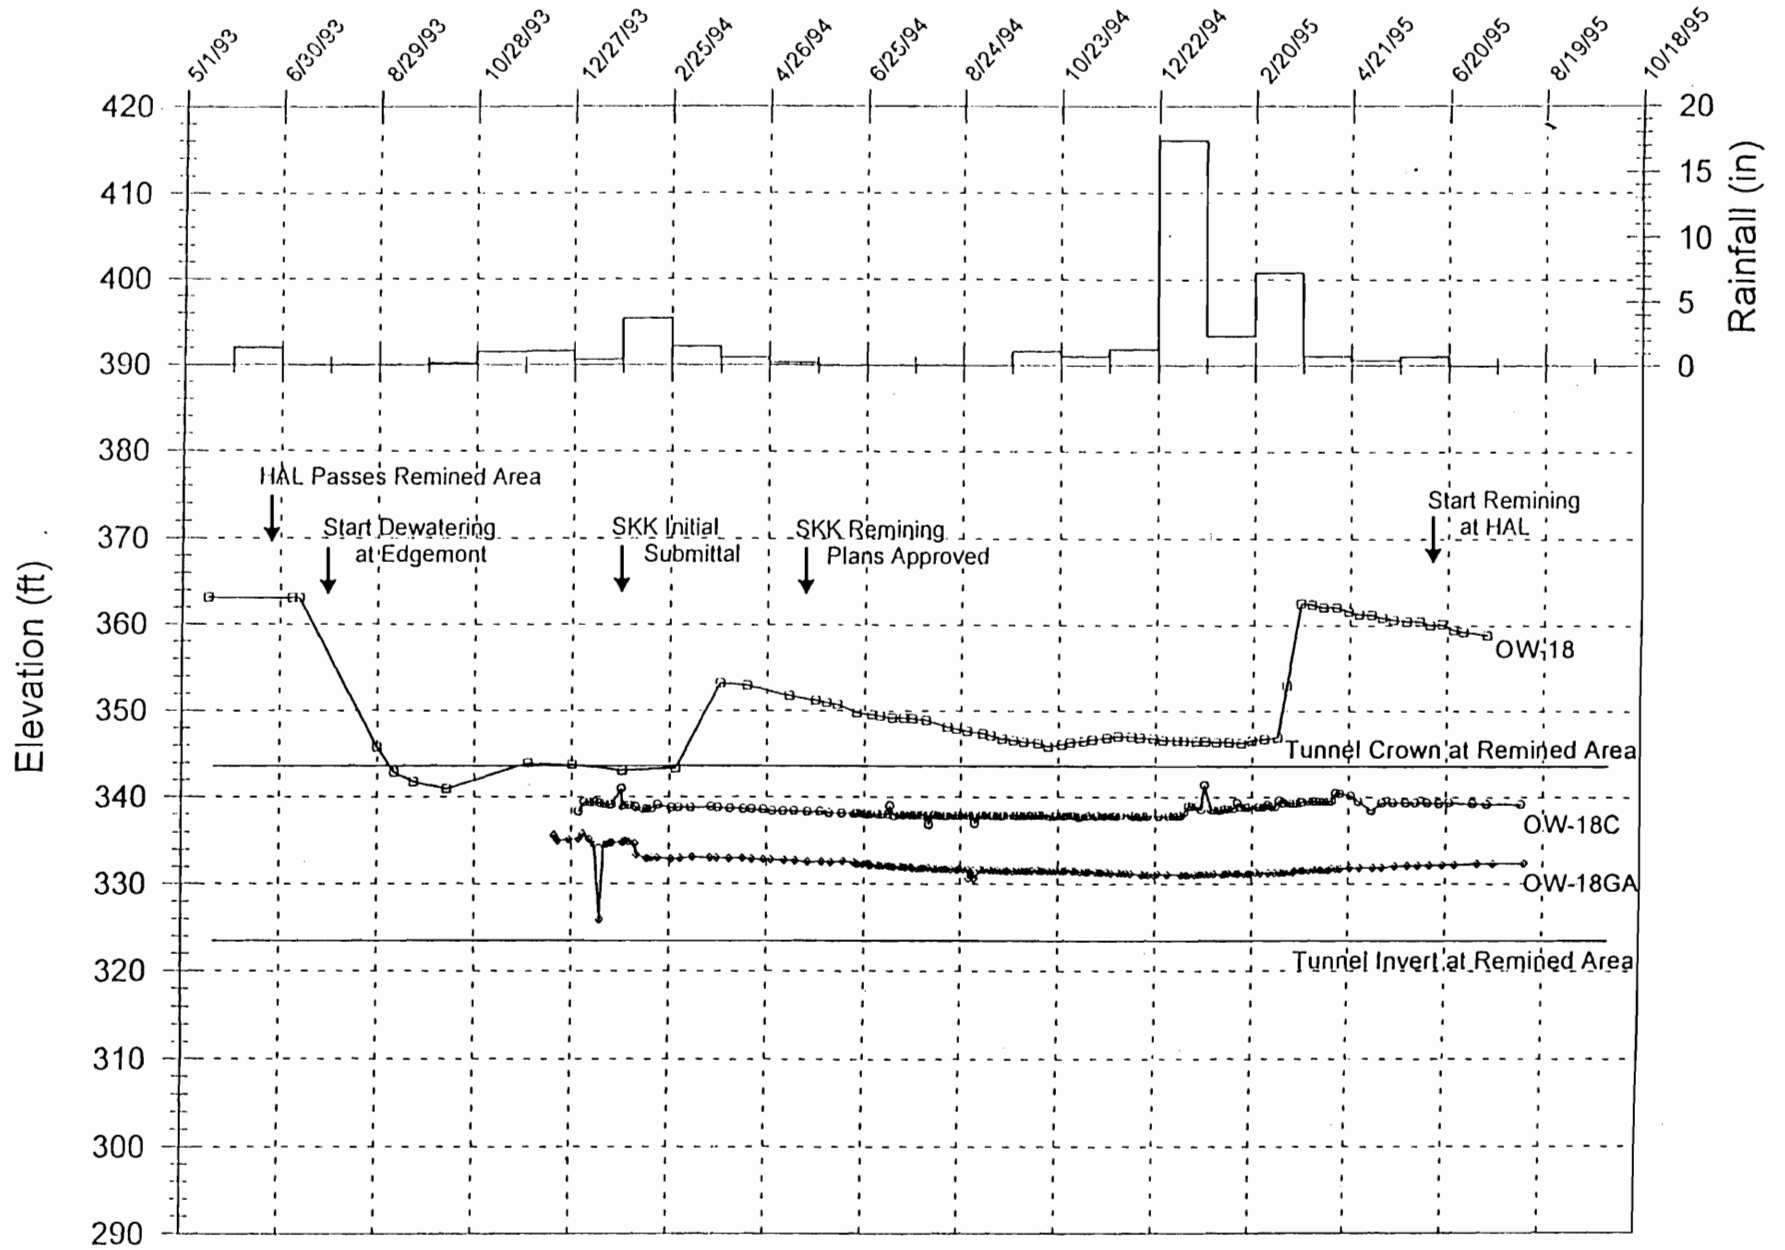
Fig. 3.3 Ground Water Levels Near HAL Remined Area

The temporal variations of groundwater levels near the HAL remined area are shown in Fig. 3.3. Data from observation wells OW-18, 18C and 18GA are presented. Also shown are the rainfall data recorded at the Hollywood Dam rain gage by the Los Angeles Department of Water and Power (LADWP). The OW-18 water levels show significant variations over time. After the water levels had dropped from the effects of the dewatering system at Edgemont Street, two episodes of rapid groundwater rise and subsequent gradual fall were observed. The other wells show no such variations. The two rapid rises in OW-18 lag behind the peak rainfall in both 1994 and 1995 by about 45 days. Barnsdall Park is the topographic high in the area. As noted in the GRV/S Report (1990), Barnsdall Park is the recharge area for the local ground water which tends to flow away from this area along the alluvium and Puente formation interface. OW-18 is screened throughout its entire depth and is therefore hydraulically connected to the alluvium. These water level changes are thus in response to recharge from precipitation. The other wells shown are all screened at greater depths and thus apparently are not hydraulically connected to the alluvium, or are screened in clay soils within the alluvium.

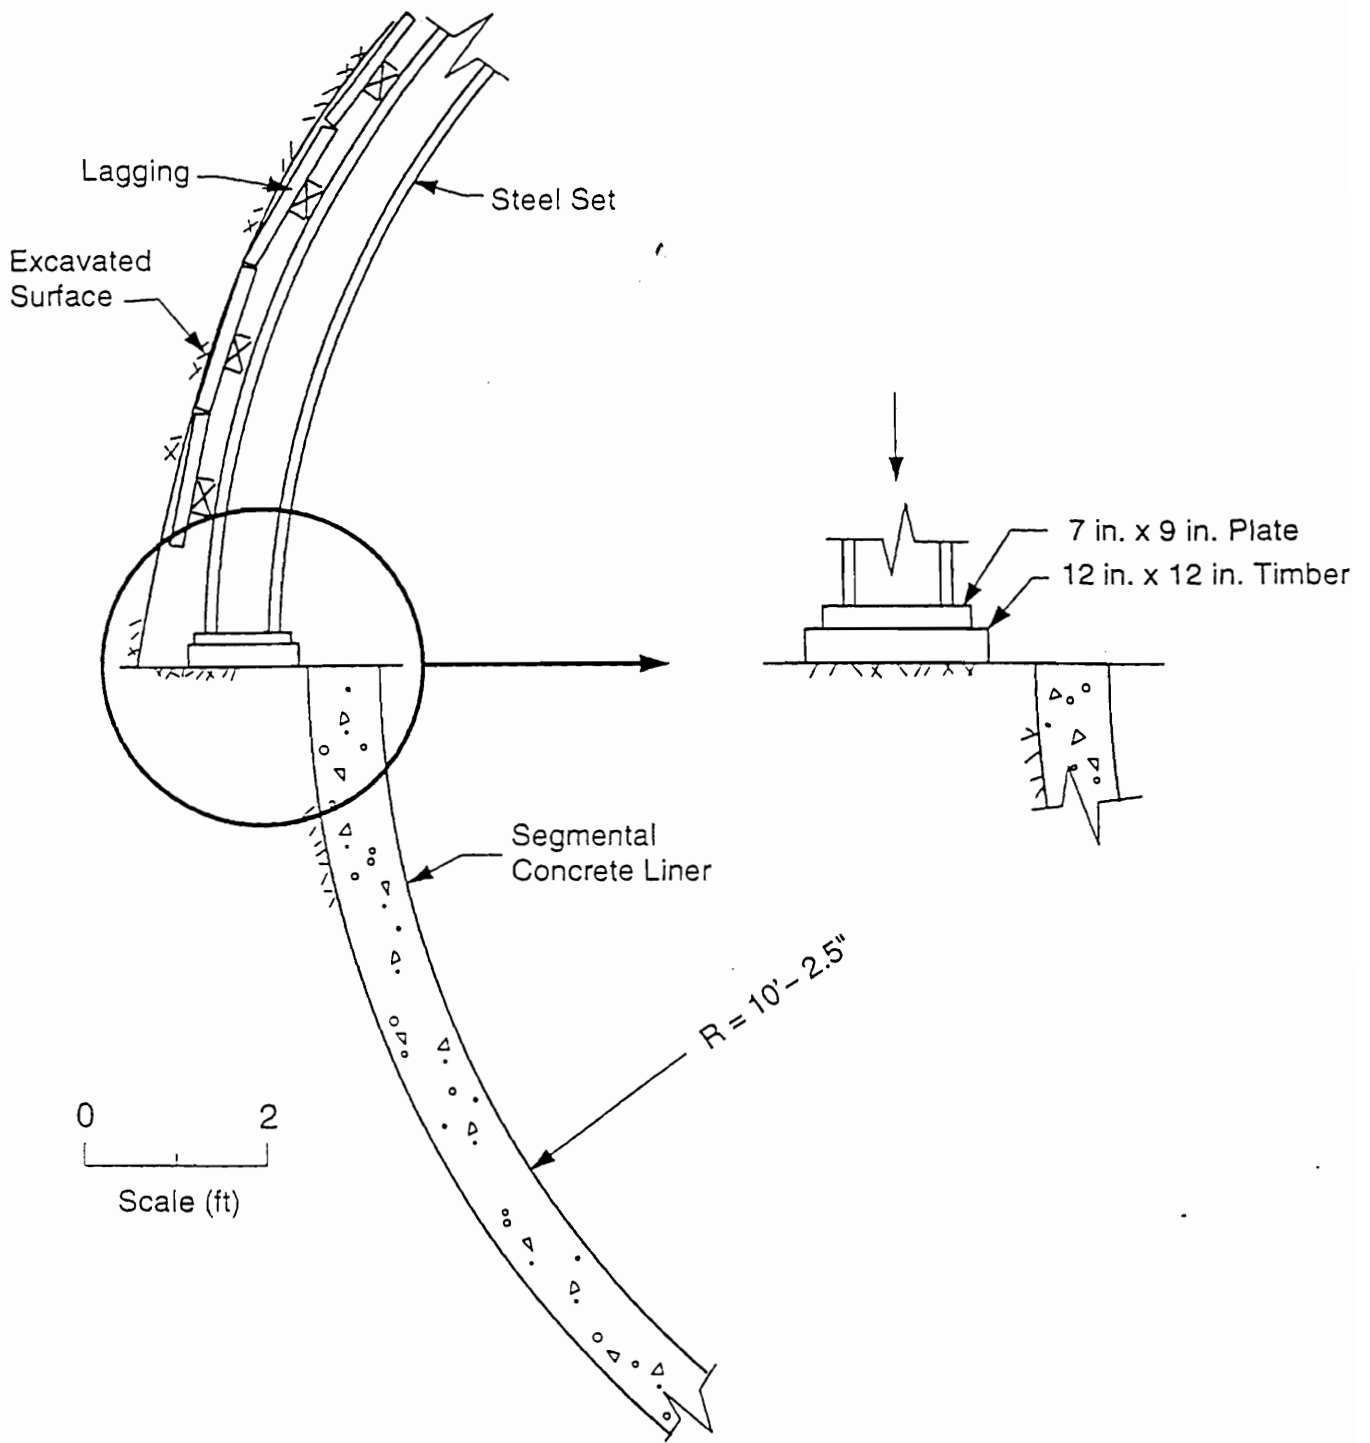
Fig. 5.1 Typical Foot Block For Steel Sets

Evaluating the bearing capacity of the earth on which a foot block rests is a standard step in design of rib linings. Safe support of the foot blocks is essential during the heading operation. The results of the bearing capacity calculations indicate the ultimate load which each steel set can support varies from 9 to 23 kips, about equal to the load expected from seepage forces and nominal earth load, and much less than the 307 kip load corresponding to 60 ft of overburden pressure. The design of the resupport system was deficient in that the bearing capacity of the foot blocks apparently was never considered. While it is unrealistic to require the foot blocks to carry 60 ft of overburden pressure, it is also unrealistic to *design* the foot blocks without provisions for earth loading.

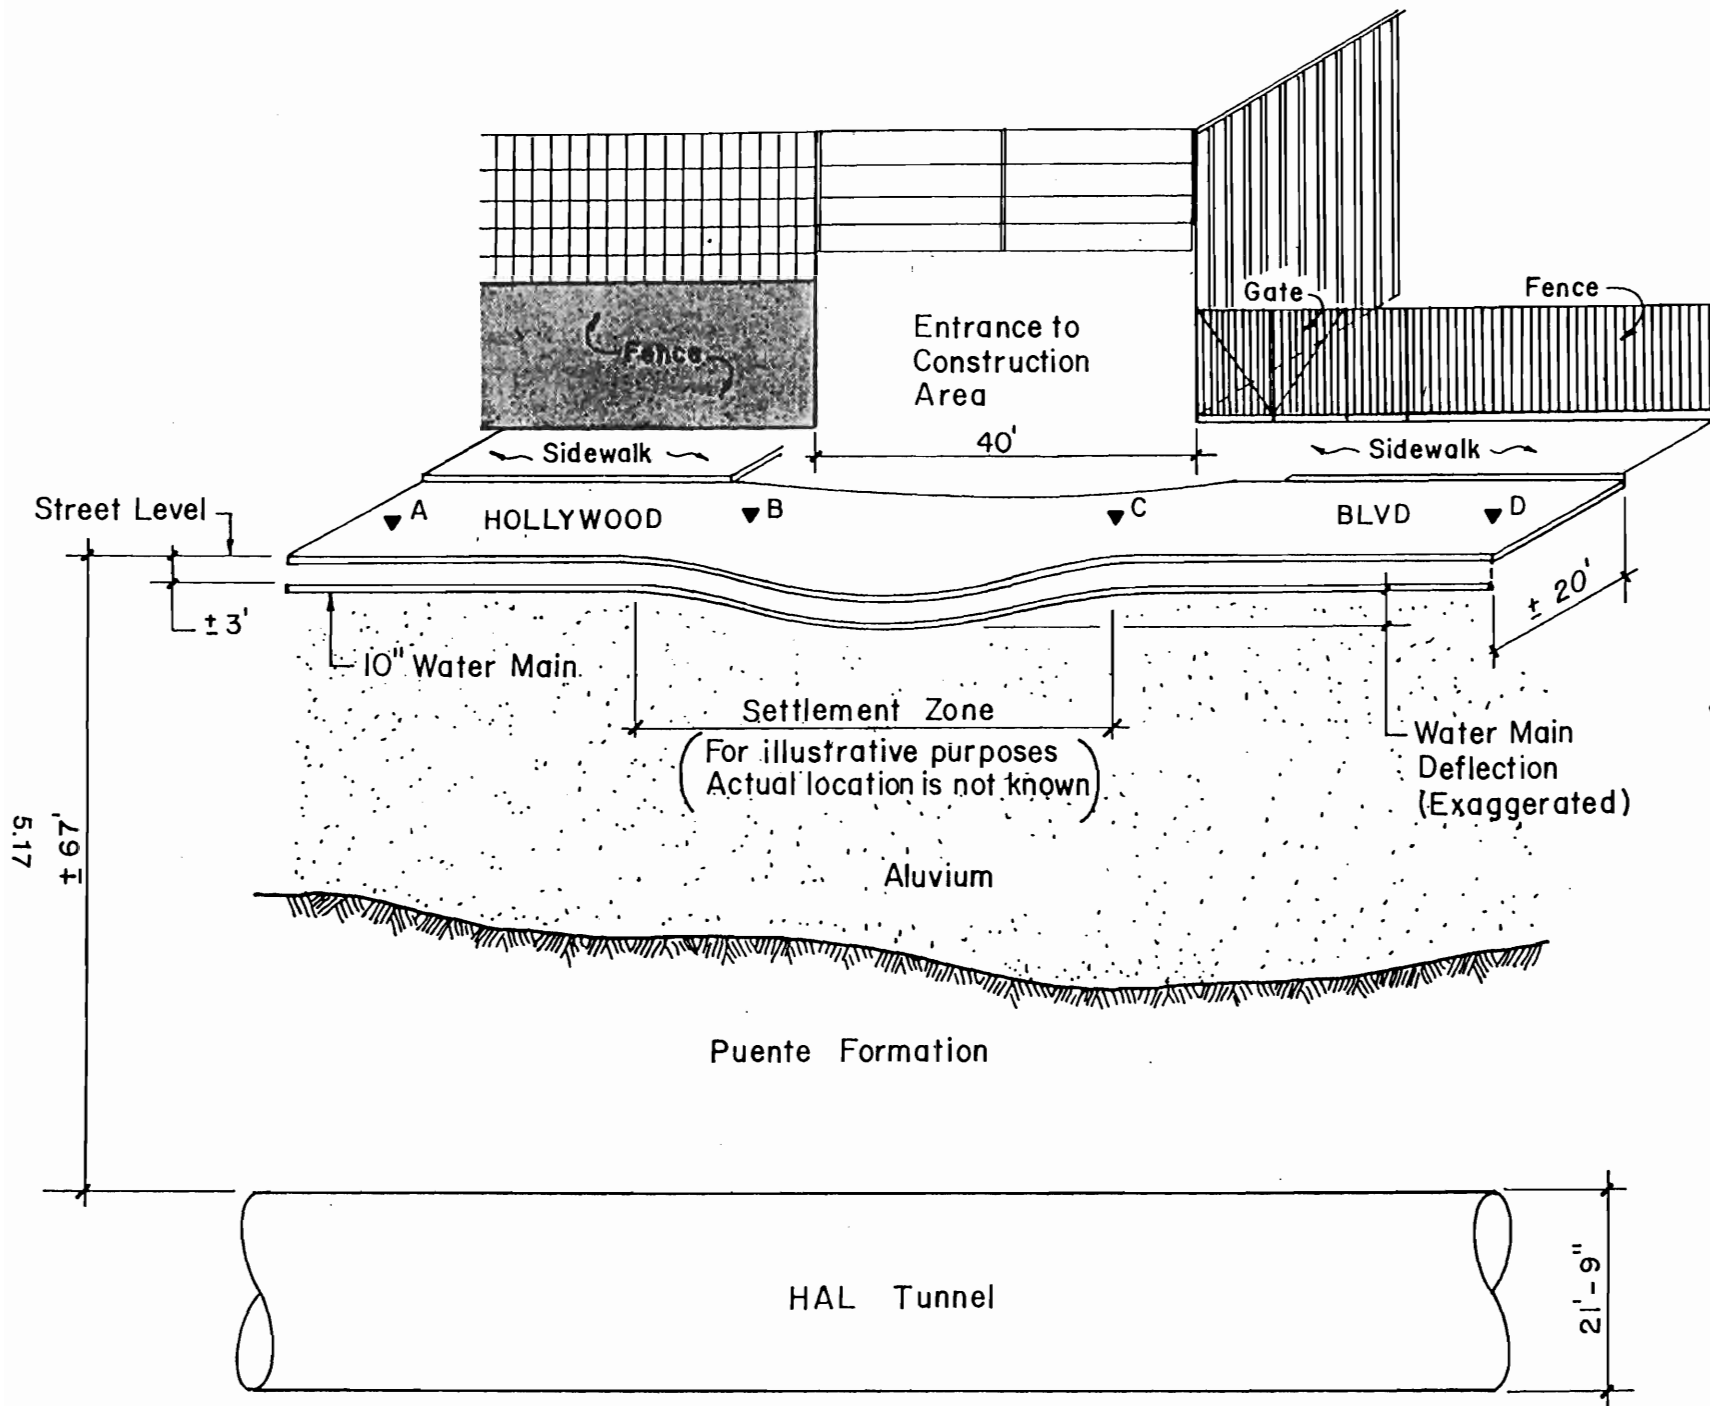
indicates the length of the settlement zone corresponding to rupture in the pipe is about 32 ft. If the prior 1.5 in. settlement is added, the length of the settlement zone corresponding to rupture of the water main is about 37 ft. These lengths are somewhat less than the size of the original sinkhole, but rupture of the water main due to larger ground movements in the tunnel is conceivable. Therefore, this analysis does not rule out the chronology indicated by site observations and LADWP records; that is, the water main ruptured before the tunnel completely collapsed.

Fig. 5.4 - Illustration of water main settlement above remined area

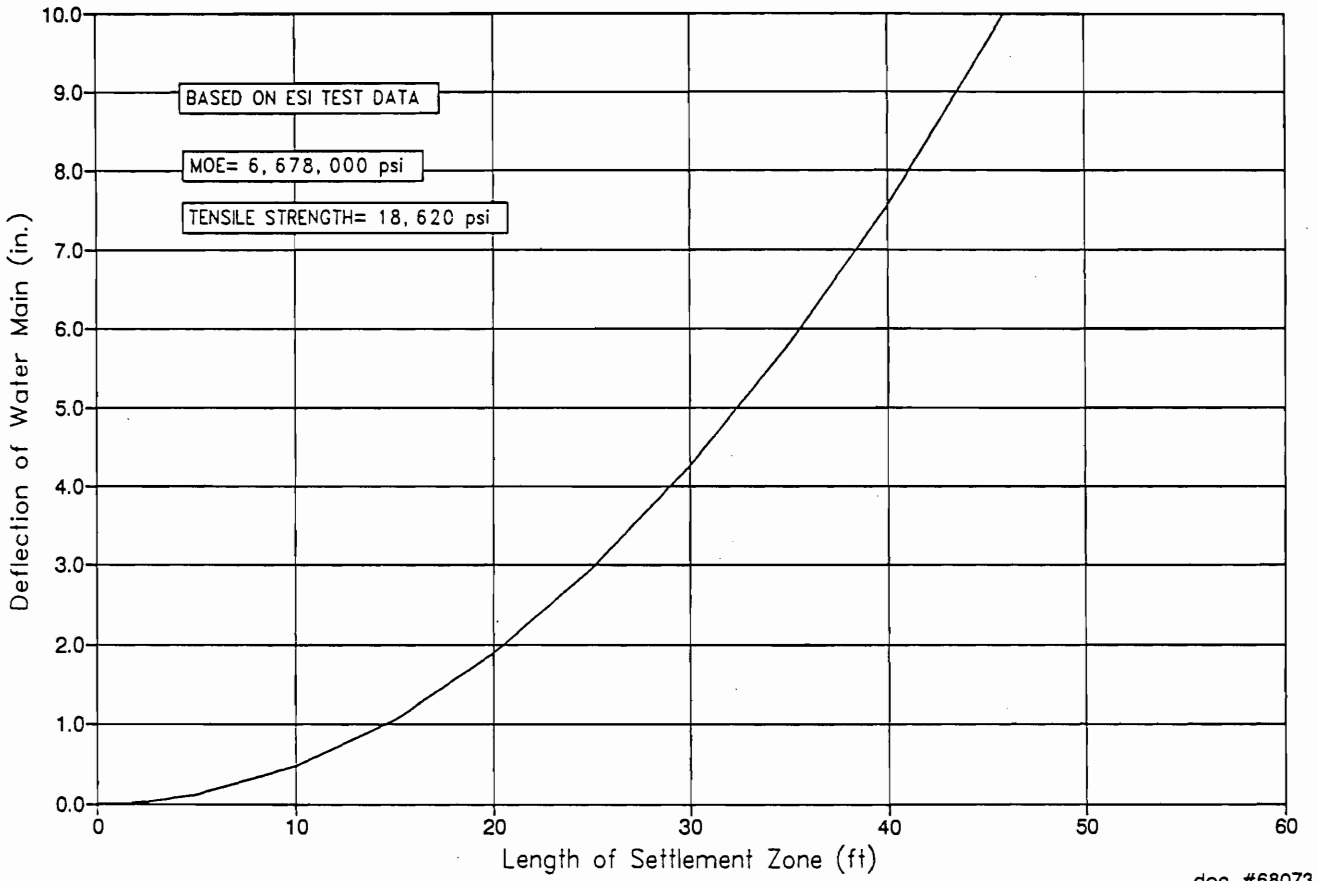
Fig. 5.5 - Critical water main deflection vs length of settlement zone
