AIRCRAFT ACCIDENT REPORT

HORIZON AIR, INC.
DEHAVILLAND DHC-8
SEATTLE-TACOMA INTERNATIONAL AIRPORT
SEATTLE, WASHINGTON
APRIL 15, 1988

NTSB/AAR-89/02

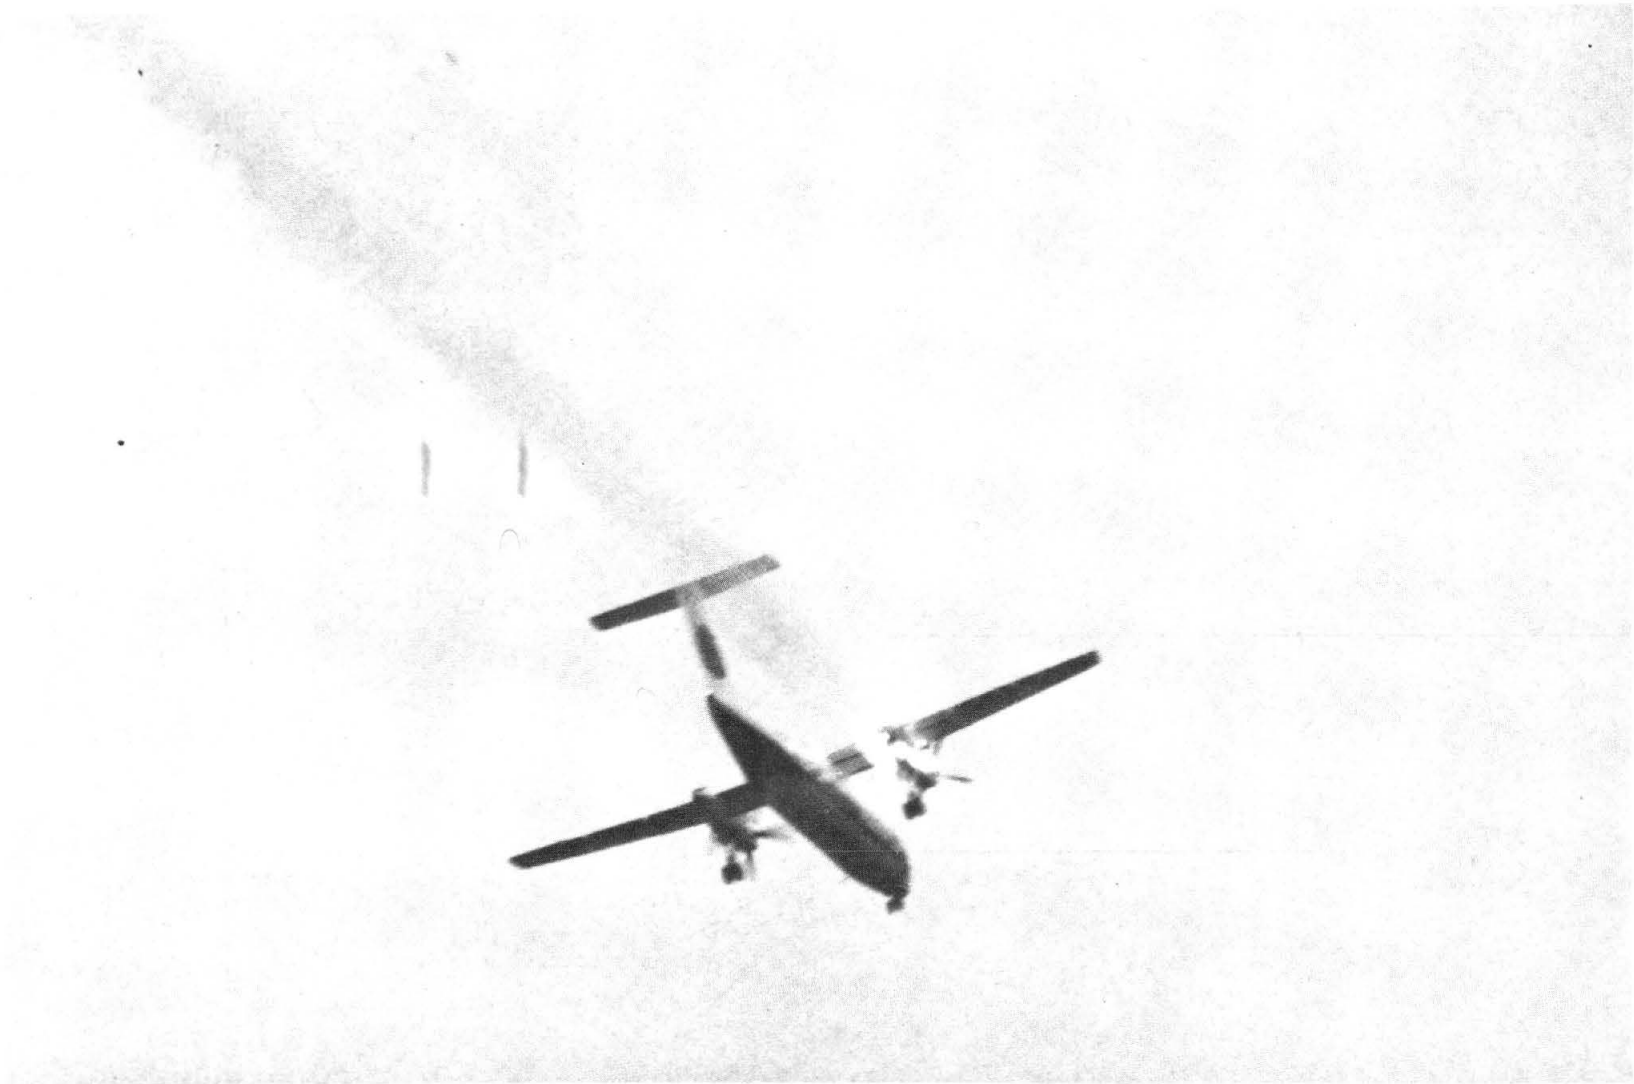
Figure 1. A photograph of N819PH on its final approach

The first officer stated that as he was scanning for traffic out the right side window during the turn to final approach, he observed a "flash" from the right engine. The first officer then observed that the center access panel on the left side of the right nacelle was missing and that an orange/yellow flame was in that area. The passenger in seat 9E also observed the fire and saw sections of engine cowl fall from the right nacelle. At 1831:03 the first officer stated, "We got a fire." Three seconds later the captain stated, "Max power . . .," and at 1831:09 he called for 15° of flaps. According to the FDR, the flaps began to move down shortly thereafter. After informing the captain of the fire, the first officer returned his attention to the engine instruments. The captain then retarded the right condition lever to the Start and Feather position and told the first officer to pull the fuel cutoff T-handle and fire the extinguisher bottles. After the first officer fired the extinguisher bottles and pulled the fuel cutoff T-handle, he observed that the fire was still burning and also that the green landing gear lights were no longer illuminated. (See figure 1.)

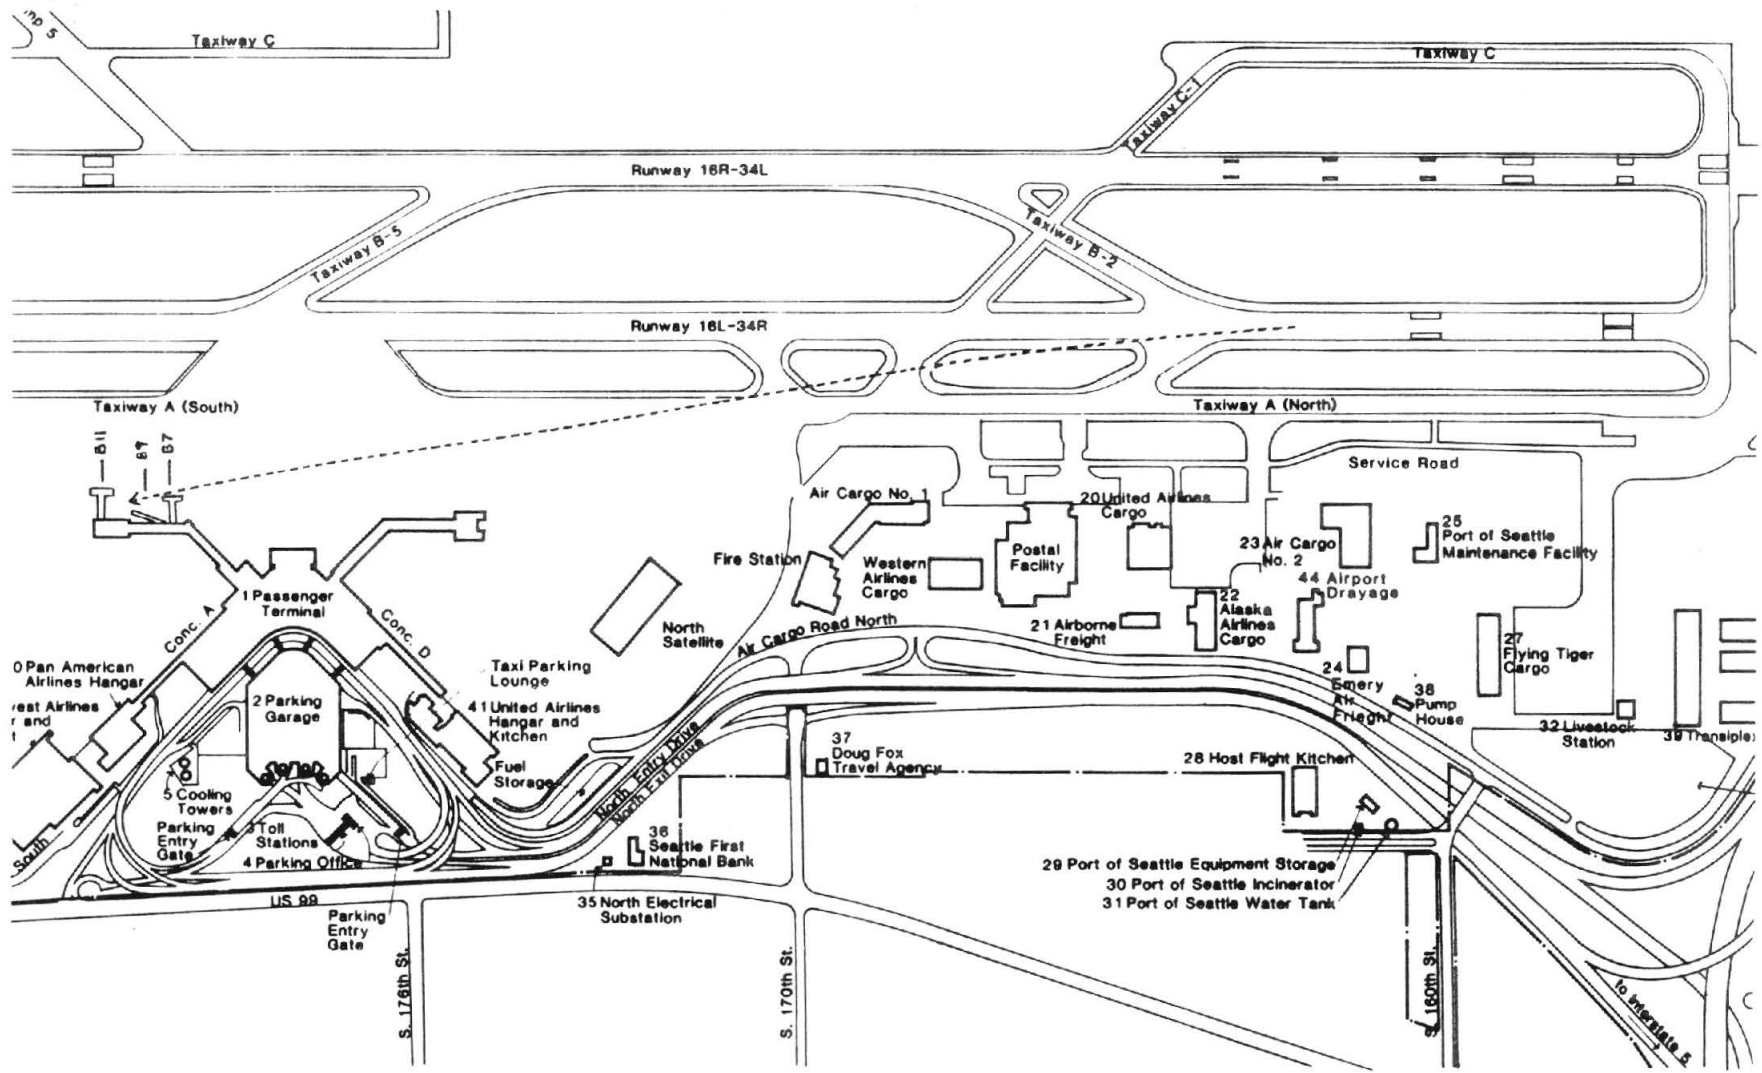
The first officer also tried his right rudder pedal, but it was already full right. He then noticed that the right brake pedal was already depressed and that the emergency brake was locked. He then advised the tower that the airplane was out of control and manually locked his and the captain's shoulder harnesses. As the airplane rolled onto the ramp pavement after crossing grass areas and taxiways on the airport, it struck and destroyed a frangible lighted runway designator sign. By this juncture, the airplane heading had changed another 2° to the left. Neither crewmember felt any deceleration. As the airplane entered the ramp area south of the tower, it struck jetway B7 damaging the outboard left wing. After striking the first jetway, the airplane struck jetway B9 causing the outboard left wing to separate from the airplane. The airplane struck and destroyed several baggage carts and pieces of ground equipment as it traversed the area between jetways B7 and B9 and came to rest against jetway B11 at 1832:31. (See figure 2.)

Figure 2. Diagram of the ground path of the airplane

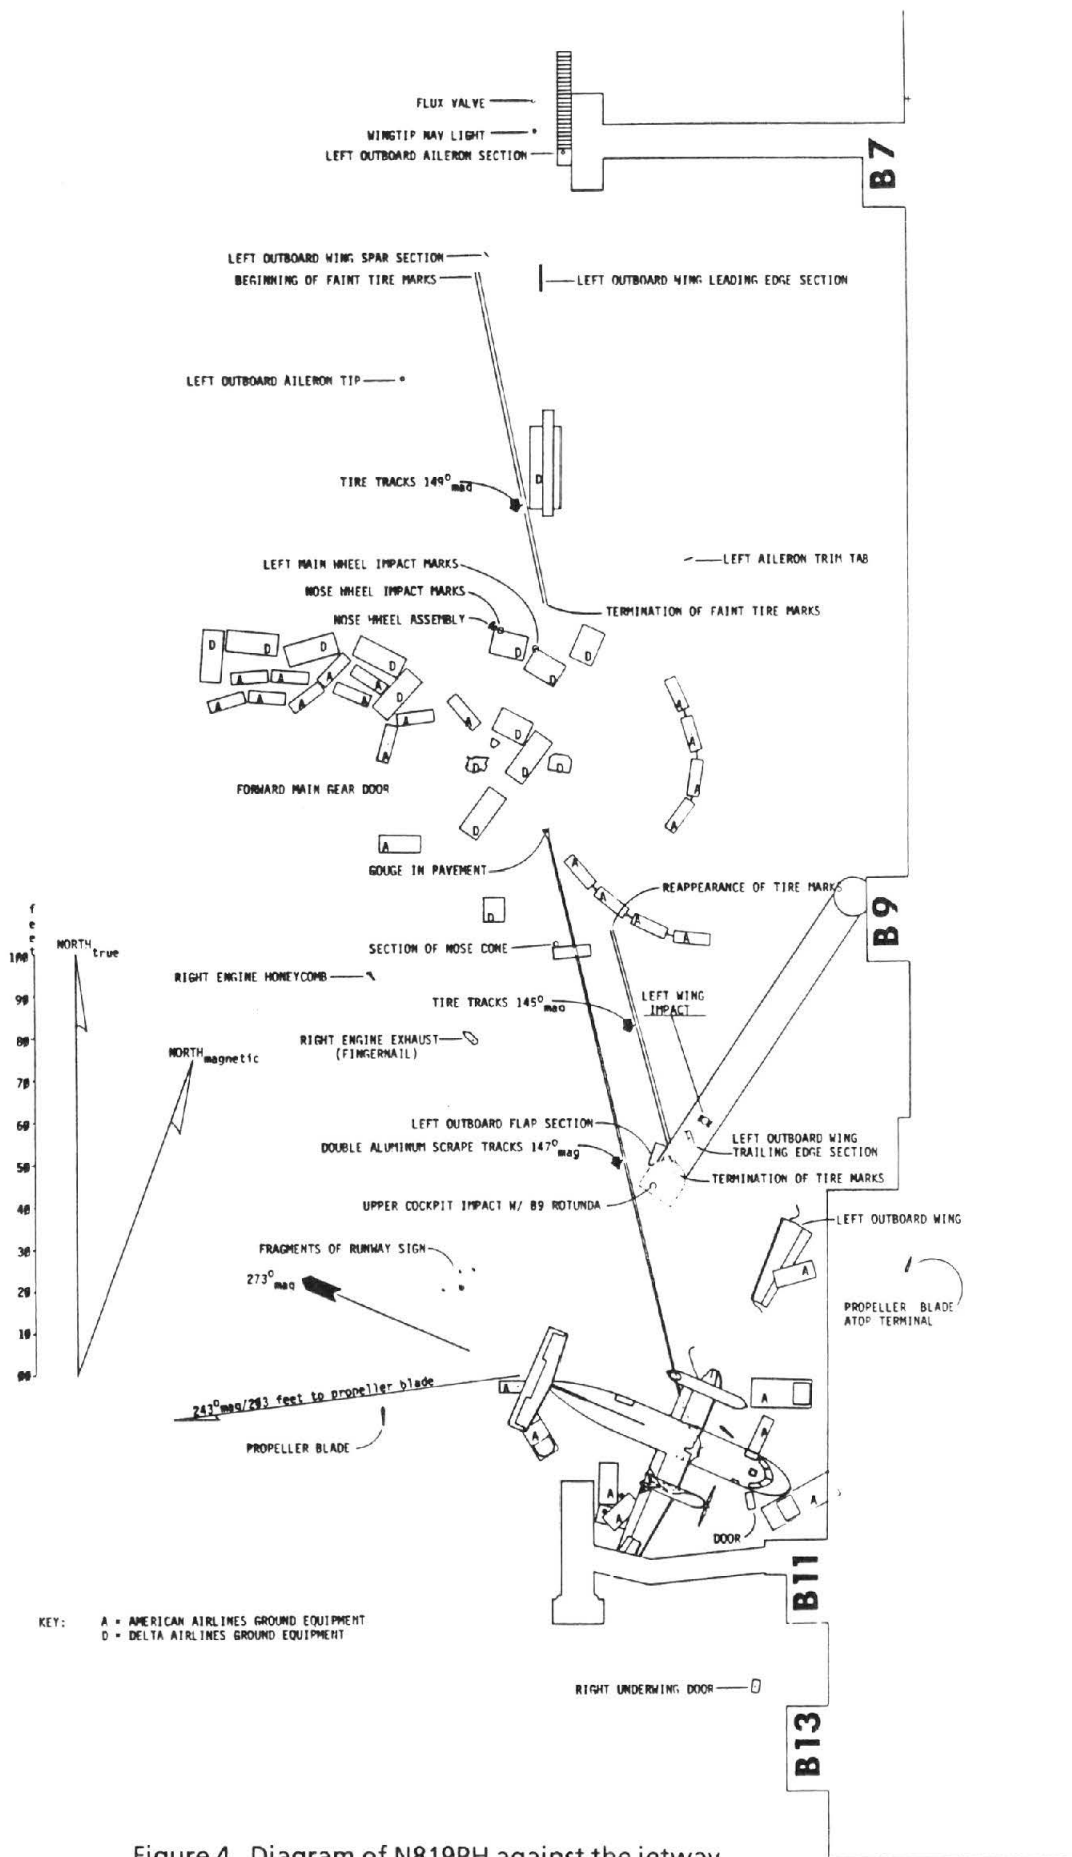
The right wing and right engine/engine nacelle sustained heavy fire damage. The aft portion of the nacelle was consumed by fire. The propeller was attached to the engine; however, one blade had separated and was recovered about 15 feet behind the left engine nacelle. (See figure 4.)

Figure 4. Diagram of N819PH against the jetway

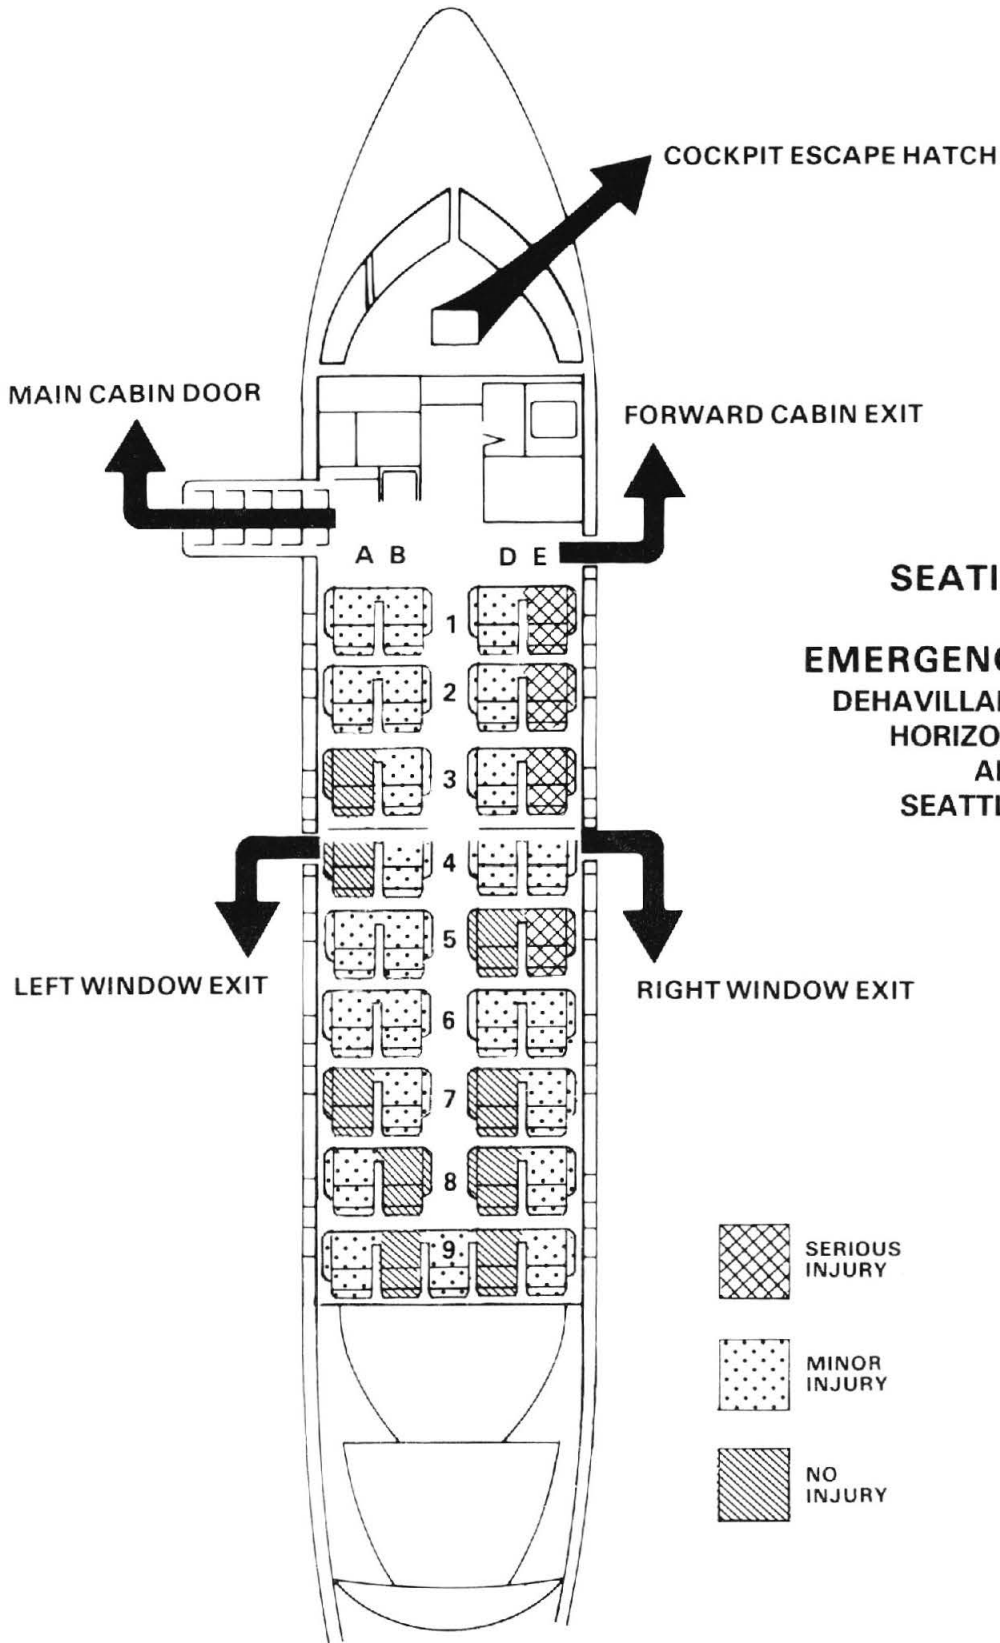
Figure 5. Injury distribution chart and seating arrangement

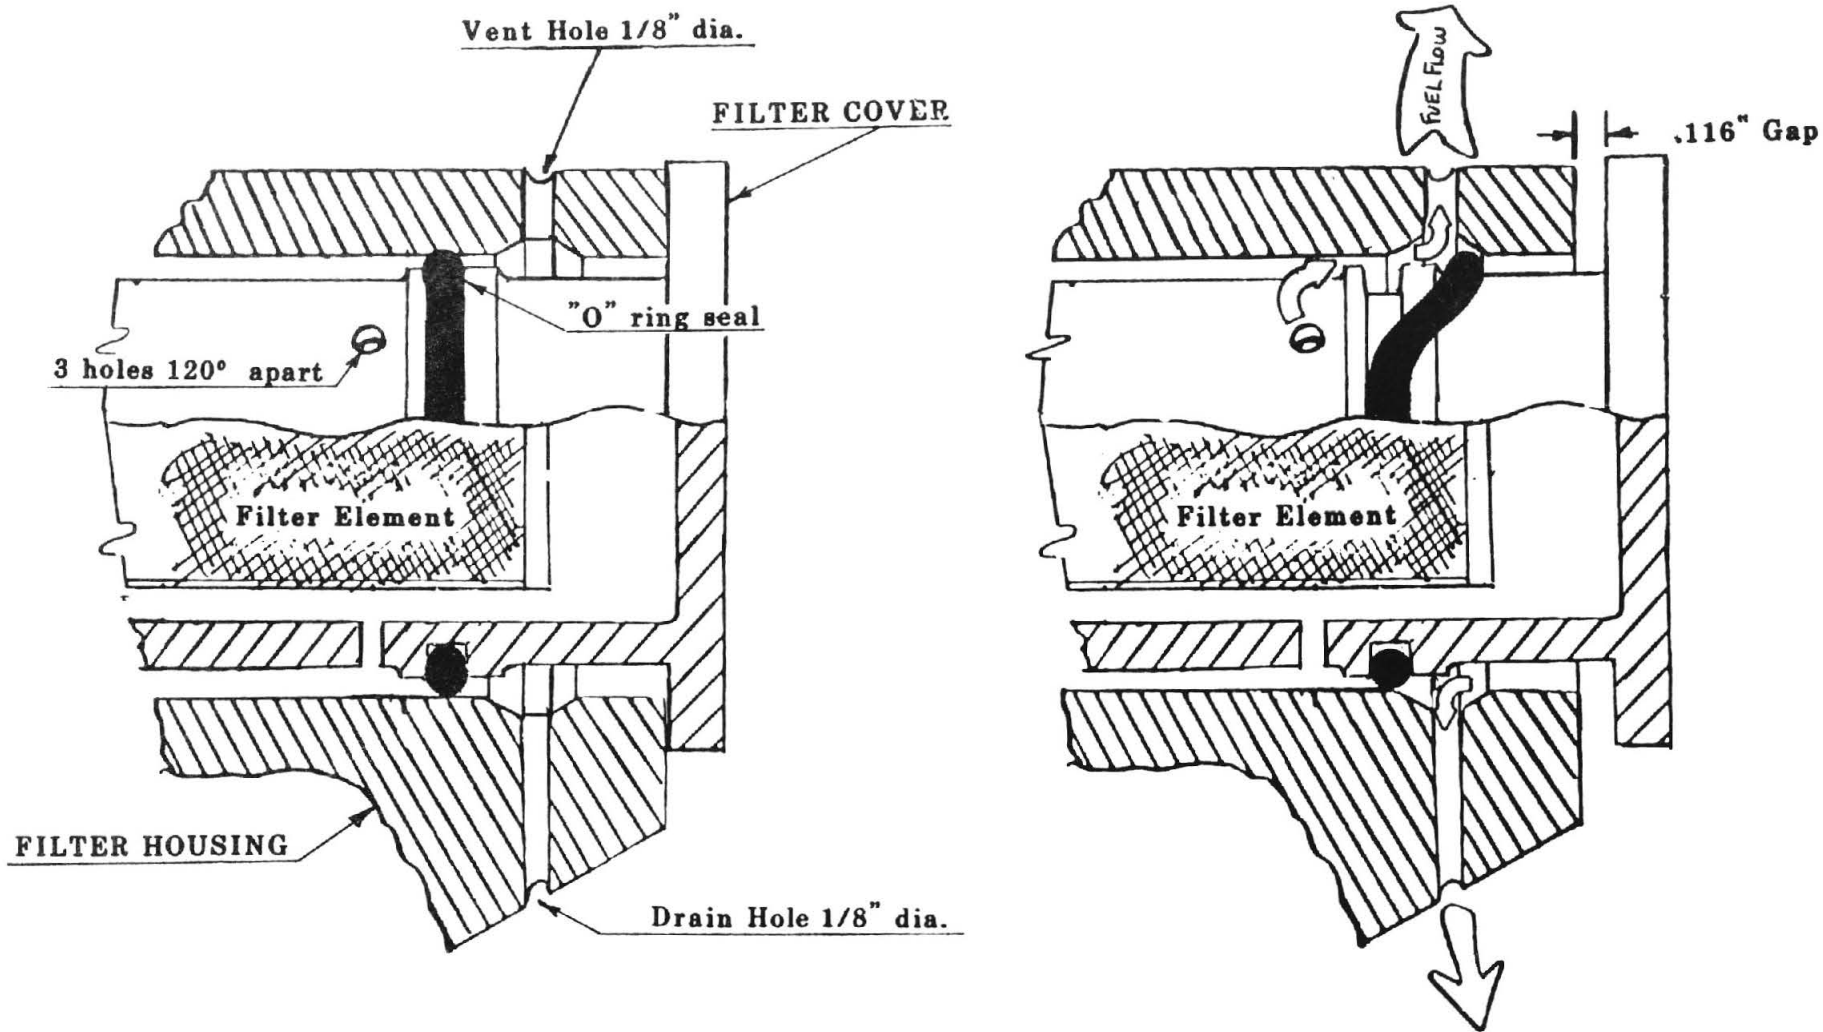
HP Fuel Pump Filter Assembly

There was a 0.116-inch gap between the HMU high pressure fuel filter cover and the face of the housing. Fuel was observed leaking from the bottom of the gap 22 hours after the accident. The fuel filter cover on the left engine was examined, and the cover was noted to be bottomed against the filter housing; there was no gap. Specified torque on the fuel filter cover is 100 to 150 inch pounds.

Filter Assembly and O-Ring
In Normal Position

Filter Assembly (with gapped cover)
and O-Ring in Extruded Position

To remove the fuel filter cover required 80 in/lbs. breakaway and 40 in/lbs. running torque, which gradually decreased to a point where the cover could be removed by hand. A visual examination of the cover showed that the threads were in good condition. The o-ring was in one piece and in the proper position, but it exhibited some abrasion in the area where it had been forced out of its groove. It also exhibited a small cut in this area. When the pump was disassembled, it revealed that the power lever shaft seals exhibited considerable heat damage. The power lever portion of the HMU as installed in the airplane was in an area of moderate to heavy fire damage.

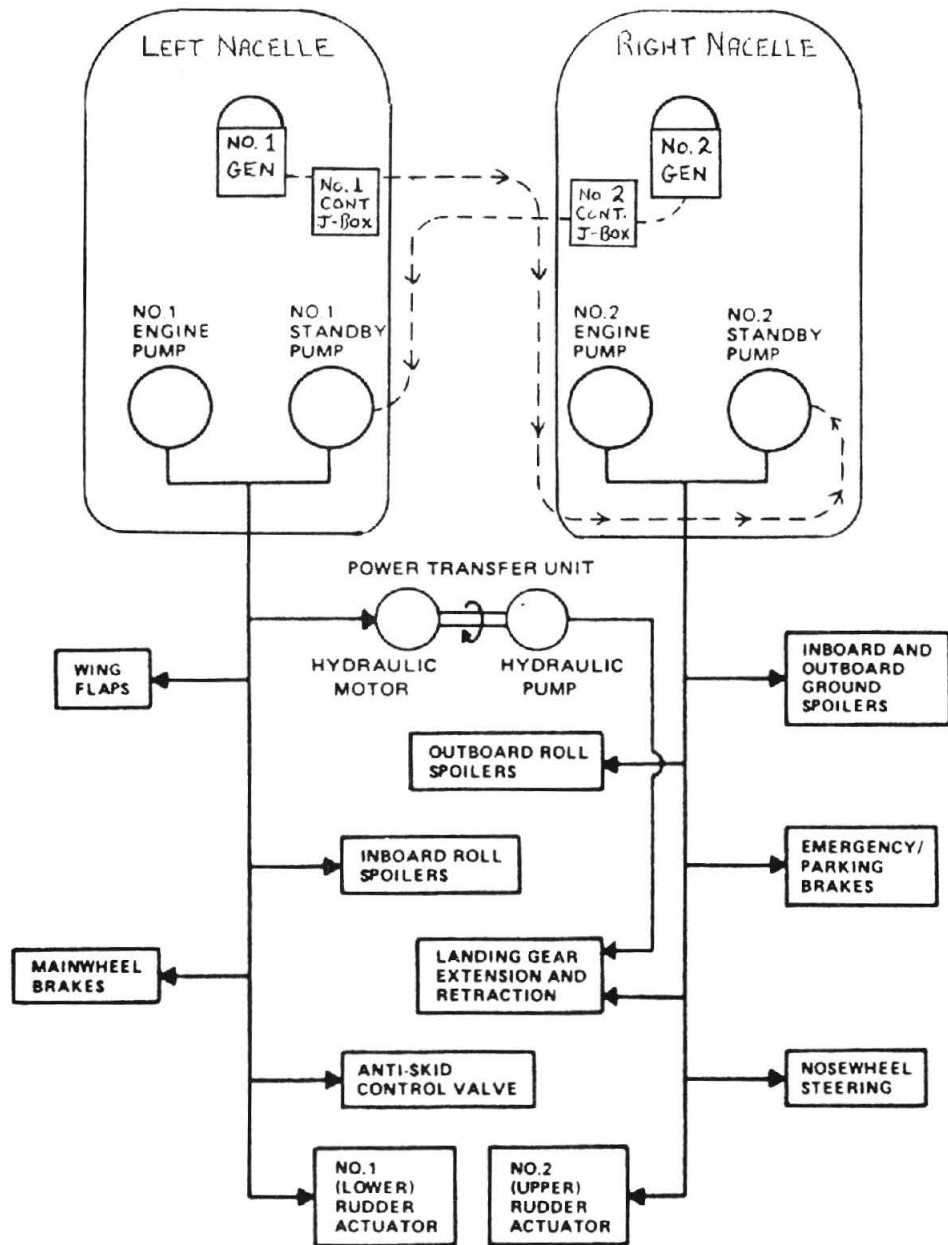
Figure 7. Schematic of the DHC-8 hydraulic system primary component

The N819PH was equipped with two independent constant pressure, variable flow hydraulic systems called the No. 1 (left) and the No. 2 (right) systems. By design, it was not possible to transfer control of hydraulic devices from one system to the other. The airplane was equipped with an emergency hydraulic system hand pump for use during emergency extension of the landing gear. Also, a power transfer unit (PTU) was installed to aid in the retraction of the landing gear in the event of a right engine failure on takeoff. The PTU consisted of a No. 1 (left) system hydraulic motor mechanically linked to a hydraulic pump that provided emergency pressure to the landing gear retract cylinders, a No. 2 (right) system component. No fluid transfer between hydraulic systems could occur normally in the PTU. The output pressure of the engine driven hydraulic pumps was rated at about 3,000 psi. Their flow rate was rated as 9.2 gallons per minute. The output pressure of the electric standby hydraulic pumps was rated as 2,750 psi under load. Their flow rate was rated as 1.56 gallons per minute. The No. 1 (left system) electric standby hydraulic pump received electrical power from the No. 2 (right) electrical supply contactor junction box, and vice versa. (See figure 7.)

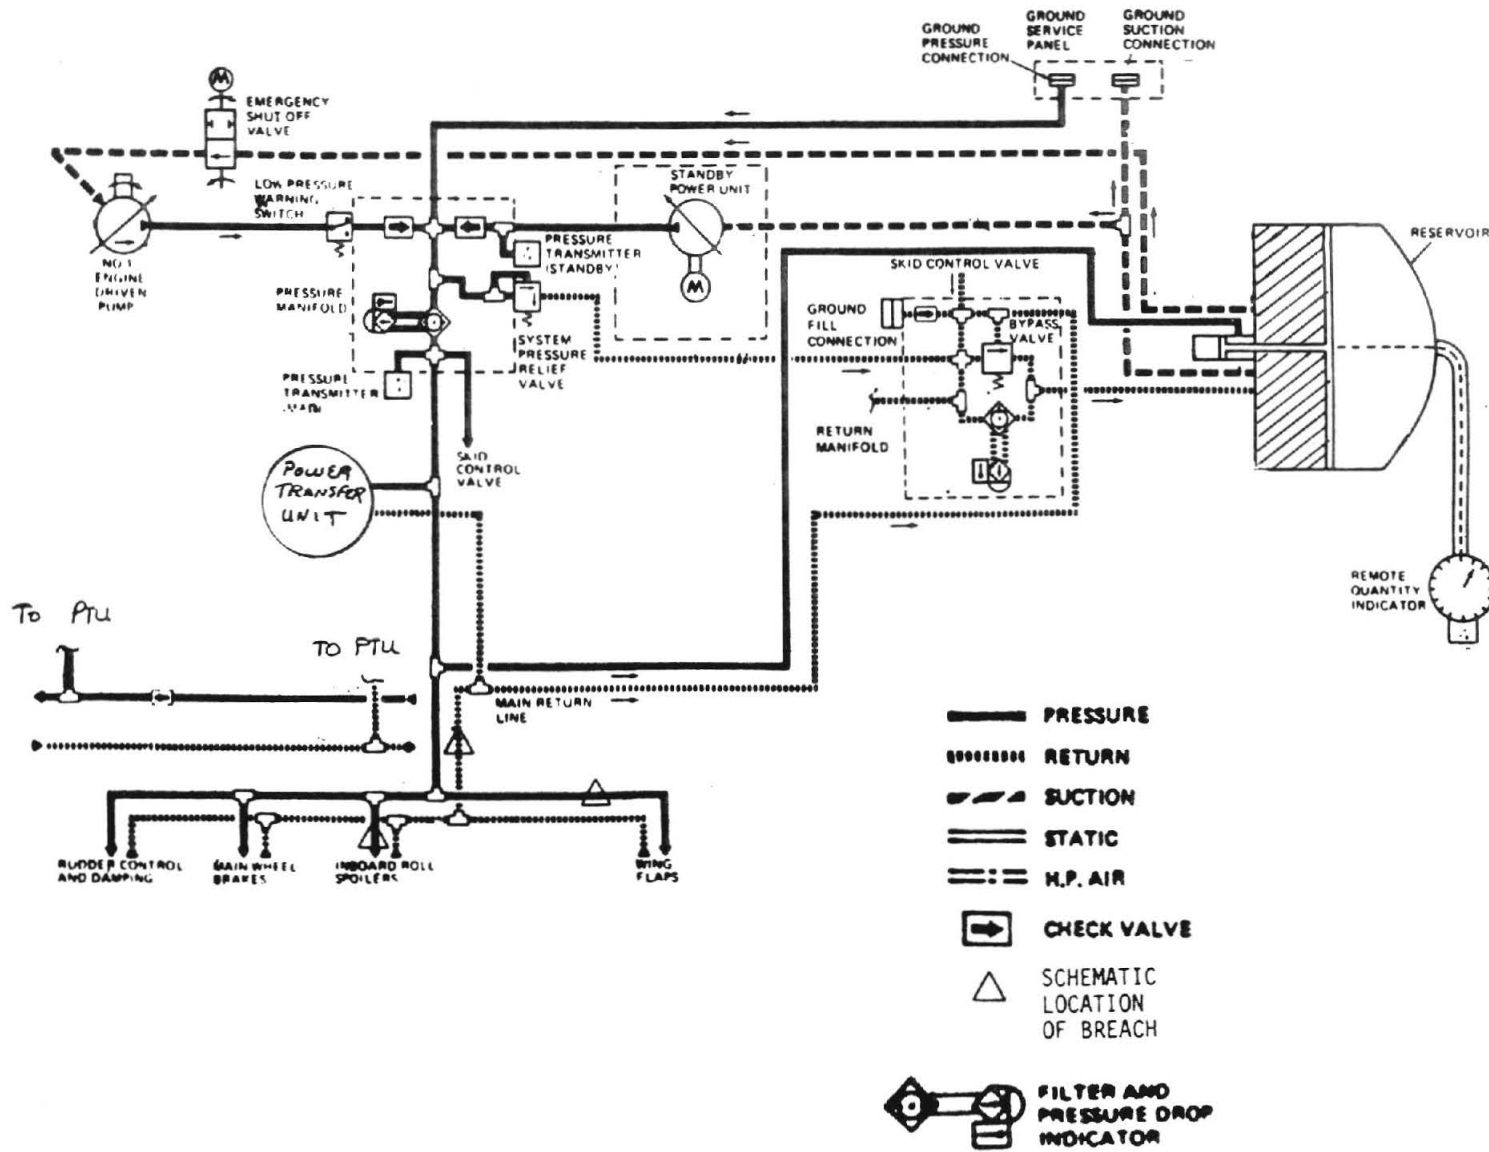
Three No. 1 (left) hydraulic pressure and fluid return lines in the right wing rear spar area of the right wheel well had been burned through by the fire. These fluid return lines included: one 1/4-inch diameter hydraulic pressure supply line to the right wing inboard roll spoilers; one 1/4-inch diameter lift dump pressure line; and one 3/8-inch diameter No. 1 hydraulic system return line. Also, the emergency/parking brake accumulator unit was found intact but both hydraulic lines to it were burned through. (See figure 8.) The destruction of these five hydraulic lines disabled both hydraulic systems.

Figure 8. Simplified schematic of the No. 1 hydraulic system

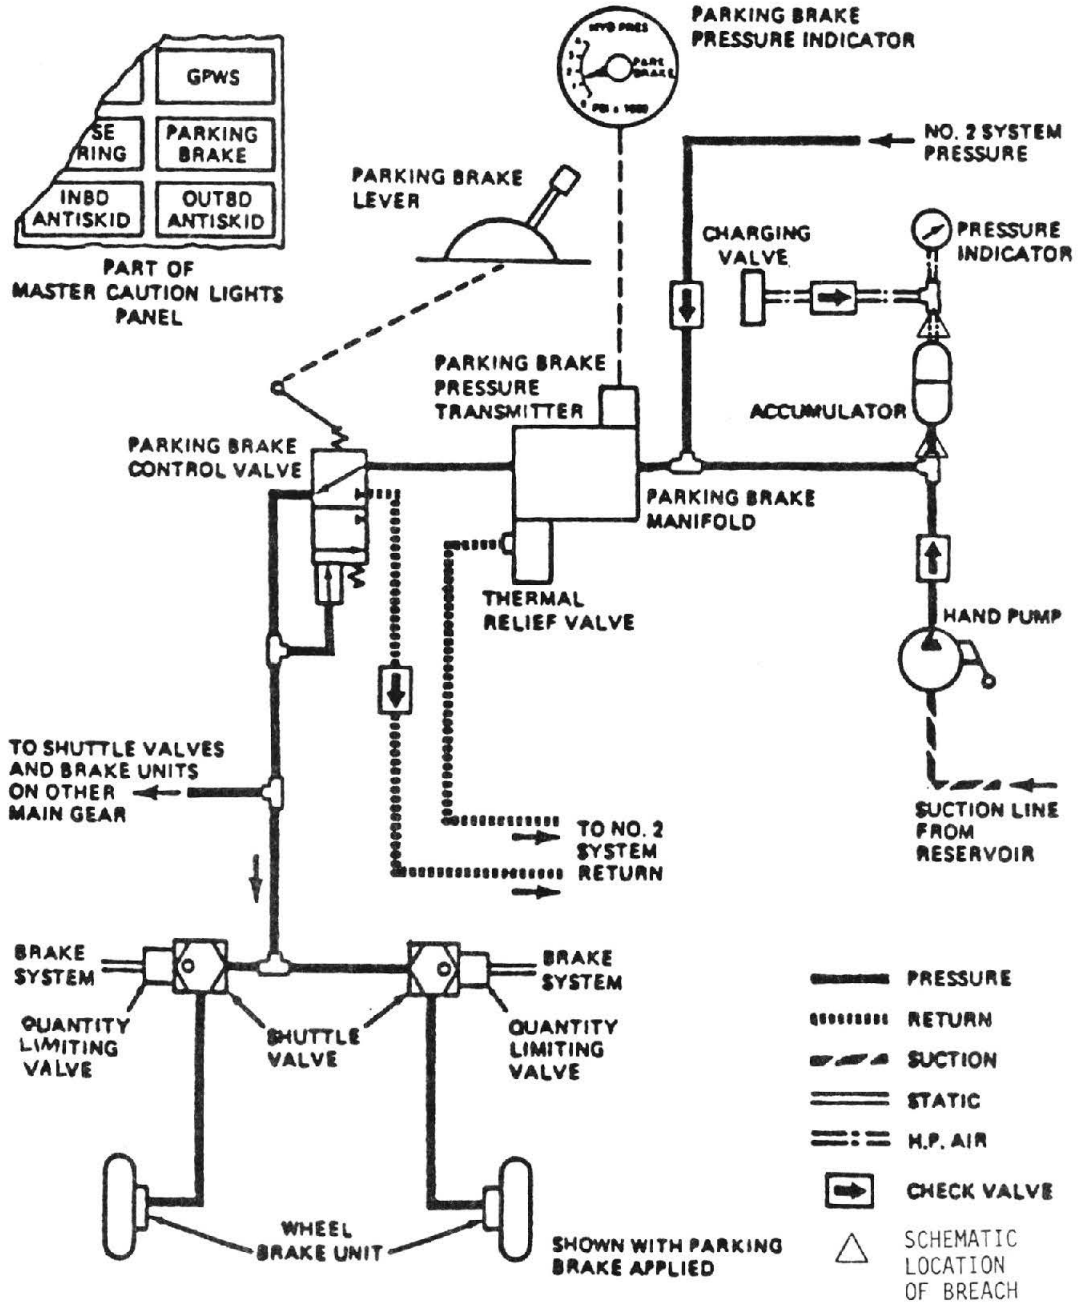
The DHC-8 emergency/parking brake system provides an independent source of braking to the main wheel brakes. During normal operations, the system receives hydraulic pressure from the No. 2 system engine-driven hydraulic pump. A check valve isolates the system from the No. 2 system pump in the event of an upstream line failure. An accumulator provides power for the system when engine-driven pump pressure is unavailable. The system is operated by a handle on the center console and serves as a parking brake system under normal operations. The crew may activate the lever and use a spring loaded button on the control lever to lock the lever in the on position. This provides hydraulic pressure to the main wheel brakes through the system powered by the accumulator. In an emergency, the lever is activated to provide braking to the main wheel brakes independent of No. 2 system hydraulic pressure. (See figure 9.)

Figure 9. Schematic of the emergency/parking brake system
