INTERSTATE COMMERCE COMMISSION.

REPORT OF THE CHIEF INSPECTOR OF SAFETY APPLIANCES IN RE INVESTIGATION OF ACCIDENT ON THE PACIFIC ELECTRIC RAILWAY, NEAR LOS ANGELES, CAL, ON JULY 13, 1913.

AUGUST 6, 1913

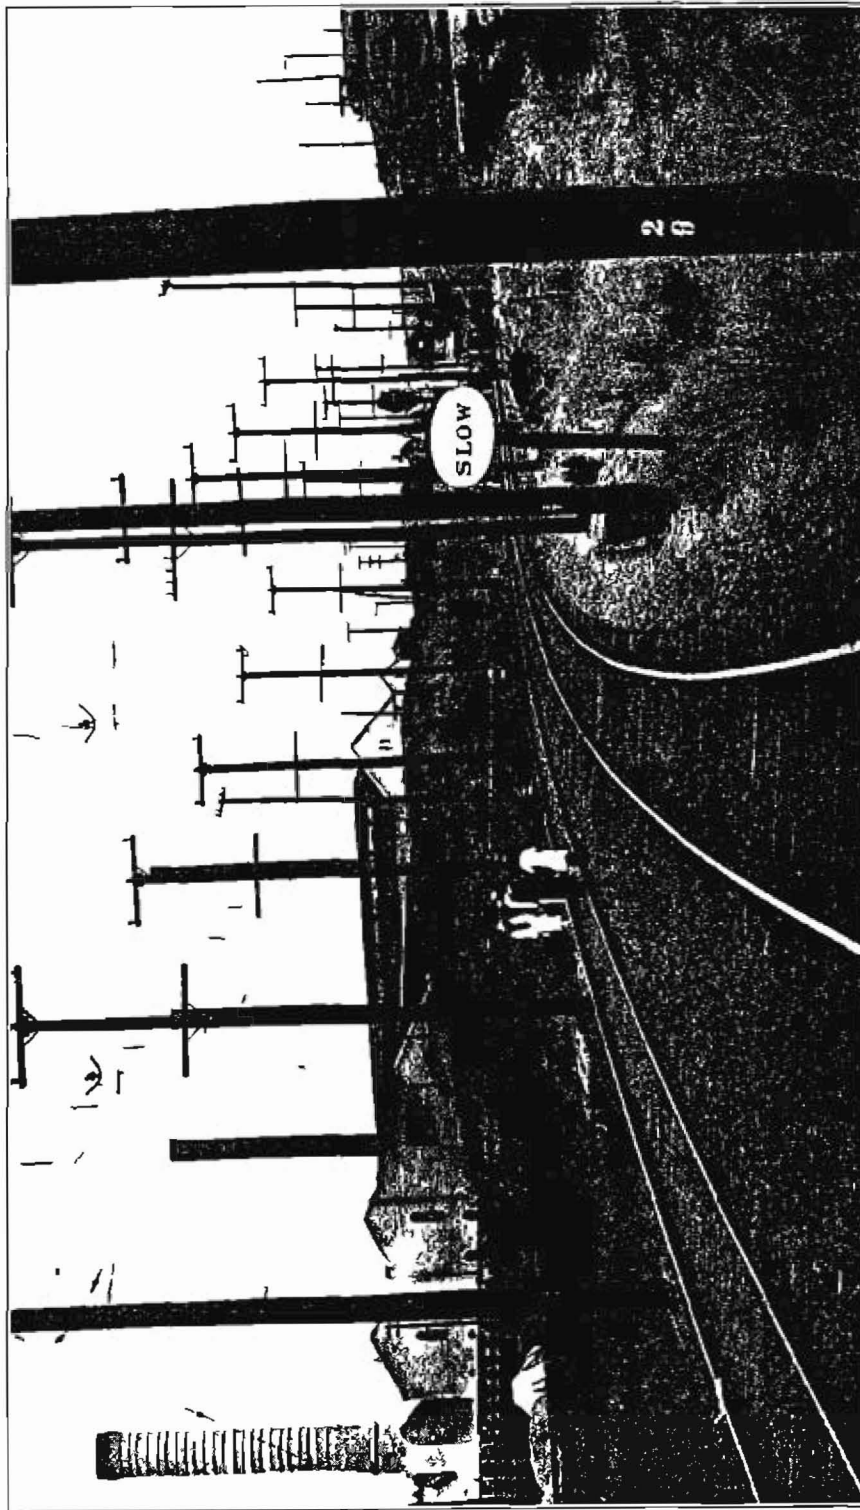
The track is straight for a distance of about 180 feet west of the point where the accident occurred, and then there is a curve of about $2\frac{1}{2}^{\circ}$, 639 feet in length, diverging toward the south. A slow board is located on this curve, 609 feet from the point where the collision occurred and 1,000 feet from the junction at Vineyard. Approaching from the west the view of the track at the point of collision was obstructed by the bank of a cut and by poles lining the track.

General view of track approaching scene of accident, showing slow board, bank of cut, and trolley poles along the track

In this case it is believed that the flagman did not go back the required distance, the evidence indicating that he had not reached the slow board which was only 609 feet from the rear end of the standing train, and although he had both fusees and torpedoes with him he did not use either.

Had the motorman of extra 874 observed the speed restriction in effect at this point the accident probably would have been averted, in spite of short flagging. The evidence indicates that the speed of the train when it passed the slow board was in excess of 30 miles per hour and it was undoubtedly more than 10 miles per hour when the collision occurred. On July 16 tests were made with a train of three cars of the 800 class to determine the distance within which a train of this character could be brought to a stop. During these tests there were about 30 people in the train, and the speed in each case was 41 miles per hour. In the first test the current was shut off at the slow board and immediately a 10-pound reduction was made, resulting in a service application of the brakes, and the train was brought to a full stop in 425 feet. In the second test an emergency application of the brakes was made at the slow board and the train was brought to a full stop in 400 feet. As a result of these tests, it is believed that had the motorman of extra 874 applied the brakes at the slow board the train would have been stopped in time to avert the collision, the distance between the slow board and the point where the accident occurred being sufficient to allow for the greater distance required for stopping the loaded train as compared with the train used in these tests.

The rules restricting the speed of trains at dangerous points along the road should be strictly adhered to and rigidly enforced. On a road of this character, where trains run from terminal to terminal without direct supervision of superior officers, signalmen, or operators, train employees should be impressed with the absolute necessity of obeying rules and orders issued and established for the safety of train operation.
