# Los Angeles County Metropolitan Transportation Authority

WESTSIDE PURPLE LINE EXTENSION, SECTION 3 STATIONS

VA STATION MURAL FINE ARTS REPORT

VA STATION MURALS CONDITIONS ASSESSMENT – MARCH 20, 2020

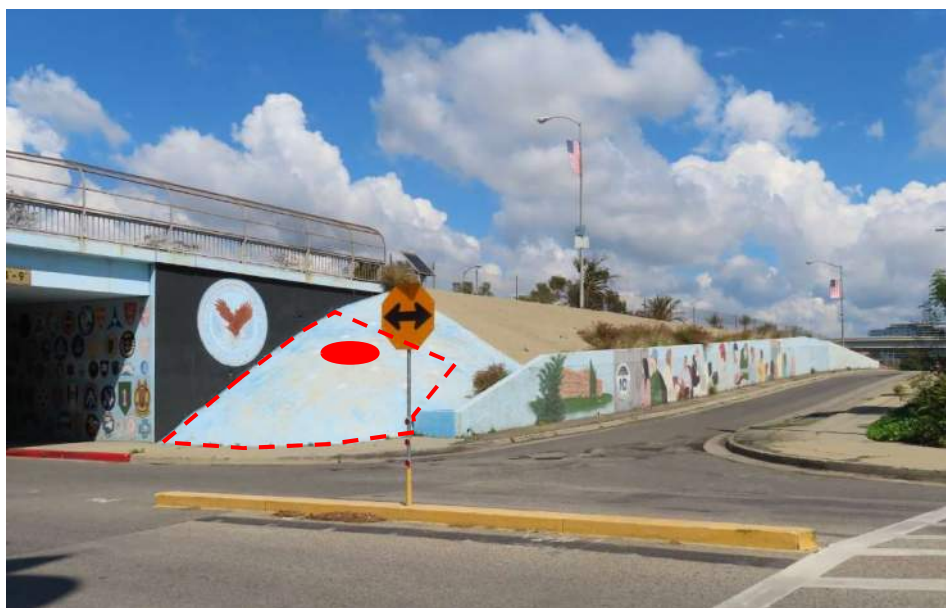
Figure 10 – Southeast retaining wall and corner slope (Wilshire Blvd. on-ramp, eastbound).  
Note proposed column location (in red) and proposed area of concrete slope to be removed (dashed lines). (source: ARG)

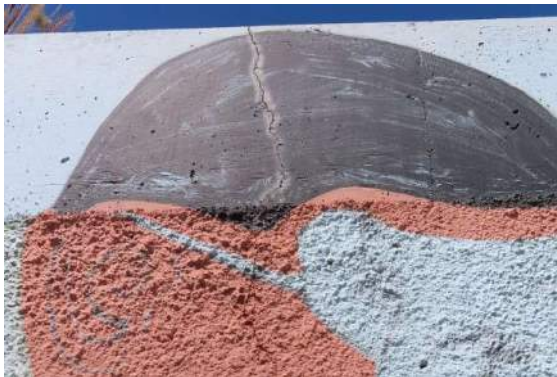
Photo 15: Crack at southeast wall, approx. 1/8-inch wide. Discoloration and paint loss at crack associated with water intrusion.

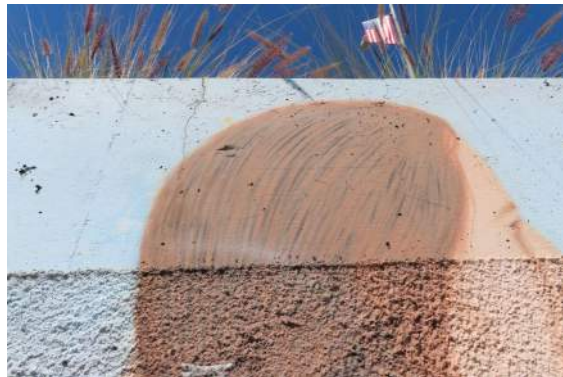
Photo 16: Hairline crack at southeast wall.

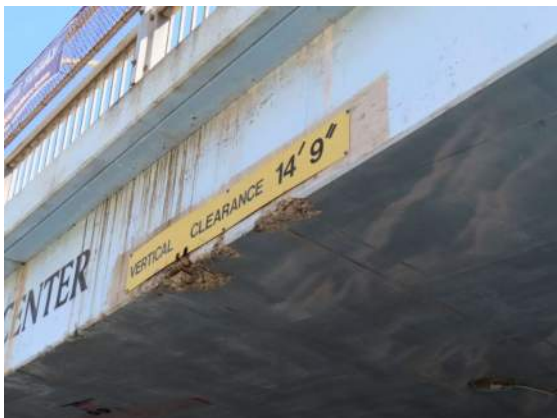
Damage to the concrete was observed at the north entrance of the Bonsall Ave. underpass. At this location, it appears that trucks or other high clearance vehicles have collided with the bridge, causing spalling of the concrete at the edge. The impact has exposed embedded reinforcing bars, which are now corroding (see photo 17). The damage also continues onto the ceiling of the underpass, where heavy paint loss and abrasion marks were noted through key portions of the mural (squadron of biplanes, see photo 18).

Photo 17: Detail of Bonsall Ave. underpass north entrance; note concrete spalling and corroded reinforcement, related to impact from trucks.

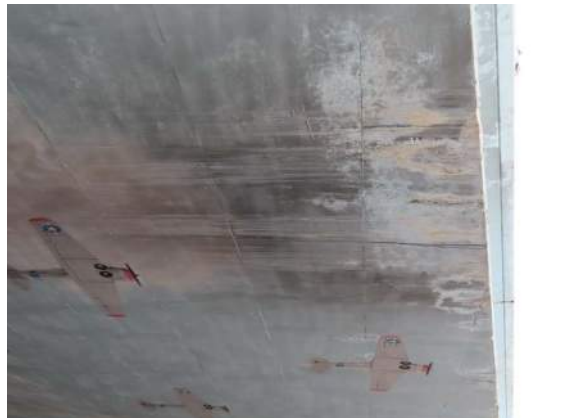
Photo 18: Detail of underpass ceiling at north entrance; note paint loss and abrasion damage from trucks.

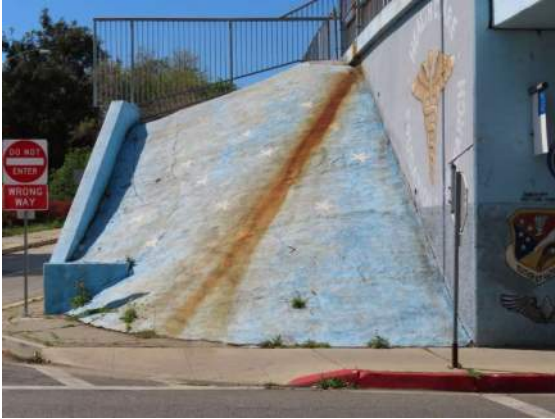
Photo 19: Southwest corner slope; note rust staining and eroded/faded paint.

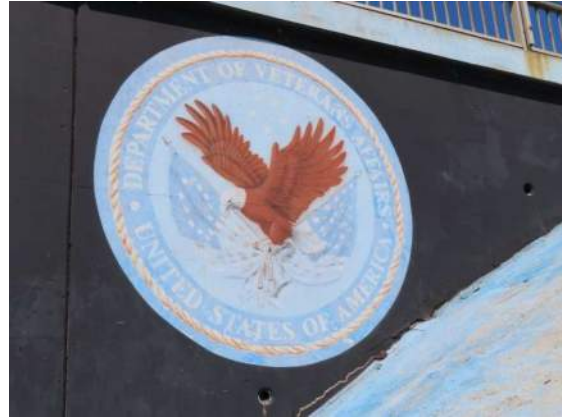
Photo 20: Detail of insignia at south elevation of bridge; note faded paint and lack of definition.

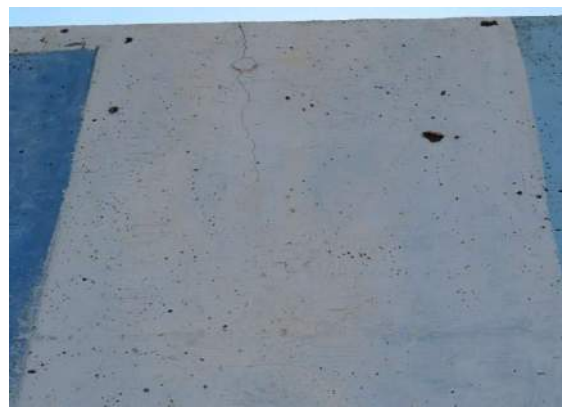
Painted surfaces appear to largely intact. ARG noted a few locations where there is cracking or peeling paint (see photo 22), or where there is paint loss (see photo 21). In some locations at the heavily textured surfaces, it is unclear if the paint loss is due to weathering and damage over time, or if the surfaces were incompletely painted originally due to the difficulty of covering the heavy texture (see photo 23). At one location on the southeast wall, it appears that the paint loss may be related to cleaning or removal of previous graffiti (see photo 24).

Photo 22: Detail at northeast wall; note cracking and peeling paint. Also note hairline crack above.

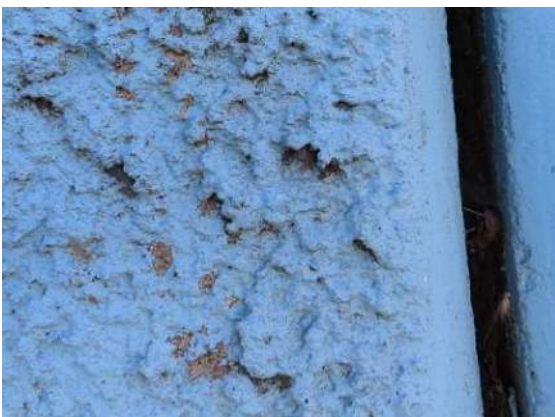
Photo 23: Detail at northeast wall; note paint loss, or possibly missing paint due to

lack of original coverage at highly textured surface.

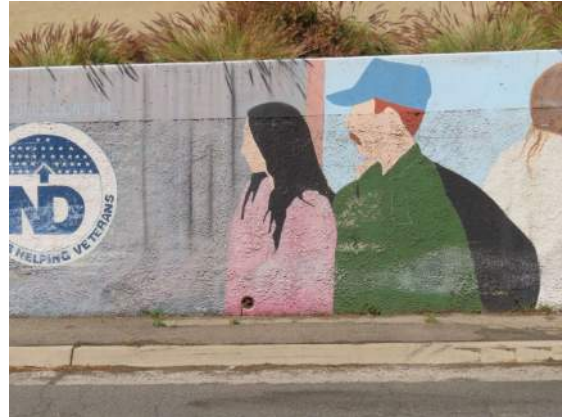
Photo 24: Detail at southeast wall; note paint loss at base of wall, possibly from prior

graffiti removal. Also note dark vertical lines (drip staining/soiling).

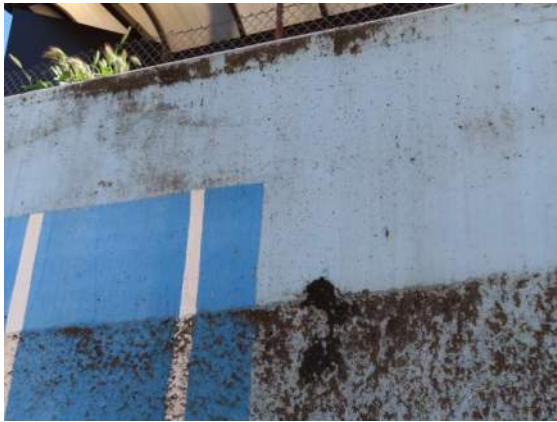
Photo 25: Detail at northwest wall; note heavy soiling.

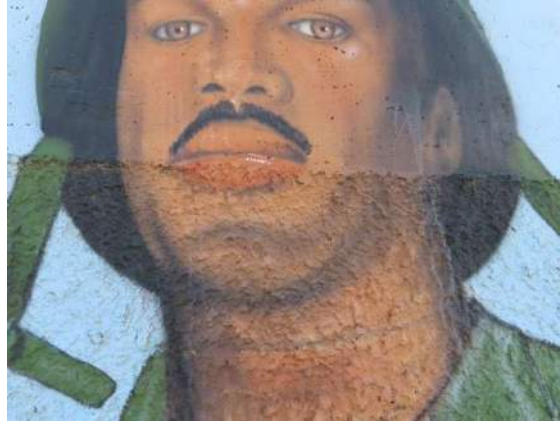
Photo 26: Detail at northeast wall; note drip stains.

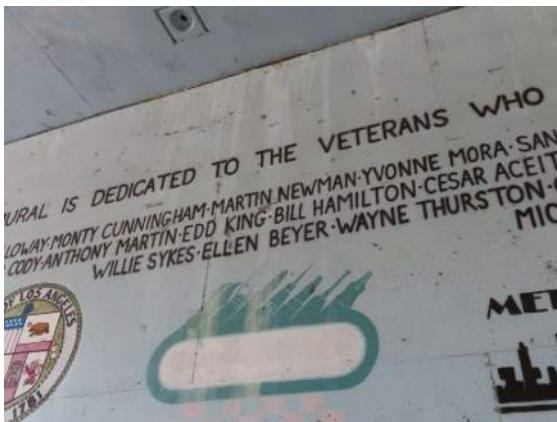
Photo 27: Detail of east elevation of Bonsall Ave. underpass; note drip stains and associated paint loss.

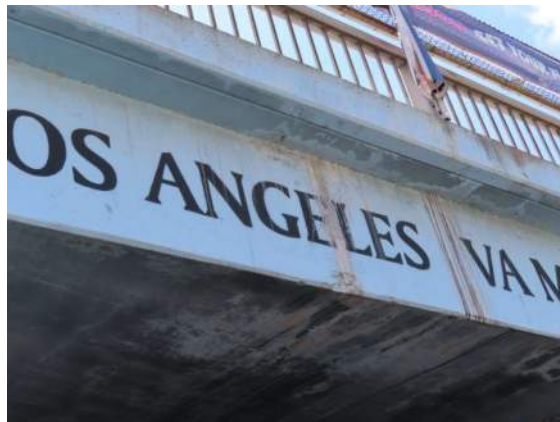
Photo 28: Detail of Bonsall Ave. underpass north entrance; note drip stains, efflorescence, and paint loss at bridge fascia and ceiling.

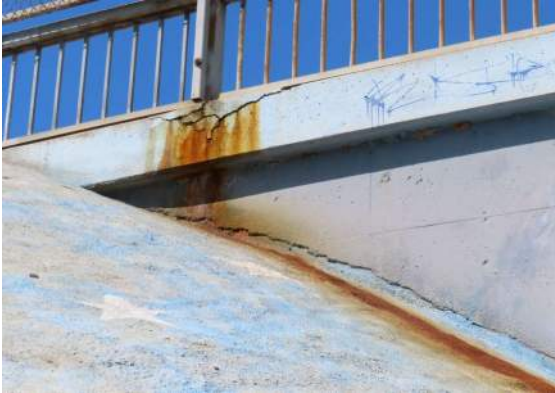
Mural surfaces are generally soiled overall. This includes soil erosion from adjacent planted areas or slopes, as well as atmospheric soiling from the urban environment. The soiling varies by location from light to heavy accumulations (see photo 25). Drip stains and other residues were noted in several locations. The stains can be disfiguring to the mural work (see photo 26), and in some locations, have also caused paint loss (see photos 27-28). At two of the corner slopes, the painted surfaces are stained by corrosion of adjacent embedded steel at the bridge above (see photo 29).

Photo 29: Detail at southwest corner slope; note rust stains associated with corrosion of embedded steel above.

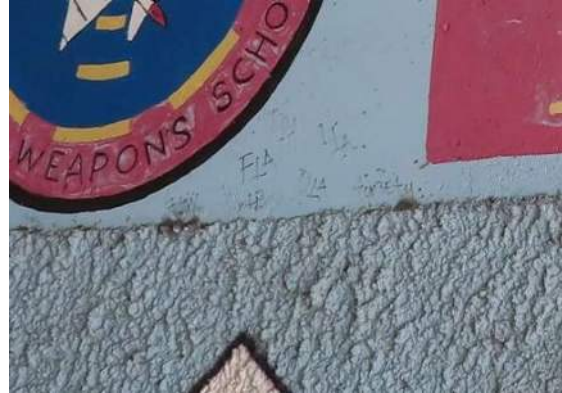
The murals have very little current damage from graffiti. Writing or pen marks were noted in two locations (Bonsall Ave. east elevation and northwest wall; see photo 30); and spray paint graffiti was noted in two locations (southwest and southeast walls; see photo 31). In other areas, it appears that previous graffiti has been painted over with non-matching paint (see photo 32 for an example).

Photo 30: Detail of east elevation of Bonsall Ave. underpass; note writing/graffiti.

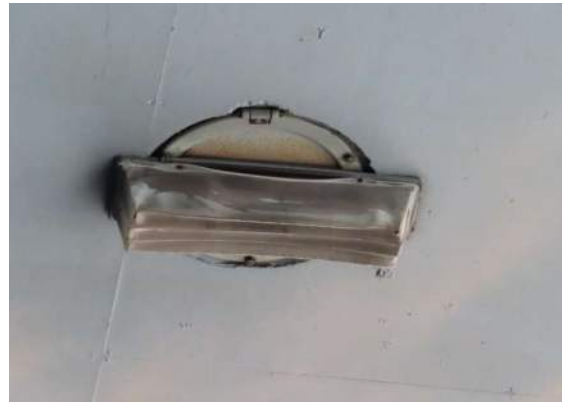
Photo 38: Light fixture at underpass ceiling.

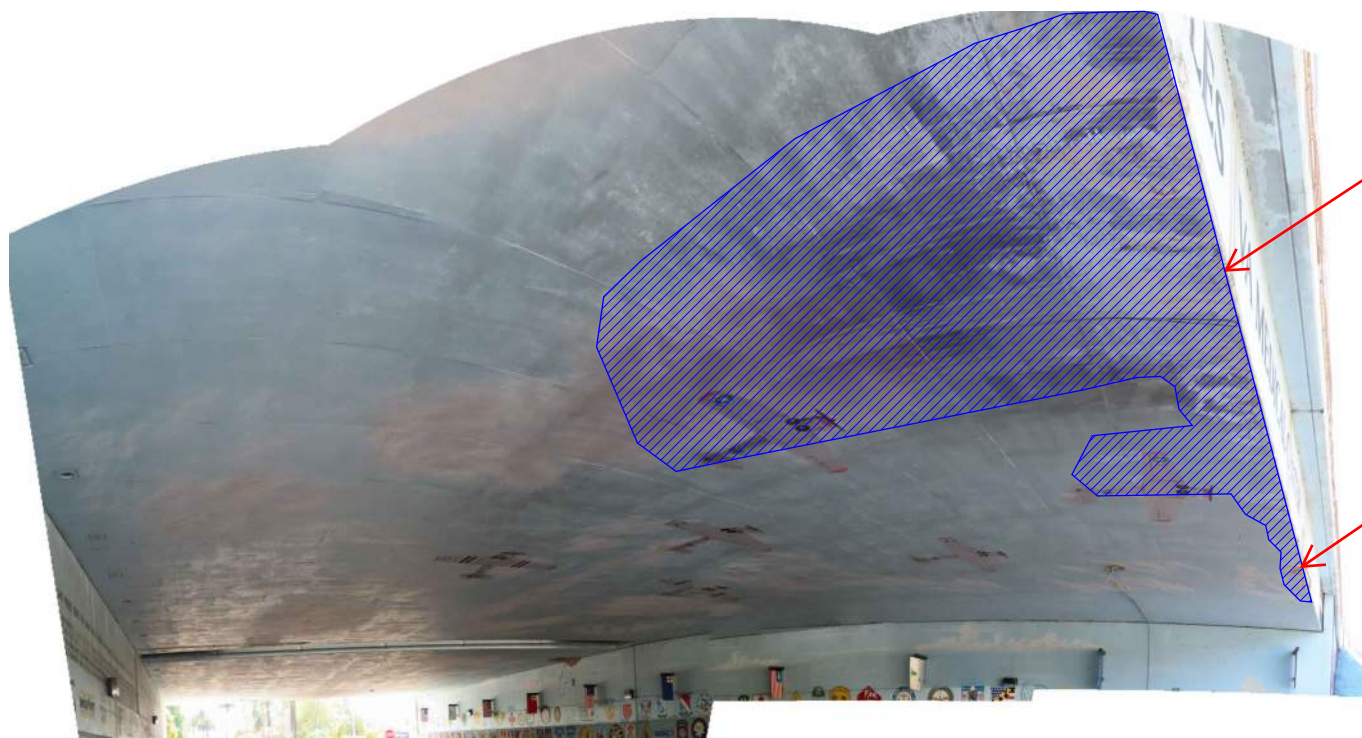
**1** UNDERPASS CEILING - VIEW NORTH  
NOT TO SCALE

ABRASION DAMAGE & CHIPPED EDGES FROM HIGH VEHICLES

SPALLS AT CONC. EDGE; REINFORCEMENT EXPOSED AND CORRODED

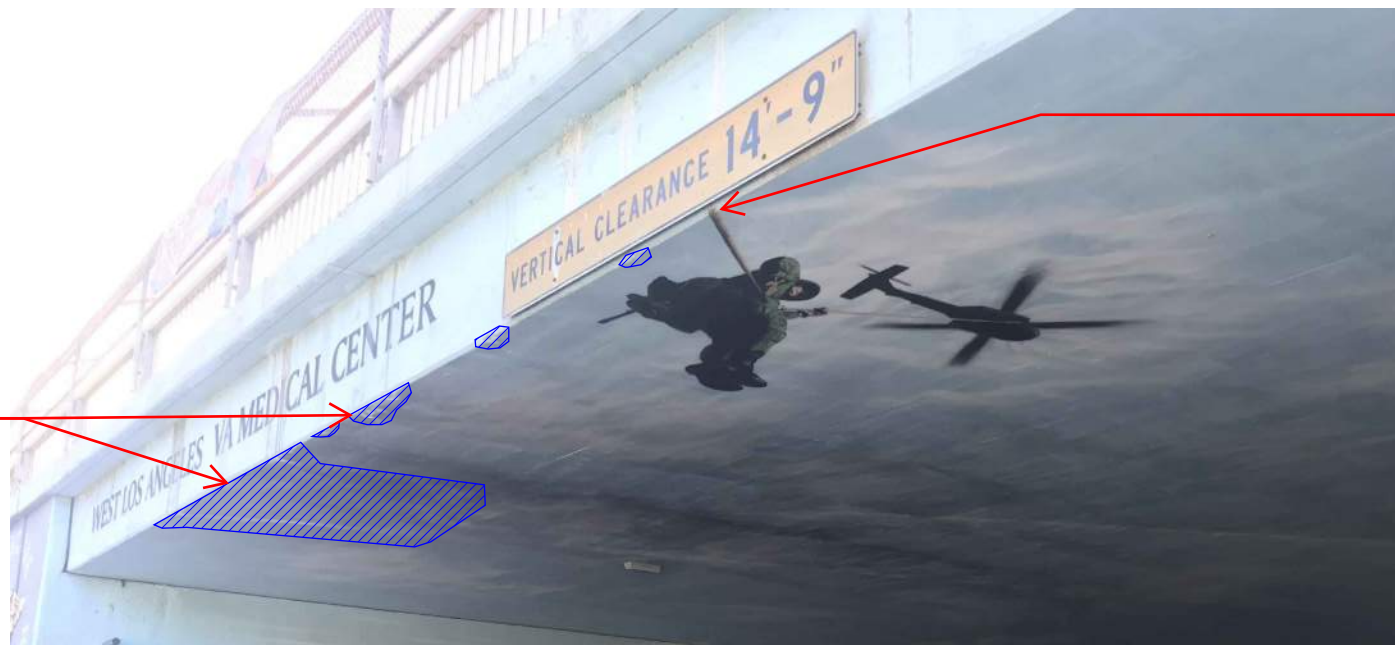
**1** UNDERPASS CEILING - VIEW SOUTH  
NOT TO SCALE

ABRASION DAMAGE & CHIPPED EDGES FROM HIGH VEHICLES

SIGN COVERS PORTION OF MURAL THAT WRAPS FRONT OF FASCIA

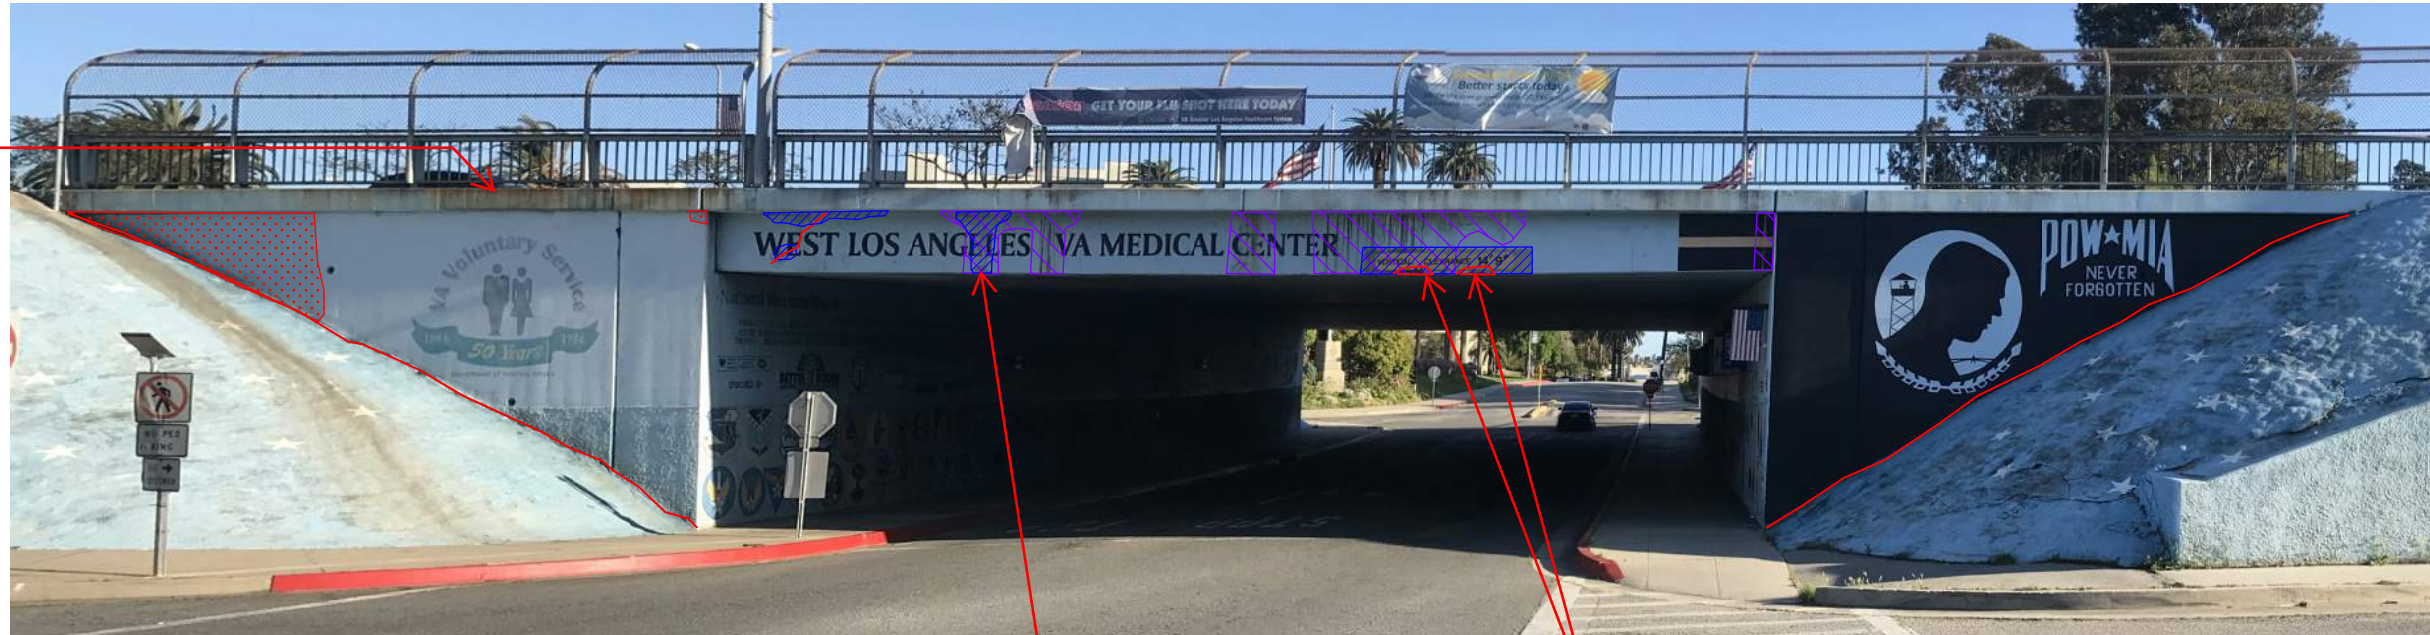
**1** WILSHIRE BLVD. BRIDGE - NORTH ELEV.  
NOT TO SCALE

RUST STAINS TYP. AT CURB

STAINS/EFFLORESCENCE, PAINT LOSS AT FASCIA

SPALLS AT CONC. EDGE; REINFORCEMENT EXPOSED AND CORRODED

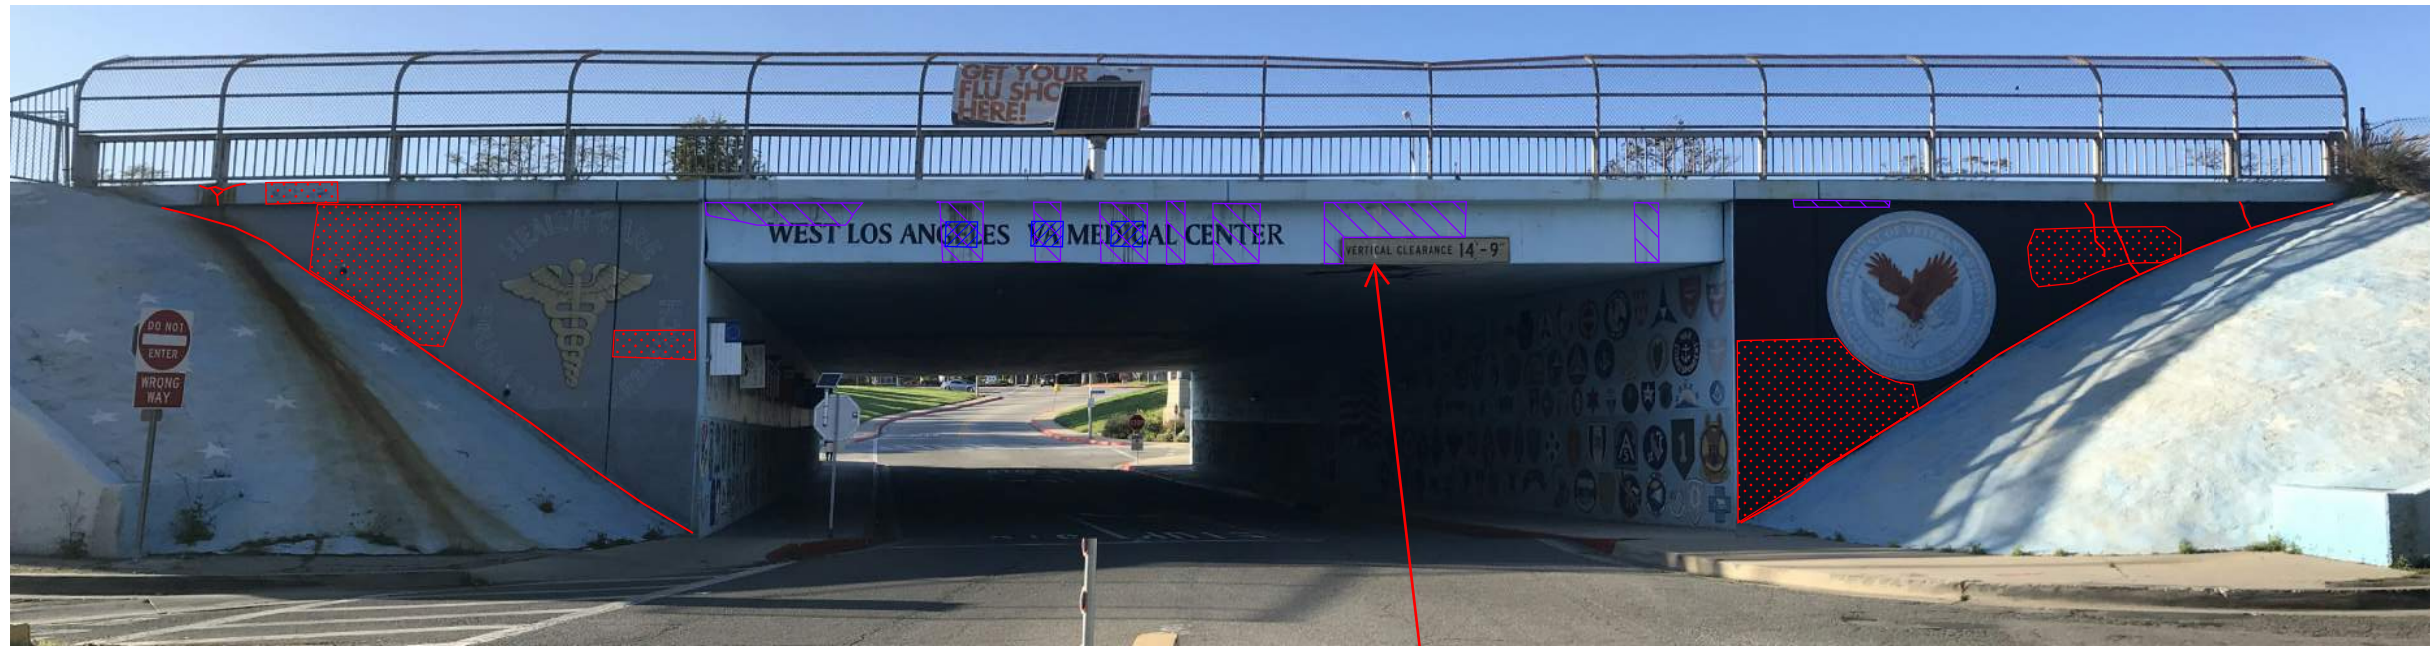
**2** WILSHIRE BLVD. BRIDGE - SOUTH ELEV.  
NOT TO SCALE

SIGN COVERS PORTION OF MURAL THAT WRAPS FRONT OF FASCIA

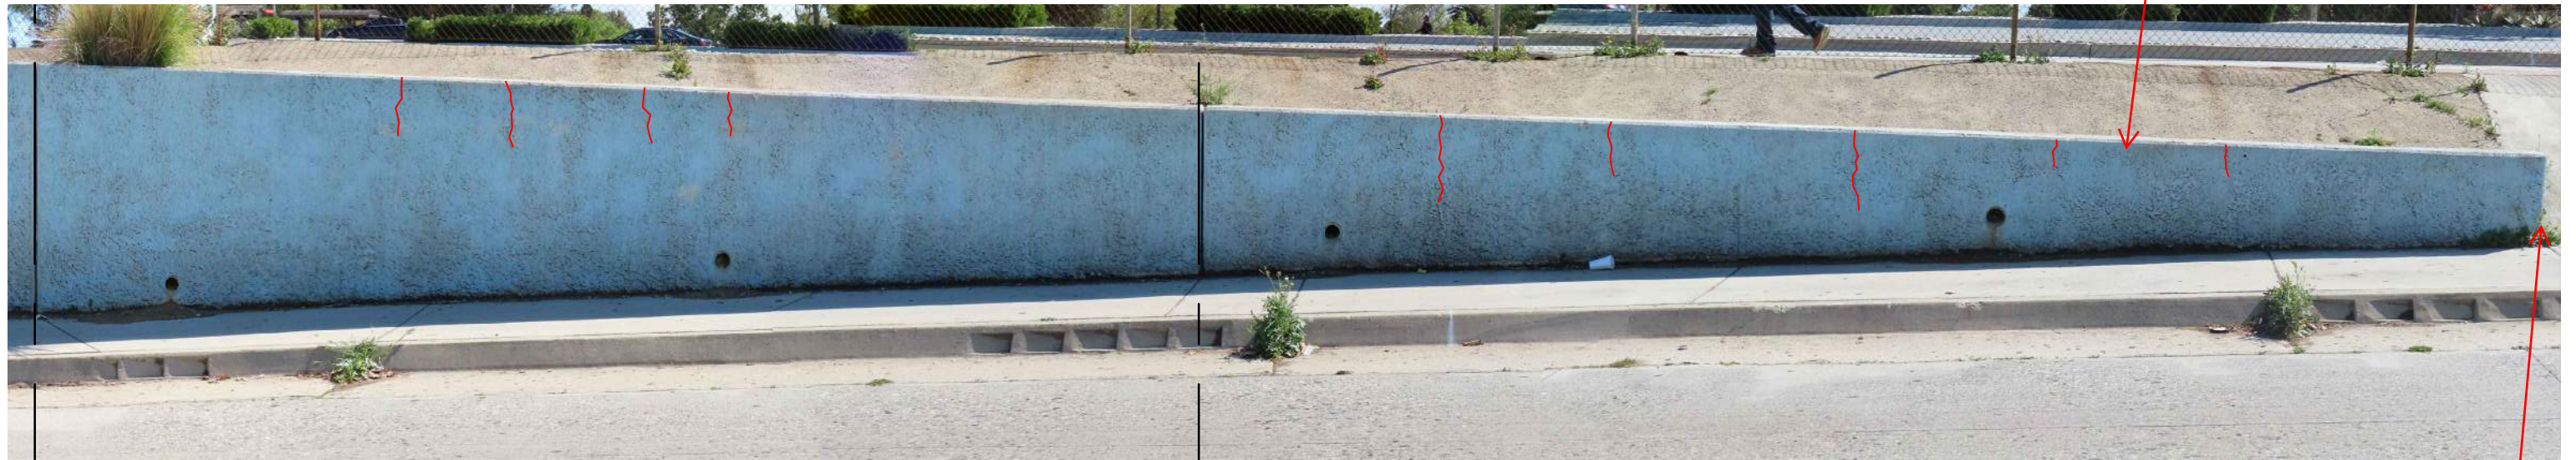
**2** WILSHIRE ON-RAMP SOUTH ELEV. (PANELS 7-8)  
NOT TO SCALE

CONC. FINISH SPALL AT END OF WALL

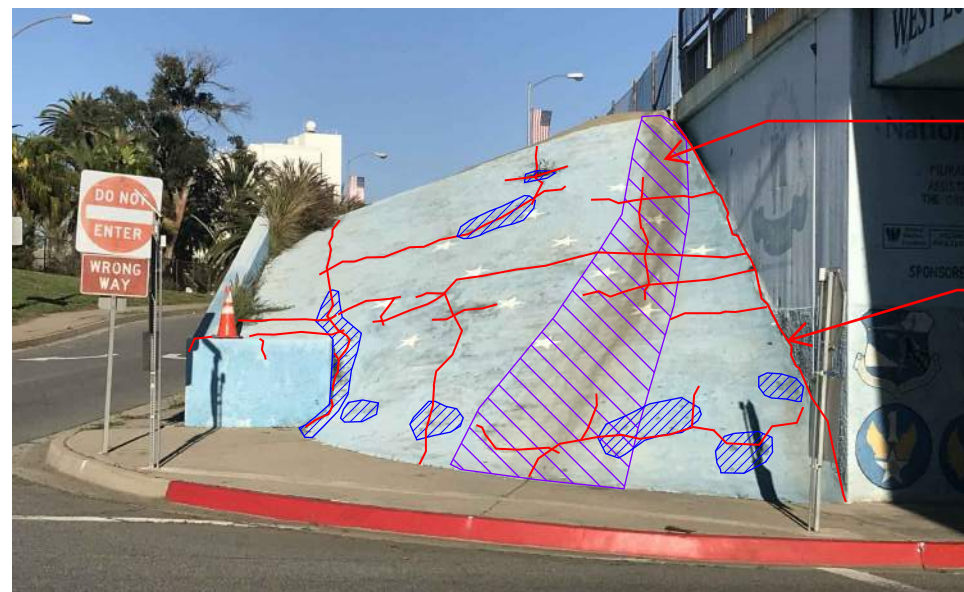
**2** NORTHEAST CORNER  
NOT TO SCALE

RUST STAINS  
CRACK AT WALL, TYP.

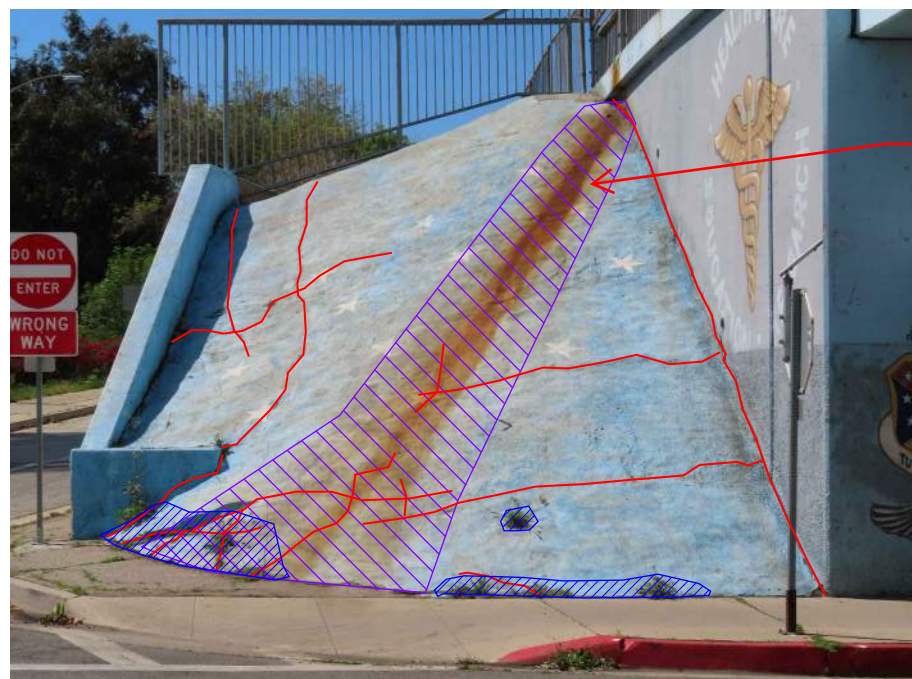
**3** SOUTHWEST CORNER  
NOT TO SCALE

RUST STAINS

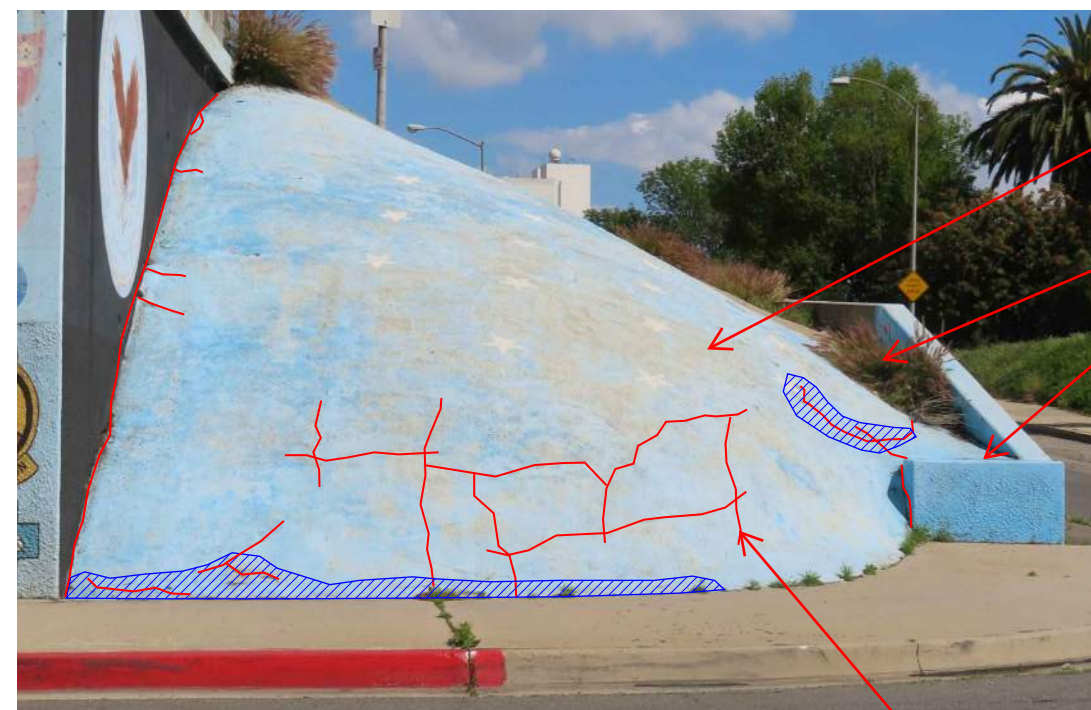
**4** SOUTHEAST CORNER  
NOT TO SCALE

PAINTED SURFACES HEAVILY ERODED/FADED, TYP.  
WEEDS, TYP. AT SLOPE EDGES & BASE  
STANDING WATER BEHIND WALL

WEB-LIKE CRACKING, TYP.
