**EFFECTS OF PROPOSED
TUNNELING OPERATIONS
ON BUILDINGS
B221 ALIGNMENT**

H.J. DEGENKOLB ASSOCS, ENGINEERS

January 15, 1991

Reference: **EFFECTS OF TUNNELING OPERATIONS ON BUILDINGS
B221 TUNNEL ALIGNMENT
[DEGENKOLB JOB NO. 85005]**

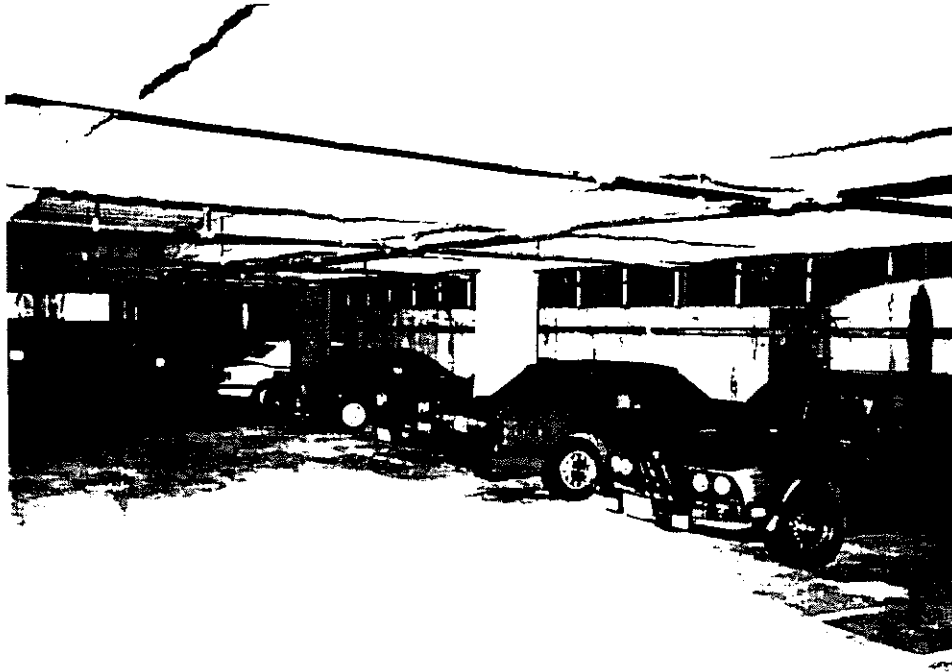
During our site visit, we discovered that the building appears to have a severe water infiltration problem through the exterior concrete walls in the two lowest parking levels, suggesting the presence of a significant amount of ground water. The walls are covered with efflorescence and appear to be generally in a poor state of repair. According to a building maintenance employee, the pump located in the sump described above operates almost continuously, even during summer months. The north basement wall in the lowest parking level and the sump are shown on Plate 2-3.

PARKING LEVEL 4
NORTH BASEMENT WALL ELEVATION
LOOKING TO NORTHWEST

Due to the deteriorated condition of the basement walls in the lower two parking levels, we recommend that a pre-construction survey of the property be performed to document the locations and sizes of wall cracks as well as any other existing conditions which might be later claimed as being caused by the tunneling work.

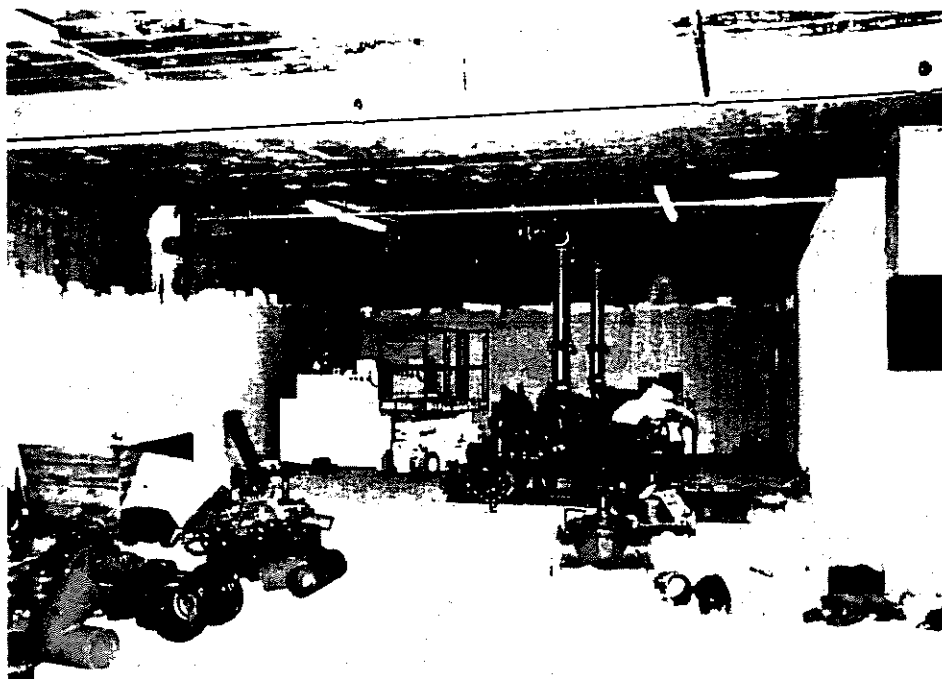
During our visit to the site we observed that new mechanical equipment was being installed in the fifth parking level in the southeast corner of the garage adjacent to the south wall as shown on Plate 8-3. This equipment is located adjacent to the portion of the basement wall expected to be most affected by the tunneling operations. We do not expect that the tunneling operations will have any direct impact on this equipment although the location of the equipment will complicate corrective measures should they be required.

SOUTHEAST CORNER OF BUILDING
LOOKING SOUTH BETWEEN GRID LINES 17.3 & 19

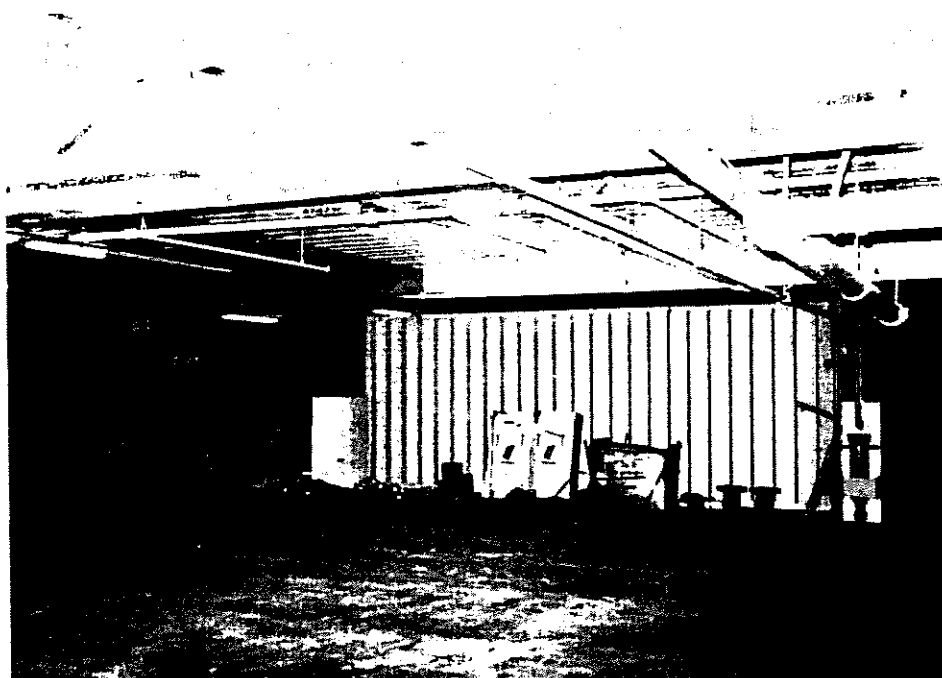
SOUTHEAST CORNER OF BUILDING
LOOKING SOUTH BETWEEN GRID LINES 15.5 & 17.3

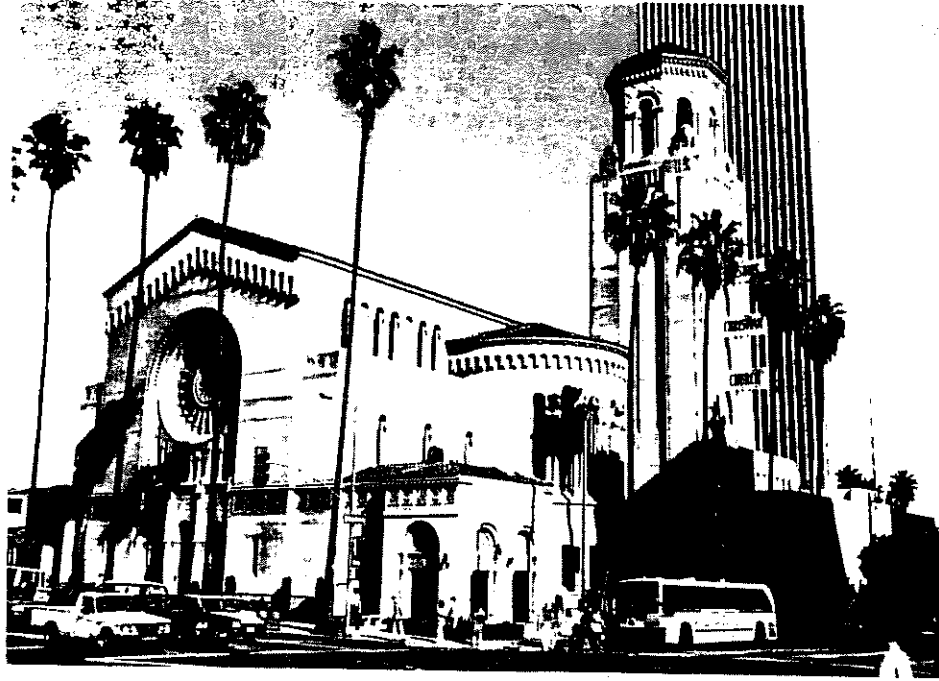
WILSHIRE
CHRISTIAN CHURCH
PLATE 10-1

During our site visits to the building, we observed concrete spalling and cracking at many locations on the structure. The deterioration appears to have resulted from inadequate concrete cover over the reinforcing steel which has led to rusting of the steel and spalling of concrete. We recommend that a comprehensive pre-construction survey of the building be performed to document these existing conditions.

The Wilshire Christian Church is not expected to experience significant damage as a result of the potential settlements due to the tunneling operations. Consequently, we recommend that no building protection measures be undertaken prior to tunneling. Any minor damage which may occur, such as cracking in the exterior walls and shifting of windows along Wilshire Boulevard, should be repaired after both tunnels have passed the building.
