METRO RED LINE, SEGMENT 2, CONTRACT B251

Investigation of Tunnel Collapse and Sinkhole

Wiss, Janney, Elstner Associates, Inc.

FINAL REPORT

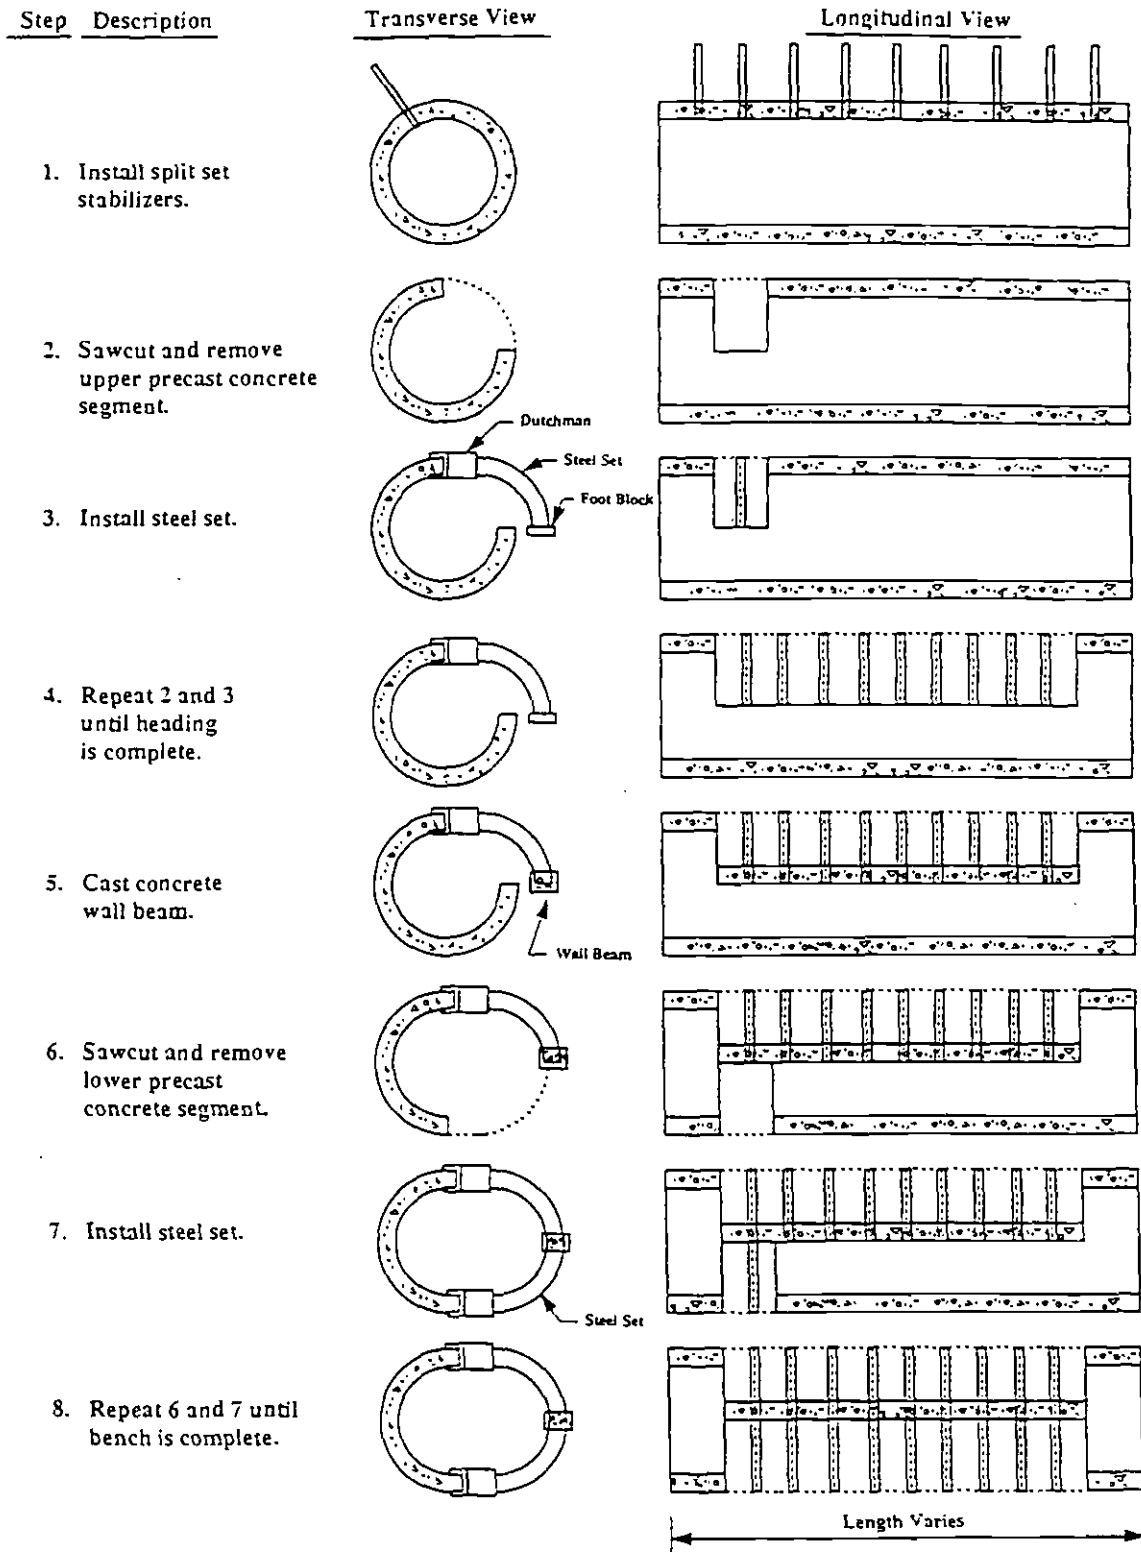
Fig. 3.1 Remining and Resupport Operations

No calculations were available for review by WJE which evaluated either the bearing capacity of the concrete wall beam or the bearing capacity of the foot blocks before the concrete beam was placed, steps 3 through 6 in Fig. 3.1. These temporary conditions were not considered in the calculations

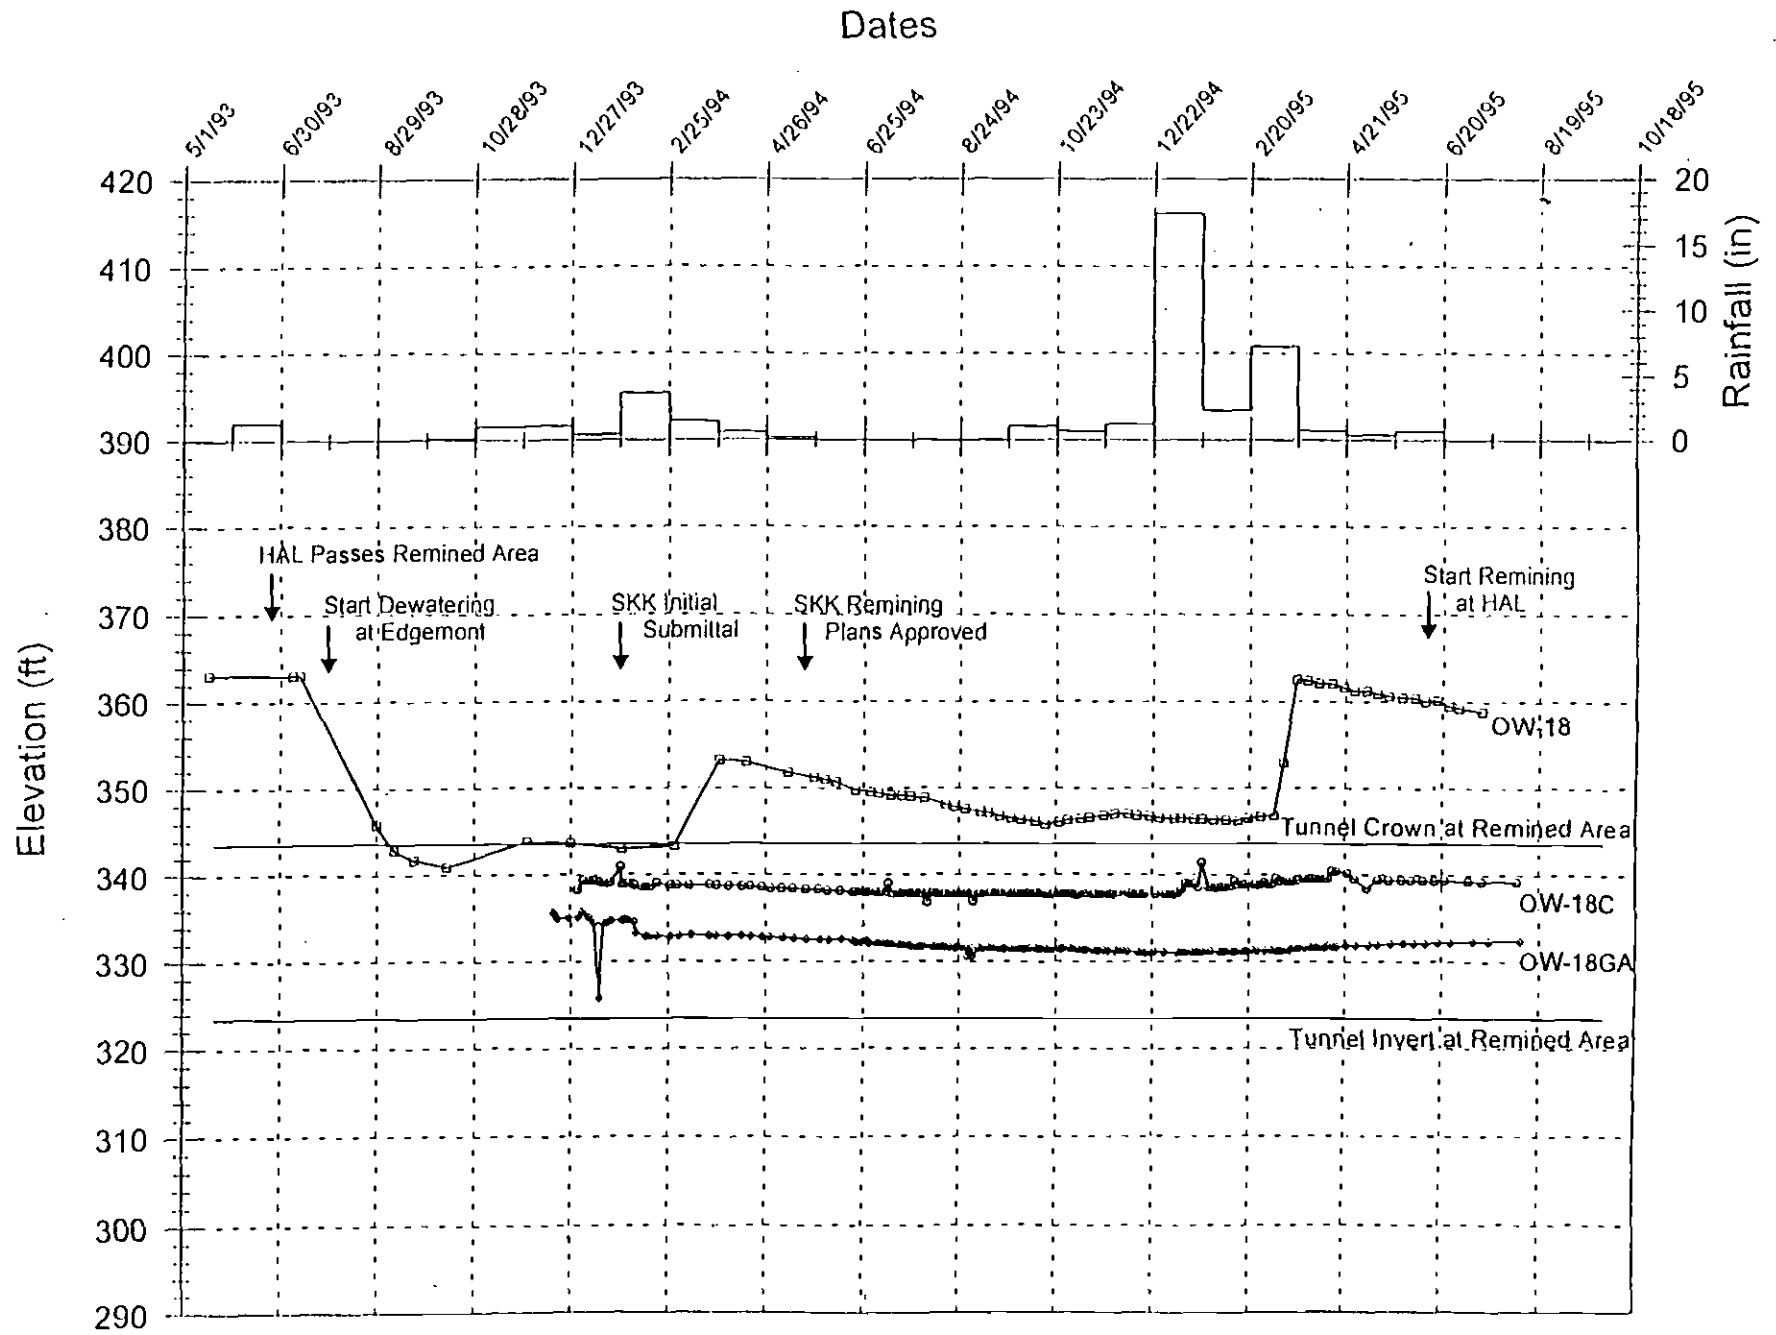
Fig. 3.3 Ground Water Levels Near HAL Remined Area

The temporal variations of groundwater levels near the HAL remined area are shown in Fig. 3.3. Data from observation wells OW-18, 18C and 18GA are presented. Also shown are the rainfall data recorded at the Hollywood Dam rain gage by the Los Angeles Department of Water and Power (LADWP). The OW-18 water levels show significant variations over time. After the water levels had dropped from the effects of the dewatering system at Edgemont Street, two episodes of rapid groundwater rise and subsequent gradual fall were observed. The other wells show no such variations. The two rapid rises in OW-18 lag behind the peak rainfall in both 1994 and 1995 by about 45 days. Barnsdall Park is the topographic high in the area. As noted in the GRV/S Report (1990), Barnsdall Park is the recharge area for the local ground water which tends to flow away from this area along the alluvium and Puente formation interface. OW-18 is screened throughout its entire depth and is therefore hydraulically connected to the alluvium. These water level changes are thus in response to recharge from precipitation. The other wells shown are all screened at greater depths and thus apparently are not hydraulically connected to the alluvium, or are screened in clay soils within the alluvium.

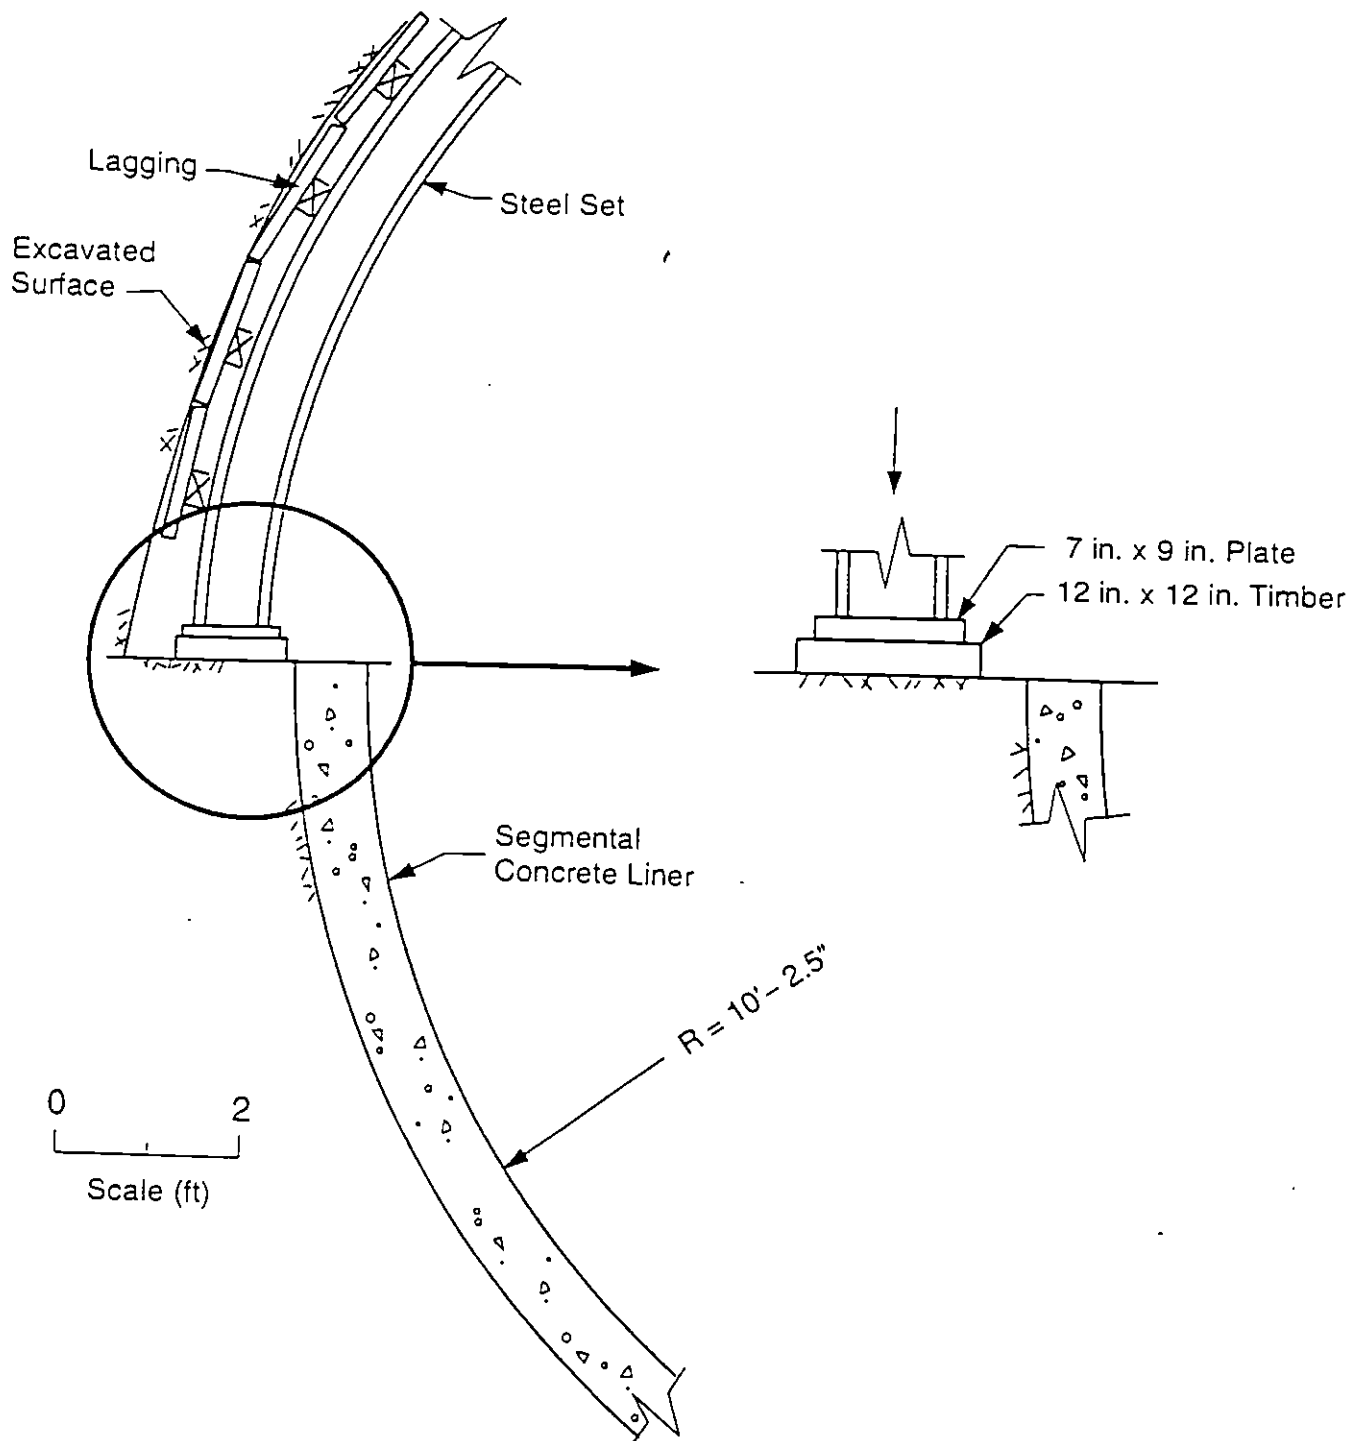
Fig. 5.1 Typical Foot Block For Steel Sets

Evaluating the bearing capacity of the earth on which a foot block rests is a standard step in design of rib linings. Safe support of the foot blocks is essential during the heading operation. The results of the bearing capacity calculations indicate the ultimate load which each steel set can support varies from 9 to 23 kips, about equal to the load expected from seepage forces and nominal earth load, and much less than the 307 kip load corresponding to 60 ft of overburden pressure. The design of the resupport system was deficient in that the bearing capacity of the foot blocks apparently was never considered. While it is unrealistic to require the foot blocks to carry 60 ft of overburden pressure, it is also unrealistic to *design* the foot blocks without provisions for earth loading.

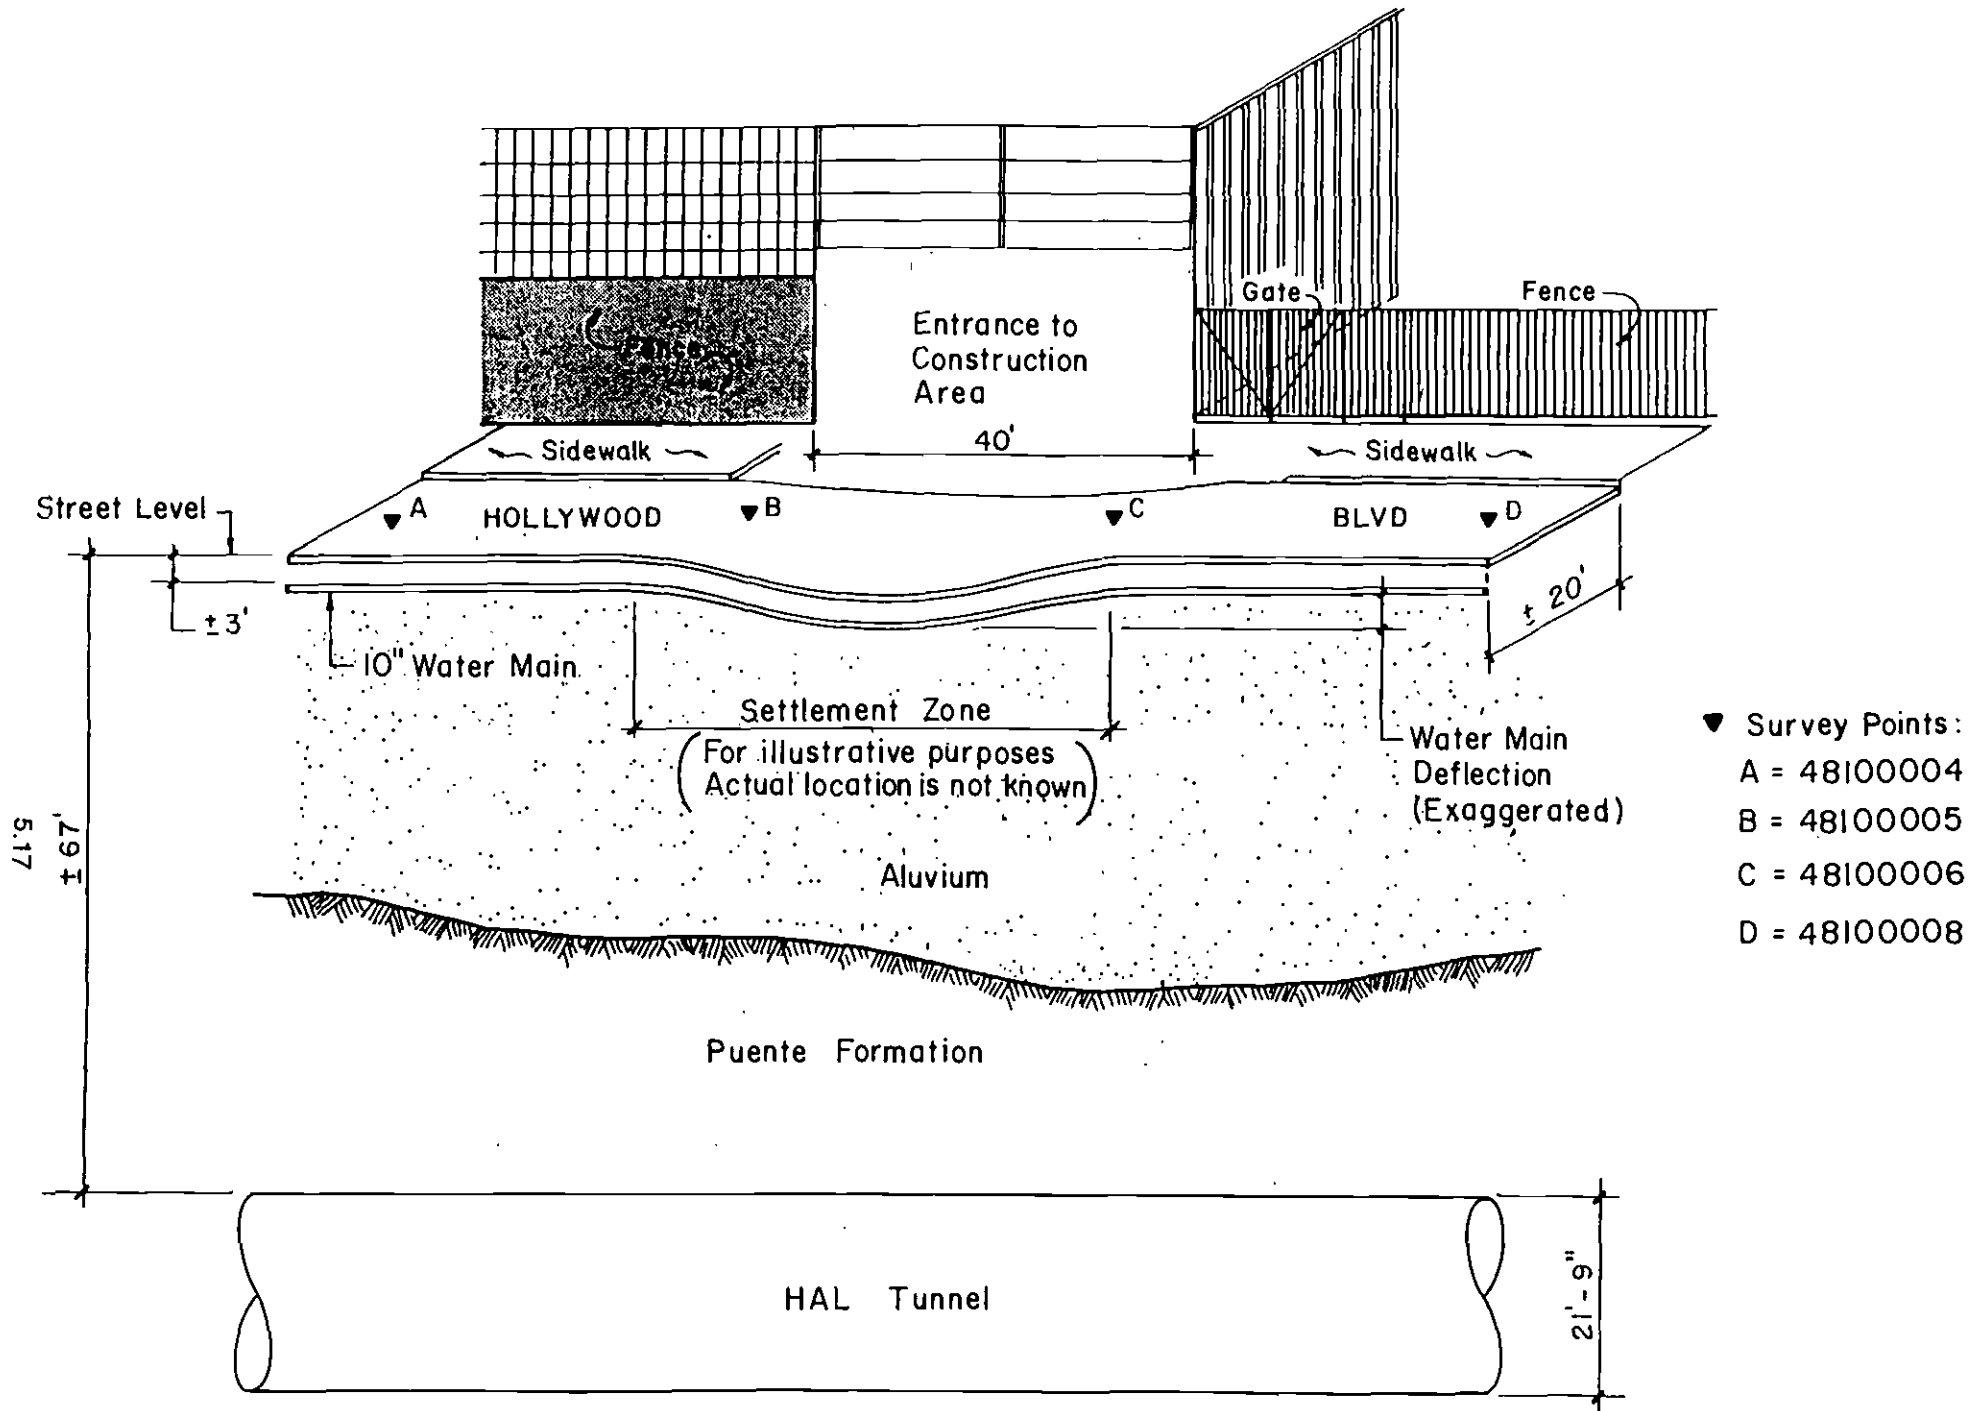
Fig. 5.4 - Illustration of water main settlement above remined area

resulted in settlements at the ground surface. The surface settlement induces stress in the water main, eventually causing the pipe to rupture. The water main probably broke before the collapse of the tunnel supports since the collapse reportedly occurred at 6:10 a.m. and the LADWP records indicate the water main ruptured 10 minutes earlier. Apparently, the sudden influx of water at a rate of about 14 cfs directly lead to the first collapse at 6:10 and development of the sinkhole at 6:15. Water and earth from this first collapse flowed about 260 ft west into the HAR tunnel. Had the water main been shut off before it ruptured, damage may have been limited to large ground movements in the tunnel and resulting surface subsidence.

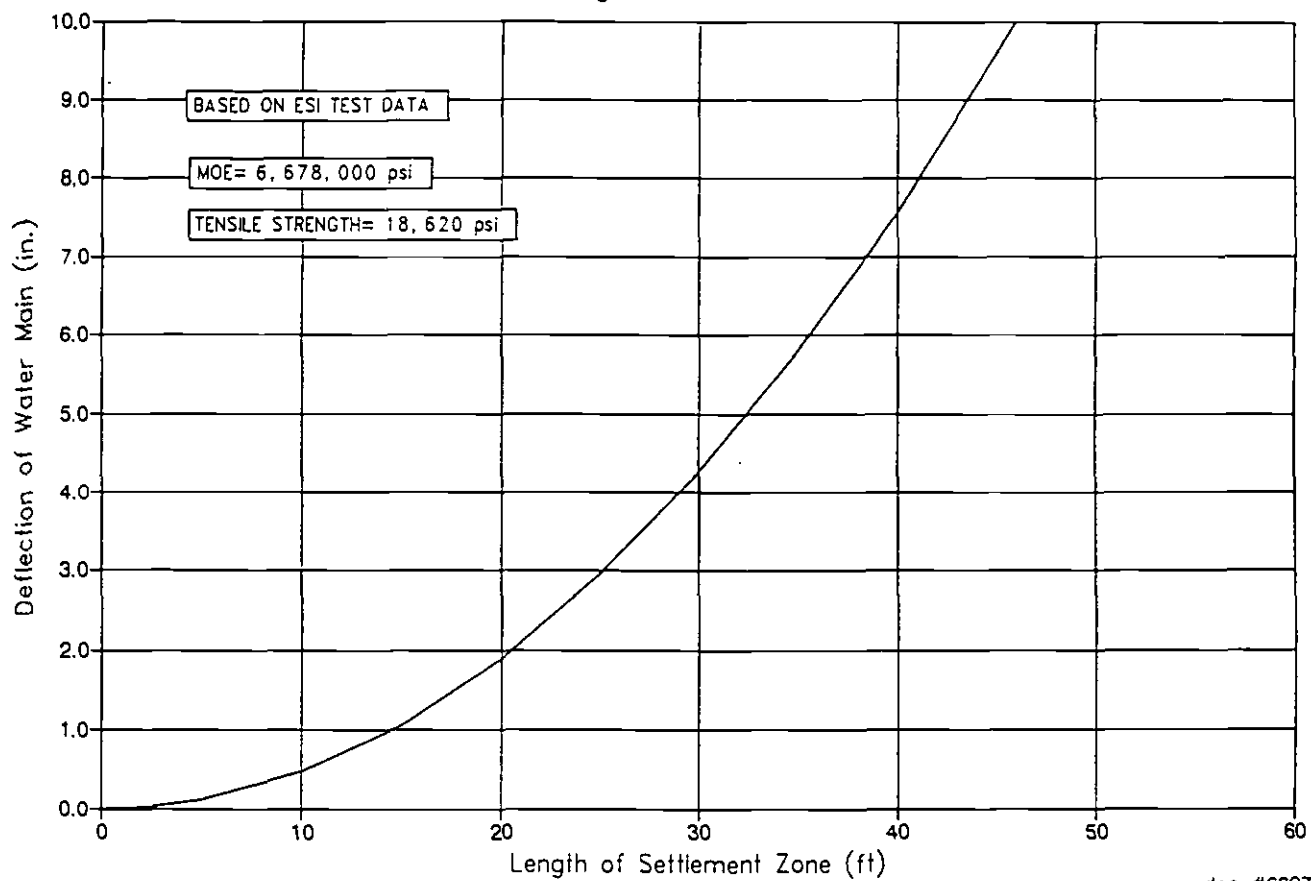
Fig. 5.5 - Critical water main deflection vs length of settlement zone

indicates the length of the settlement zone corresponding to rupture in the pipe is about 32 ft. If the prior 1.5 in. settlement is added, the length of the settlement zone corresponding to rupture of the water main is about 37 ft. These lengths are somewhat less than the size of the original sinkhole, but rupture of the water main due to larger ground movements in the tunnel is conceivable. Therefore, this analysis does not rule out the chronology indicated by site observations and LADWP records; that is, the water main ruptured before the tunnel completely collapsed.
