**U N I O N S T A T I O N
L O S A N G E L E S**

**INITIAL STUDY
FOR
REHABILITATION
AND
REUSE**

SURVEY OF CONDITIONS

**PREPARED FOR CATELLUS DEVELOPMENT CORPORATION
HARDY HOLZMAN PFEIFFER ASSOCIATES
AUGUST 1991**

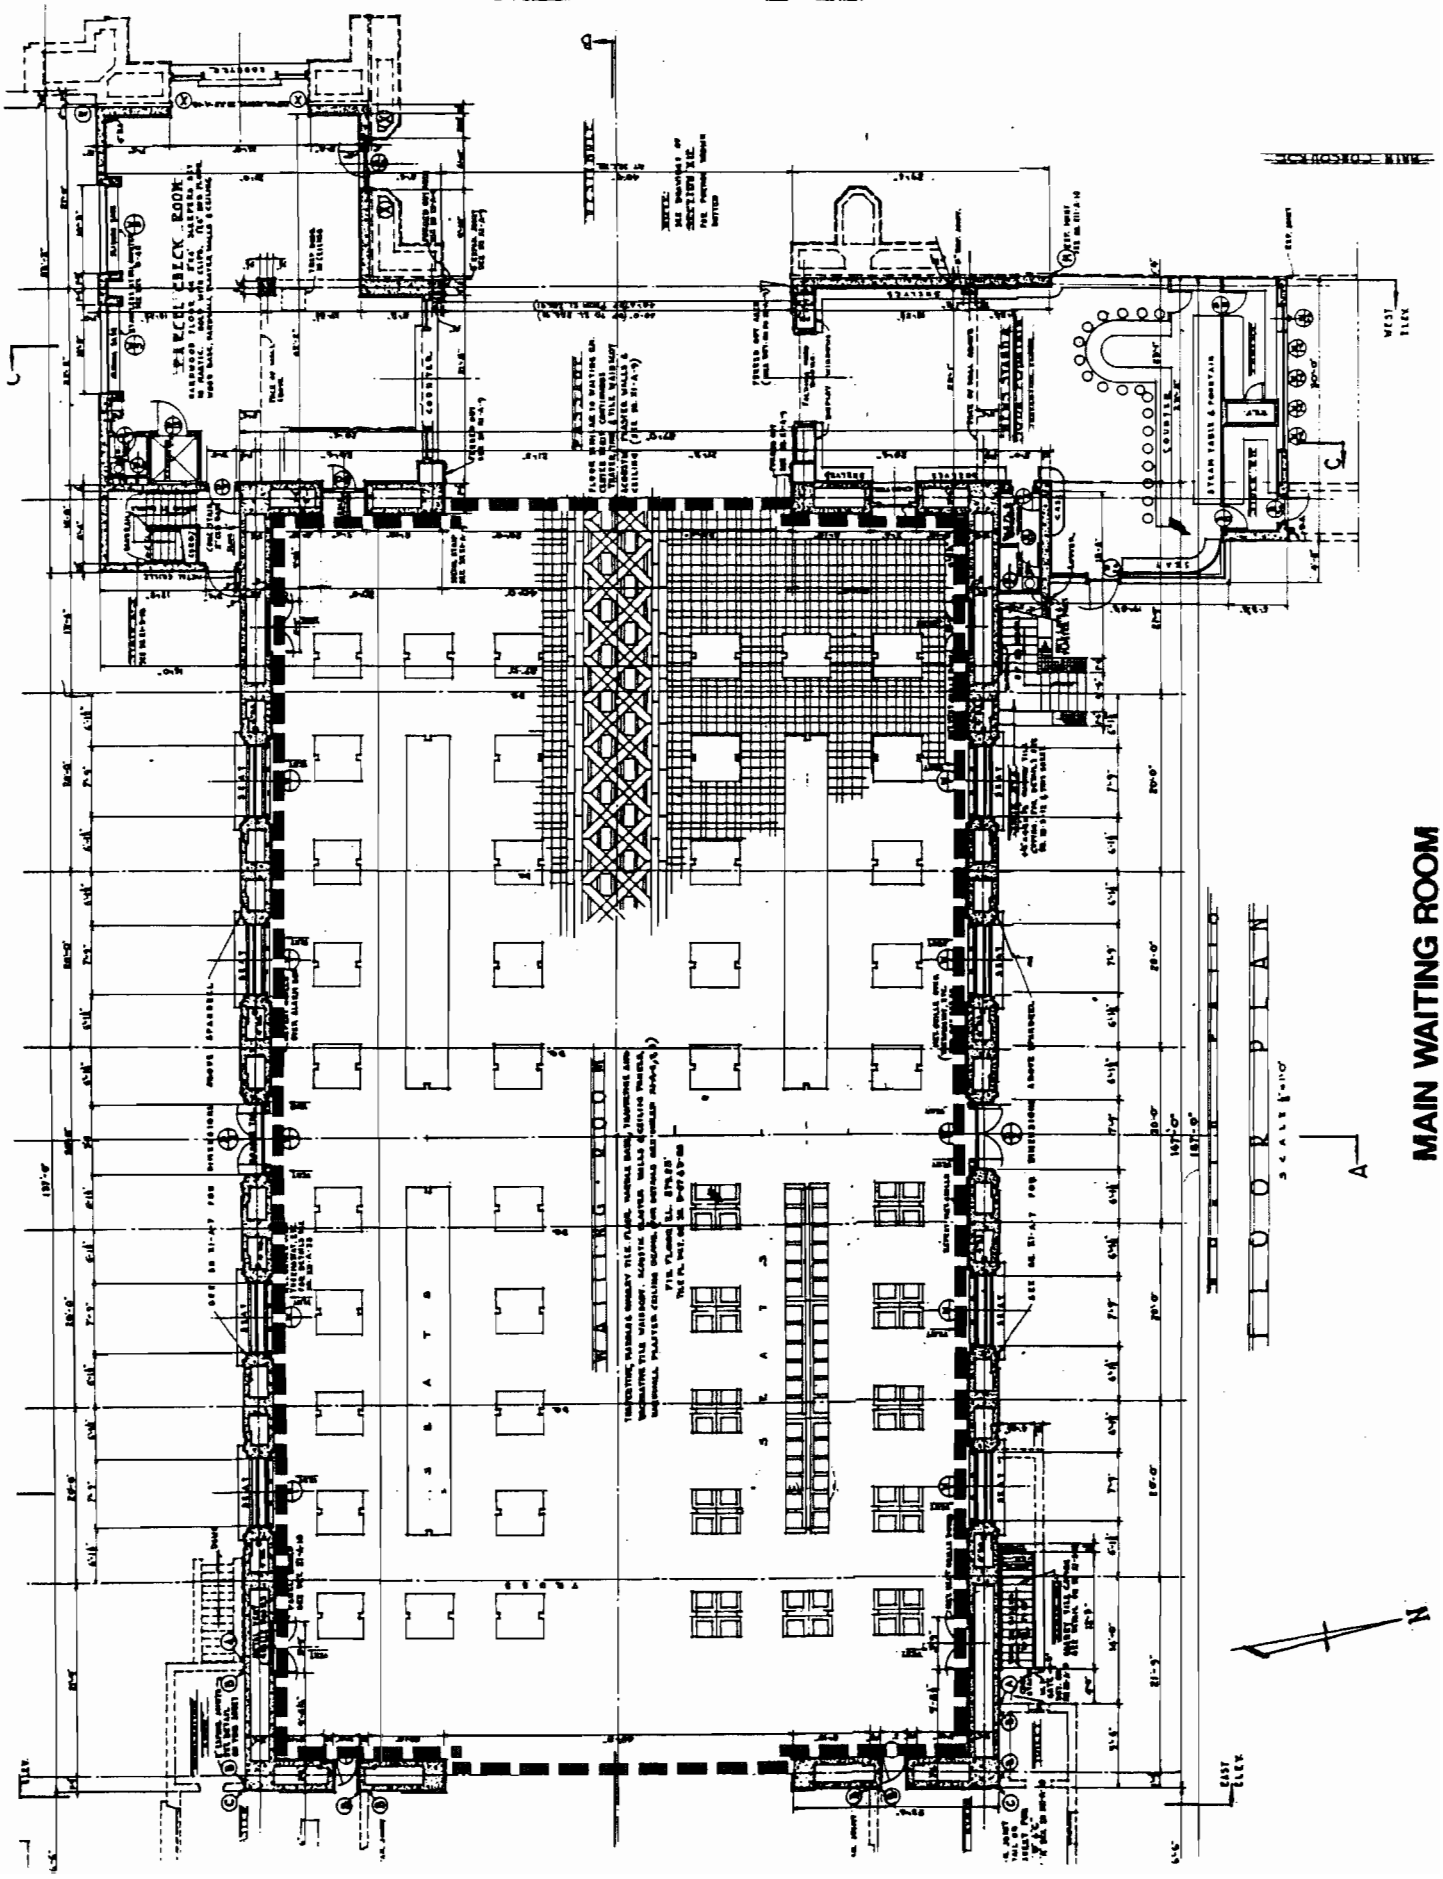
MAIN WAITING ROOM

3. CURRENT USE - Main Waiting Room
4. ORIGINAL USE - Main Waiting Room
5. CONDITIONS - The wooden panels in the northwest corner of the room, (surrounding McCarthy's Cafe seating) were added at a later date. The panelling does not appear in historic photographs.

The acoustic panels on the upper walls are dirty, especially the west wall. Stencilled ceiling panels are dim and yellowed. The wooden seats are worn and scarred and the original leather was replaced with brown Naugahyde. Many of the covers are torn and worn out. Mortar between the floor tiles is worn unevenly. Many glass panes are missing from chandeliers. Ornamental speakers require cleaning.

19. RECOMMENDATIONS FOR HISTORIC UPGRADE - Venetian blinds need cleaning and replacement with screens or motorized blinds. Upper wall panels on the east wall need cleaning and repair. On the west wall two unused speaker holders require removal and the spray paint requires removal. Bulbs in chandeliers need replacement and fixtures require cleaning and upgrade. Remove inconsistent elements: soda machines, photo booths and non-historic wood partitions. Repair, refinish and recover wooden seats. Reconfigure wooden seats to original plan. Remove trash bins and replace with bins similar to historic. Limit access of motorized carts to exterior areas only, in order to prevent further damage to the ceramic tile wainscot, wood seats and marble floors.

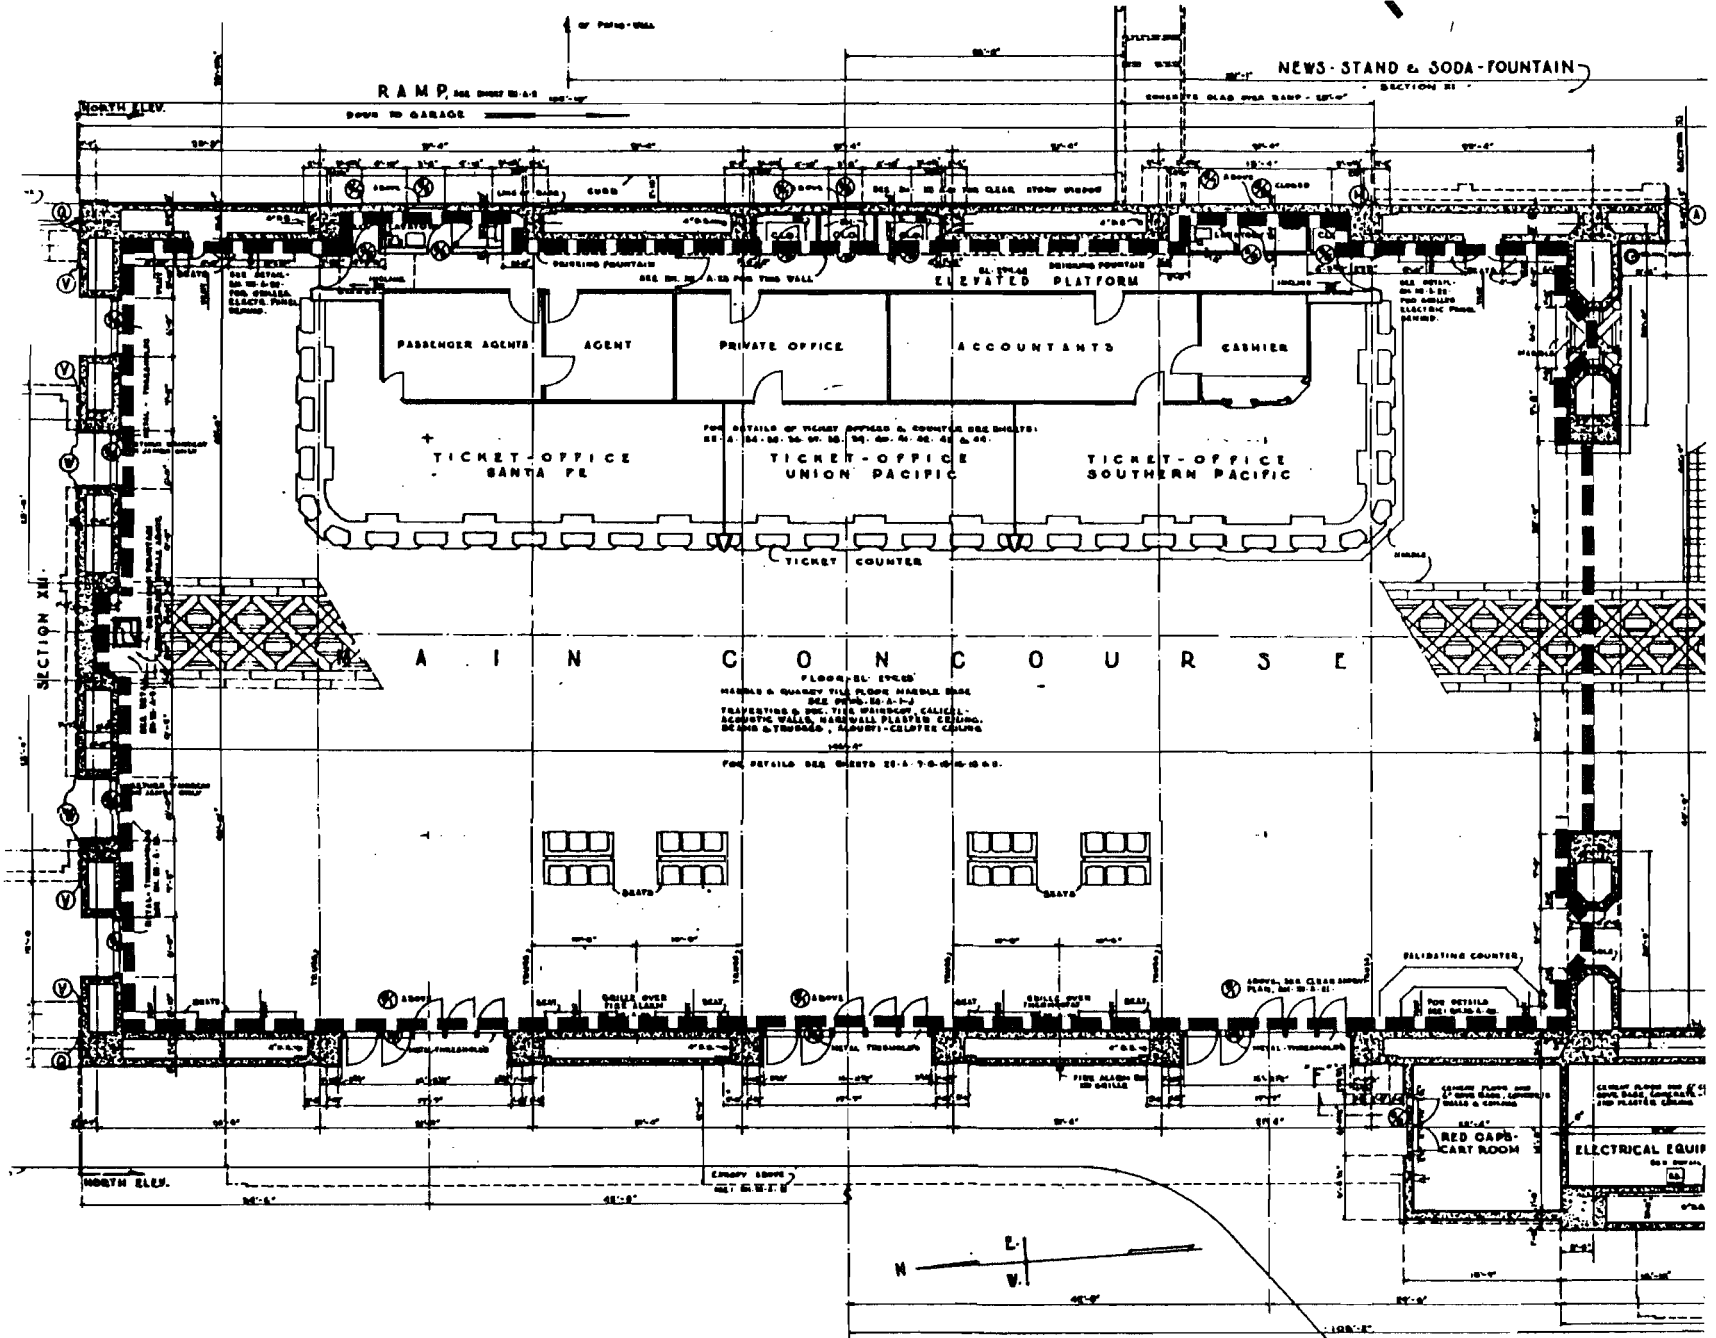
MAIN CONCOURSE

4. ORIGINAL USE - Ticket counter and waiting area.
5. CONDITIONS - Floors and tile walls remain in good condition but require cleaning. The wood on the ticket counter appears worn and dry. The truss beams are stained with pigeon droppings and the stencils appear dark and faded. The Venetian blinds are in disrepair. Many window panes have been replaced with mismatched panes which appear yellow. The rooms behind the ticket booths are in disrepair. The mortar between the floor tiles is blackened and worn unevenly. The acoustic panels are blackened and damaged.

19. RECOMMENDATIONS FOR HISTORIC UPGRADE - Research historic signage and repair and replace missing signs. Restore and replace wood seats. Clean and match, glass window panes, replace broken Venetian blinds with motorized blinds or screens. Clean and repair brass doors. Clean ceramic tile. Repair and refinish ticket counters for adaptive reuse. Upgrade lighting levels, clean and repaint trusses. Clean ceiling. Research original trash receptacles and replace existing with style similar to original.

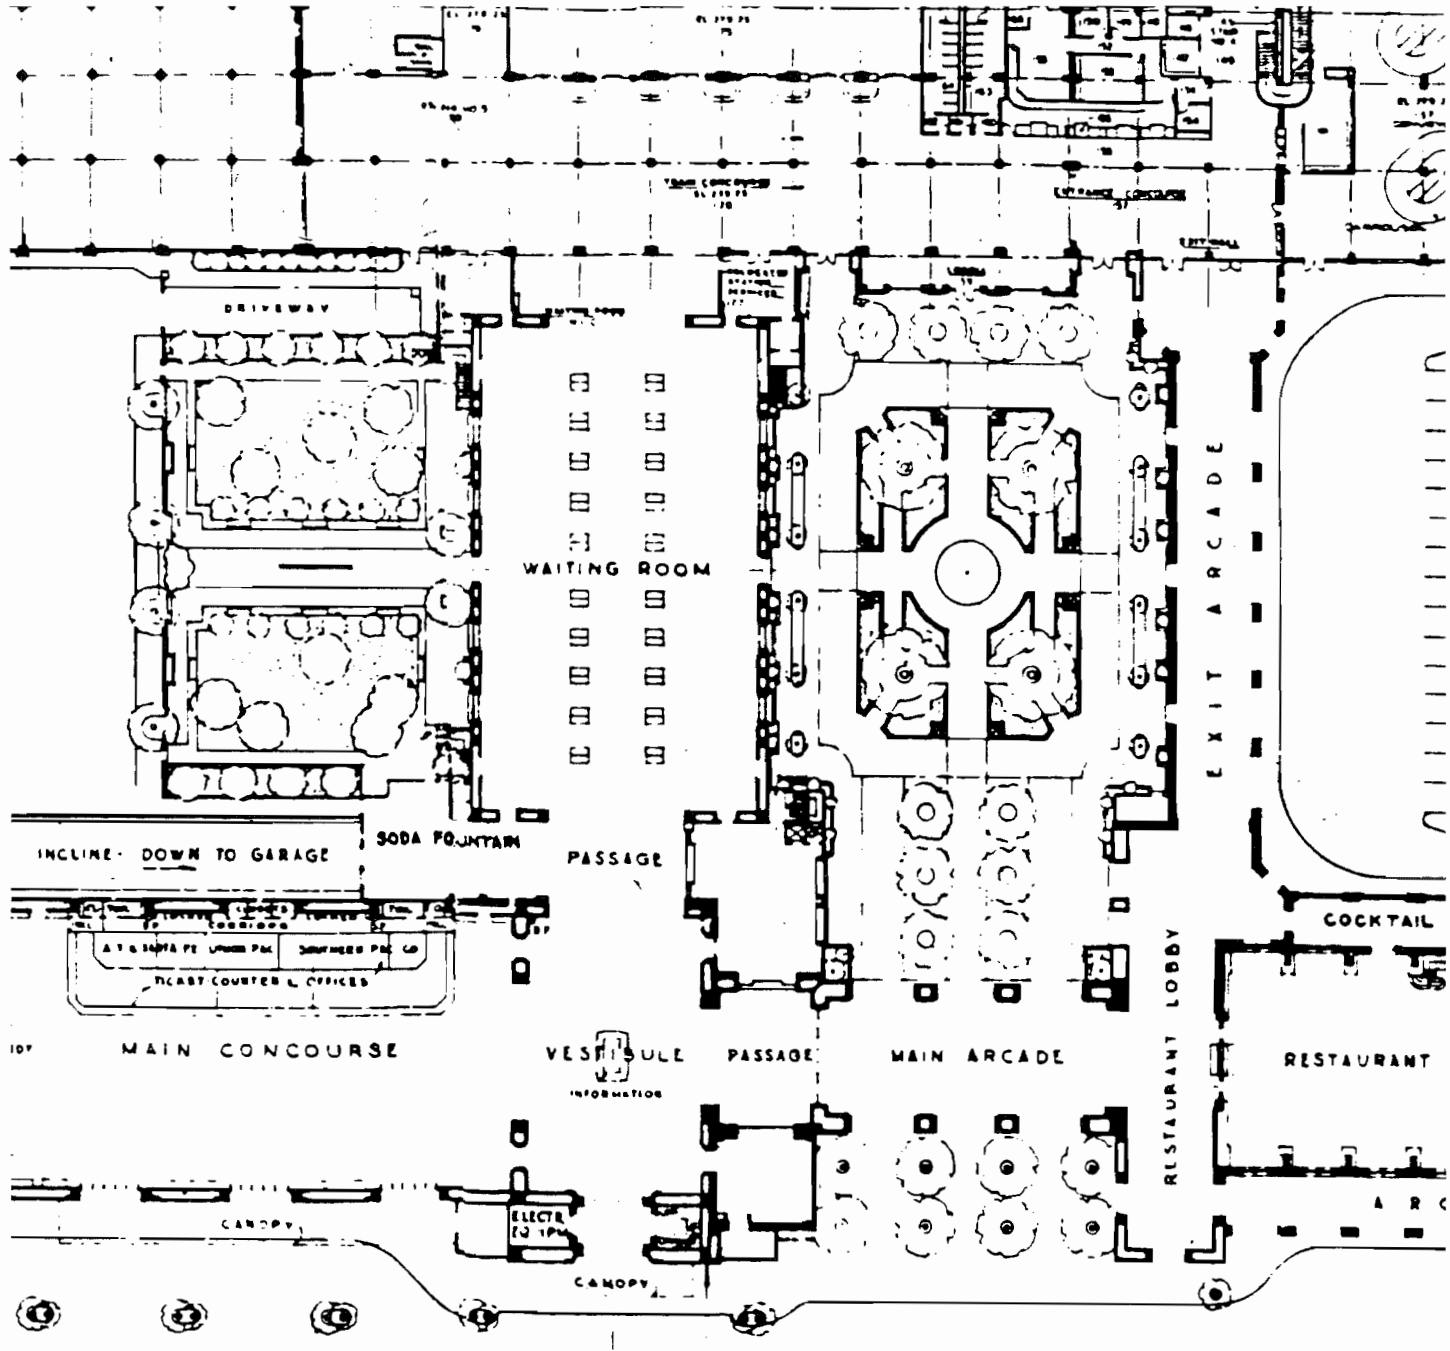
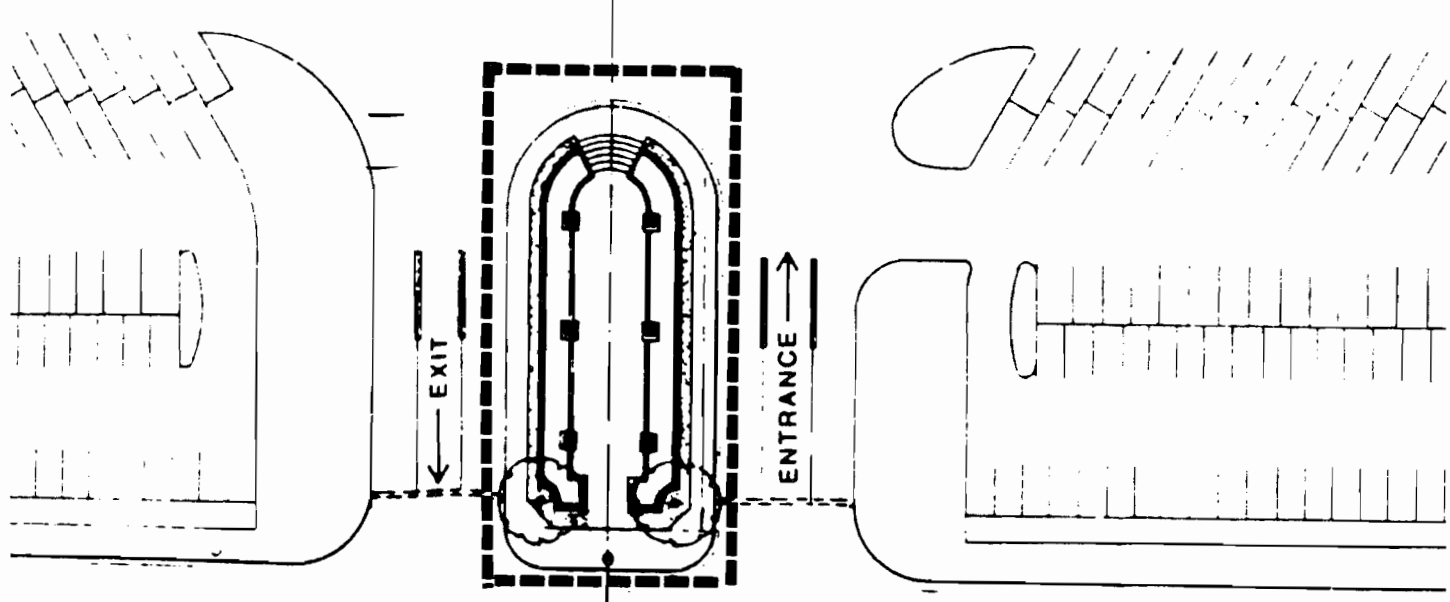
FORE COURT

4. ORIGINAL USE - Forecourt.
5. CONDITIONS - Landscaping is well maintained.
6. LIGHTING - Six light pedestals provide nighttime lighting.
7. LANDSCAPE ELEMENTS - Light pedestals, paving pattern, sundial, low walls around planting areas.

13. INCONSISTENT ELEMENTS - Not applicable.
14. AREAS FOR RESEARCH/TESTING - Research original landscaping intentions.
15. FUTURE USES - Undetermined.
16. RECOMMENDATIONS FOR HISTORIC UPGRADE - Match or use landscaping similar to original.

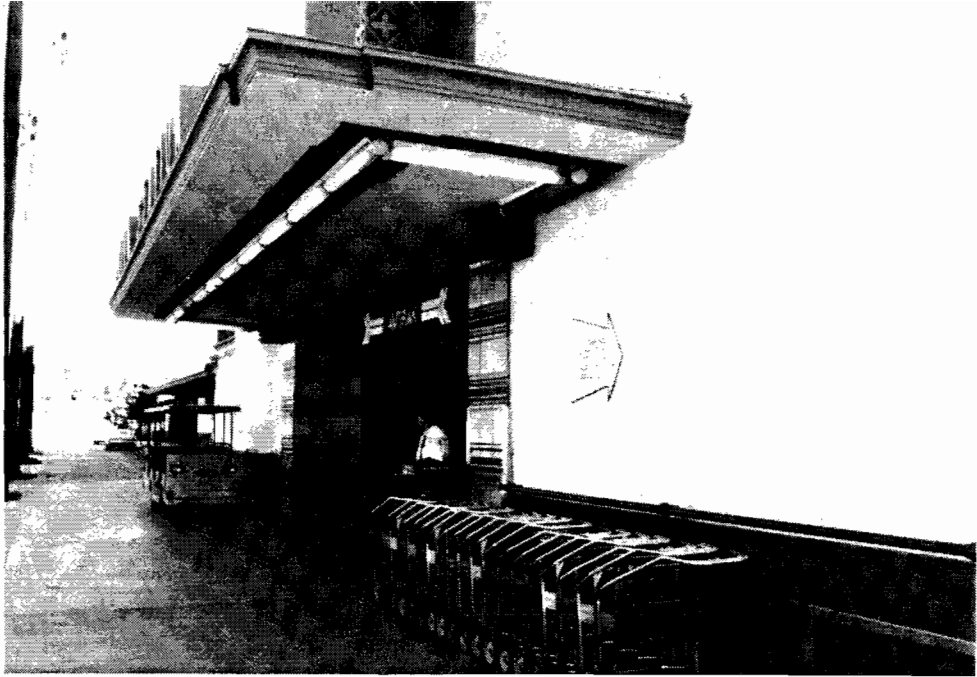
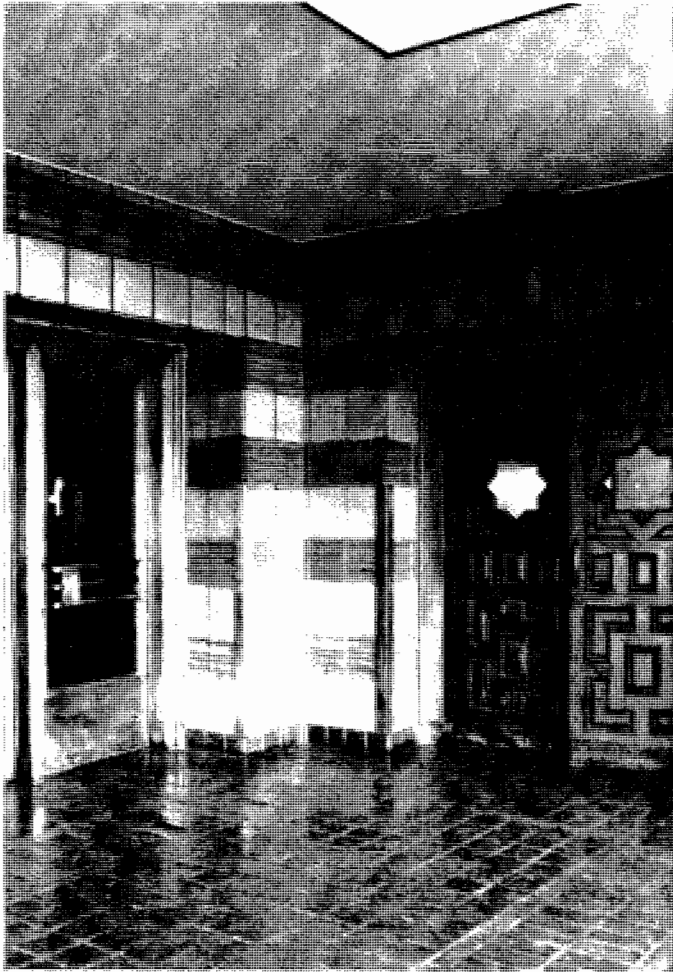
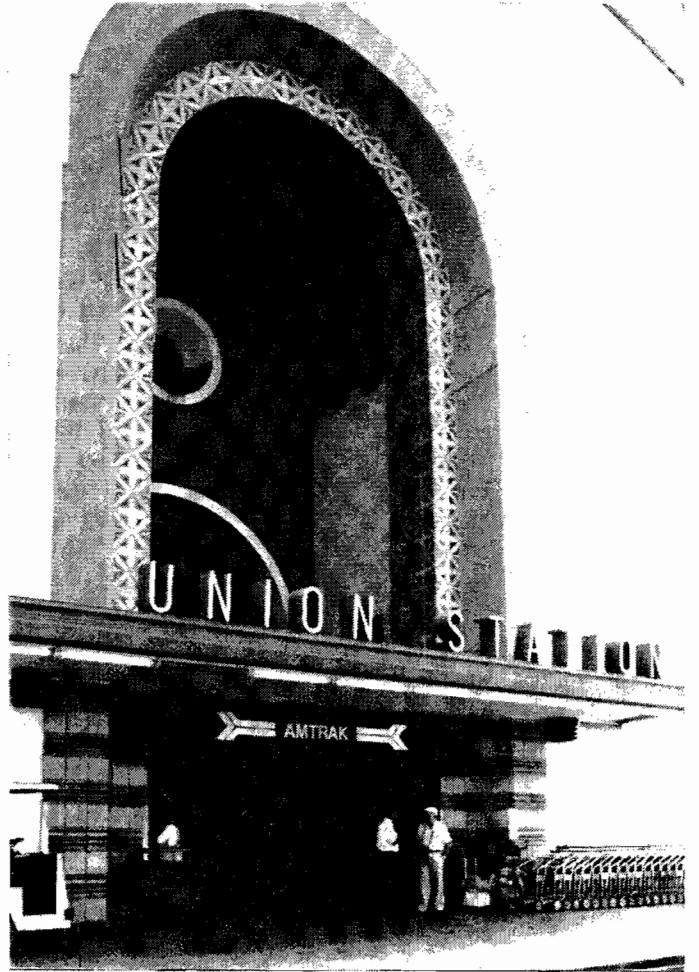
ENTRANCE VESTIB

3. CURRENT USE - Entrance vestibule.
4. ORIGINAL USE - Entrance vestibule.
5. CONDITIONS - The light fixtures need cleaning and upgrading. The oculus is very dirty. Walls need cleaning and repainting. The wood doors are scarred. Tiles at the entryway are chipped and broken. Ceramic tiles are dirty.

15. FUTURE USES - Undetermined.
16. RECOMMENDATIONS FOR HISTORIC UPGRADE - Clean and repaint as required. Remove trash bins and replace with bins similar to historic type. Relocate baggage cart dispenser. Prohibit parking of motorized carts and front entrance. Match and repair masonry on entrance walls. Repair the front doors.

- 1) Jasco paint and epoxy remover to remove the lacquer.
 - 2) Oxalic acid and pumice.
 - 3) Wash.
 - 4) Highlighting with dry buffing.
 - 5) 4-5 coats of lacquer.

The doors will also be squared and repaired.
18. IMPACT ON OPERATIONS - Pedestrian traffic is directed through doors in the main concourse.

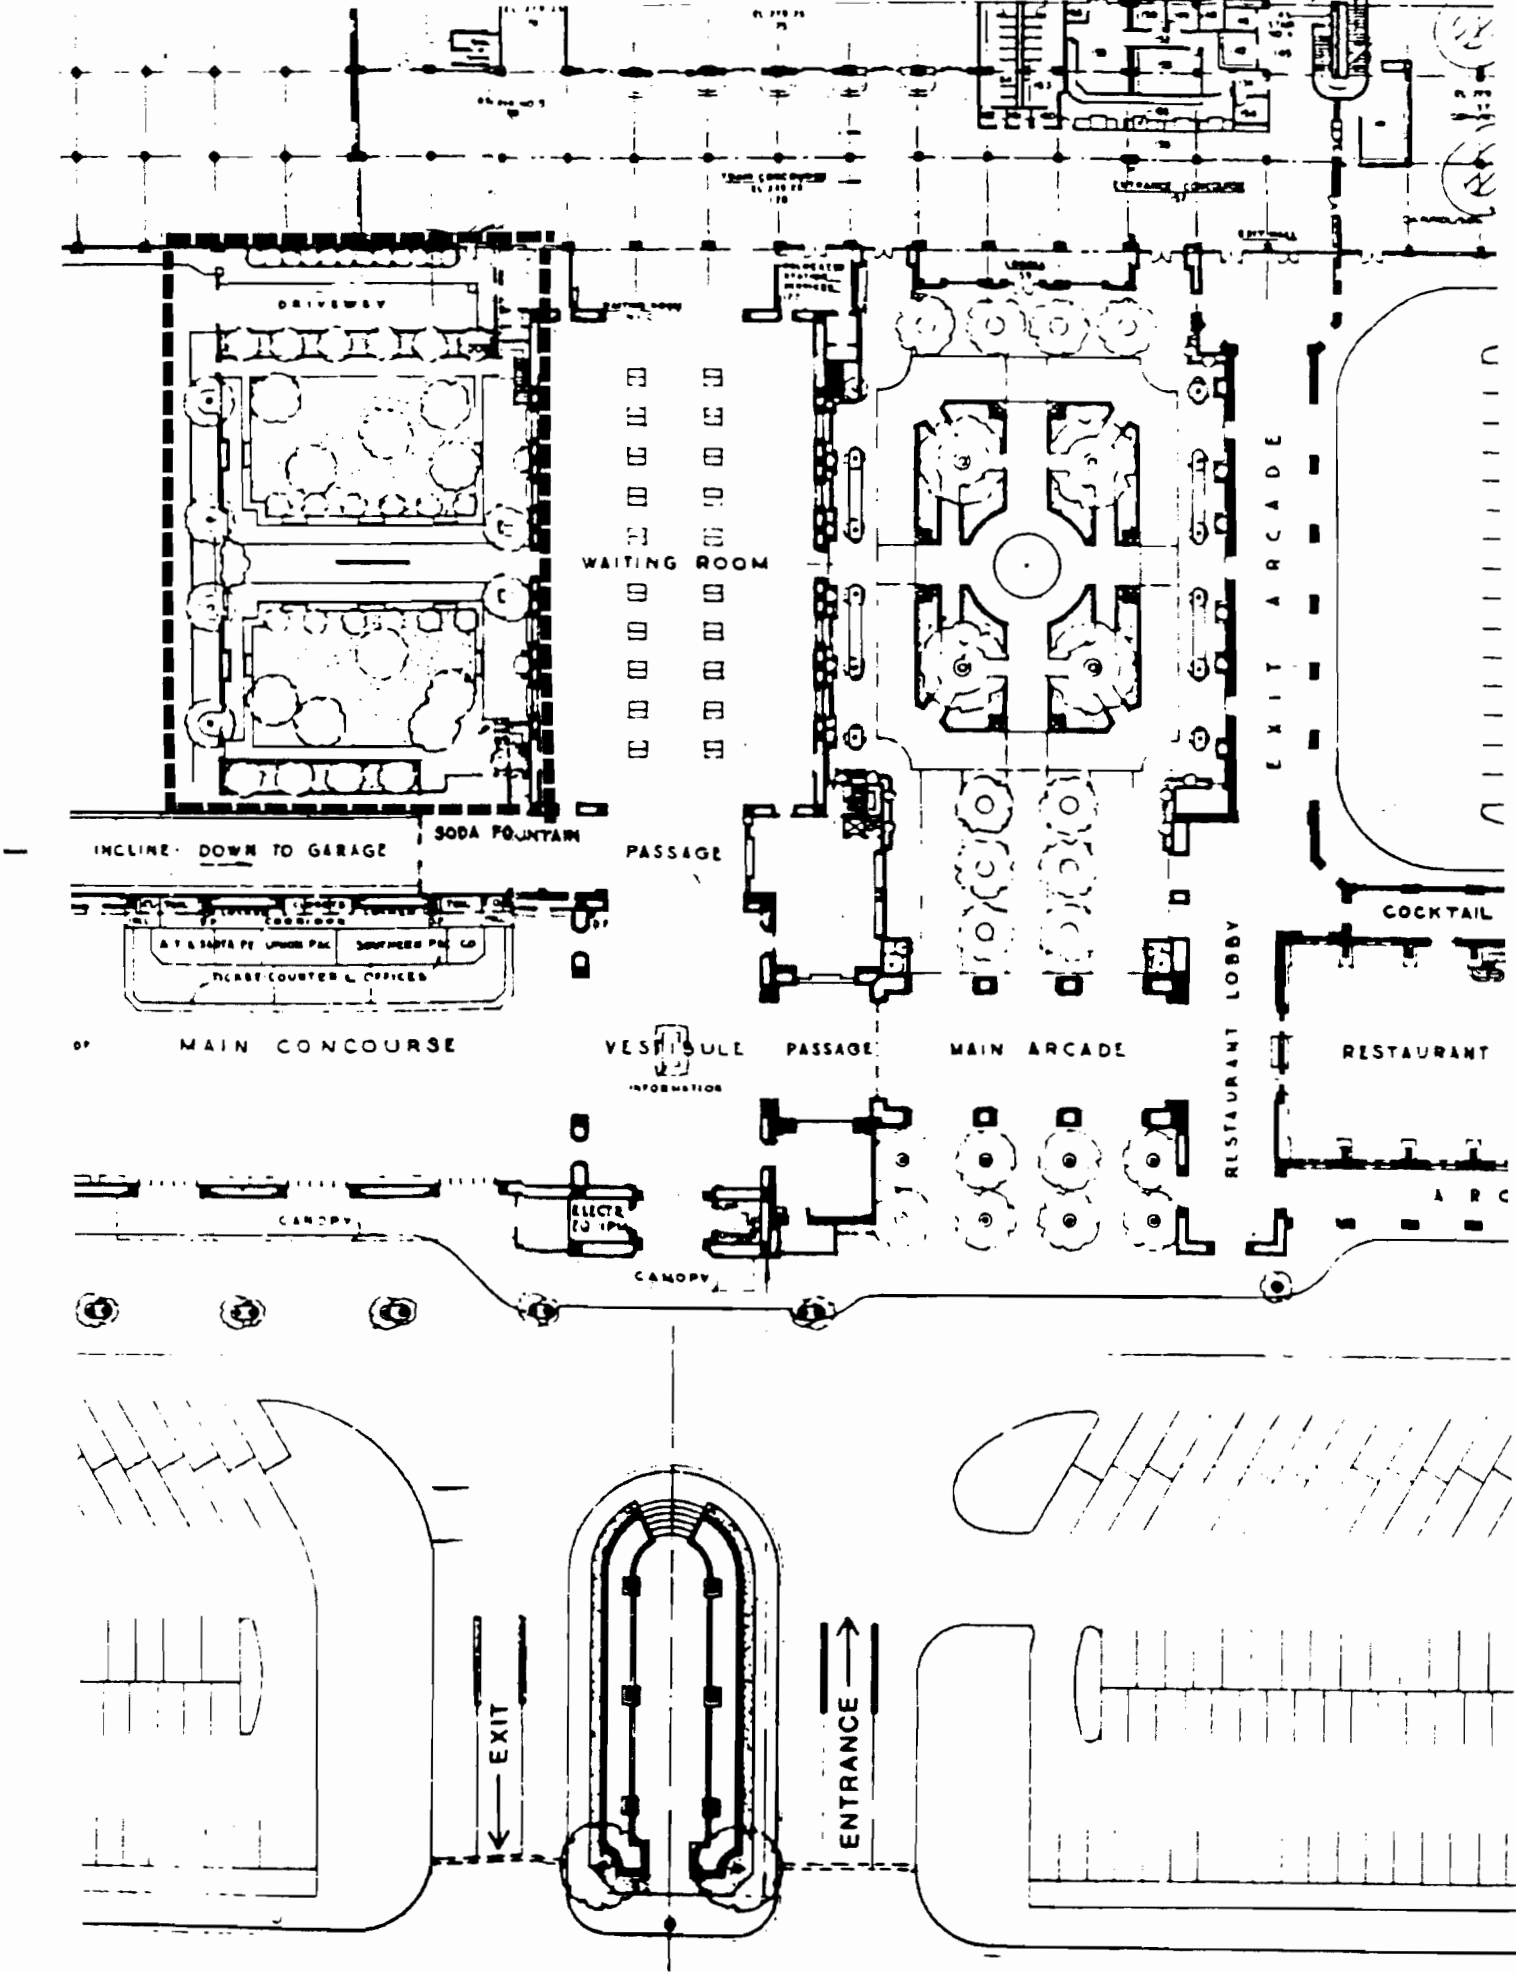
NORTH PATIO

5. CONDITIONS - Quiet except for piped in radio and sounds of mechanical equipment. Landscaping well maintained. Fountain not operating. Windows requires cleaning. Paint dirty in some areas. Benches worn and need repainting. Light globes missings.

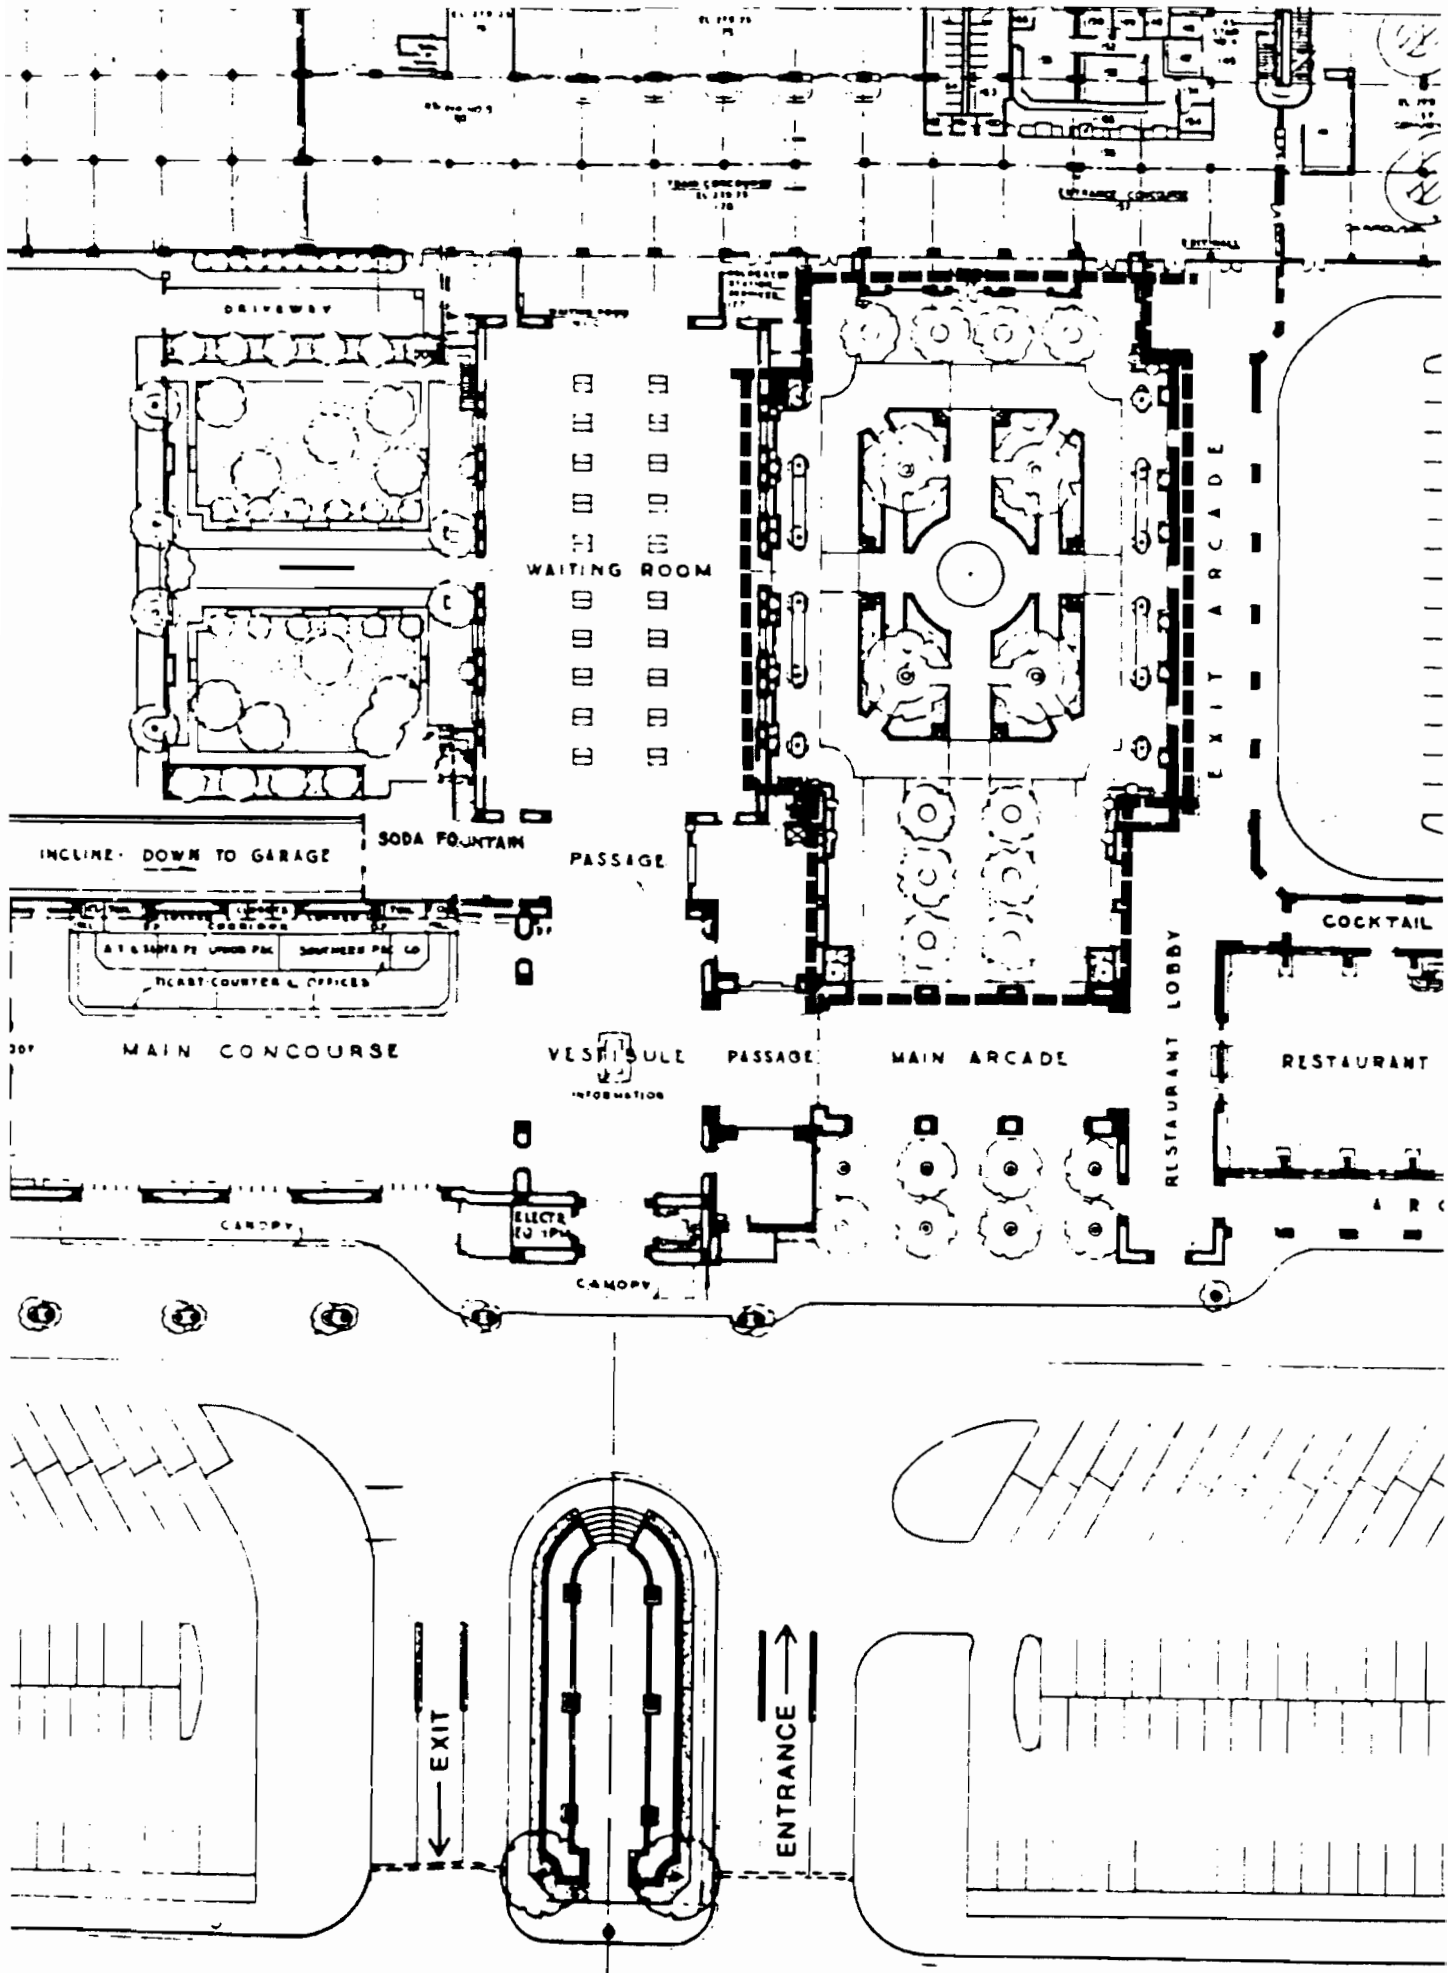
SOUTH PATIO

5. CONDITIONS - Landscape is similar to original plan, but the trees are much smaller than intended.
6. LIGHTING - Four pairs of light pedestals and four lamp posts in the corners comprise the elements in this area.

13. INCONSISTENT ELEMENTS - The new doors on Amtrak building, trash bins, and the trees are smaller than originally intended.
14. AREAS FOR RESEARCH/TESTING - Further research on the original planting and plant materials.
15. FUTURE USES - Undetermined.
16. SUMMARY OF HISTORIC UPGRADE - Match and replace square, decorative medallions above the windows and door to the main waiting room. Upgrade lighting.
17. ONGOING WORK - Not applicable.
18. IMPACT ON OPERATIONS - Not applicable.
