Report No. UMTA-IT-06-0026-74-11

STATE-OF-THE-ART CAR DEVELOPMENT PROGRAM FINAL TEST REPORT

VOLUME 4: SIMULATED DEMONSTRATION TEST

Boeing Vertol Company
(A division of The Boeing Company)
Surface Transportation Systems Branch
Philadelphia, Pa. 19142

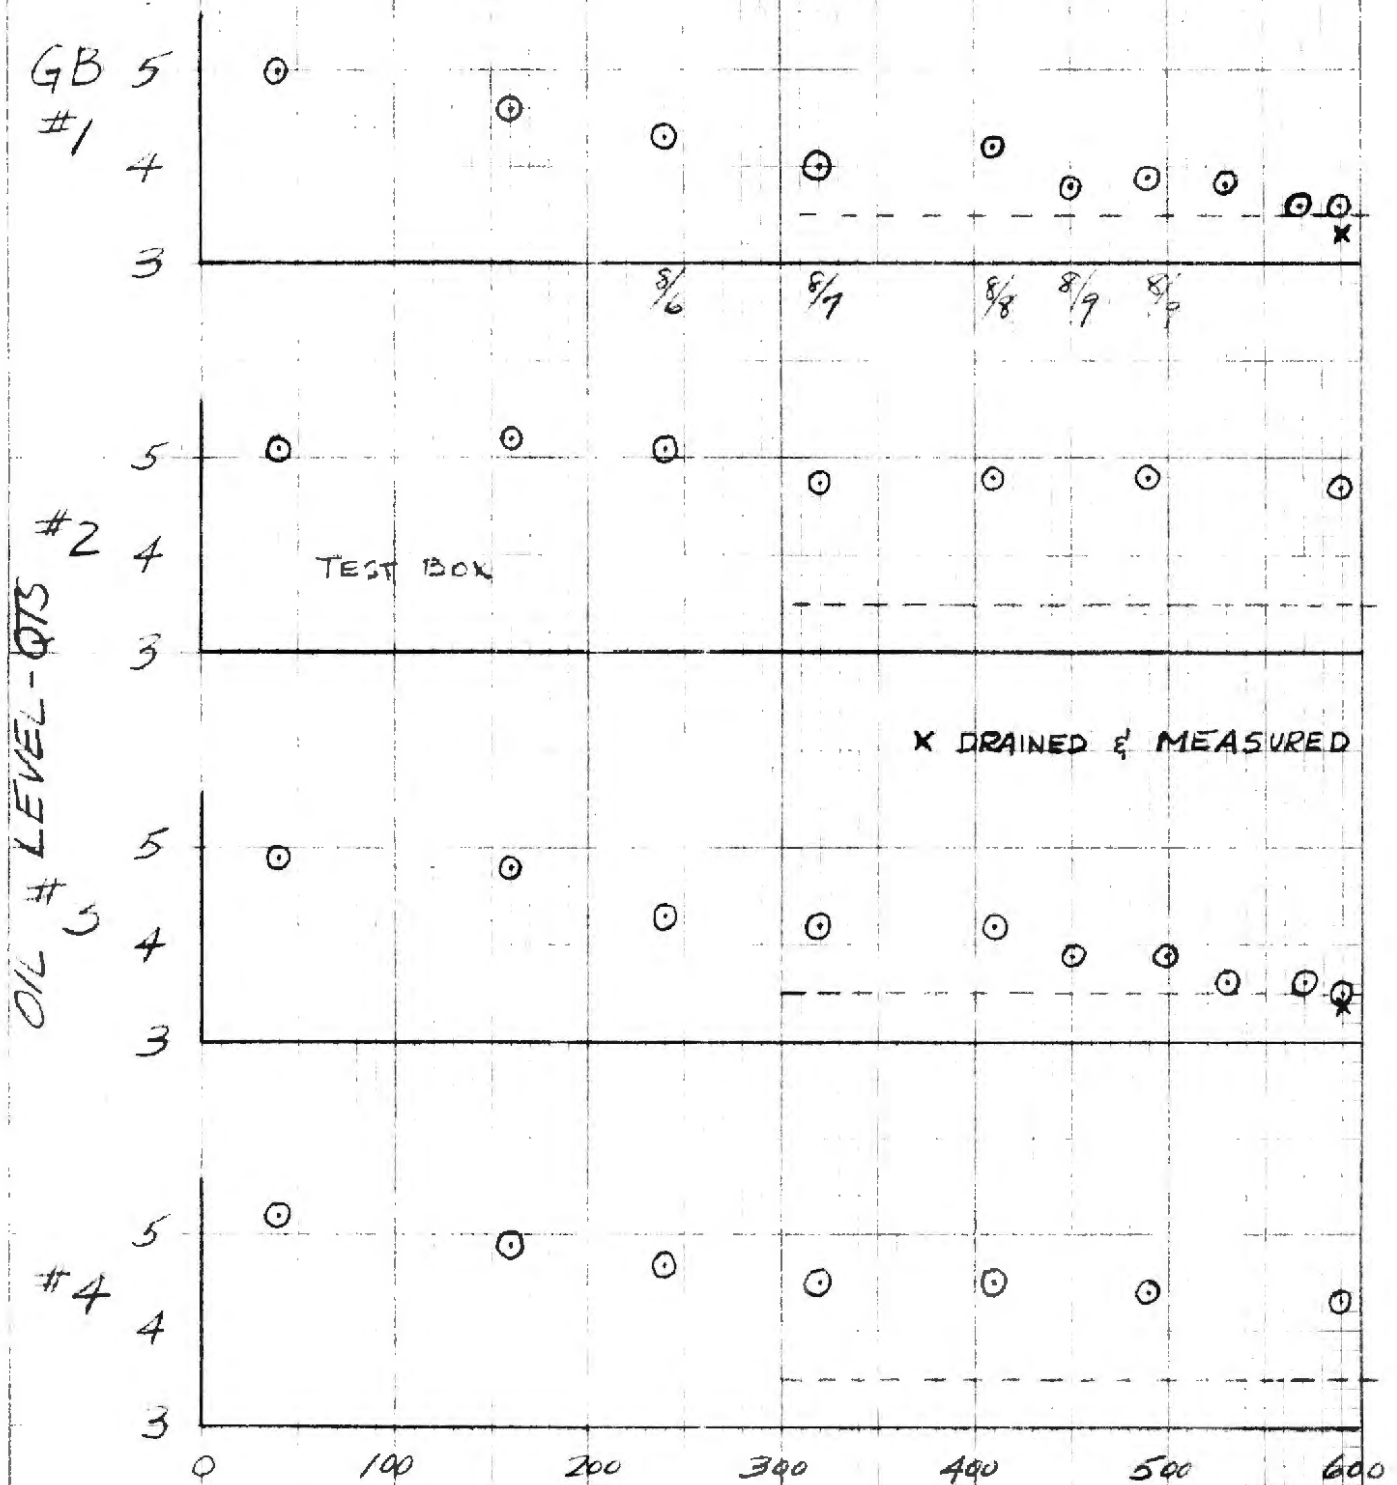
FIGURE 4

During the simulated demonstration it was noted that excessive oil leakage was occurring. Although this problem did not prevent operation it was considered undesirable and in need of correction.

The gearboxes were frequently measured for oil level during the runs to establish the amount of leakage. (The "Oil Leakage Data Sheets" from which this report is written are filed in the SOAC Engineering Data File at the Surface Transportation Systems Branch of Boeing Vertol.) It was discovered that the oil-level dipsticks were improperly calibrated which had resulted in over-filling of the gearboxes. After the oil-level dipsticks were properly calibrated and the gearboxes were filled to the recommended level, the oil leakage was substantially reduced. Review of the oil level data indicated that the prime factor affecting leakage was the number of starts and stops.

OIL LEVEL MEASUREMENTS

SOAC NO. 1

OIL LEVEL VS DISTANCE TRAVELED

Laboratory tests conducted by Garrett-AiResearch traced the oil leakage problem to the omission of oil drain holes between the labyrinth seal and the tapered roller bearing adjacent to it. The effectiveness of the labyrinth seal decreases with decreasing shaft speed. When the gearbox was operated under repetitive stop-start conditions oil leaked out through the labyrinth seal. The gearbox was modified by adding two 3/4 inch drain holes, at the labyrinth seal and also to the seal cavity on the cover side of the gearbox. These holes permit oil that accumulates in the seal cavity during operation to drain back into the sump when the car stops. The modified gearbox, when tested, had an oil leakage rate of 0.88 ounce per 600 stops. This is considered an acceptable oil leakage rate.

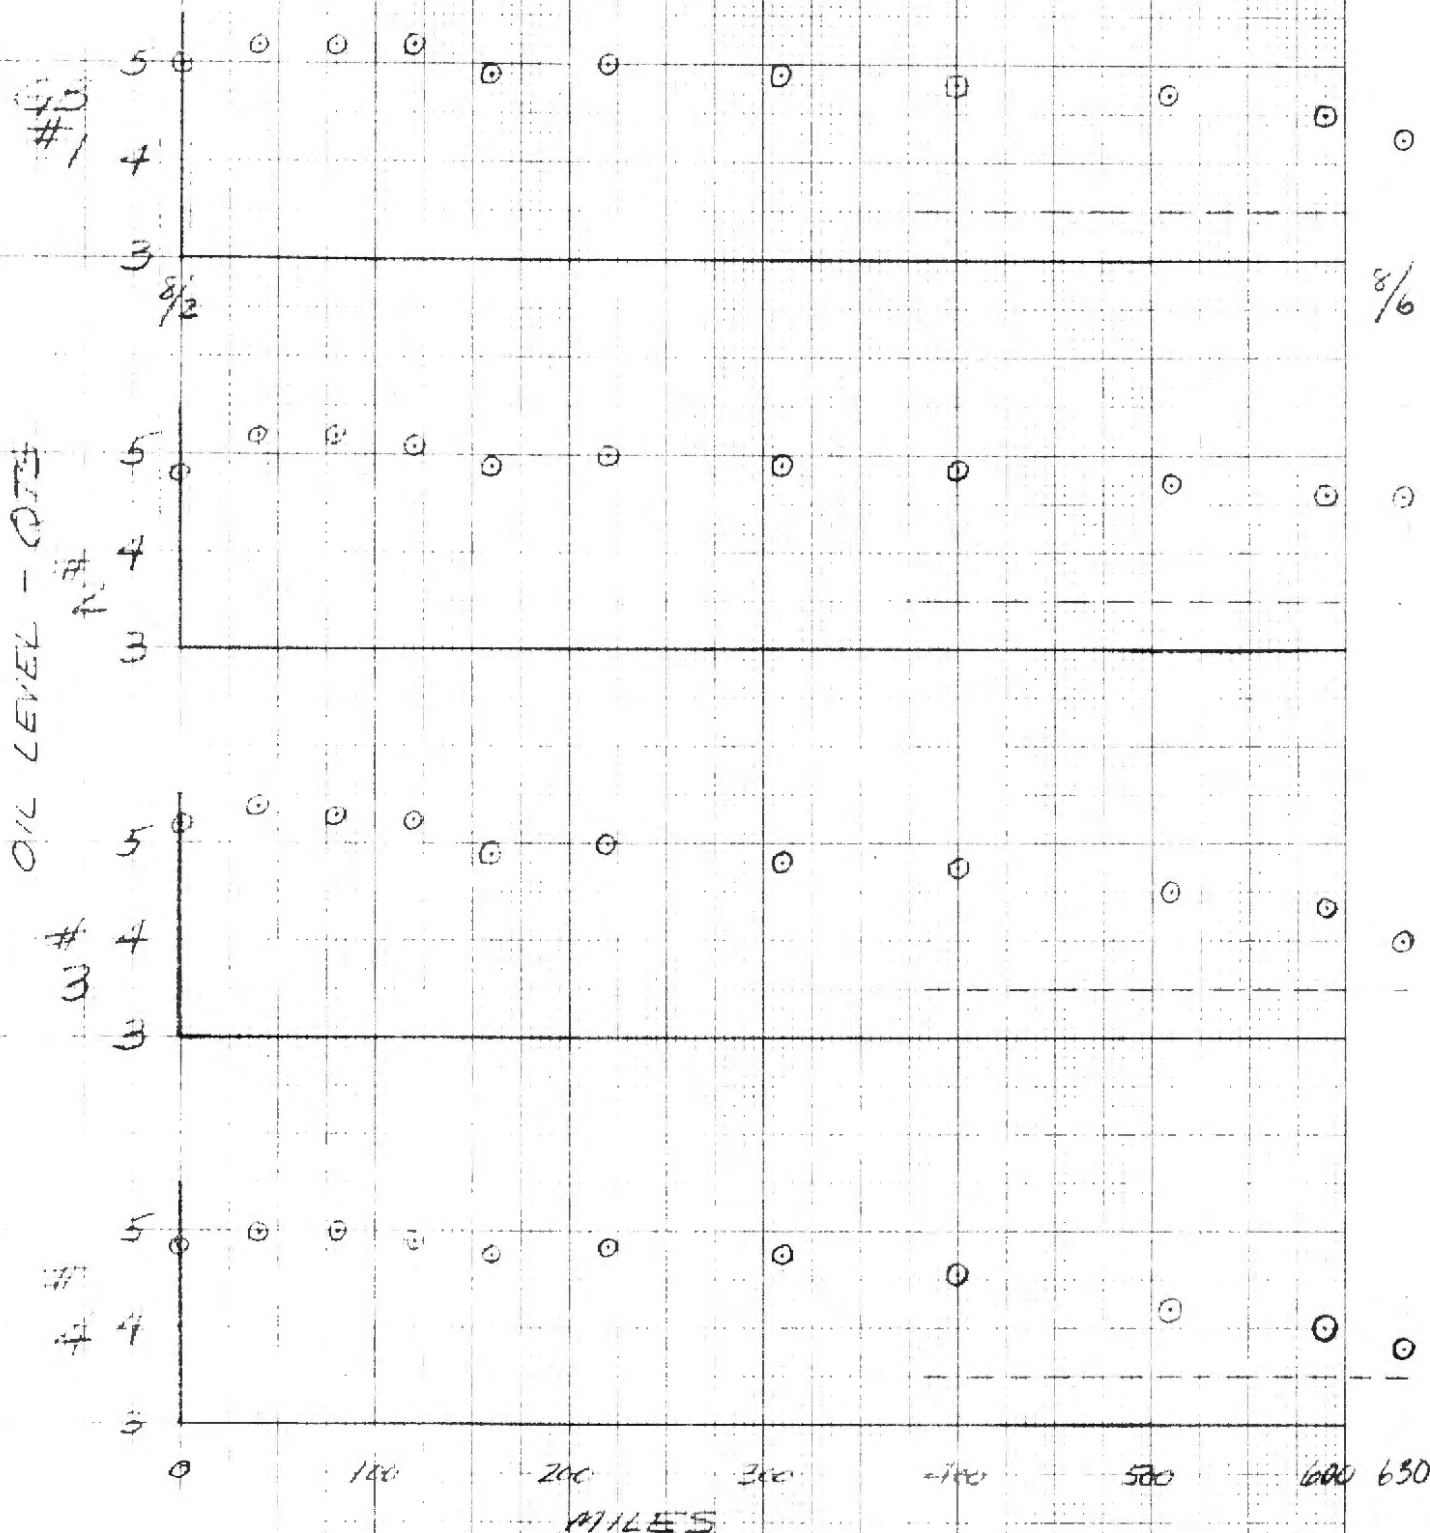
FIGURE 5

OIL LEVEL MEASUREMENTS

SOAC NO 2

OIL LEVEL vs DISTANCE TRAVELED
