CASE STUDIES OF BUILDING BEHAVIOR IN RESPONSE TO ADJACENT EXCAVATION

FINAL REPORT

1. Report No. UMTA-IL-06-0043-78-2	2. Government Accession No.	3. Recipient's Catalog No.	
4. Title and Subtitle Case Studies of Building Behavior in Response to Adjacent Excavation		5. Report Date October, 1978

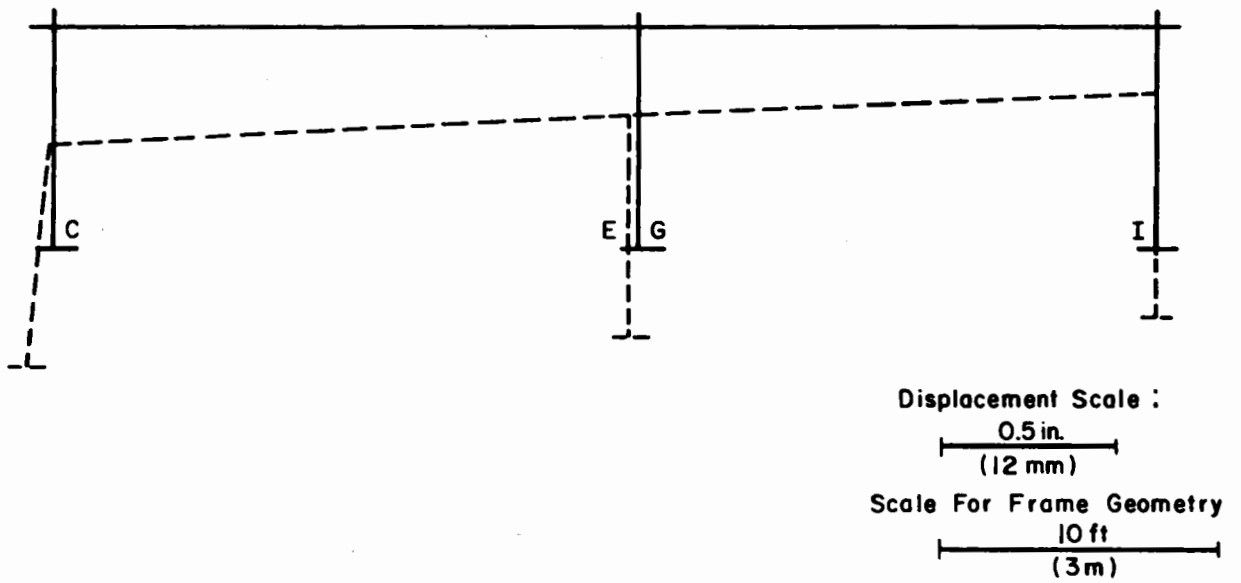
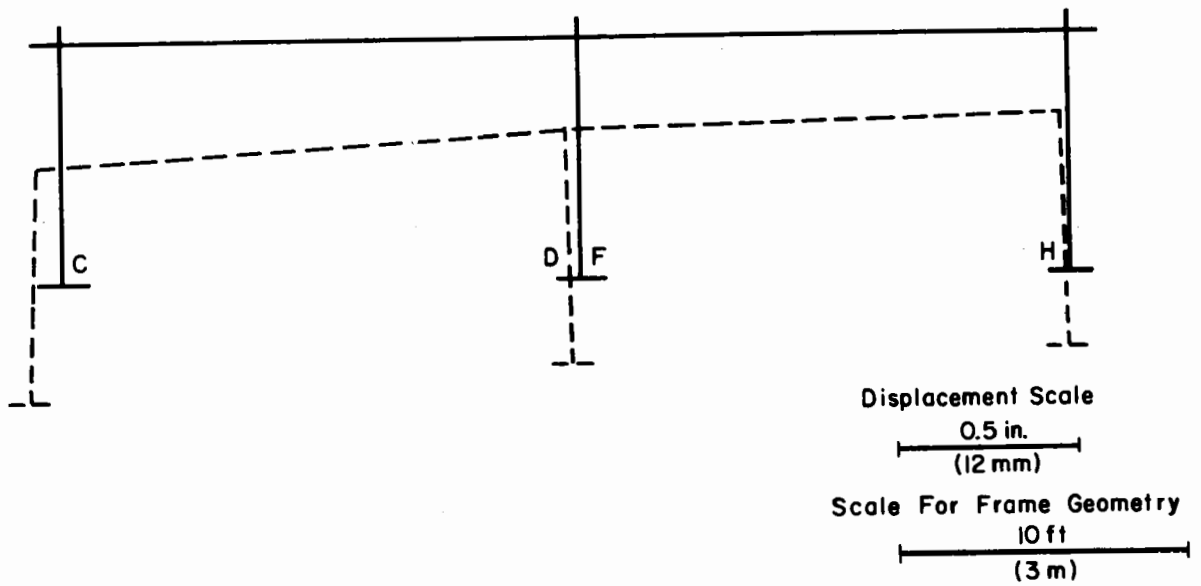
FIGURE 2.9 SKETCHES OF BUILDING DISTORTION BASED ON CUMULATIVE DISTORTION THROUGH 2 DECEMBER 76

Figure 2.9 presents exaggerated views of the distorted building frame as observed along section C-H and C-I. The shape of the distorted structure has been developed from the extensometer and settlement measurements at the columns. It is evident that the building distortion is a function of relative displacement both vertically and horizontally. As shown in Figure 2.5, the angular distortion experienced by the structure is essentially the same as that determined for the ground surface. The horizontal strains calculated for each tape extensometer cross-section are approximately the same as the angular distortions. The similarity of horizontal and angular strains implies that, at the location of the building, horizontal ground movements were of nearly the same magnitude as the settlements.

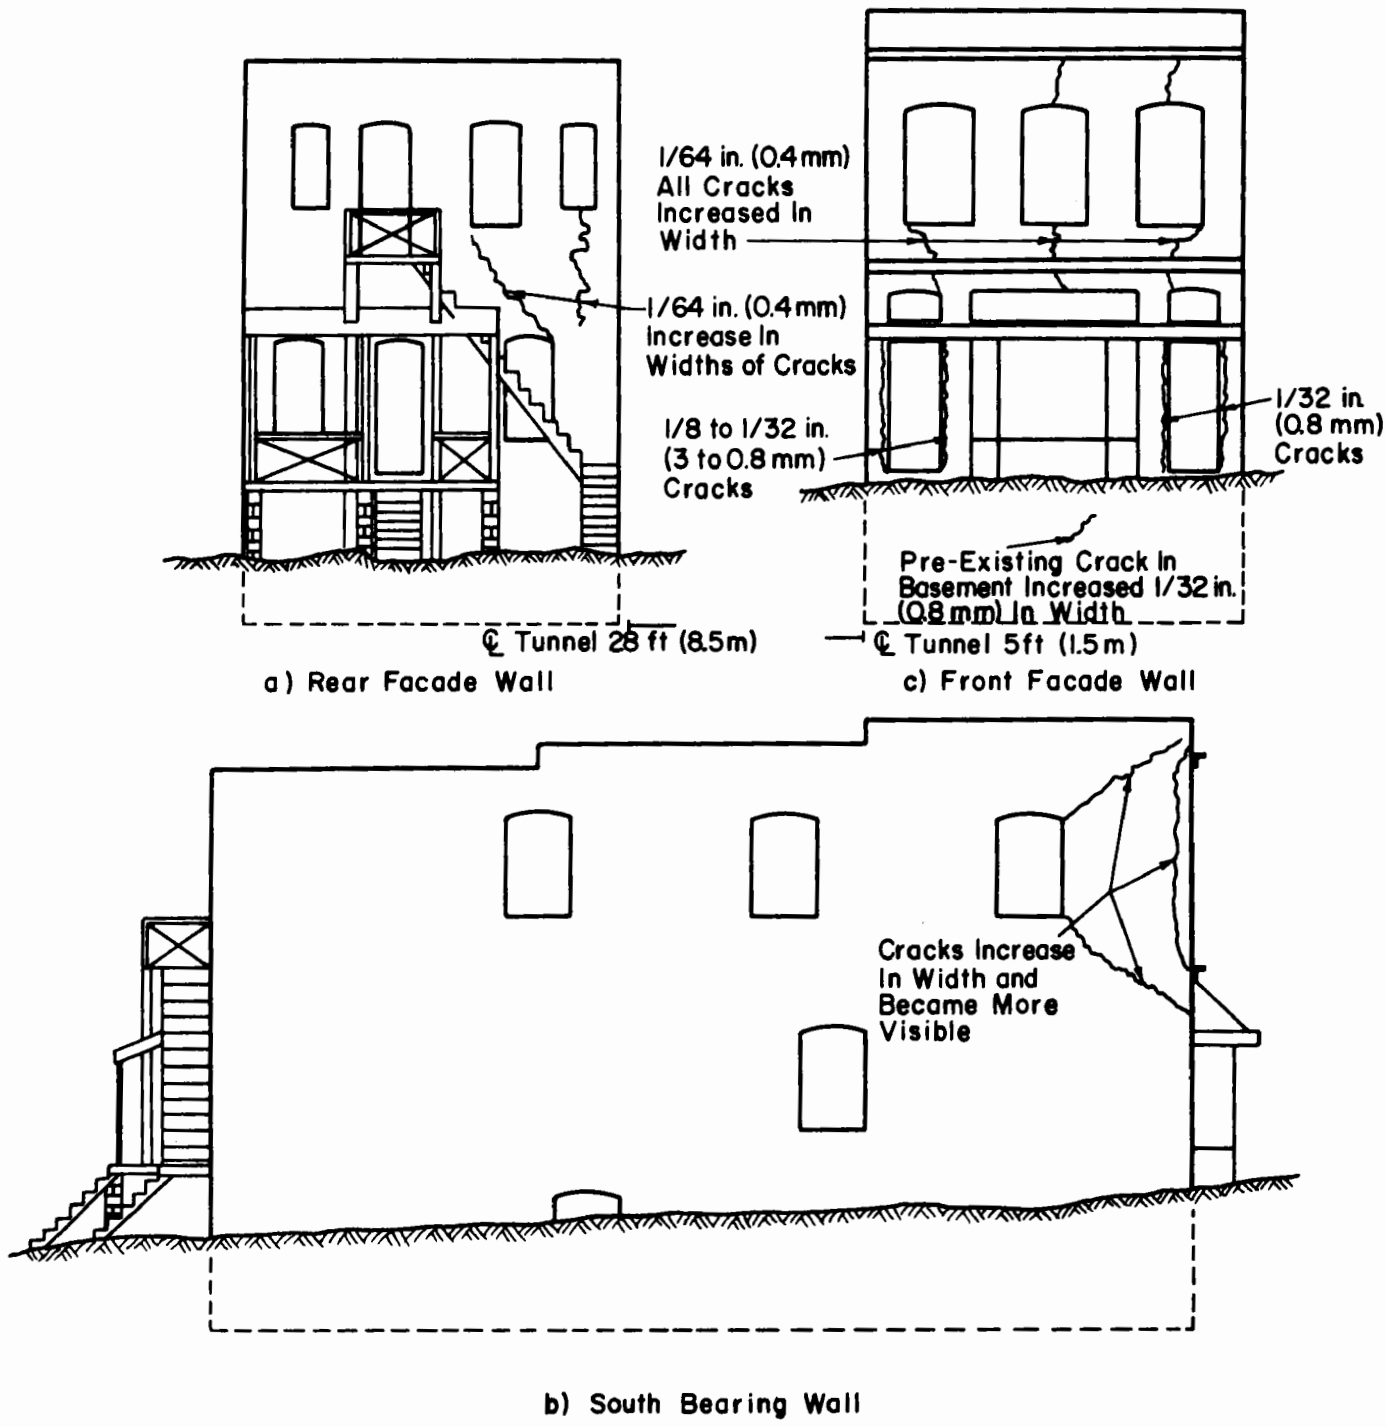
FIGURE 3.17 LOCATION OF CRACKS ON EXTERIOR OF BUILDING I

In Building I new cracks and an increase in the width of existing cracks were found during and after the tunnel excavation. The areas where the cracking was noticed include the front and rear facade walls, the south bearing

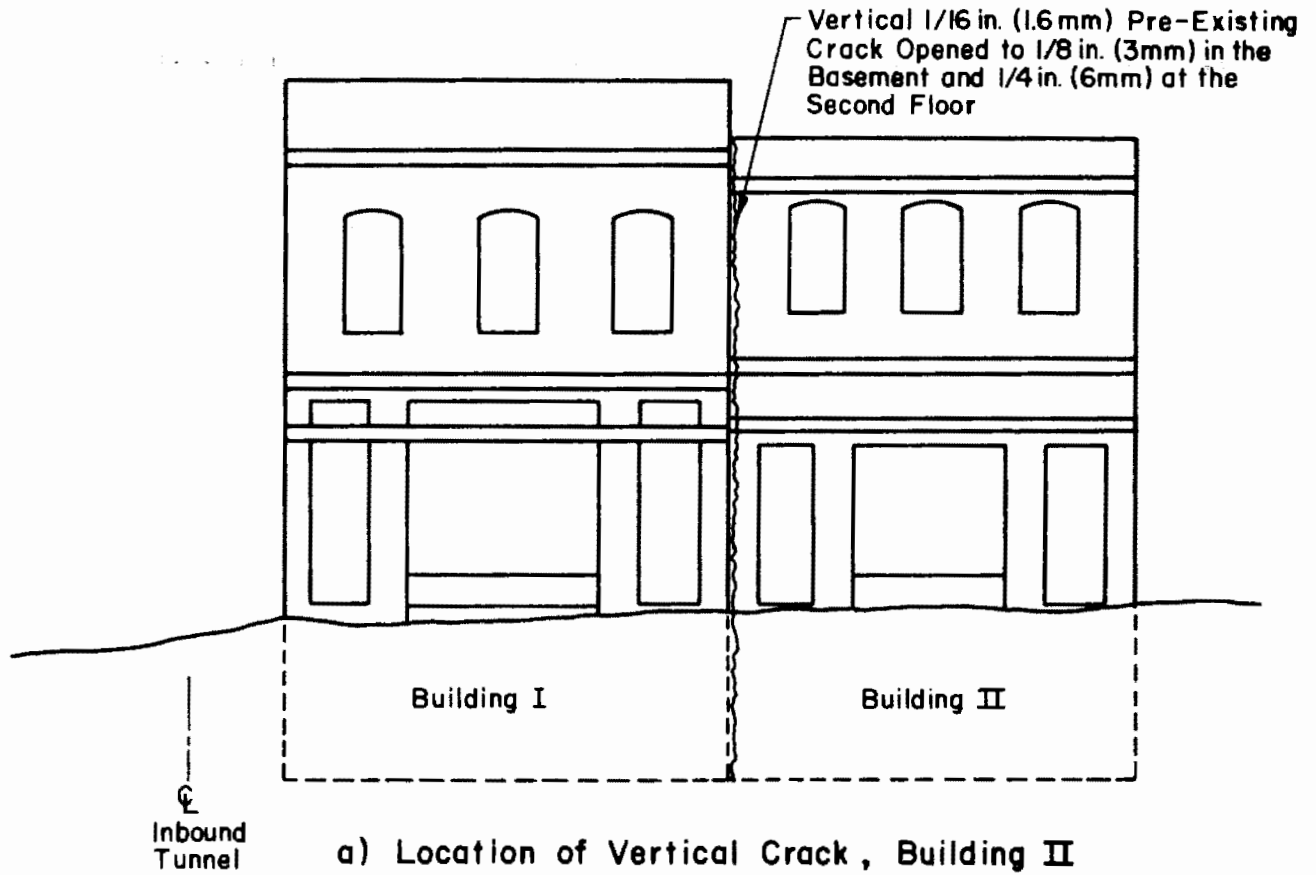
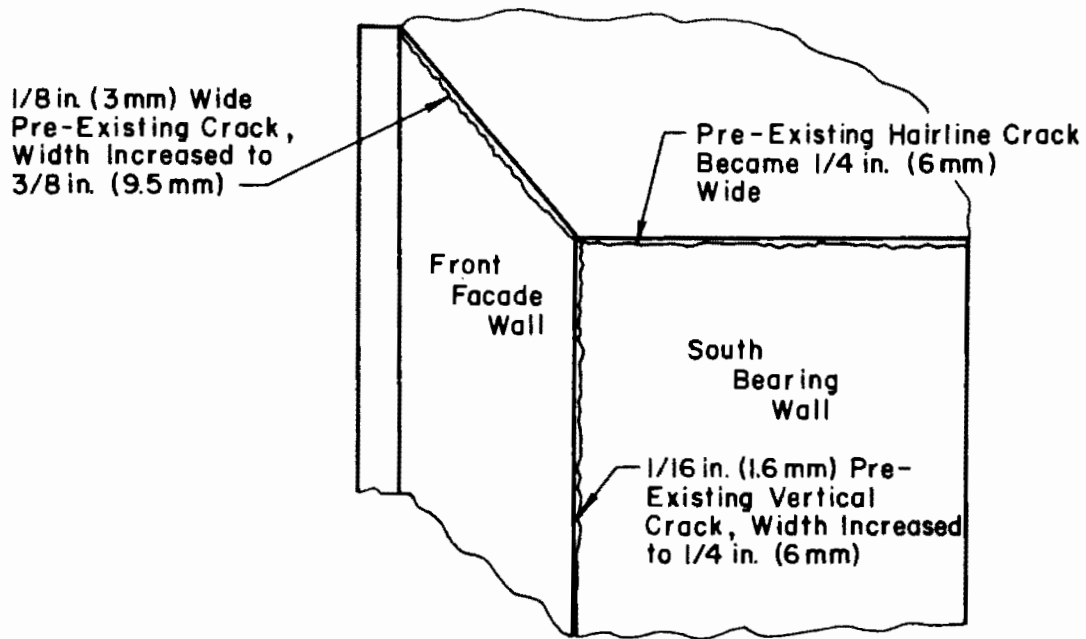
FIGURE 3.19 OPENING OF CRACKS IN RESPONSE TO TUNNEL EXCAVATION, BUILDING II

The cracking in Building II was concentrated around the corner of the south bearing wall and the front facade wall (Fig. 3.19). A pre-existing $1/16$ in. (1.6 mm) vertical crack between the bearing wall and the facade wall opened to $1/8$ in. (3 mm) in the basement to $1/4$ in. (6 mm) at the second floor.

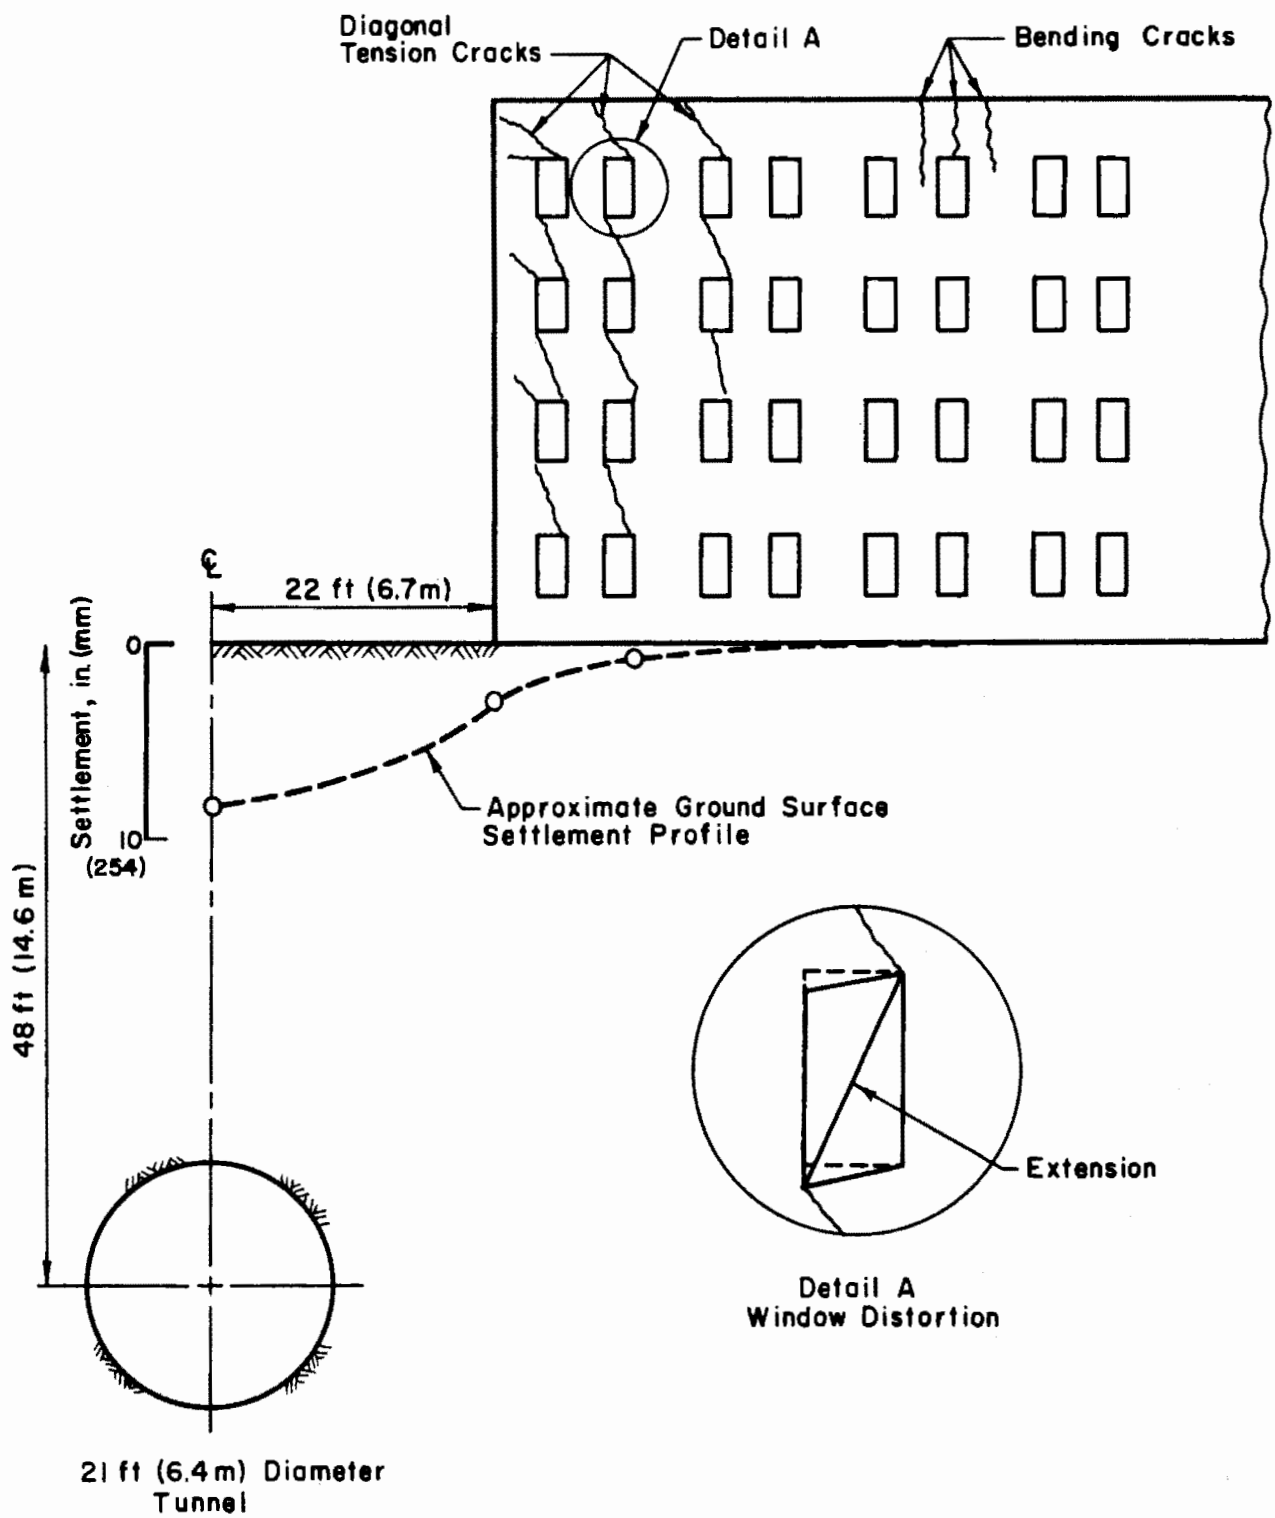
FIGURE 4.7 CRACKING IN SIDE OF BUILDING, CASE D.

Both bending cracks and diagonal cracks were readily visible in an exposed bearing wall, Fig. 4.7 . The diagonal cracking occurred near the front of the structure, within a distance from the excavation equal to H, the height of the building. The bending cracks occurred approximately at a distance H from the front of the building and near the top of the bearing wall. The windows in the bearing wall were also severely distorted, (Fig. 4.7). At the fourth floor it was noted that the facade wall had pulled away 1 in. (25 mm) or more from both the ceiling and the floor.

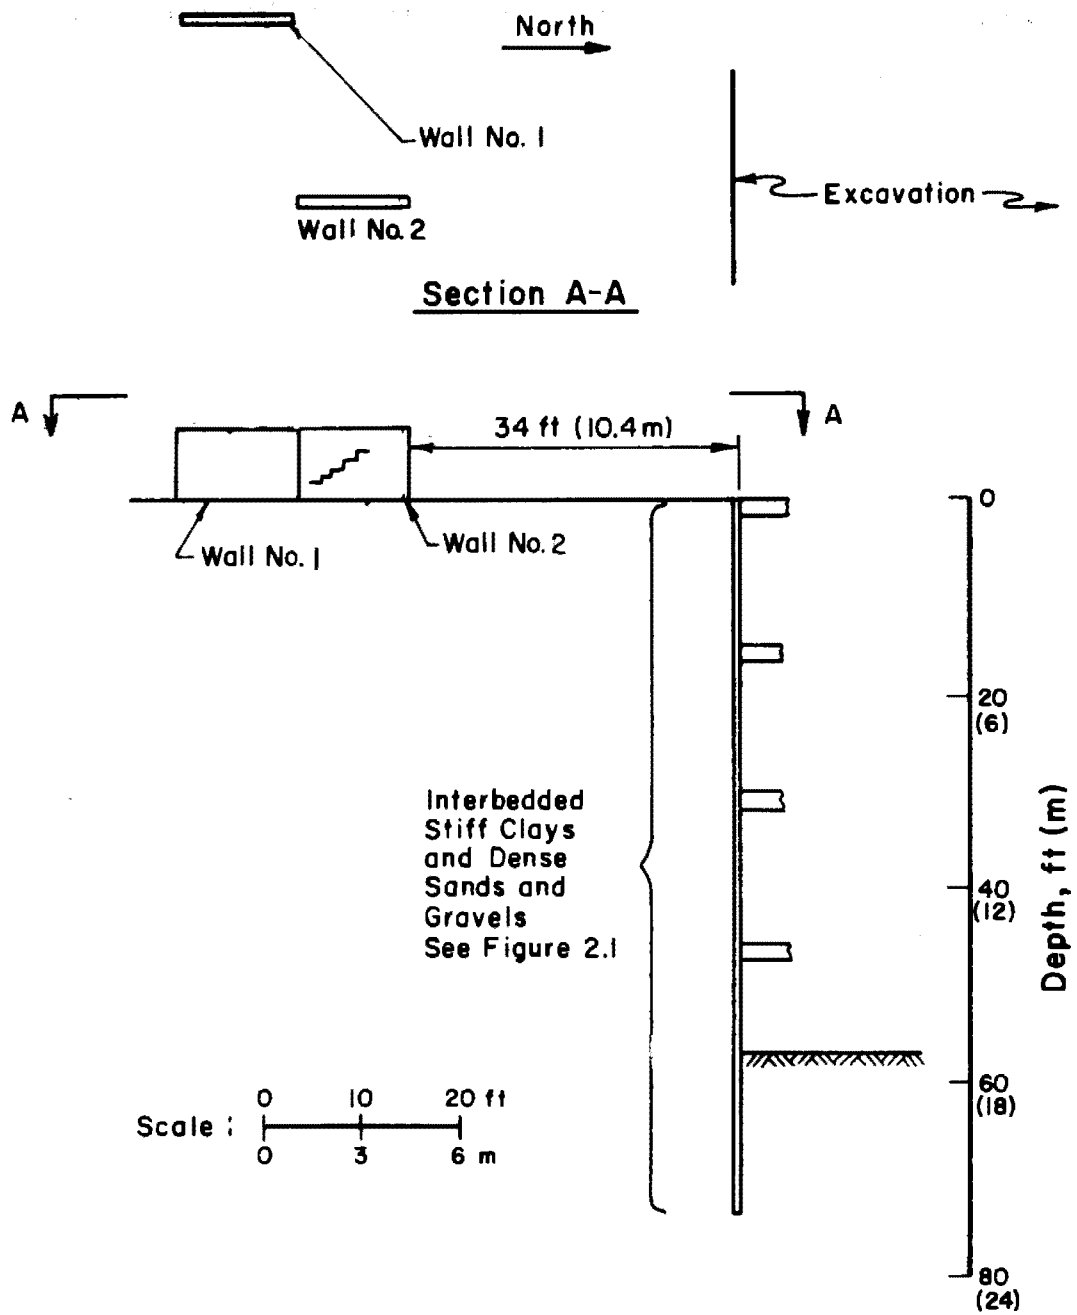
FIGURE 4.8 CASE E, TWO BRICK WALLS

Settlement and distortion were observed along two brick courtyard walls located next to a 60-ft (18-m)-deep open cut in dense sands interbedded with stiff clays, the same excavation described in Chapter 2 of this report (Figure 4.8). Both walls ran perpendicular to the edge of the open cut. One started 34 ft (10 m) from the edge of the excavation while the other began 47 ft (14 m) from the edge of the cut. The walls were 7.5 ft (2.3 m) high, 12 ft (3.7 m) long, and 8 in. (203 mm) thick. The foundations for the walls were concrete strip footings about 2.5 ft (0.8 m) below the ground surface.
