WHEELCHAIR SECUREMENT
on
BUS AND PARATRANSIT VEHICLES

Interim Report No. 1

April 1981

Carl F. Stewart
Herbert G. Reinl

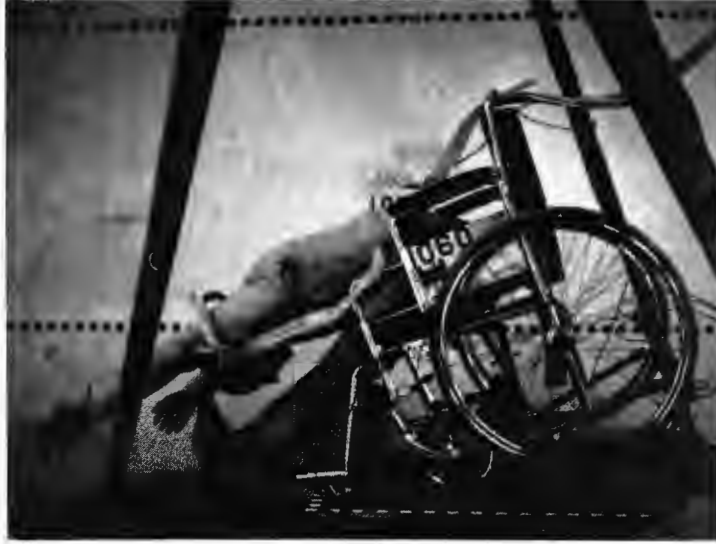
Figure A-5

DUMMY: The dummy head and chest accelerations are shown in Figures A-7 and A-8. The spikes in the head plots were caused by the dummy's head hitting the legs. The acceleration of the head striking the legs was judged to be minor from an injury standpoint. The head injury criteria (HIC) was calculated as 172, $T = 167$ ms, $T_2 = 218$ ms. Head excursion was 56 inches.

Test 1060--Post Test Conditions

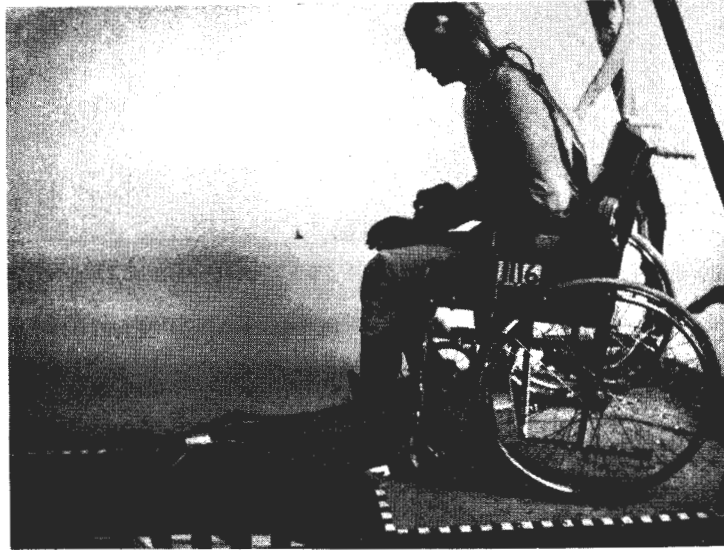
Figure A-10

WHEELCHAIR: The wheelchair was undamaged.

DUMMY: Forward excursion of the head relative to its initial position on the sled was 41 inches.

Test 1116--Post Test Conditions

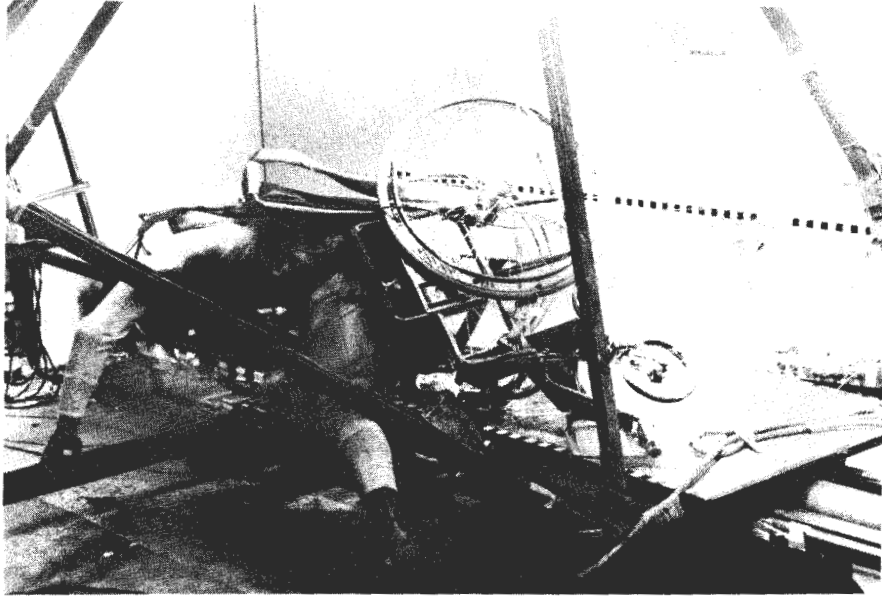
Figure A-12

DUMMY: Seat belt load was low with a maximum of 400 lbs. A relatively high forward head excursion of 71 inches was recorded. Head and chest accelerations were relatively low. A minor head injury criteria of 54, $T_1 = 156$ ms, $T_2 = 284$ ms was calculated.

Test 1074--Post Test Conditions

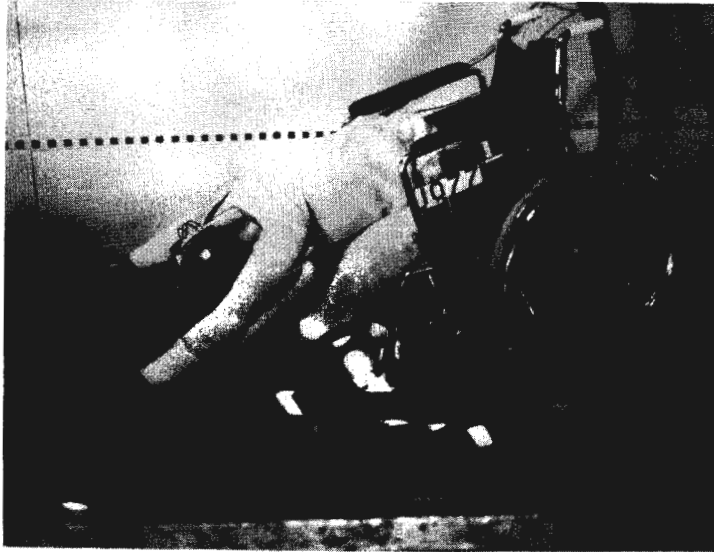
Figure A-13

DUMMY: Head acceleration data (Figure A-14) indicated a minor head strike at 250 ms which was probably caused by the head striking the dummy's legs. The maximum head injury criteria (HIC) was calculated as 246 ($T_1 = 120$ ms, $T_2 = 259$ ms). Head excursion was 41 inches.

Test 1077--Post Test Conditions

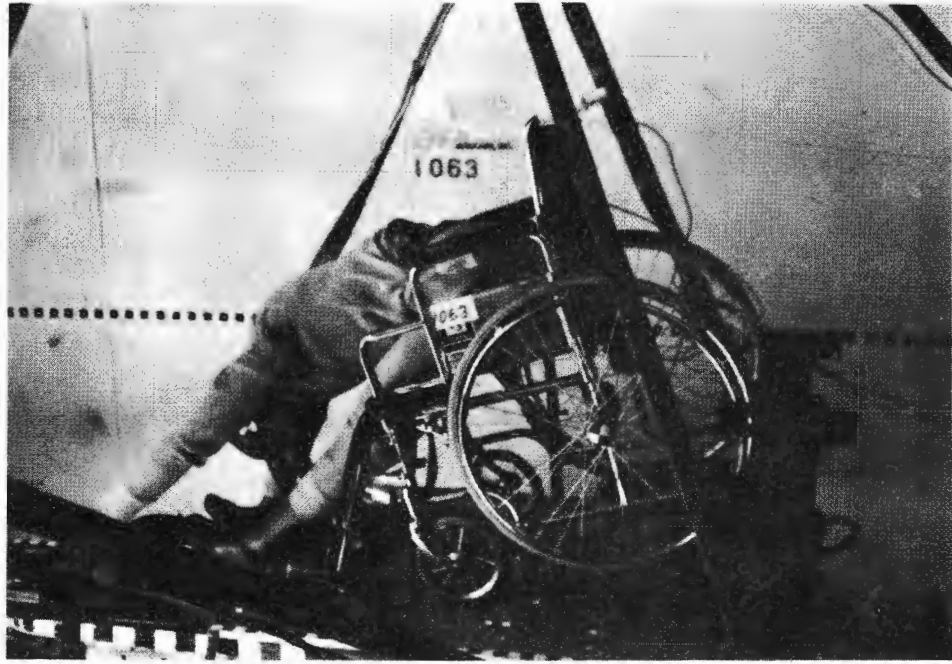
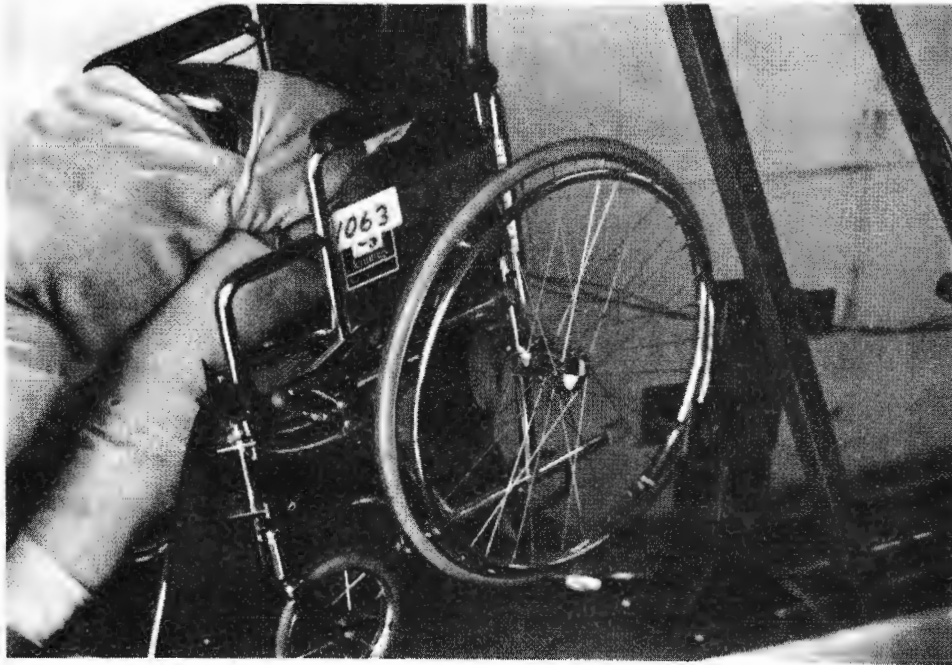
Figure A-19

DUMMY: Recorded data showed an early onset of lap belt load at about 50 ms and a peak load of 1200 lbs. in the belt (approximately 2400 lbs on the dummy). Head excursion was 45 inches. Head and chest accelerations were nominal (HIC = 172, $T_1 = 108$ ms, $T_2 = 274$ ms).

Test 1063--Post Test Conditions

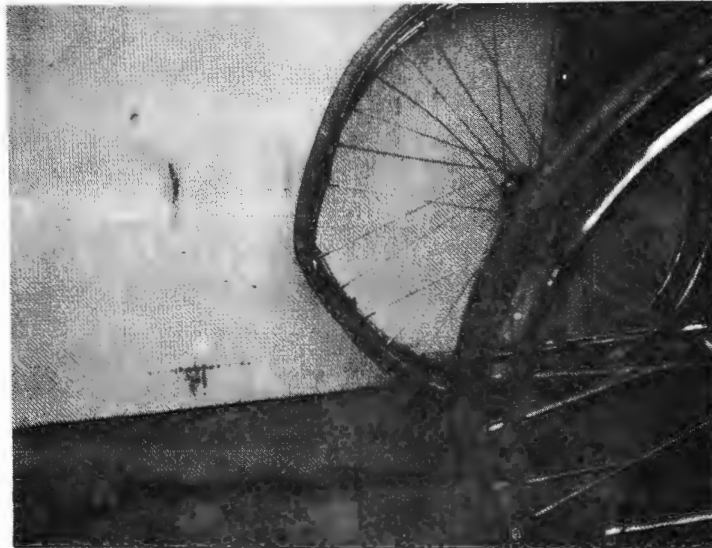
Figure A-21

Test 1100--Wheel Damage

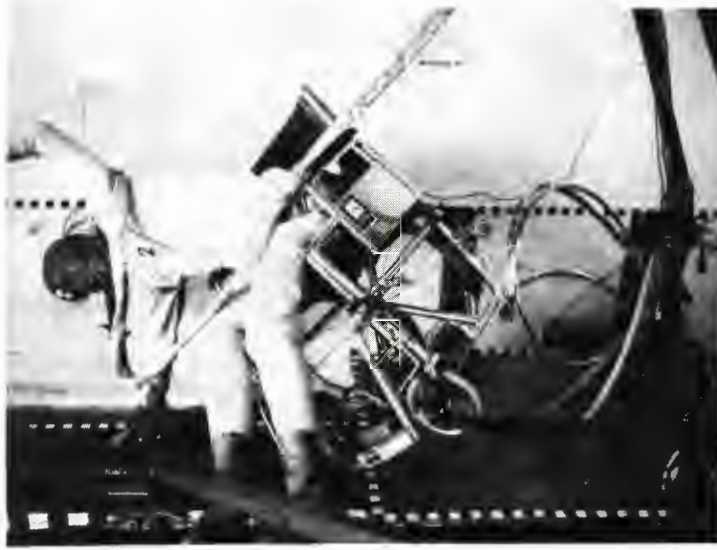
Figure A-25

DUMMY: Recorded head and chest accelerations were nominal with no particular indication of injury (HIC = 44, $T_1 = 127$ ms, $T_2 = 308$ ms). However, impact of the dummy against the armrest raises the possibility of injury. Excursion of the head in the direction of travel relative to its initial position on the sled was 61 inches. Maximum seat belt load was 1000 lbs.

Test 1072--Post Test Conditions

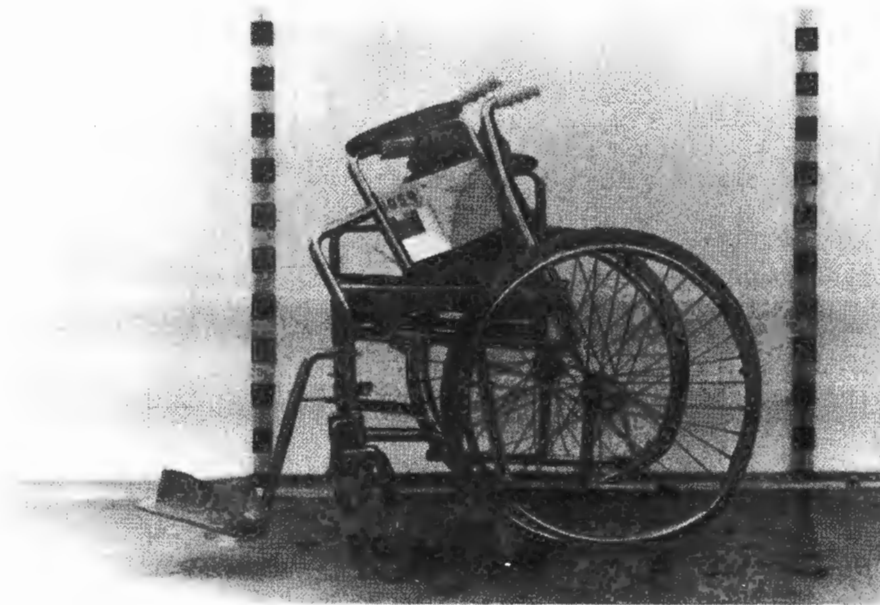
Figure A-27

DUMMY: Belt force on the abdominal area of the dummy (Figure A-28) was 900 lbs (twice belt load). Forward excursion of the head was 53 inches. Securement of the dummy was judged inadequate due to the imminent loss of the waist belt attachment to the chair.

Test 1054--Post Test Conditions

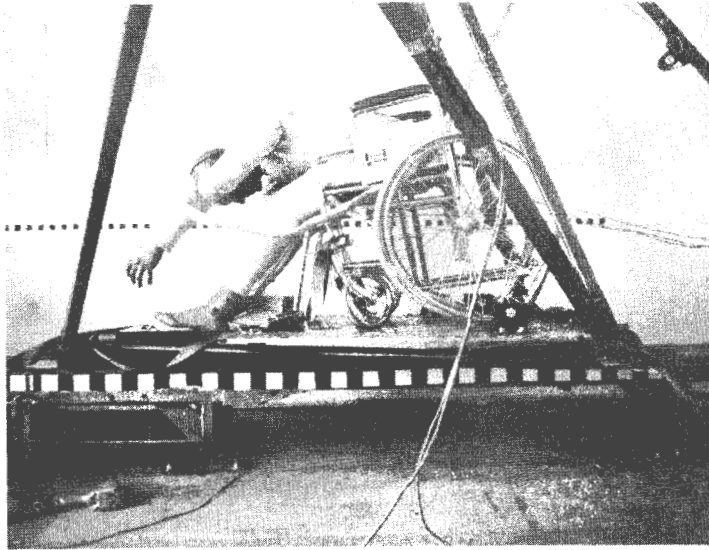
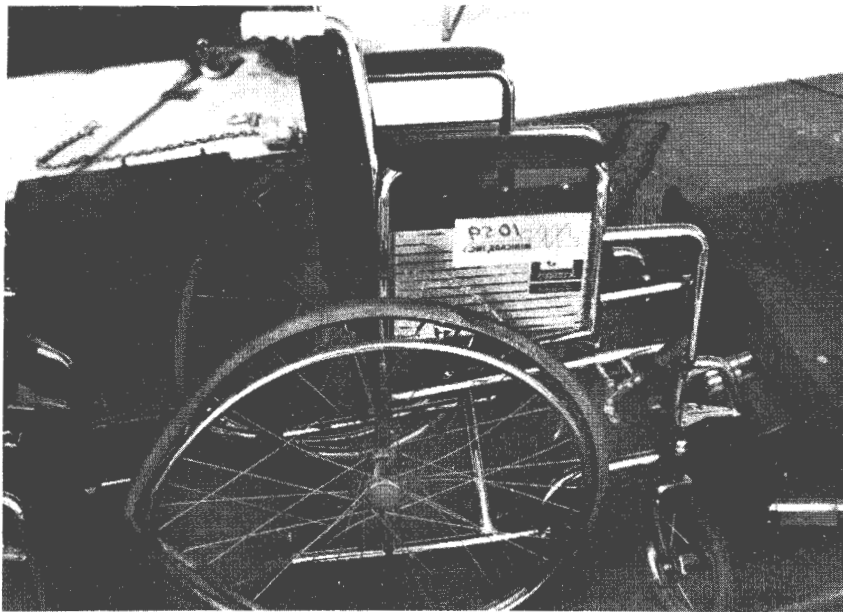
Figure A-29

DUMMY: Forward head excursion was 44 inches. Very low head and chest decelerations were recorded (Figures A-31 and A-32). HIC = 158, $T_1 = 112$ ms, $T_2 = 248$ ms.

Test 1059--Post Test Conditions

Test 1059--Wheel Damage

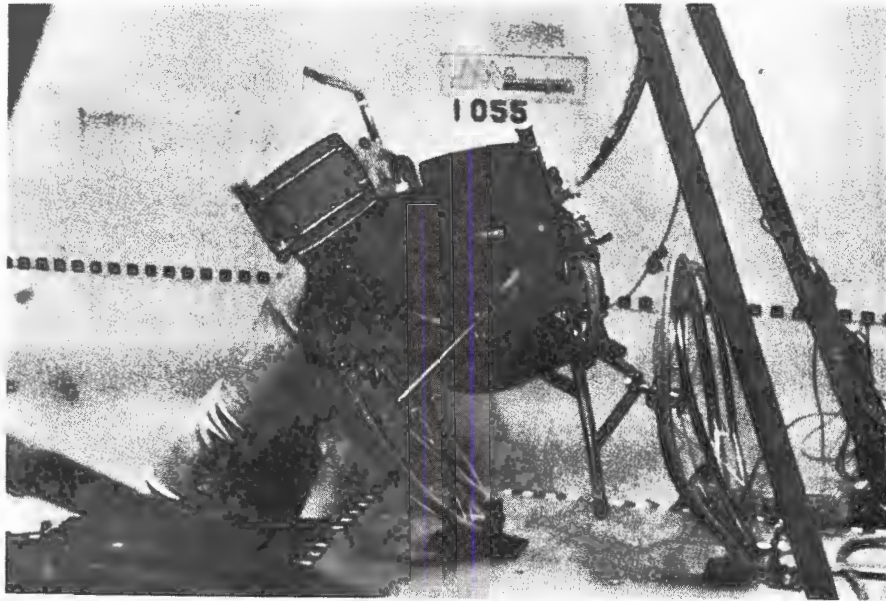
Figure A-33

DUMMY: Seat belt load was 300 lbs. Forward head excursion was 56 inches. The dummy was not confined by the securement provided.

Test 1055--Post Test Conditions

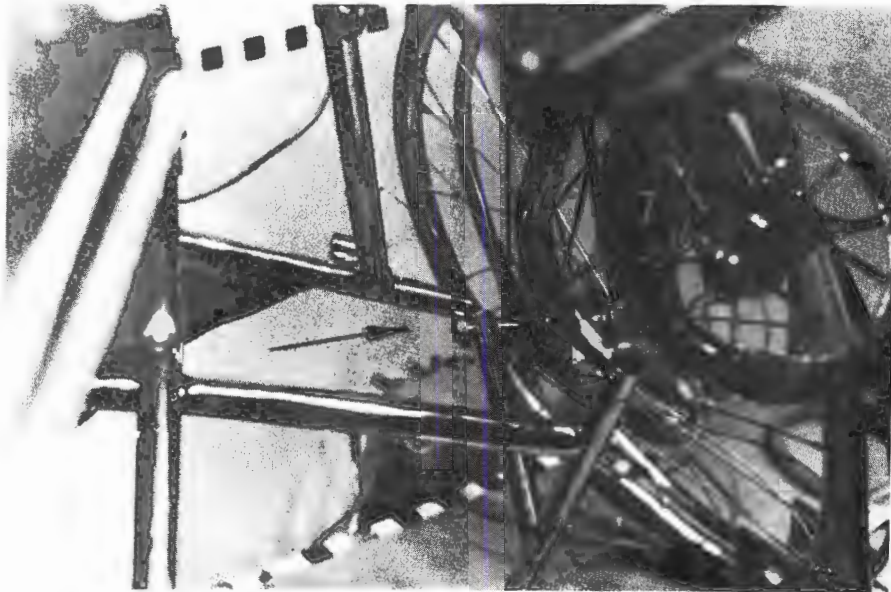
Figure A-34

Test 1055--Back Post Failure

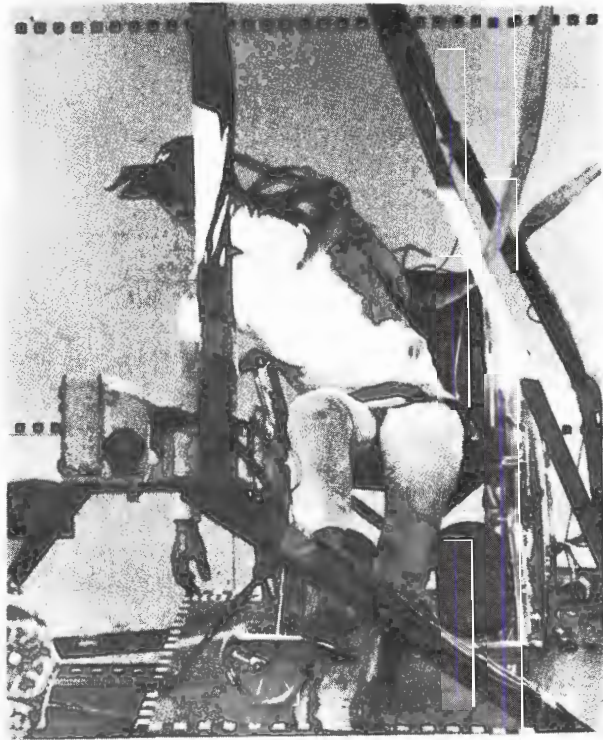
Figure A-36

Test 1087--Post
Test Conditions

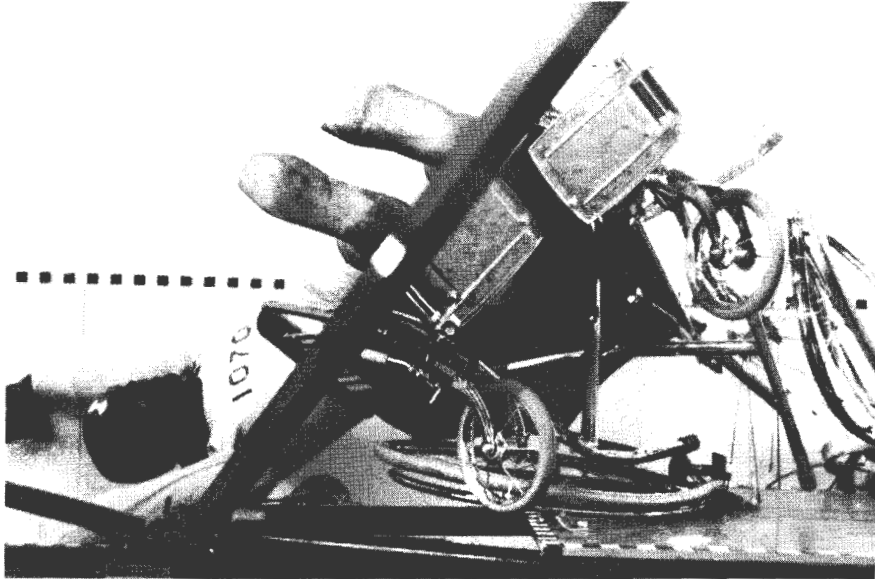
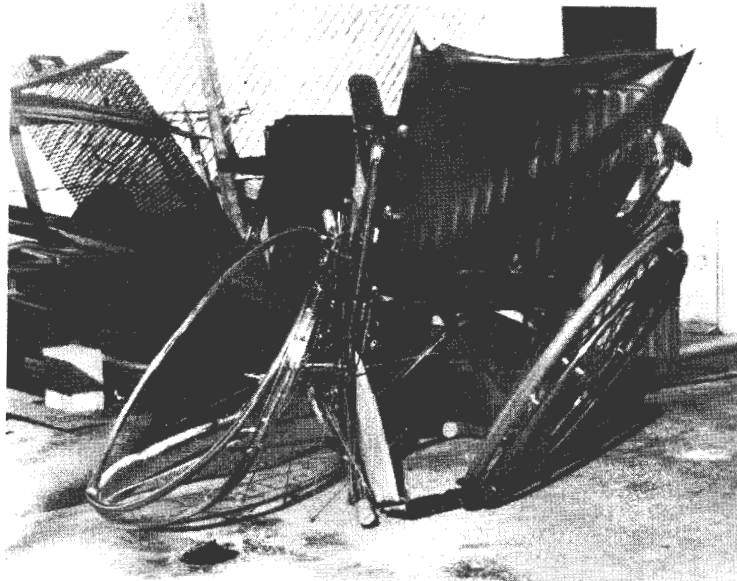
Figure A-38

DUMMY: Seat belt data was invalidated due to the fouling of a transducer. Head and chest accelerations were relatively low (HIC = 46, $T_1 = 115$ ms, $T_2 = 243$ ms). Head excursion was 56 inches.

Test 1070--Post Test Conditions

Test 1070--Chair Damage

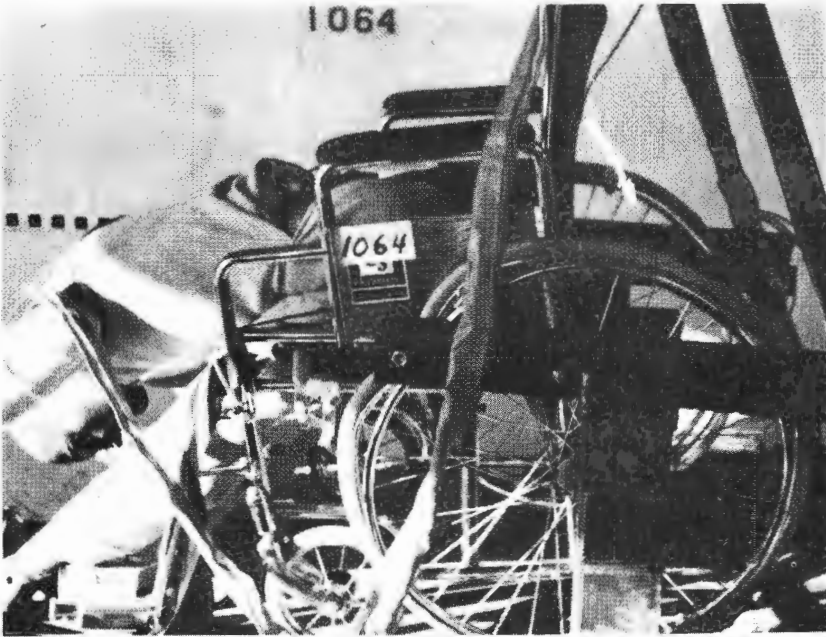
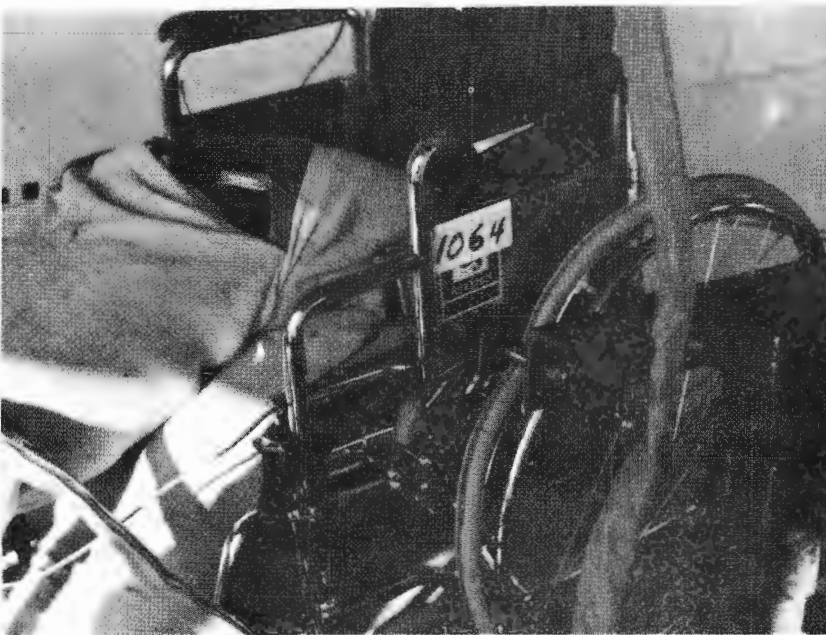
Test 1064

DUMMY: Head and chest accelerations were nominal. An early onset of lap belt load was recorded at 50 ms peaking at 2000 lbs. Head excursion was 48 inches.

Post Test
Conditions

Wheel
Damage

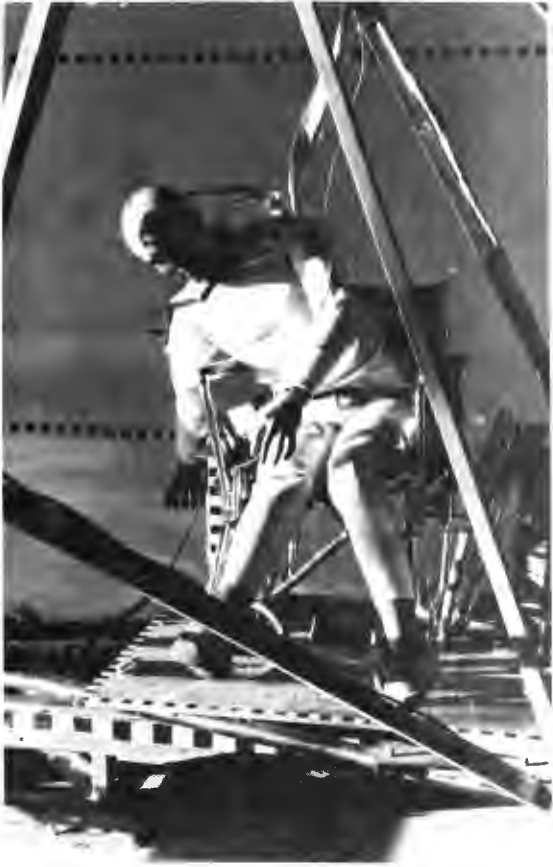
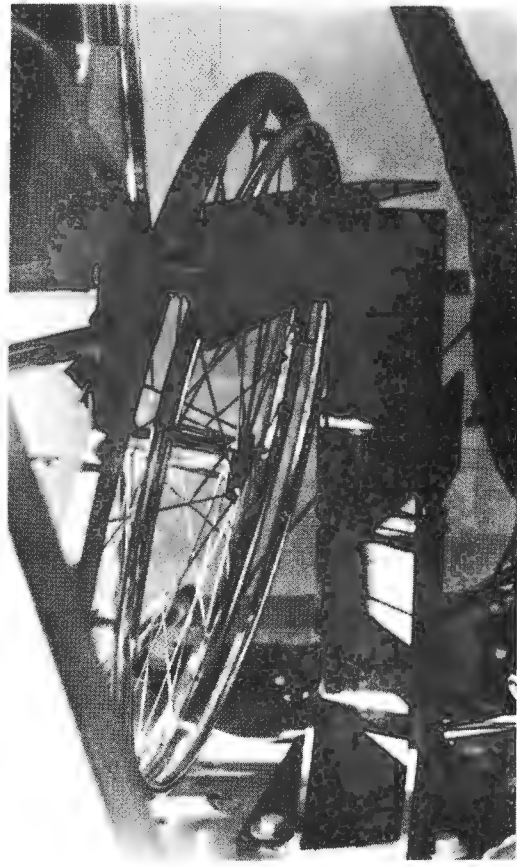
Test 1071

DUMMY: The data traces indicate a relatively high lap belt load of 1300 lbs with early onset at 60 ms into the event. Although head and chest data traces show only nominal accelerations with no particular indication of injury (HIC = 186, $T_1 = 114$ ms, $T_2 = 172$ ms), sideways bending of the torso and impact of the ribs on the armrest could have resulted in severe injuries. Head excursion in the direction of travel was 39 inches.

Post Test Conditions

Trailing Side Damage

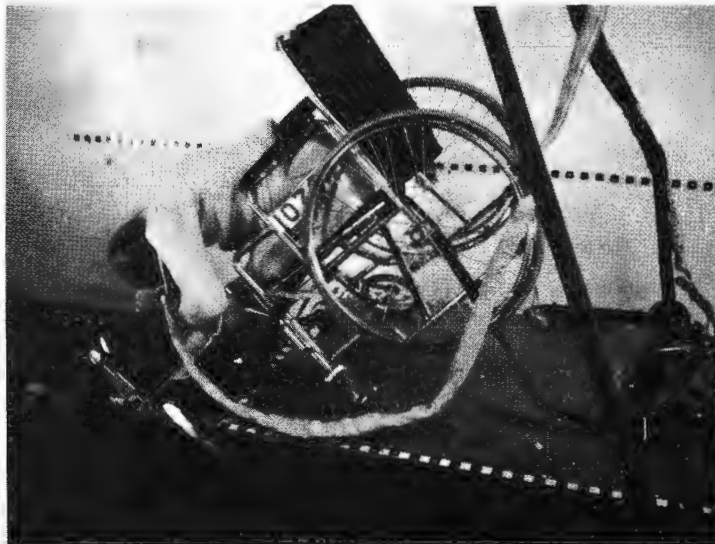
Figure A-43

DUMMY: Maximum floor belt load was measured at approximately 2000 lbs. The horizontal component of the approximately 45° belt ($2 \times 2000 \times .707 = 2830$ lbs) agrees well with the observed 15 g occupant chest acceleration [$2830 / (165 + 45) = 13.5$ g] recorded between the 80 to 120 ms interval. The peak belt load is near the expected failure level for a single belt system using standard D-ring attachments. The high speed films showed that the elasticity of the hold-back belts allowed the chair to move back during sled run-up, which delayed onset loading of the belt and resulted in a final high belt load. The occupant suffered a moderate head strike (HIC = 500, $T_1 = 180$, $T_2 = 182$) apparently from an impact on its legs. Forward head excursion was 64 inches.

Test 1079--Post Test Conditions

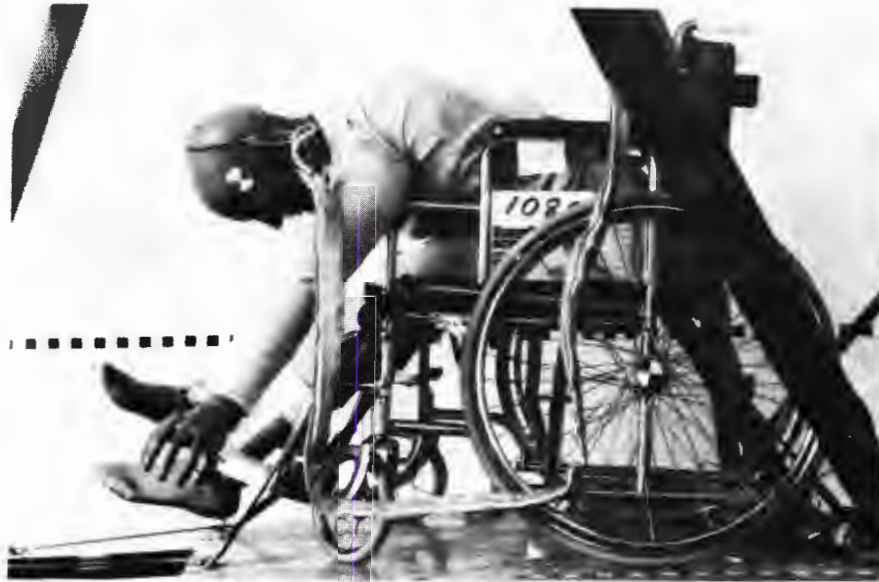
Figure A-44

DUMMY: Maximum floor belt tension was measured at approximately 2400 lbs (4800 lbs on the dummy). As in Tests 1079 and 1099, the occupant suffered a sharp head strike (HIC = 424, $T_1 = 182$, $T_2 = 184$) probably due to a leg-head interaction. Head excursion was not measured but is assumed to be similar to that in Test 1079.

Test 1086--Post Test Conditions

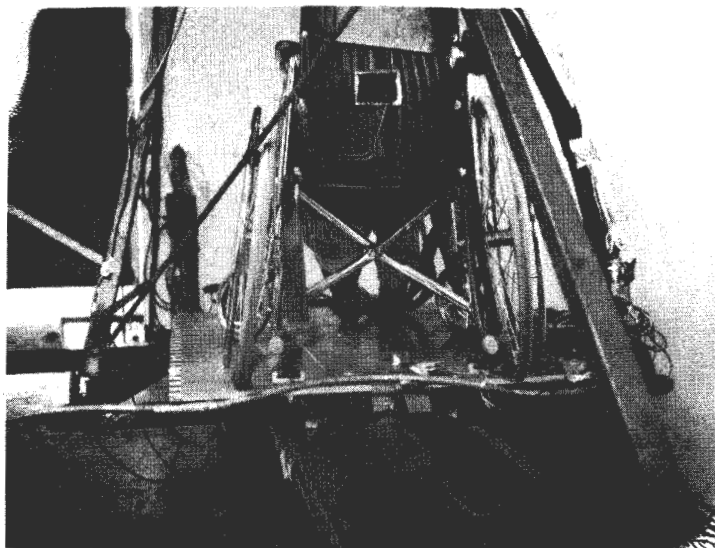
Figure A-45

DUMMY: Maximum floor belt load was measured at approximately 2400 lbs (4800 lbs on dummy). The occupant suffered a severe head strike (HIC = 1338, $T_1 = 157$, $T_2 = 160$) apparently from an impact on its legs (Figures A-46 and A-47). Forward head excursion was 50 inches.

Test 1099--Post Test Conditions

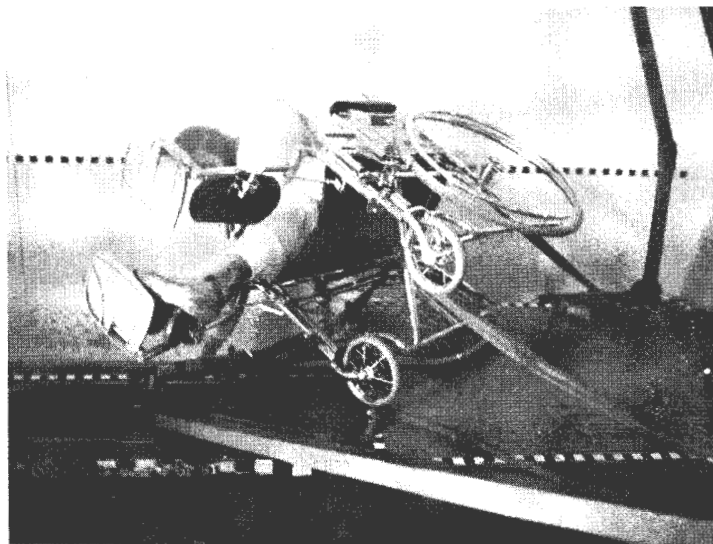
Figure A-49

DUMMY: The dummy remained with the chair as it rotated forward and to the side. Forward excursion of the head relative to its initial position on the sled was 44 inches. Instrumentation was not provided to measure dummy accelerations. Belt loads were moderate with a maximum of 650 lbs tension in the trailing belt.

Test 1078--Post Test Conditions

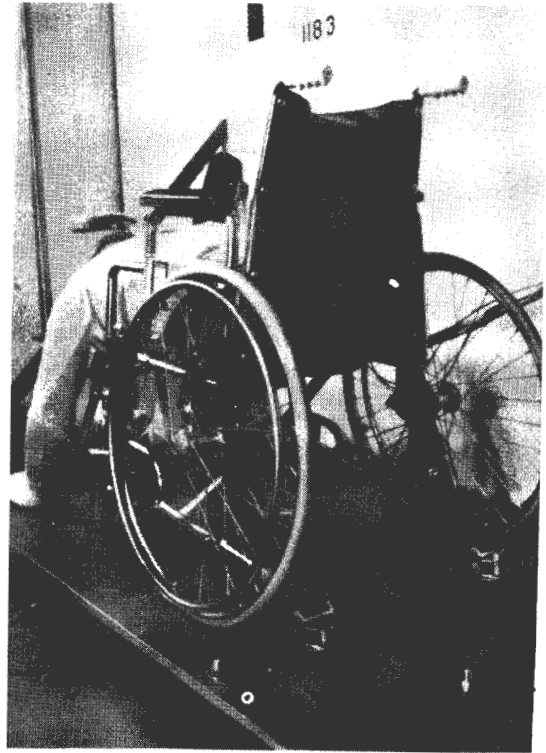
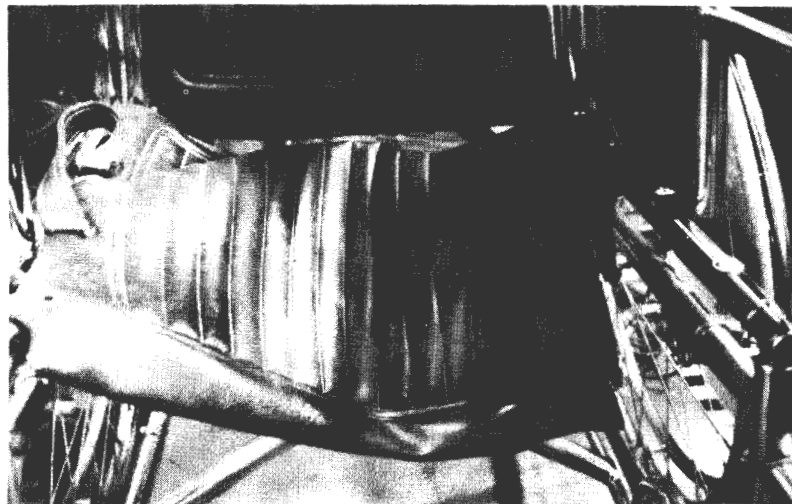
Figure A-54

DUMMY: The data recorded a minor head strike (HIC = 306, $T_1 = 10$, $T_2 = 128$). Maximum head excursion was 50 inches. Maximum recorded tension in the seat belt was 450 lbs.

Test 1183--Post Test Conditions

Test 1183--Seat Damage

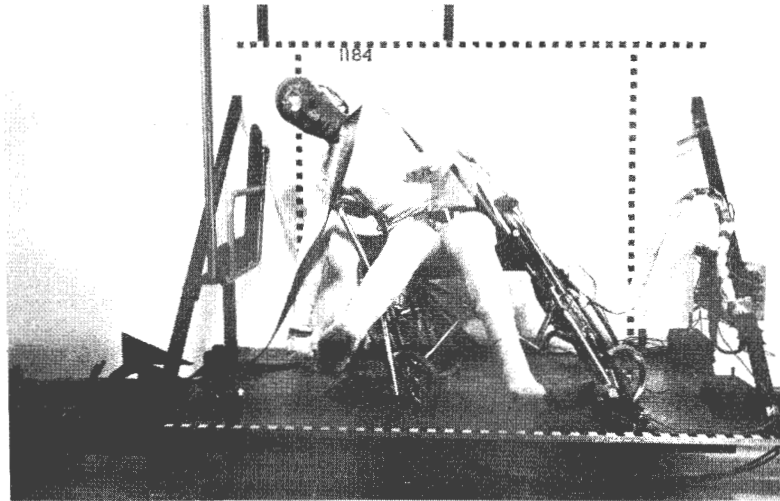
Figure A-55

DUMMY: The blow to the side of the head on the obstruction registered acceleration (Figure A-56) which indicated fatal injury (HIC = 1532, $T_1 = 188$, $T_2 = 191$).

Test 1184--Post Test Conditions

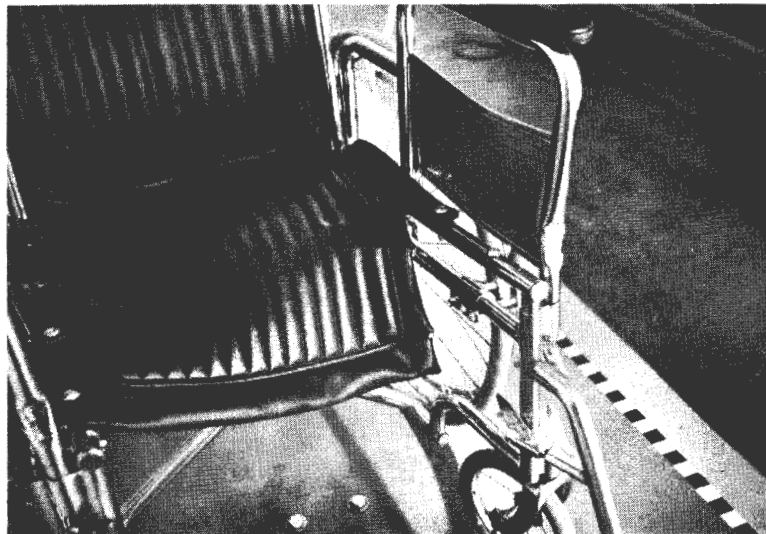
Figure A-60

Test 1185--Chair Damage

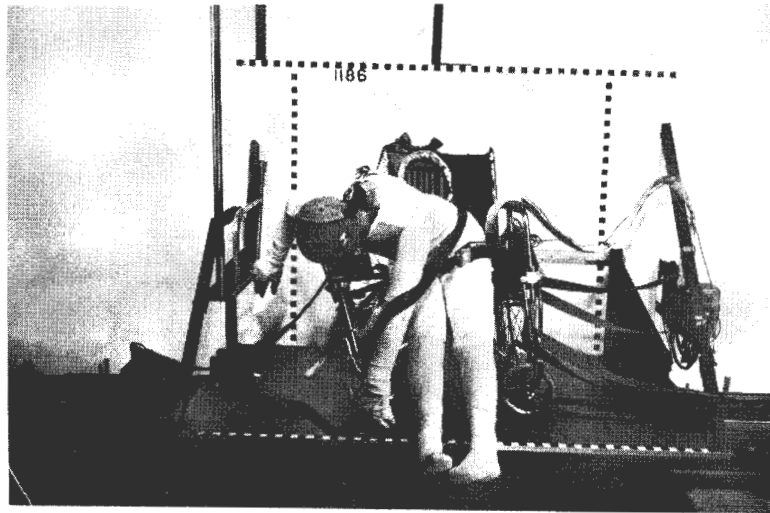
Figure A-61

Test 1186--Post Test Conditions

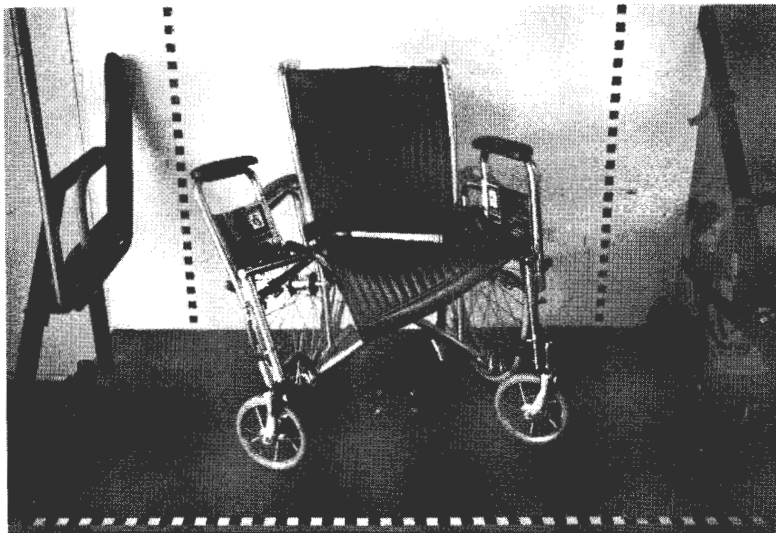
Figure A-62

Test 1186--Chair Damage

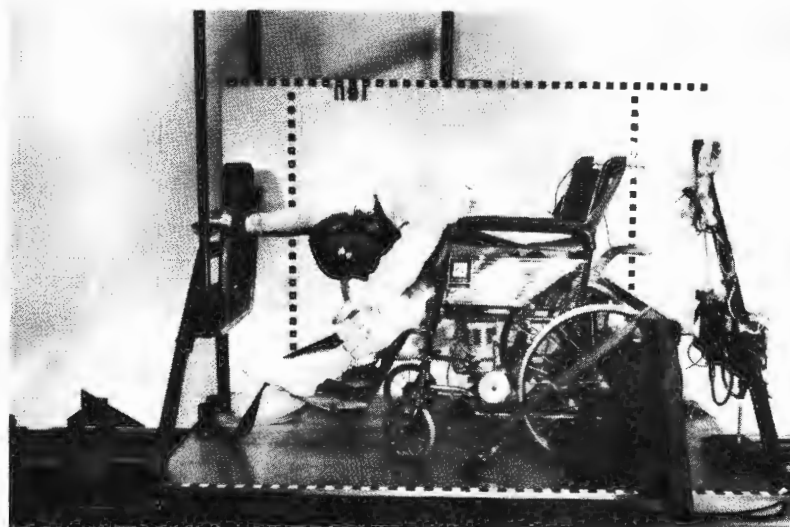
Figure A-64

DUMMY: A maximum head excursion of 43 inches was measured. Peak seat belt load was recorded at 500 lbs (1000 lbs on the dummy). Although significant head strikes were not noted, head injury criteria calculated from acceleration (Figure A-66) was fairly high in the minor range (HIC = 352, $T_1 = 118$, $T_2 = 230$).

Test 1191--Post Test Conditions

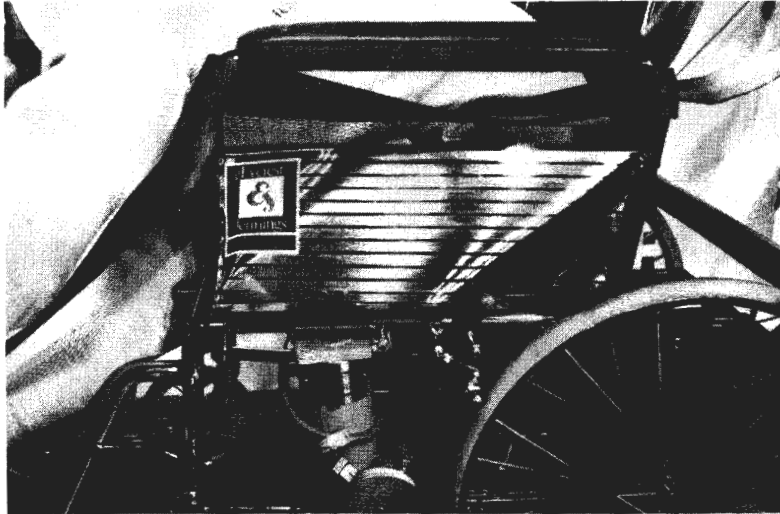
Figure A-65

Test 1191--Armrest Damage

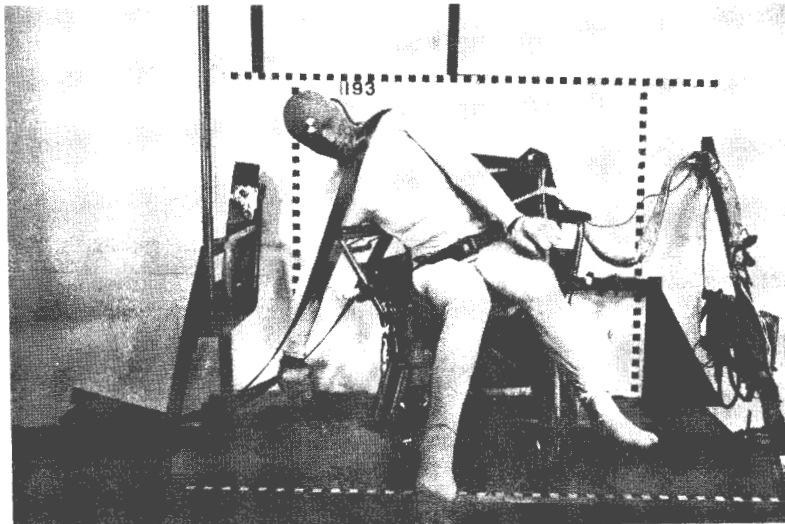
Figure A-67

DUMMY: The head strike on the forward obstruction registered accelerations resulting in a minor head injury criteria (HIC = 286, $T_1 = 15$, $T_2 = 242$). Maximum head excursion was 58 inches. Seat belt load peaked at 1200 lbs. Sideways bending of the torso was extreme, indicating the potential for injury.

Test 1193--Post Test Conditions

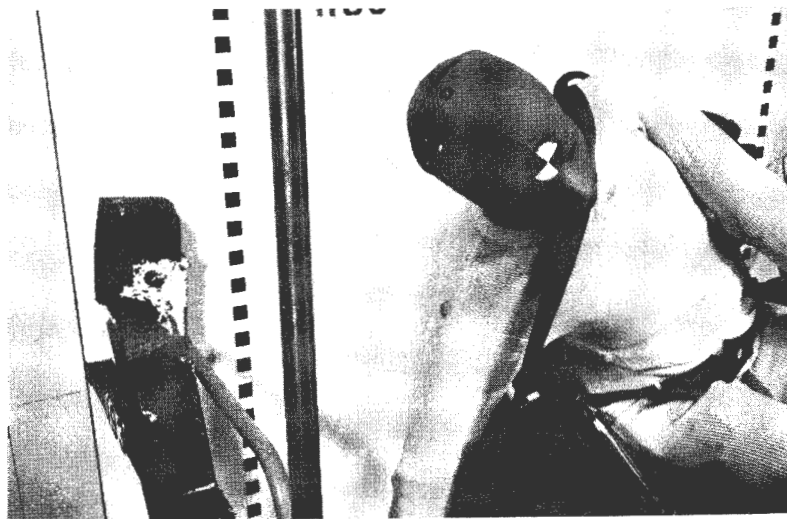
Figure A-68

Test 1193--Head Strike

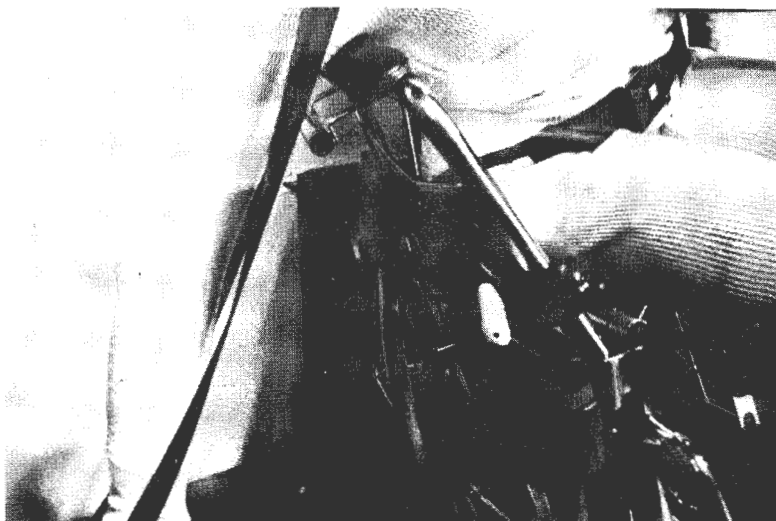
Figure A-69

Test 1193--Armrest Damage

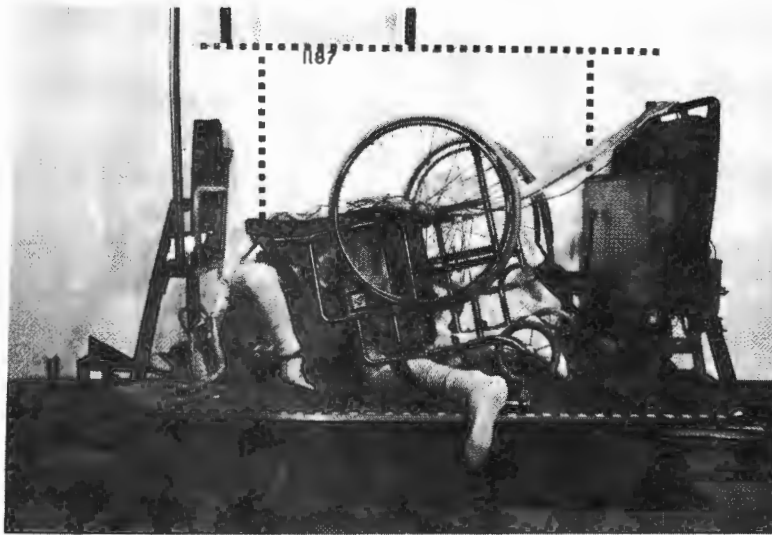
Figure A-71

Test 1187--Post Test Conditions

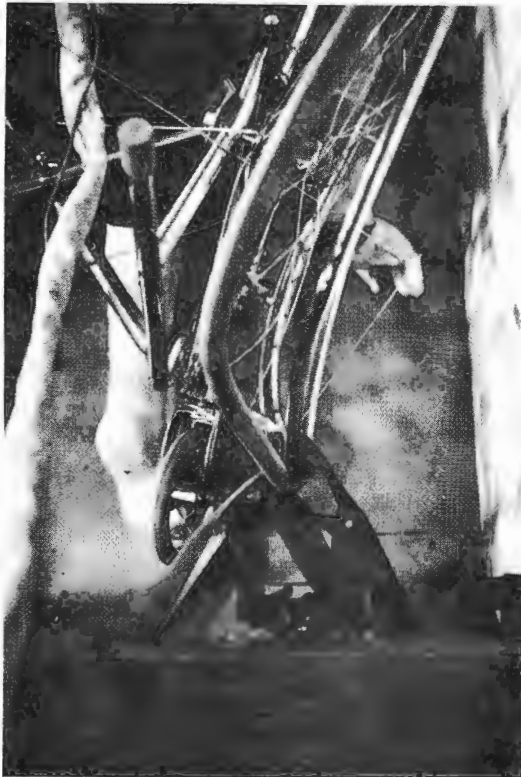
Figure A-72

Test 1187--Right
Rear Wheel

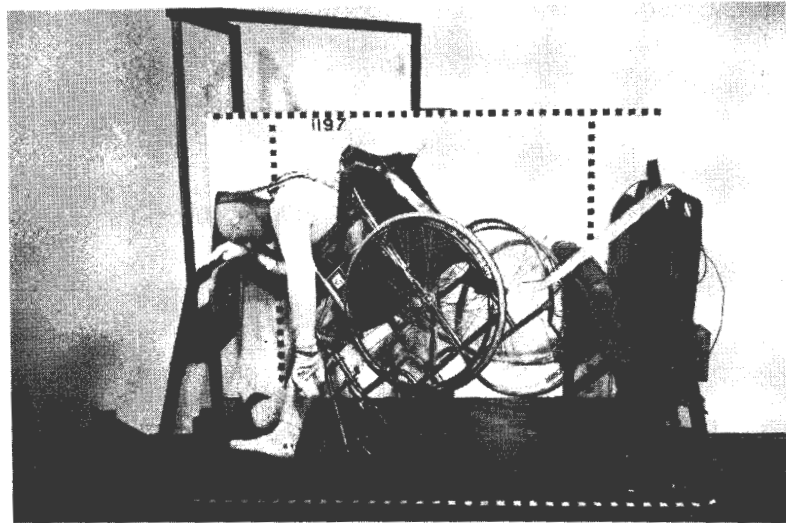
Figure A-76

DUMMY: Maximum head excursion in the direction of travel was 54 inches. However, excursion was limited by the shoulder impact on the stanchion. Although calculated severity indexes and injury criteria were low (HIC = 128, CSI = 98), injury to the shoulder could be expected from the blow on the stanchion. The maximum seat belt load recorded was only 180 lbs (360 lbs on the dummy) indicating minimal restraint by the single wheel attachment.

Test 1197--Post Test Conditions

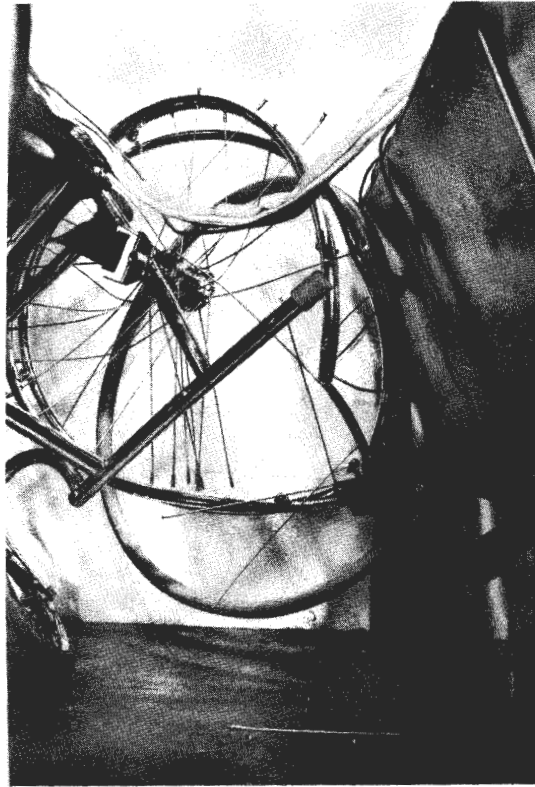
Figure A-77

Test 1197--Wheel Failure

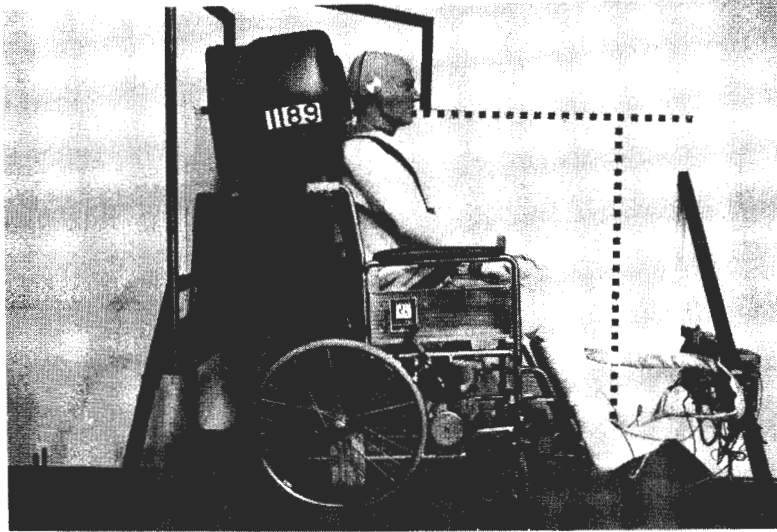
Figure A-79

DUMMY: Downrange head excursion into the securement padding was 14 inches. The impact of the head on the securement padding registered accelerations which indicate a minor head injury criteria (HIC = 144, $T_1 = 114$, $T_2 = 160$). Lap and shoulder belts recorded a maximum tension of 100 lbs on rebound.

Test 1189--Post Test Conditions

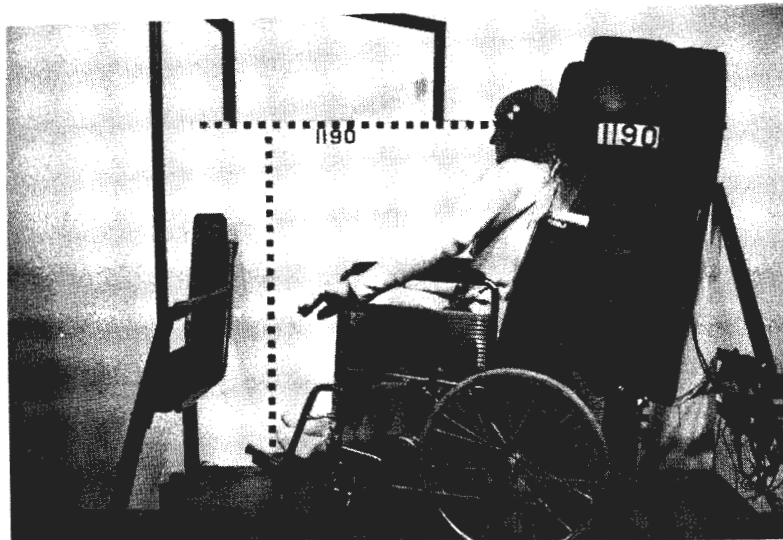
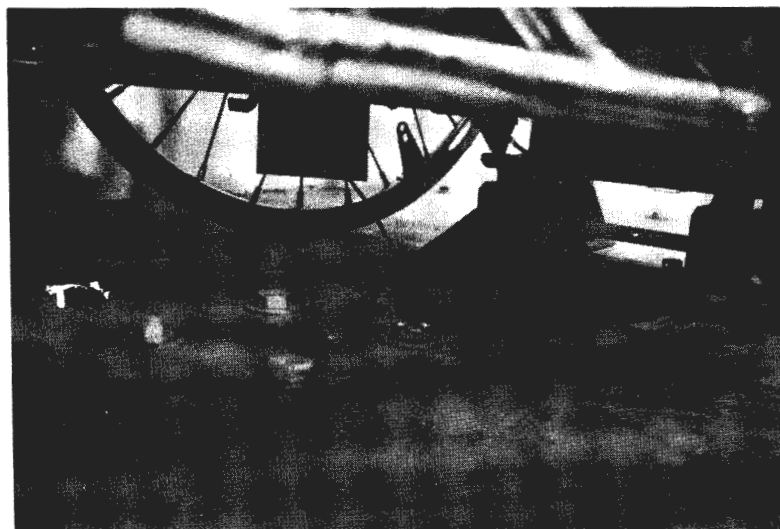
Figure A-80

DUMMY: Maximum head excursion in the direction of travel was 24 inches. Seat belt load reached a maximum of 460 lbs. Tension in the shoulder belt peaked at 250 lbs.

Test 1190--Post Test Conditions
(Note failed cable restraint)

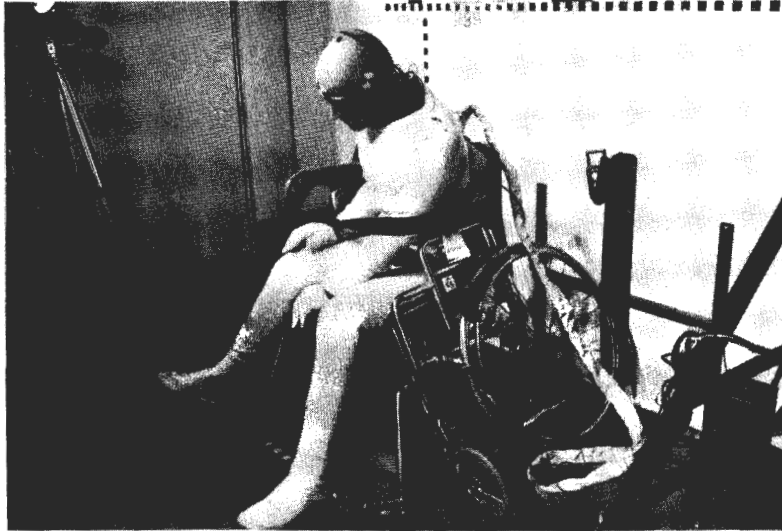
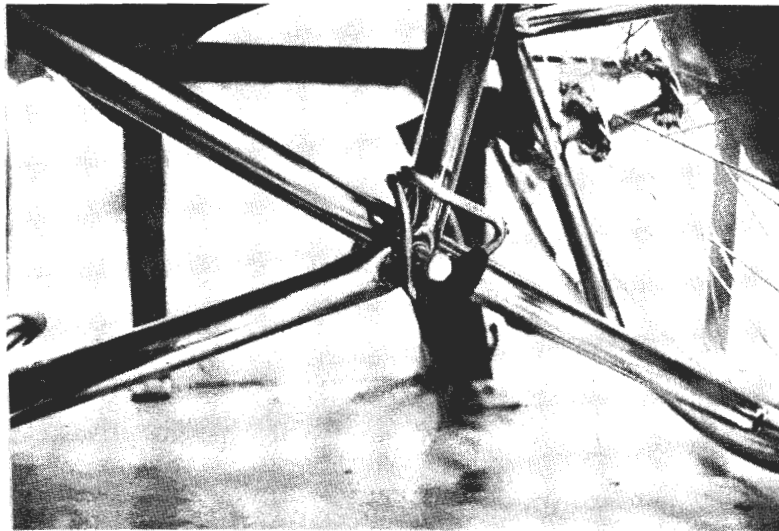
Figure A-82

DUMMY: Maximum downrange head excursion was 54 inches. However, excursion was limited by impact on the obstruction armrest. Although not indicated by the calculated injury criteria (HIC = 130, $T_1 = 198$ ms, $T_2 = 298$ ms), side impact and torso twisting could have resulted in injury. Seat belt loads reached a maximum of 1100 lbs.

Test 1199--Post Test Conditions

Test 1199--Cross Frame Failure

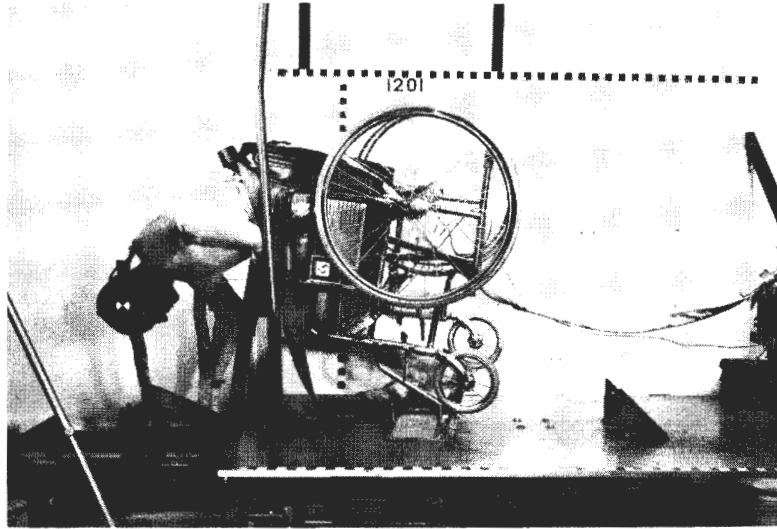
Figure A-84

DUMMY: Maximum head excursion was not measured since movement was not restricted by the securement. Seat belt load reached a maximum of 370 lbs. (720 lbs on the dummy) at failure of the securement cable. Although calculated severity indexes and injury criteria were low (CSI = 80, HIC = 70), injury to the shoulder could be expected from the blow o the stanchion.

Test 1201--Post Test Conditions

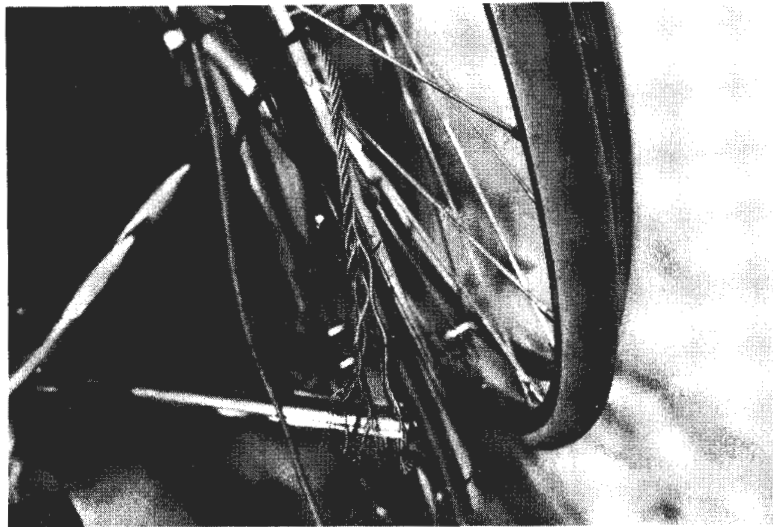
Figure A-85

Test 1201--Failed Cable
