WHEELCHAIR SECUREMENT
on
BUS AND PARATRANSIT VEHICLES

Interim Report No. 1

April 1981

Carl F. Stewart
Herbert G. Reinl

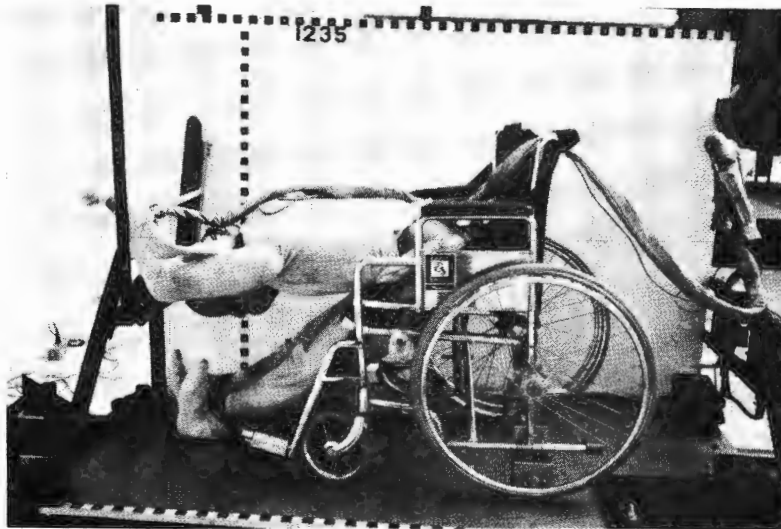
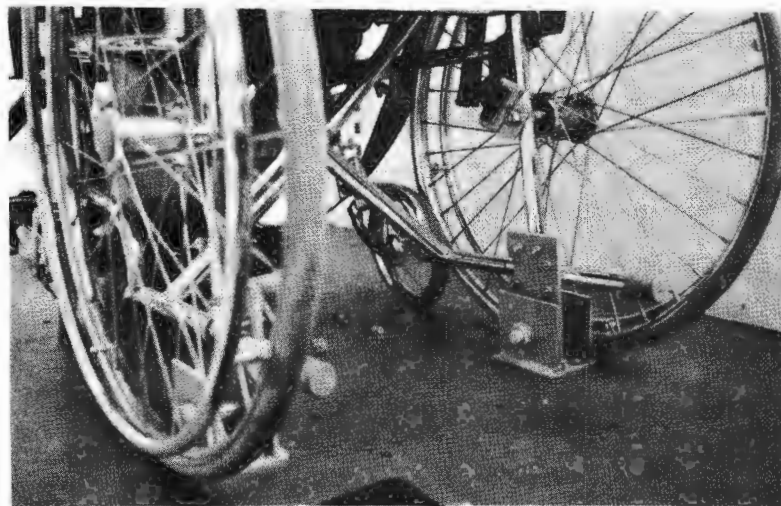
Figure A-87

DUMMY: Maximum seat belt load was recorded as 300 lbs (600 lbs on the dummy). Recorded head accelerations confirmed the head strike on the dummy's leg of a minor nature (HIC = 306, $T_1 = 114$, $T_2 = 211$). Maximum head excursion was 39 inches.

Test 1235--Post Test Conditions
