# Vulnerability of Transportation Systems to Earthquakes--U.S.

Report No.  
FHWA/RD-81/128

Final Report  
October 1982

Federal Highway  
Administration

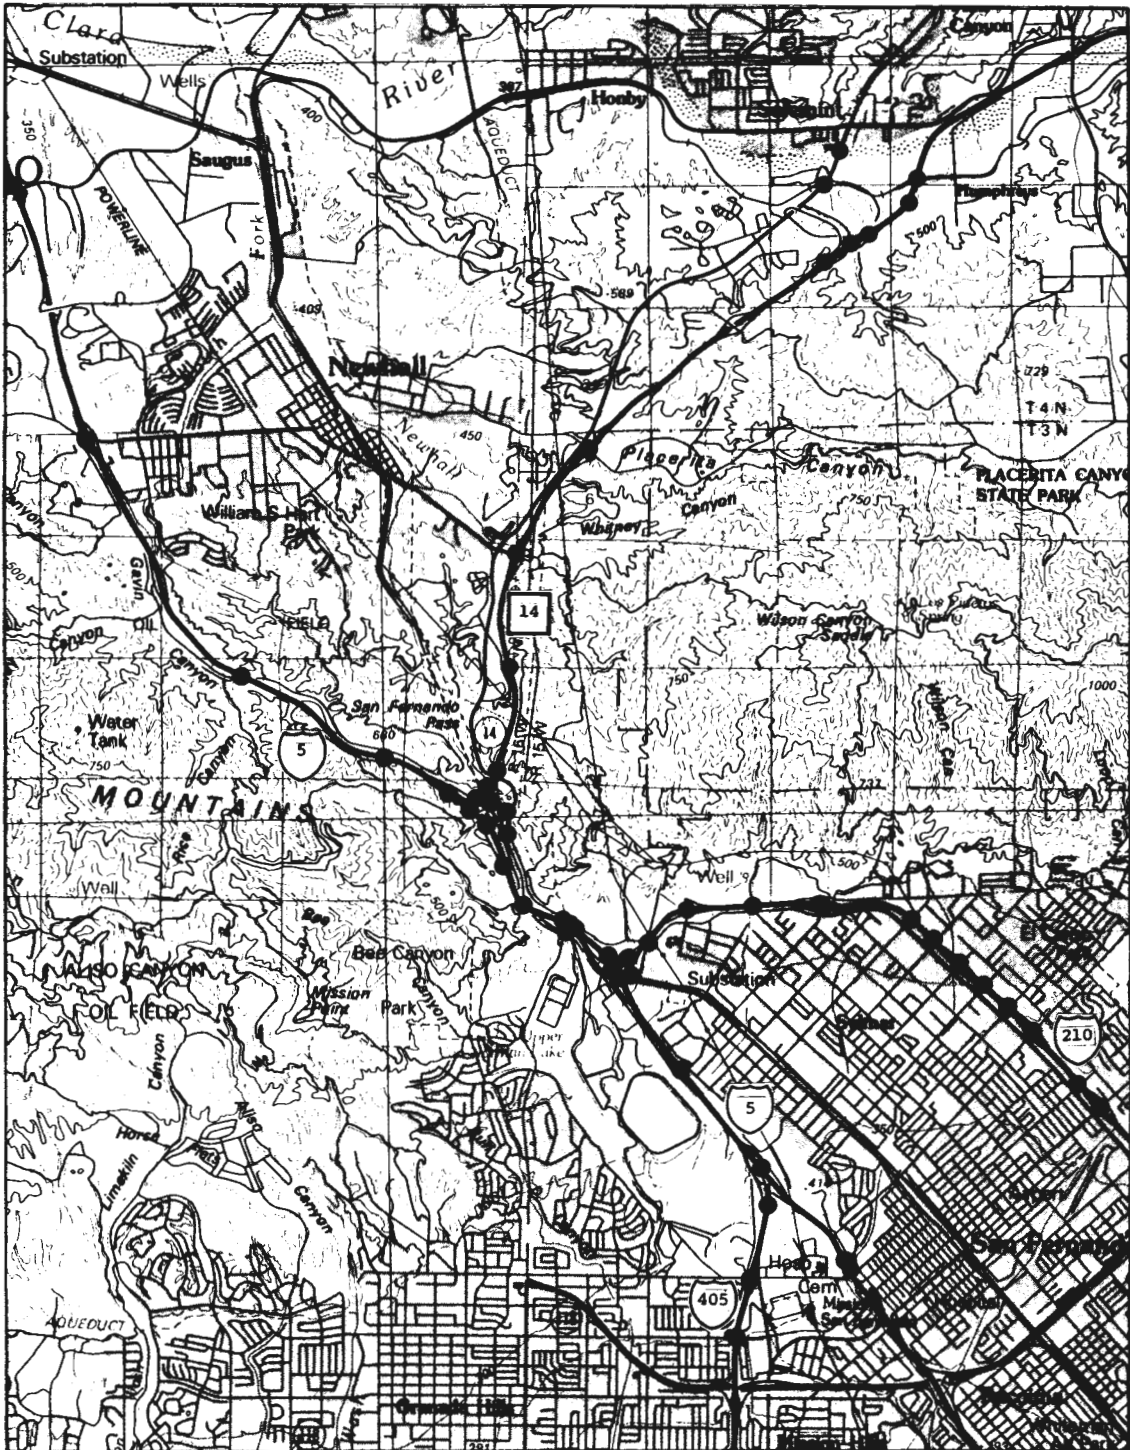
Figure 8. Location of bridges damaged in San Fernando earthquake.  
(After Elliot)

Railroad traffic also was disrupted owing to displacement and distortion of rails and to a collapsed overpass which fell onto the track. In front of the San Fernando Valley Juvenile Hall facilities, railroad tracks were twisted and broken and displaced as much as 1.2 meters.

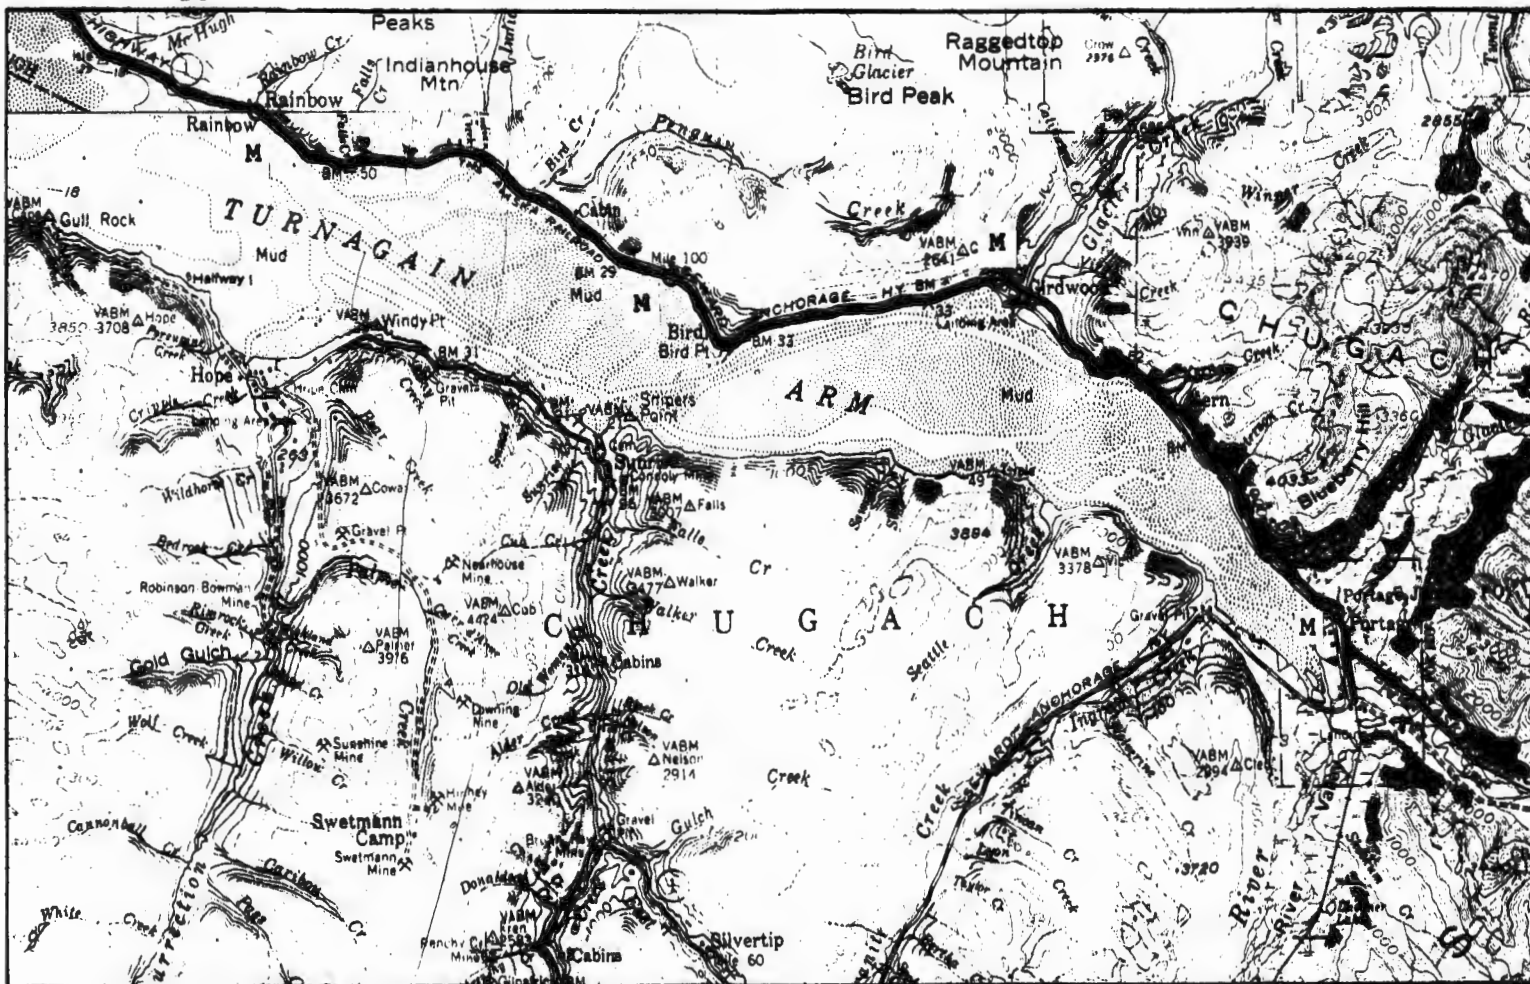
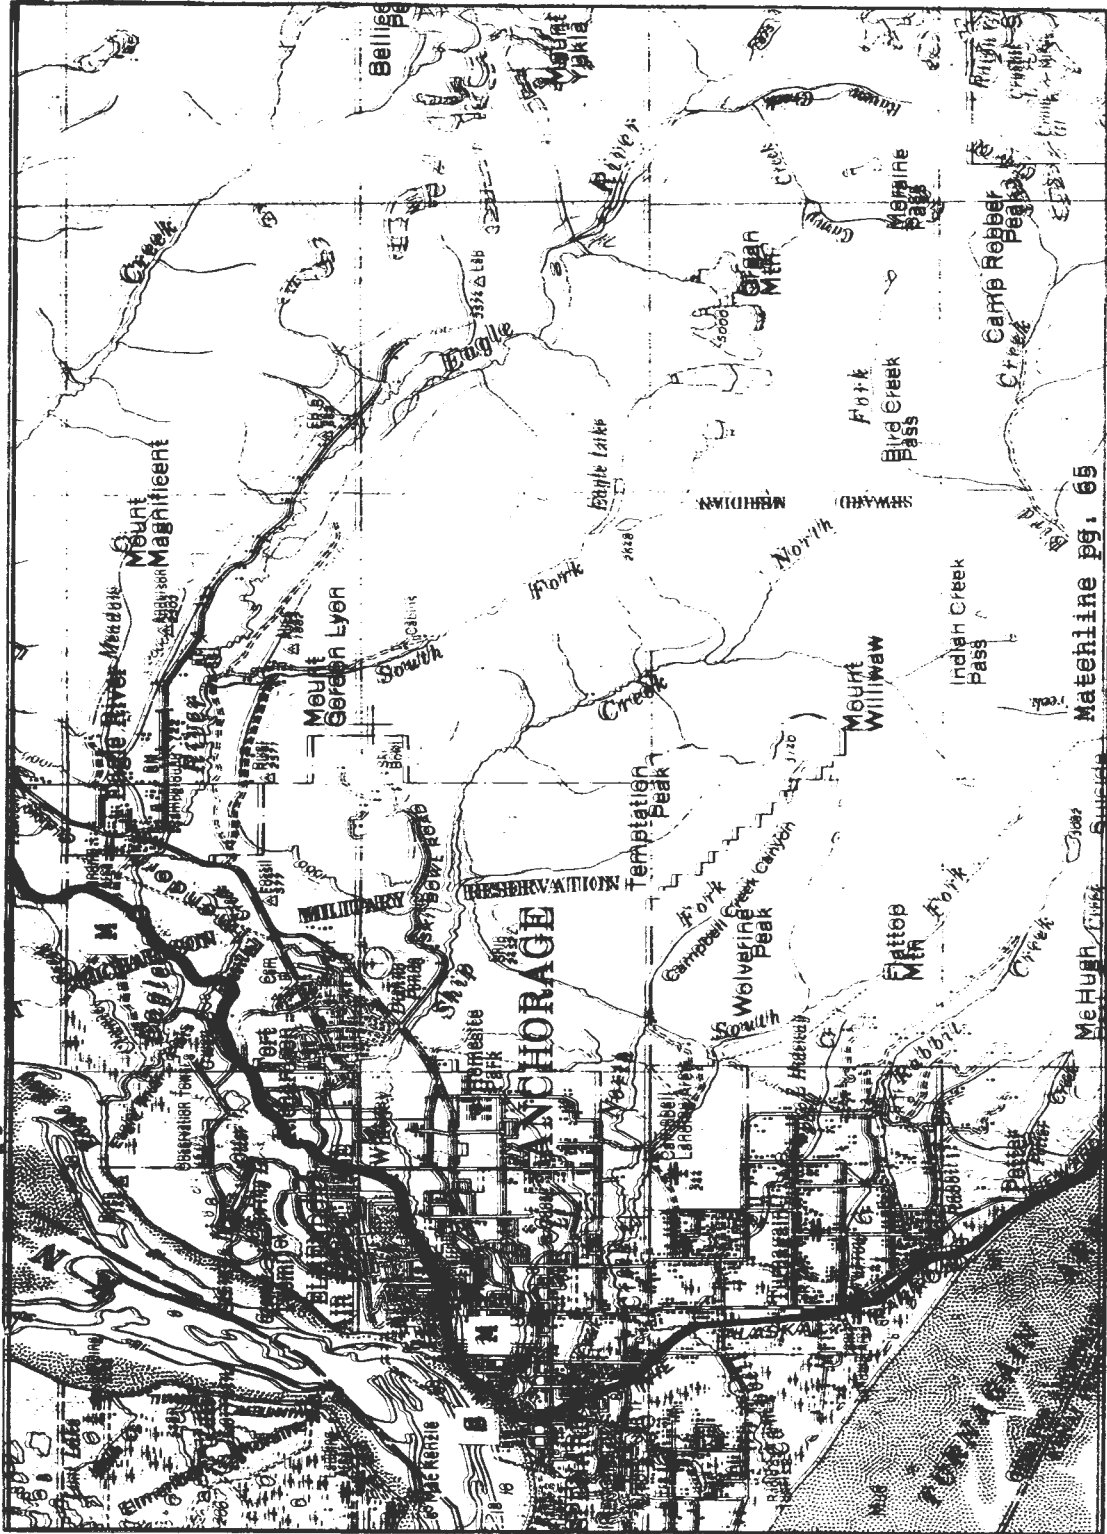
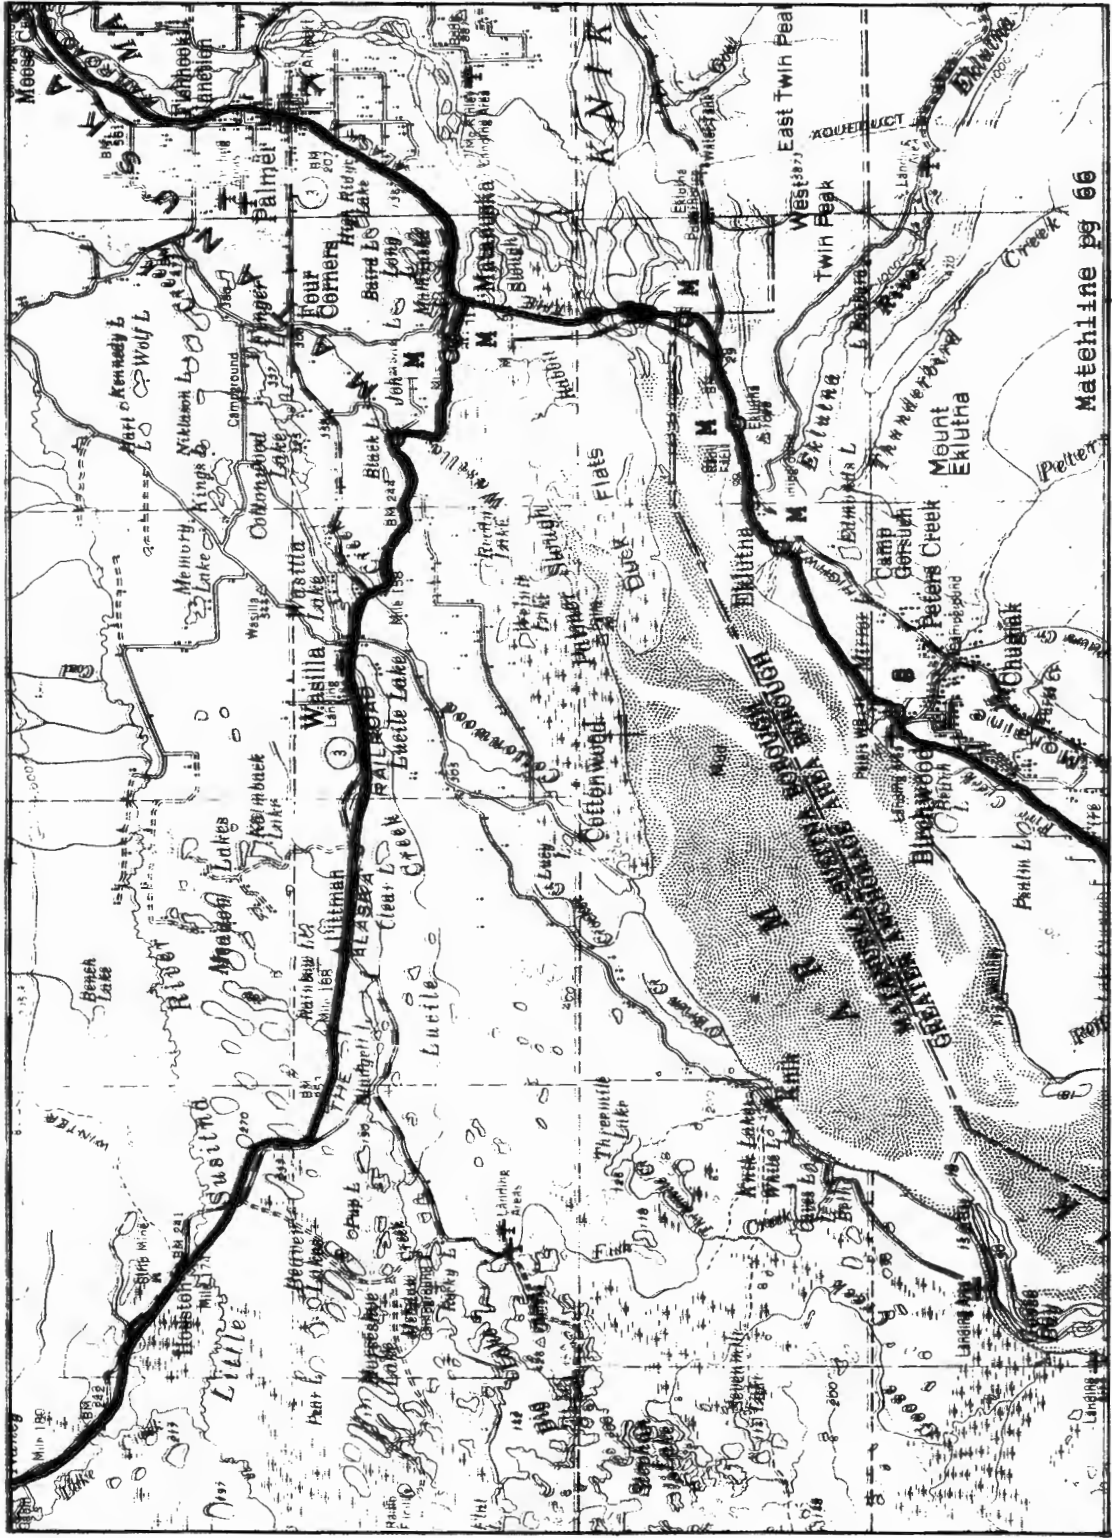
Figure 18. Continuation of Route of Alaska railroad from Portage to Moose Creek and Nancy. (After McCulloch & Bonilla)

At Potter Hill a major slide occurred carrying disintegrating blocks of earth, track, and ties as much as 140 feet horizontally. Along Turnagain Arm, waves eroded the railroad embankment which had been lowered due to tectonic subsidence. In Anchorage several shop and office buildings of the Alaska Railroad were damaged.

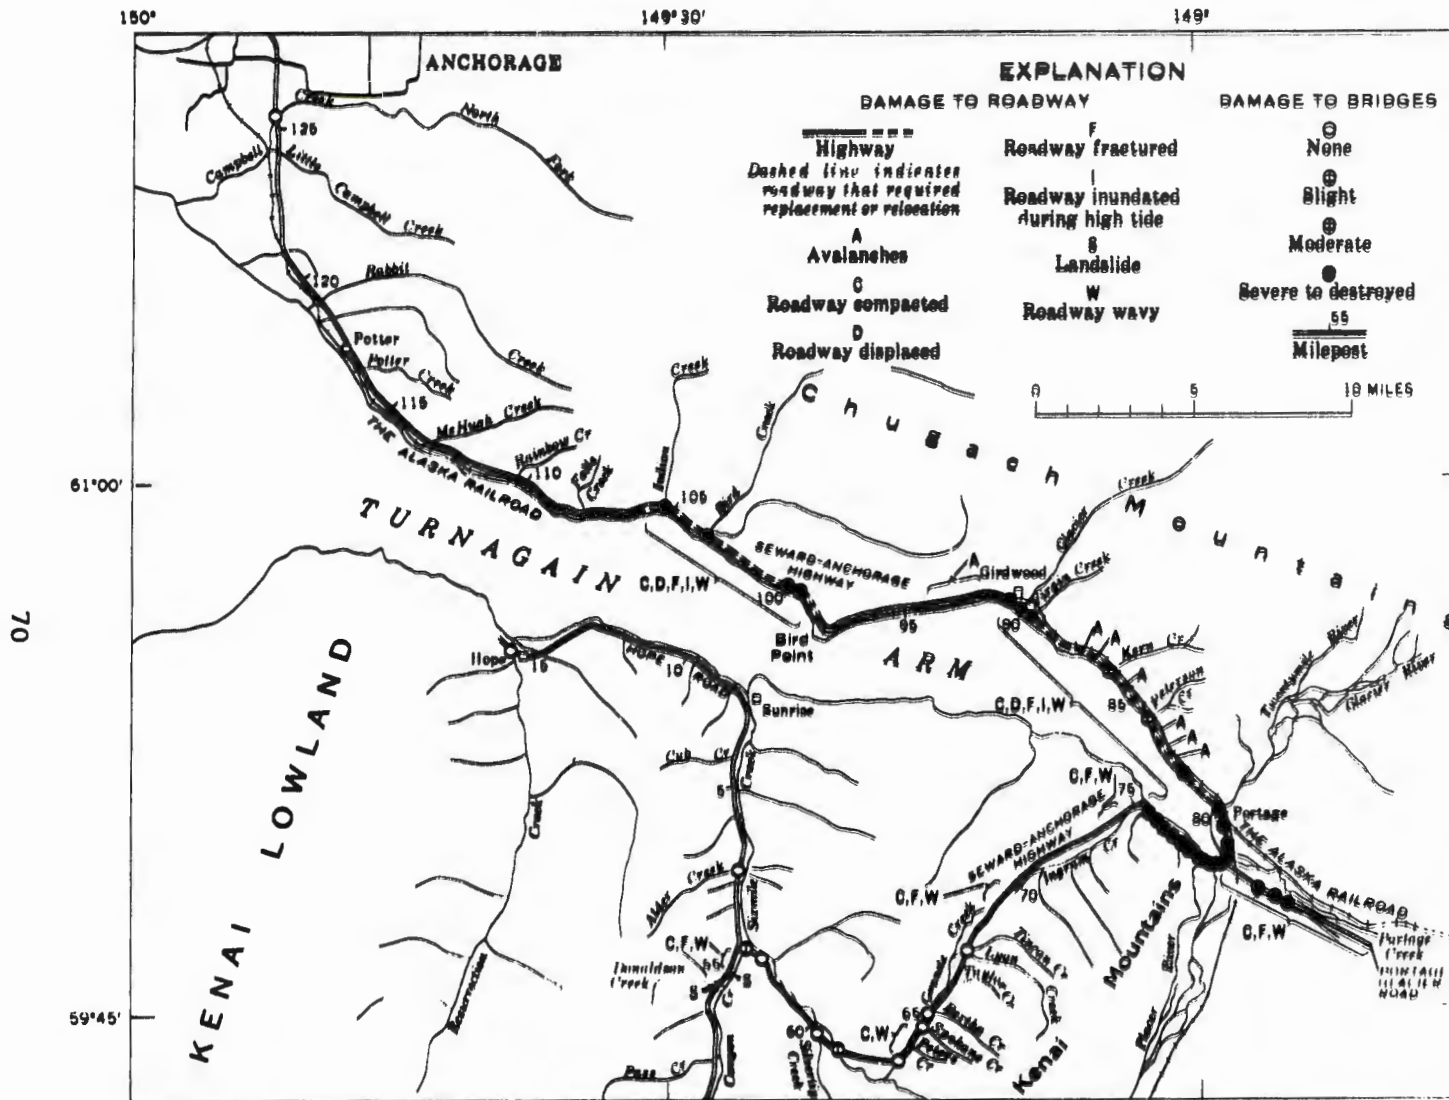
Figure 19. Damage to bridges on Seward-Anchorage Highway, Hope Road, and Portage Glacier Road. (After Kachadoorian)

On the Anchorage-Seward Highway (Figure 19) after the earthquake there was no useable land communication route between Anchorage and Seward and between Anchorage and the Kenai Peninsula towards Seldovia and Homer. High tides threatened the highway and railway roadbed between Potter and Ingram Creek, and flooded the highway from Portage to Ingram Creek. About 24 highway bridge crossings required construction of temporary bridges to carry traffic, while 30 other bridges required light to heavy repairs. It was estimated that the temporary bridges would be needed for about five years before permanent reconstruction could be accomplished.

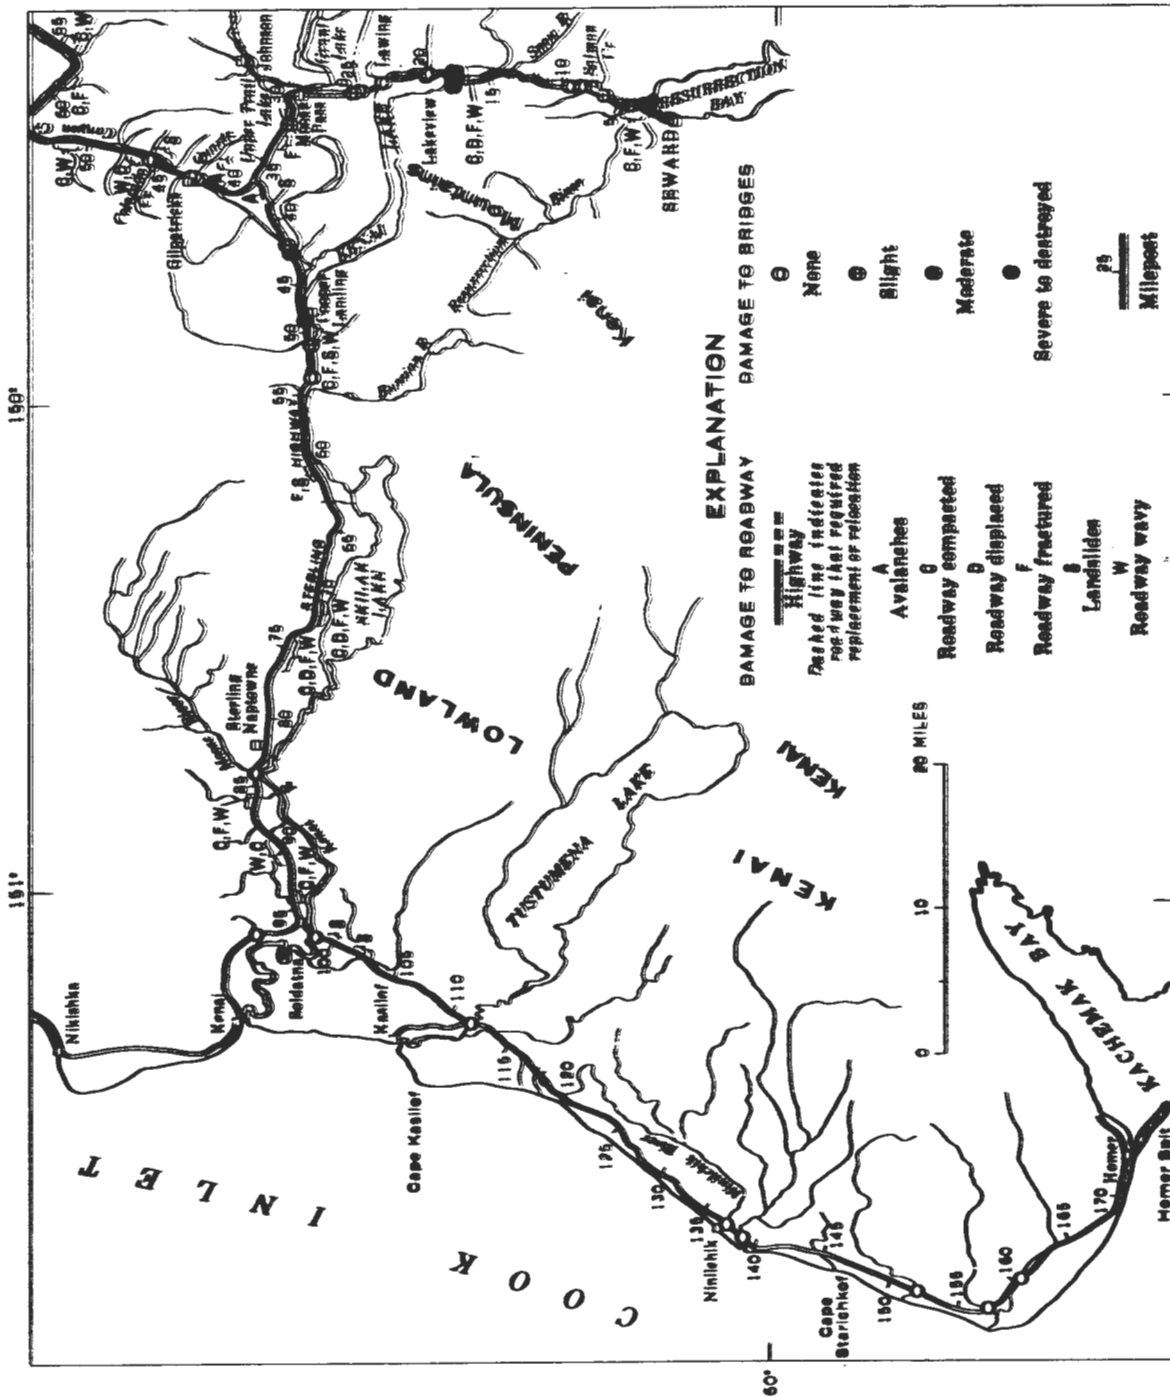
Figure 20. Damage to bridges on Sterling and Seward-Anchorage highways.  
( From Kachadoorian)

On the Sterling Highway (Figure 20) from Seward Highway to Homer - the primary bridge damage was the collapse of the bridge at Cooper Landing over the Kenai River. A temporary Bailey bridge was needed to restore traffic. On the Glen Highway - from Anchorage to the north (Figure 21) - very little damage to bridges was reported except at the Knik River Bridge located about 45 miles from Anchorage. Several piers were shifted out of line. On the 12 mile section of the Copper River Highway (Figure 22) between Cordova and the municipal airport, five of the twelve bridges needed reconstruction. Considerable damage was done to the bridges on the section of highway from the municipal airport to the Million Dollar Bridge (Figure 22). Several long spans of reconstructed railroad bridges were dropped into the river. Kachadoorian states that all the structures in this area were severely damaged and would require replacement. On the Richardson Highway (Figure 23) the bridges over Valdez glacial stream number 3 and the Little Tonsina River were severely damaged.

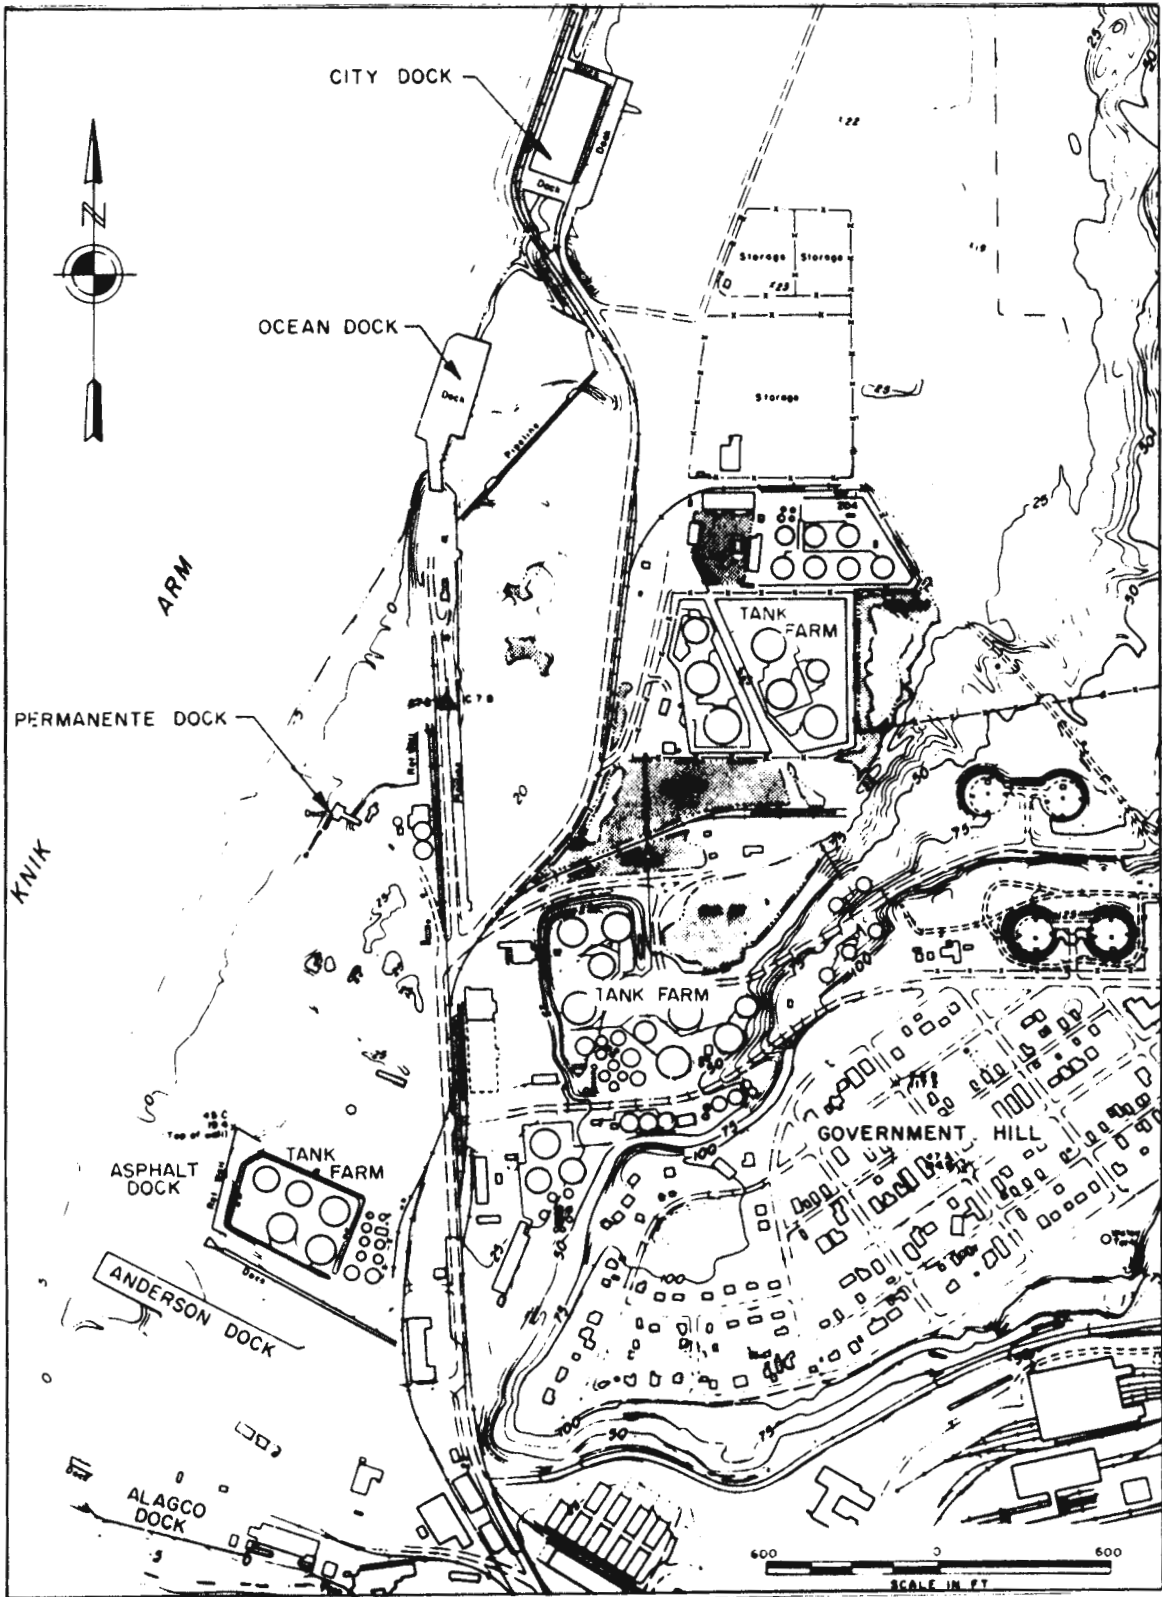
Figure 25. Anchorage waterfront facilities. (From Arno and McKinney)

No slides or fires occurred. When the tsunami arrived, the water rose above the deck of both the City dock and the Ferry dock, pulling pile caps loose from drift pins and allowing many pile caps to be dislocated. The damage was repaired. Deep water vessels have used the port since the time of the earthquake.

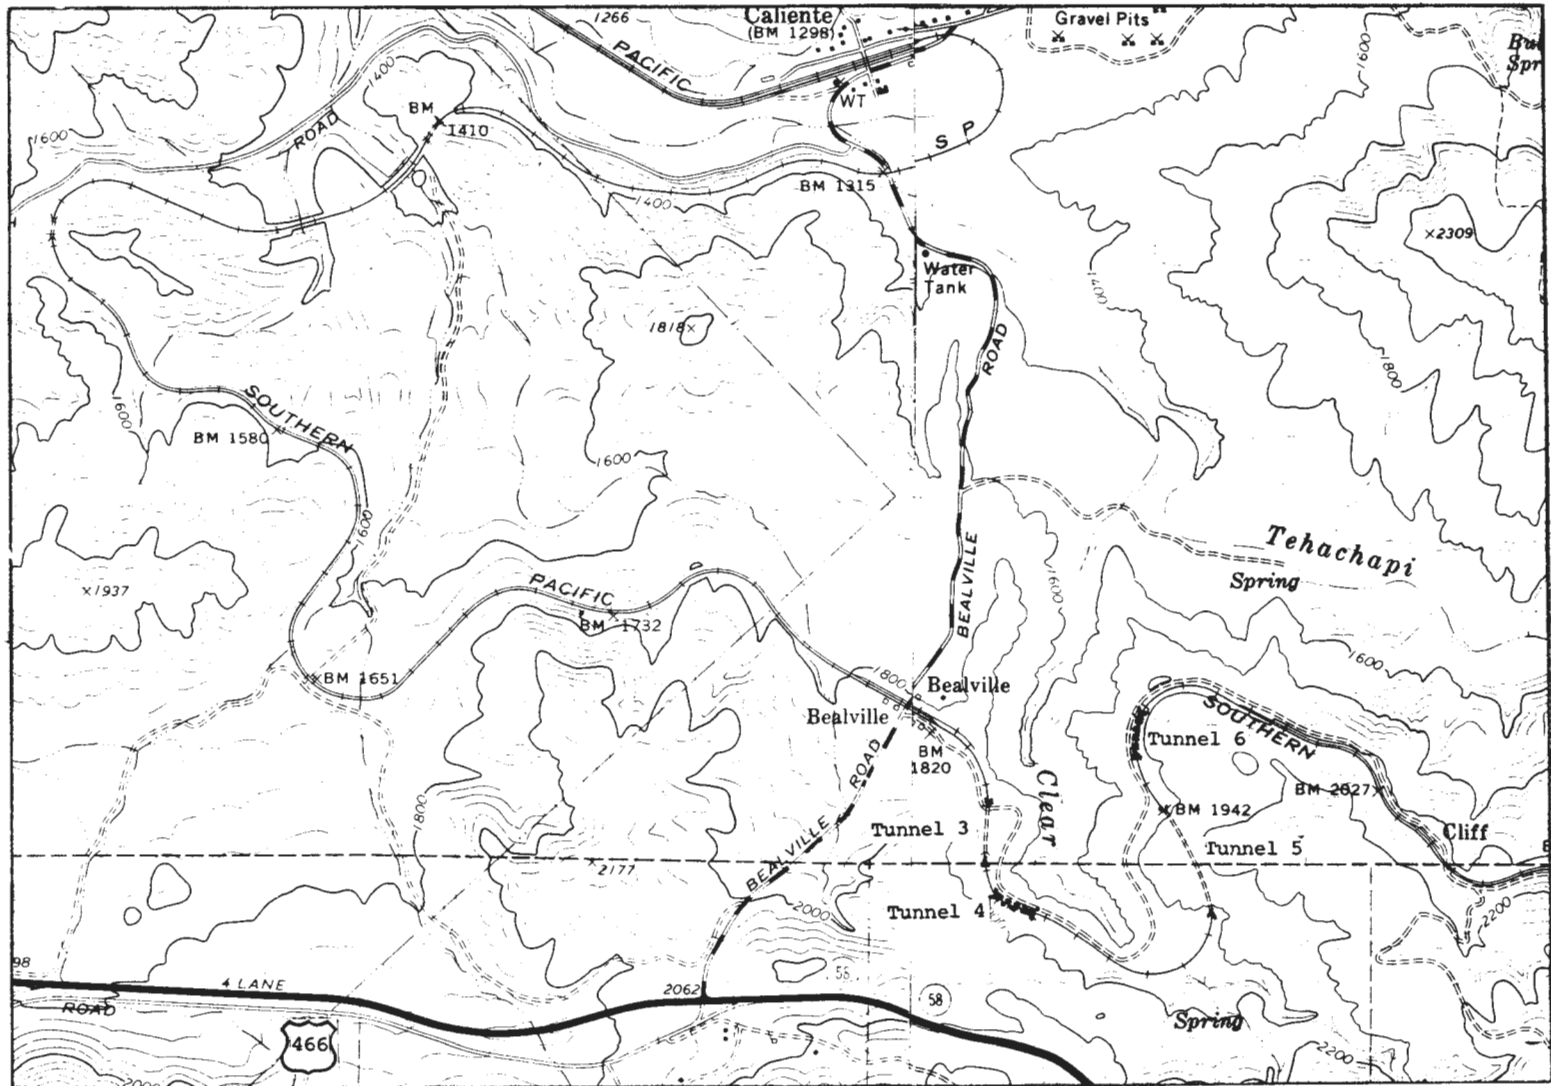
Figure 27. Location of tunnels damaged in Kern County earthquake. (After Jenkins and Oakeshott)

The tunnels in the area were lined with steel-reinforced concrete walls from 12 to 24 inches thick. Large slabs of concrete that were held in place by reinforcing after the main shock broke loose in aftershocks. Between Bakersfield and Mohave boulders and large rock masses slumped onto the tracks

so that most of the track had to be straightened, leveled, and cleared. Traffic on the line was suspended for 25 days.
