PATH Car Motor Controller Unit Investigation

Port Authority Trans-Hudson Corporation and
Parsons, Brinckerhoff, Quade & Douglas, Inc.

February 1985

This report describes the tests and analyses conducted to determine possible cause(s) of the Motor Controller fire on PATH Car 725. In addition, tests were made to determine possible cause(s) of the Motor Controller bolt erosion.

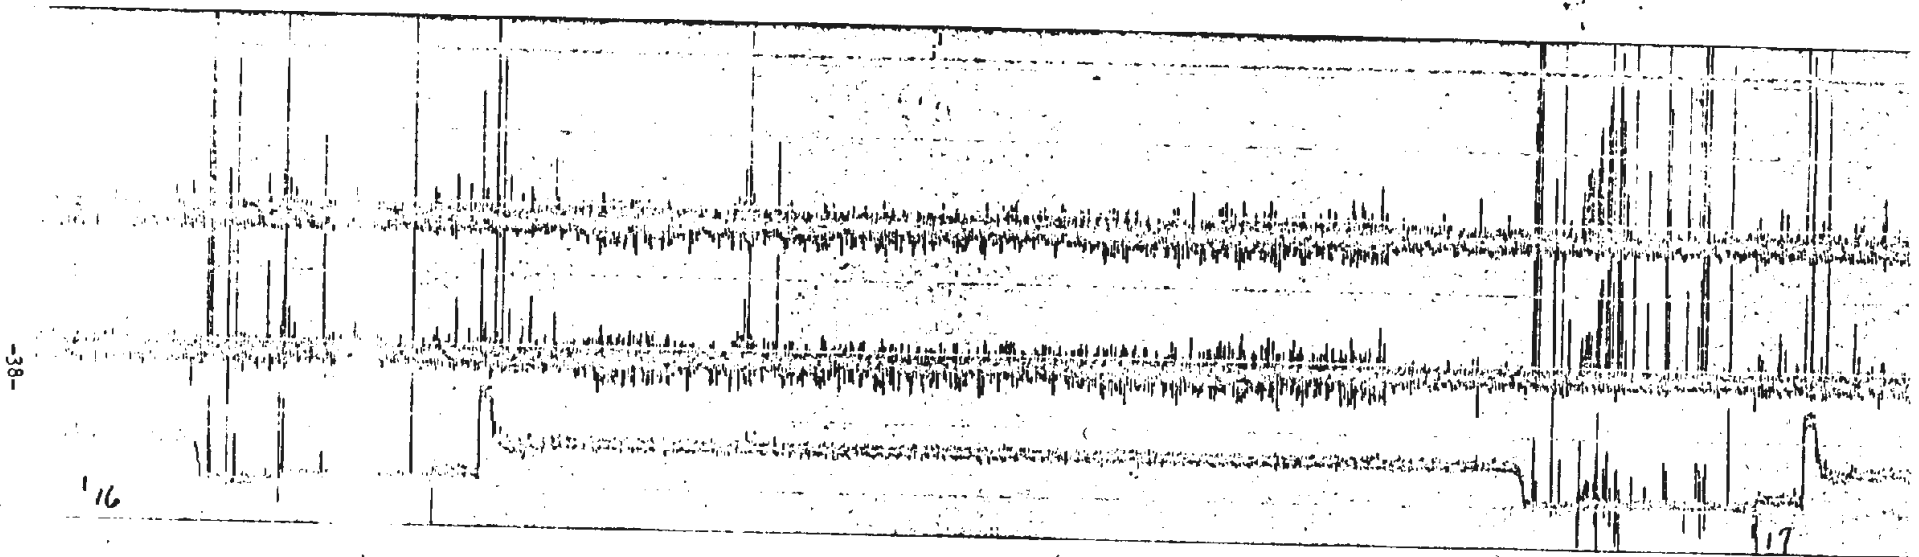
FIGURE 2 - 123 SECONDS OUT OF JOURNAL SQUARE
BOLT CURRENT VS. PROPULSION AMPERES
AT HACKENSACK RIVER BRIDGE

Upper trace - Bolt 4 current (one inch = 60 amperes)
Middle trace - Bolt 1 current (one inch = 60 amperes)
Lower trace - Propulsion amperes (one inch = 700 amperes)

- Positive bolt currents indicate currents from main group to ground
- Time scale - one inch = 0.625 seconds in real time

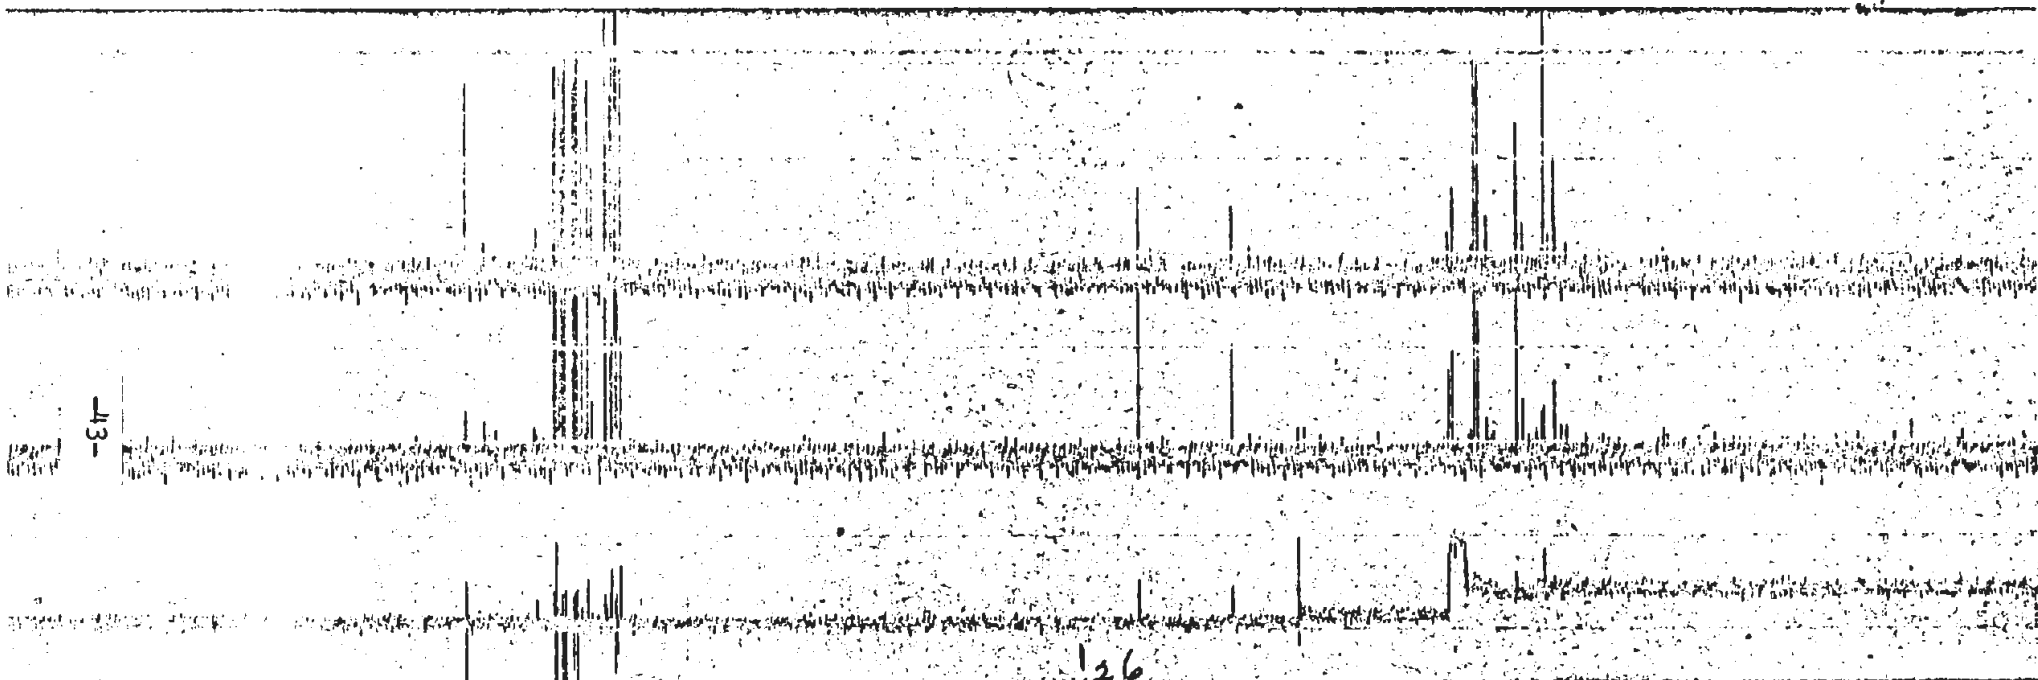
FIGURE 7 - 195 SECONDS OUT OF JOURNAL SQUARE

- An example of collector arcing followed by a power application

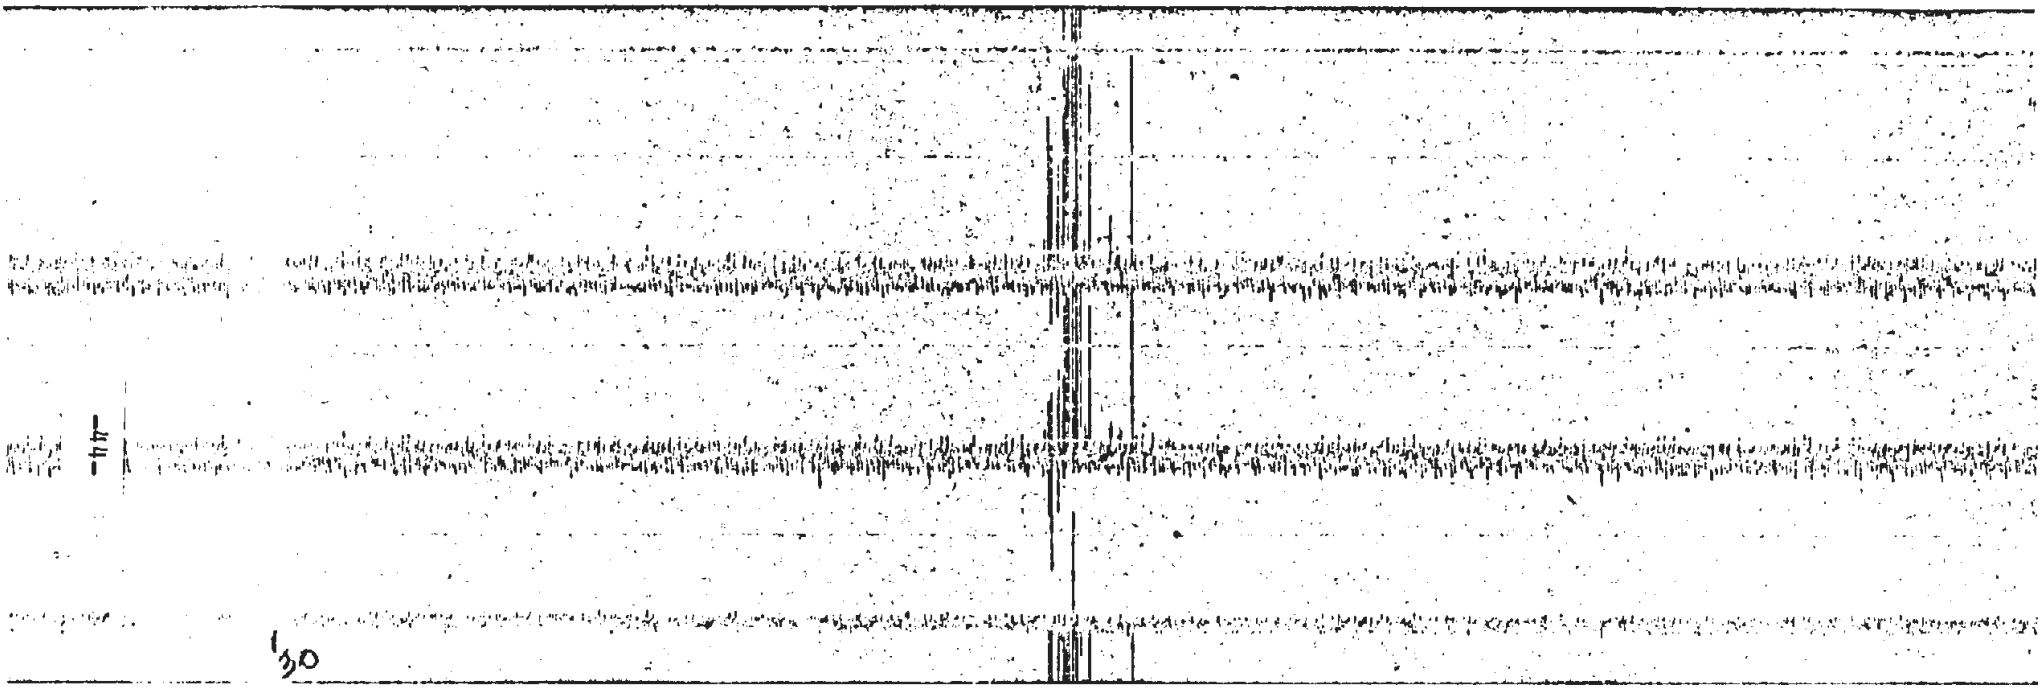
FIGURE 8 - 228 SECONDS OUT OF JOURNAL SQUARE

- An example of collector arcing

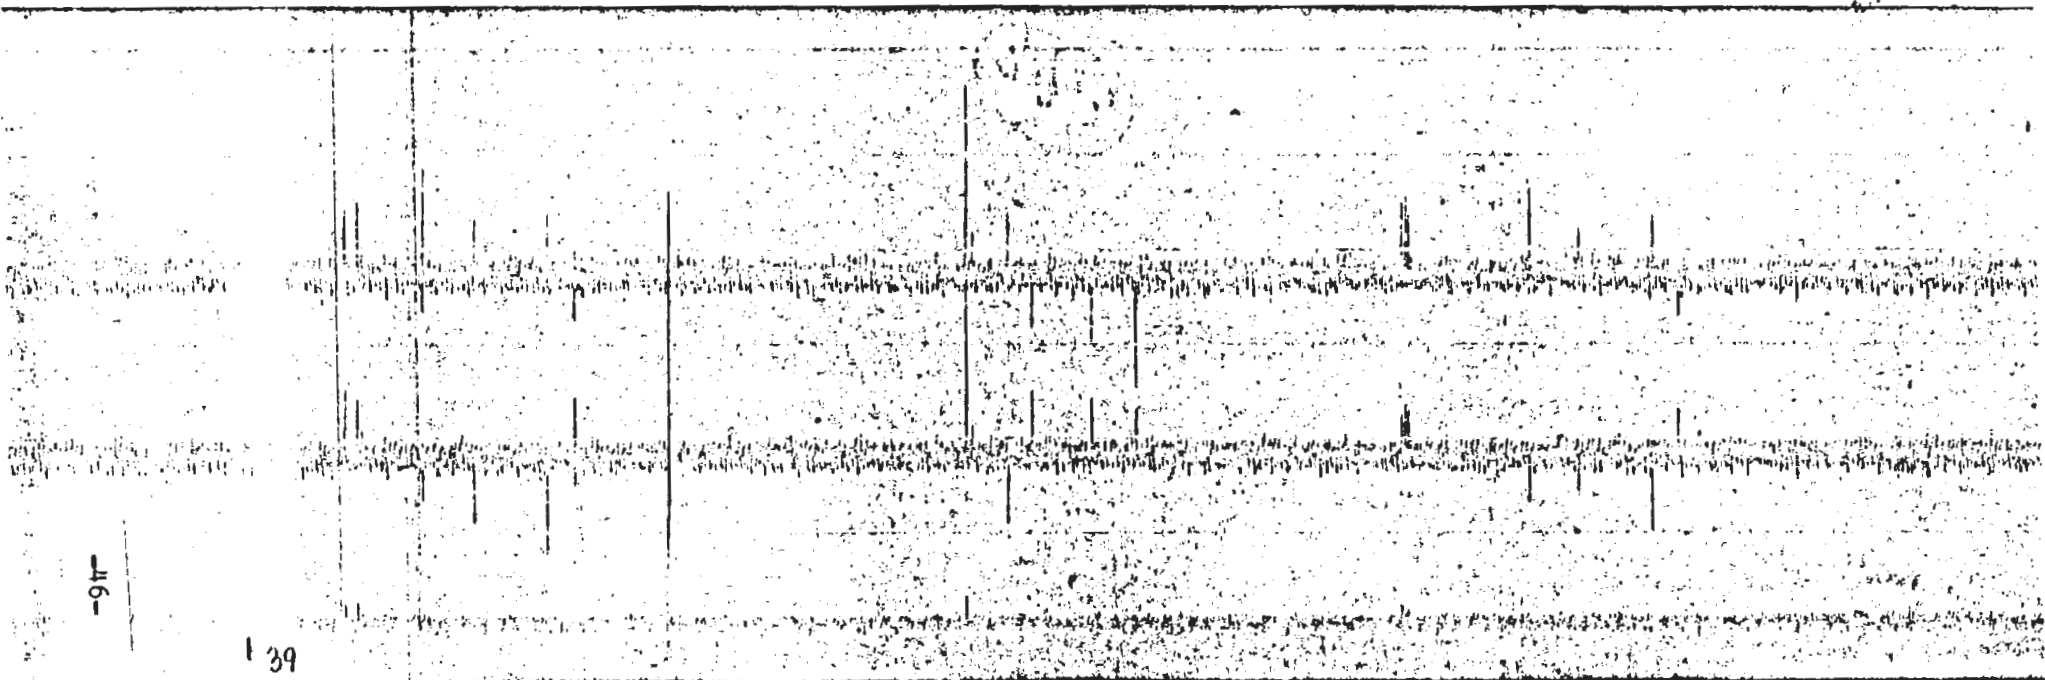
FIGURE 10 - 295 SECONDS OUT OF JOURNAL SQUARE

- An example of positive and negative simultaneous bolt currents

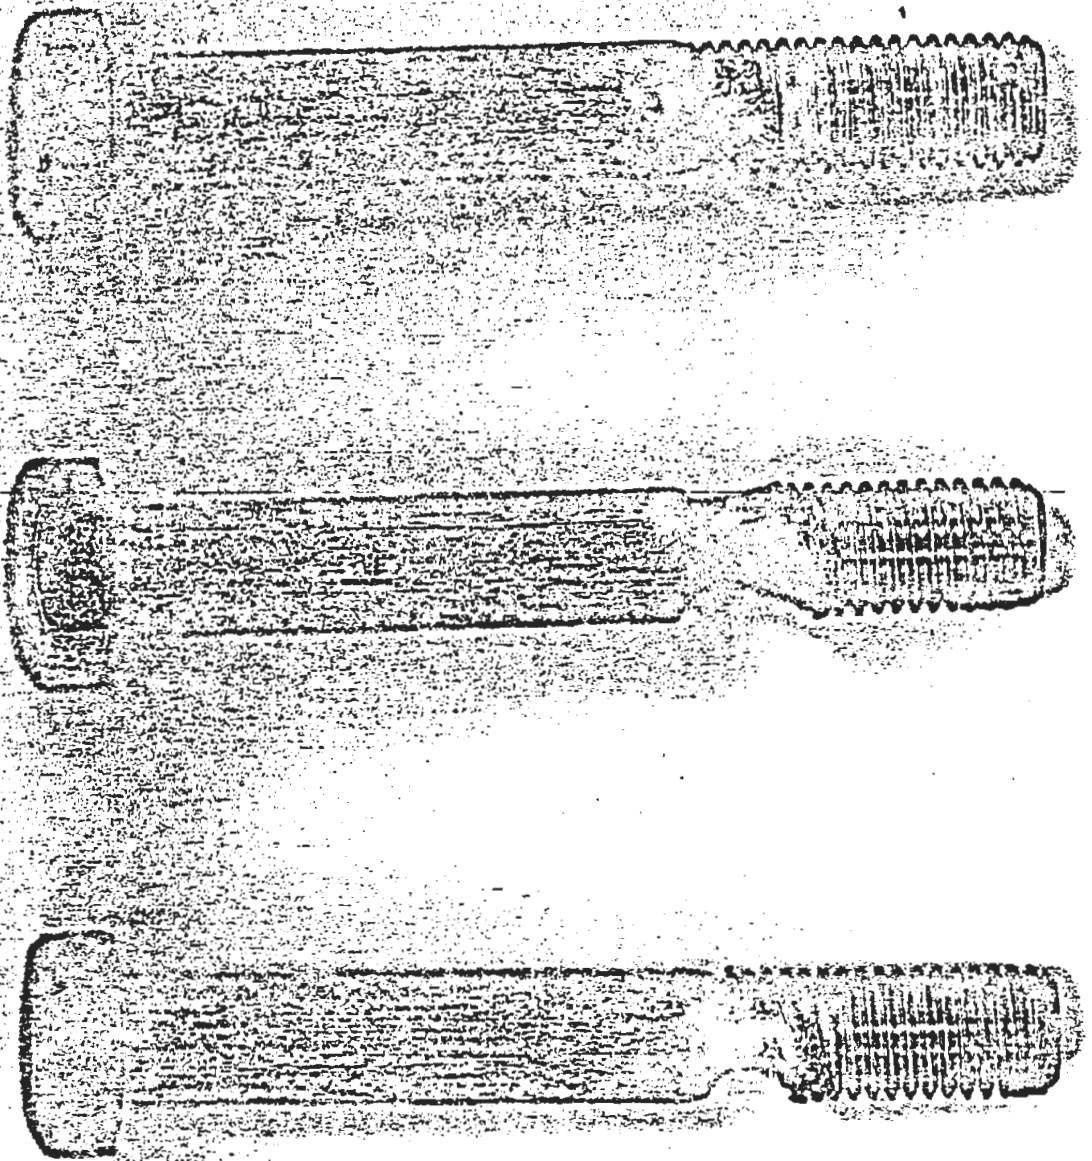
FIGURE 13

Car 159 was chosen as the test vehicle because the bolts found on this car were very severely eroded. Three of these bolts are shown in Appendix 1, Figure 13. The fourth bolt showed no erosion. Variations in erosion among the four bolts may be a random occurrence. However, Henderson Shop personnel observed that the bolt nearest to the line switch usually shows the maximum erosion. Designating this bolt as number 1, the remaining bolts are numbered 2, 3, and 4 in a counterclockwise direction when looking down on the main control group (see Figure 15).

HANGER BOLTS FROM MAIN GROUP OF CAR 159

- Note cutting of bolts occurs at interface between bolt and the top metal of main group.

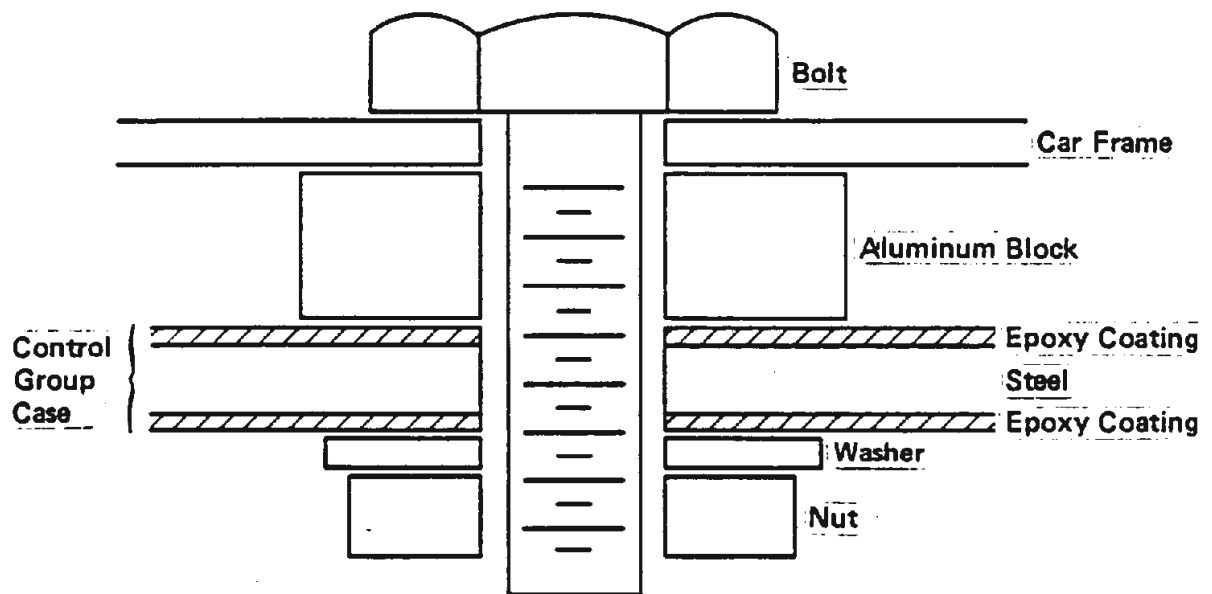
FIGURE 18. CONTROL GROUP MOUNTING BOLT

The control groups on the remaining PATH cars are mounted to the underframe of the car with four bolts passing through four aluminum blocks. Each control group has an epoxy coating on the inside and outside of the case with a combined thickness of 0.03 inch. (See Figure 18.)

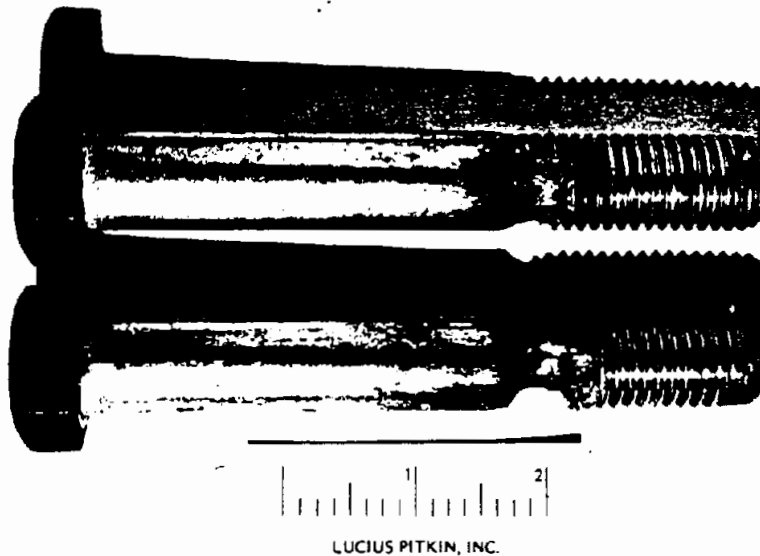
Fig. 1 SUBMITTED SUPPORT BOLTS - AS RECEIVED

Photograph showing the submitted support bolts in the as-received condition. It can be seen that wastage occurred at several threads adjacent to the shank of the bolt. This location corresponds to the support package frame.

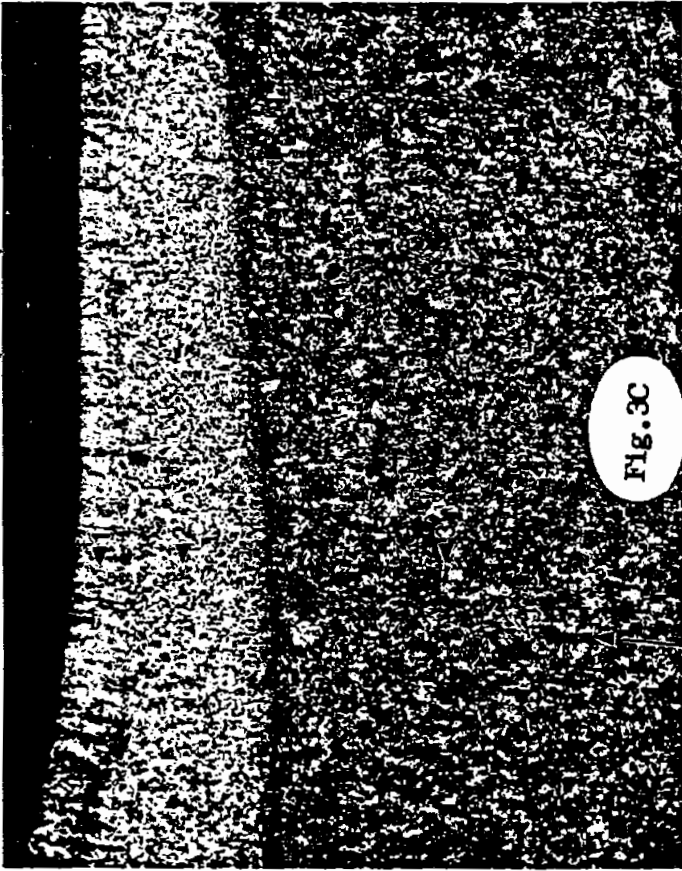
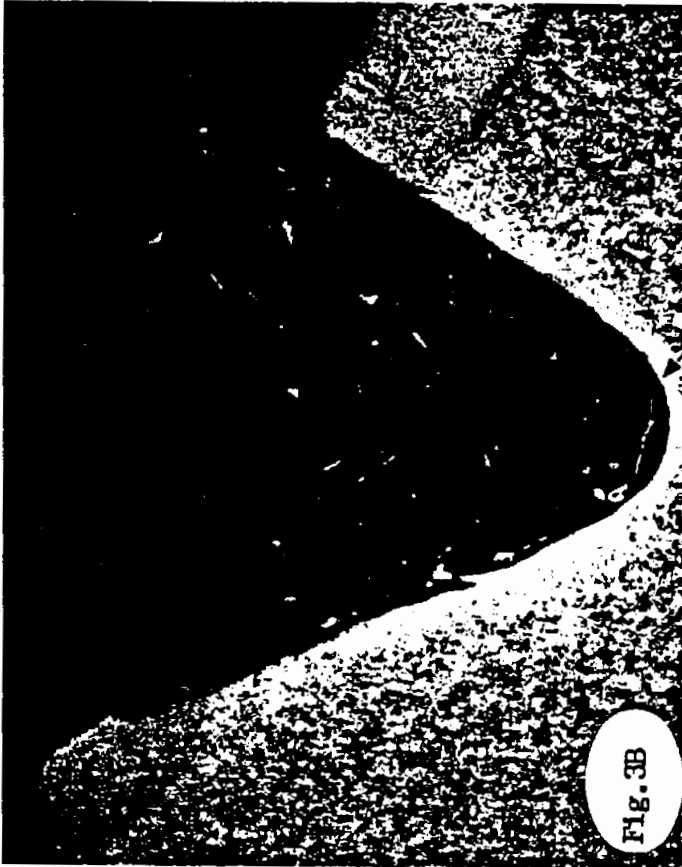
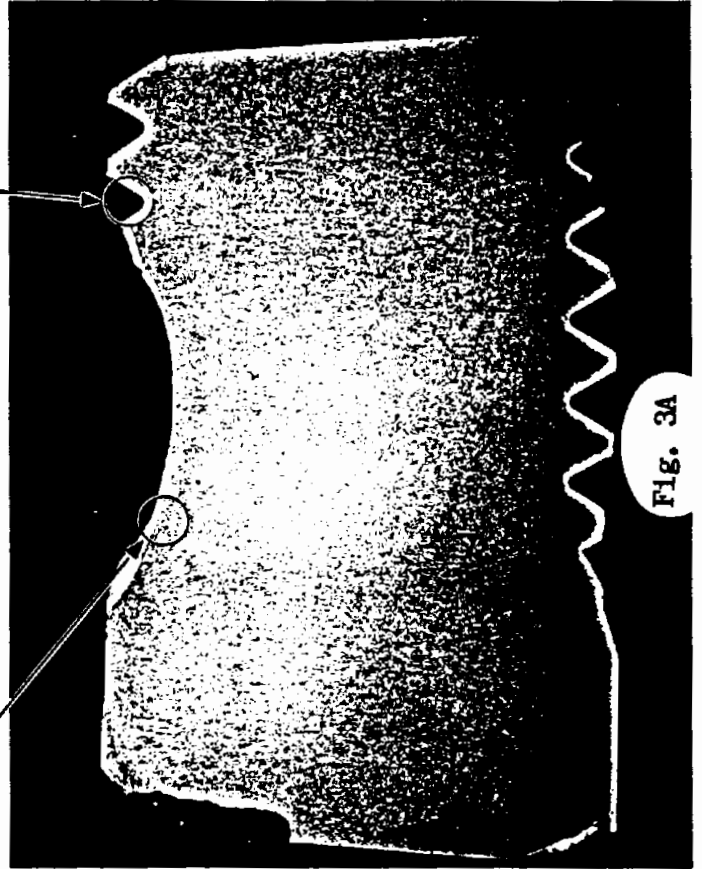
Figs. 3B and 3C show the melted and resolidified microstructure exhibited in the wasted area. It is apparent in Fig. 3C that three layers of microstructure are present:

- layer 1 is a melted and resolidified zone
- layer 2 is a heat-affected zone of untempered martensite resulting from very high temperatures and fast cooling
- layer 3 is the general microstructure of the bolt material which consists of uniformly tempered martensite
