Guidelines for Detection, Analysis, and Treatment of Materials-Related Distress in Concrete Pavements Volume 3: Case Studies Using the Guidelines

PUBLICATION NO. FHWA-RD-01-165

AUGUST 2002

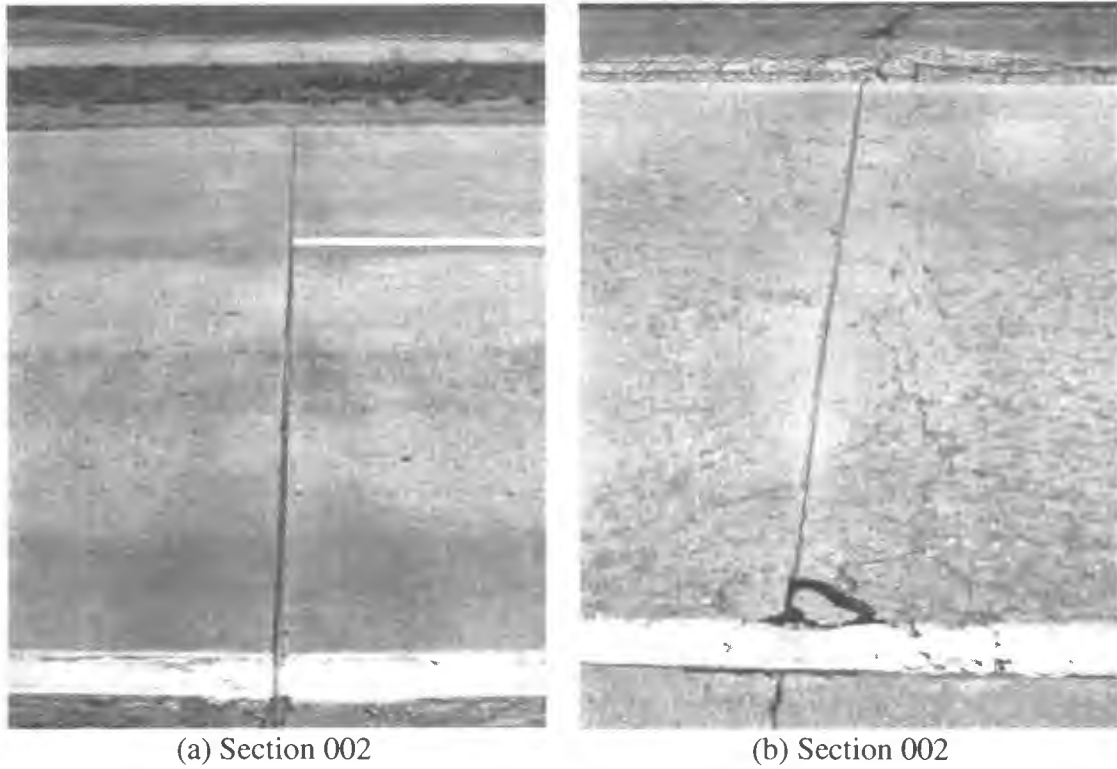
Figure 3-2. Typical distress manifestation observed on SD-090-019-002.

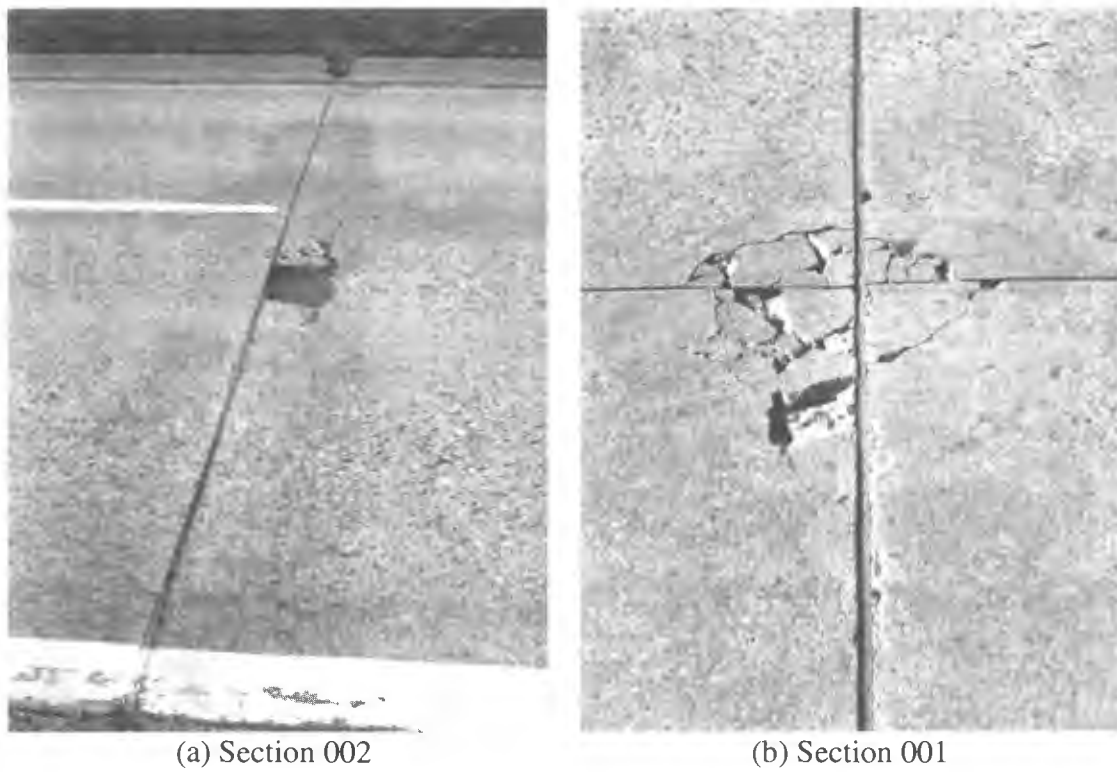
Figure 3-3. Typical distress manifestation observed on SD-090-019, Sections 1 and 2.

On both pavement sections, map cracking was observed throughout the entire area. On Section 001, the cracks appear to be confined to the upper 50 mm at the pavement surface. The majority of cracks run perpendicular to the centerline, but there are some cracks that run parallel to the centerline. The combination of cracks forms a criss-cross pattern on the surface. Although the cracking pattern is similar on Section 002, the transverse cracks on Section 001 are more pronounced and some are opened at the surface.

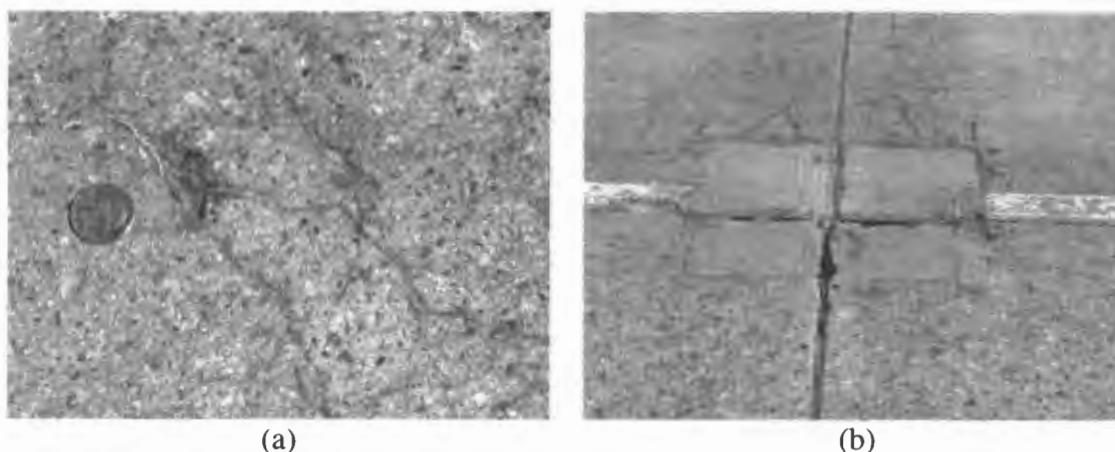
Figure 3-4. Typical distress manifestation observed on SD-090-019-002.

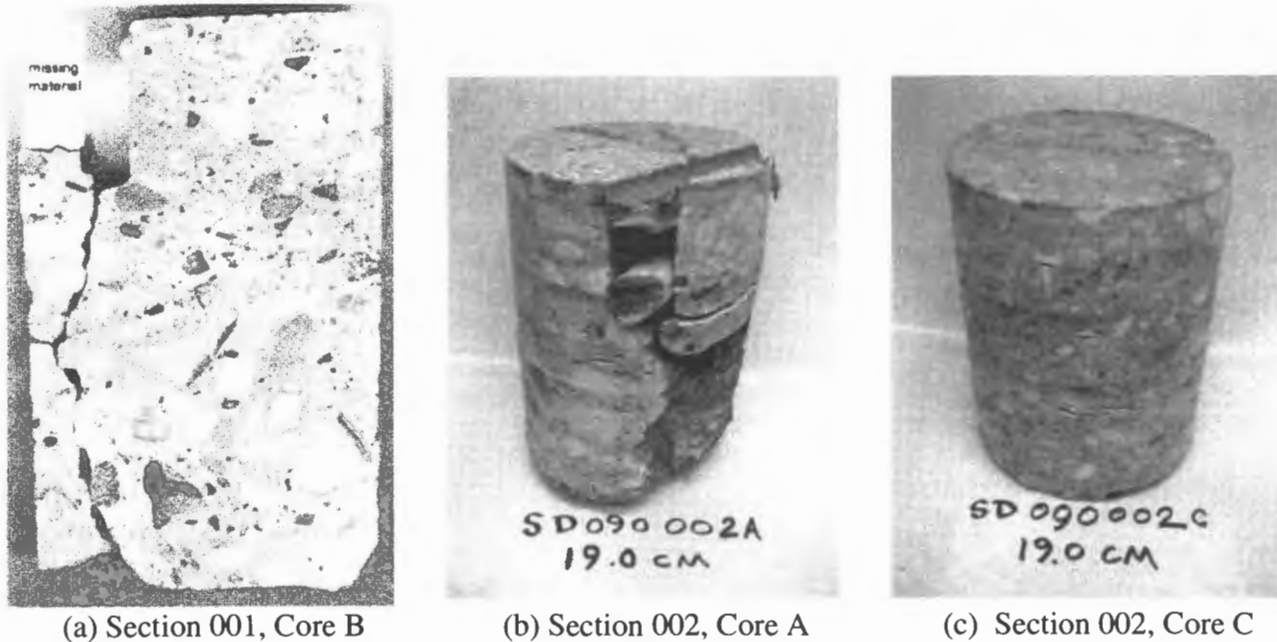
Based upon the field survey, distress was detected at joints and near slab corners. Photos of typical distresses are shown in figure 3-5. To look at concrete from more than one slab, Cores B and D were selected from Section 001 and Cores A, B, and C were selected from Section 002. All cores were cut to produce slabs for examination with stains.

Figure 3-5. Core specimens from SD-090-019.

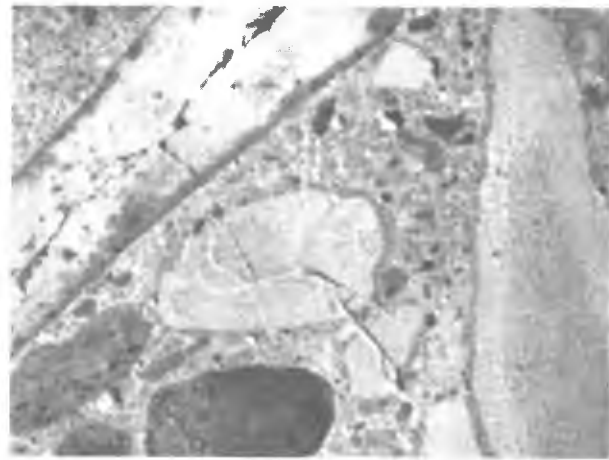
(b) Siltstone and rhyolite aggregate

Figure 3-6. Stereo optical micrographs of typical cracking pattern associated with porous siltstone aggregate SD-090-019.

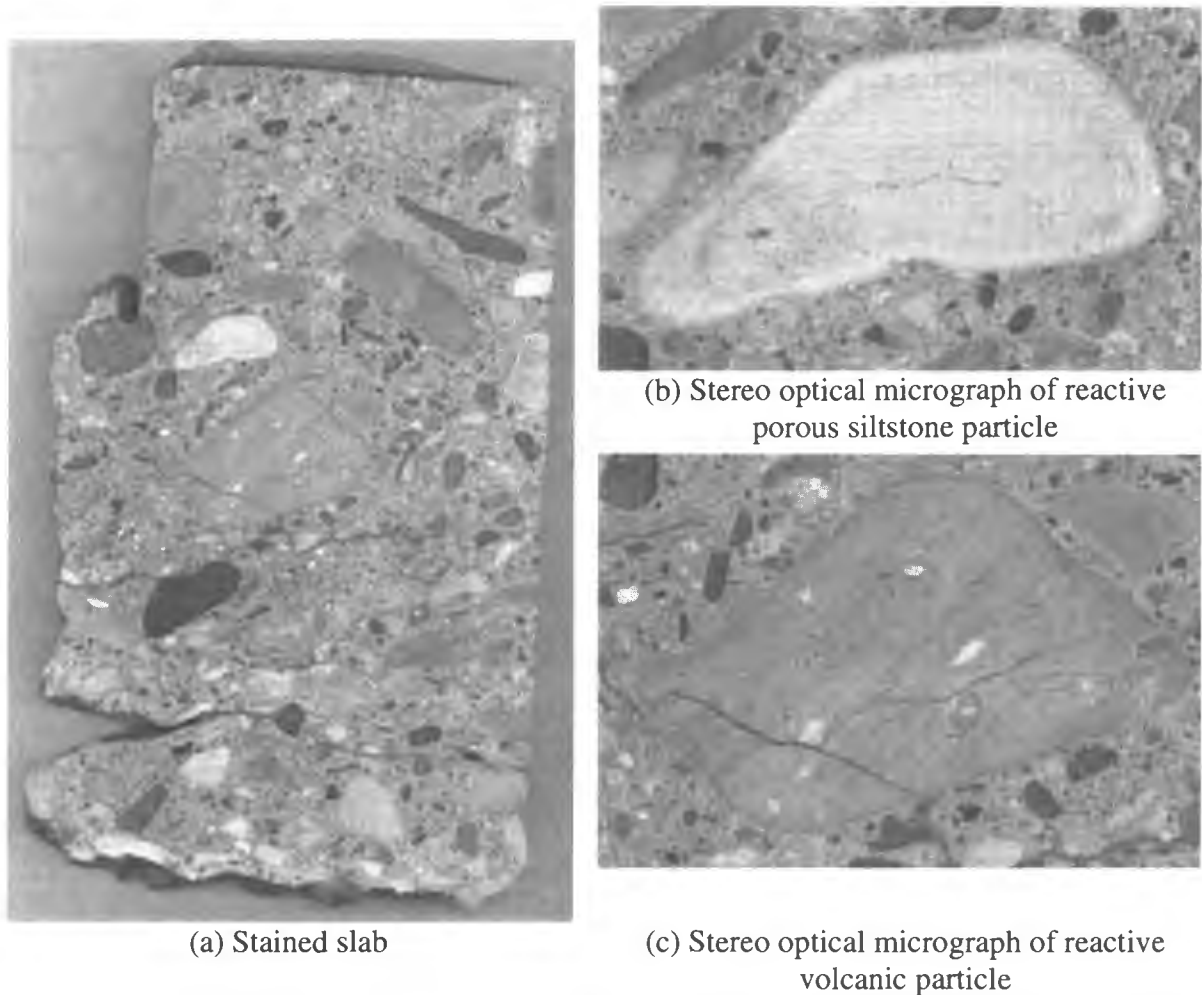
The sodium cobaltinitrite/rhodamine B staining tests were applied and a number of aggregates were identified as being susceptible to alkali-silica reactivity (ASR). The phenolphthalein staining method was used to determine the depth of carbonation on freshly cut surfaces. Slabs cut from the analyzed cores were tested for depth of carbonation with no core having a depth of carbonation greater than 2 mm below the road surface. Barium chloride/potassium permanganate stain was used to identify sulfate minerals. Examples of the stained slabs are presented in figures 3-8 through 3-11.

Figure 3-8. Slab 1B stained with sodium cobaltinitrite/rhodamine B from SD-090-019-001.

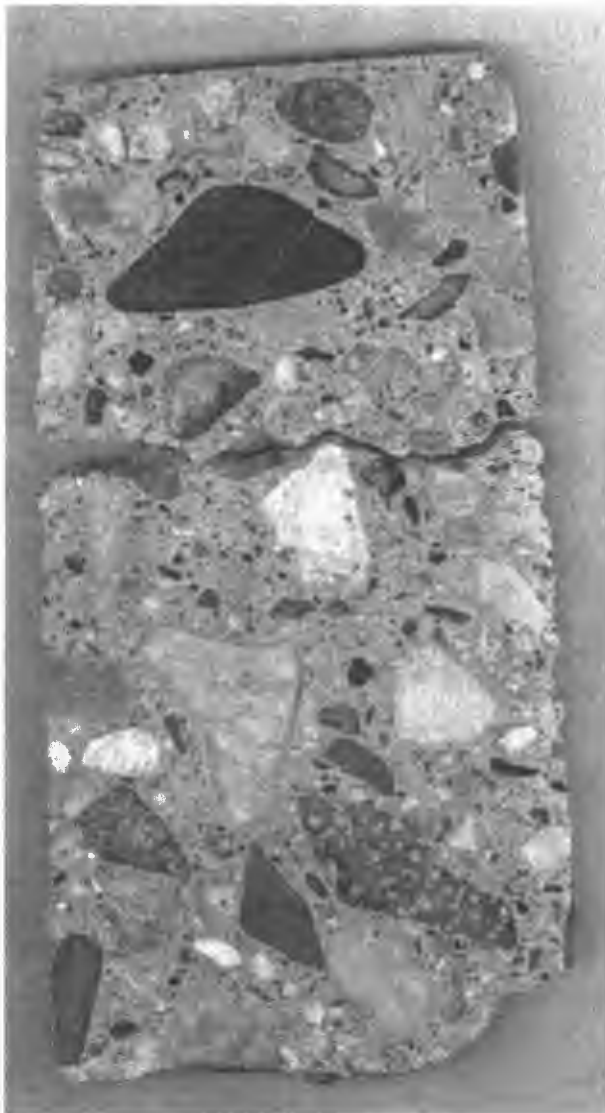
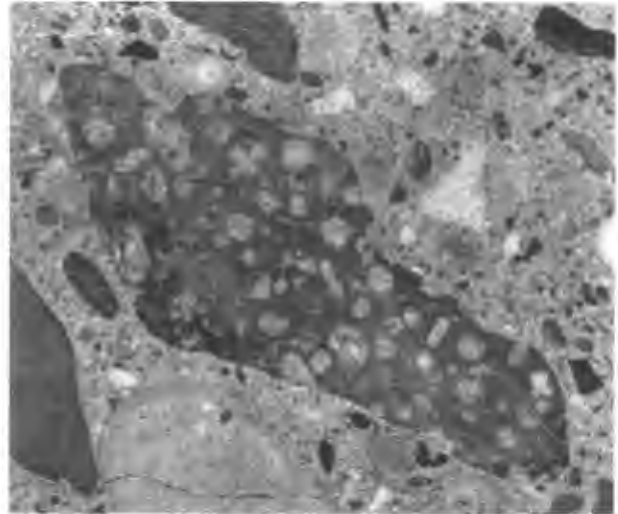
(a) Stained slab

(b) Stereo optical micrograph of reactive rhyolite particle

Figure 3-9. Slab 1B stained with sodium cobaltinitrite/rhodamine B from SD-090-019-001.

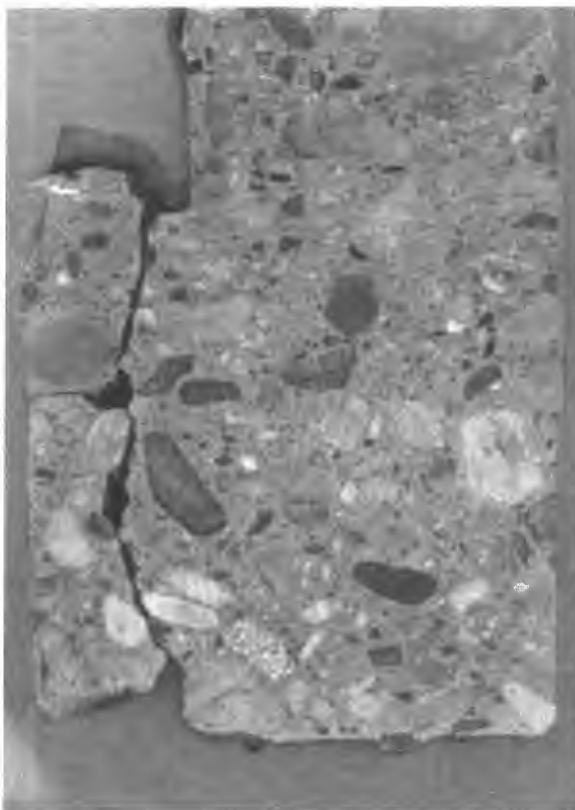
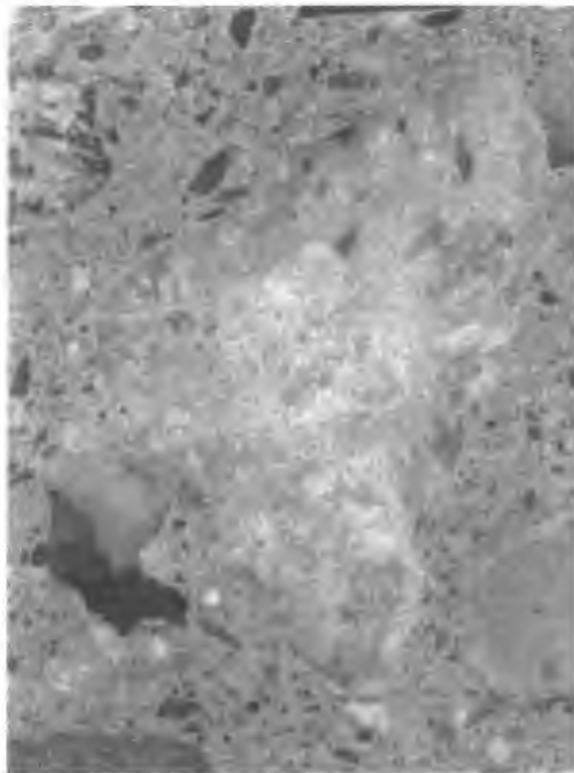
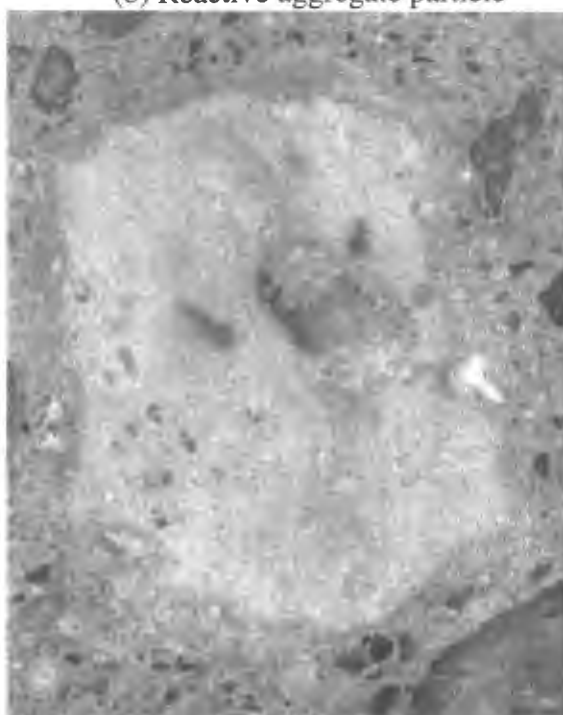
(a) Stained slab

(b) Reactive aggregate particle

(c) ASR gel filled void

(d) Reactive aggregate particle

Figure 3-10. Slab 2B stained with sodium cobaltinitrite/rhodamine B from SD-090-019-002.

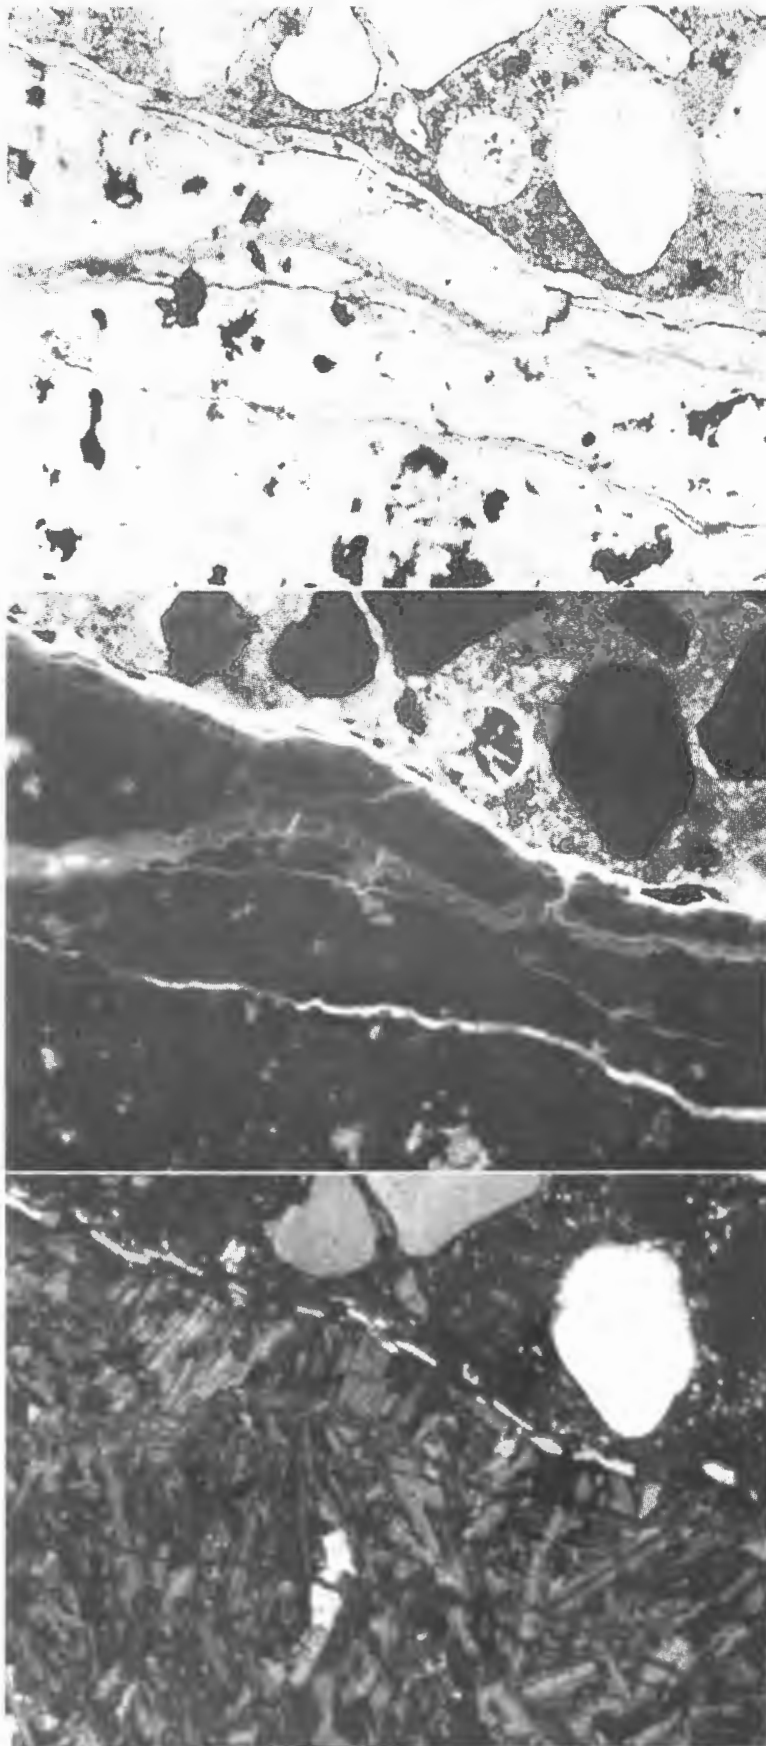
Figure 3-12. Core SD-090-019-001B, thin-section micrographs of same rhyolite aggregate that was stained with sodium cobaltinitrite ASR stain as shown in figure 3-9 (b).

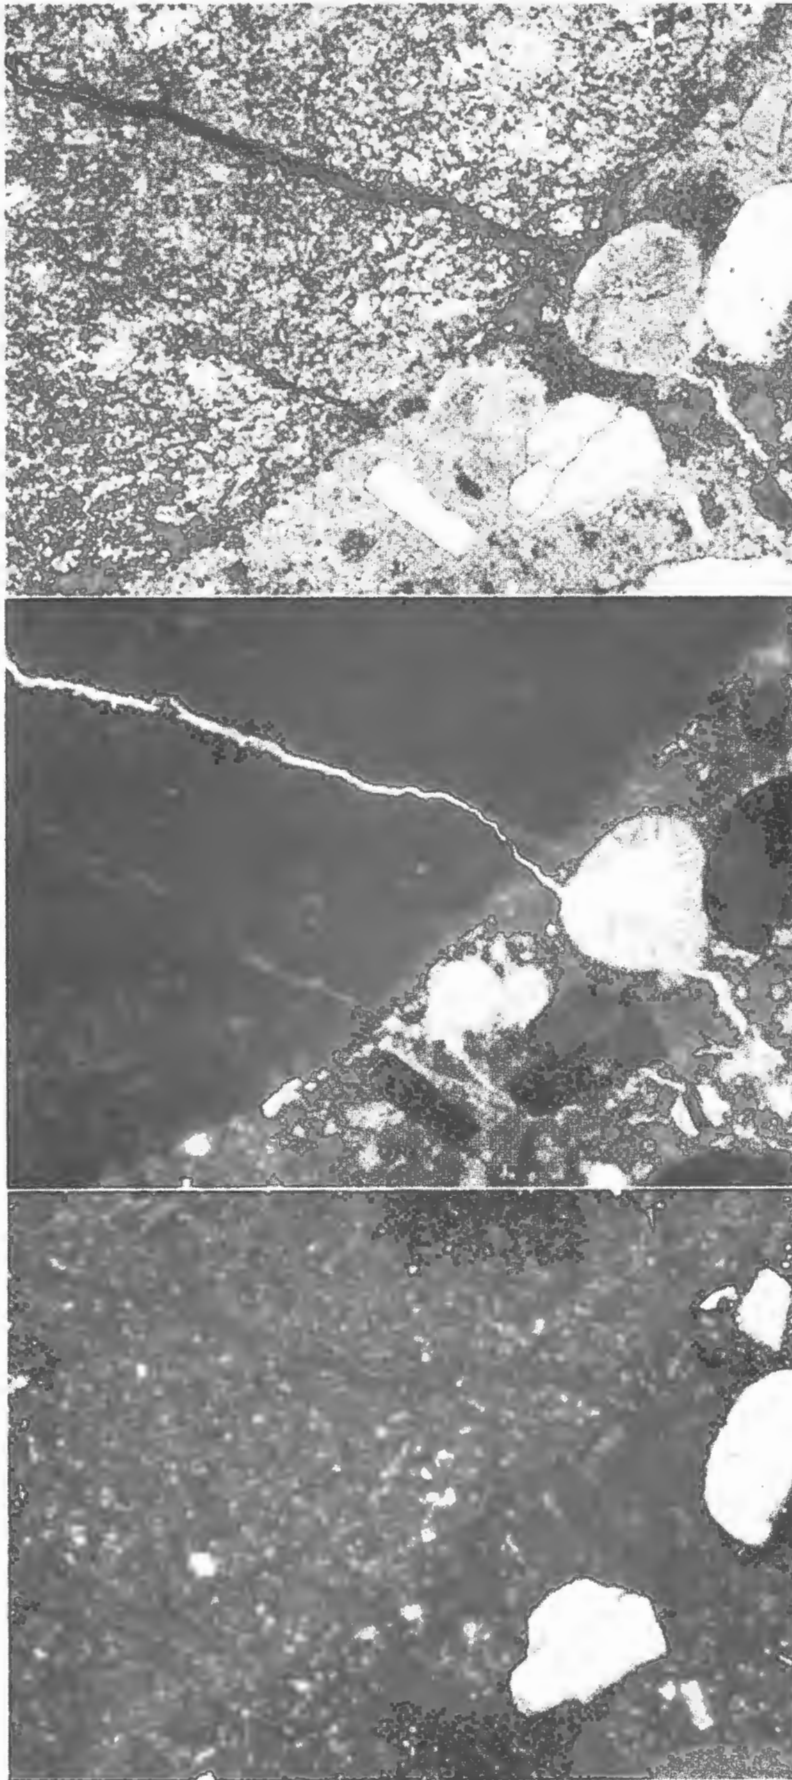
Figure 3-13. Core SD-090-019-001B, thin-section micrographs of same volcanic aggregate that was stained with sodium cobaltinitrite ASR stain as shown in figure 3-8 (c). From top to bottom: transmitted plane polarized light, epifluorescent mode, and transmitted cross polarized light. Ettringite can be seen filling the entrained air void, ASR gel can be seen in the crack within the aggregate, and hydrocalumite can be seen in the small entrained air void in the lower right hand corner. This same area was analyzed with the SEM to collect quantitative chemical information about the gel, ettringite, and hydrocalumite.

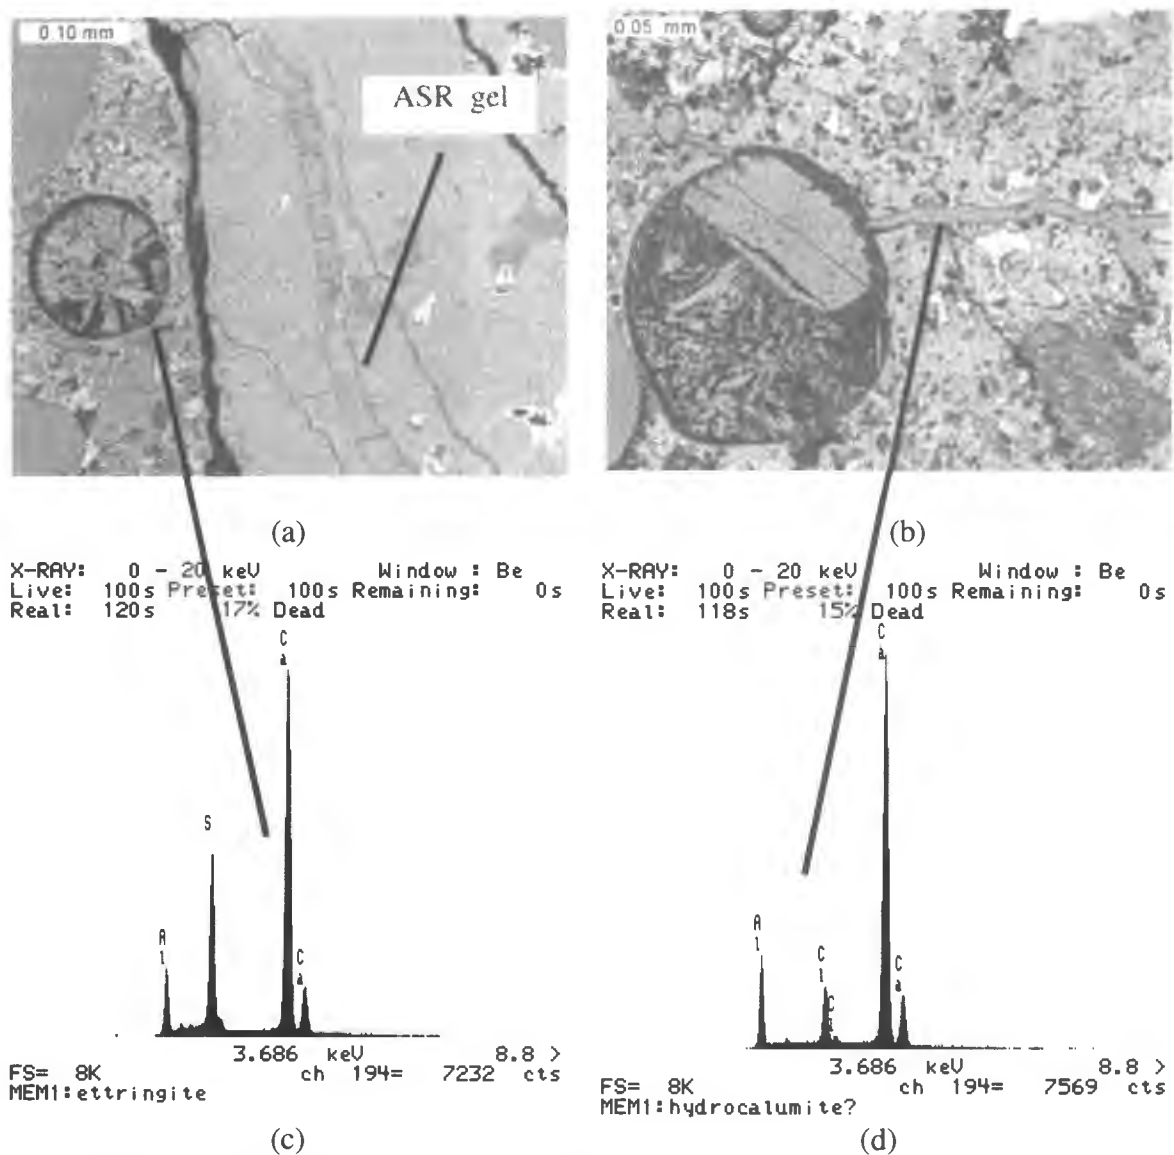
A conventional SEM was used to identify secondary deposits seen in the petrographic microscope examination to confirm those observations. Figure 3-14 contains a backscattered electron image showing an ettringite filled void, a crack filled with hydrocalumite, and characteristic x-ray spectra from each phase illustrating their compositions. The SEM analysis confirmed the petrographic analysis with regards to the composition of the secondary deposits. The phase identified as hydrocalumite was confirmed, as were the presence of ettringite and the composition of various ASR reaction products. The results of x-ray microanalyses of the ettringite and the hydrocalumite phases are presented in tables 3-7 and 3-8, respectively. Figure 3-15 presents the ternary diagram showing the probable range of composition for the hydrocalumite deposits.

Figure 3-14. Ettringite (a) and hydrocalumite (b) infilling in void and crack, respectively. Example spectra from each phase are shown in (c) and (d), respectively.

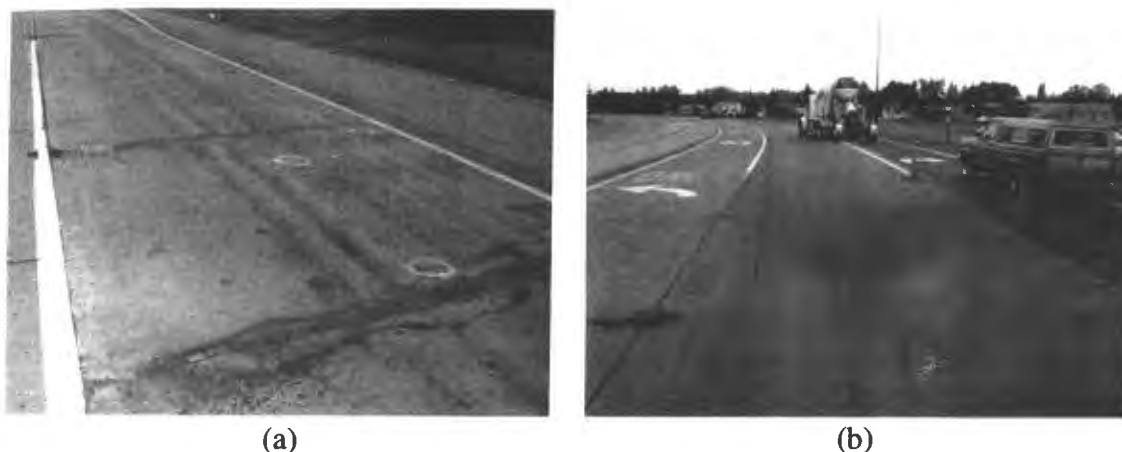
Figure 3-21. Typical distress manifestations observed at MN-065-064.

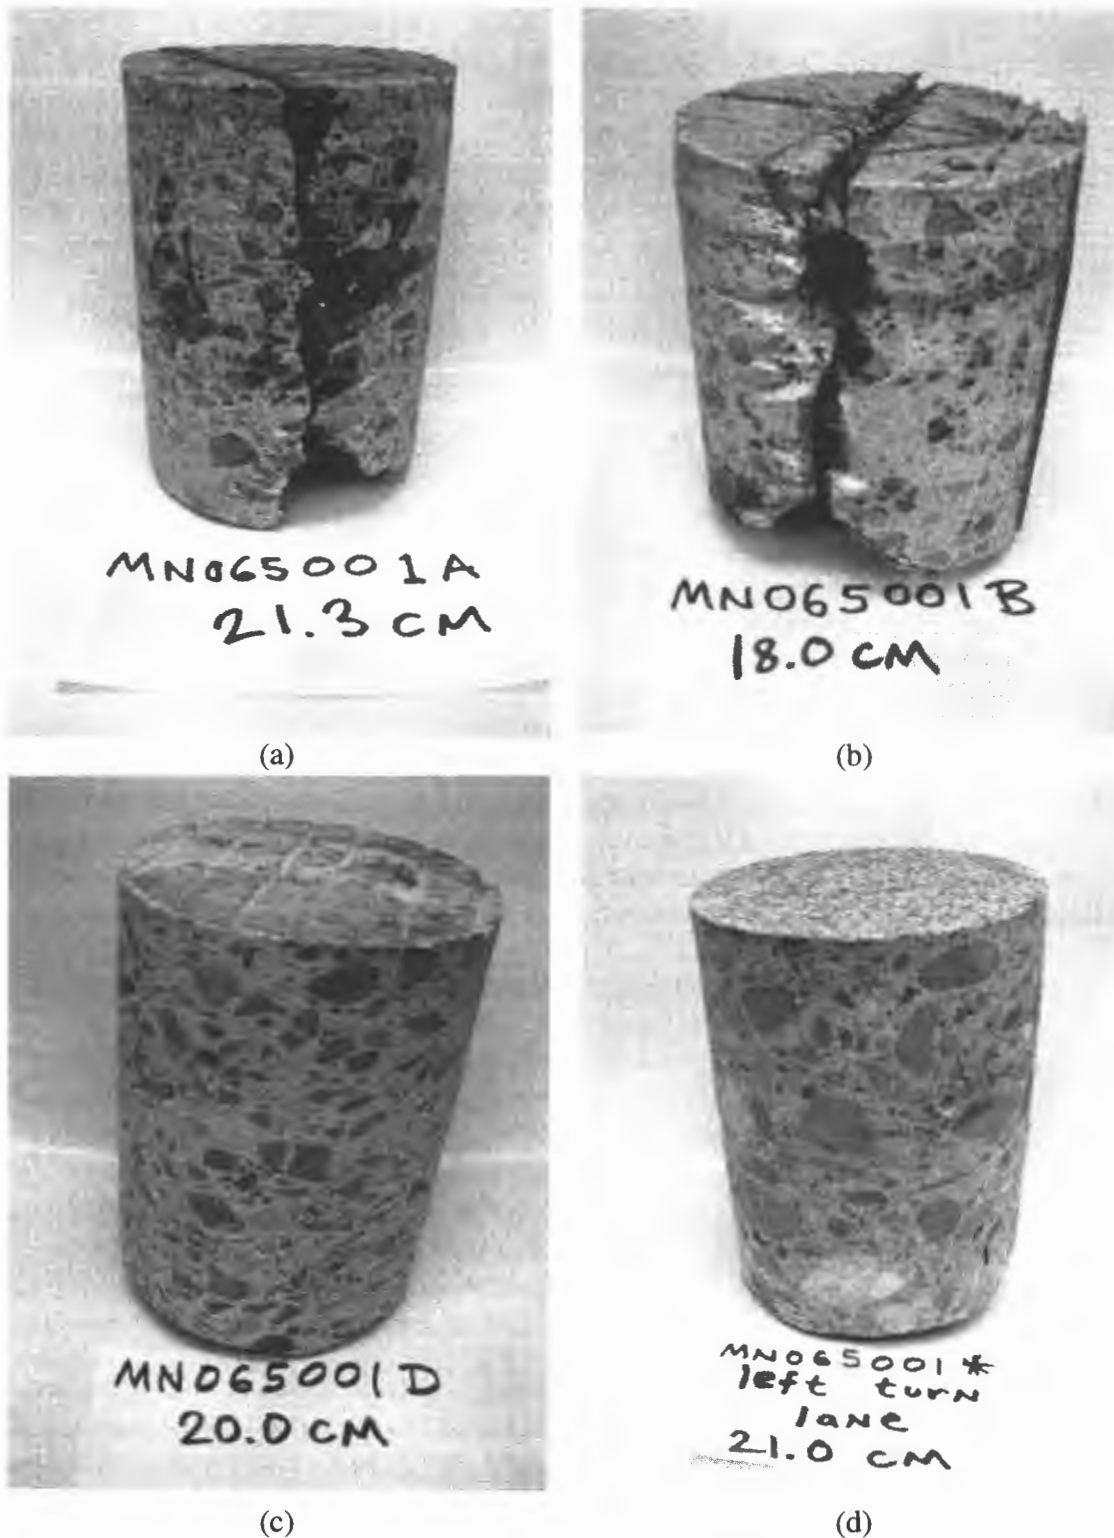
Figure 3-22. Cores evaluated for MN-065-064.

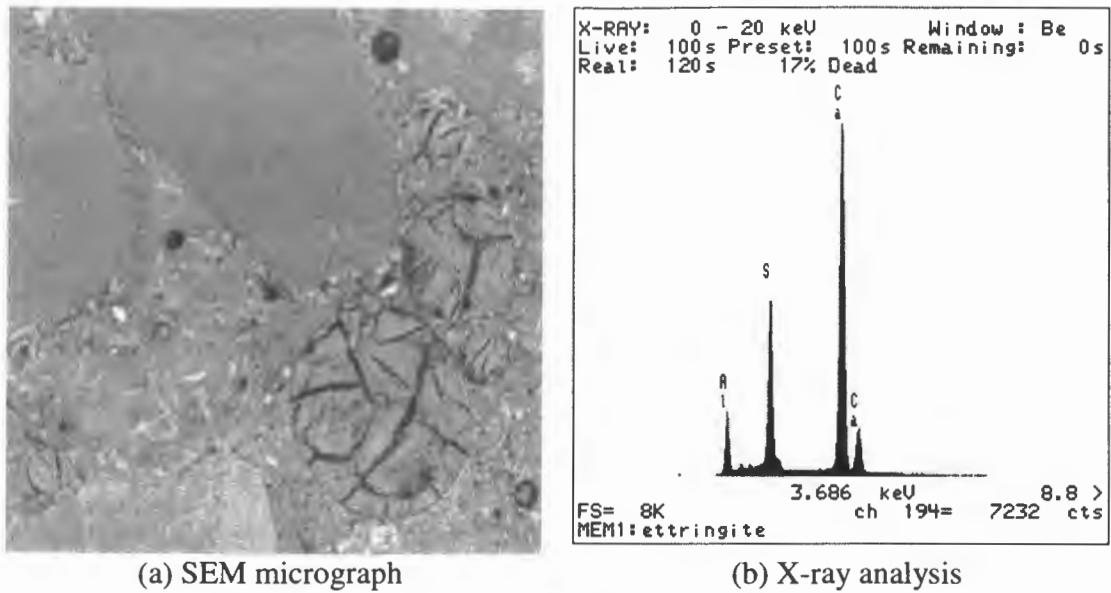
SEM was used to identify infilling material in voids and cracks. As indicated earlier, the principal materials identified were ettringite and hydrocalumite as shown in the typical SEM micrographs and x-ray analyses presented in figures 3-39 and 3-40.

Figure 3-39. Typical SEM micrograph and x-ray analysis for ettringite infilling air void.

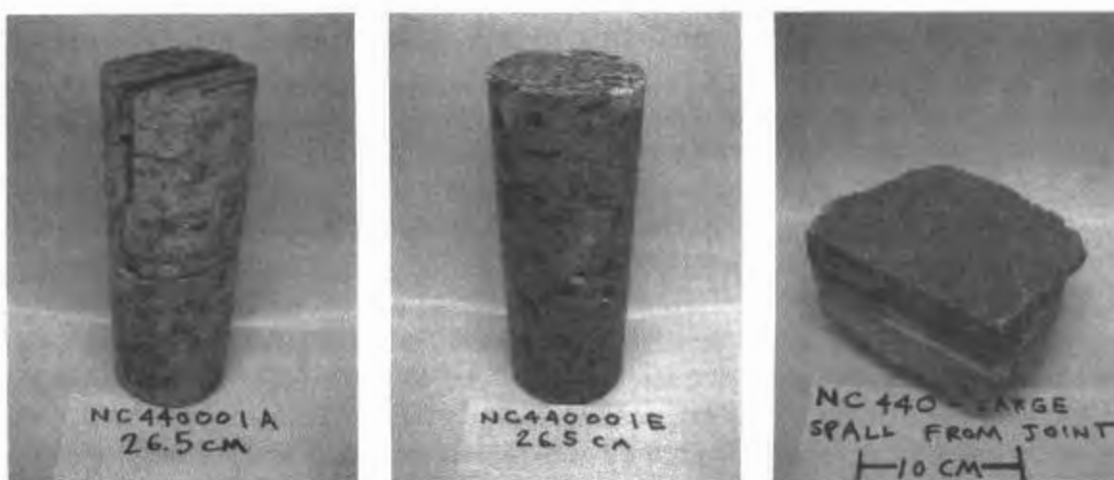
Figure 3-47. Cores and specimens evaluated from NC-440-015.

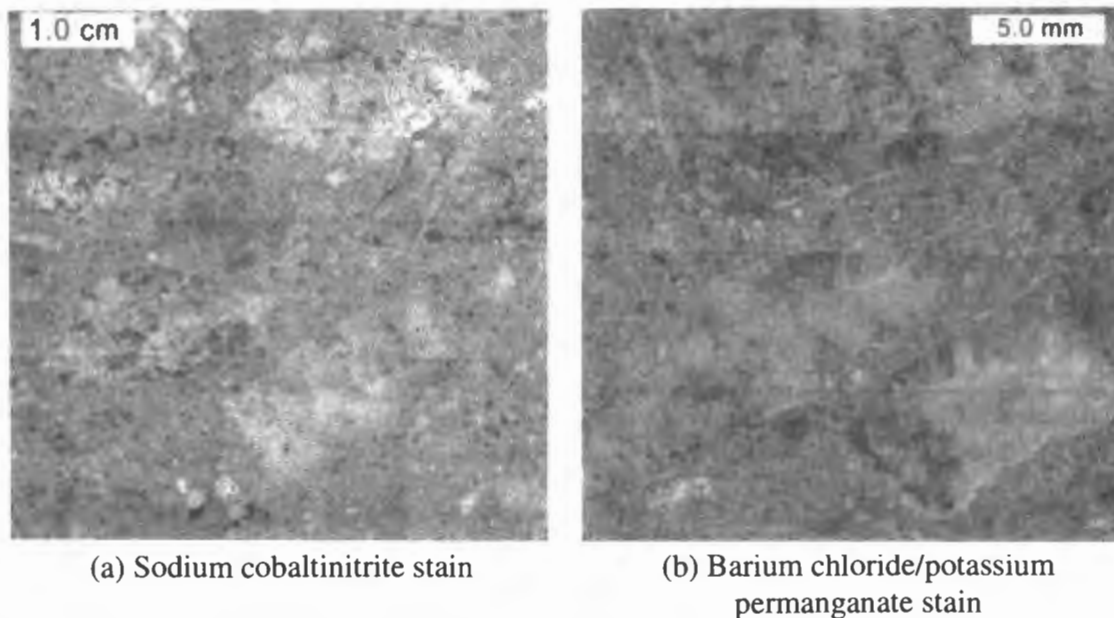
Figure 3-49. Typical stereo optical micrographs of stained concrete. Note that the broad banding occurs from the montage process to create a single image.

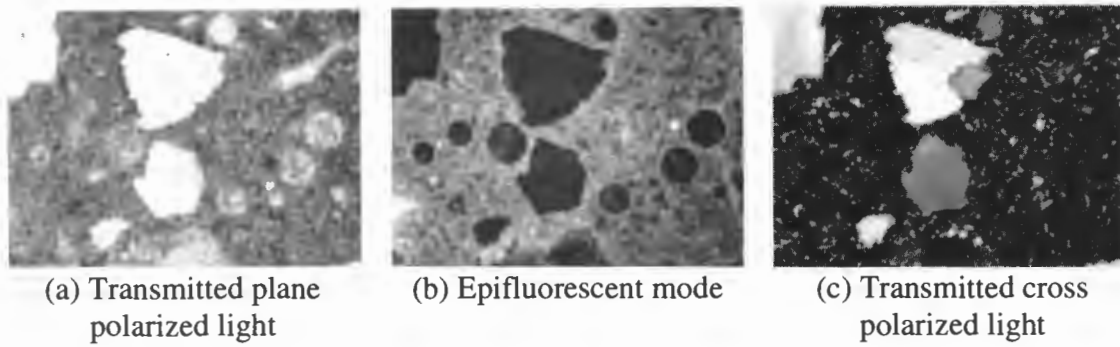
Figure 3-50. Petrographic micrographs from spall obtained from NC-440-015 showing ettringite filled entrained air voids. Ettringite growths are unusually dense.

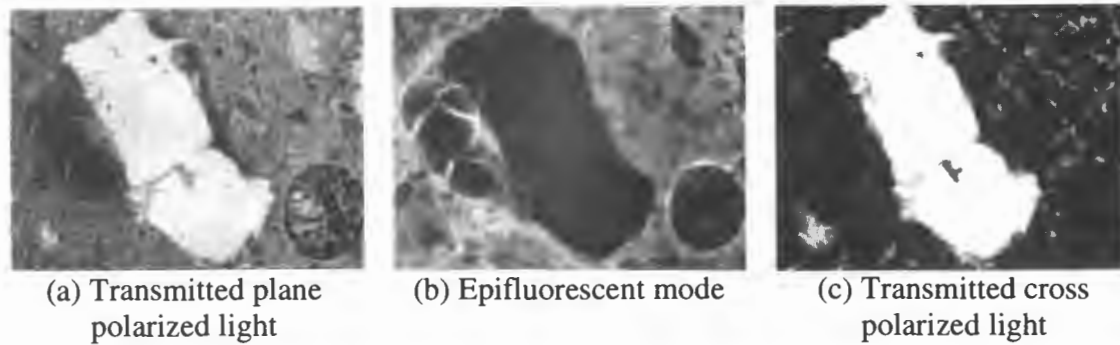
Figure 3-51. Petrographic micrograph of a tan to red coating observed on some of the fine aggregates that appears to undergo ASR from spall obtained from NC-440-015.

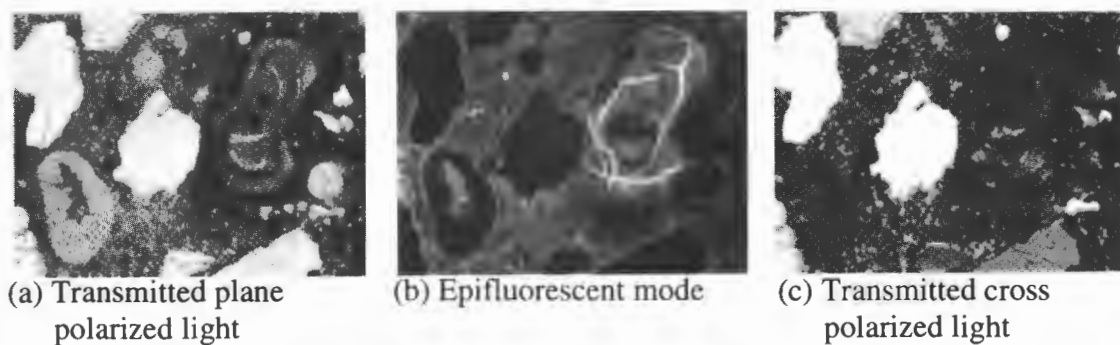
Figure 3-52. Petrographic micrograph of ettringite and “ASR gel blob” from spall obtained from NC-440-015. The term ASR gel is misleading in this example, since the reaction product is slightly birefringent and, therefore, crystalline.

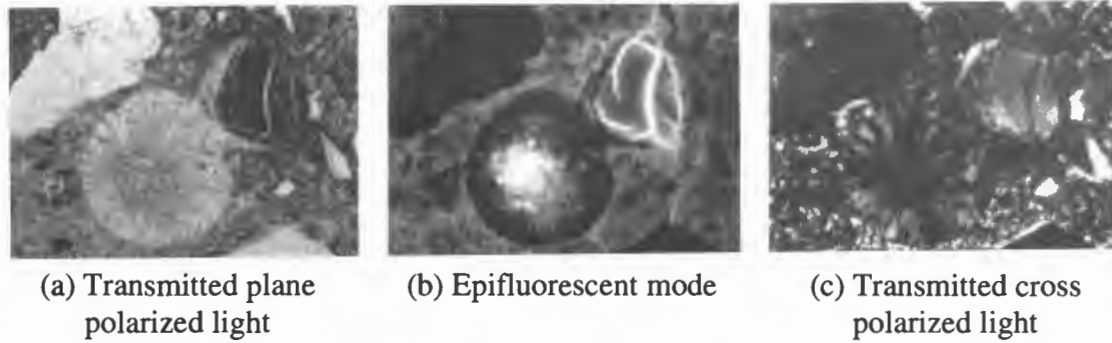
Figure 3-53. Petrographic micrograph of ettringite intermixed with ASR gel. As in figure 3-52, the ASR “gel” in this image is birefringent and crystalline.

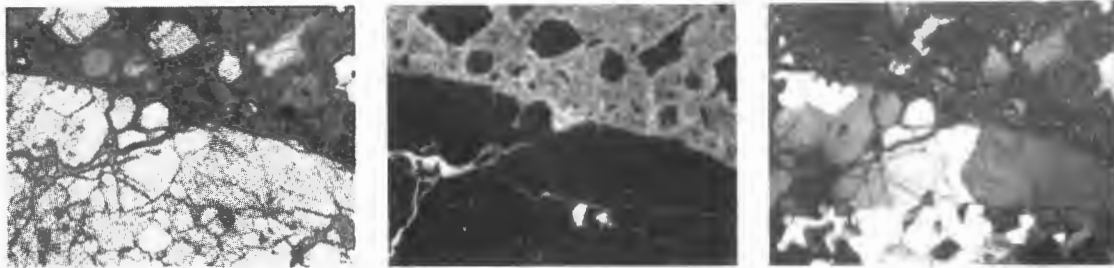
Figure 3-54. Petrographic micrograph of ASR gel in crack within coarse aggregate. The gel deposit in this image was analyzed with the SEM. Again, the ASR “gel” in this image is birefringent and crystalline.

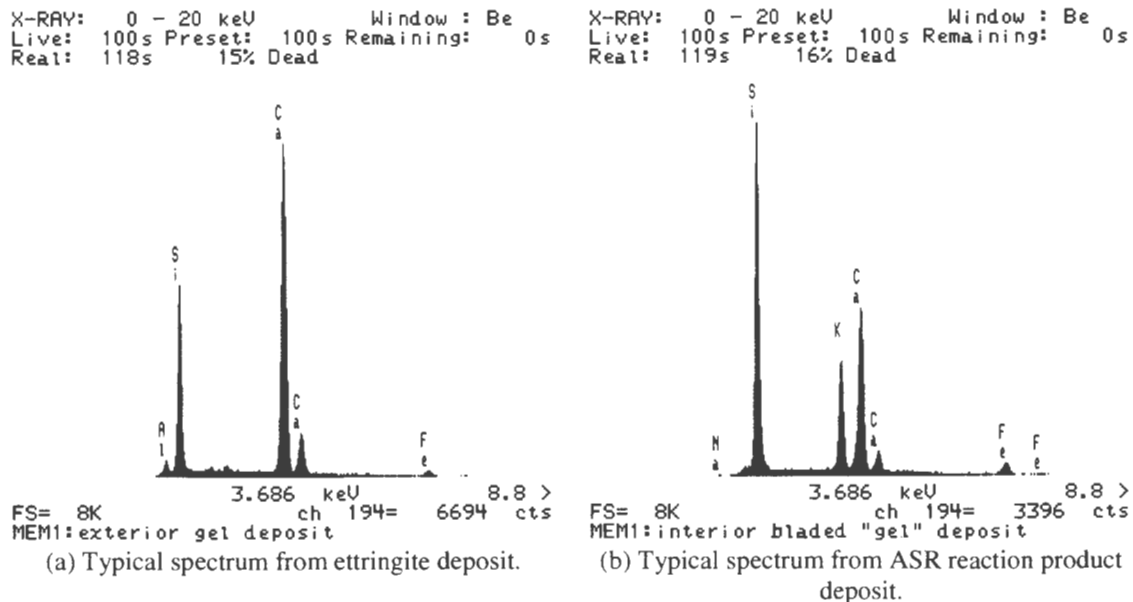
Figure 3-57. Typical spectra for ettringite and ASR reaction product.

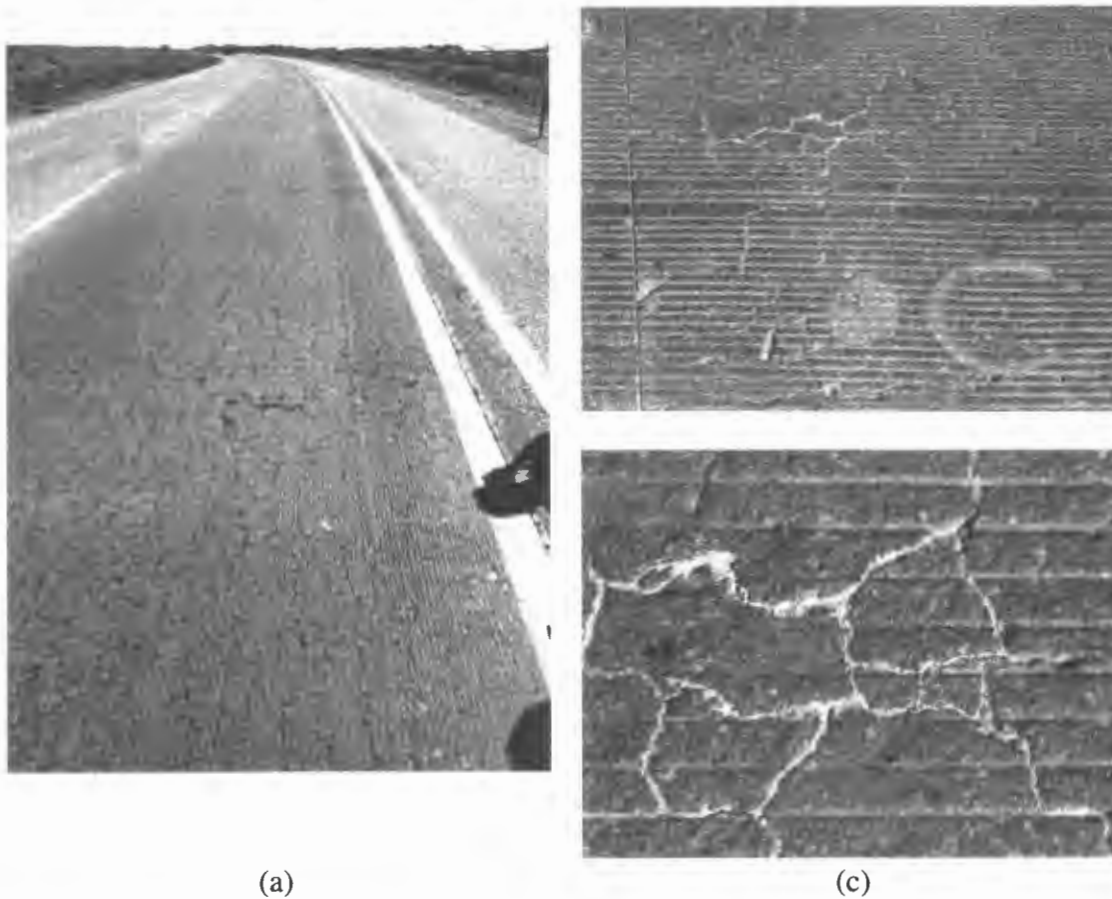
Figure 3-63. Typical conditions at CA-058-141.

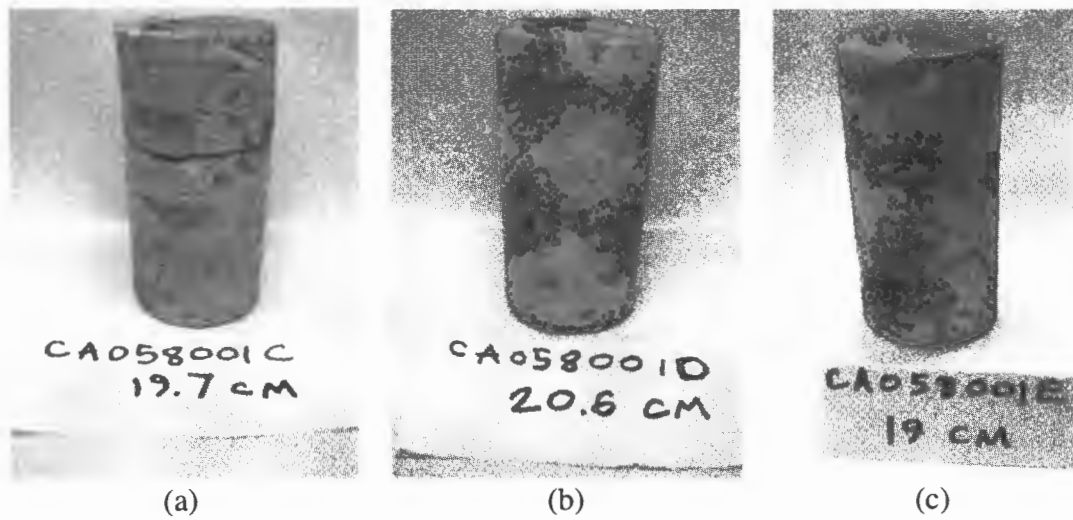
Figure 3-64. Photographs of core specimens analyzed from CA-058-141.

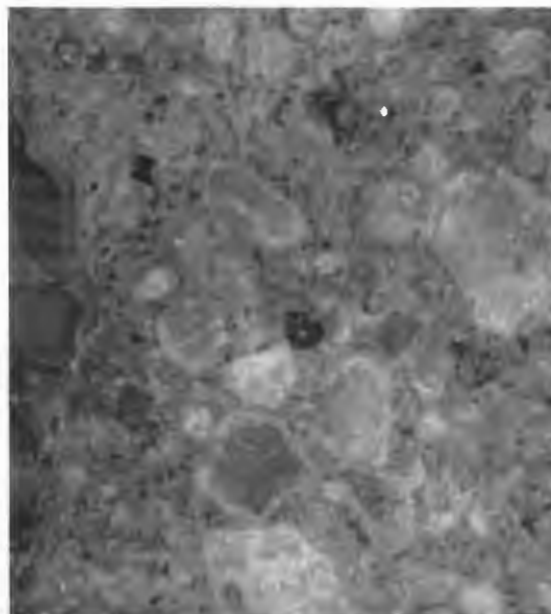
(b) An unpolished cut surface that has been stained to show ettringite filled cracks and voids

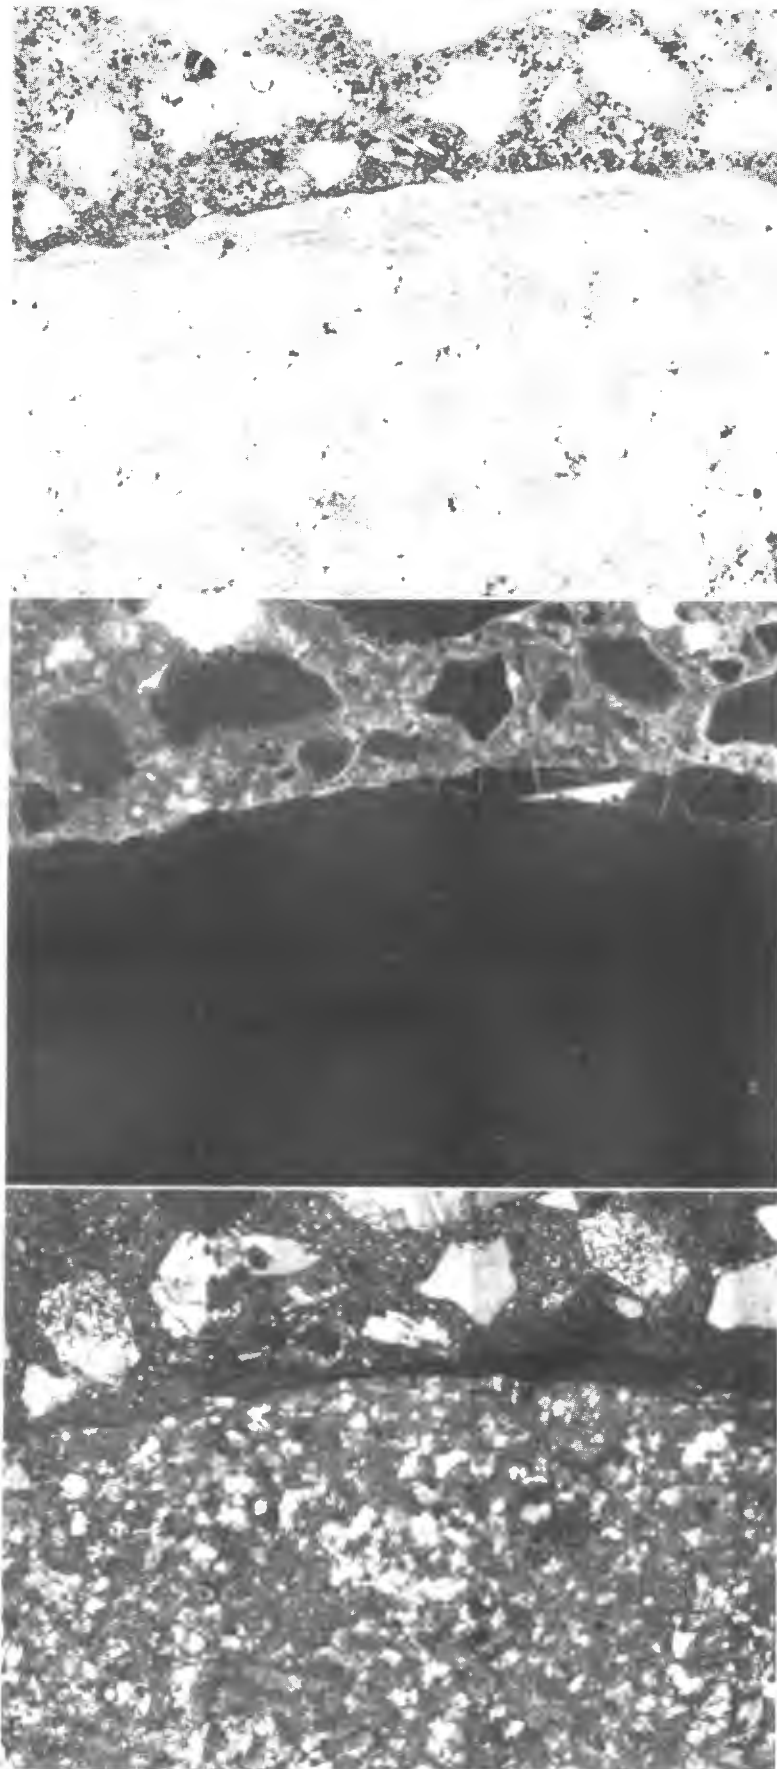
Figure 3-66. Petrographic micrograph of core CA-058-141-001E, thin-section micrographs of ASR gel deposit in crack along felsic volcanic aggregate. The same deposit was analyzed with the SEM to collect quantitative chemical information about the gel. From top to bottom: transmitted plane polarized light, epifluorescent mode, and transmitted cross polarized light (magnified 48x).
