Guidelines for Detection, Analysis, and Treatment of Materials-Related Distress in Concrete Pavements Volume 3: Case Studies Using the Guidelines

PUBLICATION NO. FHWA-RD-01-165

AUGUST 2002

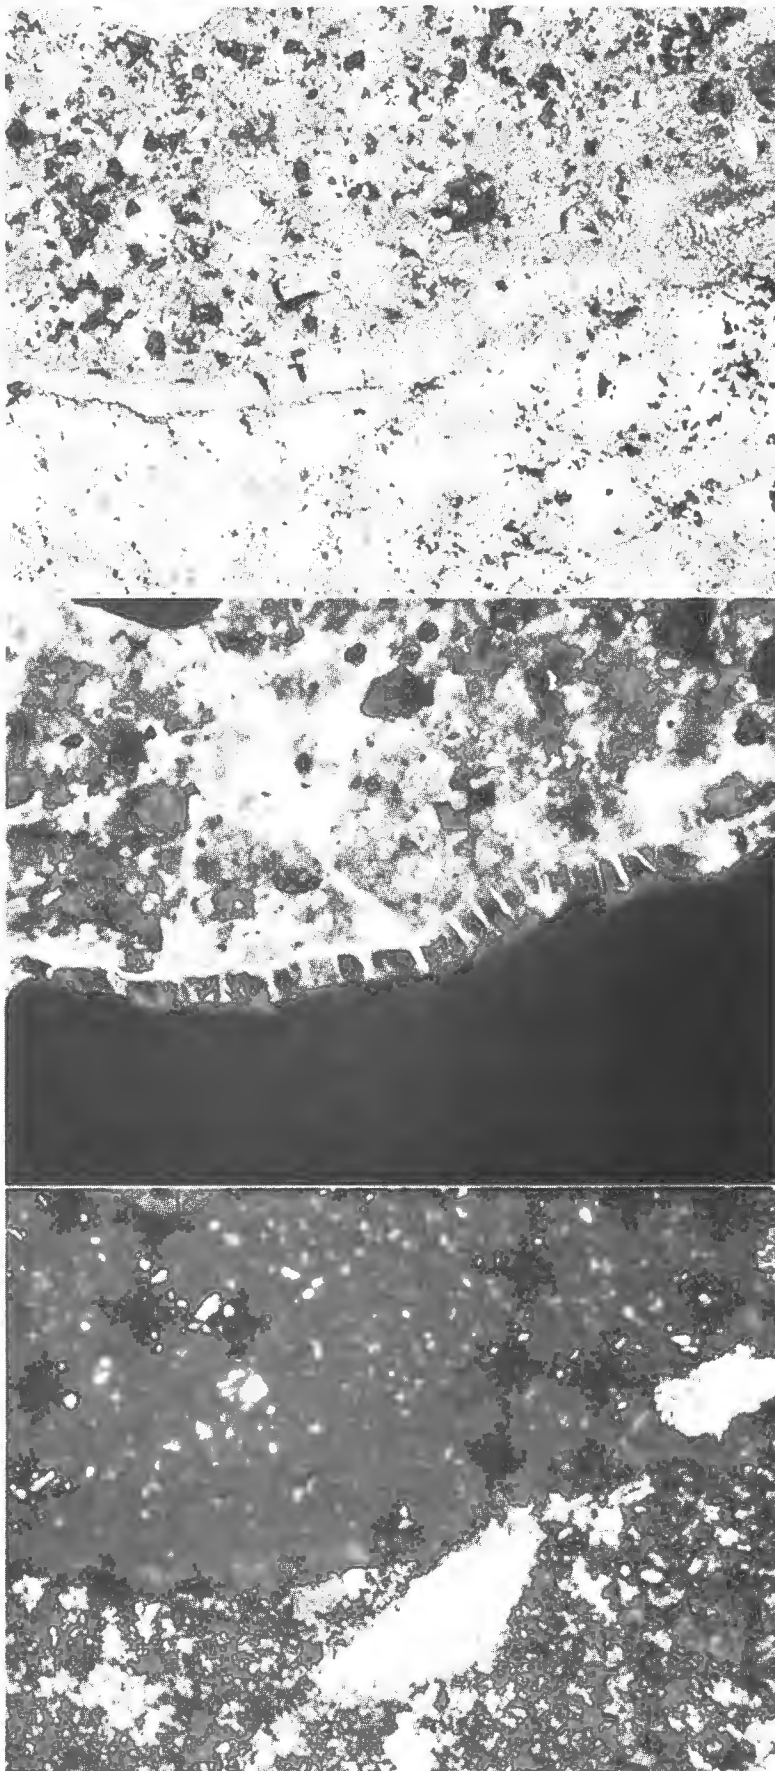
Figure 3-67. Petrographic micrograph of core CA-058-141-001E, thin-section micrographs of ettringite filled crack along contact between coarse aggregate and cement paste. From top to bottom: transmitted plane polarized light, epifluorescent mode, and transmitted cross polarized light (magnified 188x).

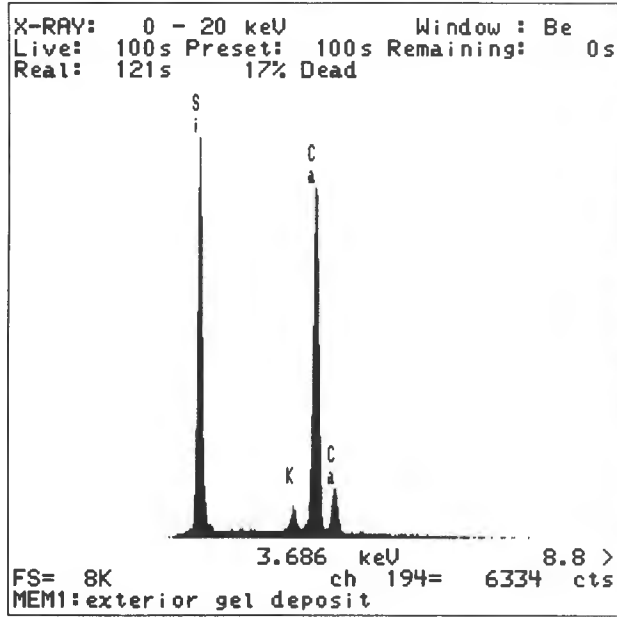
(a) Typical spectrum from ASR gel adjacent to volcanic aggregate pictured in (b).

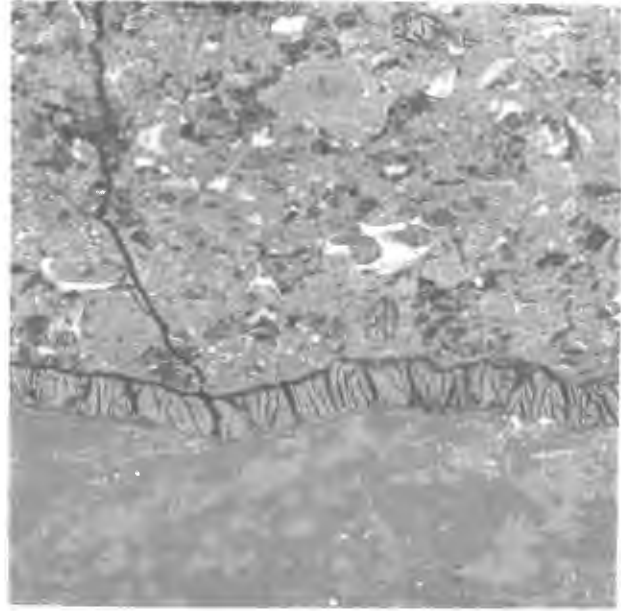
(b) BSE image of ettringite filling a crack along the contact between a coarse aggregate and the cement paste.

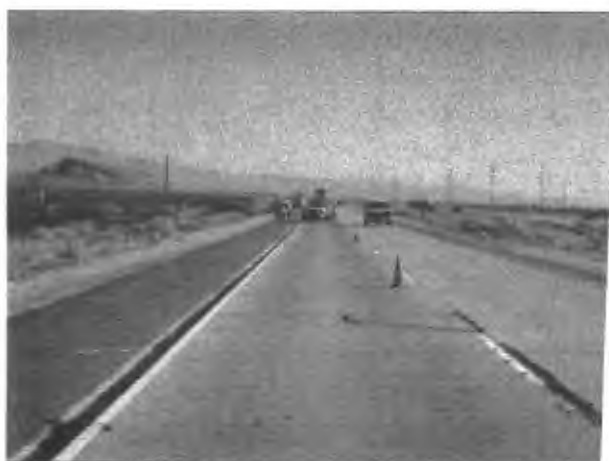
(a) Section overview

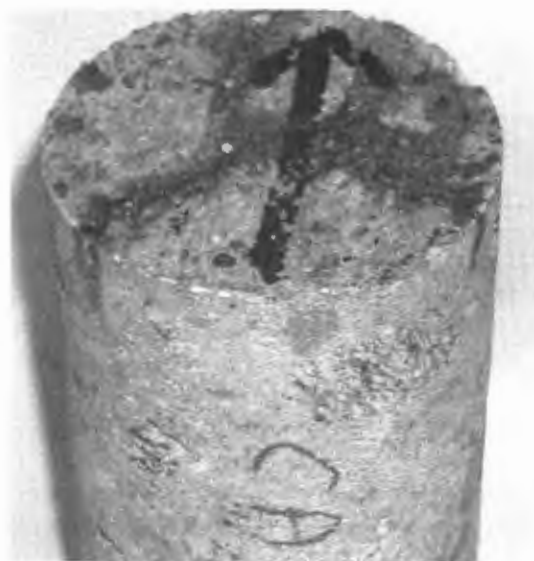
Figure 3-75. Map cracking pattern on core CA-014-011-001E, emphasized by wetting down the surface.

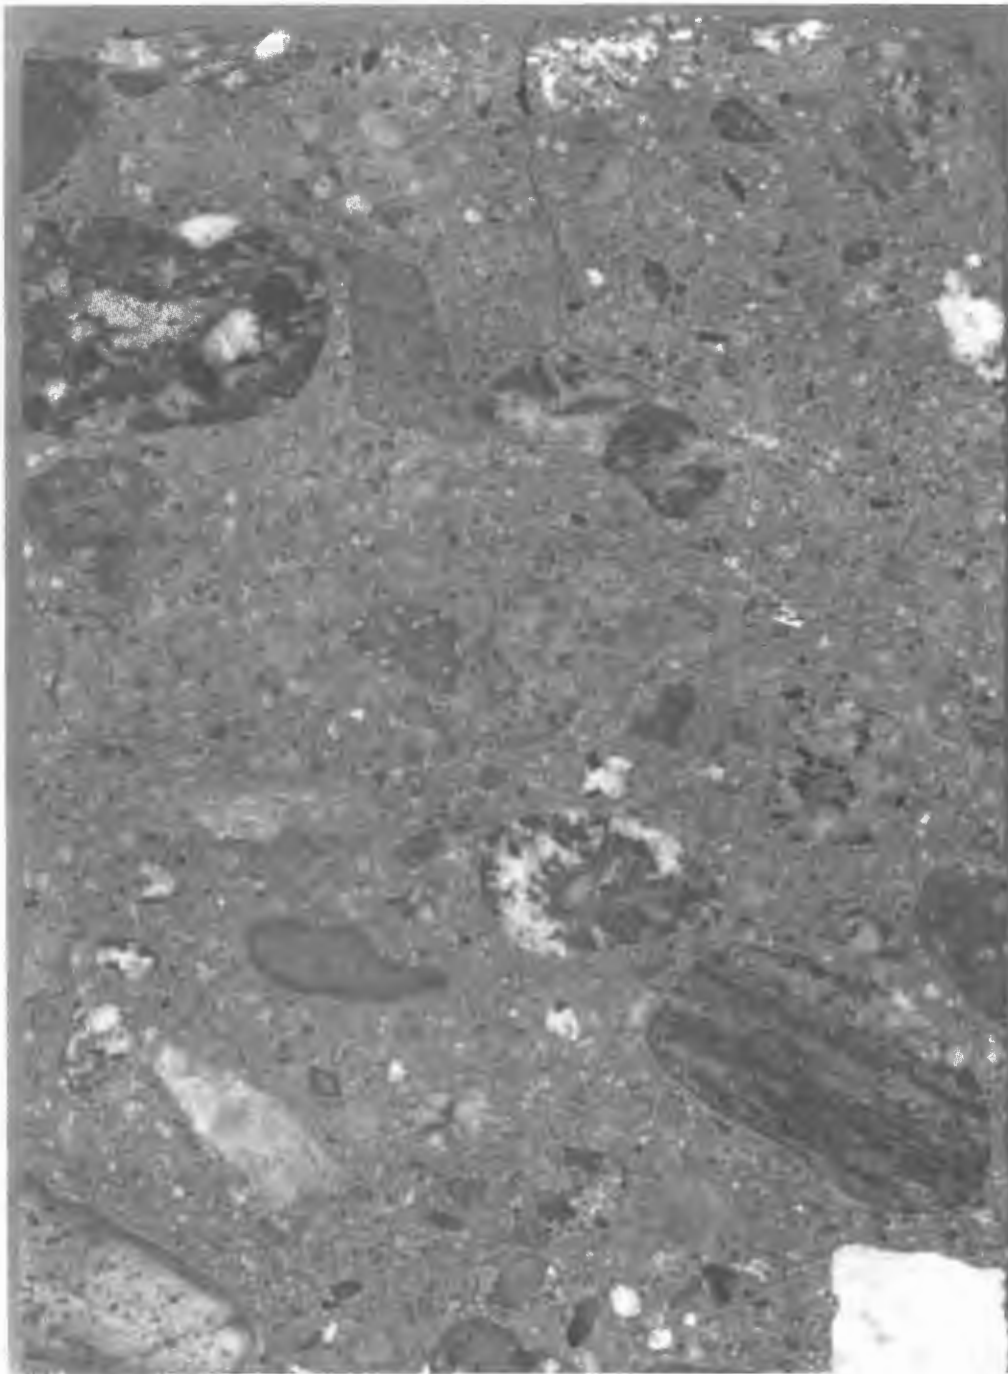
Figure 3-77. Same area of core CA-058-011-001E as shown in figure 3-78, included to show darkened reaction rims on some of the coarse aggregate (magnified 1.5x).

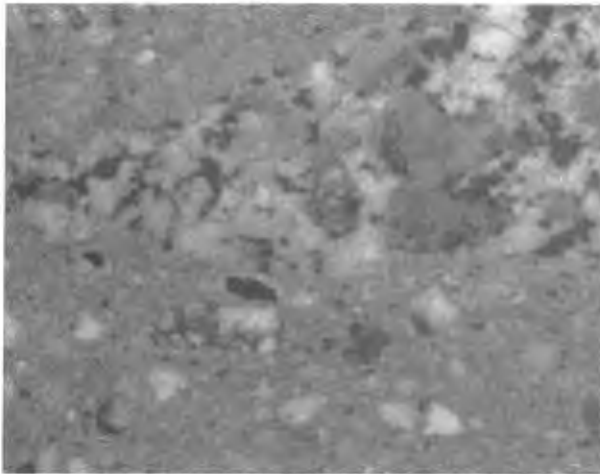
(a) Yellow sodium cobaltinitrite stain for ASR gel in cracks associated with granitic coarse aggregate

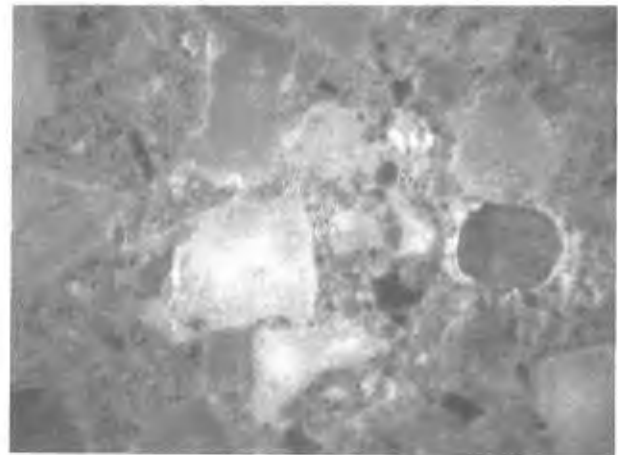
(b) Ettringite filled air voids that have picked up the purple to pink stain from the solution of barium chloride and potassium permanganate

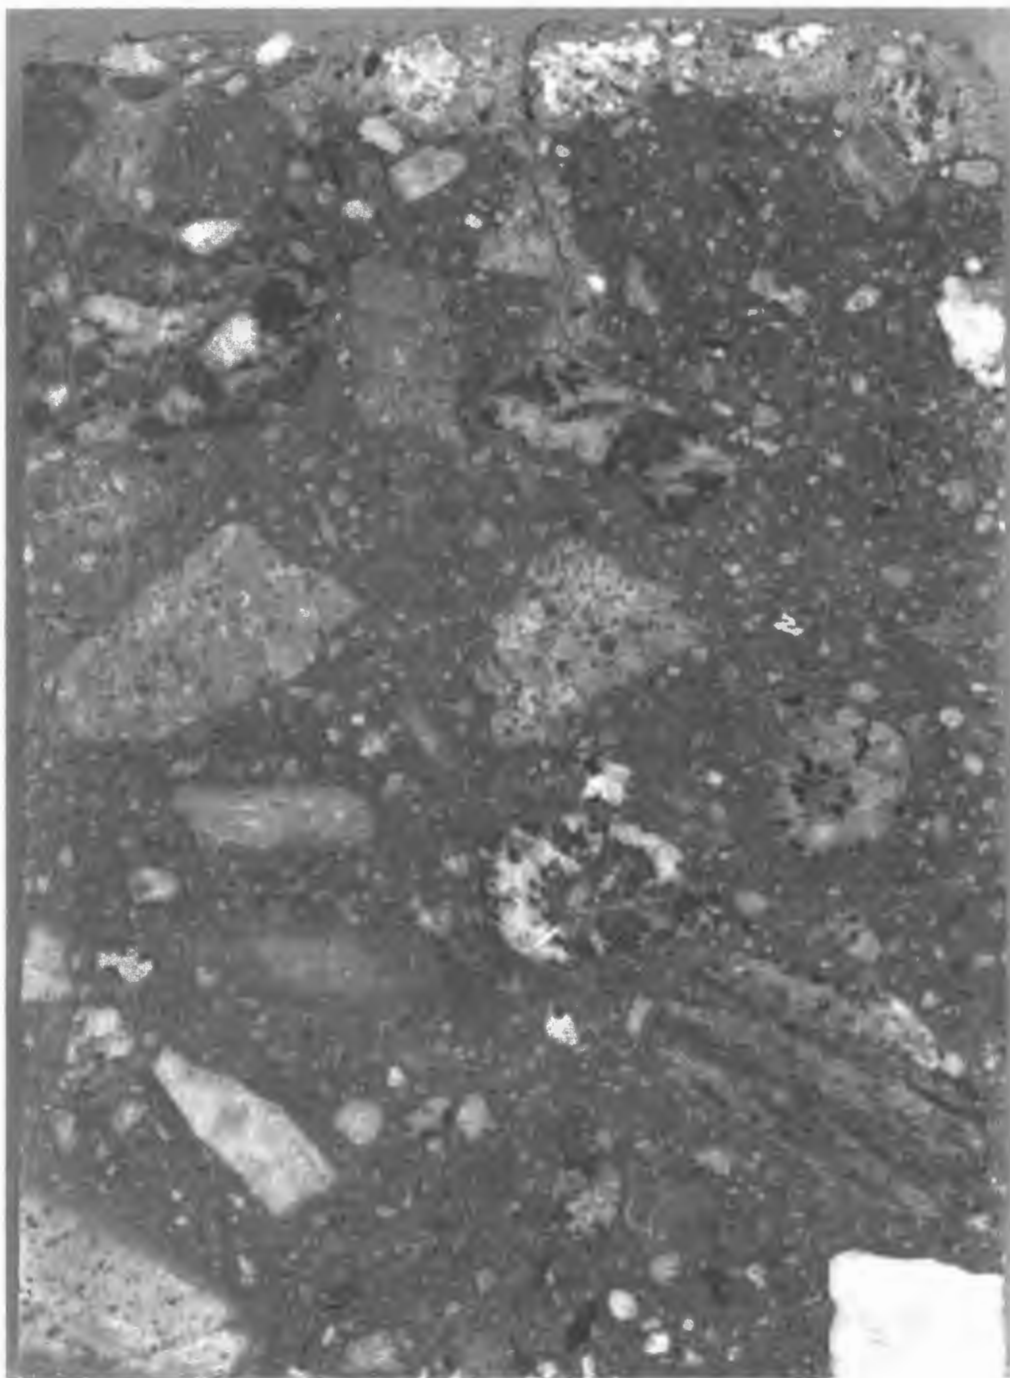
Figure 3-79. Phenolphthalein stained polished slab, showing carbonation along plastic shrinkage crack (magnified 1.5x).

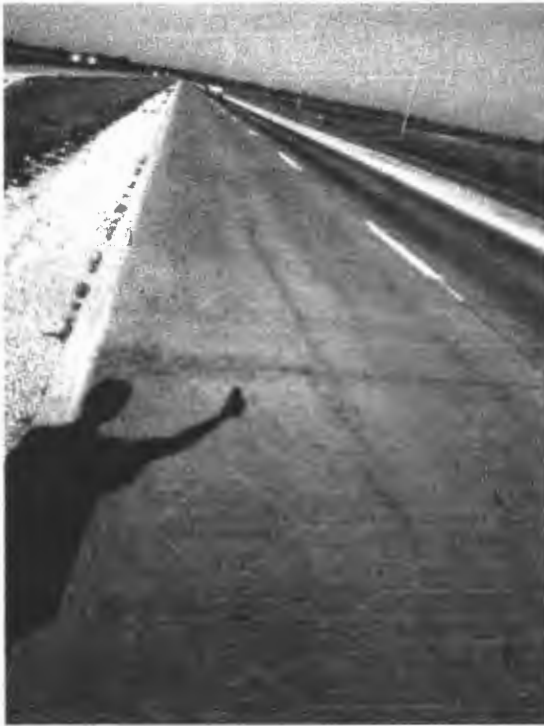
(a) Staining along longitudinal cracks

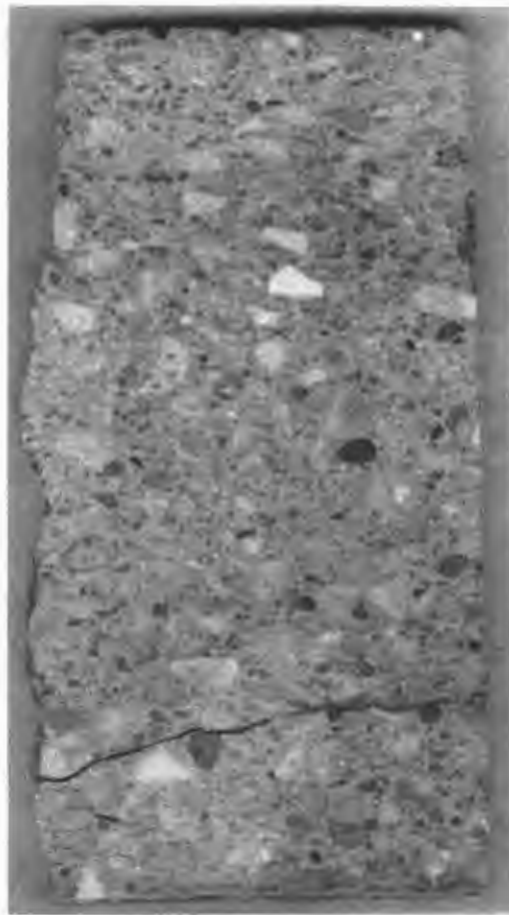
Figure 3-83. Polished slab from core IA-002-002-001A. The irregular surface along the left-hand side of the core is a cross-sectional view of the transverse joint texture.

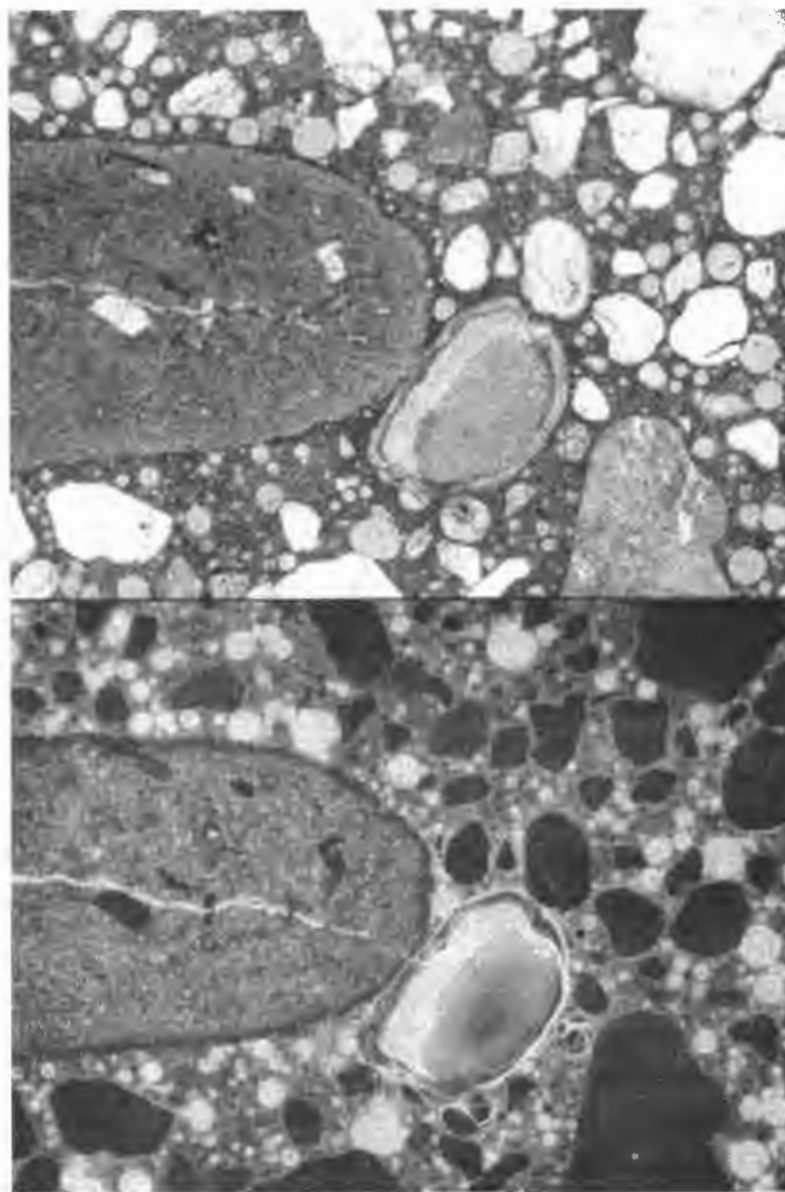
Figure 3-85. Reactive fine aggregate particle with alkali-silica gel filled air voids as viewed in thin section. Top image is transmitted plane polarized light, bottom image is in epifluorescent mode, magnified 20x.
