ATSP CASE STUDIES

Volume II
February 2016

Metro

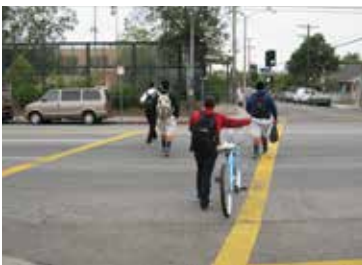
School crossings

Some crosswalks near schools have low visibility, long crossing distances, short crossing times, and long waiting times.

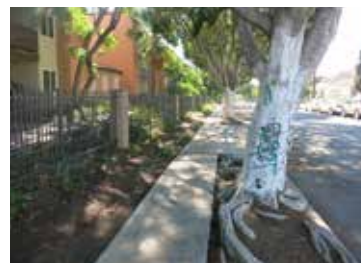
Narrow Sidewalks

Most sidewalks in the station area are in good condition with sufficient width. However, in a few residential locations, narrow widths create a potential access barrier.

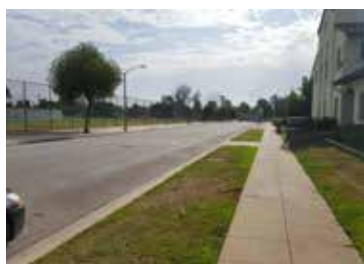
Lack of landscaping and shade

Although most of the study area is well shaded with trees, there are some areas that lack protection from the sun. During a hot day, this can lower a person's sense of comfort.

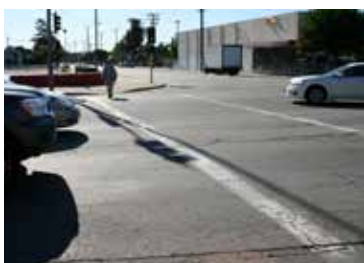
Unenhanced crosswalks or lack of crosswalks

Some long roadway segments along busy commercial streets are without crosswalks. Existing crosswalks are generally unenhanced and inadequately marked, without such features as continental striping or advance stop lines. In addition, several crossings in the study area are without curb cuts.

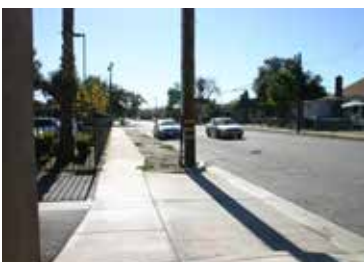
Lack of landscaping and shade

The residential neighborhood in the study area's southeast quadrant lacks tree cover, and parkway strips are sometimes not well maintained. The two east-west commercial streets lack shade and landscaping.

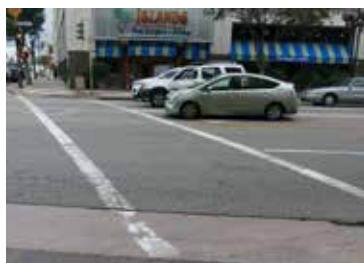
Poorly marked (or lack of) crosswalks

While most crosswalks in the walkable commercial district are clearly marked, some crosswalks in the study area (especially on other commercial corridors) are generally unenhanced and sometimes inadequately marked, without such features as continental striping and advance stop lines.

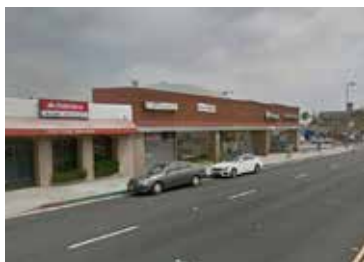
Lack of shade on some commercial corridors

While much of the study area is well shaded with mature trees, sections of commercial streets lack tree cover. In addition, some residential streets are lined with palm trees, which do not provide shade.

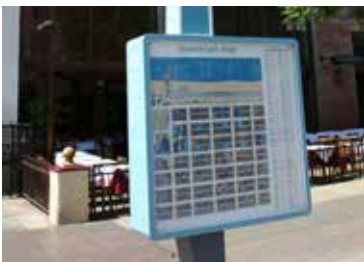
Wayfinding signage

There is some wayfinding and directional signage in the commercial core around the shopping promenade. However, they focus on cultural and retail destinations rather than offering directions to transit stops and bicycle facilities.

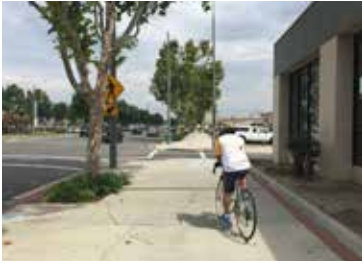
No bicycle facilities

There are currently no bicycle facilities in the study area. People who are bicycling often ride on the sidewalk or alongside fast-moving cars, which can be unsafe for all users of the road.

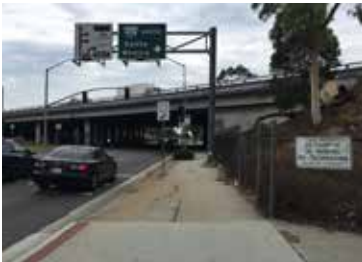
Freeway underpasses

The freeway is a major barrier that disconnects the station from the residents to the south and the west. Underpasses can feel unsafe during the night.

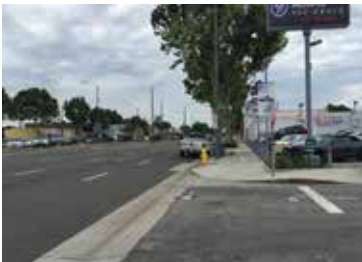
Crossings at the rail line

While most of the crosswalks in the study area are designed better than most in the County, important crossings along the rail line, the primary east-west street, and routes to school lack high visibility, accessibility, or safety amenities.

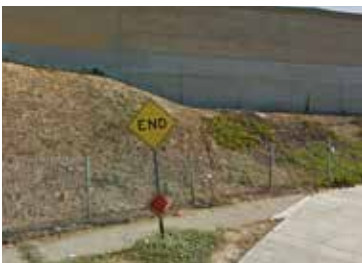
Dead ends caused by the freeway

Traveling from the southwest region of the study area to the transit stop is constrained as the freeway cuts through the street grid, resulting in dead ends that limit connectivity.

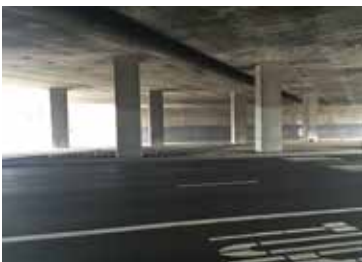
Lack of lighting

Although the north-south street has pedestrian-scaled lighting, several residential streets and underpasses do not. This lack of lighting can make traveling to the station feel unsafe.

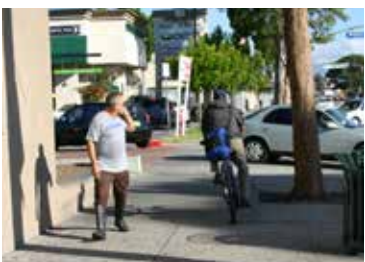
Lack of bicycle facilities

There are currently no bicycle facilities in the study area. People who are bicycling often ride on the sidewalk or alongside fast-moving cars, which can be unsafe for all users of the road.

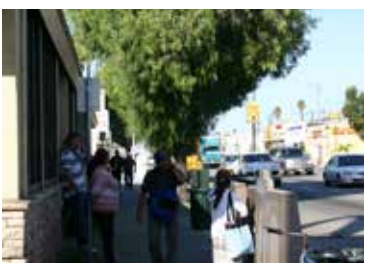
Lack of amenities at some bus stops

Many bus stops lack adequate shelters or shade-providing elements, and some are without any seating. Bus stops generally do not have nearby bicycle parking. Insufficient sidewalk widths add challenges when making enhancements to existing bus stops.

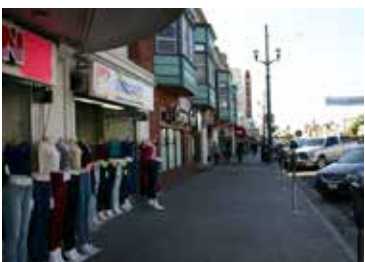
Lack of landscaping and shade

Commercial streets lack adequate landscaping and shade. While the primary commercial street has adequate space for the addition of landscaping and trees, other commercial streets do not have adequate existing sidewalk widths to accommodate new landscaping and trees.

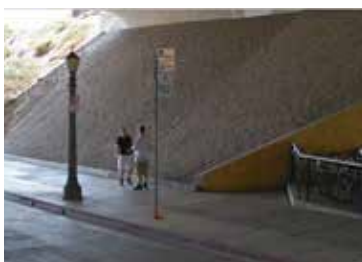
Unenhanced bus waiting areas - next to station portal

Many bus waiting areas, including right next to the station are unenhanced and can benefit from the addition of seating and real-time arrival information.

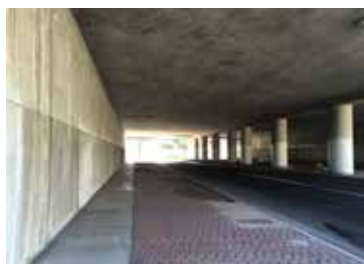
Freeway underpasses

Although some of the freeway underpasses have enhancements, such as planting and sidewalk buffers, the lack of lighting and other amenities makes the underpass feel unsafe, especially during the night.

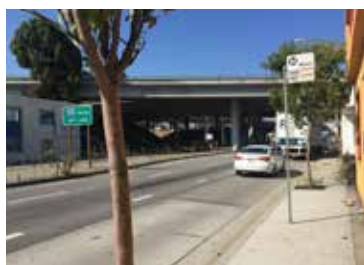
Unpleasant bus waiting areas throughout the site

There are several bus stops in the study area, but only a few of them have benches, waste receptacles, and shade to make it comfortable for people waiting.

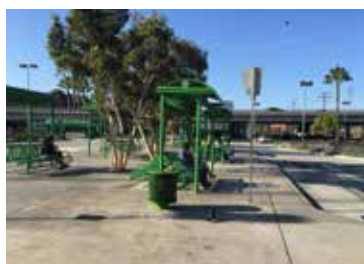
Lack of station identity and difficulty navigating

The transit center is difficult to see from the street or sidewalk and there are only a few identifying markers or landmarks around the area. The curvilinear design of the streets also makes navigating to and from the station difficult unless you know where you are going.

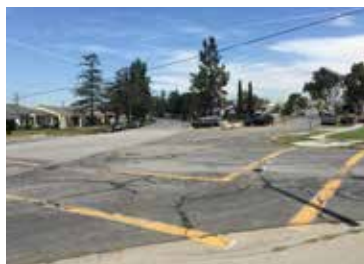
There are several crosswalks throughout the study area that lack highly visible crossings to alert drivers of people crossing the street. Although most crosswalks have curb ramps, they can be improved upon with the addition of truncated domes and unidirectional curb ramps.

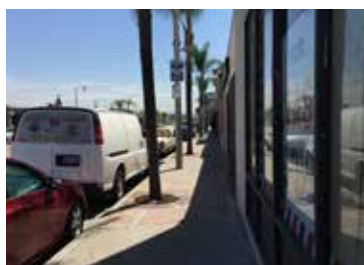
Narrow or missing sidewalks throughout the study area

There are some portions of sidewalk that are too narrow to adequately accommodate people walking. Some of the residential areas to the north lack sidewalks altogether, which means people have to travel alongside fast-moving traffic without a protective buffer.

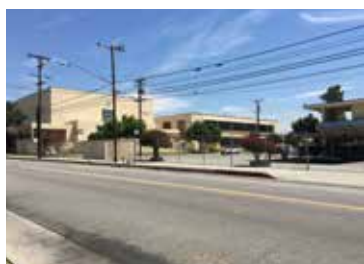
Although there are some street lights, there is a general lack of lighting at the scale that is suitable for people walking, bicycling, or rolling. This discourages people to travel to and from the transit stop, especially at night.

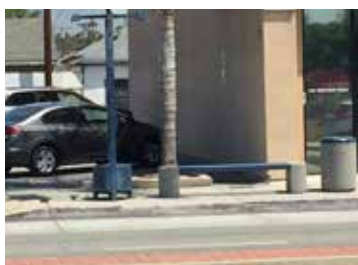
There are no bicycle facilities at the transit stop or in the study area. This discourages people from bicycling on the street and creates an unsafe environment if they choose to ride on the sidewalk. The lack of protection against the sun at nearby bus stops can make waiting for the bus uncomfortable.

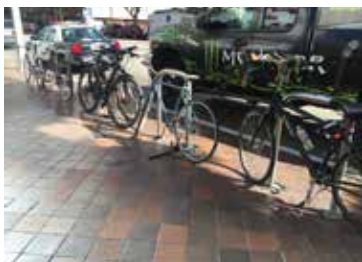
There are major gaps in the bicycle network and a general lack of bicycle parking. This can discourage people to bicycle to and from the station if there are not enough places to safely secure their bicycle.

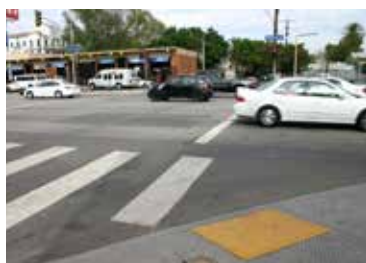
Vehicle speeds (and rates of speeding) are high on many larger commercial streets and some residential streets. At peak hours, roadway congestion can lead to lower speeds, but peak-hour curbside travel lanes bring vehicular traffic closer to the sidewalk and make bicycling on the roadway hazardous.

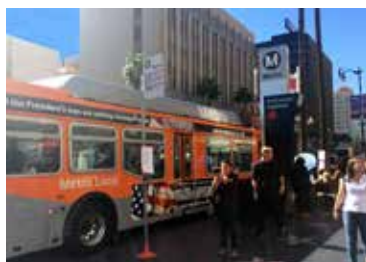
Many bus stops lack amenities such as shelters, bicycle parking, and shade-providing elements, and some are without seating (including the bus stop just outside the station area). Many bus waiting areas are in locations without sufficient sidewalk width to accommodate amenities.

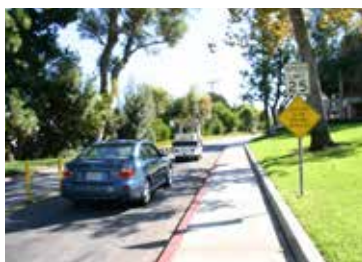
Traffic speeds on major streets are high. In addition, on a campus roadway (left), people bicycling share narrow lanes with vehicles that often travel over the speed limit. Comfort and safety for people walking is reduced by the lack of a buffer between the sidewalk and roadway.

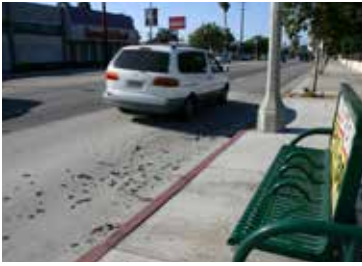
Vehicle speeds are high on many of the larger commercial streets and on some residential streets. Peak-hour curbside travel lanes on some streets bring fast-moving vehicular traffic closer to the sidewalk, decreasing the pedestrian buffer as well as making bicycling on the roadway hazardous.

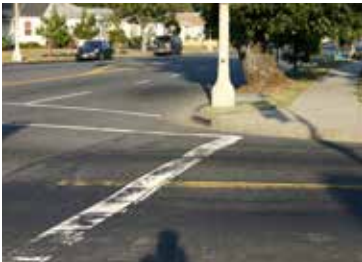
Many existing crosswalks do not have adequately maintained striping, and are without enhancements such as continental striping or advance limit lines. Long stretches along some commercial boulevards are without pedestrian crossings. A few crossings in residential areas are without curb ramps.

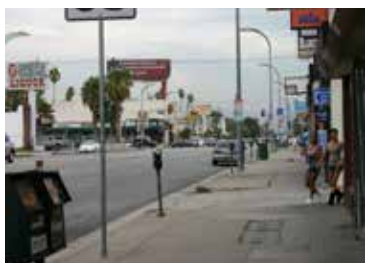
Sidewalk environments along the main commercial corridors generally lack landscaping and shade-providing trees. Sidewalk pavement conditions are generally good, although there is a lack of street furniture and lighting for people who walk.

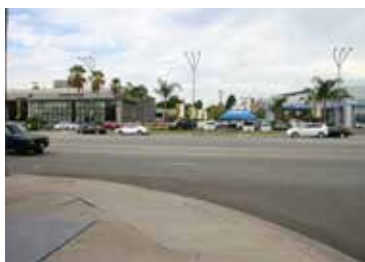
Many unsignalized intersections lack crosswalks, resulting in long stretches (up to 1/4 mile) without any crosswalks.

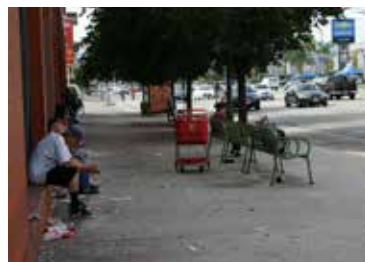
Many of the bus waiting areas within the station area lack amenities such as sufficient seating, shelters, and shade trees.

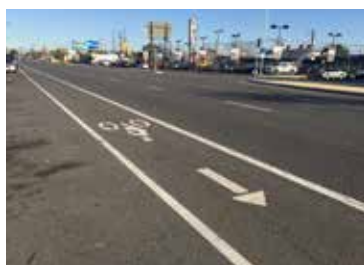
The only bicycle lane in the study area does not fully connect to the station and other major destinations. The lane is separated from fast-moving traffic only by paint. The lack of bike facilities forces many people to ride on the sidewalk, creating unsafe environments for people walking.

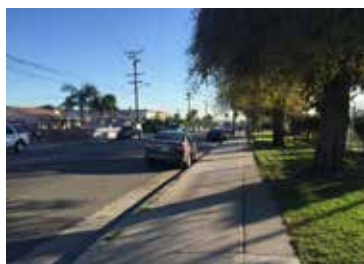
Most of the study area, except at the station, lacks sufficient lighting for people walking and bicycling. The lack of illumination can discourage many people from getting to and from the station, especially during the night.

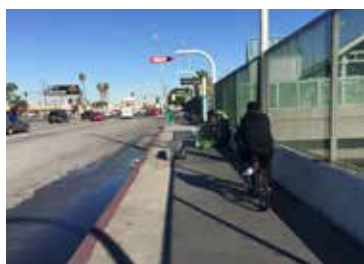
There is fast-moving traffic along the major commercial streets, which making bicycling on the road feel unsafe. People may also feel uncomfortable crossing the street with these conditions.

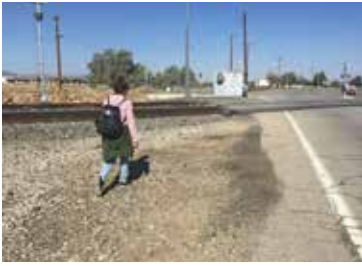
Currently, a person walking or bicycling from east of the station has only one access point to get to the station. Without establishing greater connectivity, any design recommendation east of the rail line will not help to encourage people to walk or bicycle to the station.

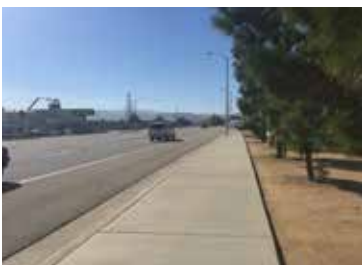
People walking to and from the station must travel long distances, sometimes traveling past their destination, because there are no signalized places to cross the street. This discourages people from walking and encourages jaywalking.

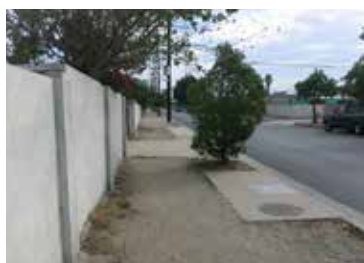
Many street segments in the residential neighborhoods lack paved sidewalks. The resulting pathway is usually dirt or trampled grass, creating a significant accessibility barrier for people with mobility impairments. Sometimes there is no sidewalk space at all, so people walk in the roadway.

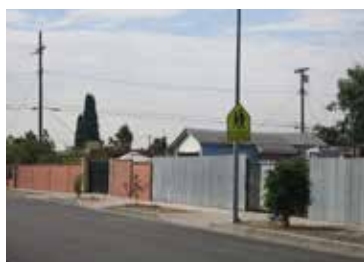
Many sections of the study area lack landscaping. Streets generally lack mature and consistent tree cover.
