Supportive Transit Parking Program

A key first step of the STPP Master Plan effort was the collection of quantitative data regarding how Metro’s parking spaces and qualitative information related to their condition and access. The purpose of the Facility Assessment effort was to understand current system operation and performance, which served as baseline information required to recommend future policy and operational changes, and to recommend and quantify the cost of improving the parking facilities.

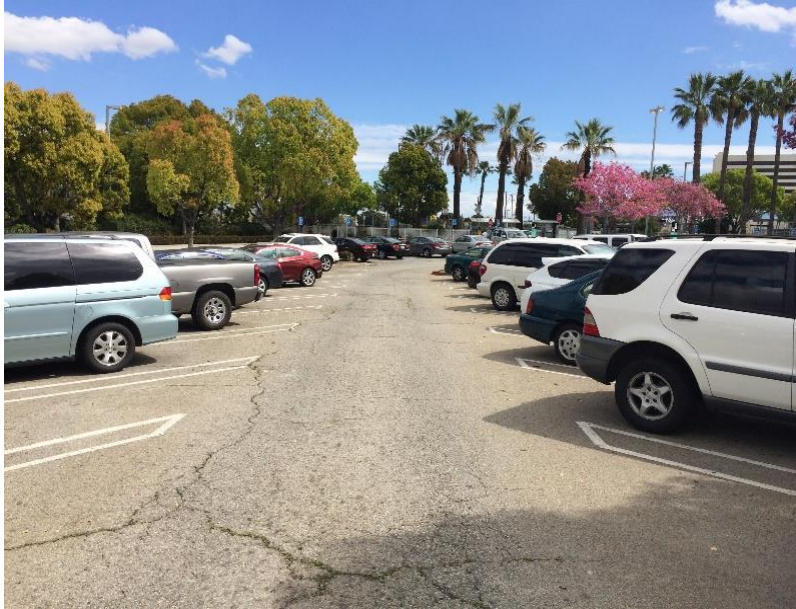
Photo 14: Cracks in the Pavement

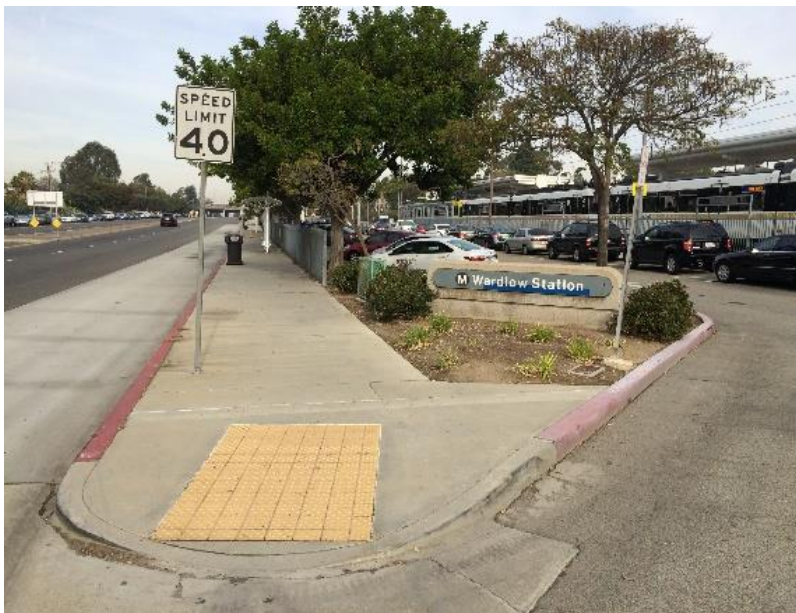
The monument sign for this station is on Wardlow Road and is difficult to see from Pacific Place. There is no signage on Pacific Place indicating parking for a Metro facility, and while the entrance to the North Lot has a worn monument sign, there is no signage at the South Lot entrance.

Photo 23: Sign at Entrance to Parking Lot

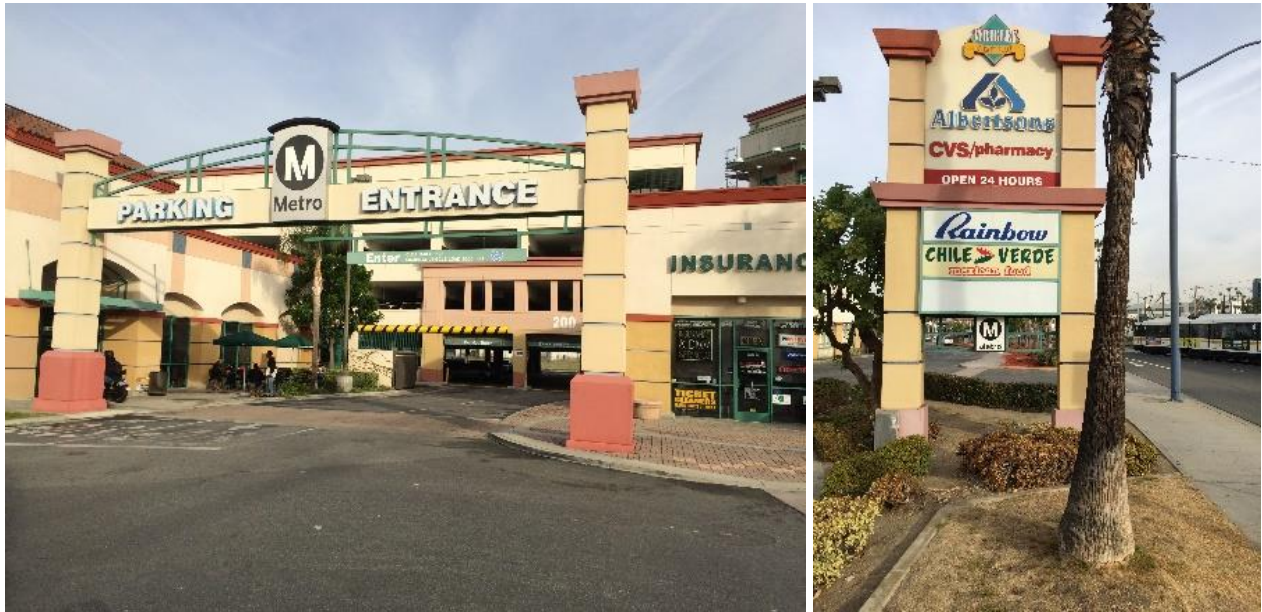
There are no parking wayfinding signs on adjacent streets and the typically-found Metro monument signs are absent, or well-hidden making identifying parking entrances more challenging. There is a Metro sign attached to the shopping center's monument at the entrance on Long Beach Blvd., but none at the Willow St. entrance. This is a large monument entrance to the structure within the shopping center, but this is not visible to passing motorists on Willow St. The North Lot was empty but motorists are not made aware of this.

Photo 26: Large Monument Sign at Entry to Parking Structure (L); Small Metro Sign on Shopping Center Monument Sign (R)

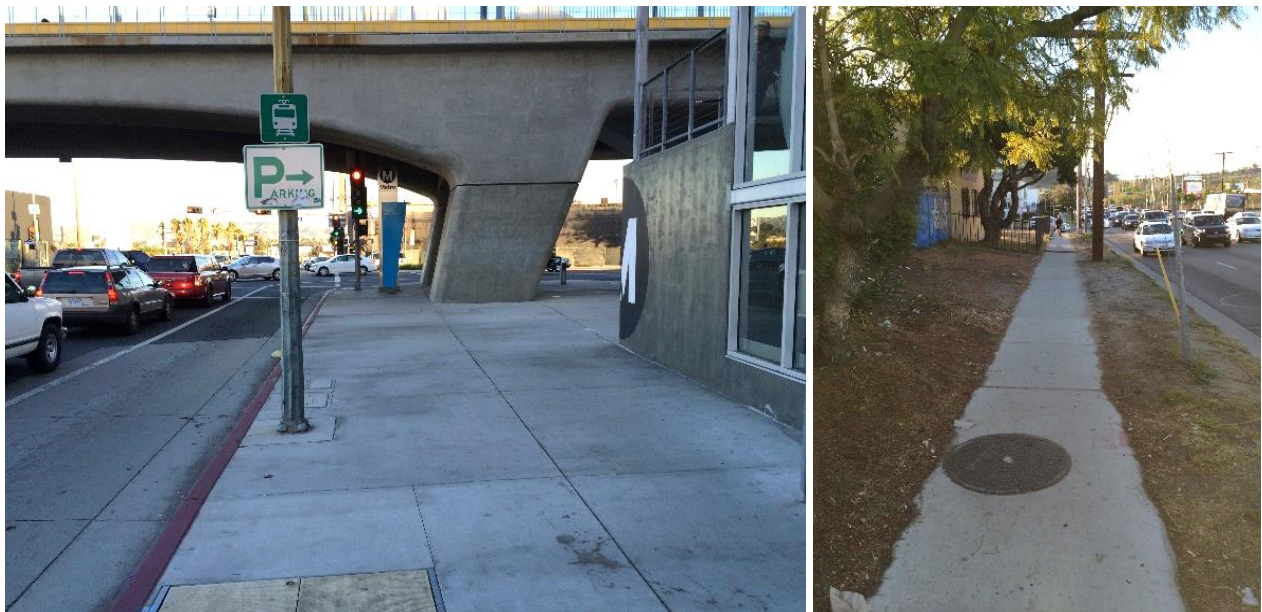
Sidewalks are present on all roadways. Sidewalks on La Cienega are wide, but unbuffered from a very busy roadway. The sidewalk on the north side of Jefferson west of La Cienega is narrow and substandard, with light poles obstructing the sidewalk in several locations. The sidewalk on the south side of Jefferson west of La Cienega has been replaced by the Expo Line bike path. While the pedestrian infrastructure is good, crossing La Cienega at its intersection with Jefferson can be challenging given the congestion at the intersection, and frequent occurrence of vehicle queues blocking the crosswalks.

Photo 33: Sidewalk along La Cienega Blvd. Looking North (L); Sidewalk along La Cienega Blvd. Looking South (R)

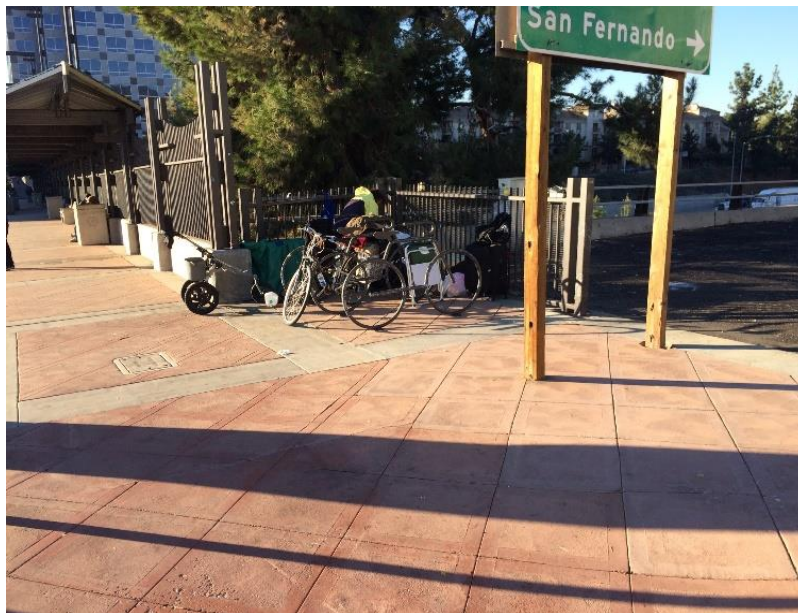
No issues were observed in the parking lot. There was a homeless encampment around the bicycle racks at the corner of Lake Ave. and Maple St. which may deter individuals from walking to the station platform from the parking lot or it requires a rider to cross Lake Ave. to access the platform in order to avoid the homeless encampment.

Photo 87: Bike Racks Covered by Homeless Encampment

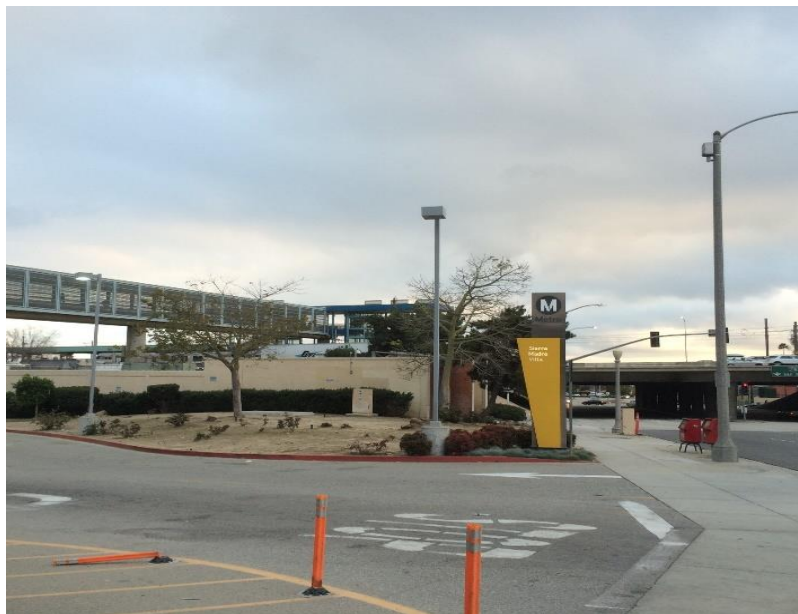
Sidewalks approaching the station area are not continuous as there is no pedestrian east/west crossing for Sierra Madre Villa Ave. on either side of I-210. The closest east/west crossing is at Foothill Blvd. north of the station. Sidewalks in the area appear to be in good condition. Also, pedestrian access from Sierra Madre Villa Ave. to the station is not clear. Once inside, there is good signage directing riders to the fourth floor to access the pedestrian bridge leading to the station platform.

Photo 90: Sidewalk along Sierra Madre Villa Ave.

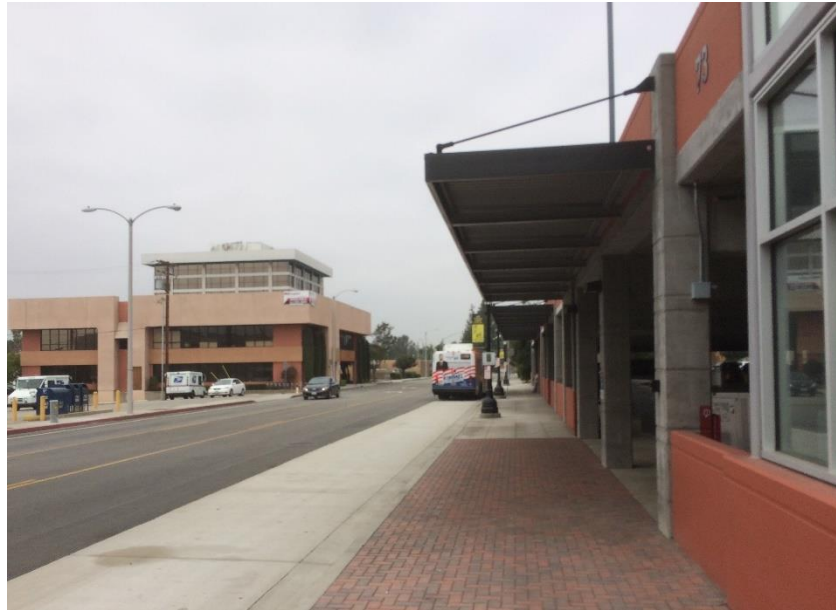
On a Saturday afternoon, a couple individuals were seen walking to the second floor of the parking structure and then later loitering on the first floor of the parking structure. An individual was seen standing near the ADA parking area. In both cases, the individuals may have been waiting for arriving Gold Line riders as there is no designated pick-up/drop-off area.

Photo 95: Bus Layover along East Santa Clara St. Prior to Garage Entrance/Exit

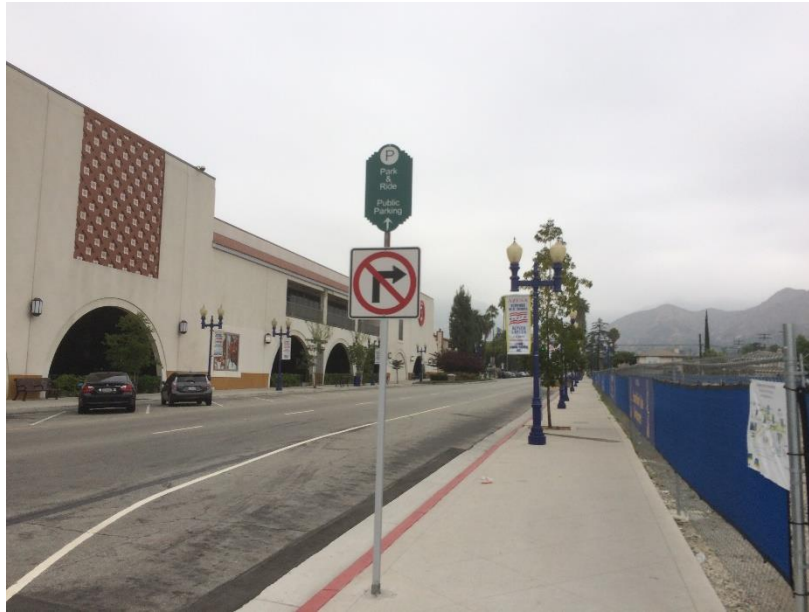
There are small parking wayfinding signs that direct drivers heading westbound on East 9th St. and northbound on Azusa Ave. to the parking structure. There were no signs observed on Foothill Blvd. or on North San Gabriel Ave. Drivers on northbound Azusa Ave. should identify the parking structure after seeing the station monument sign. However, it is less apparent to drivers who arrive from East 9th St. There are no signs on the structure that indicate Metro parking.

Photo 110: Signage along Azusa Ave. Directing to Parking

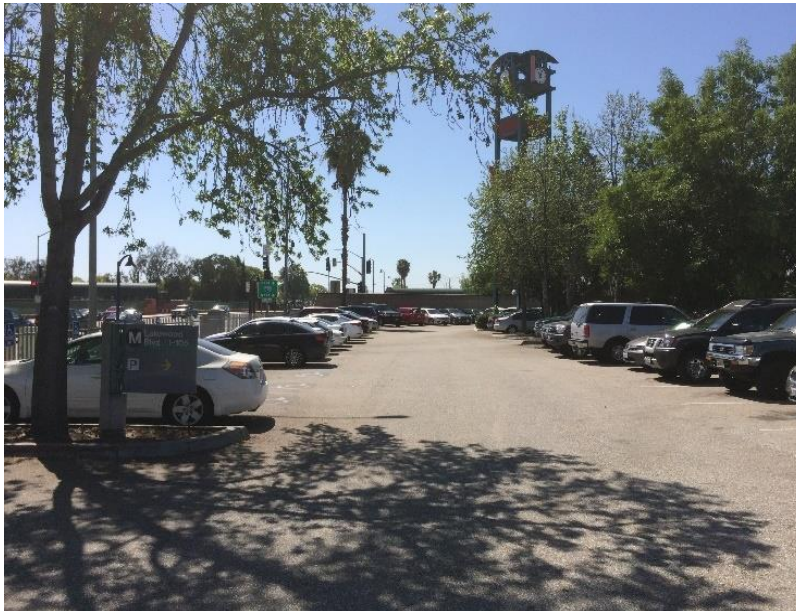
Pavement conditions are good. Some of the striping is faded.

Photo 127: Faded Striping

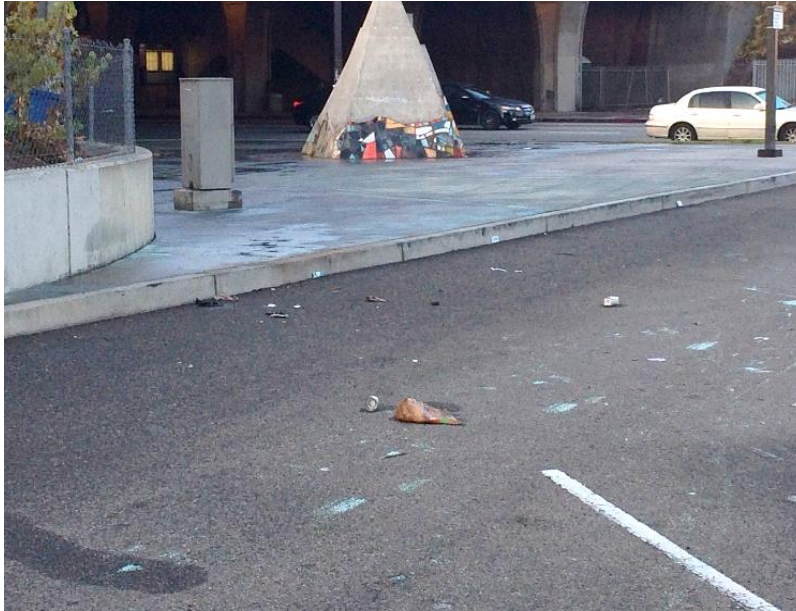
Photo 136: Visible Trash in Parking Lot

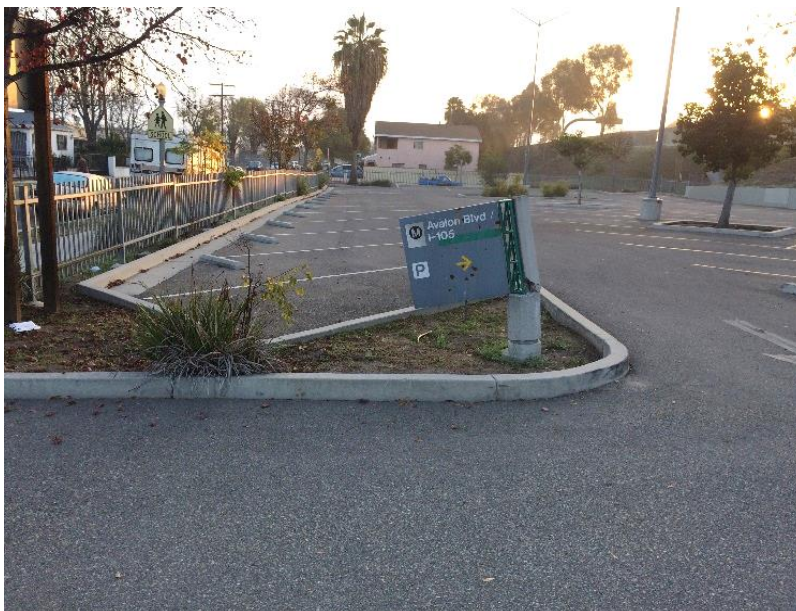
The parking lots appear to be fairly well-maintained. The sign at the entrance to the Northeast Lot appeared to be broken.

Photo 137: Broken Sign at Northeast Entrance to Lot

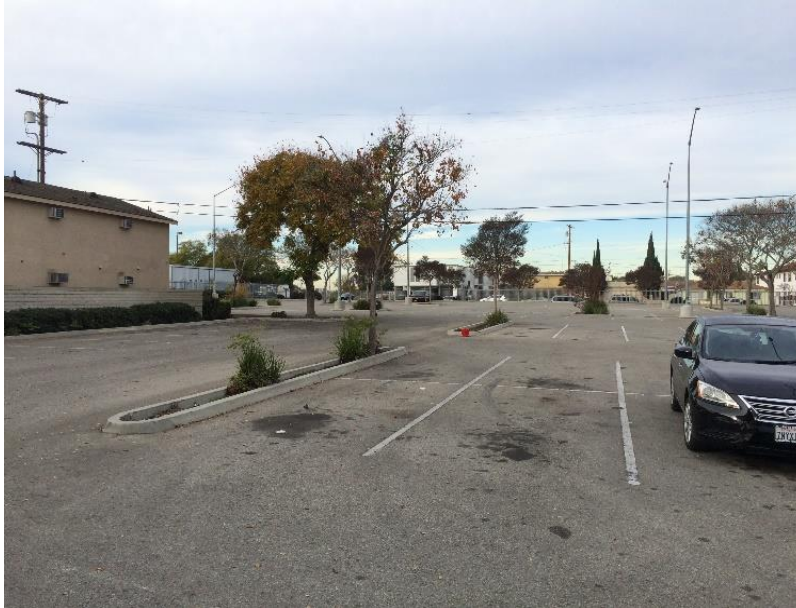
Photo 146: Trash in Parking Lot

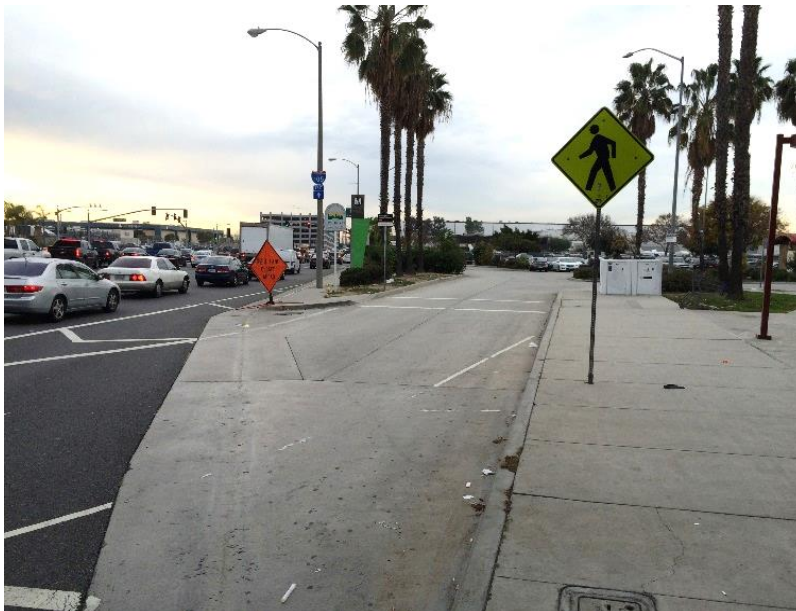
Pedestrian connectivity in the station area is challenged as there are no crosswalks to cross Crenshaw between West 118th Place and West 120th St. The sidewalks along Crenshaw are wide and in good condition and there are station entrances on both sides of the St. There is a walkway on the northern side of the lot that leads to the station.

Photo 149: Walkway Leading to Station from Sidewalk on West Side of Crenshaw Blvd.

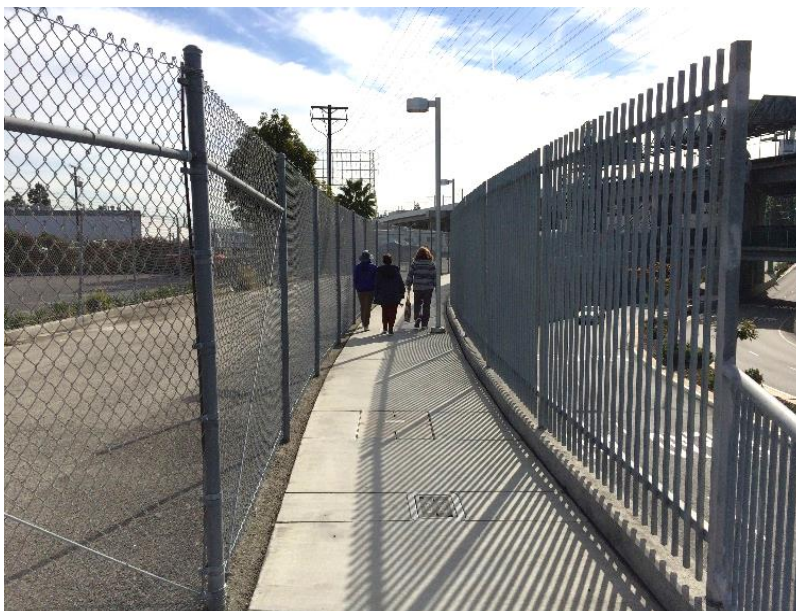
There is good pedestrian connectivity to/from the station area. The sidewalks are in good condition from the parking lot to the station. However, the walk from the parking lot to the station is long and enclosed as there are high walls/fences on both sides. Also, there is no pedestrian wayfinding signage from the lot to the station.

Photo 165: Walkway Connecting Lot to Station Platform

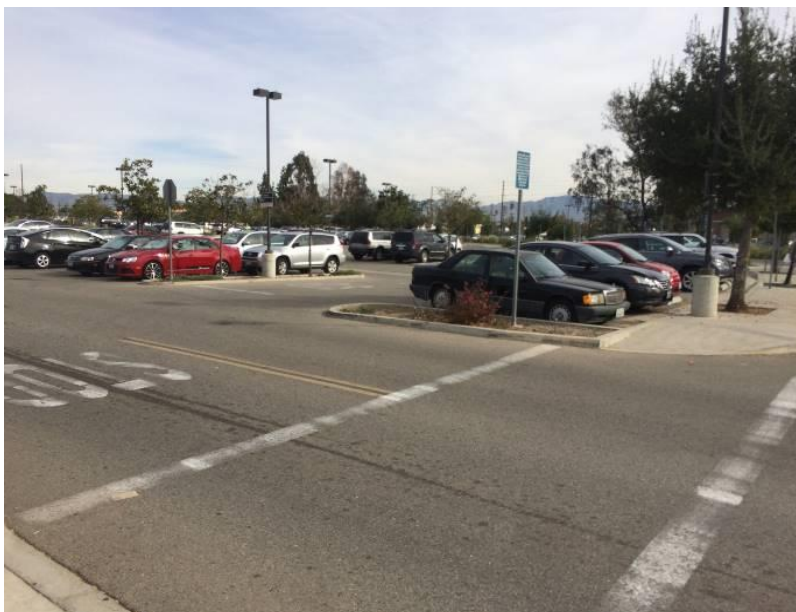
The Orange Line Pedestrian and Bicycle path runs along the north side of the busway, and continues running northwest/southeast of the station along the Orange Line busway. Sidewalks leading to/from the station are in good condition. The station is not visible from main roads. Haskell Ave. is used as a cut through between Victory Blvd. and Sepulveda Blvd. The last leg of the cut through involves speeding through the parking lot. Traffic calming measures should be implemented to discourage this cut through and to reduce speeds in the parking lot.

Photo 181: Pedestrian Crosswalk within Lot

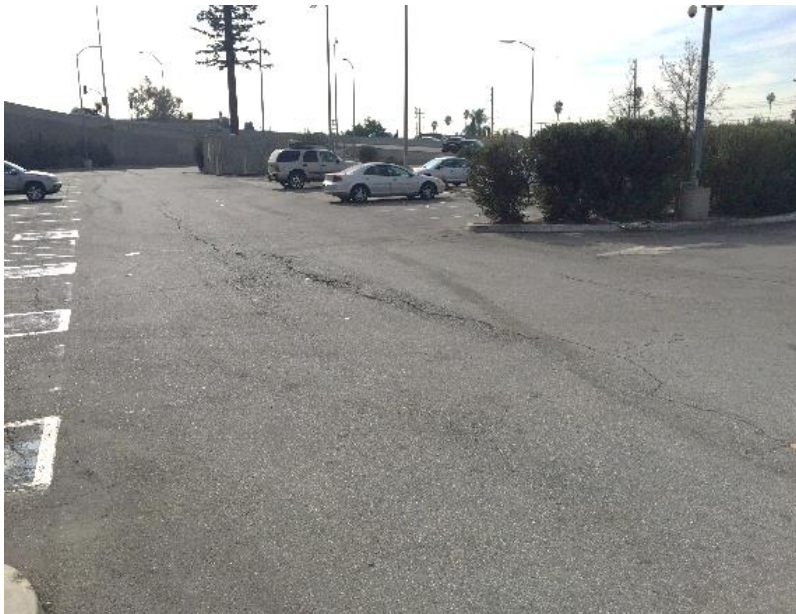
The pavement quality is below average and beginning to crack. The striping is faded and poor.

Photo 220: Pavement Cracking in Lot

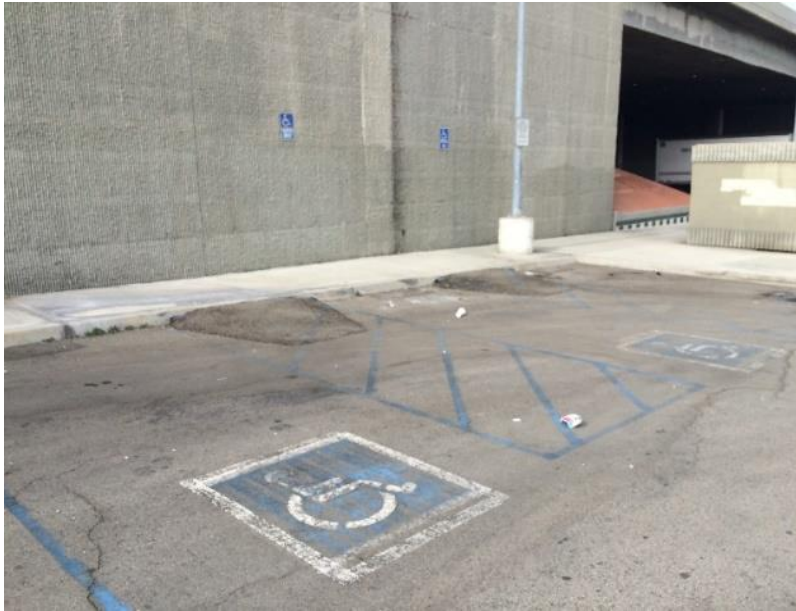
Photo 221: Non-Compliant ADA Ramps

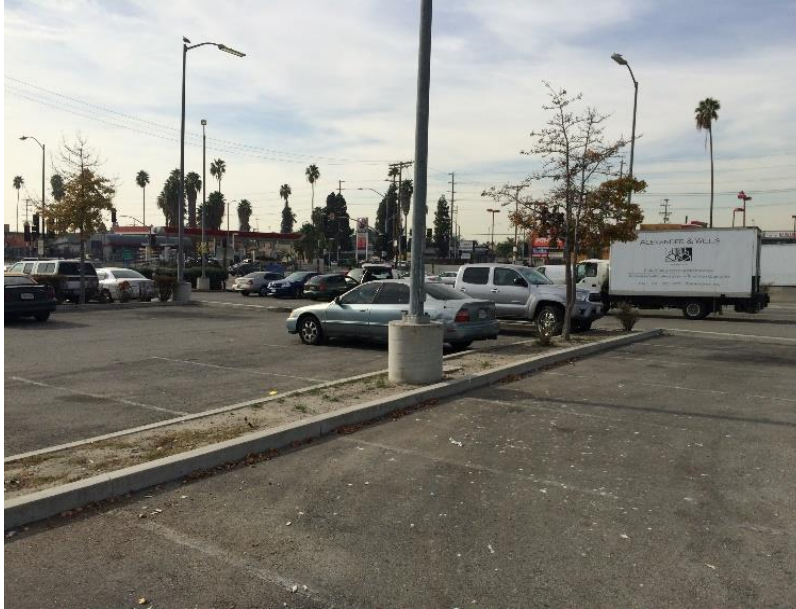
Photo 224: Faded Striping and Trash in Lot

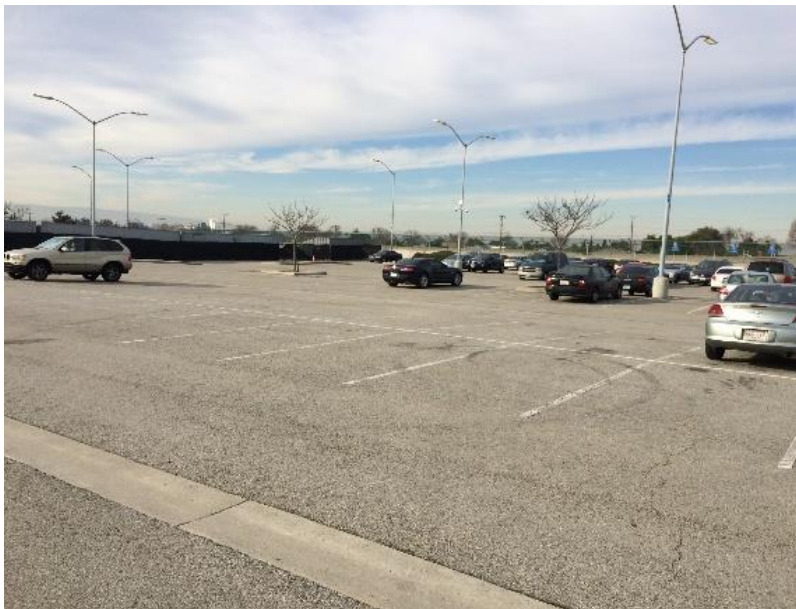
The striping is clearly visible although the pavement has some cracks.

Photo 228: Cracked Pavement in Lot

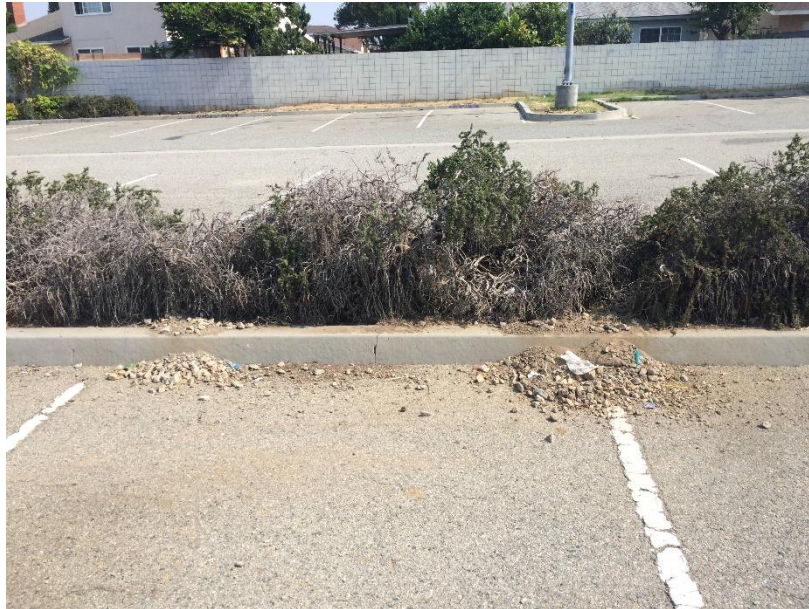
Photo 244: Poorly Maintained Landscaping and Litter in Parking Lot
