**Metro Gold Line Eastside Extension  
Four Quadrant Gate Feasibility Study**

September 2009

This report addresses the December 2008 motion to determine feasibility for the installation of four quadrant gates along the Metro Gold Line Eastside Extension.

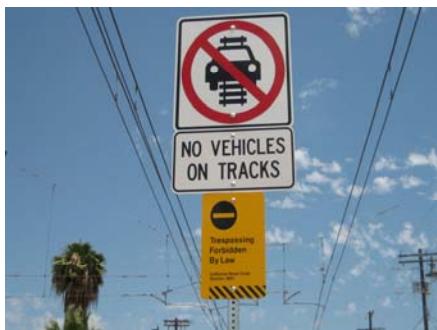
Figure 1 – No Trespass and No Vehicle Signs

Signs have been placed within the 1<sup>st</sup> Street and 3<sup>rd</sup> Street trainways to warn pedestrians of trespass and motorists that vehicles are not permitted on the tracks. These signs are appropriate. However, the No Trespass sign size and lettering appear to be too small. The team was not able to easily read the sign until they were in the trainway itself, defeating the purpose of the sign. On the other hand the "No Vehicle on Tracks" sign and "No Vehicles" symbol sign, appear to be appropriately sized. See Figure 1

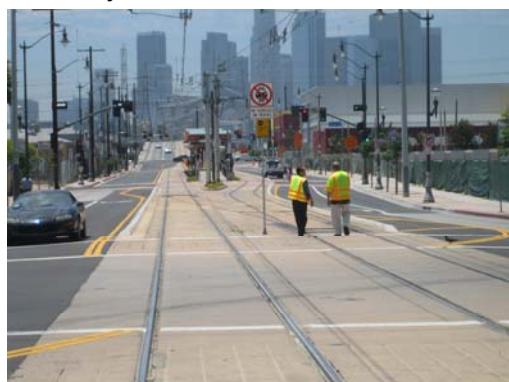
Trainways should be delineated to clearly indicate that it is not a roadway for motor vehicle traffic and to define the dynamic envelope of the train. The latter is particularly important for those segments where trains mix with vehicular traffic, such as in roadway intersections. Typical means to delineate the trainway are by striping, curbs (including mountable curbs), raised buttons or other tactile treatment. Along 1<sup>st</sup> Street and 3<sup>rd</sup> Street, the trainway is delineated by a 6-inch mountable curb, colored stamped concrete, and in some

locations reflective paddles atop the curbs. The panel found the stamped concrete to be  
Figure 2 – Trainway Contrast noticeable during daylight hours. During hours

of darkness, the color contrast of the stamped concrete area with the roadway was much less discernable. This is a concern as a motorist negotiating a turn may mistake the trainway for the roadway, and as a consequence, enter the trainway. Additional treatment is needed to more clearly indicate that the trainway is not a roadway and that motorists are not to enter it. See Figure 2.

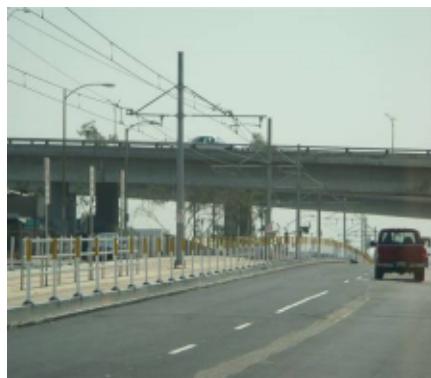
Figure 4 – Reflective Paddle Delineators

The reflective paddles along 3<sup>rd</sup> Street visibly outline the trainway. However, the paddles are likely to become a maintenance issue as they are easily damaged. Several damaged paddles were seen during site visits. There are several other treatments that can achieve the same effect. One option is to place yellow raised buttons on the curbs with reflective pavement markers placed every third one or so. Another option is to simply place reflective pavement markers on the curb. If reflective paddles are to be retained, they should be placed at approximately 15-foot intervals.

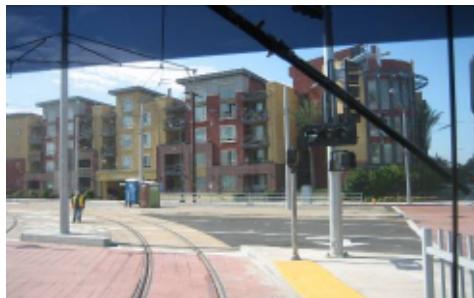
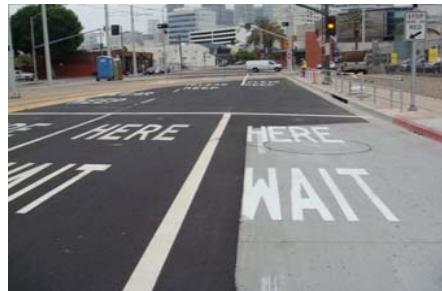
### **1<sup>st</sup> Street and Alameda Avenue**

Eastbound train moves from Little Tokyo Station through 1<sup>st</sup> Street and Alameda Avenue require operators to negotiate the move at 10 mph due to the sharp curve.

Trains moving through this crossing frequently encounter motor vehicles encroaching in the designated "Clear Zone". The encroachment may be due to motorist confusion as to where to stop, as the "Wait Here" and "Keep Clear" zones appear to blend together. The encroachment creates two problems. First, it may impede train movements. Second, a train moving through the crossing may collide with the stopped vehicle, as it may not always be evident to the operator that there is insufficient clearance. The use of markers to define the dynamic envelope will assist the operator in knowing whether it is safe to proceed through the curve. Train clearance markers have an added benefit. They provide a visual queue to the operator where the end of the train is in relation to the curve and when it is safe to accelerate.

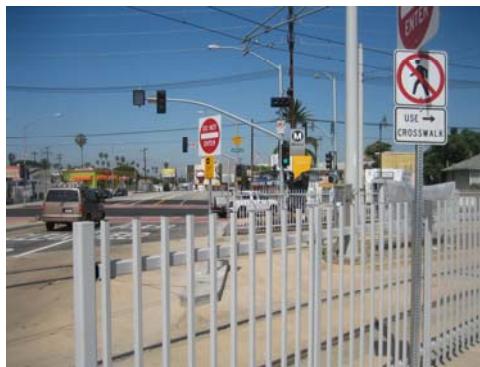
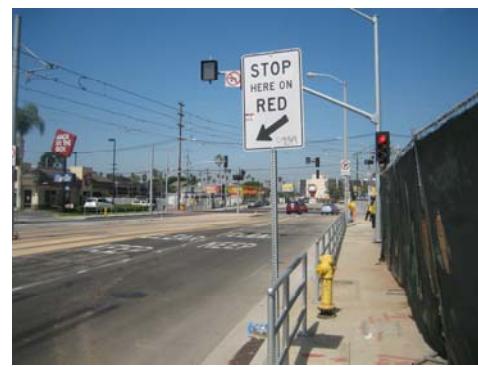
### **3<sup>rd</sup> Street and Indiana Avenue**

The photographs above show a view on 3<sup>rd</sup> street looking west at Indiana Avenue. The light rail station is just to the right in each photograph. Pedestrians approaching Indiana Avenue from the west (northwest quadrant of the intersection) are directed across

Indiana (toward the northeast quadrant) and onto what appears to be a pedestrian island. The area is not a pedestrian island, but in fact the northeast corner of the intersection. After reaching the corner, pedestrians are to proceed to the pedestrian crossing located on the south end of the 3<sup>rd</sup> and Indiana Station, if they wish to continue east along 3<sup>rd</sup> Street. Pedestrians are not to continue across the tracks as it places them into the roadway with no safe refuge, such as a sidewalk.

*Consideration should be given to extending the picket fence on the island to discourage pedestrians from continuing straight across the light rail tracks. A sign stating that pedestrian are prohibited from crossing the tracks at this location should be placed on the fence, as well.*

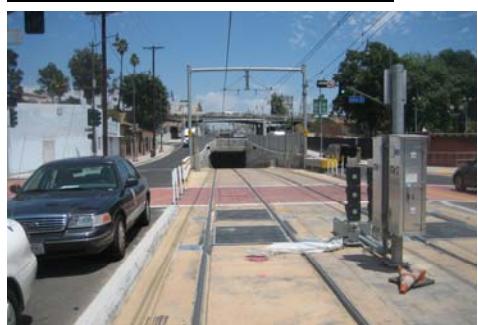
**1<sup>st</sup> Street and Gless Avenue**

1<sup>st</sup> Street and Gless Avenue is the locality of the west end of the tunnel. Prior to the construction of the tunnel portal, vehicular traffic was permitted to cross 1<sup>st</sup> Street at this location. Now, high curbs with large reflective paddles on top have been put in place as a crossing barrier. A number of active and passive signs were also in place, informing motorists that they must not turn and proceed straight ahead. Although no damage to the barrier was found, the signage at this location

was cluttered and may be confusing. There were “No U Turn” and “No Left Turn” signs on Gless Street (only right turns are permitted. Signage at this location should be evaluated.

**Recommendation 24 – Reevaluate Signage**

*Reevaluate the signage on Gless Avenue, as many of the signs are no longer applicable.*

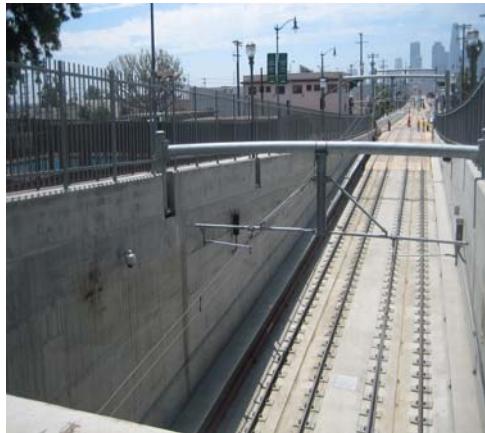
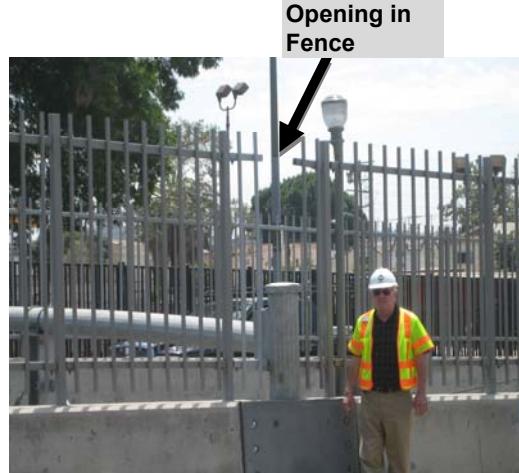
A significant safety issue was identified at the west portal (above photographs). The pickets on the perimeter of the portal walls are spaced far enough apart to permit objects from being pushed through and landing on the trainway, making contact with the catenary, or being dropped in front of an approaching train. Additionally, there is a large opening (see photograph on the right) that allows a person to climb on to the pipe spanning the tracks. Tight wire mesh or other tightly woven fabric should be placed on the pickets to prevent objects from being pushed through. Additionally, the large openings on each side of the pipe span should be closed.

**Recommendation 25 – Picket Fence**

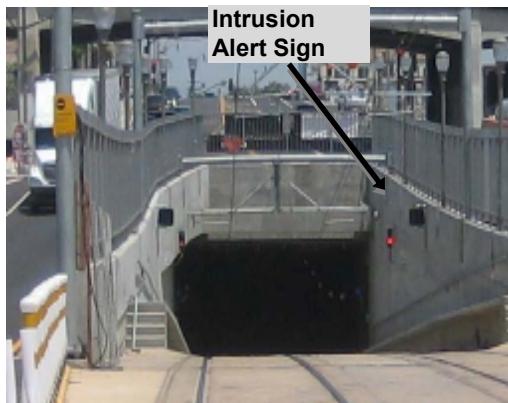
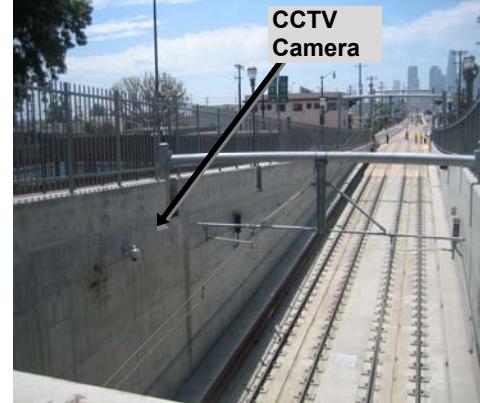
A tunnel intrusion detection system has been installed to detect unauthorized persons and vehicles in the tunnel. Upon detection, an alert is sent to the ROC. A CCTV camera, mounted on the portal wall (see lower right photograph below) permits ROC personnel to view the intrusion. Additionally, a visual alert is displayed at the portal (see lower left photograph below) to notify train operators that an intruder is in the tunnel.

At each underground station there is an intrusion detection system that will be coupled to the platform end gates. Intruders entering the tunnel through the gate are immediately detected; sending an alarm to the ROC and are viewed through a CCTV system. Intrusions by stepping off the platform and into the trainway; however, would go undetected, as the detection device is only on the gate. Moreover, the platform detection system and the portal detection system are not integrated. Consequently, an intrusion from the portal would not automatically and immediately alert train operators already in the bores (the ROC Controller would have to notify these operators of the intrusion via radio communications). Conversely, trains entering the tunnel would not know of an intrusion from one of the stations unless notified by the Controller. Similarly, a train that has passed any one of the visual alerts would not know of an intrusion. For example, an eastbound train leaving the Boyle Heights Station would not know of an intrusion from the east portal. For safety and security reasons, it is vitally important that all trains be immediately informed of an intrusion. All of the detection systems should be fully integrated; sending visual alerts to all signs. Furthermore, an audible and visual alert should be annunciated locally to inform the intruder that they have been detected and they are to leave immediately.

#### **Recommendation 32 – Detection System Integration**

*Integrate the platform and portal intrusion systems so that detection at any location will send an alert to all locations.*

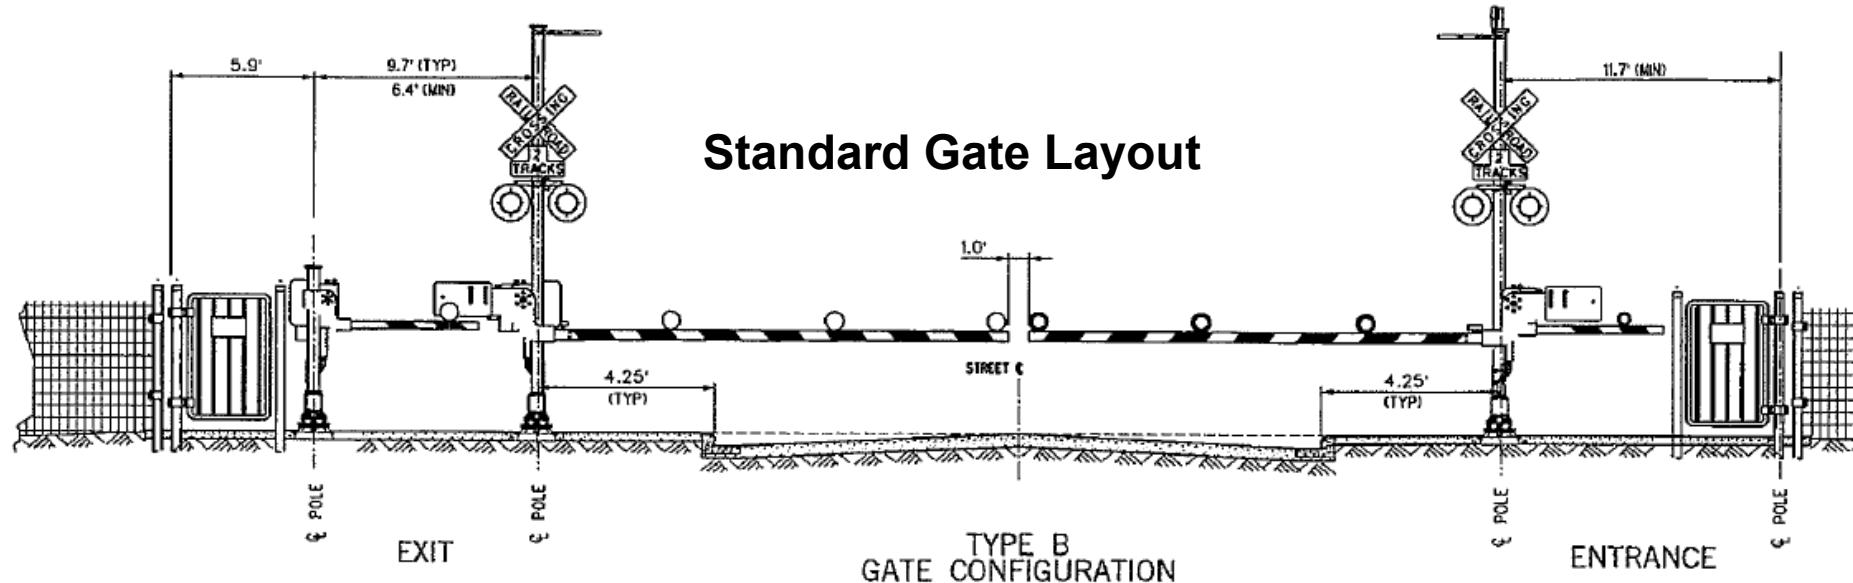
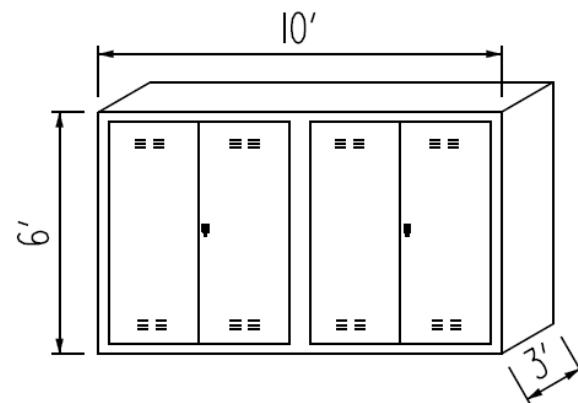
## Appendix C – Equipment

**Standard Cabinet – One per intersection**

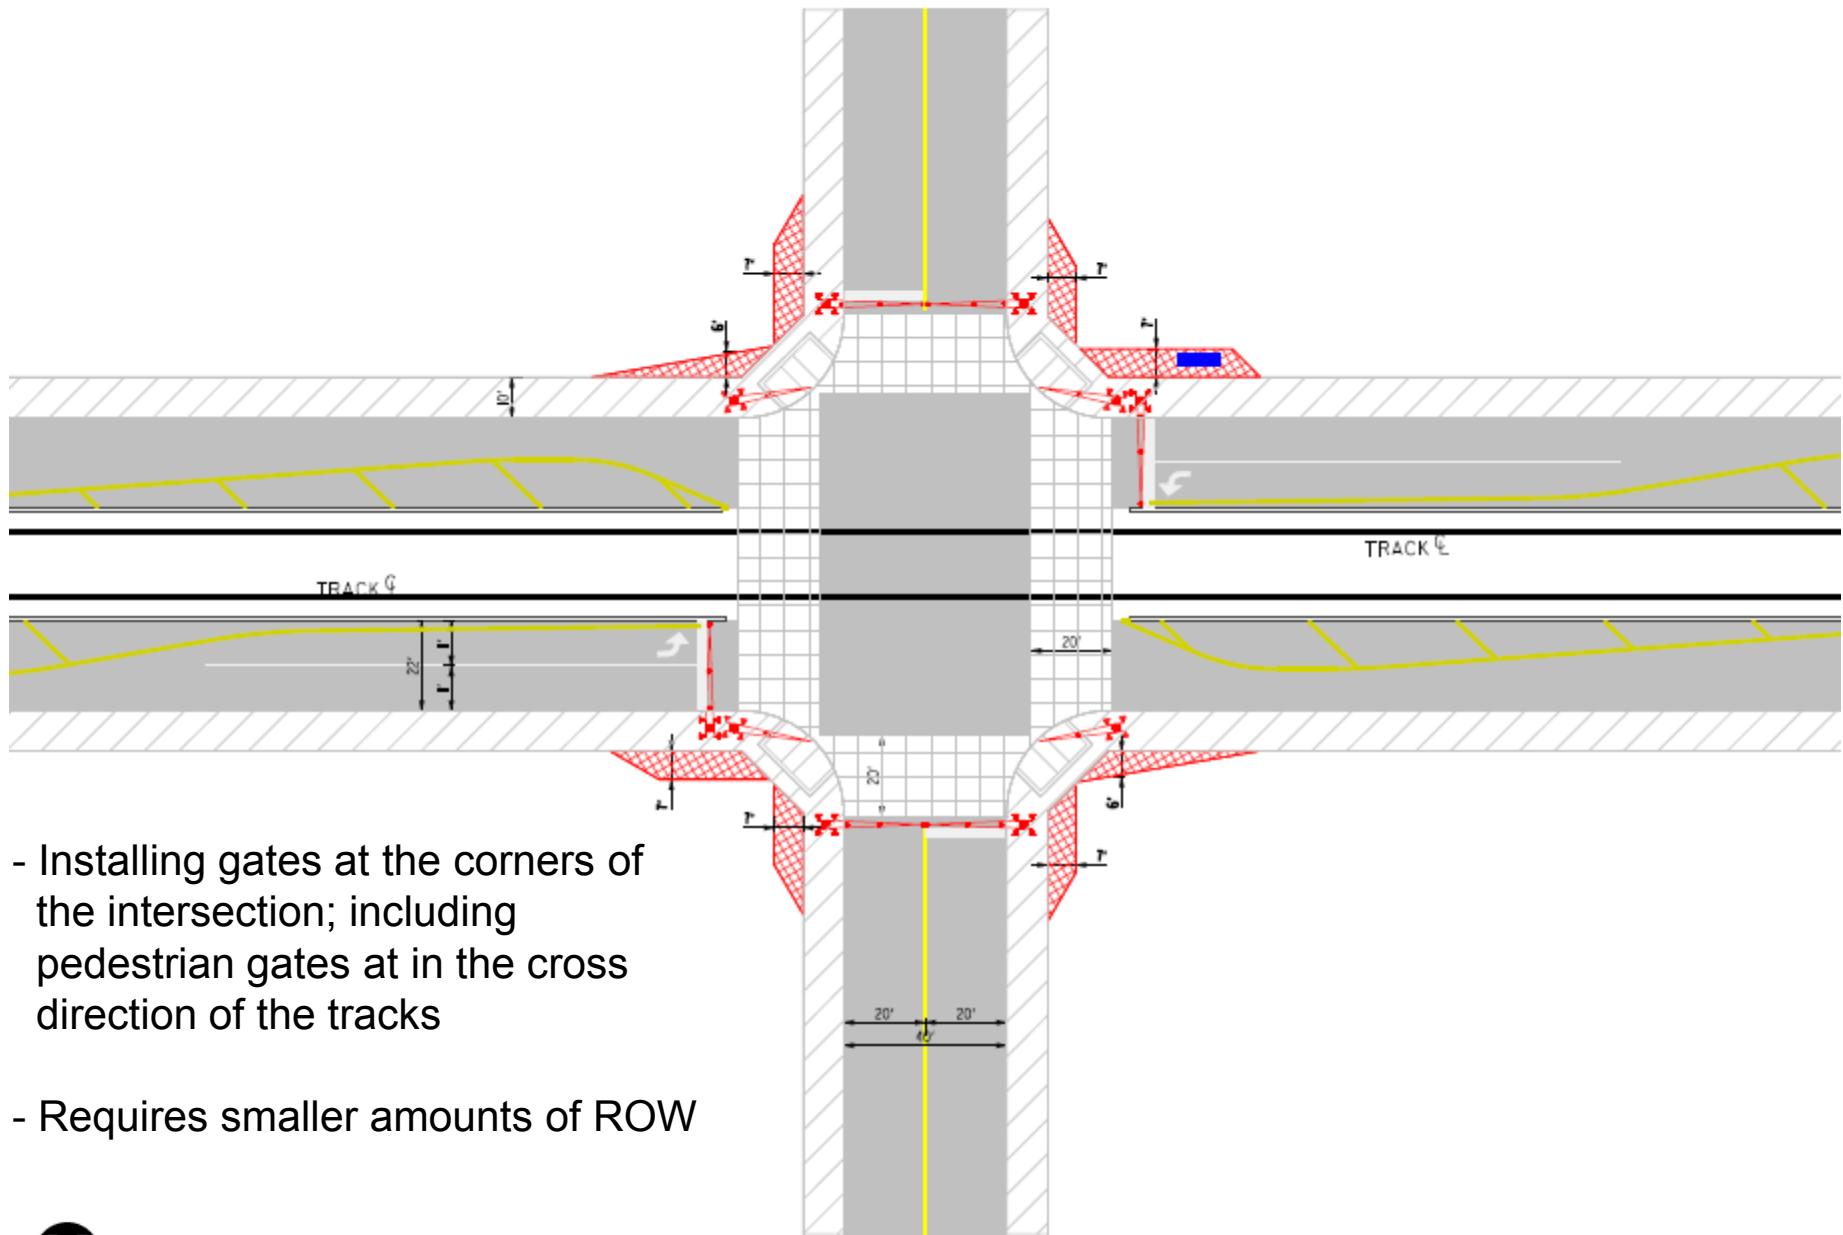
## Gates Closing the Intersection

- Installing gates at the corners of the intersection; including pedestrian gates at in the cross direction of the tracks
- Requires smaller amounts of ROW

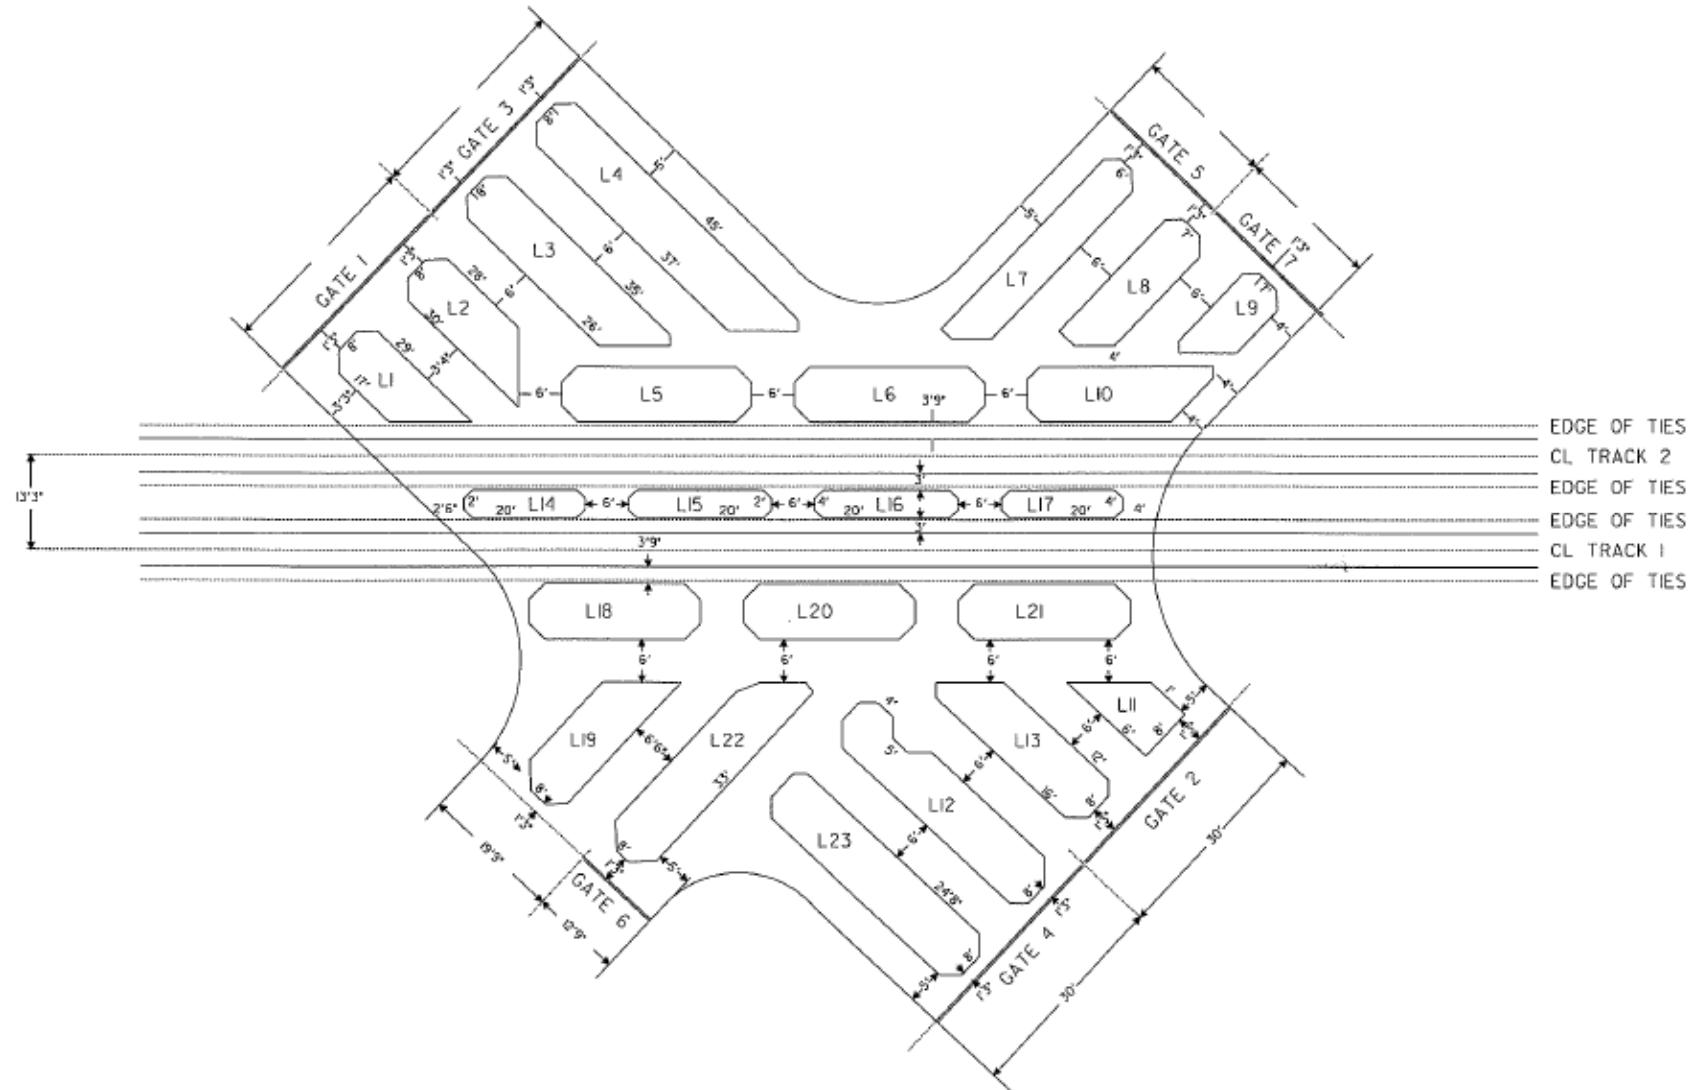
## Example Vehicle Detection Loop Layout

To insure that the exit gates fail in the up position, vehicle detection loops will also need to be installed at every intersection. An example layout of vehicle detection loops is located in Appendix H. The installation of these loops may require the relocation of existing traffic loops.
