WEST SANTA ANA BRANCH TRANSIT CORRIDOR PROJECT

**Draft EIS/EIR Appendix W
Final Cultural Resources
Survey Report—Rev 1
Part 3 of 3**

*Resource Name or # (Assigned by recorder) Oil and Storage (LACO NO. 1287)

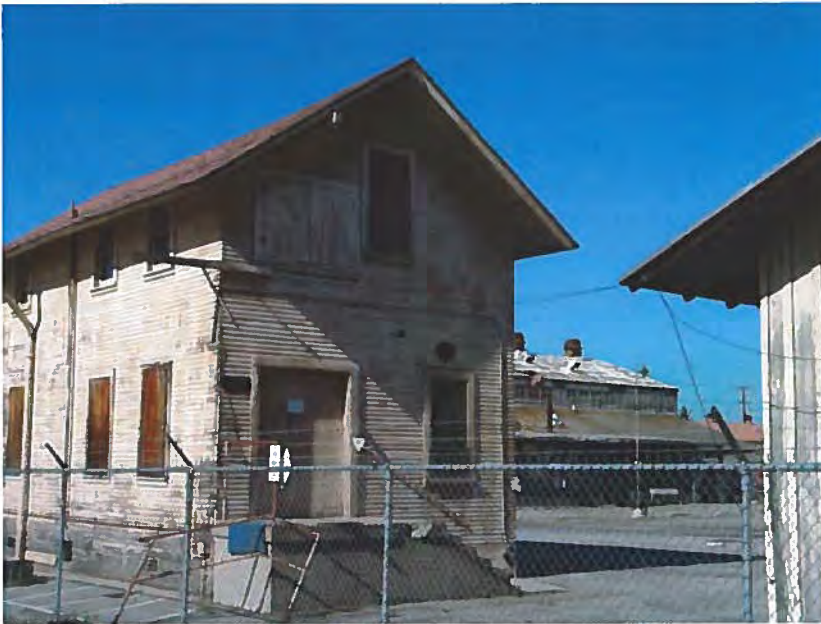
P5a. Photo or Drawing (Photo required for buildings, structures, and objects.)

The Oil and Storage building (LACO No. 1287) is located in the block bounded by Bonita Street to the north, Erickson Avenue to the west, and Gardendale Street to the south. Resembling a farmhouse in appearance, it is two stories, asymmetrical in appearance and rectangular in plan. The wood-framed vernacular building sits on a brick foundation and is clad in horizontal lapped wood siding. A steeply-pitched, front-gabled roof with overhanging eaves and exposed rafters hidden by a molded fascia caps the building. The façade contains a large entrance offset to the east, a single, one-over-one double-hung sash window on the west, and an identical double-hung sash centered in the upper story gable end. Three similar windows, unevenly spaced, are located on each level of the side elevations; the lower story windows are taller than those on the upper story. Plain wood casings with slightly projecting sills frame the openings. Concrete steps and a landing bordered by iron pipe railings provide access to the front entrance. A small shed for the water heater has been attached to the south elevation. Asphalt paving surrounds the building. The property is in deteriorated condition and its windows and doors have been boarded over.

P5b. Description of Photo: (View, date, accession #) Overview of North Façade, Facing Southwest, January 29, 2007

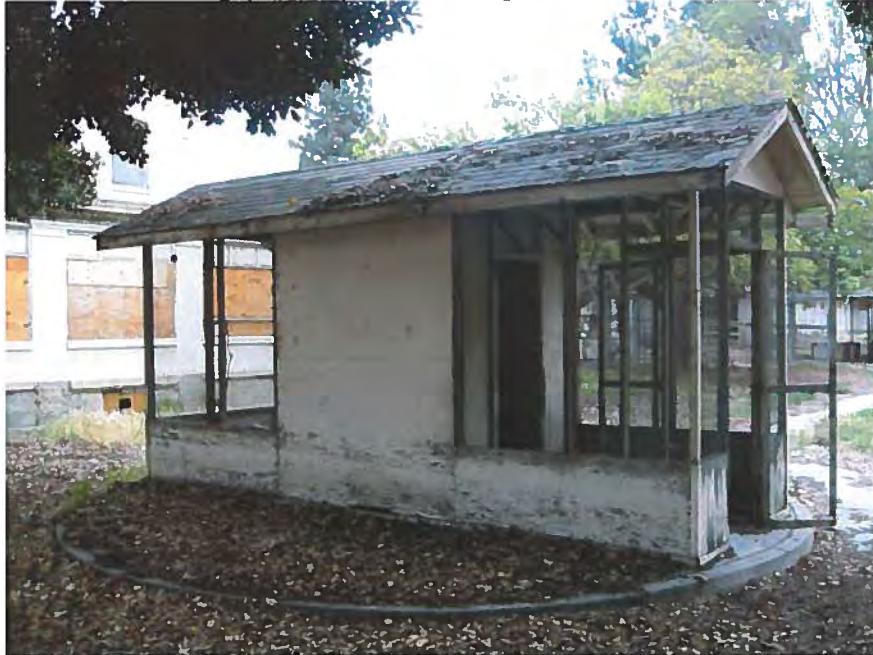
P5a. Photo or Drawing (Photo required for buildings, structures, and objects.)

The Aviary (LACO No. 1312) is located in the courtyard of the Men's Psychiatric Wards. The small structure is one-story in height and symmetrical in appearance. A rectangular structure that is longer than it is wide, it sits on a raised circular concrete slab foundation. The wood-framed structure consists of a central, enclosed space with screened-in spaces at each end. A front-gabled roof with moderately overhanging eaves caps the structure. Composition shingles cover the roof and plywood sheets cover the exterior walls. Two screen gates in succession, creating an entry cage, are located at the south end of the structure. Existing landscaping surrounding the Aviary consists of mature shrubs, trees and grass. The resource is in deteriorated condition.

P5b. Description of Photo: (View, date, accession #) *Overview of South Façade and East Elevation, Facing Northwest, January 29, 2007*

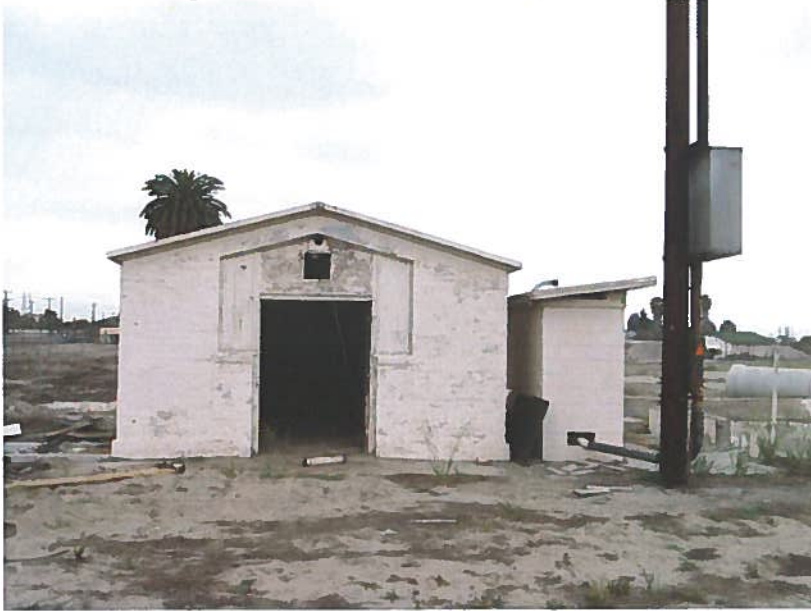
P5a. Photo or Drawing (Photo required for buildings, structures, and objects.)

The Brooder House/Vivarium Annex (LACO No. 1335) is located in an open area west of Juniper Street and north of Aliso Street. Utilitarian in style, the Brooder House is one story, symmetrical in appearance and rectangular in plan. It is capped by a low-pitched front gabled roof with slightly overhanging eaves. Rolled asphalt sheets cover the roof. The building sits on a concrete slab foundation and its exterior walls consist of painted unreinforced brick masonry. A band of concrete at the top of the wall plate forms a sort of frieze. The primary entrance is centered on the east façade and consists of a wide wood door set between two boarded up, half-sized sidelights and beneath a boarded up transom. The triangular head of this "surround" echoes the pitch of the roof. Rectangular screened vent openings are located in a linear arrangement high up on the side and rear elevations below the eaves. A series of large, rectangular openings set nearly at ground level on the side elevations indicate that they were intended for the building's original occupants, hens. A shed is located directly north of the structure and it has a concrete block structural system and wood paneled doors. The areas immediately north and west of the structure are paved with concrete. The property is in deteriorated condition and has shows evidence of fire damage.

P5b. Description of Photo: (View, date, accession #) Overview of East Elevation facing West, January 29, 2007

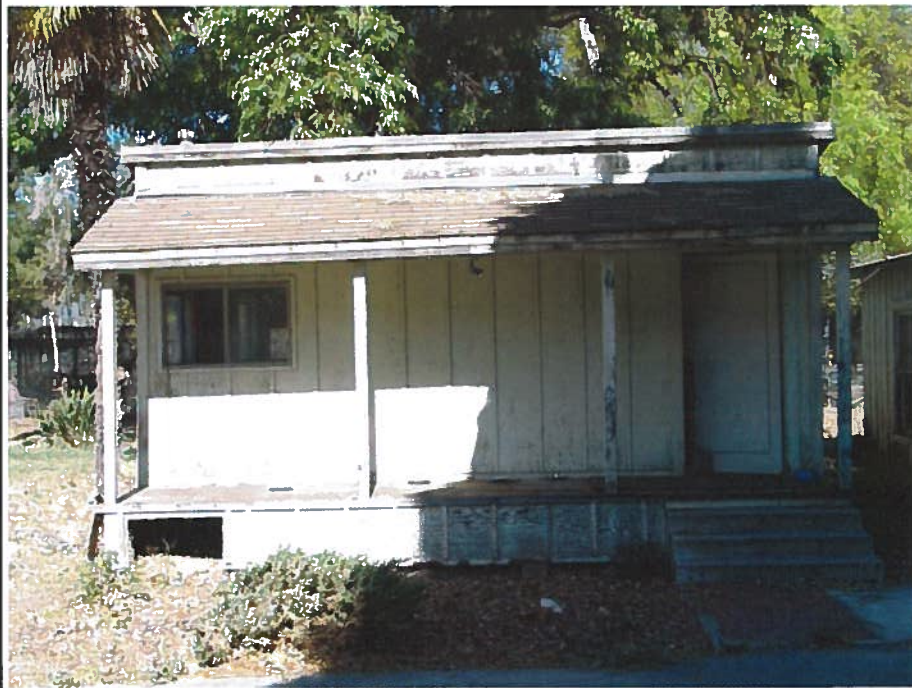
P5a. Photo or Drawing (Photo required for buildings, structures, and objects.)

P5b. Description of Photo: (View, date, accession #) Overview of East Façade, Facing West, January 29, 2007

No building permits or original architectural drawings were found for this building. Alterations include the replacement of the original wood framed windows with metal sliding windows and the replacement of the roofing material with rolled composition shingles.

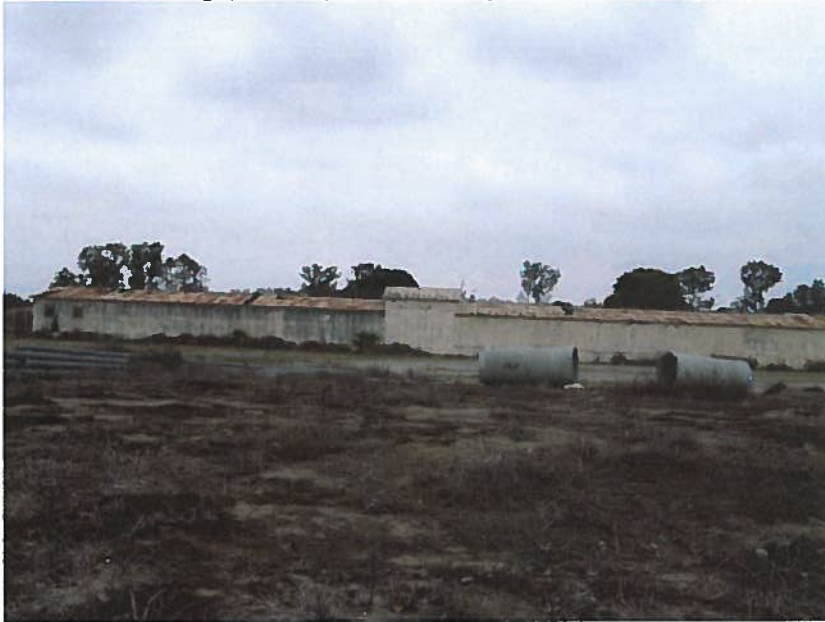
P5a. Photo or Drawing (Photo required for buildings, structures, and objects.)

P5b. Description of Photo: (View, date, accession #) Overview of South elevation, Facing North, January 29, 2007

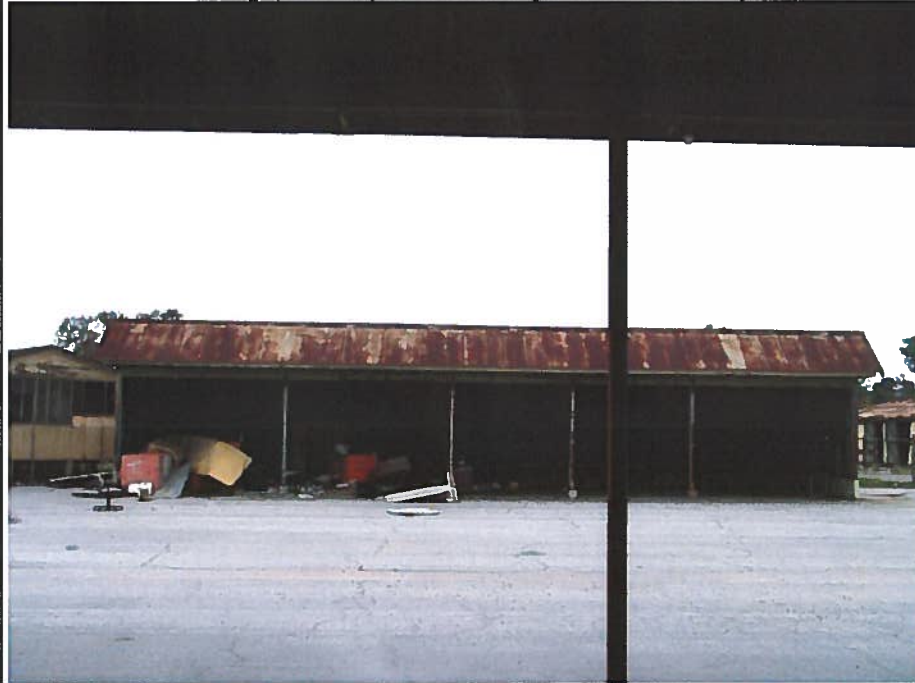
P5a. Photo or Drawing (Photo required for buildings, structures, and objects.)

P5b. Description of Photo: (View, date, accession #) *Overview of South elevation, Facing North, January 29, 2007*

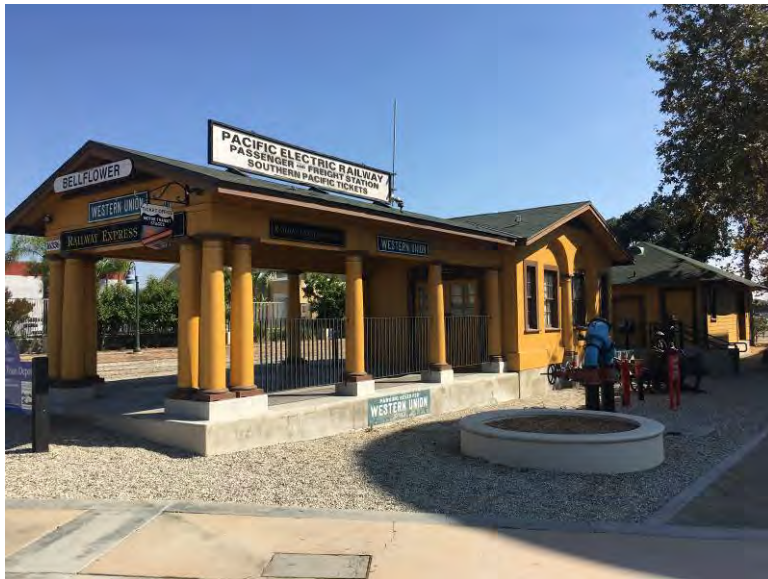
B9a. Architect: Unknown

The current survey update of the subject property was conducted as part of the West Santa Ana Branch Transit Corridor Environmental Study in Los Angeles County, California. Since the property was last evaluated, the building has been restored/rehabilitated in a historically accurate manner and its appearance is consistent with its original design. As a result, the property appears to be eligible for listing in the NRHP and CRHR under Criteria A/1 and C/3. The property is directly associated with the early transportation history of southern California and embodies the distinctive characteristics of a purpose-built street railway depot.
