**HAZARDOUS MATERIALS ASSESSMENT  
PROPOSED DESERT XPRESS RAIL CORRIDOR  
VICTORVILLE, CALIFORNIA, TO  
LAS VEGAS, NEVADA**

February 2, 2007  
Project No. 206725002

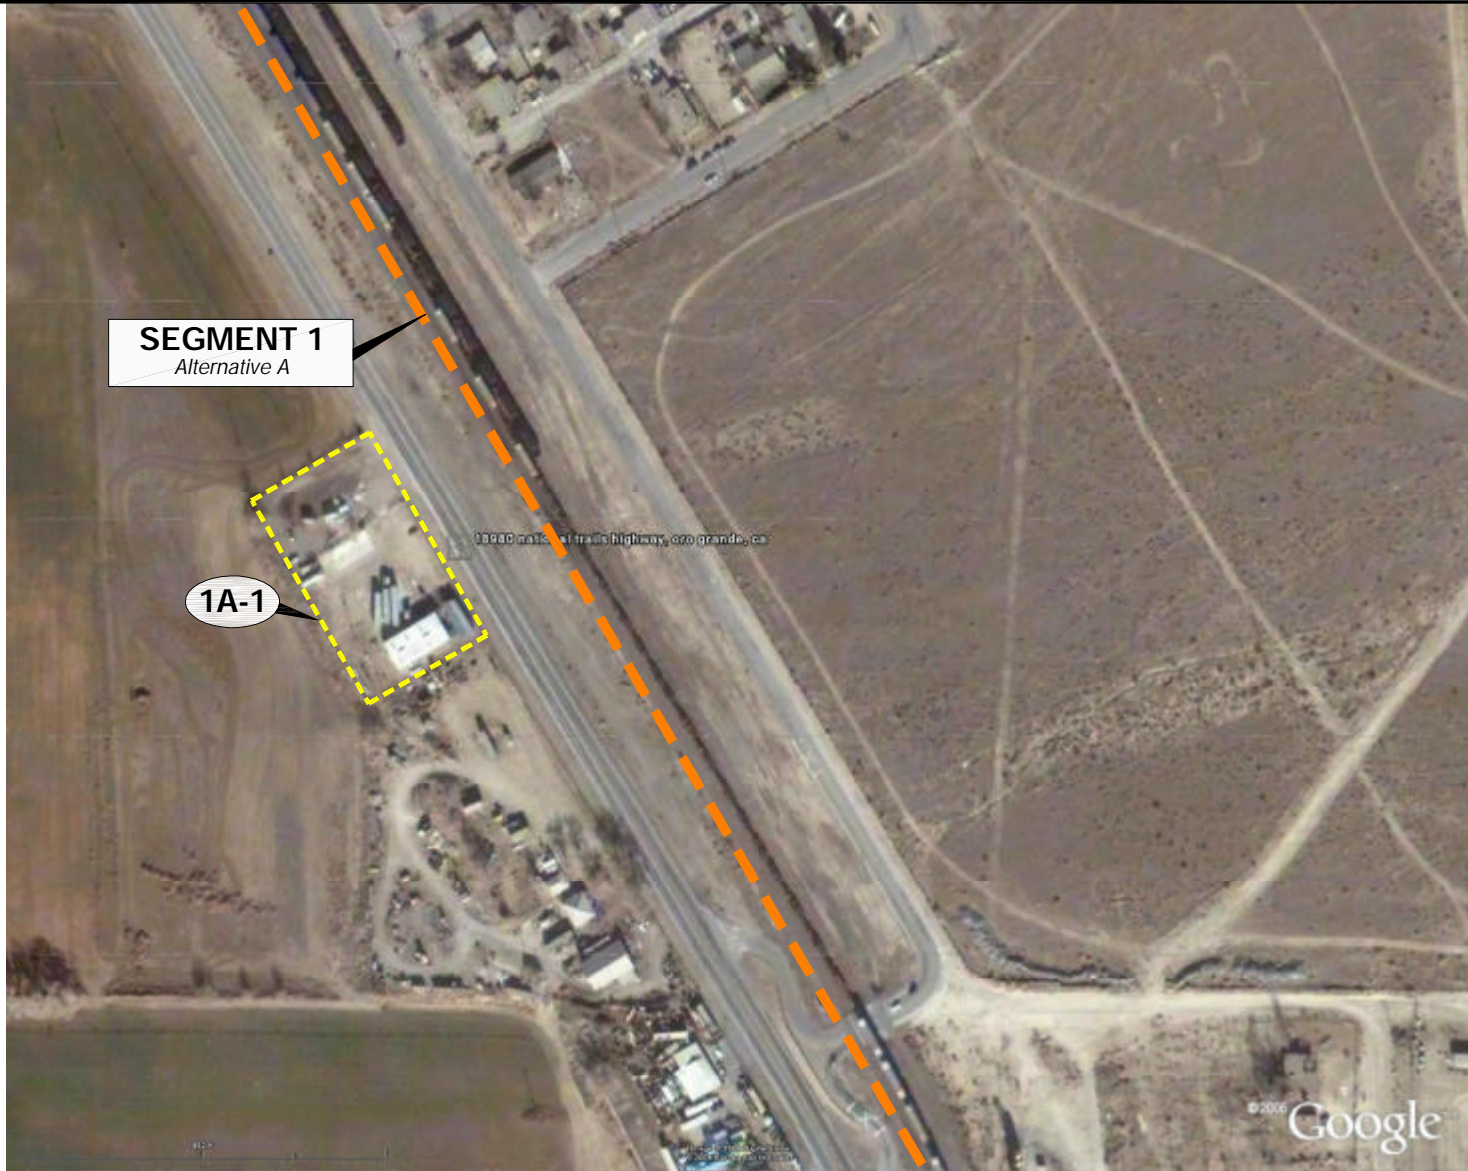
PROPERTY I.D.	PROPERTY ADDRESS	SITE OPERATIONS - REASON FOR RISK CLASS (1)	RISK CLASS
1A-1	GODSPEED AUTO (FORMER ORO GRANDE PETROLEUM COMPANY) 18980 NATIONAL TRAILS HIGHWAY, ORO GRANDE, CA	AUTO REPAIR AND GASOLINE STATION: LISTED ON LUST DATABASE, SOIL ONLY, CLOSURE IN 1999.	M

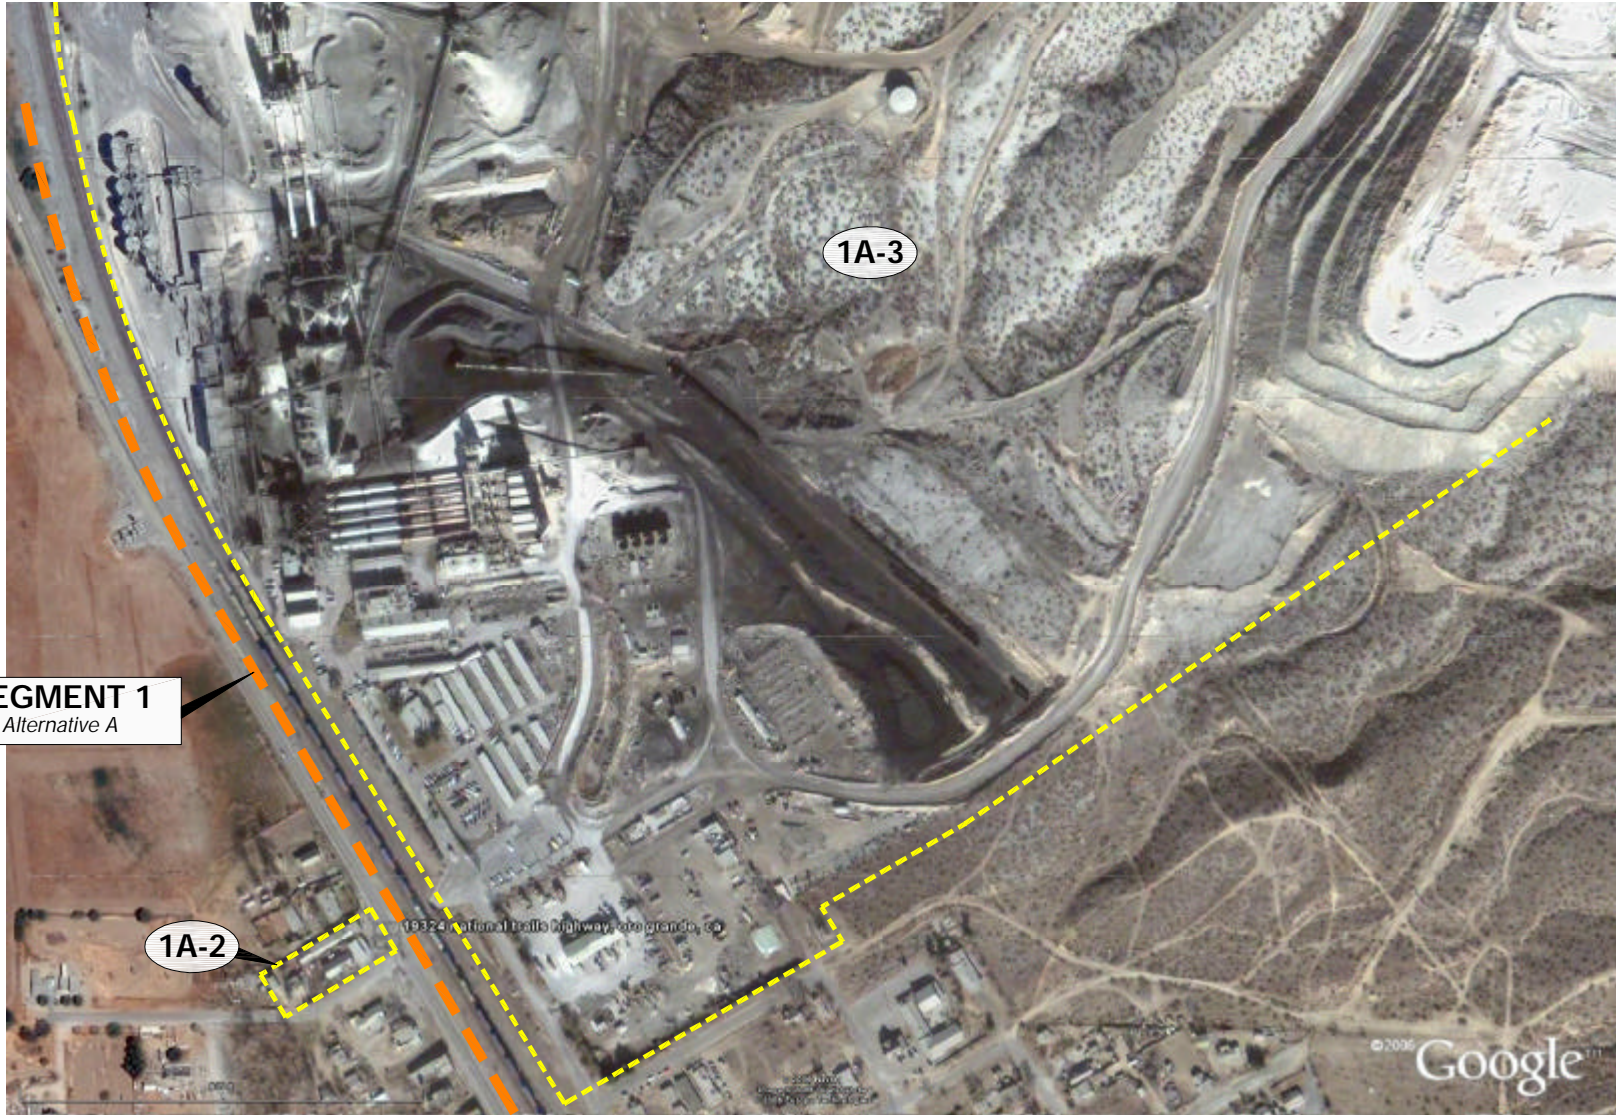
**SEGMENT 1**  
Alternative A

PROPERTY I.D.	PROPERTY ADDRESS	SITE OPERATIONS - REASON FOR RISK CLASS (1)	RISK CLASS
1A-2	CURRENTLY UNOCCUPIED (FORMER MO-HAWK MINI-MART AND PARS OIL) 19324 NATIONAL TRAILS HIGHWAY ORO GRANDE, CA	ABANDONED GASOLINE STATION: LISTED ON UST DATABASE, NO INDICATION OF UST REMOVAL OR ABANDONMENT.	M
1A-3	RIVERSIDE CEMENT COMPANY 19409 NATIONAL TRAILS HIGHWAY ORO GRANDE, CA	CEMENT PLANT, MINE, AND LANDFILL: OPERATIONAL SINCE 1895, LISTED ON CERCLIS, CAL SITES, RCRA GEN, SWLF, LUST, AND UST DATABASES, GROUNDWATER REPORTEDLY CONTAMINATED WITH CHROMIUM AND VOC'S, REMEDIAL INVESTIGATIONS RESULTED IN TRANSFER OF OVERSITE TO EPA. LIMITED INFORMATION IS AVAILABLE AFTER EPA TOOK LEAD.	H

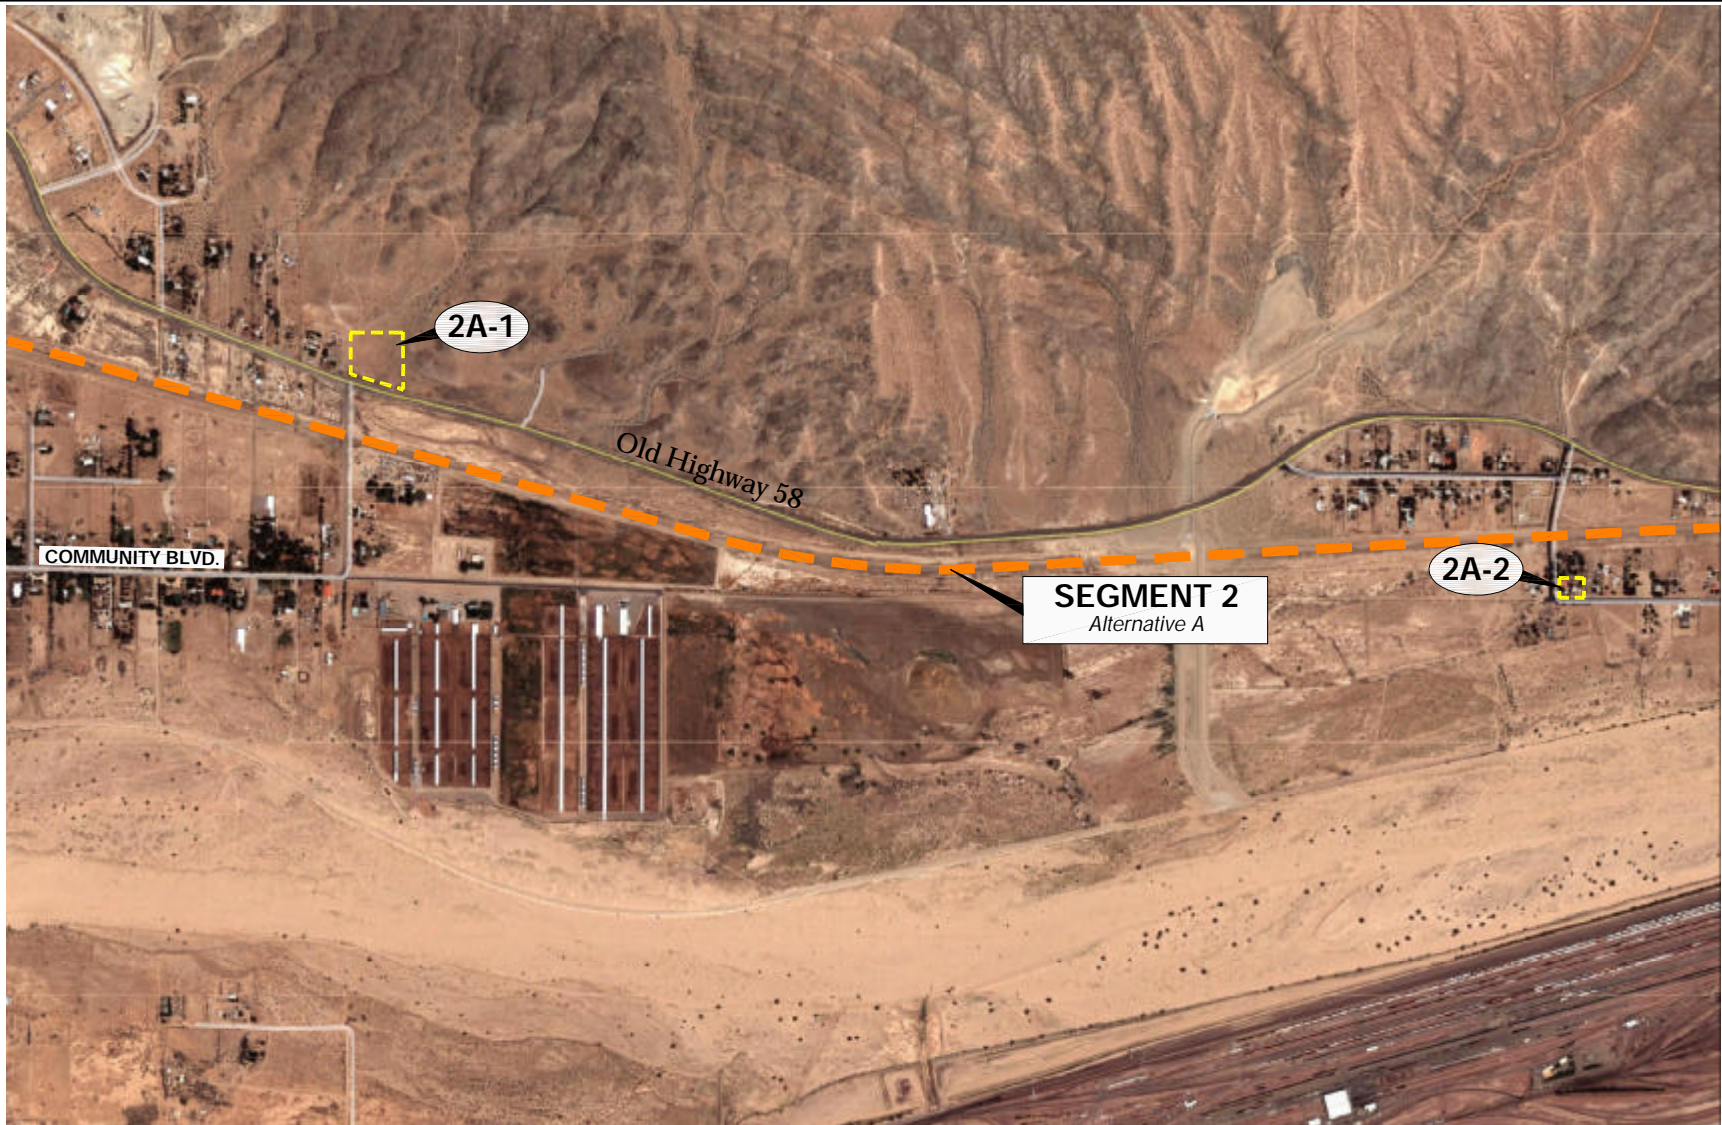
PROPERTY I.D.	PROPERTY ADDRESS	SITE OPERATIONS - REASON FOR RISK CLASS (1)	RISK CLASS
2A-1	MONITORING WELLS COMMUNITY BLVD. AND OLD HWY 58 BARSTOW, CA 92311	OBSERVED MONITORING WELL DURING SITE RECONNAISSANCE. NATURE OF INVESTIGATION UNKNOWN.	M
2A-2	GROUNDWATER MONITORING WELL RAMIREZ ROAD & WATERMAN ROAD BARSTOW, CA	GAS STATION: ABANDONED STATION, OBSERVED DURING SITE RECONNAISSANCE, STATUS OF US'TS UNKNOWN.	M

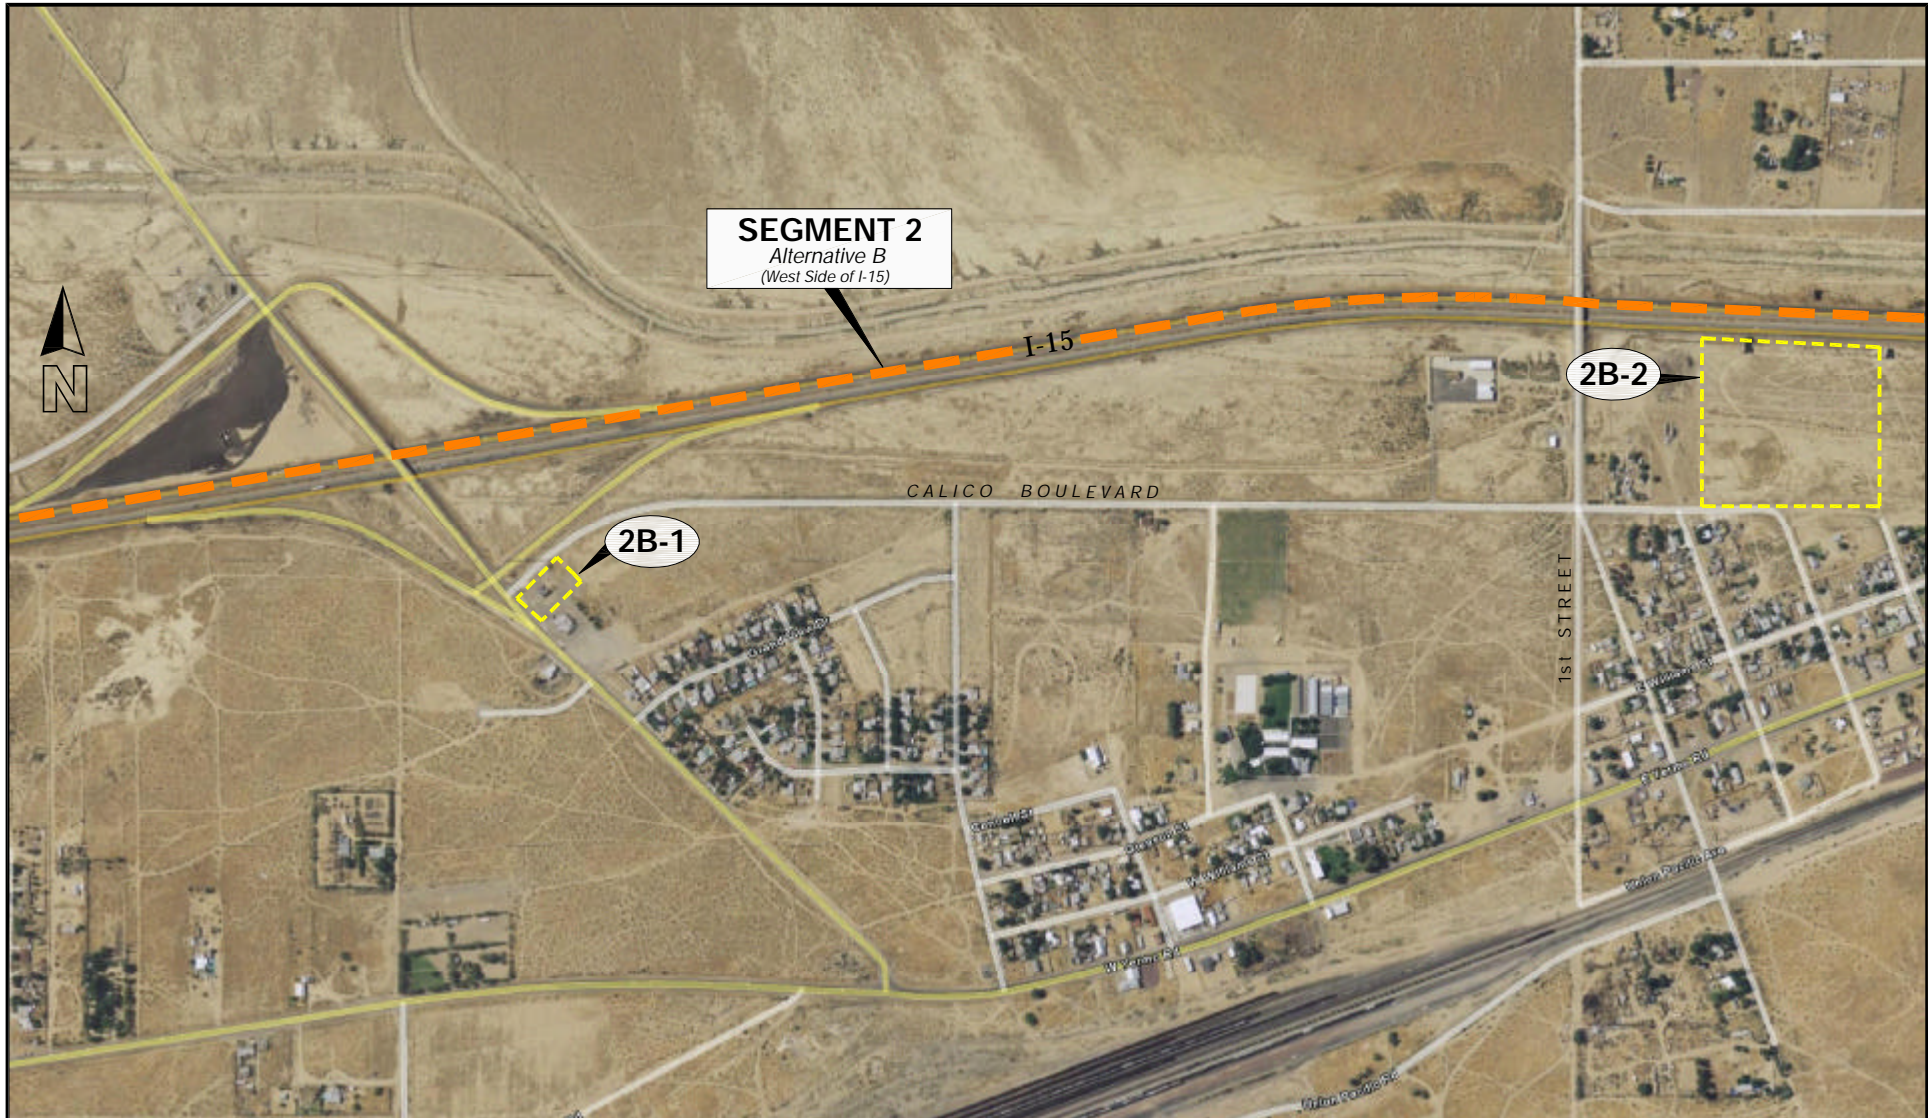
**2B-2**

PROPERTY I.D.	PROPERTY ADDRESS	SITE OPERATIONS - REASON FOR RISK CLASS (1)	RISK CLASS
<b>2B-1</b>	ABANDONED GAS STATIONS I-15 AND CALICO ROAD YERMO, CA	<b>GAS STATION:</b> ABANDONED GAS STATION OBSERVED DURING SITE RECONNAISSANCE STATUS OF USTs IS UNKNOWN.	M
<b>2B-2</b>	CALICO TRUCK STOP 37587 CALICO BLVD YERMO, CA 92398	<b>GAS STATION:</b> LISTED ON LUST DATABASE, RELEASE OF DIESEL FUEL, PRELIMINARY SITE ASSESSMENT ONGOING.	M

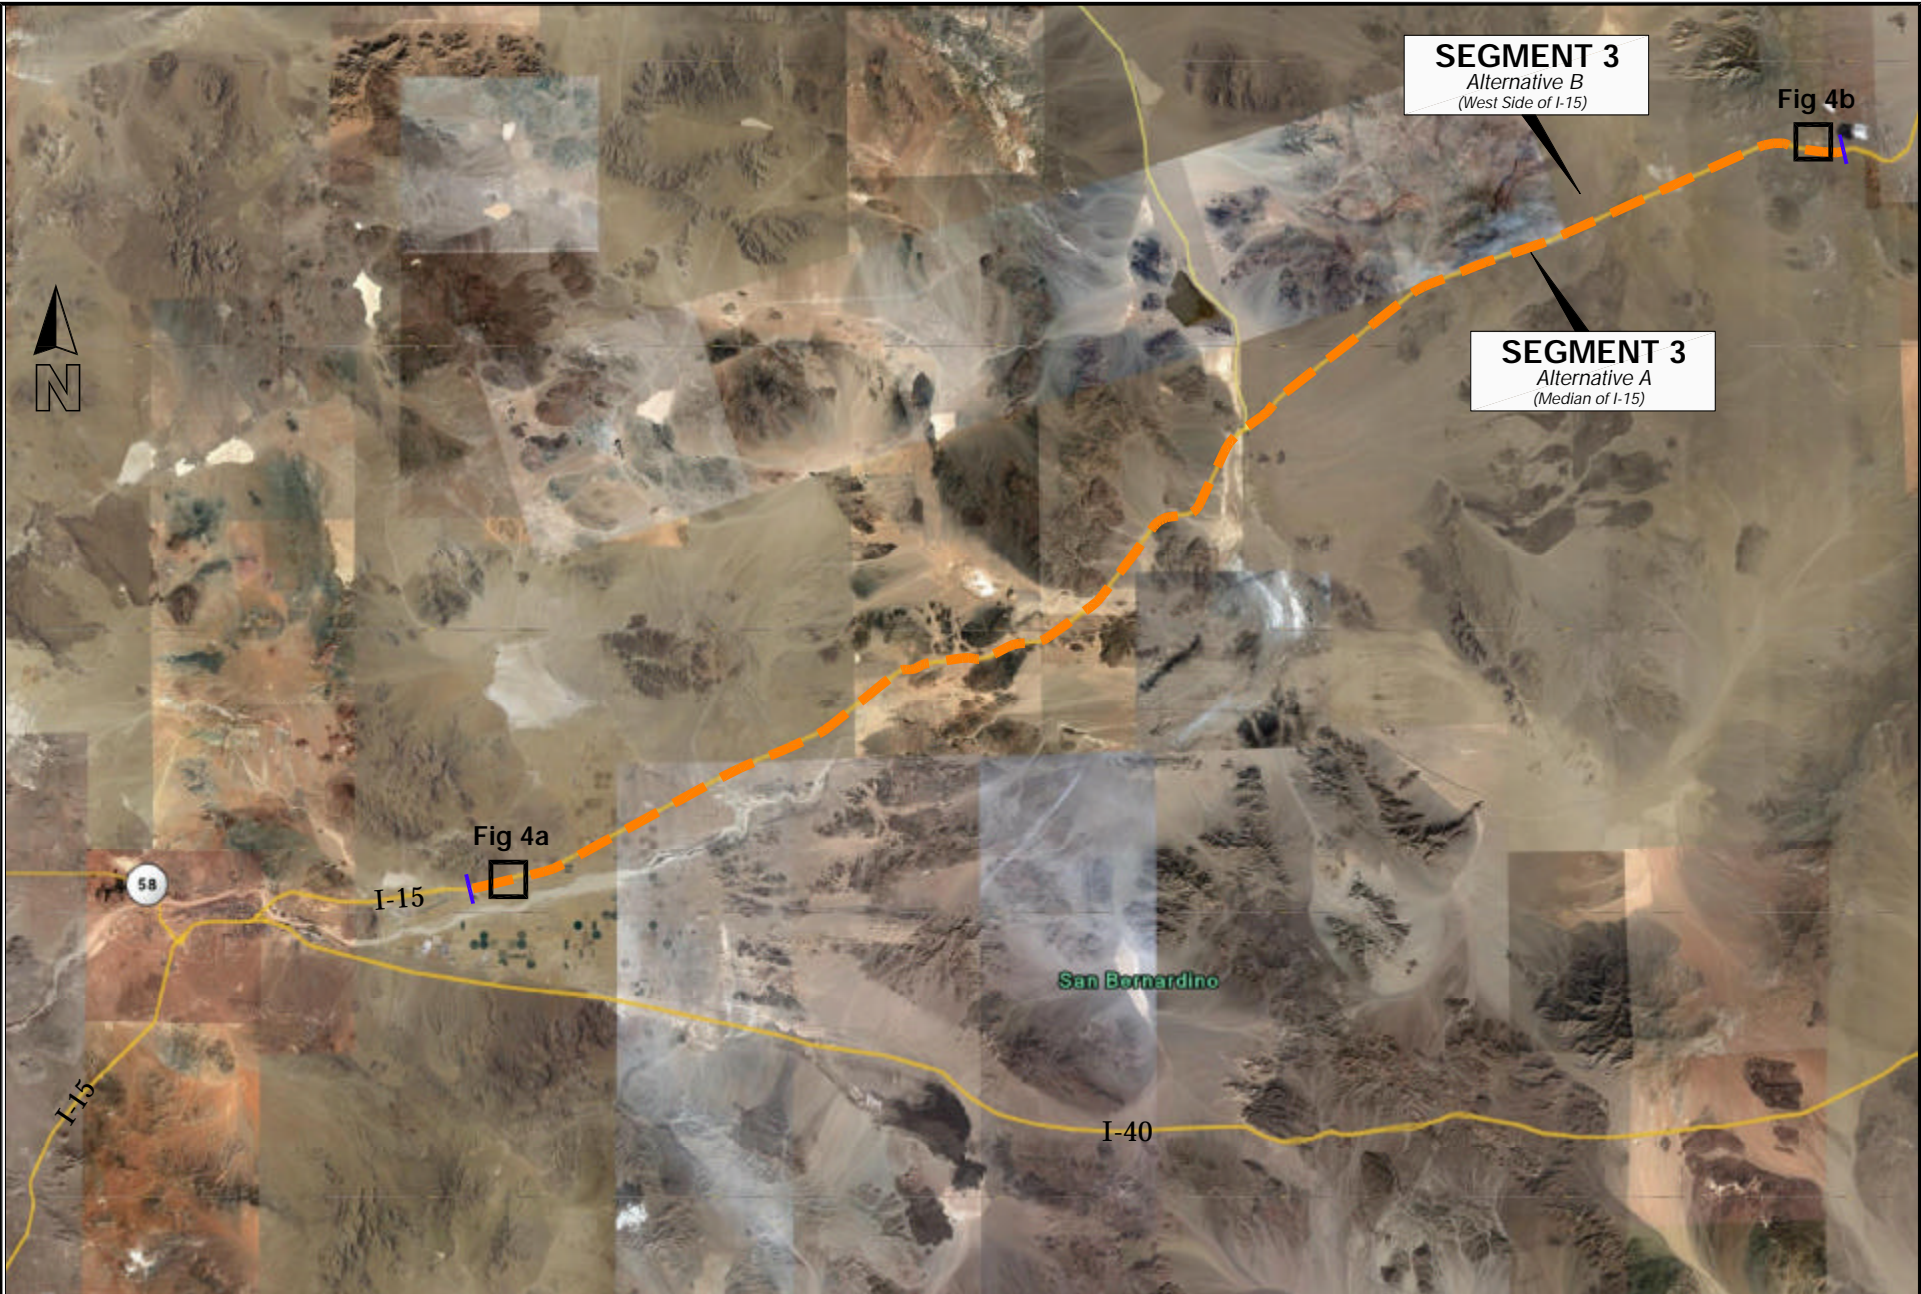
206725-A9.DWG

PROPERTY I.D.	PROPERTY ADDRESS	SITE OPERATIONS - REASON FOR RISK CLASS (1)	RISK CLASS
3A-1	ABANDONED GAS STATION SUNRISE CANYON ROAD YERMO, CA	GAS STATION: ABANDONED STATION, OBSERVED DURING SITE RECONNAISSANCE, STATUS OF USTs UNKNOWN.	M

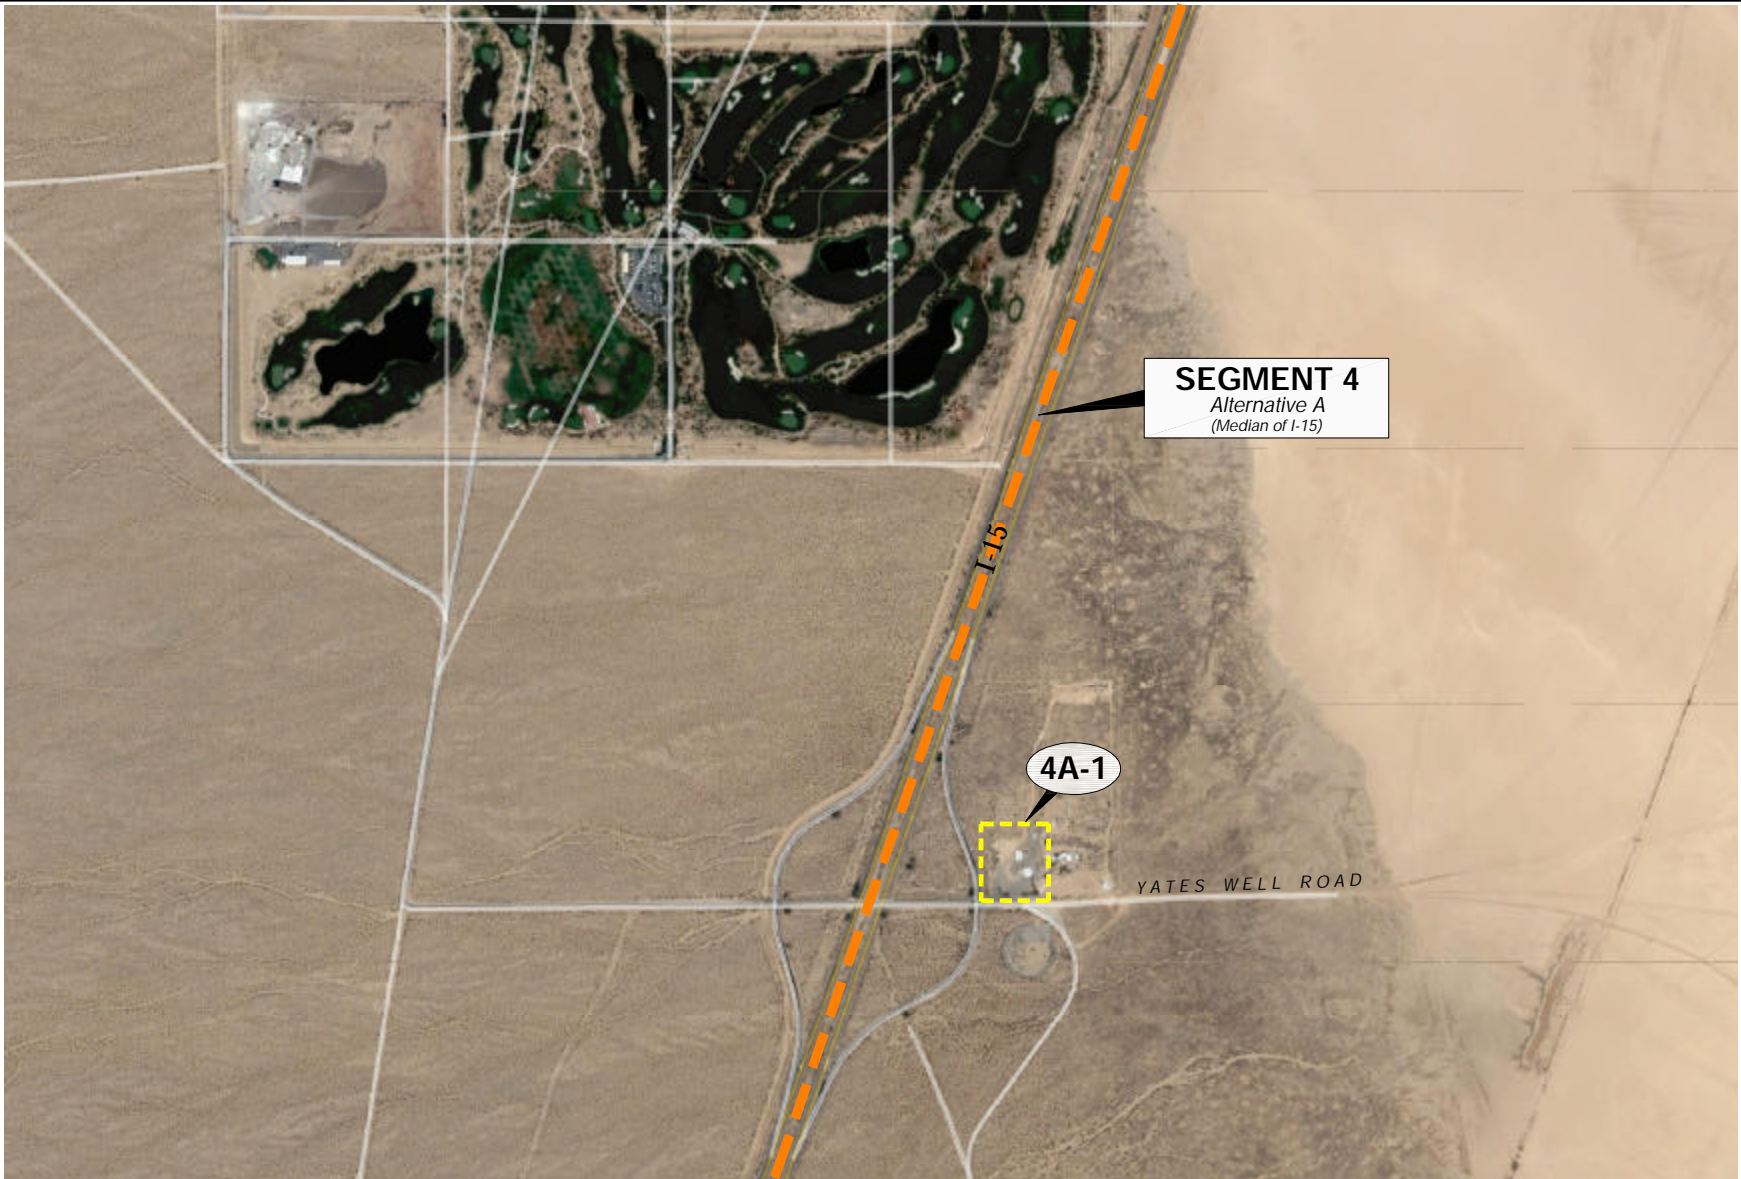
PROPERTY I.D.	PROPERTY ADDRESS	SITE OPERATIONS - REASON FOR RISK CLASS (1)	RISK CLASS
4A-1	POSSIBLE ABANDONED GAS STATION YATES WELL ROAD NIPTON, CA	GAS STATION: ABANDONED STATION, OBSERVED DURING SITE RECONNAISSANCE, STATUS OF USTs UNKNOWN.	M

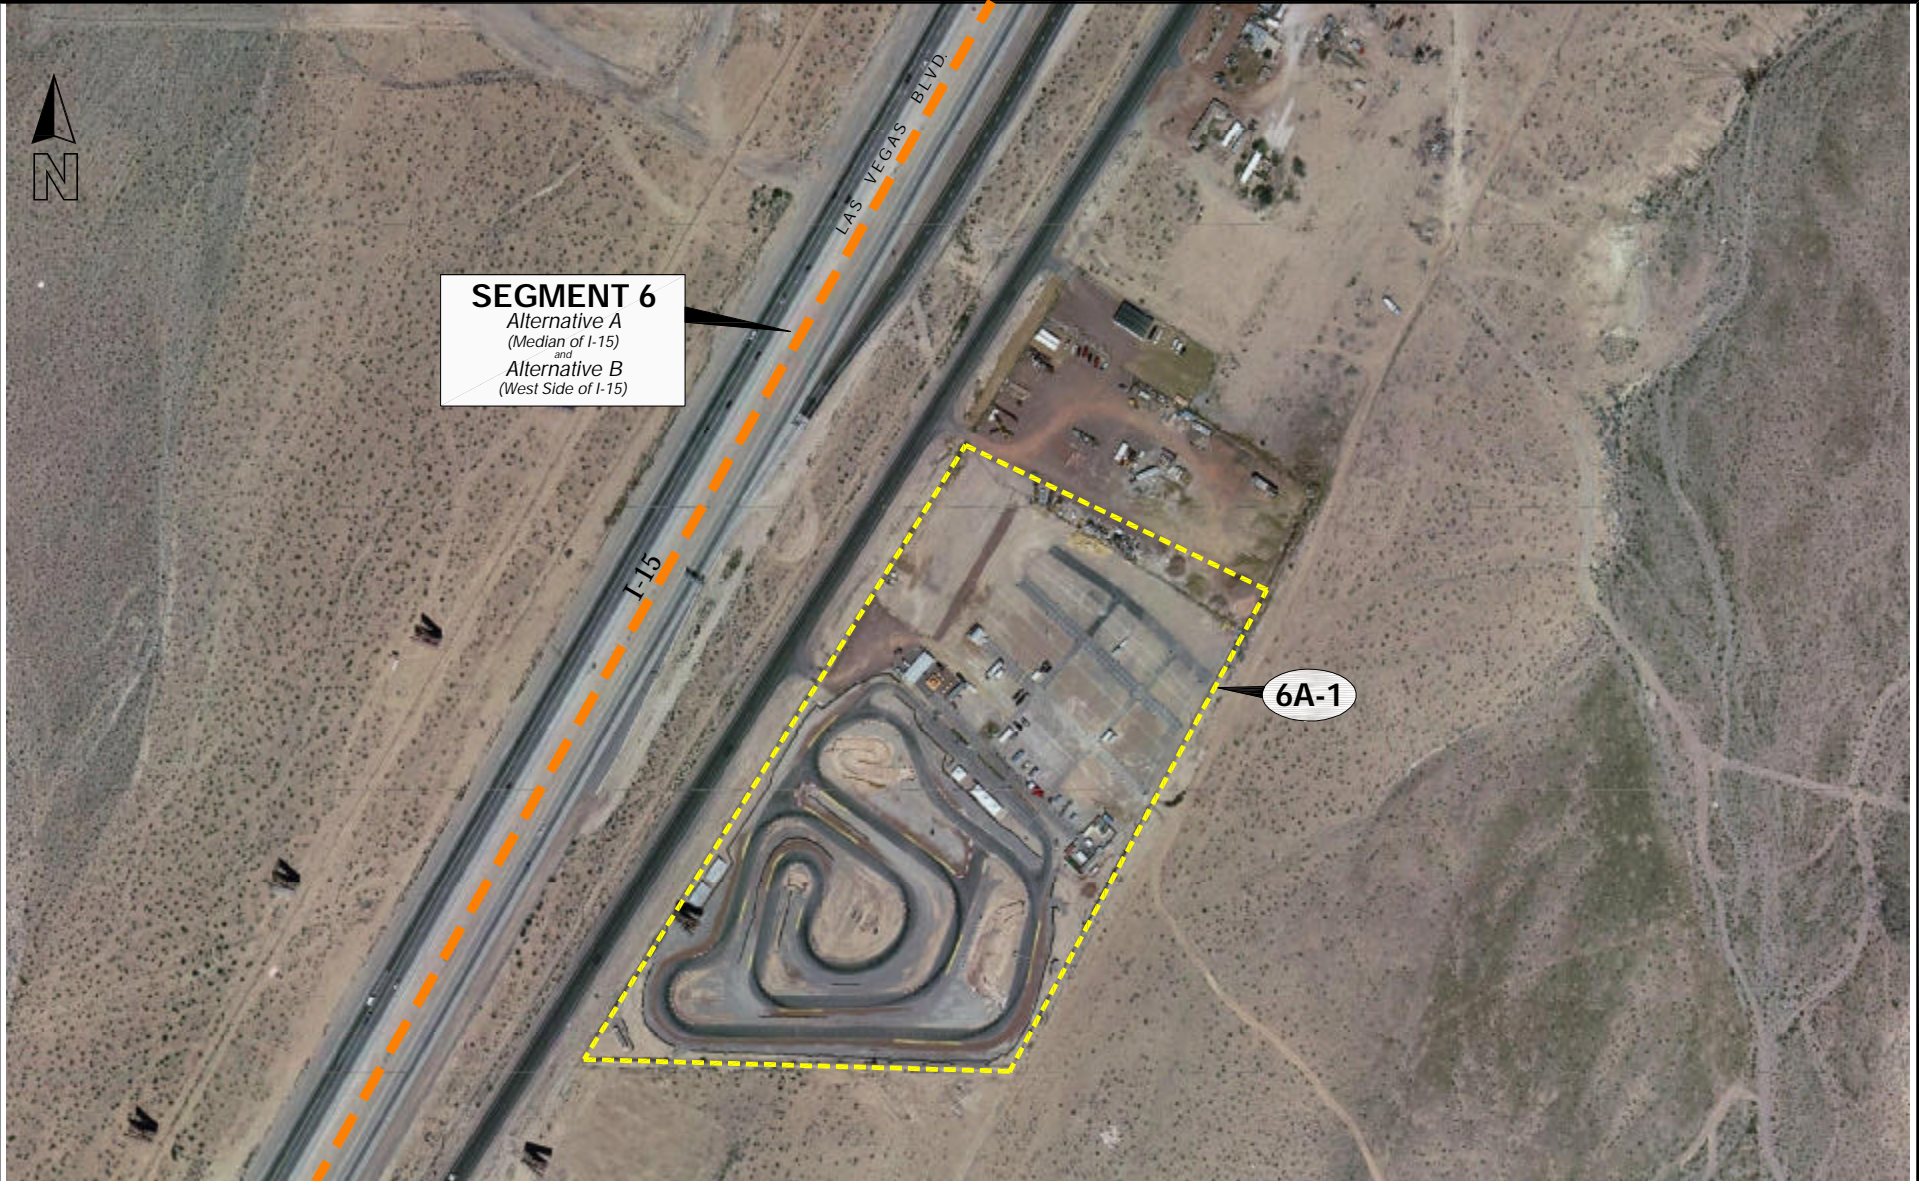
PROPERTY I.D.	PROPERTY ADDRESS	SITE OPERATIONS - REASON FOR RISK CLASS (1)	RISK CLASS
6A-1	XPLEX LAS VEGAS 15000 LAS VEGAS BOULEVARD LAS VEGAS, NV 89124	HIGH-SPEED GO-CART TRACK SURFACE STAINING OBSERVED THROUGHOUT PROPERTY.	M

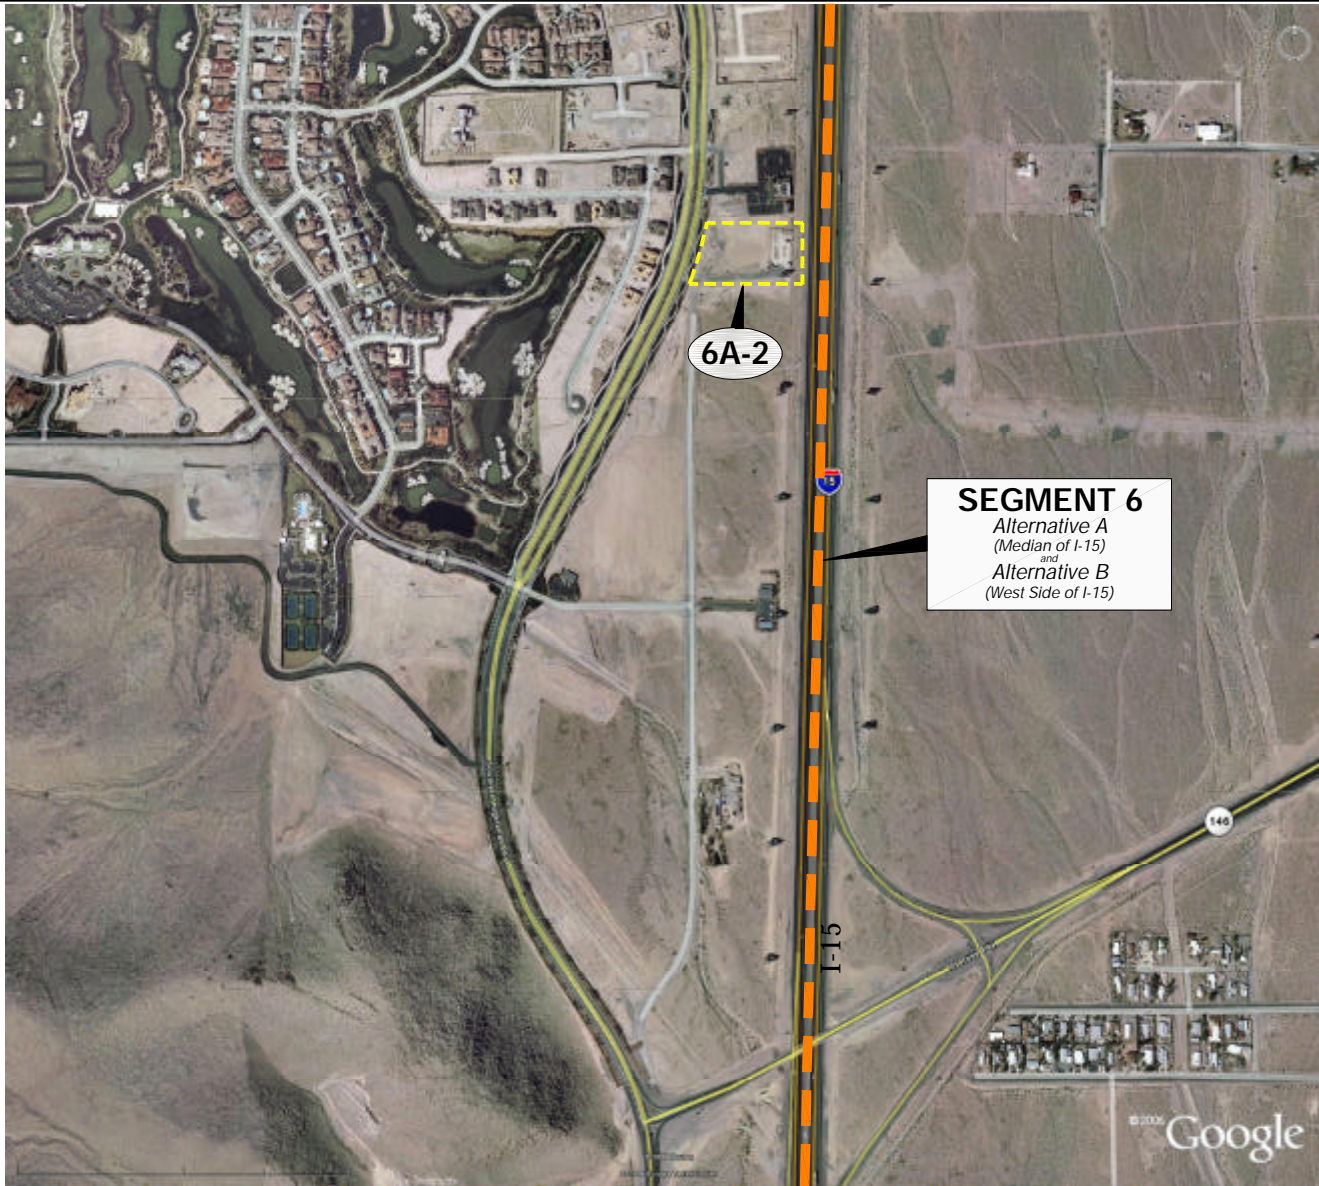
PROPERTY I.D.	PROPERTY ADDRESS	SITE OPERATIONS - REASON FOR RISK CLASS (1)	RISK CLASS
6A-2	DAISY MAE LAND HOLDINGS LLC 11978 INDUSTRIAL ROAD ENTERPRISE, NV 89103	NURSERY: OBSERVED AST DURING VISIT.	M

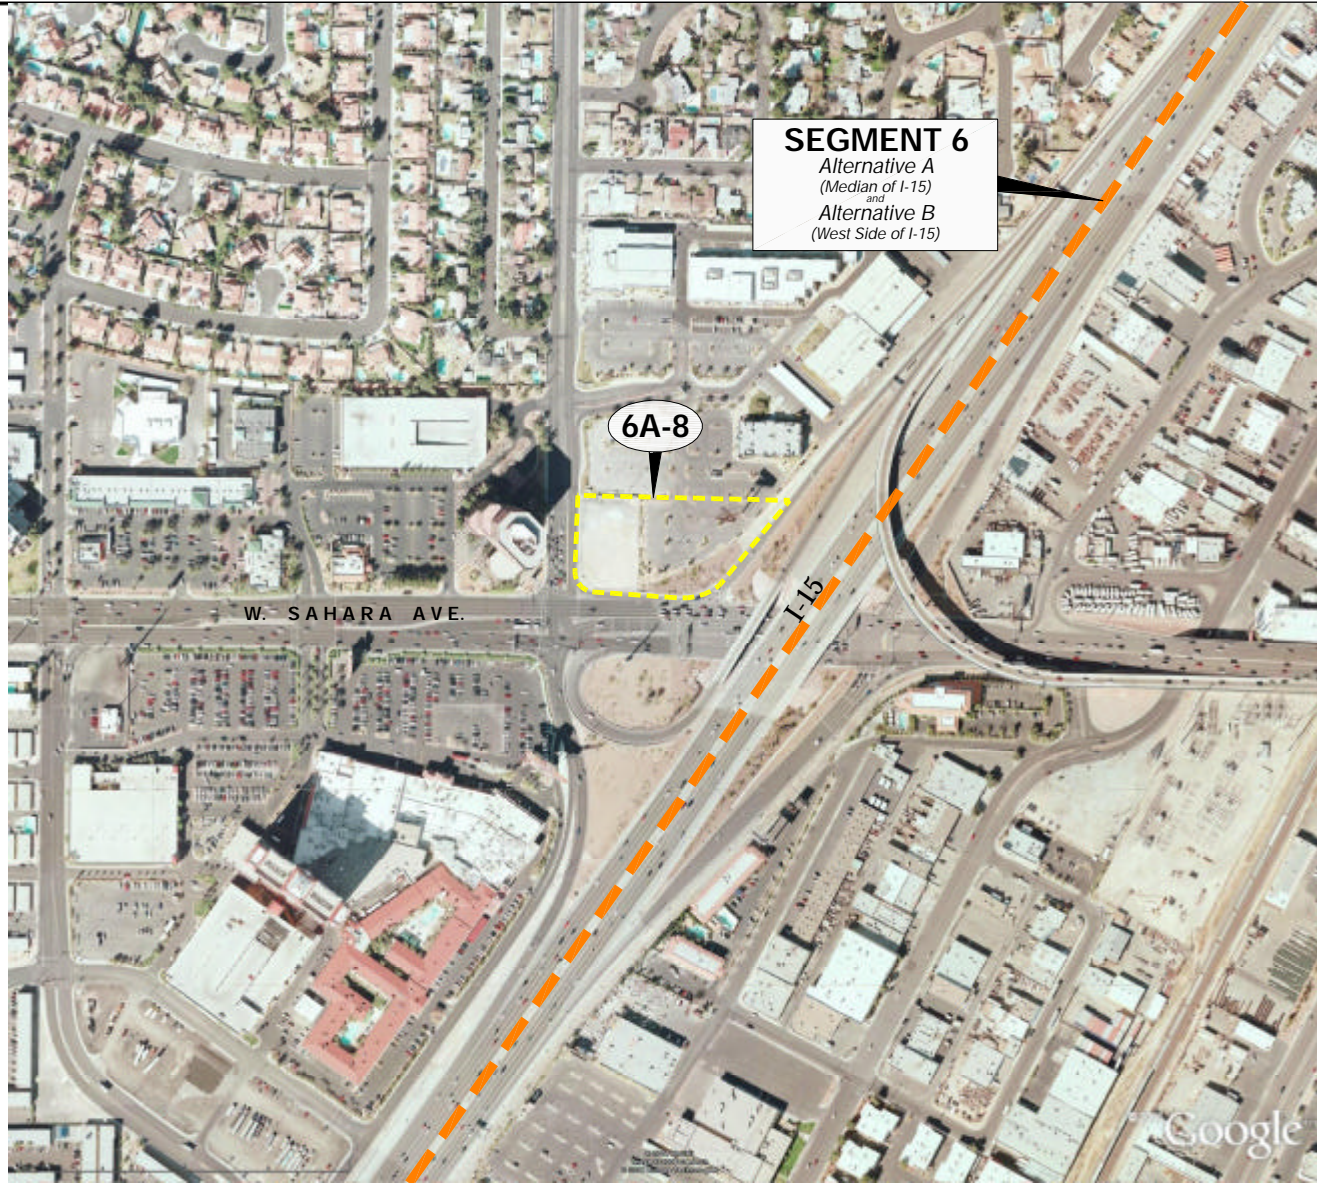
PROPERTY I.D.	PROPERTY ADDRESS	SITE OPERATIONS - REASON FOR RISK CLASS (1)	CLASS
6A-8	SAHARA RANCH OFFICE COMPLEX 2300 S. RANCH DRIVE LAS VEGAS, NV	OBSERVED DURING SITE RECONNAISSANCE, FENCED IN VACANT AREA WITH DRUMS AND WELLS.	M

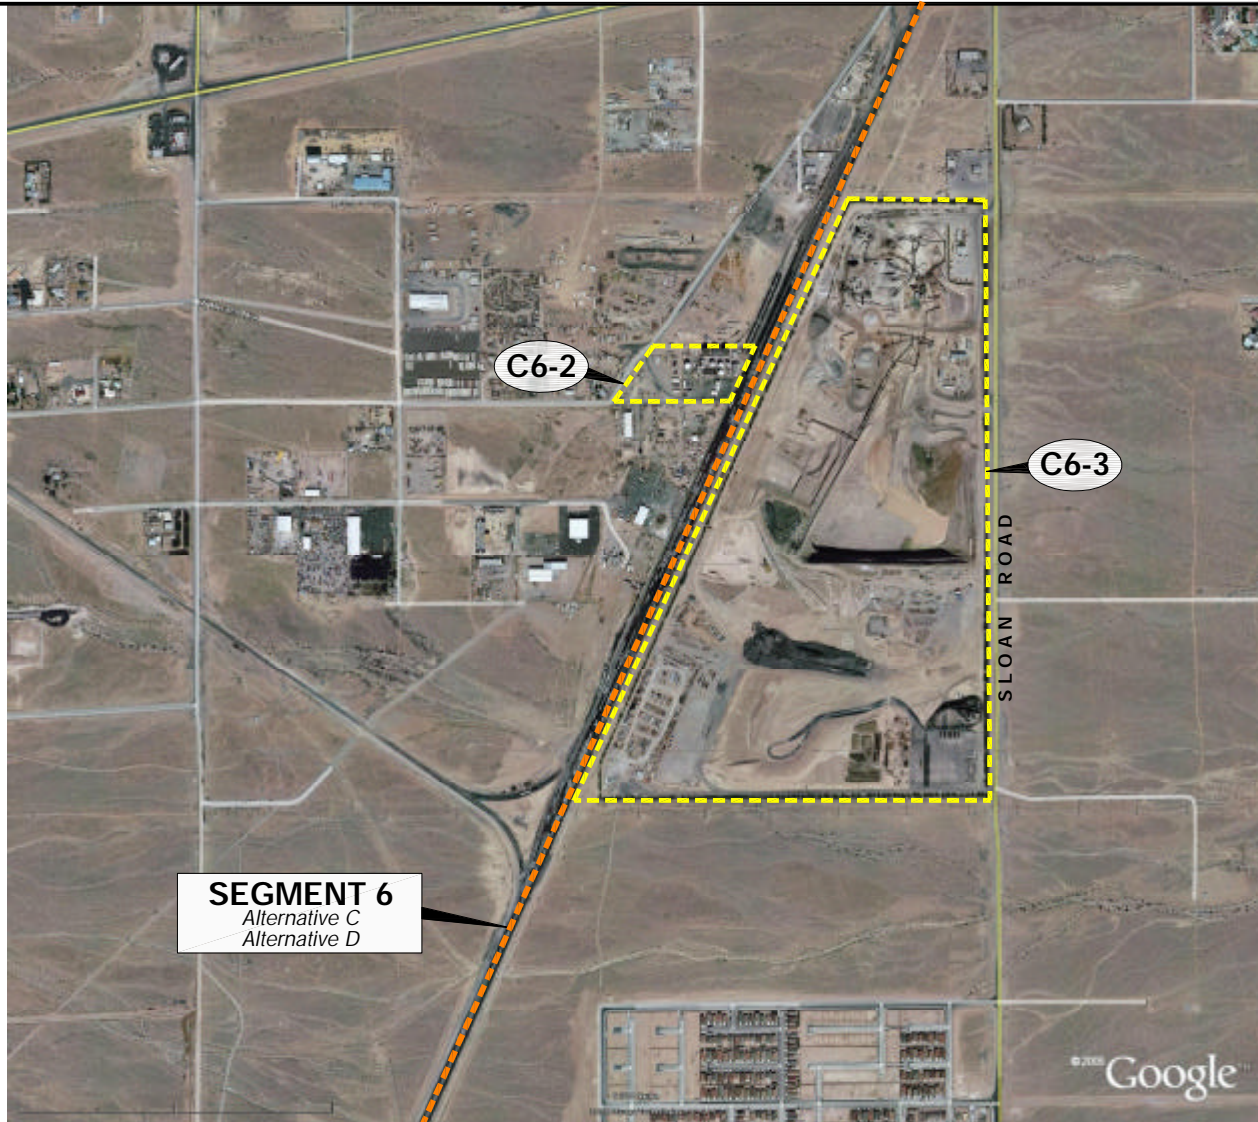
PROPERTY I.D.	PROPERTY ADDRESS	SITE OPERATIONS - REASON FOR RISK CLASS (1)	CLASS RISK
6C-2	ERGON ASPHALT PRODUCTS 6400 W. RICHMAR AVENUE ENTERPRISE, NV	ASPHALT COMPANY: LISTED ON NEVADA STATE SITE DATABASE, SEVERAL "SOIL ONLY" RELEASES OF EMULSIFIERS, CASES ARE CLOSED.	M
6C-3	LAS VEGAS PAVING CORPORATION 9325 S. JONES BLVD. ENTERPRISE, NV 89139	PAVING COMPANY: LISTED ON UST DATABASE, NO INDICATION OF UST REMOVAL OR ABANDONMENT. LARGE POND VISIBLE ON ARIAL PHOTO.	M

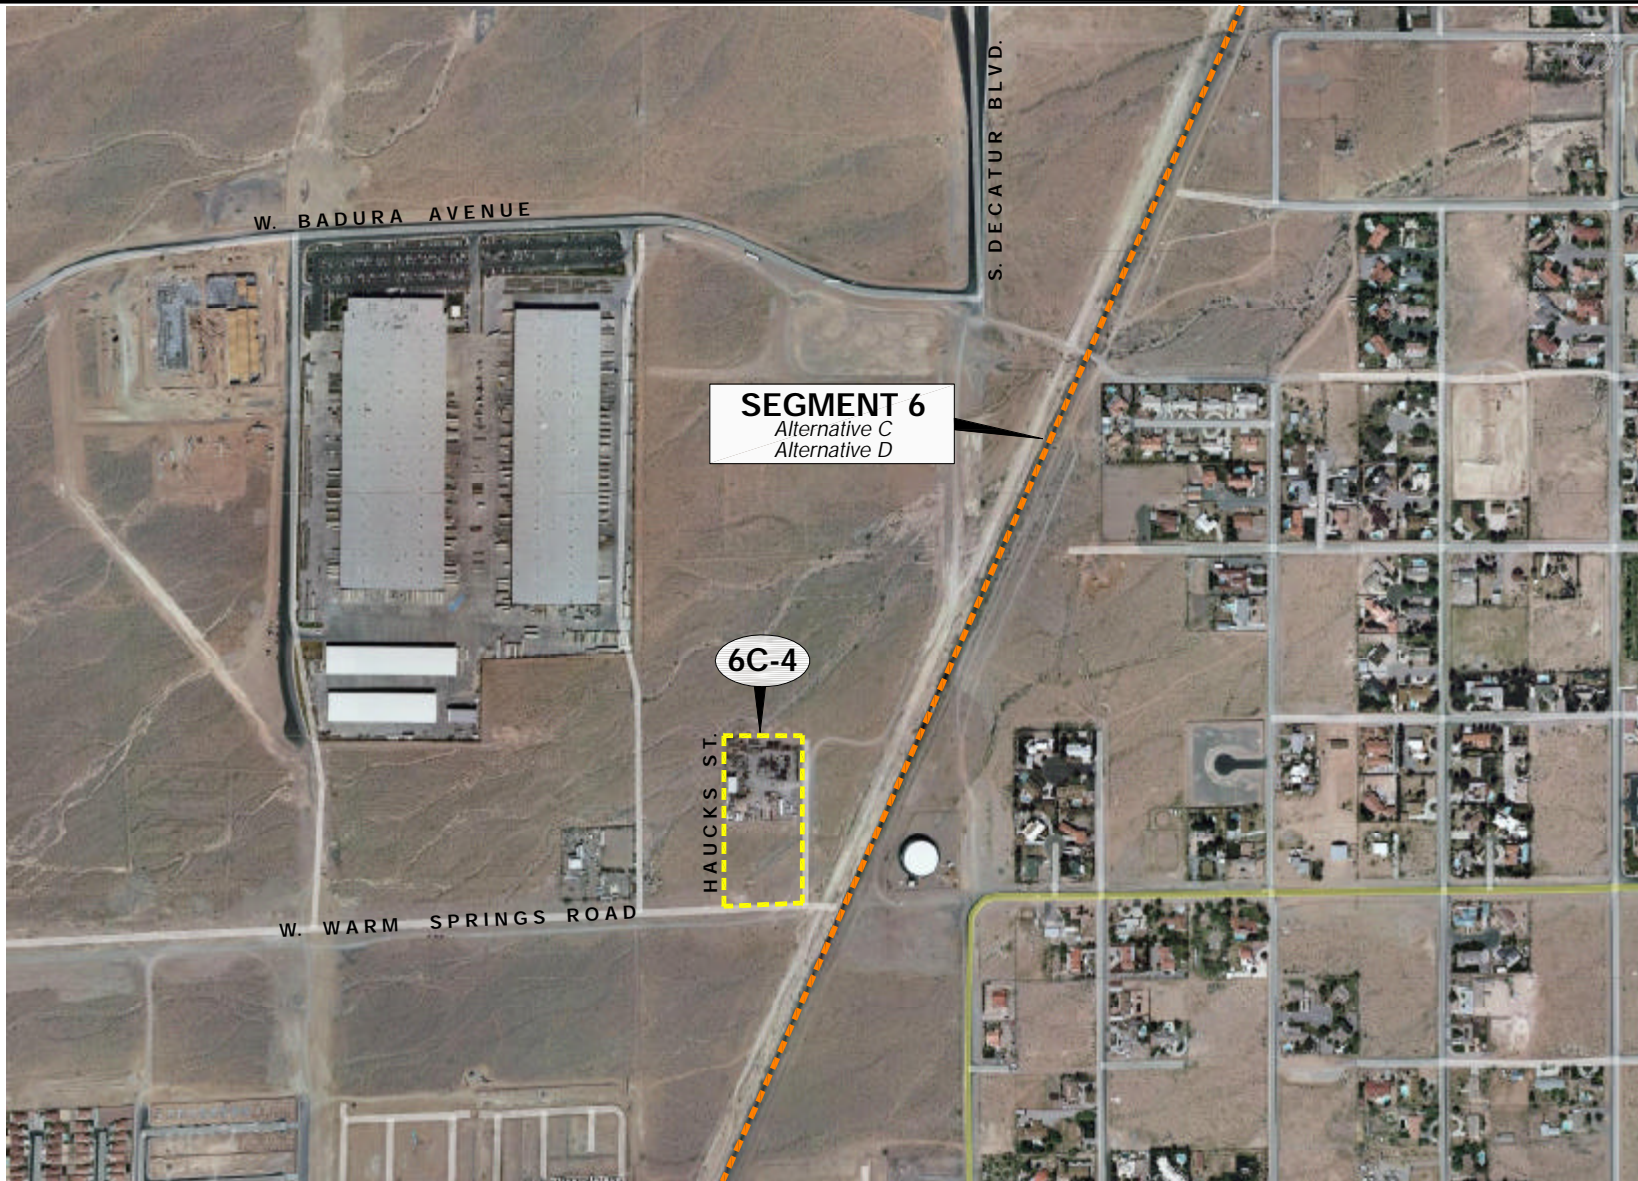
PROPERTY I.D.	PROPERTY ADDRESS	SITE OPERATIONS - REASON FOR RISK CLASS (1)	CLASS
6C-4	CLARK COUNTY DEPARTMENT OF AVIATION 7227 HAUCK STREET LAS VEGAS, NV 89118	COMMERCIAL PROPERTY: LISTED ON THE NEVADA STATE DATABASE, RELEASE TO SOIL, STATUS OF CASE UNDETERMINED.	M
