**HAZARDOUS MATERIALS ASSESSMENT  
PROPOSED DESERT XPRESS RAIL CORRIDOR  
VICTORVILLE, CALIFORNIA, TO  
LAS VEGAS, NEVADA**

February 2, 2007  
Project No. 206725002

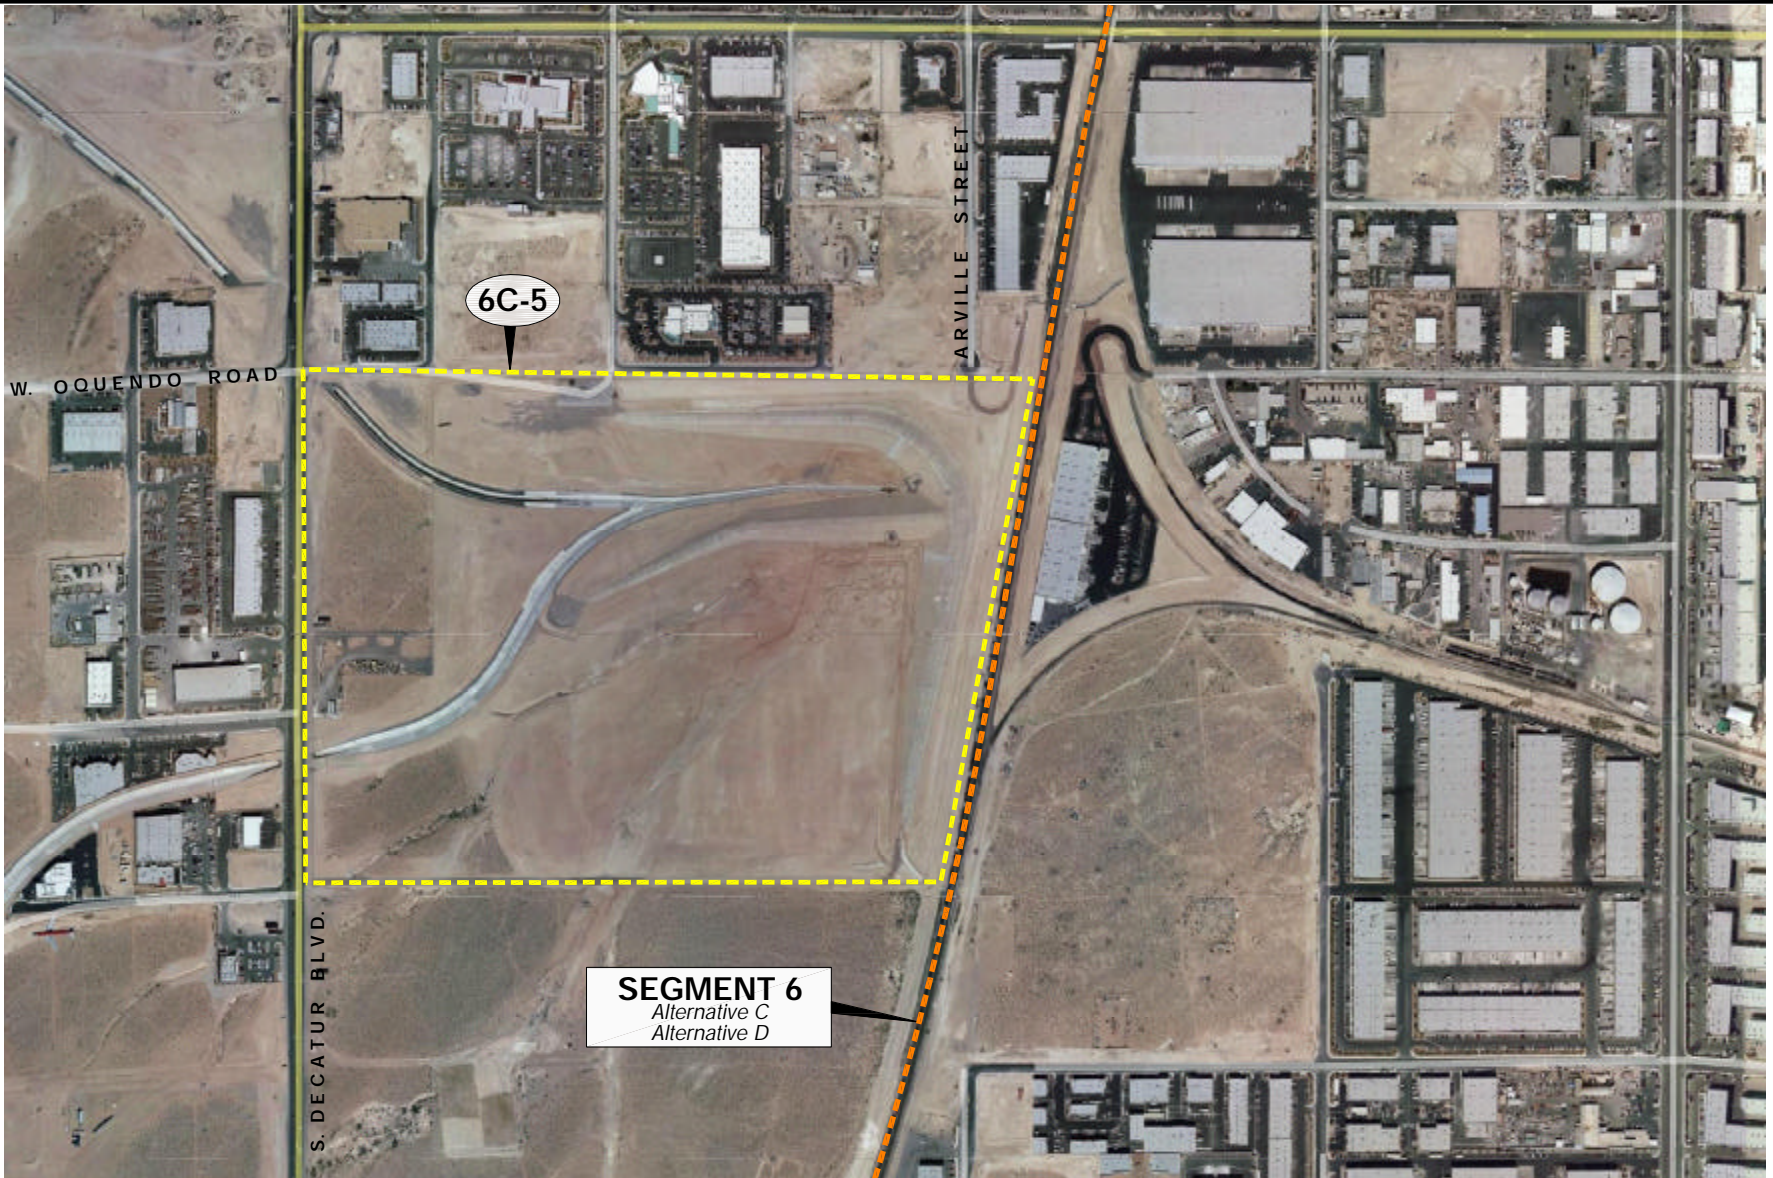
PROPERTY I.D.	PROPERTY ADDRESS	SITE OPERATIONS - REASON FOR RISK CLASS (1)	CLASS
6C-5	TROPICANA DETENTION BASIN ARVILLE AND OOUENDO STREETS LAS VEGAS, NV	LISTED ON THE NEVADA STATE DATABASE, RELEASE OF HEAVY METALS TO SOIL, CASE CLOSED IN 1999.	M

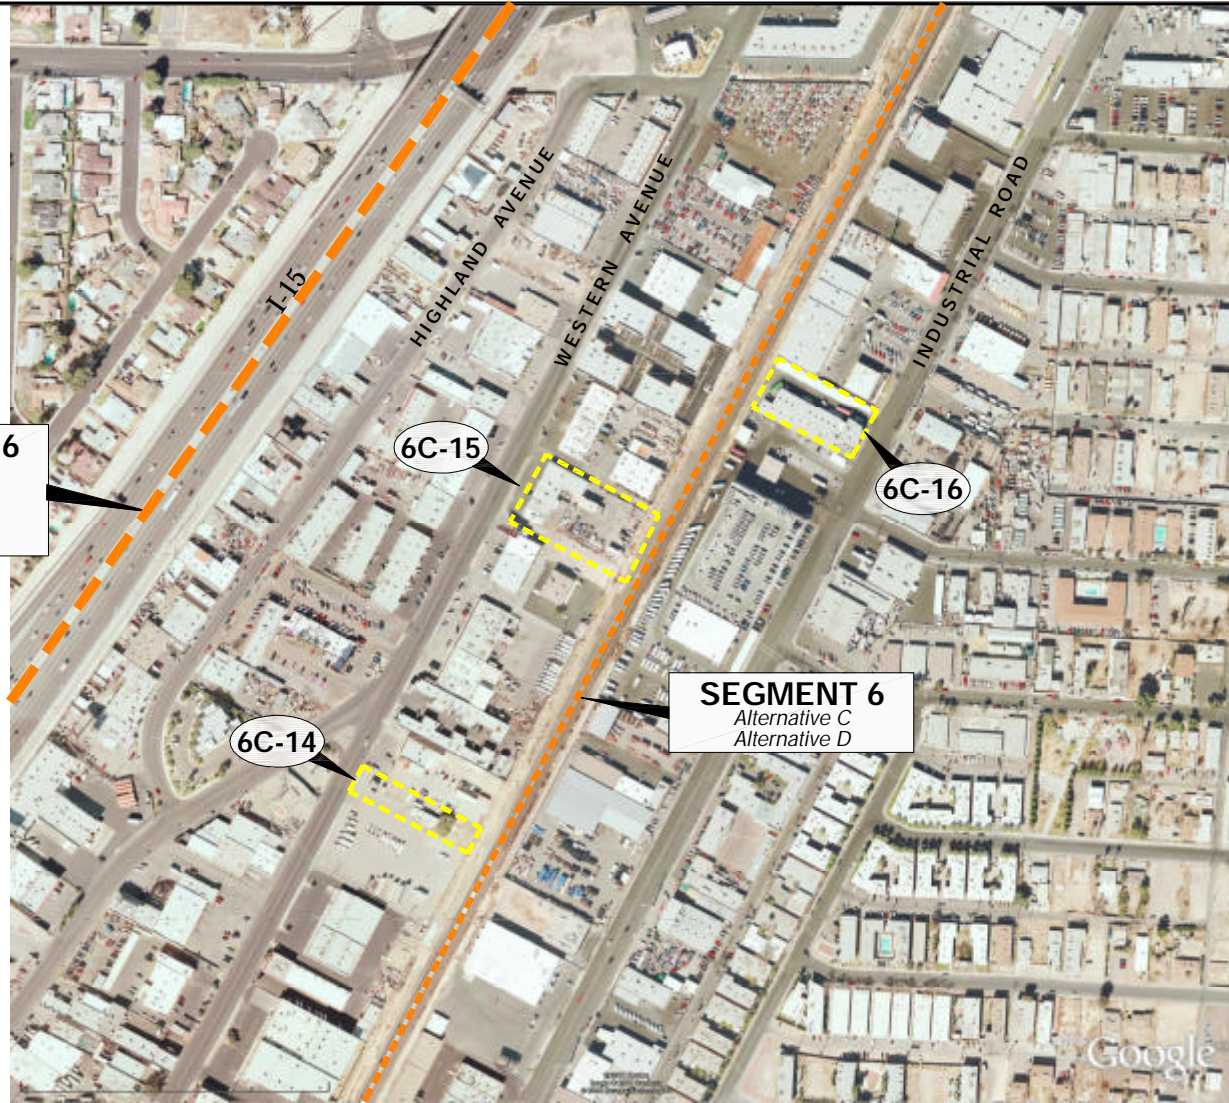
**7m**

PROPERTY I.D.	PROPERTY ADDRESS	SITE OPERATIONS - REASON FOR RISK CLASS (1)	CLASS
<b>6C-14</b>	ACE TRUCK RENTAL 2135 WESTERN AVENUE LAS VEGAS, NV 89102	LISTED ON LUST DATABASE, UNKNOWN RELEASE TO SOIL, CASE CLOSED IN 1995, LISTED ON UST DATABASE, USTs NO LONGER IN USE, NO INDICATION OF UST REMOVAL OR ABANDONMENT.	M
<b>6C-15</b>	1921 WESTERN AVENUE LAS VEGAS, NV 89102	OBSERVED DURING SITE RECONNAISSANCE: VENT PIPES OBSERVED IN THE FIELD.	M
<b>6C-16</b>	1900 DEAN MARTIN LAS VEGAS, NV 89102	OBSERVED DURING SITE RECONNAISSANCE: POTENTIAL UST, VENT PIPES OBSERVED IN THE FIELD.	M
