**DRAFT 1
AA/DEIS/DEIR GEOTECHNICAL
ASSESSMENT AND ENVIRONMENTAL
ANALYSIS**

**Los Angeles Metro Red Line/Eastern Extension
Corridor Study Area, Segment 3/MOS-3**

CCW Project No. 90-31-328-01

July 17, 1992

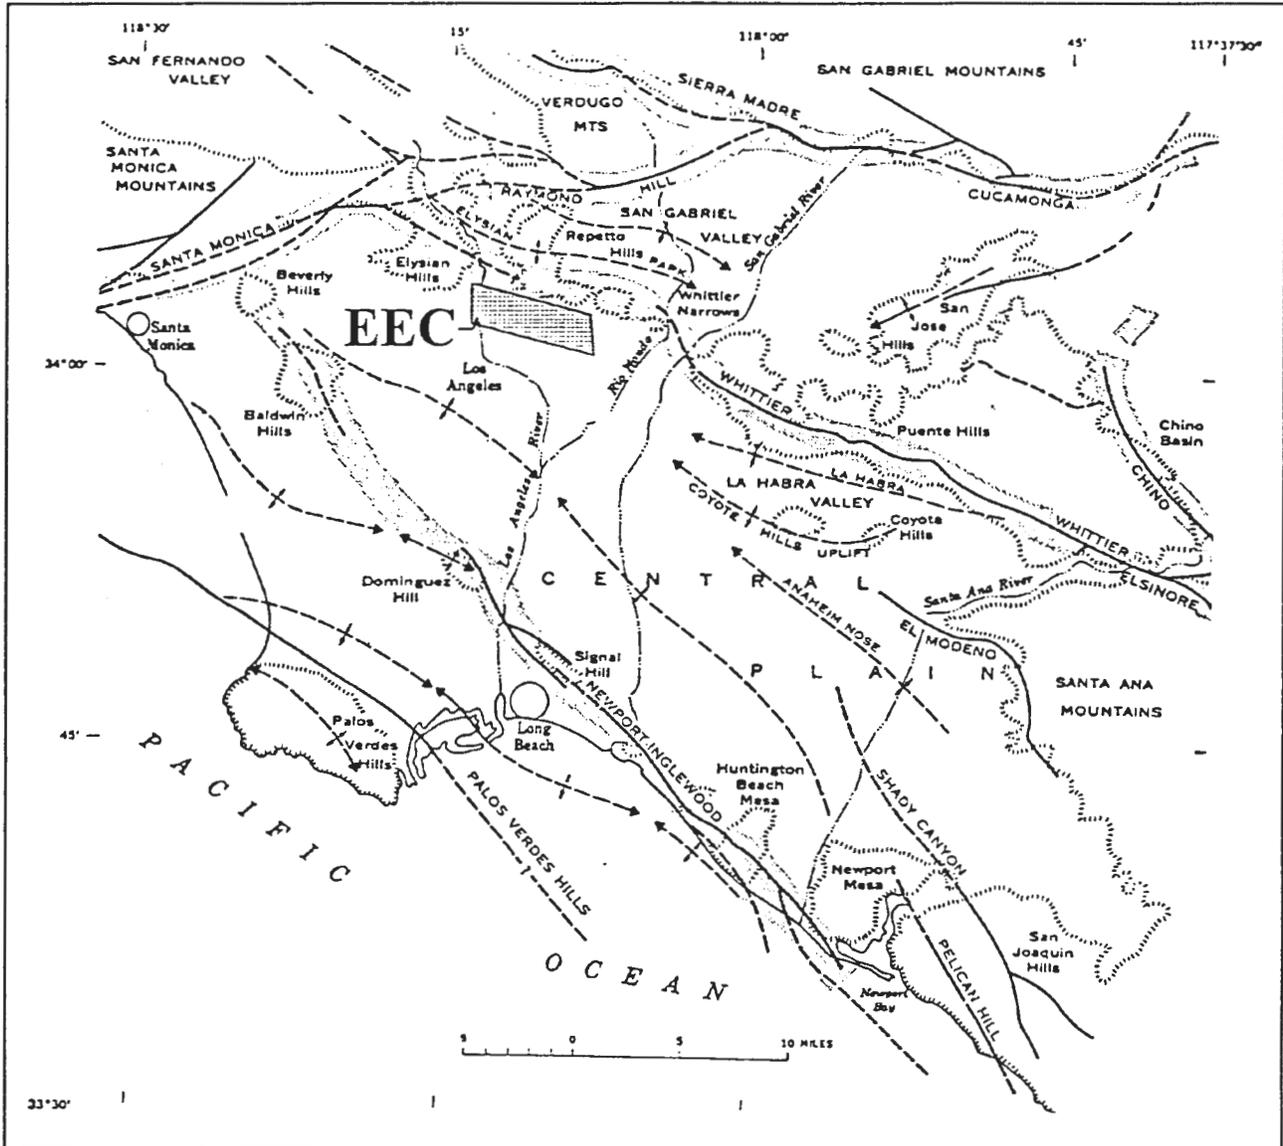
Figure 2. Major structural features of the Los Angeles Basin (modified after Yerkes, et al., 1965). EEC = Eastern Extension Corridor.

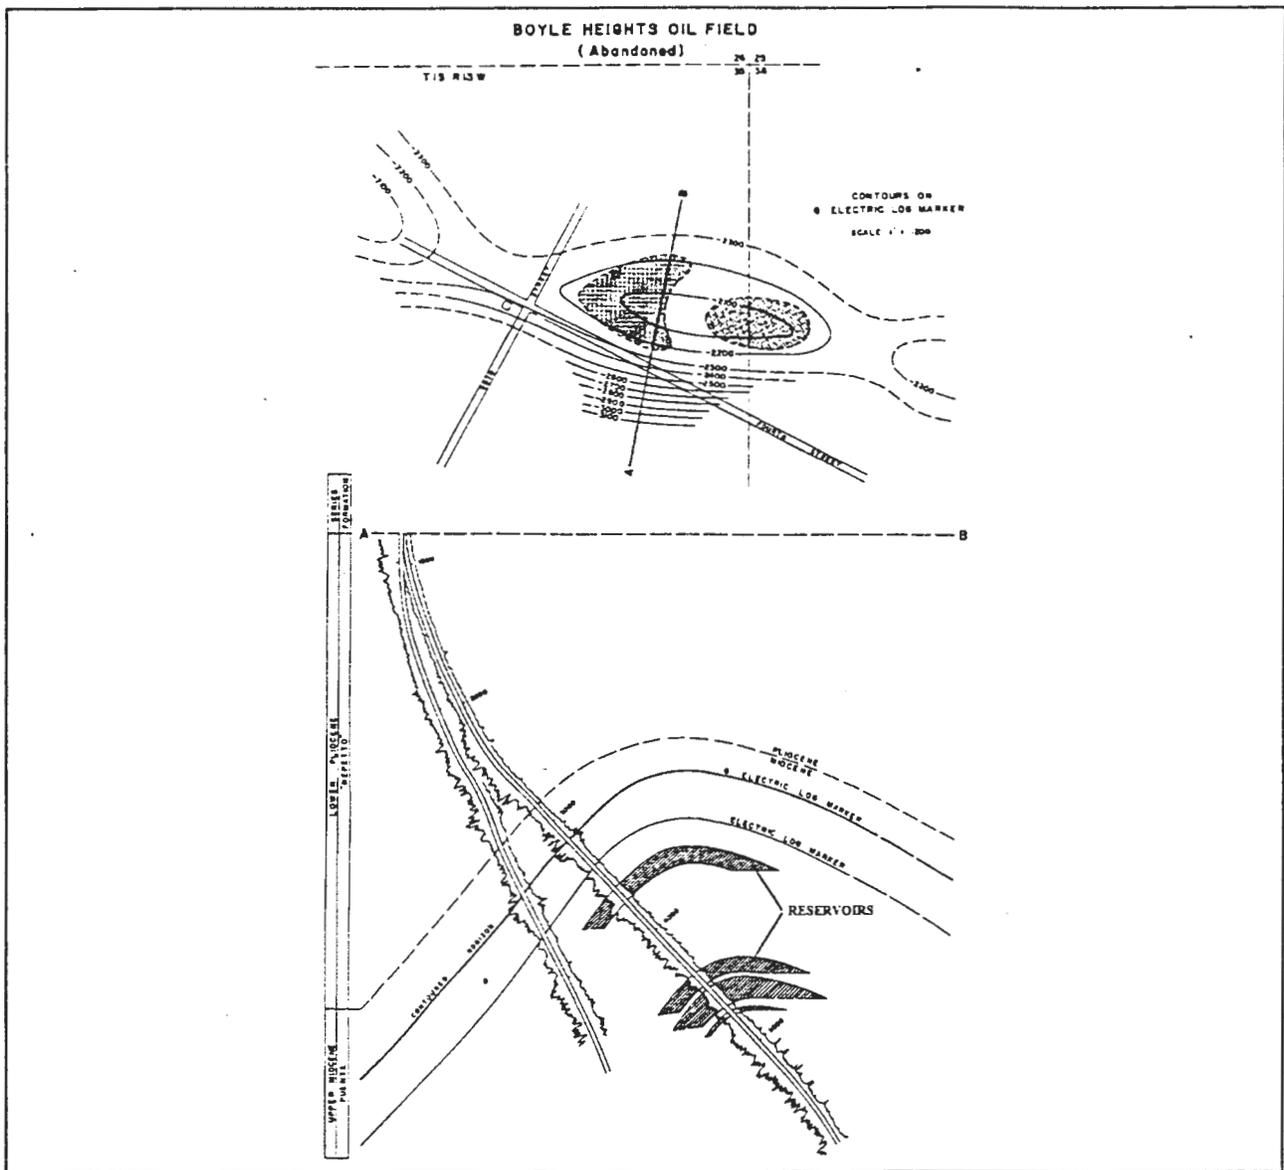
Figure 3. Typical cross section through Boyle Heights Oil Field (modified after CDOG, 1991). "Repetto" is equivalent to the Fernando Fm. Note depth adjacent to well log.

Several borings drilled around the Union Station area encountered relatively shallow (~40 feet deep) gas and minor oil in both bedrock and alluvium (see the geologic profiles and Appendix A). High volume discharges of a mixture of hydrogen sulfide gas and hydrocarbons including methane caused discharge flow measurement

problems during a pump test performed in a well located near the intersection of Alameda and Macy Streets (Converse Consultants, 1983). Gas chromatograms recorded below 37 feet in Boring 4 (Appendix A & Drawing 1) indicated 100 ppm methane and 500 ppm ethane resulting in a classification below the lower explosive limit (Converse Consultants, 1983). The continuity and geographic extent of shallow oil and gas in the EEC area is not known. Shallow oil and gas are relatively common in the northern LA basin (La Brea Tar Pits, 1985 Fairfax area explosion, etc.) and portions of the EEC are located over known producing oil fields. Therefore, there is a high probability of encountering shallow gas and possibly oil along any or all of the currently proposed alignments in the EEC.

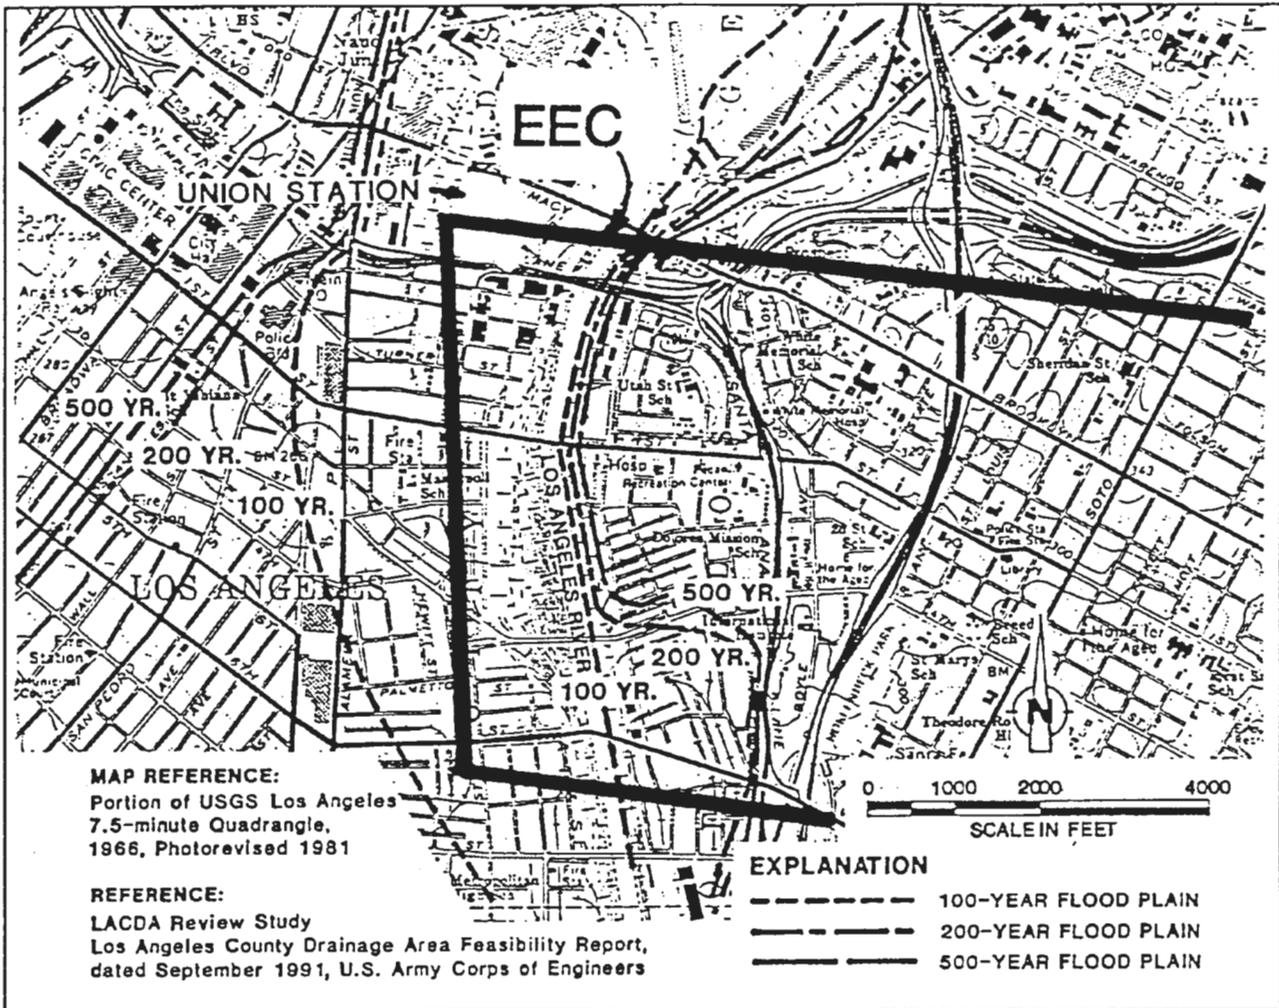
Figure 4. Map showing EEC areas within Los Angeles River floodplains (modified after CCW, 1992).

Portions of the EEC adjacent to the LA River, lie within the 100, 200, and 500 year flood plains as defined by the U.S. Army Corps of Engineers (Figure 4). In the Los Angeles County Drainage Report prepared in 1991, the Corps of Engineers concluded

that a 100 year flood event would break out in an area between the Pasadena Freeway and the Santa Monica Freeway causing major traffic congestion and property damage. A 500 year event would break out in the same general area, and flow across much of central Los Angeles before returning to the flood control channels downstream (U.S. Army Corps of Engineers, 1991).

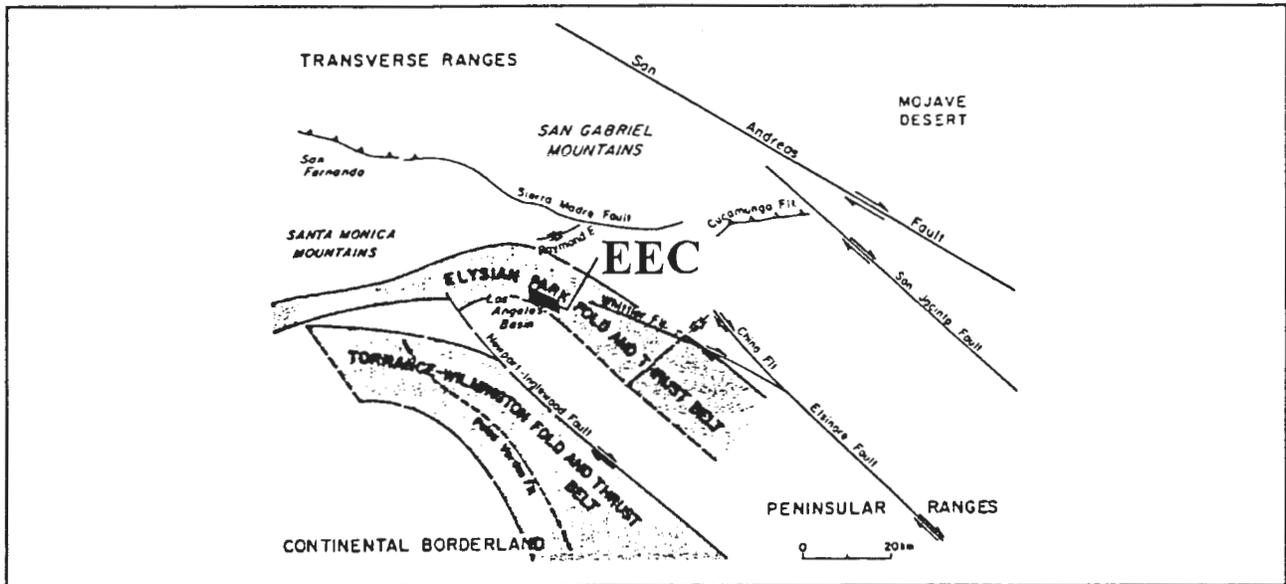
Figure 6. Schematic map of the Los Angeles Basin showing the Elysian Park Fold and Thrust Belt (shaded). Modified after Hauksson, 1989. EEC = Eastern Extension Corridor.

The Elysian Park and Repetto Hills have recently been interpreted as a fault propagated fold associated with a seismically active blind thrust fault - the Elysian Park thrust - rising off the regional detachment surface (Davis, et al., 1989; Hauksson and Jones, 1989; Hauksson and Stein, 1989; Hauksson and Saldivar, 1989). The EEC is located at the south margin of the hills near the center of the newly designated Elysian Park Fold and Thrust Belt (Figure 6). The 1987 Whittier Narrows earthquake has been attributed to the Elysian Park thrust fault (Hauksson, 1990).

Details concerning the Elysian Park thrust are limited because the fault has no surface expression and has only recently been recognized. Because the fault is buried, it is not considered a hazard in terms of surface fault rupture. However, it can generate moderate to strong ground shaking as evidenced by the Whittier Narrows event. Based on retrodeformable cross sections, Davis calculates a cumulative slip of 10 km

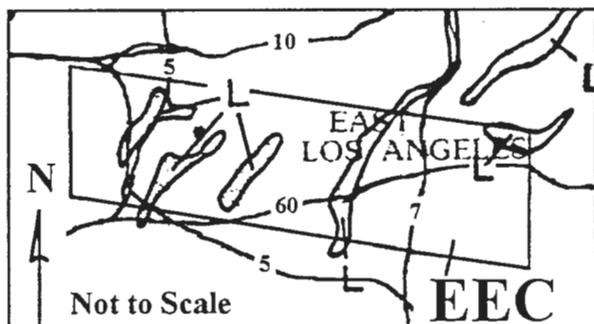
Figure 8. Sketch map of downtown area showing potentially liquefiable zones within the EEC (modified after Leighton & Assoc., 1990). L = liquefiable zone.

Liquefaction: Liquefaction is the transformation of submerged granular soils into a liquid-like mass due to excess pore pressure developed in response to earthquake ground shaking. Soils most susceptible to liquefaction are low density sands and silty sands that are submerged within 50 feet of the surface. Potentially liquefiable zones within the EEC are shown on Figure 8. The liquefiable zones are generally confined to areas of young alluvium located in small arroyos draining

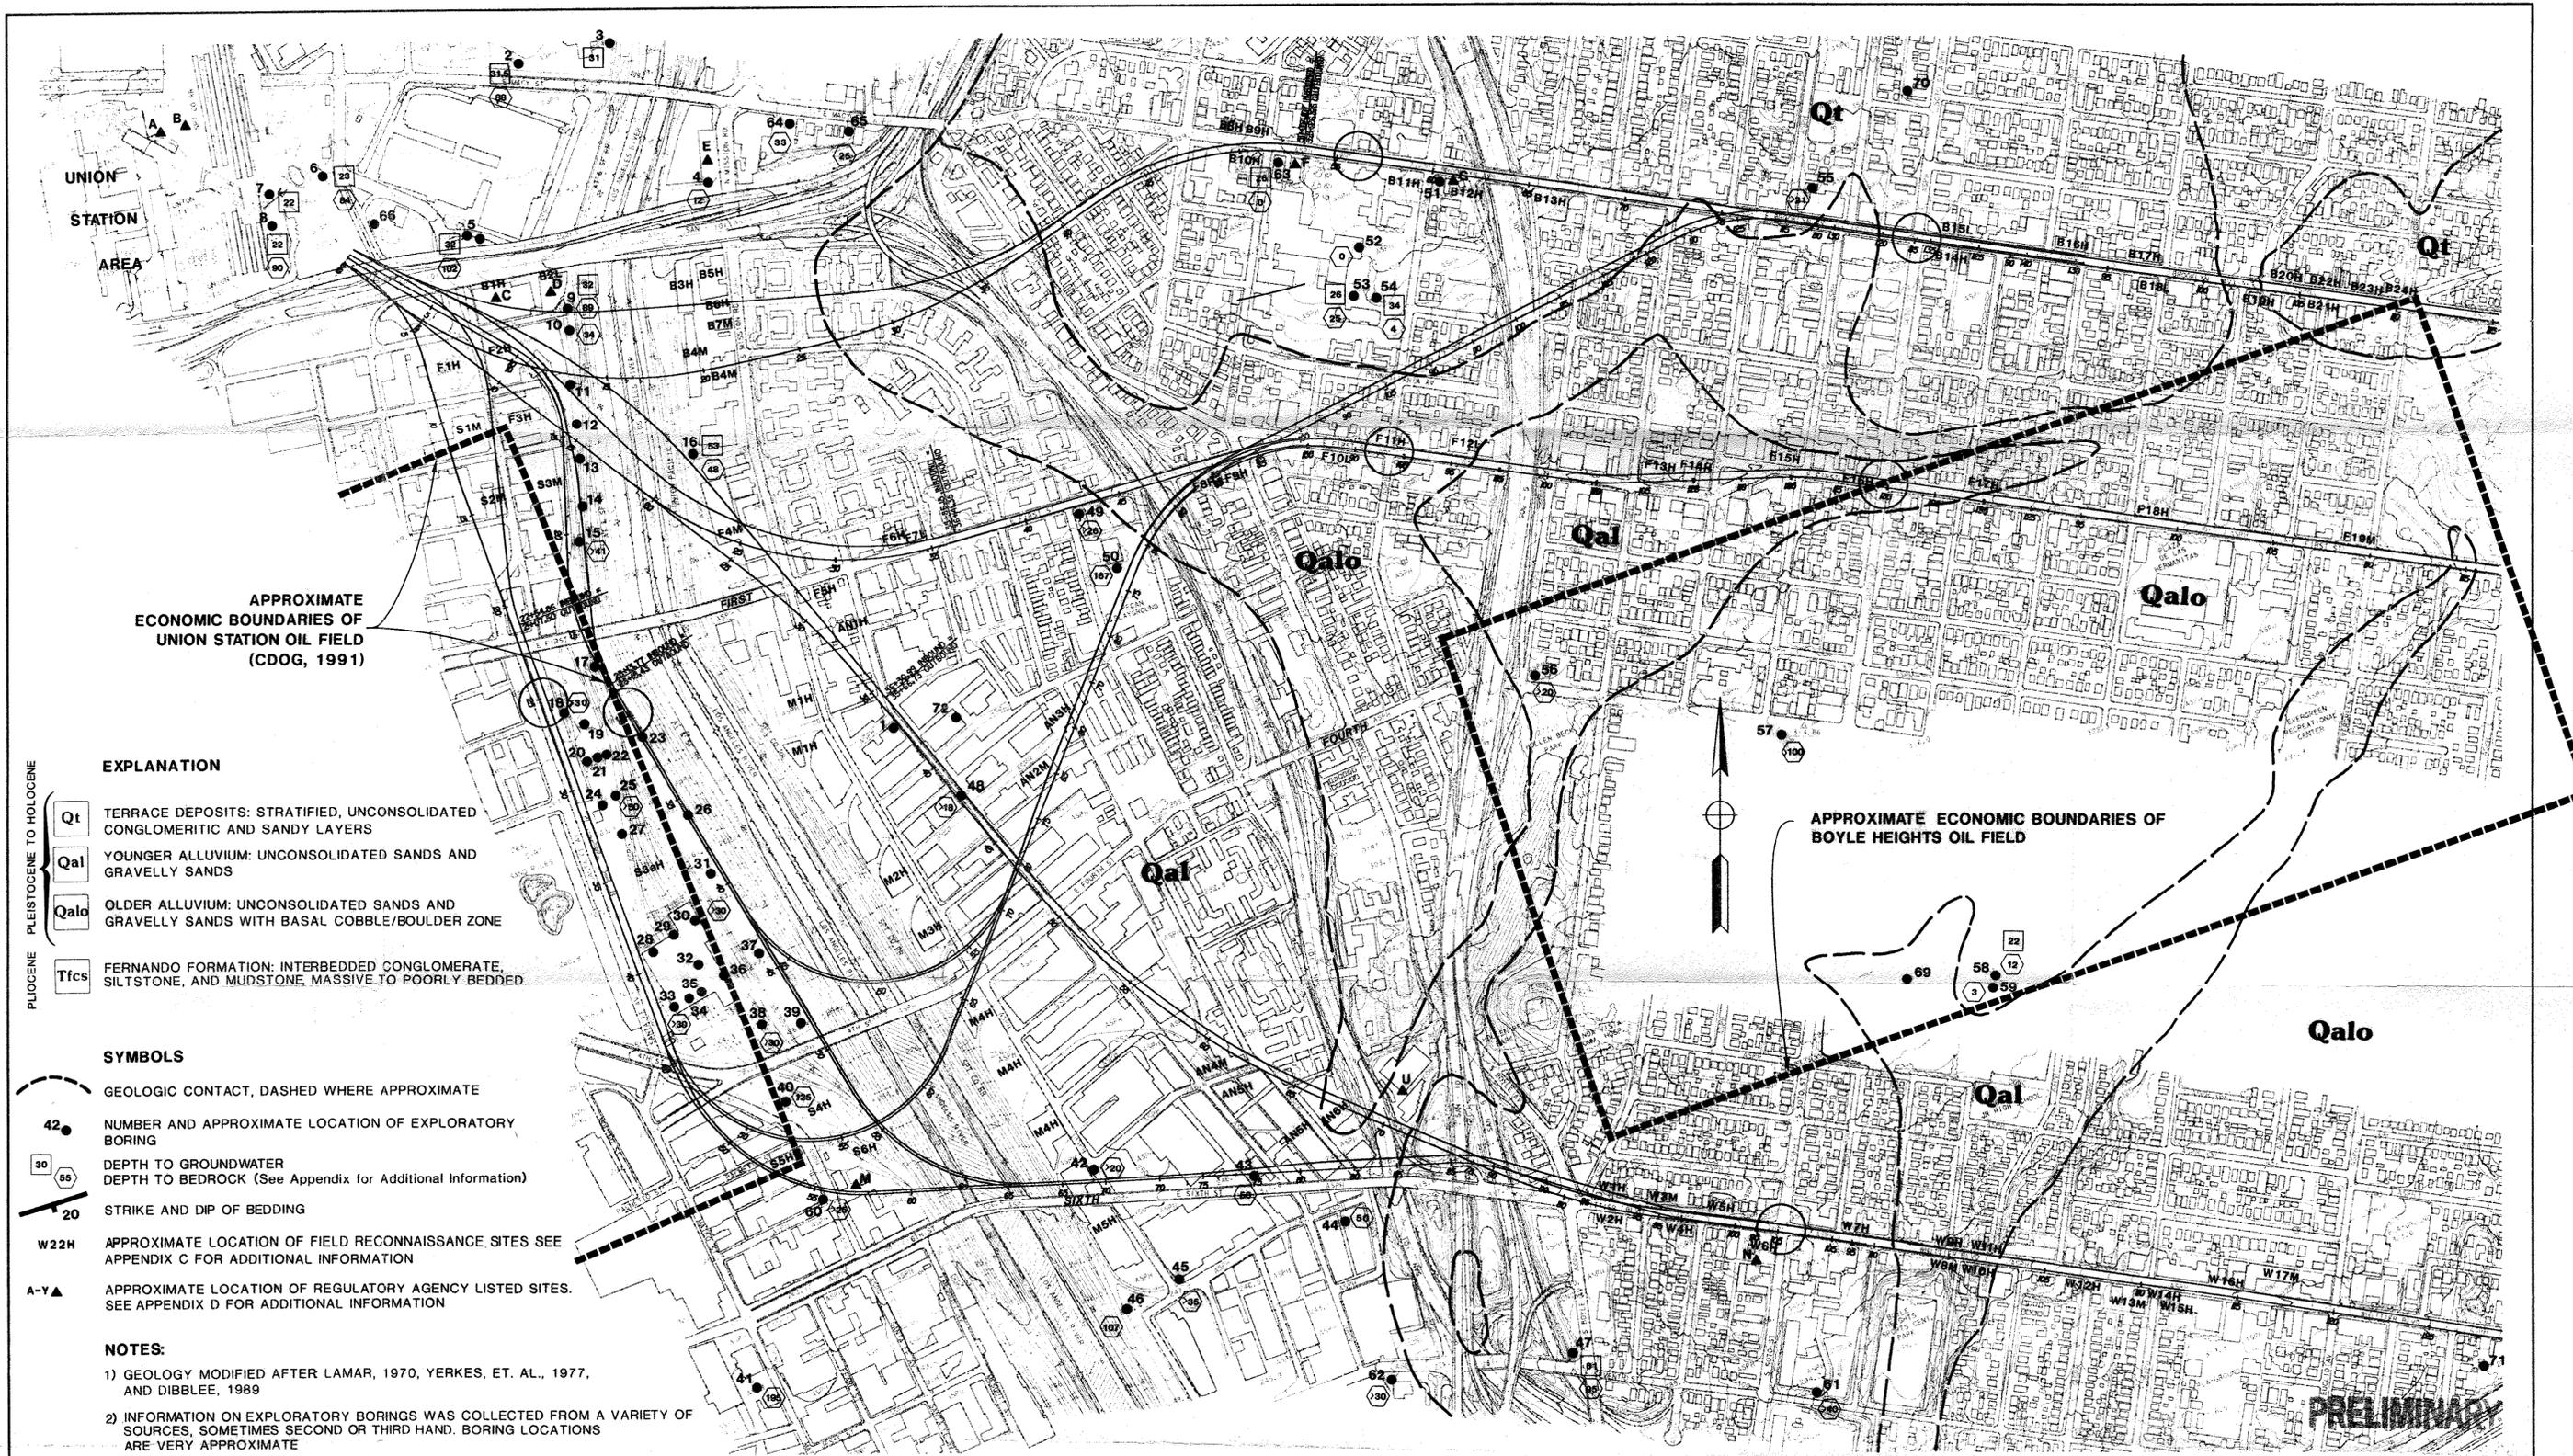
CONTRACT NO	
DRAWING NO	REV
SCALE: 1" = 400'	
SHEET NO 1 OF 4

- EXPLANATION**
- PLEISTOCENE TO HOLOCENE
- Qt TERRACE DEPOSITS: STRATIFIED, UNCONSOLIDATED CONGLOMERITIC AND SANDY LAYERS
 - Qal YOUNGER ALLUVIUM: UNCONSOLIDATED SANDS AND GRAVELLY SANDS
 - Qalq OLDER ALLUVIUM: UNCONSOLIDATED SANDS AND GRAVELLY SANDS WITH BASAL COBBLE/BOULDER ZONE
- PLIOCENE
- Tfc FERNANDO FORMATION: INTERBEDDED CONGLOMERATE, SILTSTONE, AND MUDSTONE, MASSIVE TO POORLY BEDDED.

- SYMBOLS**
- GEOLOGIC CONTACT, DASHED WHERE APPROXIMATE
 - 42 ● NUMBER AND APPROXIMATE LOCATION OF EXPLORATORY BORING
 - 30 55 DEPTH TO GROUNDWATER DEPTH TO BEDROCK (See Appendix for Additional Information)
 - 20 STRIKE AND DIP OF BEDDING
 - W22H APPROXIMATE LOCATION OF FIELD RECONNAISSANCE SITES SEE APPENDIX C FOR ADDITIONAL INFORMATION
 - A-Y ▲ APPROXIMATE LOCATION OF REGULATORY AGENCY LISTED SITES. SEE APPENDIX D FOR ADDITIONAL INFORMATION

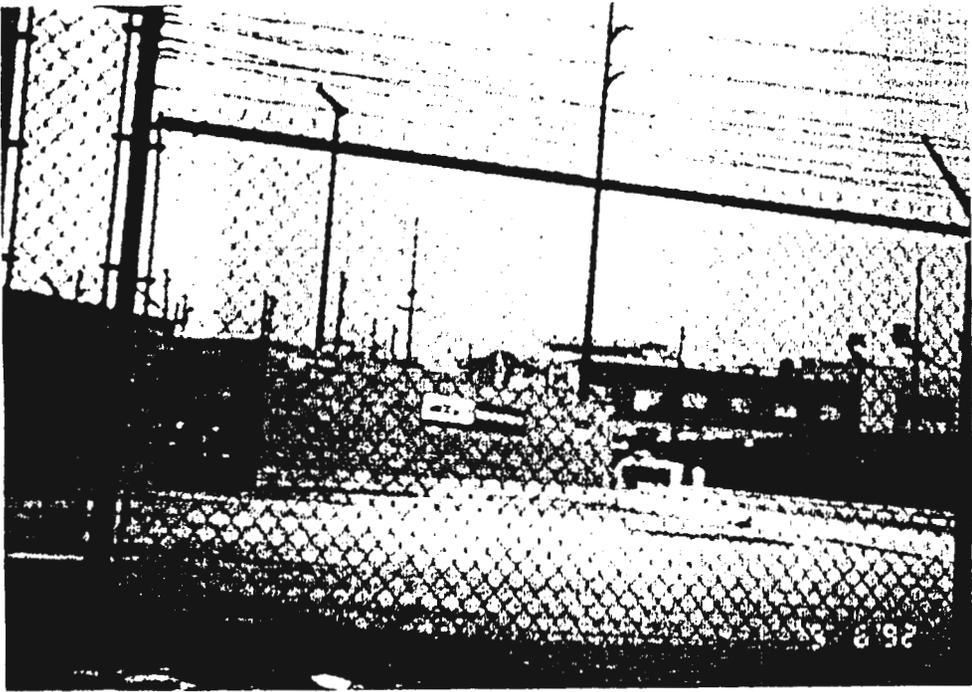
1

1. **Unocal Center Street Terminal (F1 H).** Storage and fueling area for Unocal products. ASTs observed. A high potential for environmental impact exists based on the type of operation.
2. **Manley Oil Company (F3 H).** Oil refining and distribution facility. A high potential for environmental impact exists based on the type of operation.
3. **George's Auto Dismantling and Lucio's Auto Wrecking (AN1 H).** Two adjacent auto wrecking facilities. Auto parts scattered over the site and very heavy surface staining observed. A high potential for environmental impact exists based on visual observations.
4. **Facility name: unknown (AN3 H).** Two structures appearing to be vacant. One structure has the appearance of a service garage. Diesel trucks are located in the parking lot. Pump Island observed. A high potential for environmental impact exists based on visual observations.

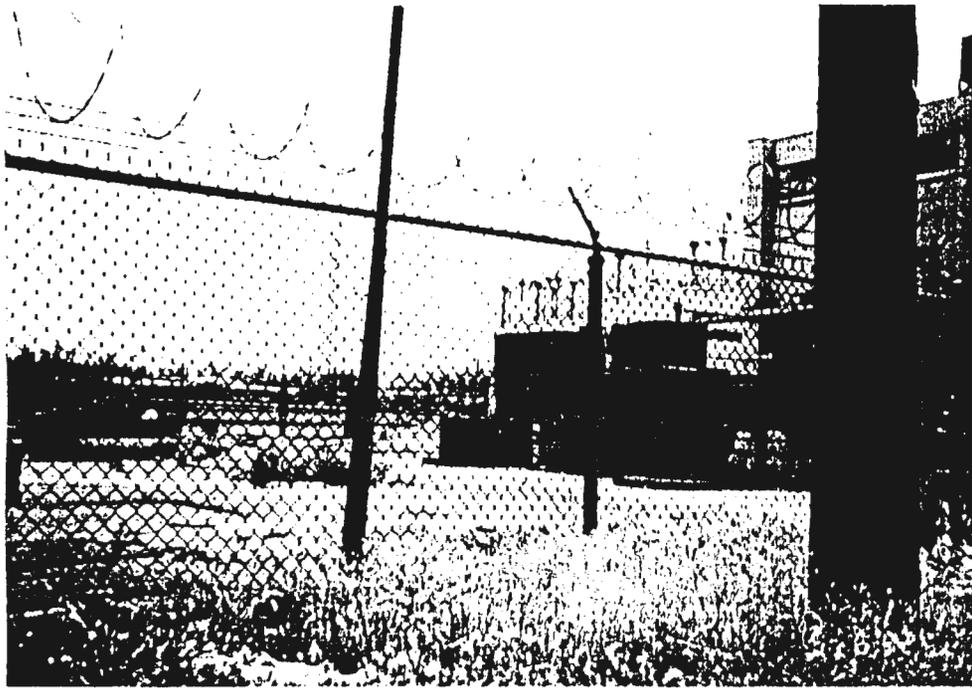
5

5. Sun Chemical, General Printing Ink Division (S6 H and Site M). Chemical manufacturing facility. Numerous 55-gallon drums observed. The site is listed as the BASF Inmont Facility on the LUST. Soil and ground water contamination has occurred at this facility and the contamination may have migrated off-site. A high potential for environmental impact exists based on the regulatory agency findings.

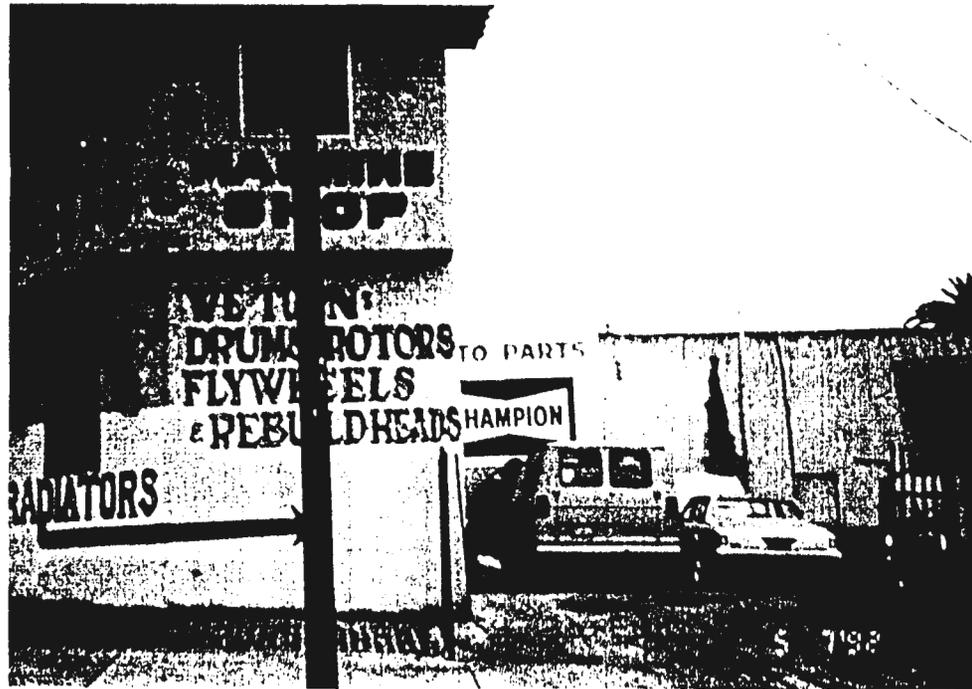
7

7. Brooklyn Radiator Service and Machine Shop (B19 H). Auto parts sales, machine shop and radiator service. Surface staining observed in the radiator repair area. A high potential for environmental impact exists based on the type of operation and visual observations.

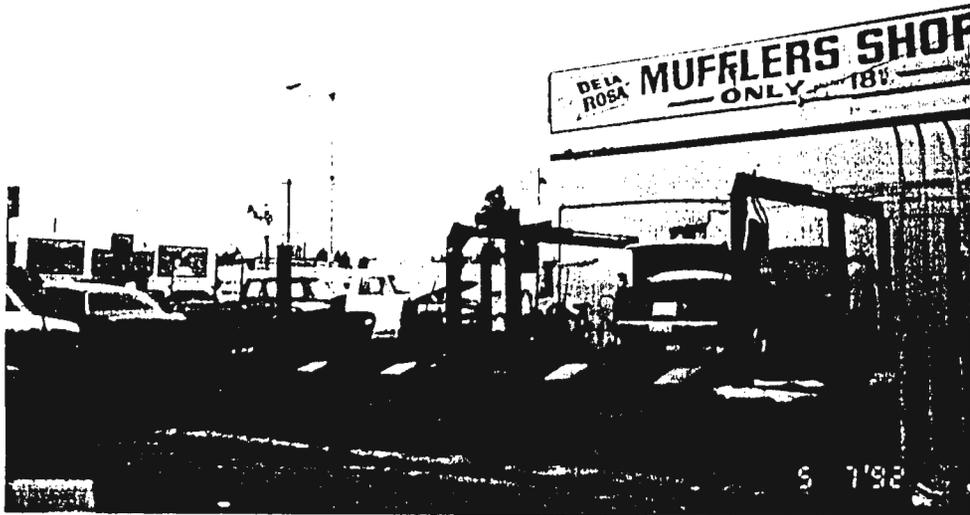
9

9. De La Rosa Mufflers Shop (B45 H). Auto repair facility. Heavy surface staining observed. A high potential for environmental impact exists based on the type of operation and visual observations.

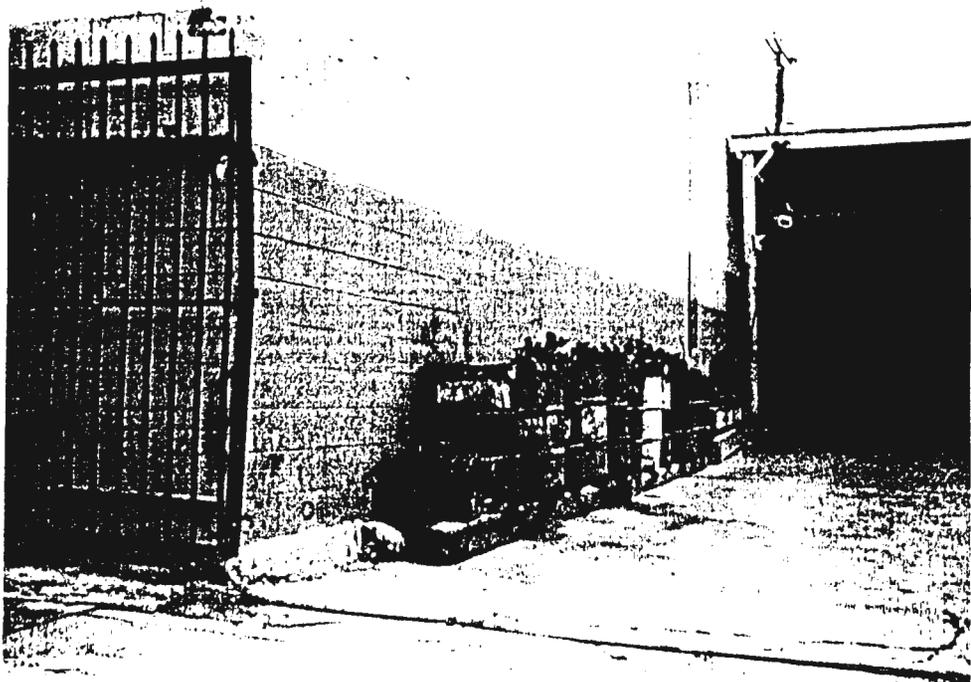
11

11. A & N Engine Rebuilders (B52 H). Auto repair facility. Multiple 55-gallon drums filled with auto parts present. Surface staining noted around the 55-gallon drums and in the main building. A high potential for environmental impact exists based on the type of operation and visual observations.

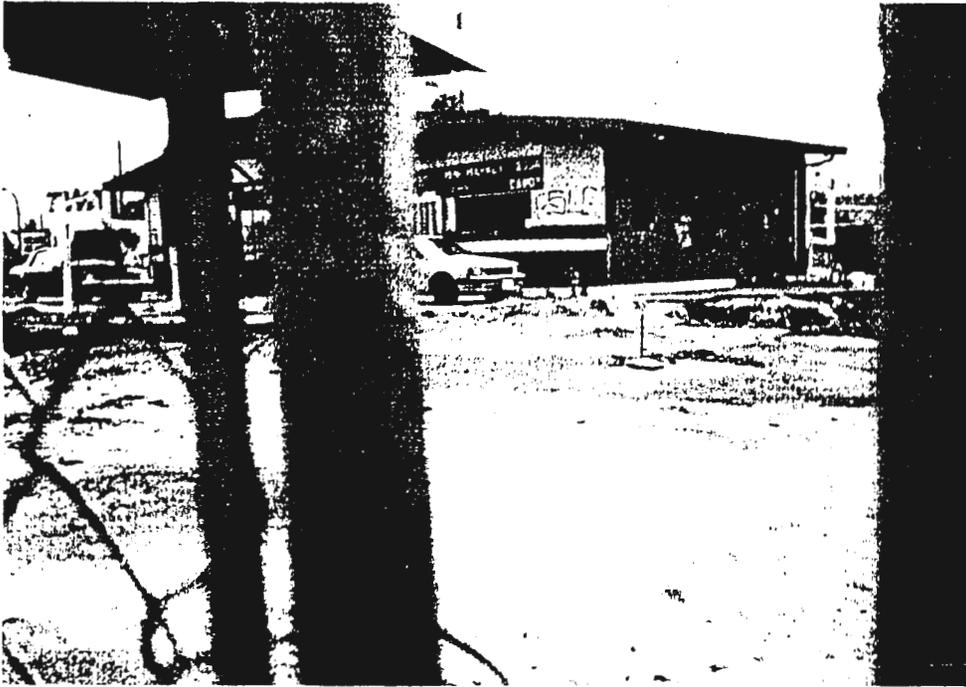
13

13. Shell Service Station (F9 H). Pump islands are present but the fuel dispensers have been removed. A large excavation is present. Auto repair appears to be occurring in the service bays. One 55-gallon paper barrel covered with oil is visible. A high potential for environmental impact exists based on the type of operation and visual observations.
14. Same as photograph #13.
15. CD Transmission, Marlenes, Corbian Auto Sales (F15 H). Auto repair facilities. 55-gallon drums, hydraulic lifts and heavy surface staining visible. A high potential for environmental impact exists based on the type of operations and visual observations.
16. M.Y. Service (F18 H). Site appears to be a former gasoline station. Auto repair is currently occurring on the site. 55-gallon drums are visible. A high potential for environmental impact exists based on the type of operation and visual observations.

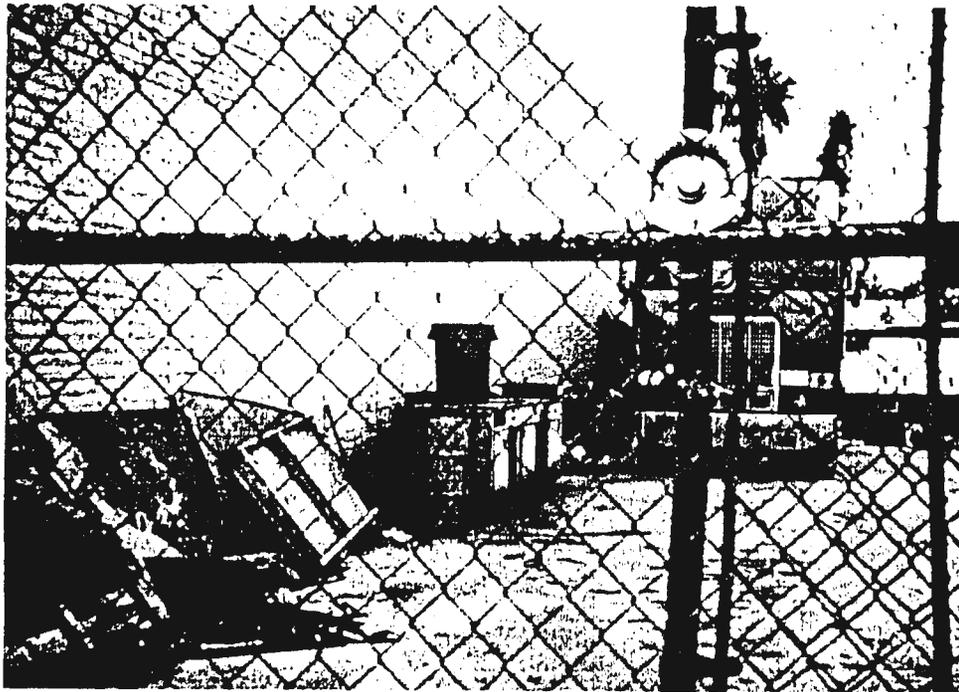
17

17. Facility name: unknown (F19 M). Fenced lot with three parked diesel trucks. 55-gallon drums and surface staining are visible. A moderate potential for environmental impact exists based on visual observations.
18. Quinteros and Sons Tires (W12 H). Auto repair and tire facility. Surface staining observed. A high potential for environmental impact exists based on the type of operation.
19. J & A General Auto Repair and Engine Overhaul (W31 H). Auto repair facility. A high potential for environmental impact exists based on the type of operation.
20. Aguilar Body Shop (W35 H). Auto repair facility. Surface staining observed. A high potential for environmental impact exists based on the type of operation and visual observations.

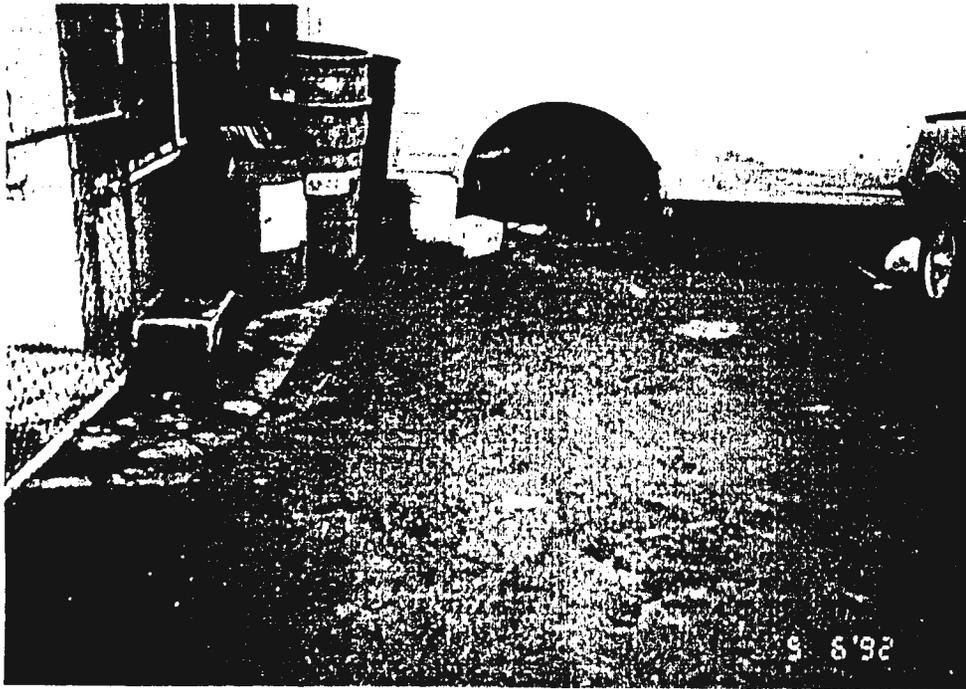
21

21. **A & F Auto Parts (W36 H). Engine rebuilding and auto repair facility. Surface staining observed. Hydrocarbon odor detected from Whittier Boulevard. A high potential for environmental impact exists based on the type of operation and visual observations.**
22. **Vacant lot (I3 H). Fenced lot with no structures. Site appears to be under remediation. Two large covered soil piles observed. A high potential for environmental impact exists based on visual observations.**
23. **Rockview Dairy (A10 H). Site appears to be a former gasoline station. A high potential for environmental impact exists based on visual observations.**
24. **Auto Liquidations (A31 M). Structures appear vacant and no vehicles are present on the lot. Car parts are hanging over a fence. Surface staining observed. A moderate potential for environmental impact exists based on visual observations.**

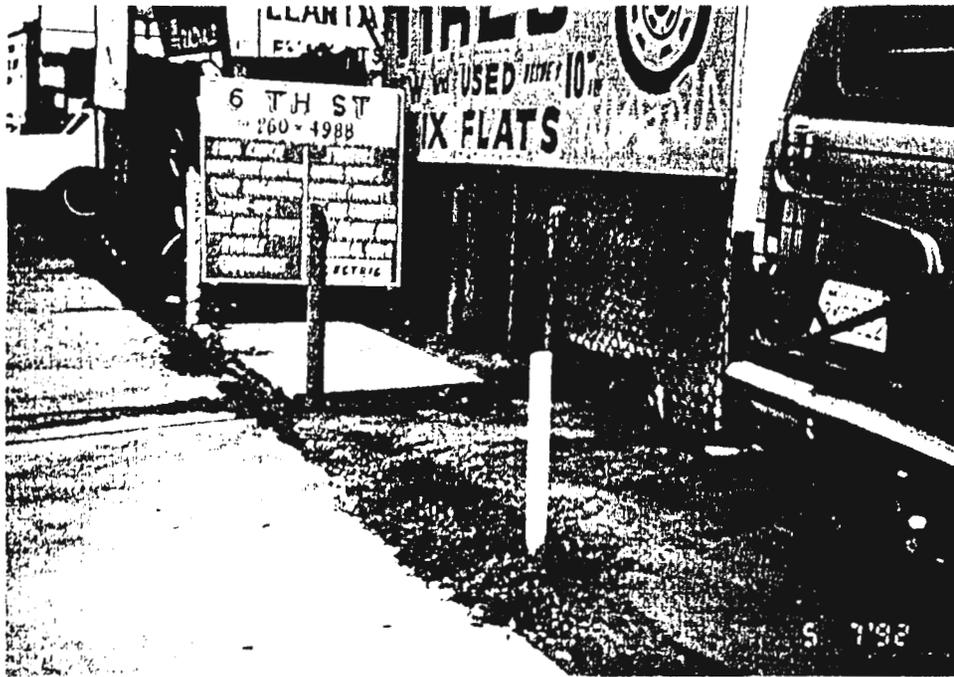
25

25. **Jesse's Auto Sales (A34 H). Sales and auto repair facility. The portion of the property which fronts Atlantic Boulevard is the sales facility. The portion of the property which fronts 6th Street appears to be the auto repair facility. Heavy staining observed. Water with a prominent oil sheen was observed running from the facility over the sidewalk and into the street gutter. A high potential for environmental impact exists based on the type of operation and visual observations.**
26. **Mario's Transmission (A42 H). Auto repair facility. Storage of auto parts and surface staining visible from Atlantic Boulevard. Located in the rear of the property, near the alley way, surface staining observed. A high potential for environmental impact exists based on the type of operation and visual observations.**
