CONFERENCE PROCEEDINGS 7

Fourth International Bridge Engineering Conference

Volume 2

TRANSPORTATION
RESEARCH
BOARD

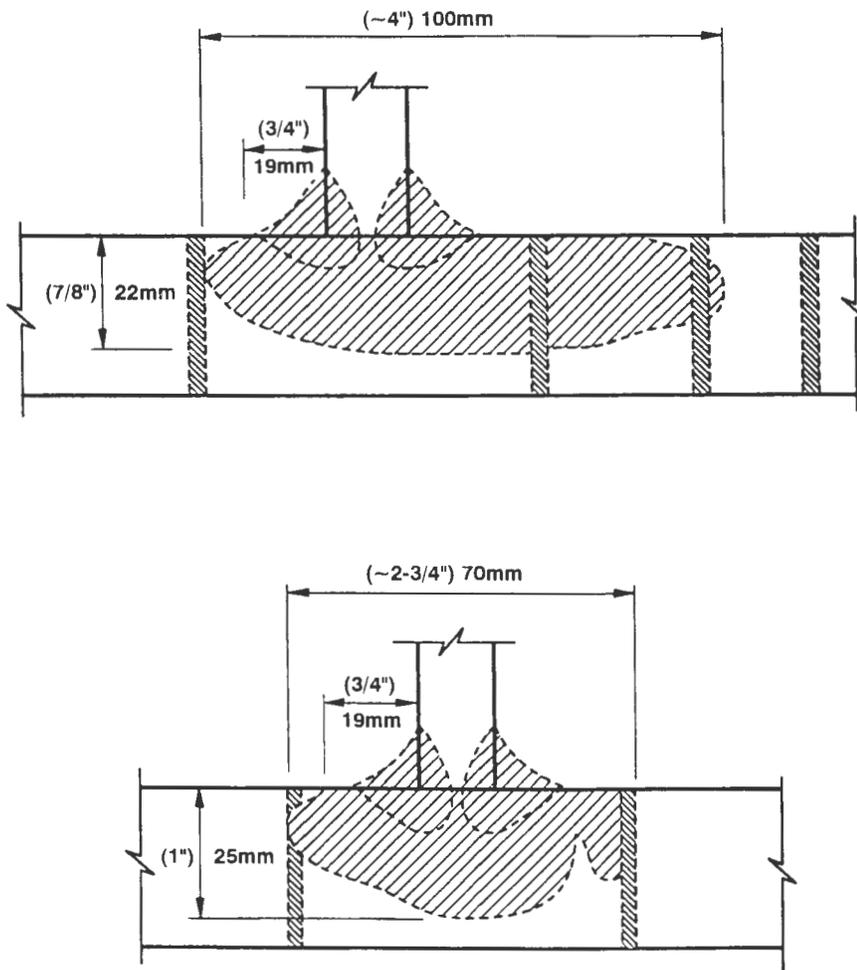
FIGURE 3 Projected crack geometry on plane perpendicular to girder flange: *top*, schematic of crack in flange at Core 17; *bottom*, schematic of crack in flange at Core 25.

The large cracks observed in Girder 301G1-3 at Cores 17 and 25 were evaluated for fatigue and fracture susceptibility. Figure 3 shows a schematic of the cracks projected on a plane perpendicular to the bending stresses in the girder flange. As discussed previously, the crack tip nearest the bottom surface of the flange exhibits a nearly horizontal orientation and hence is not

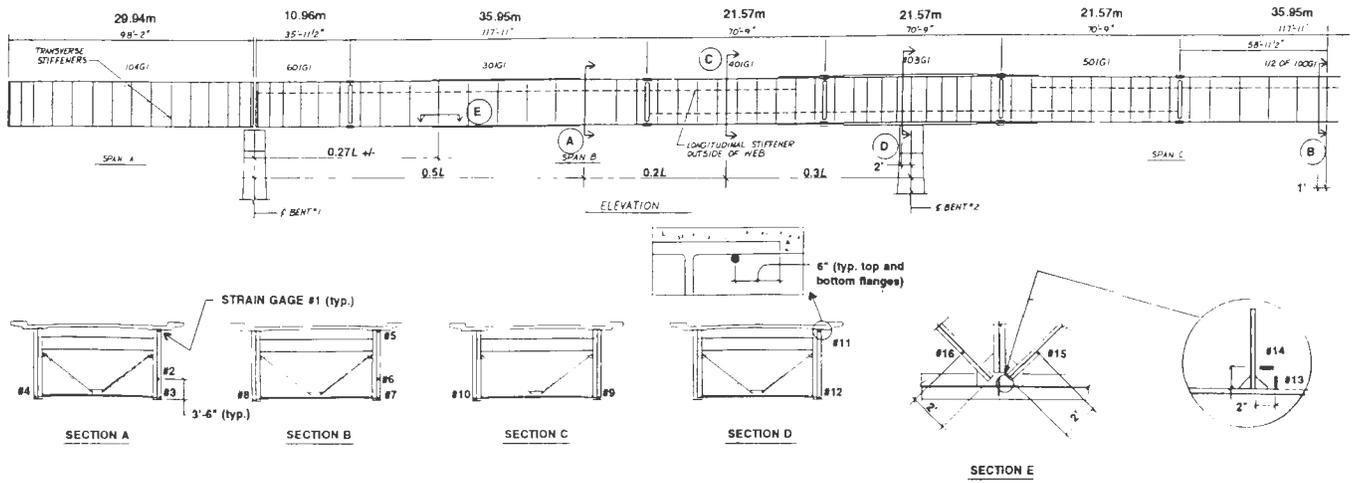
FIGURE 13 Strain gauge layout.

Strain was recorded under normal traffic for a continuous period of 24 hr. Gauge measurements for a typical passage of heavy vehicle during this period are provided in Figures 14 and 15. In addition, the 24-hr data were scanned for the largest strain event during the test period. Four maximum responses were noted in this pe-

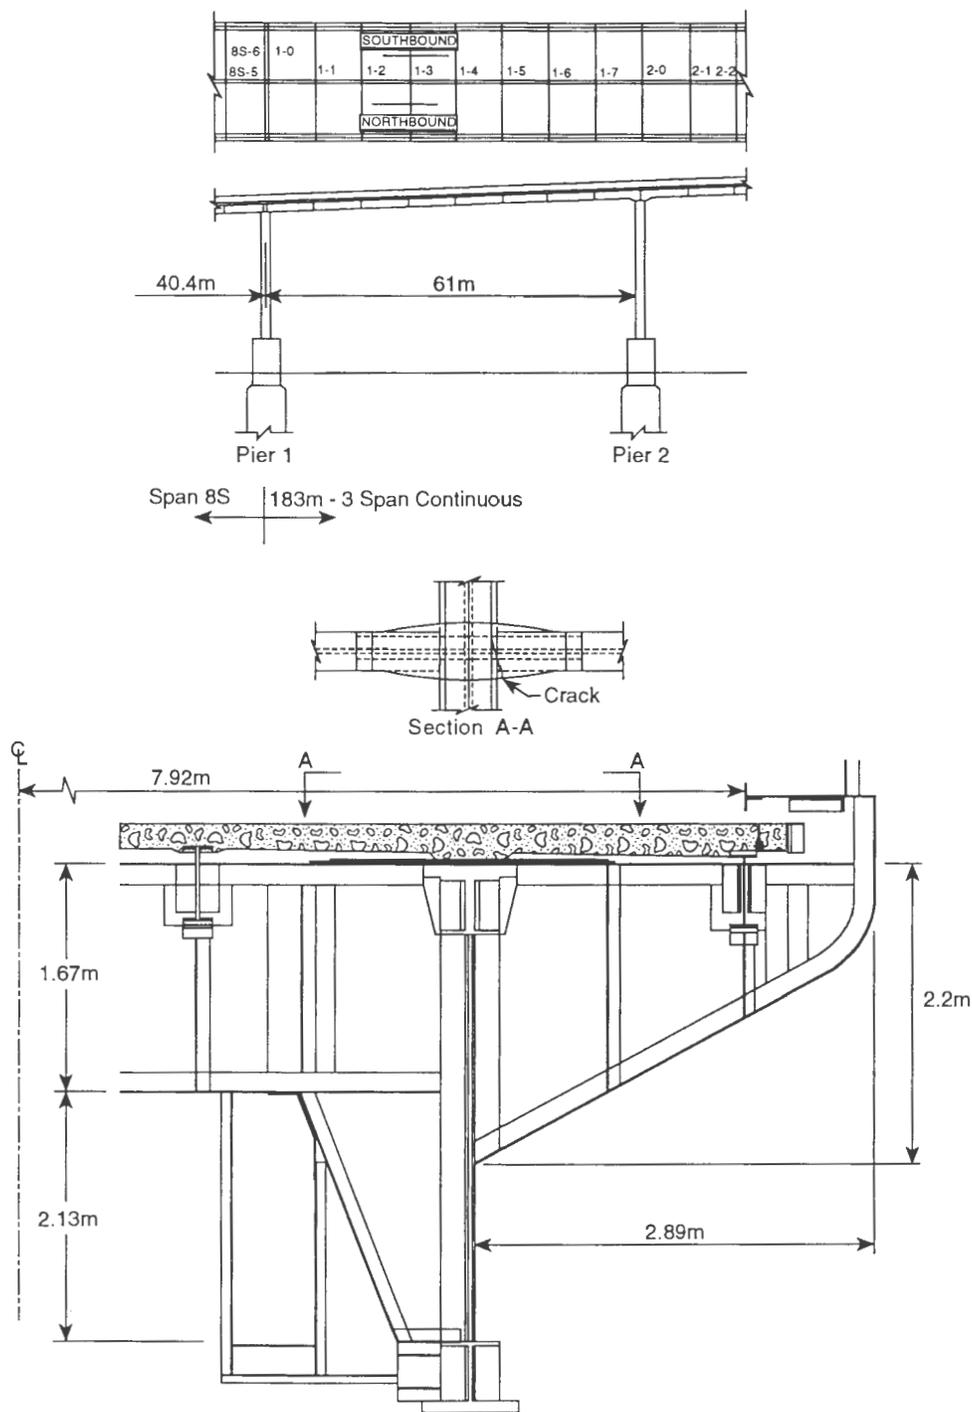
FIGURE 1 Typical span and elevation of Edison Bridge.

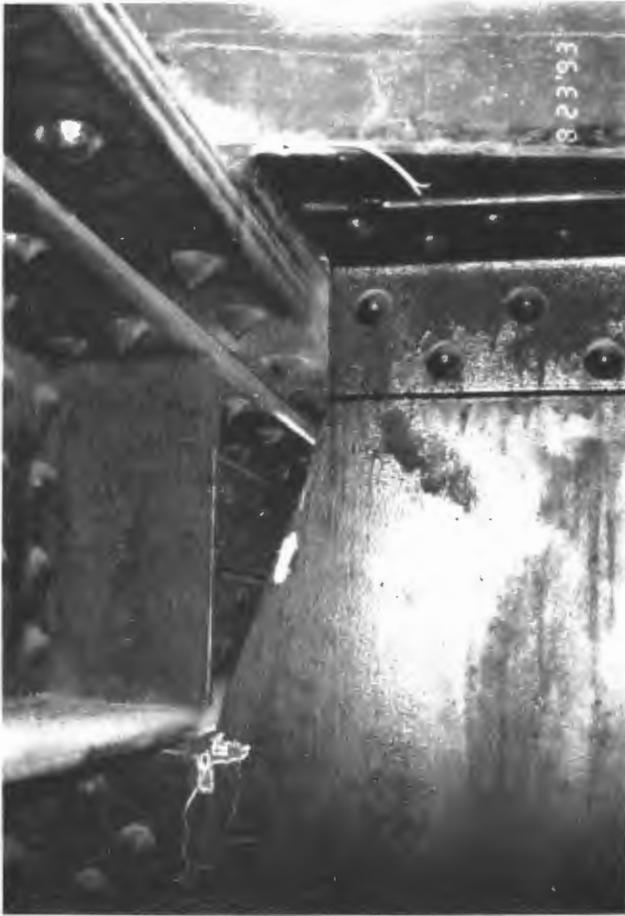
FIGURE 10 View of gauges on tie plate edge and at bracket cope.

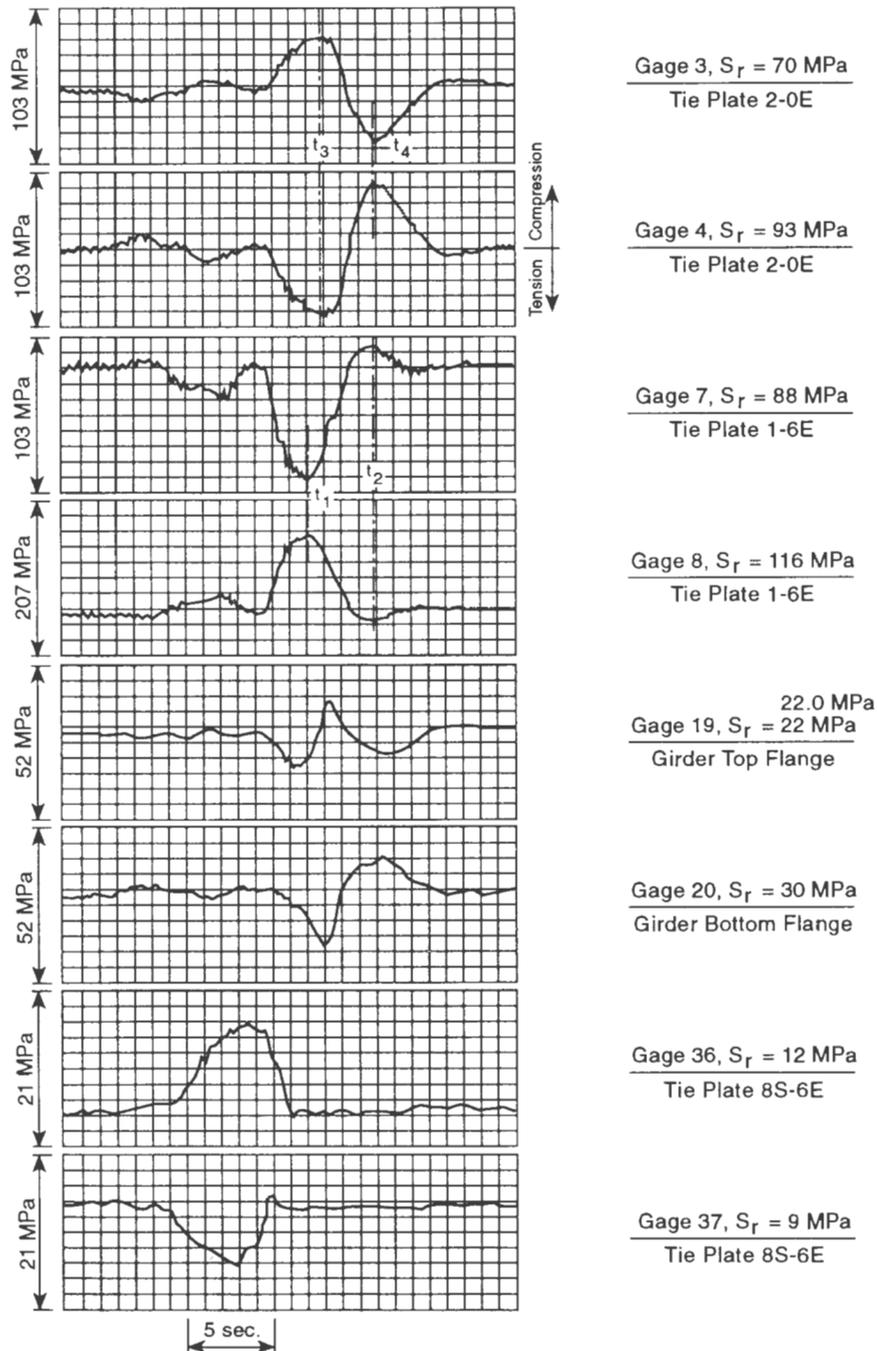
FIGURE 11 Typical strain-time response of tie plates and main girder in 61-m span (see Figure 1).

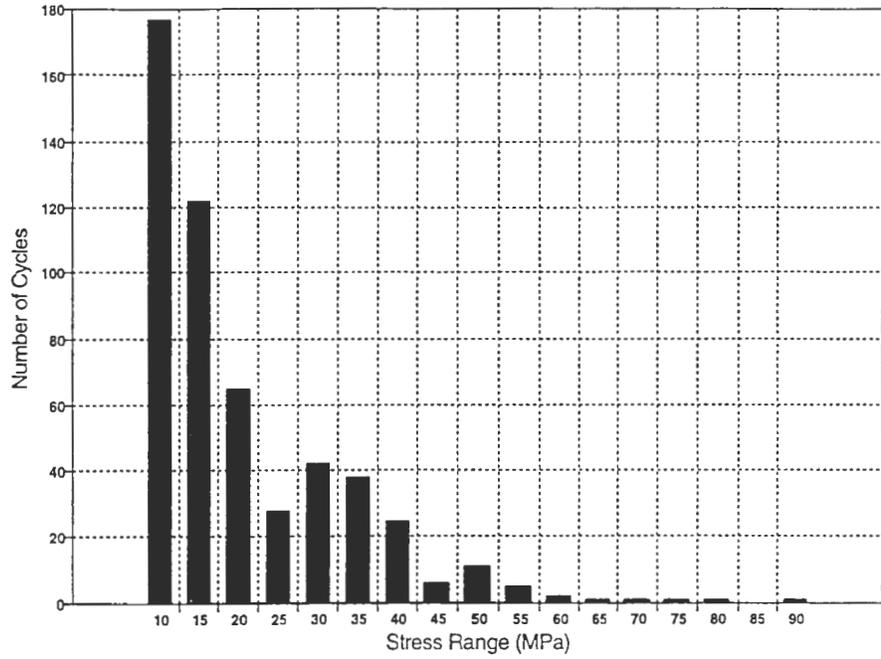
FIGURE 13 Stress range histogram for Gauge 4 on Tie Plate FB2-0E.

The stress range spectra for Gauges 4 and 8 on the east side near Pier 2 are shown in Figures 13 and 14. These plots show the skewed distribution characteristics of the truck gross vehicle weight distribution. Between 526 and 689 stress cycles greater than 10 MPa (1.5 ksi) were observed at these gauges during the 3 hr 20 min of record at Pier 2. None of the stress cycles at Pier 1 was high enough to warrant developing a stress range spectra, as the maximum stress range was 23 MPa (3.4 ksi).

The stress range data summarized in Figures 13 and

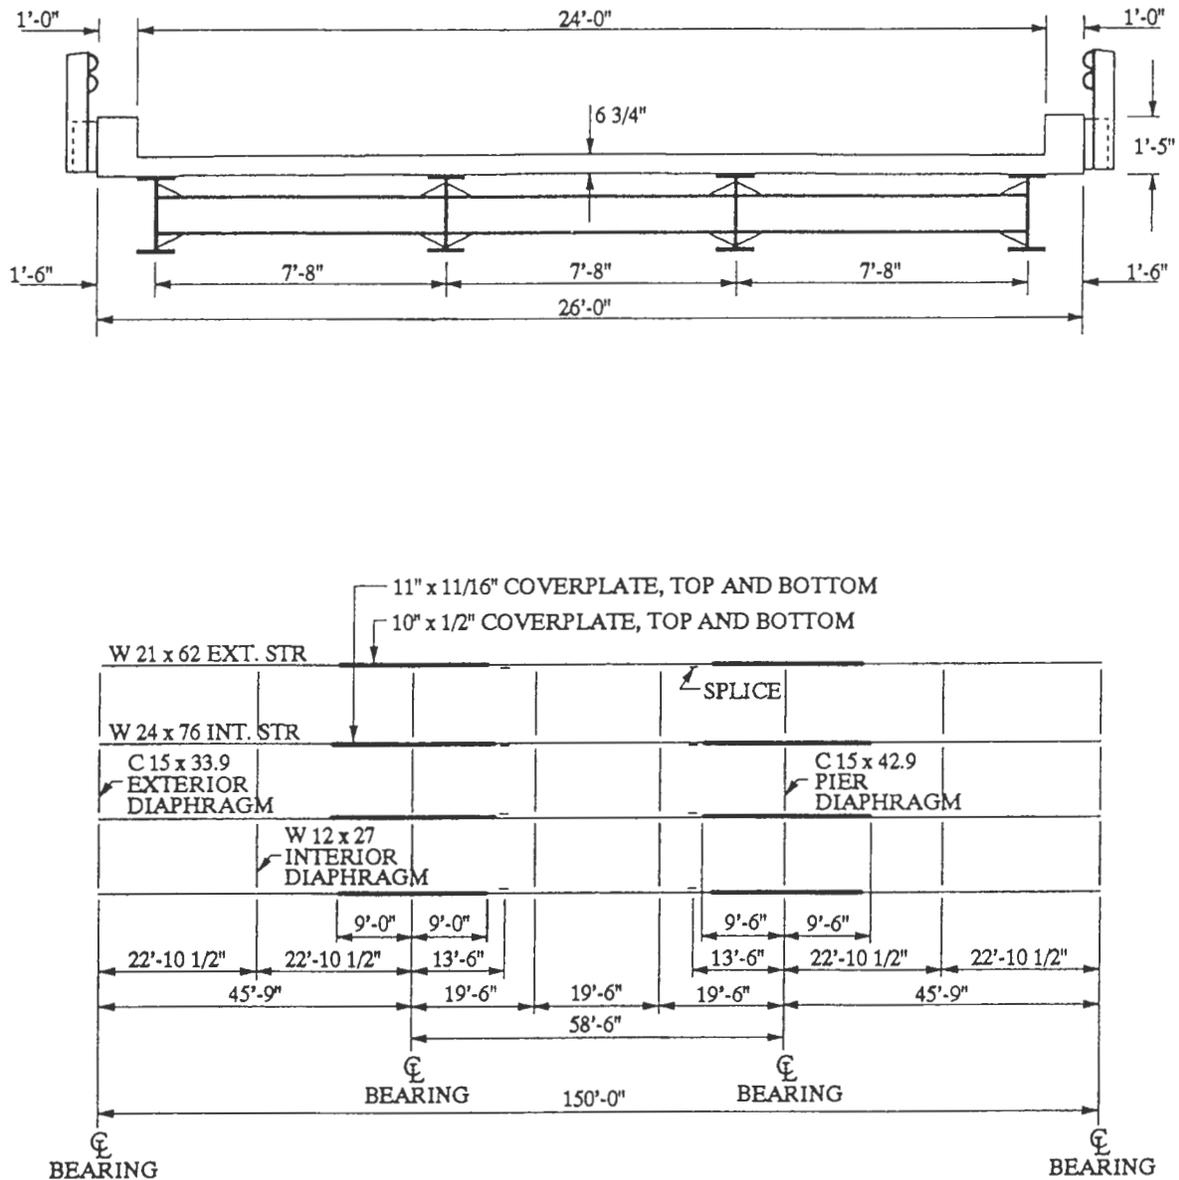
FIGURE 1 Cross section (*top*) and framing plan (*bottom*) of Bridges 1 and 2 (1 ft = 0.305 m).

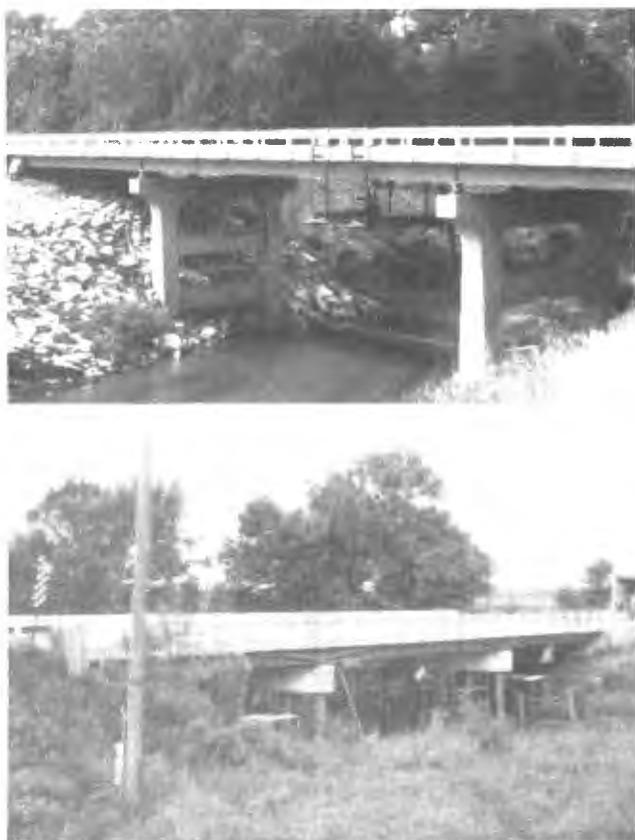
FIGURE 3 Photographs of strengthened bridges: *top*, Bridge 1; *bottom*, Bridge 2.

As previously noted, it was necessary to apply the strengthening forces to the two bridges in stages: six stages for Bridge 1, and eight stages for Bridge 2. Except for one location, forces slightly larger than theoretically required were applied to Bridge 1. In Bridge 2, the applied truss post-tensioning forces and a few of the applied beam post-tensioning forces were slightly less than the theoretical values. The effect of one post-tensioning stage on the post-tensioning forces in beams that had been post-tensioned previously was apparent in both bridges. This effect is more significant on beams in the same span and on beams in adjacent spans that are in line with those being post-tensioned. The greatest loss

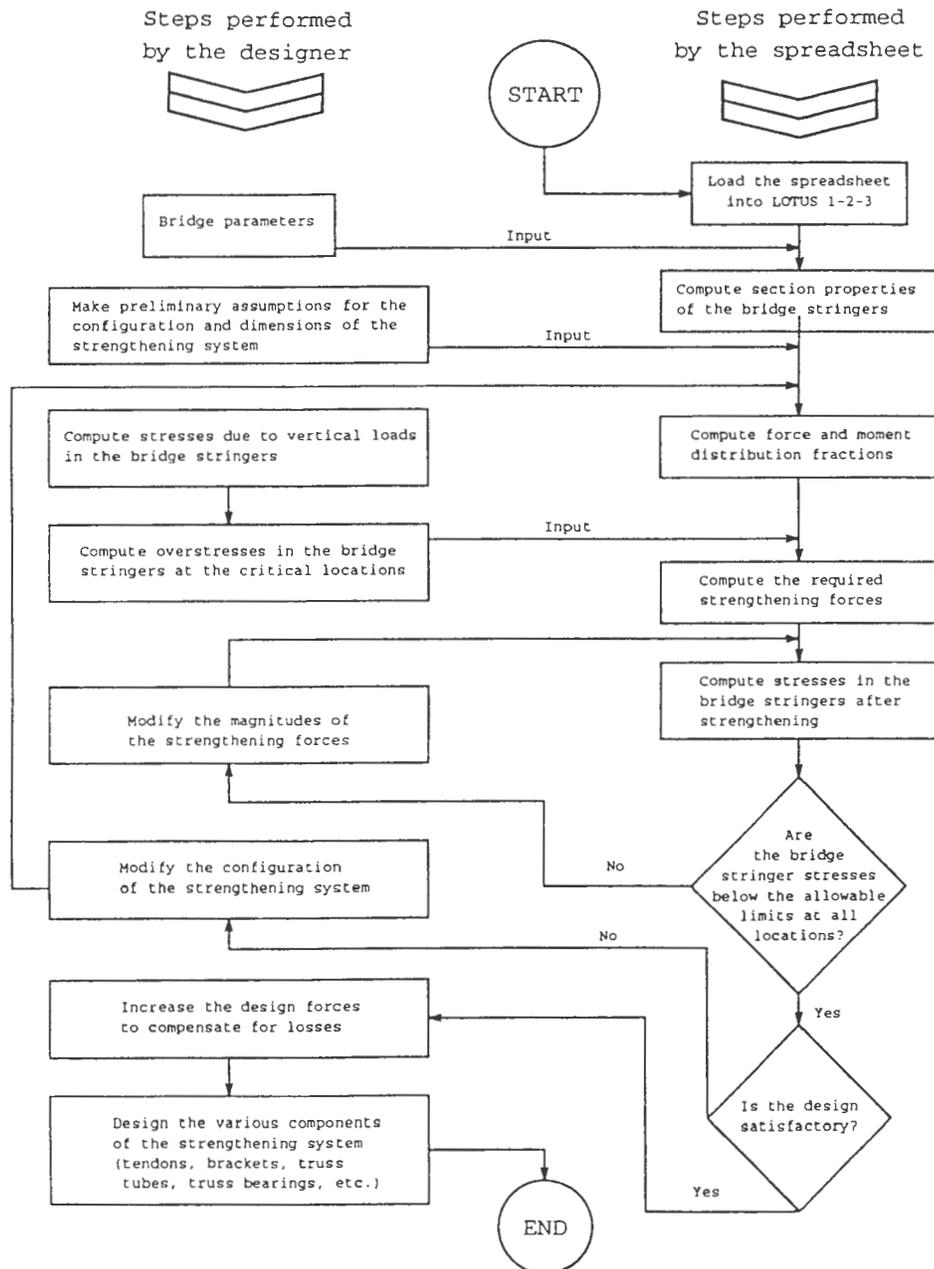
FIGURE 9 Design procedure for strengthening system.

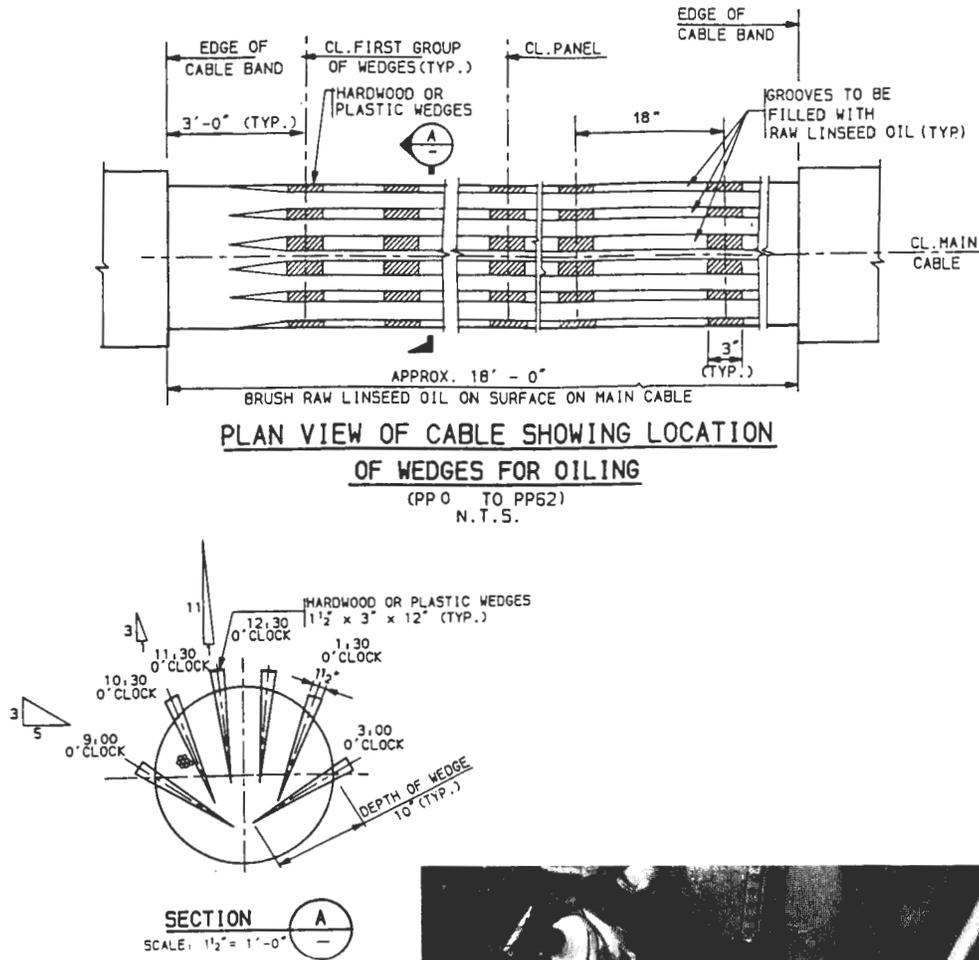
FIGURE 1 Typical main cable wedging arrangement.

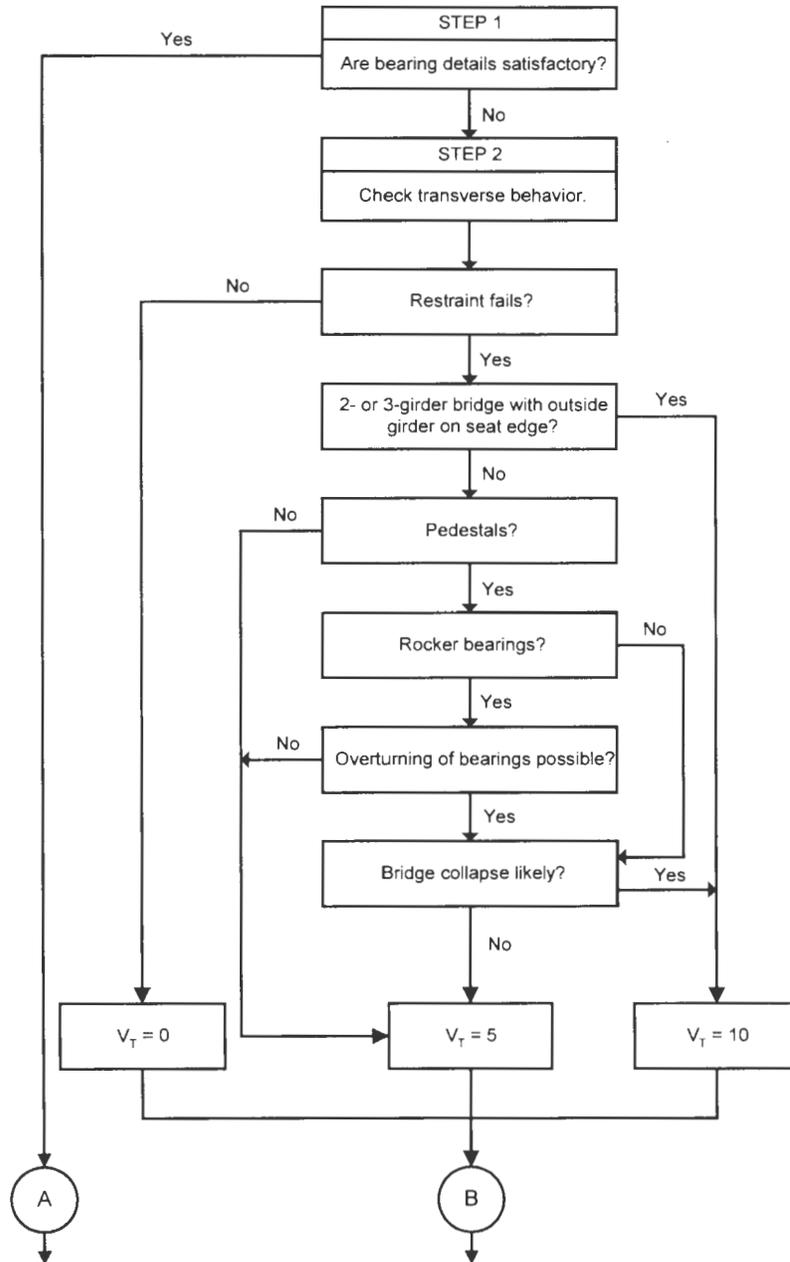
FIGURE 4 Procedure for calculating vulnerability rating for connections, bearings, and seat widths, V_T ; L = actual seat width and N = seat width required by AASHTO (5,7) (continued on next page).

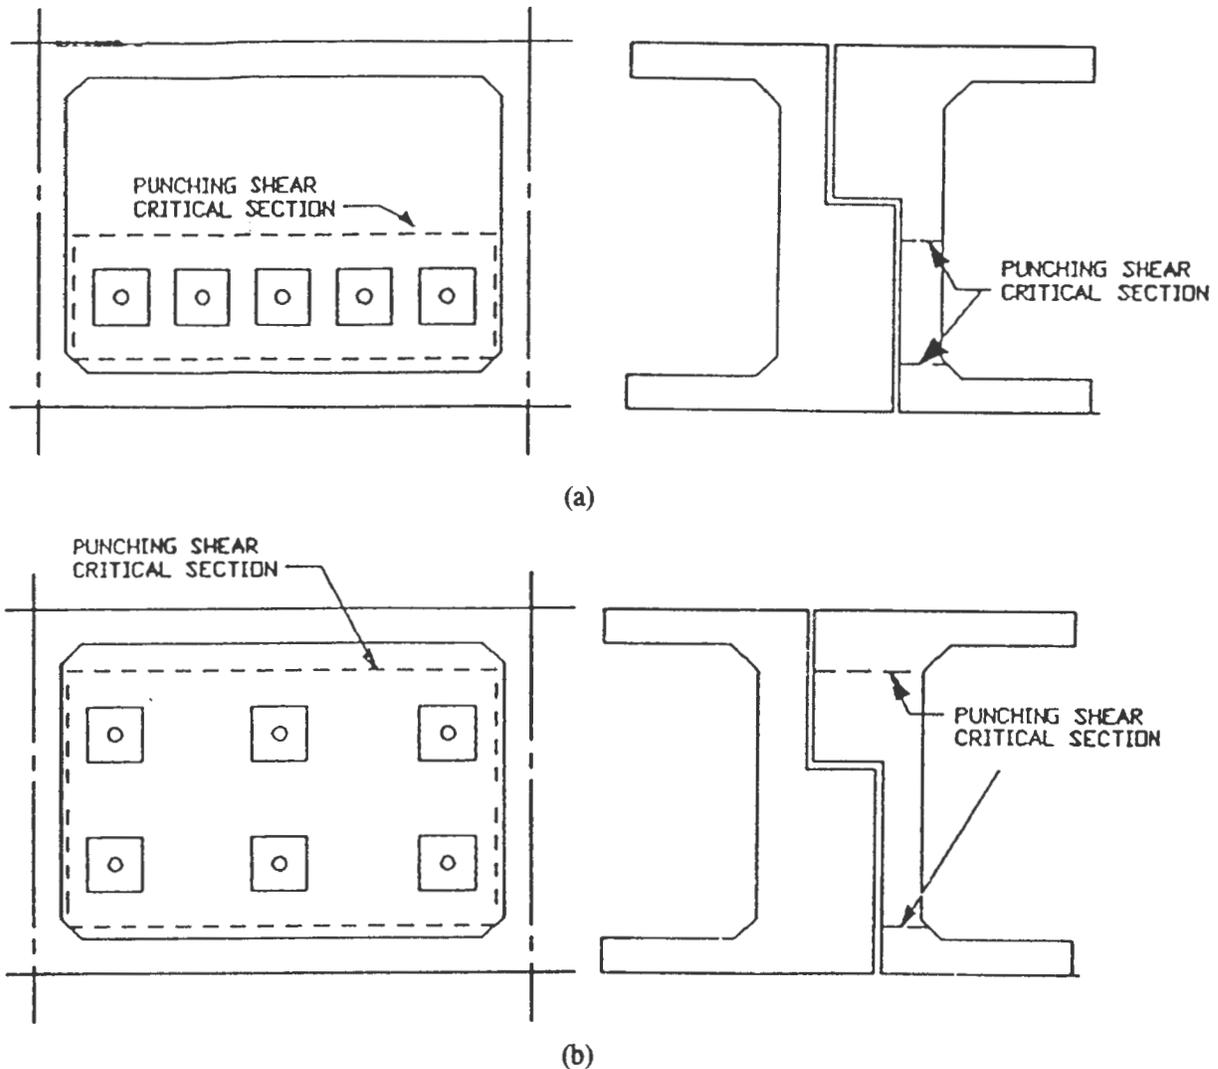
FIGURE 4 Punching shear failure lines for (a) one row of restrainers and (b) two rows of restrainers.

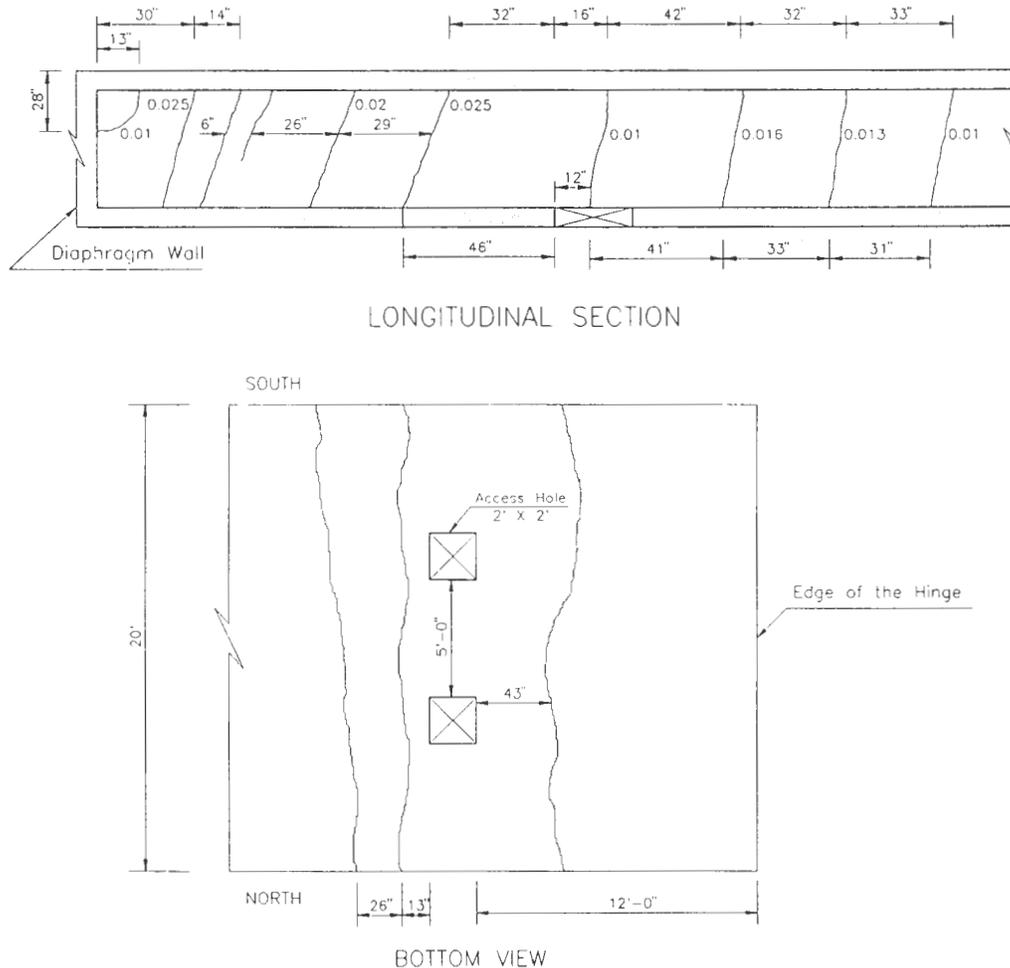
FIGURE 5 Girder and bottom slab cracks in the 92/101 Separation structure (1 ft = 0.305 m; 1 in. = 25.4 mm).

The northeast connector in the 92/101 Separation structure was investigated because of excessive crack openings in the soffit of the superstructure that were noted after all of the earthquake damage had been repaired. The superstructure is a cast-in-place, four-cell box section supported on single-column piers of various heights. The hinges are equipped with eight sets of five 17-mm ($\frac{3}{4}$ -in.) straight cable restrainers placed in all of the cells. The Caltrans Maintenance Division records indicate that the structures at the interchange suffered significant damage during the earthquake. The damage ranged from spalling of superstructure concrete near several joints to excessive hinge movements. Figure 5 shows a sample of the crack patterns. The crack widths are marked in inches. Note that the cracks were nearly

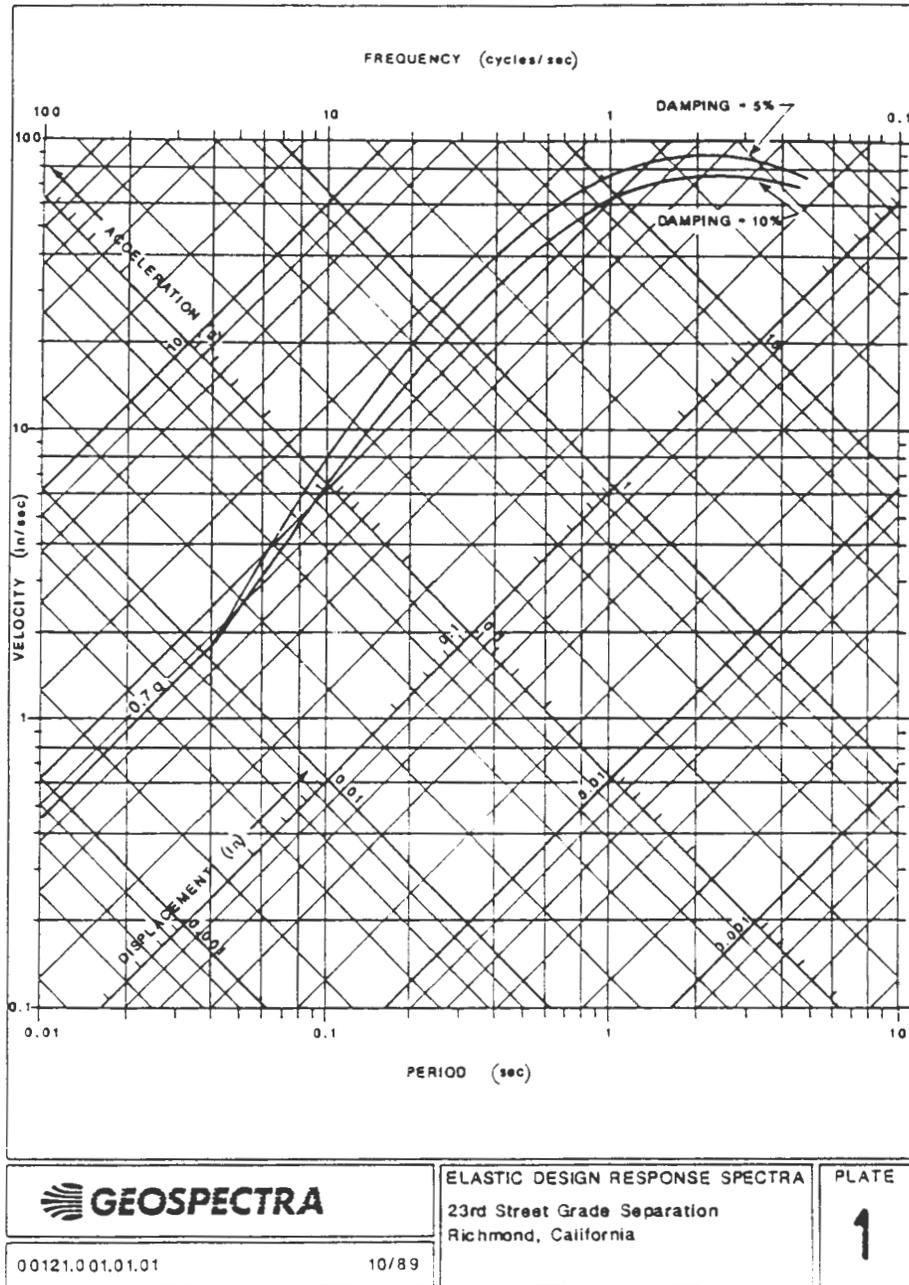
FIGURE 2 Response spectra (continued on next page).

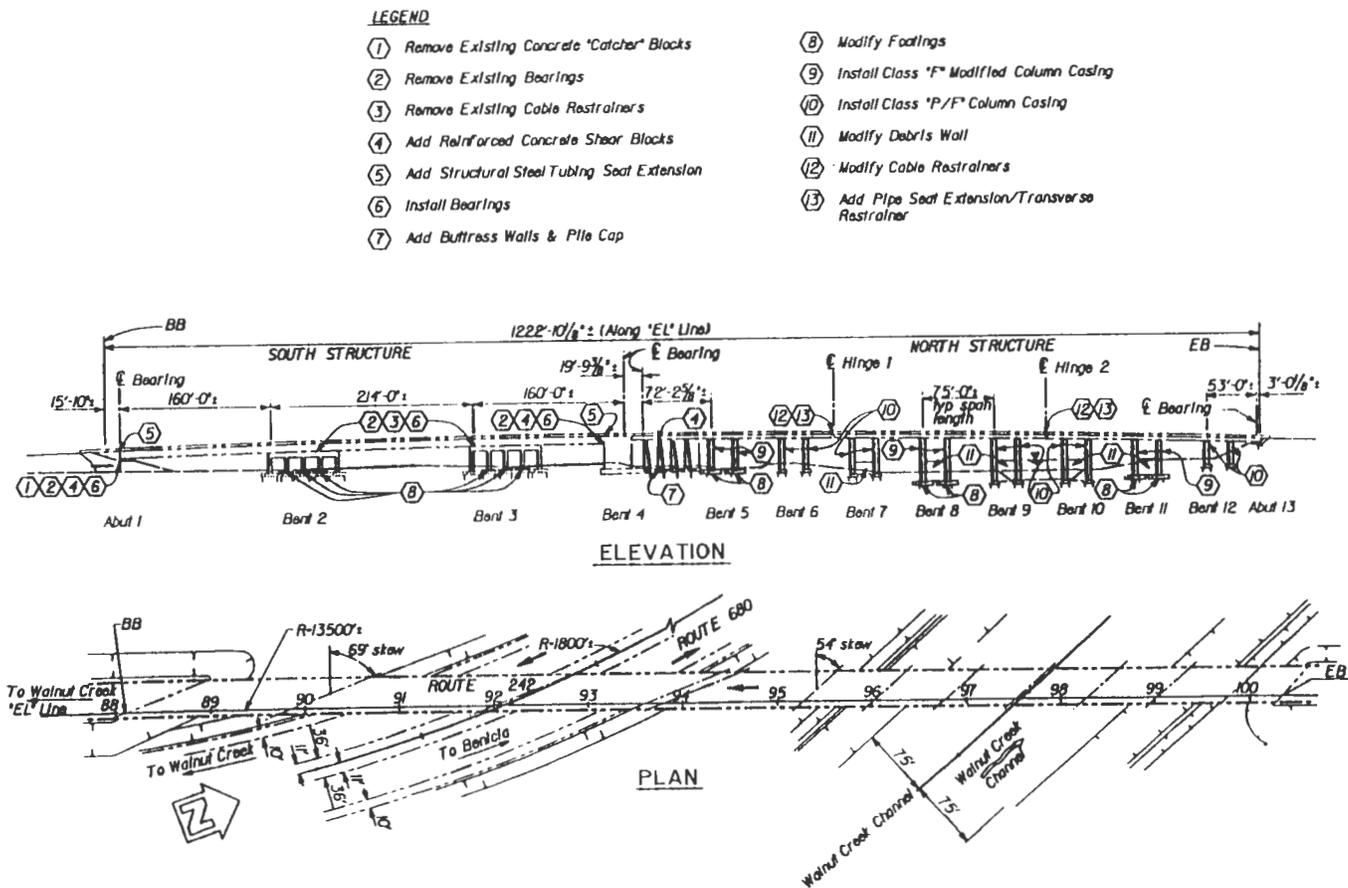
FIGURE 1 Elevation and plan of south and north structures.

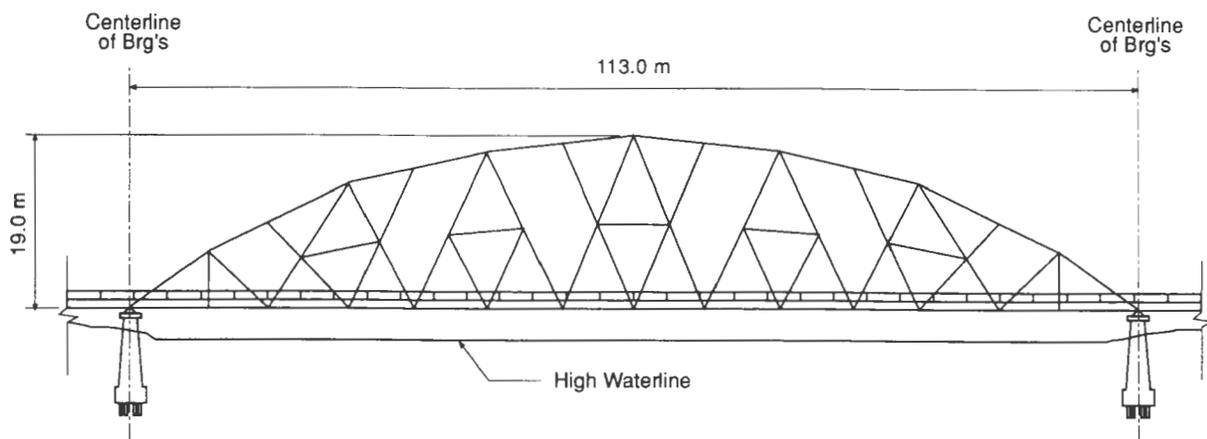
FIGURE 1 Case Study 1: elevation, Puyallup River Bridge.

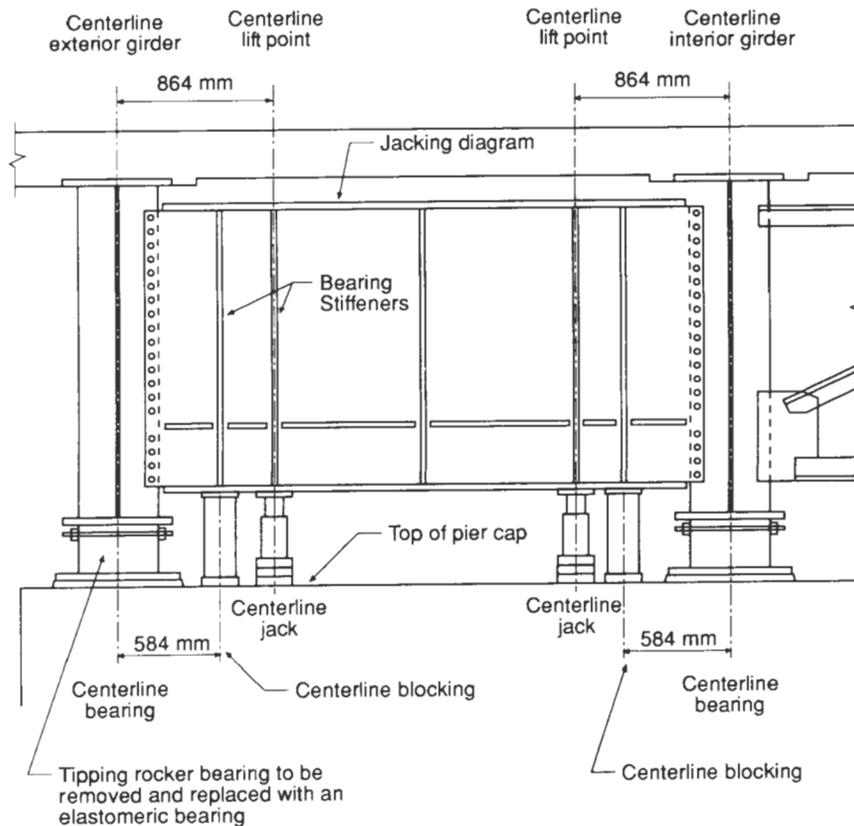
FIGURE 6 Case Study 3: jacking details, Kalama River Road Overcrossing.

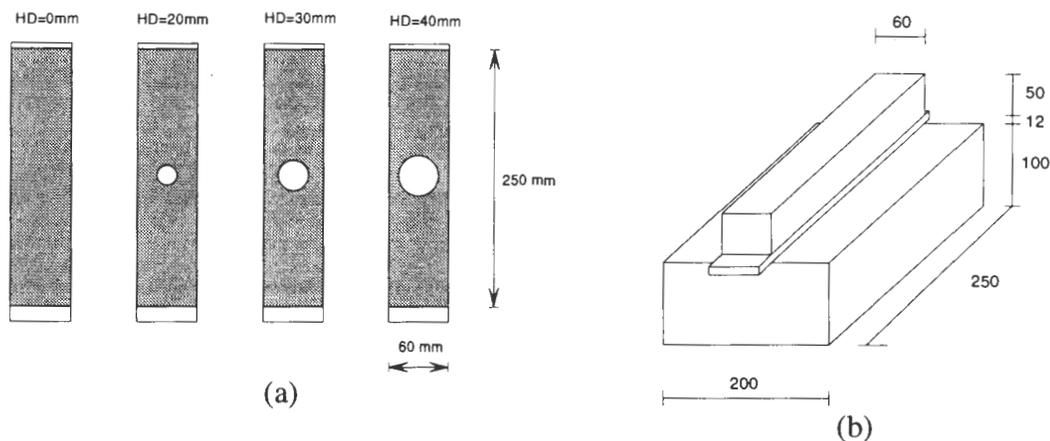
FIGURE 8 (a) Steel plates with varying hole diameters; (b) sample use in shear box investigation.

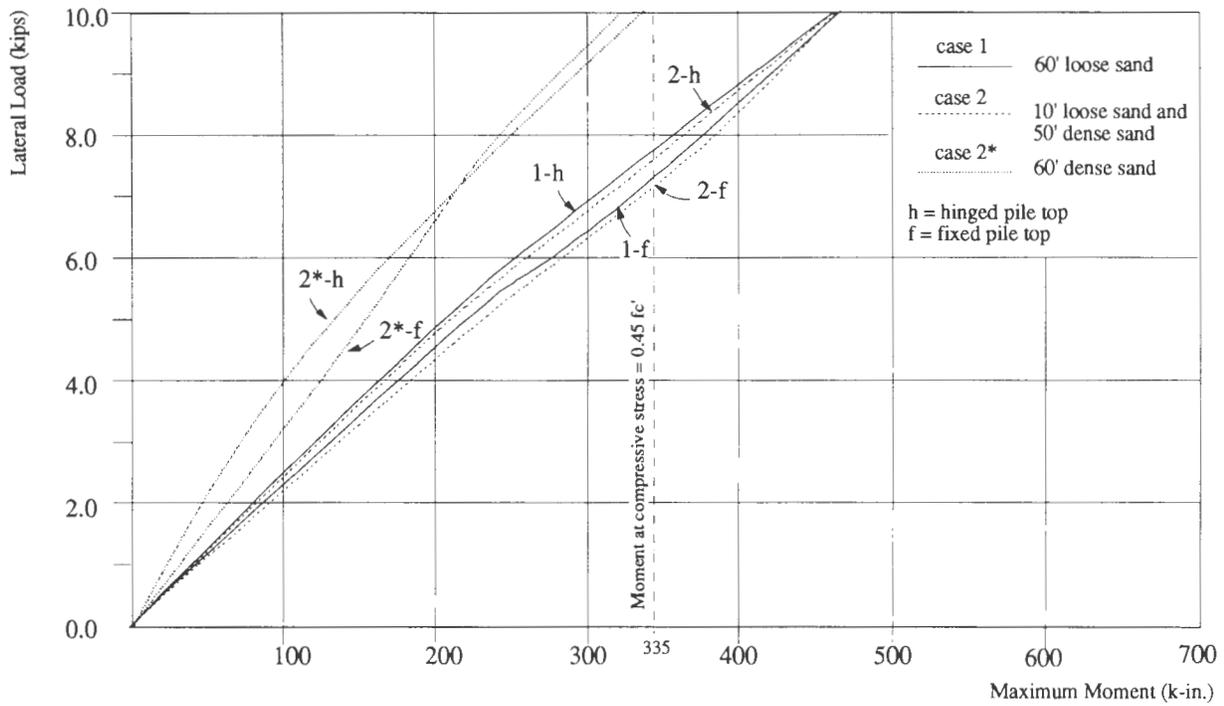
FIGURE 7 Horizontal force versus maximum bending moment for 12-in. concrete pile in sand.

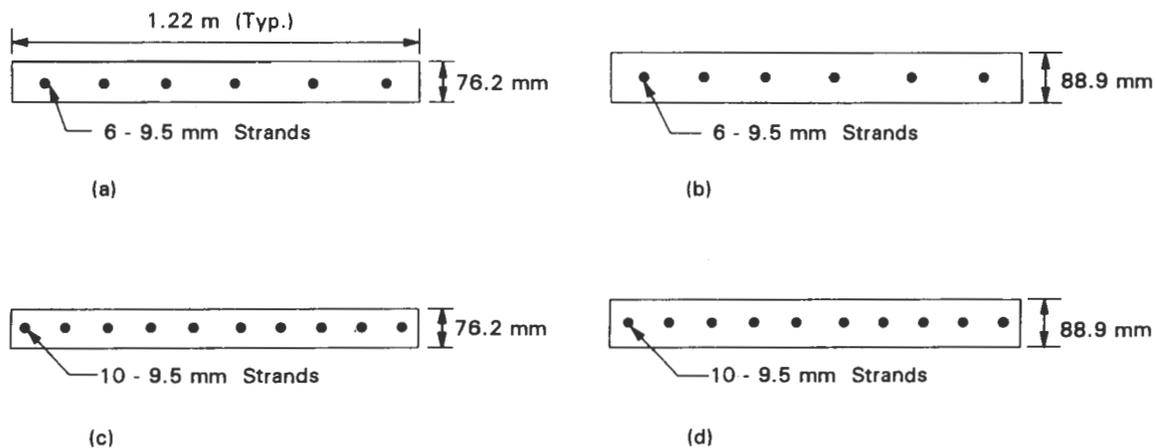
FIGURE 2 Deck panels (a) Type A; (b) Type B; (c) Type C; and (d) Type D. (1 m = 3.28 ft; 1 mm = 0.039 in.)

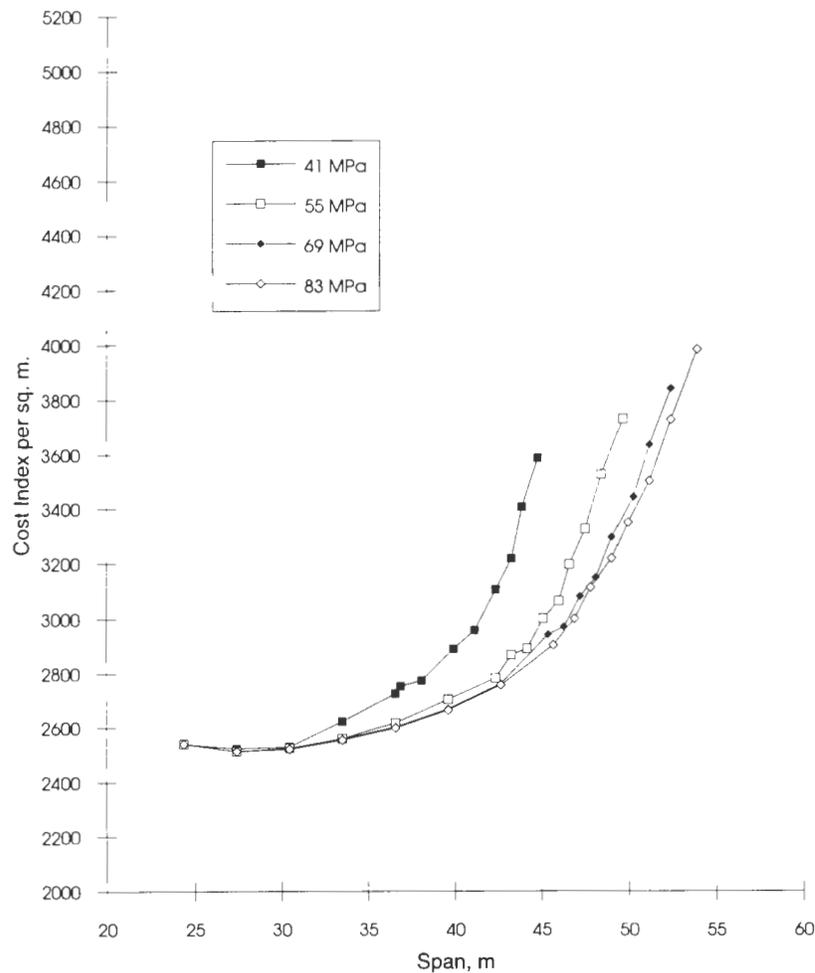
FIGURE 3 Optimum cost curves for a BT-72.

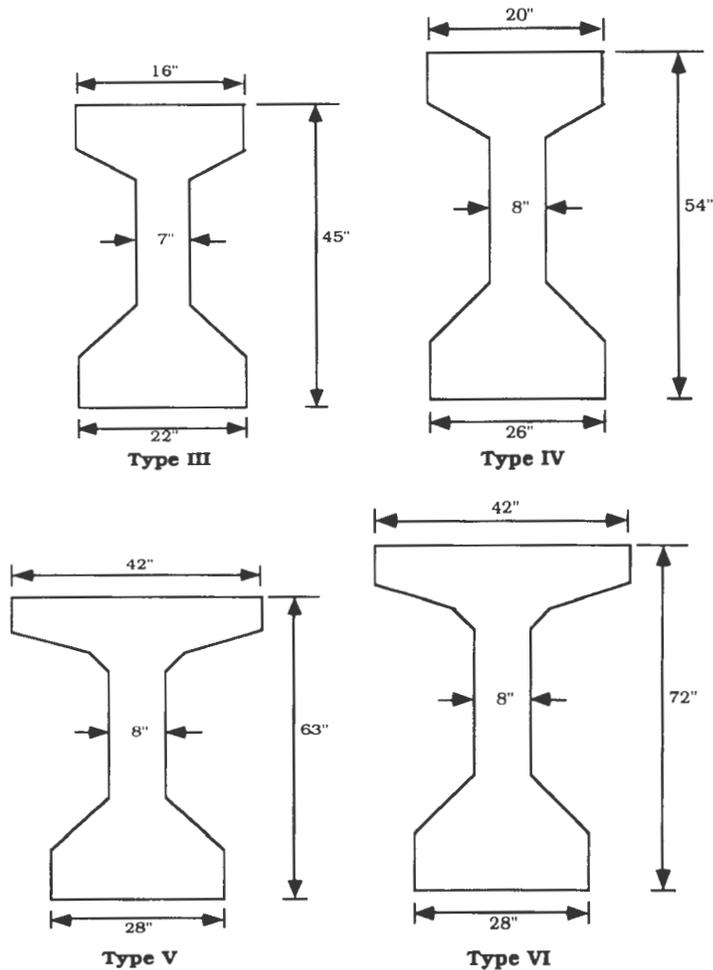
FIGURE 1 AASHTO girders Types III through VI. All dimensions are in inches (1 in. = 25 mm).

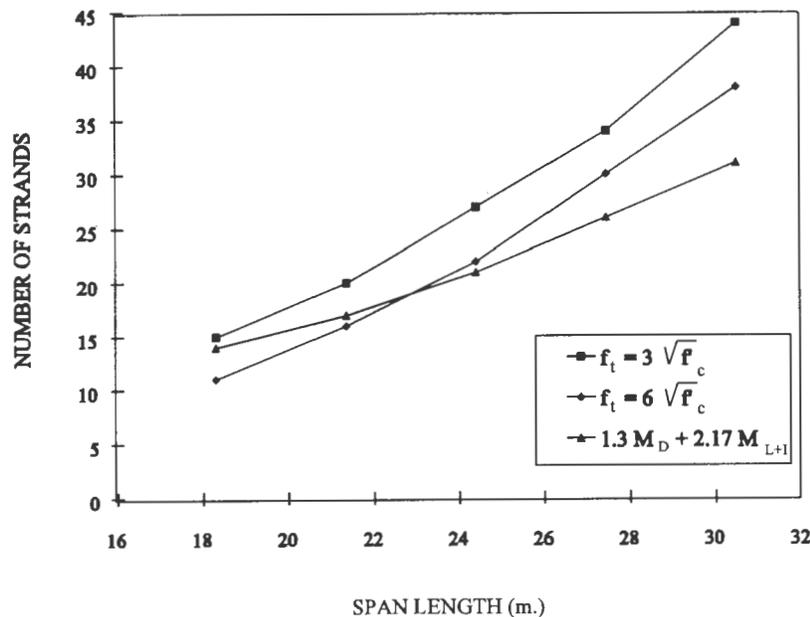
FIGURE 1 Number of strands versus simple span length for 28/63 P/S concrete I-girder.

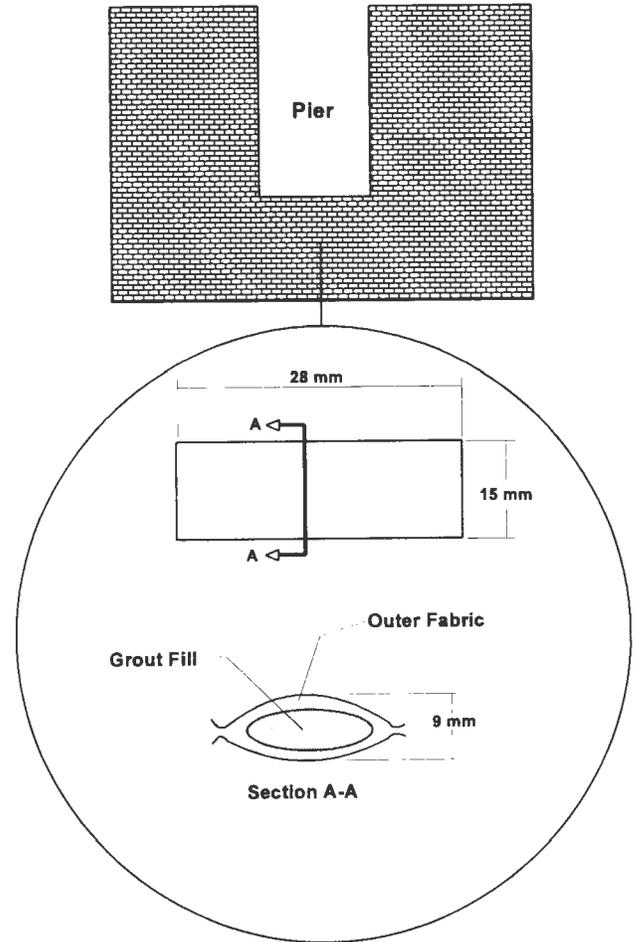
FIGURE 1 Grout mat plan view (*top*) and individual element detail (*bottom*).

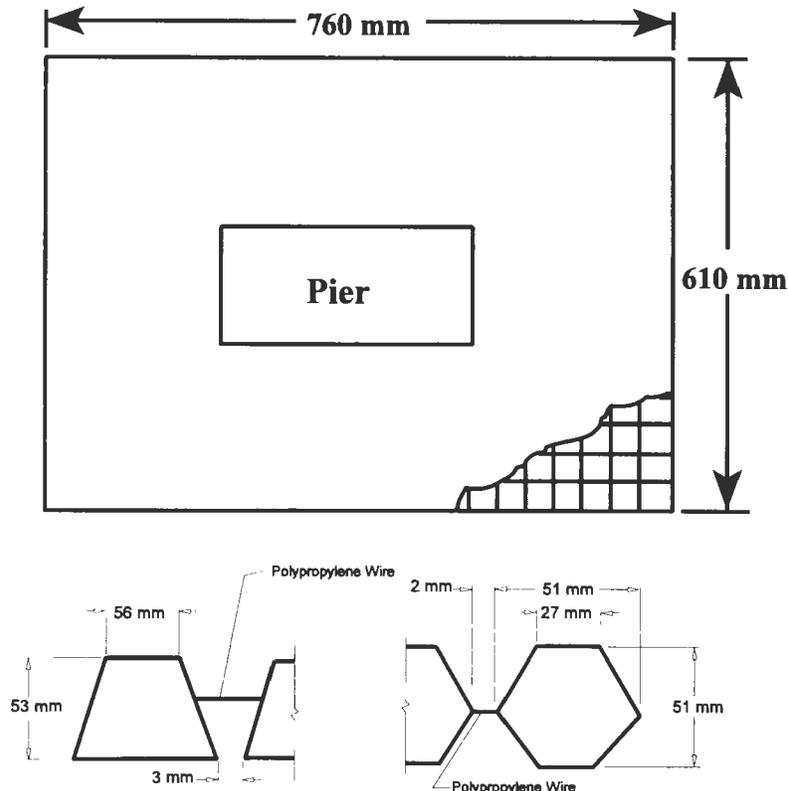
FIGURE 4 Cable-tied block plan view (*top*) and individual detail (*bottom*) for (*left*) trapezoidal and (*right*) hexagonal blocks.
