CONFERENCE PROCEEDINGS 7

Fourth International Bridge Engineering Conference

Volume 2

TRANSPORTATION
RESEARCH
BOARD

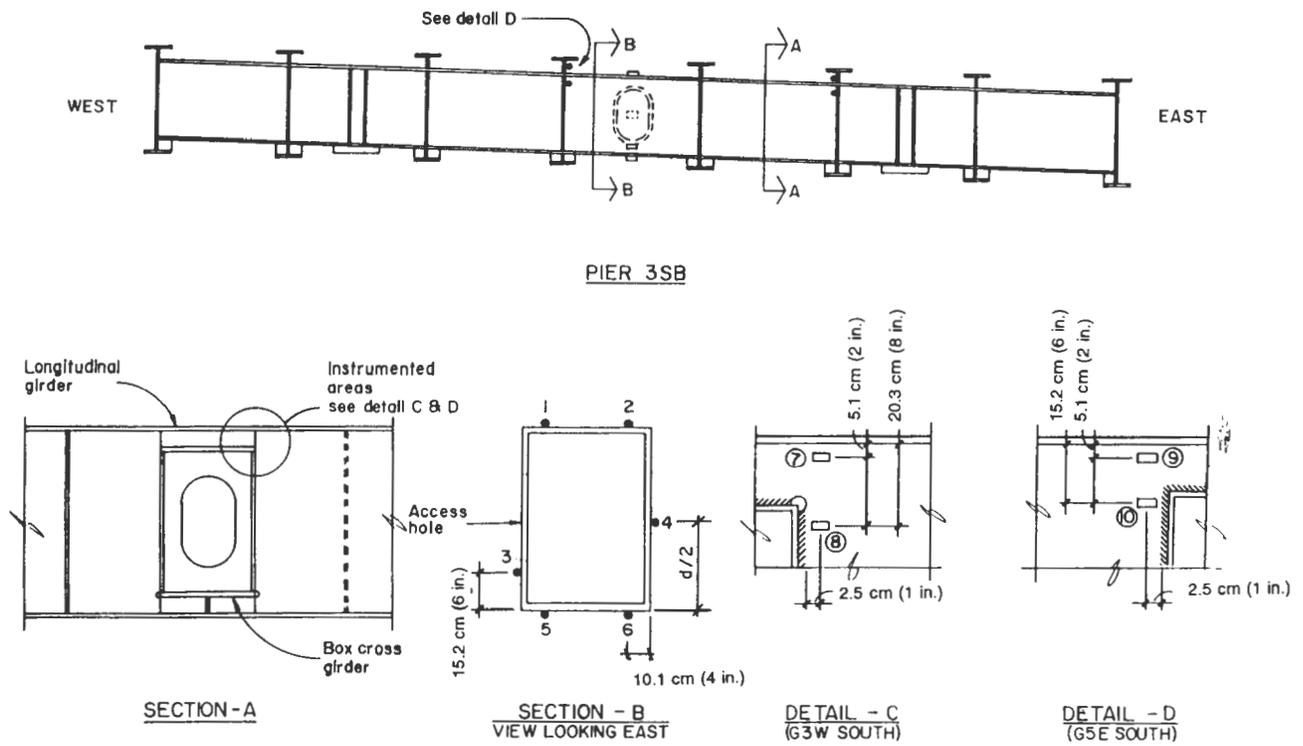
FIGURE 8 Strain gauge layout on cross-girder at southbound Pier 3.

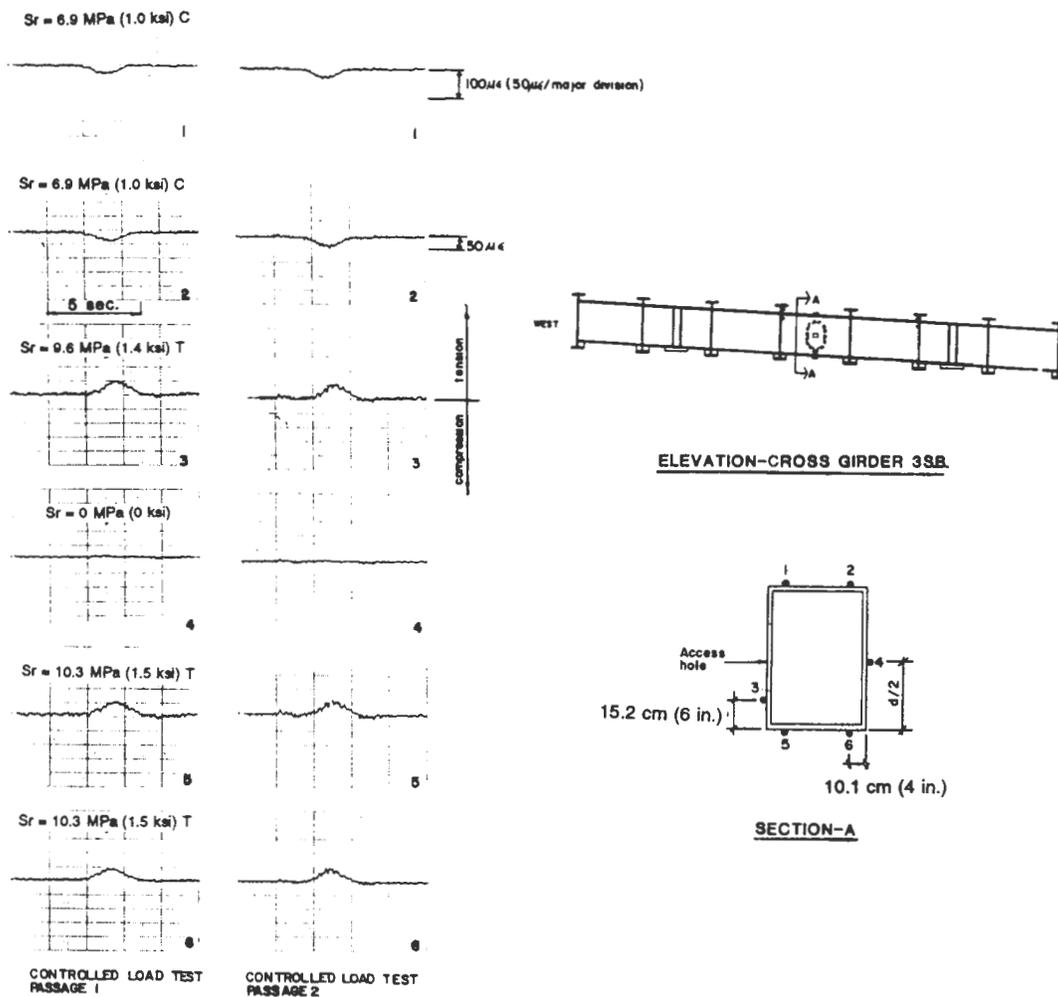
FIGURE 10 Representative strain response for cross-girder at southbound Pier 3.

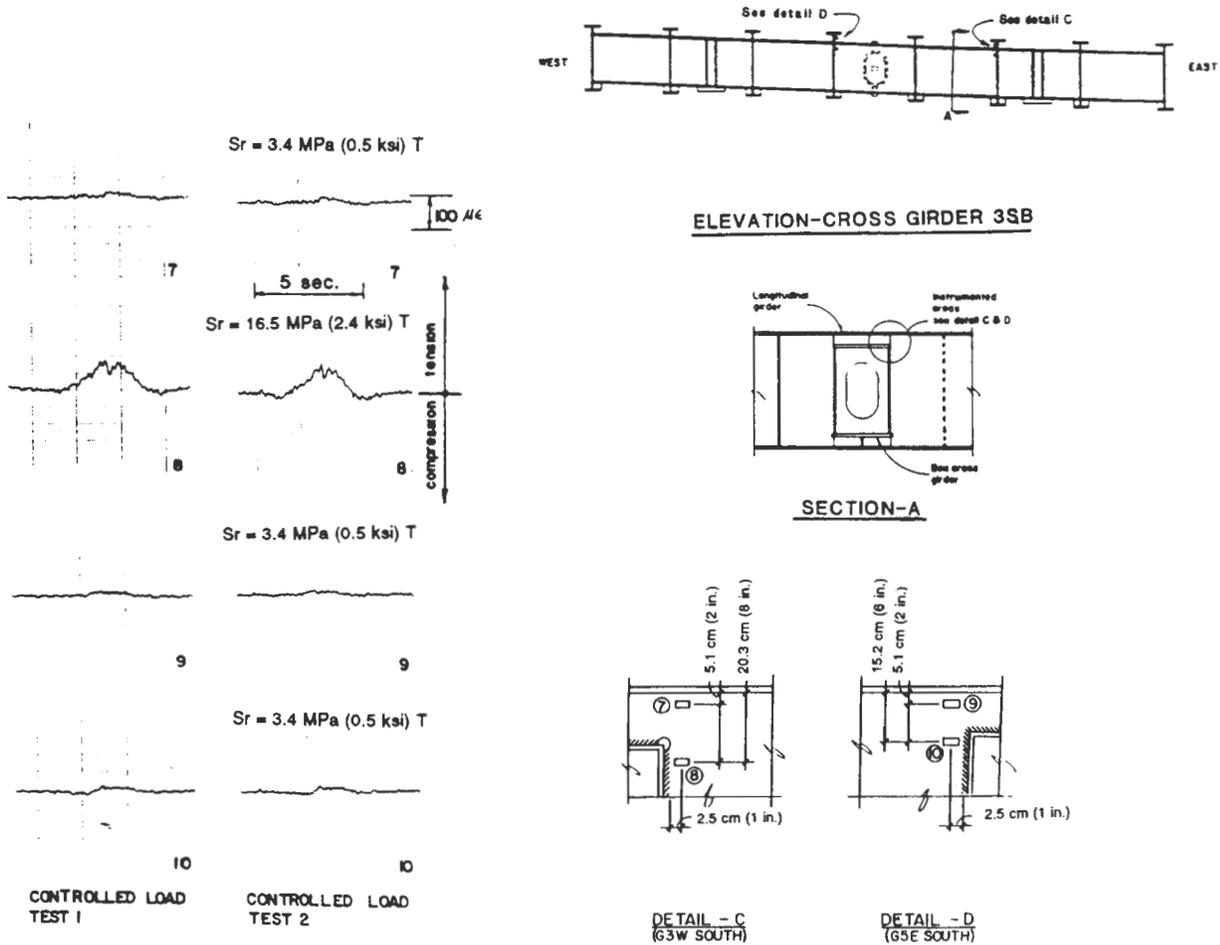
FIGURE 11 Representative strain response adjacent cracked girder to cross-girder connections.

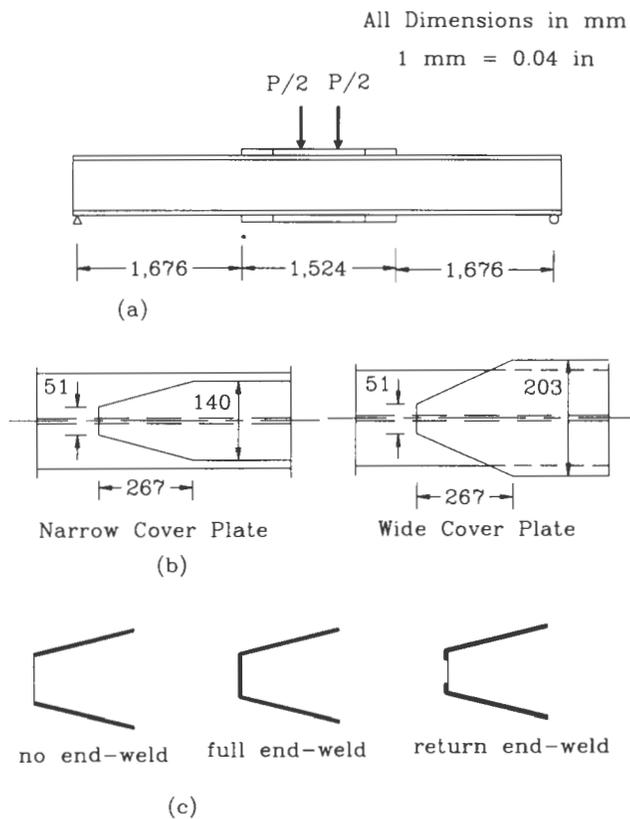
FIGURE 1 Specimen dimensions and cover plate details: (a) specimen configuration and dimensions; (b) cover plate end details; (c) end weld conditions.

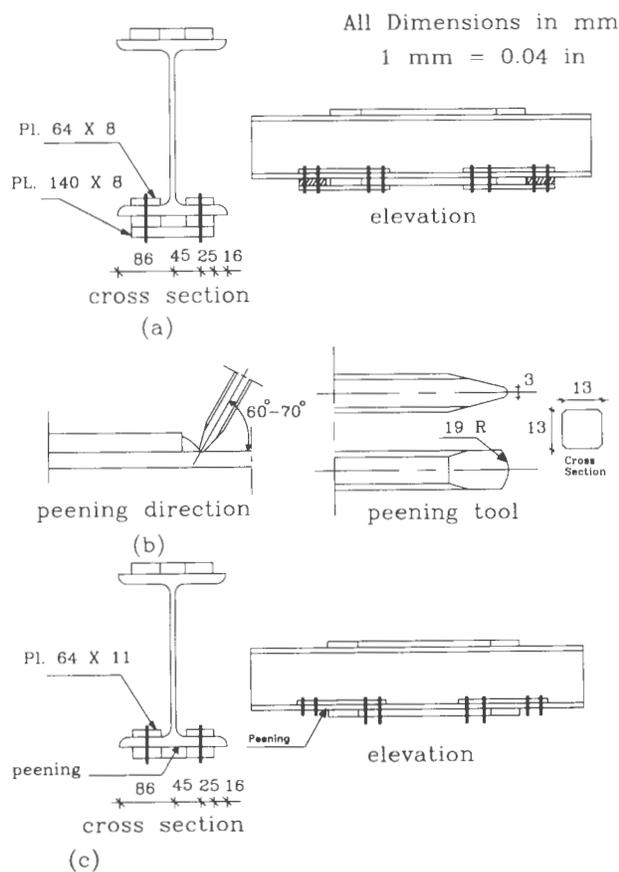
FIGURE 2 Repair methods for cover plate end welds: (a) bolted splice connection; (b) air-hammer peening; (c) partial bolted splice connection.

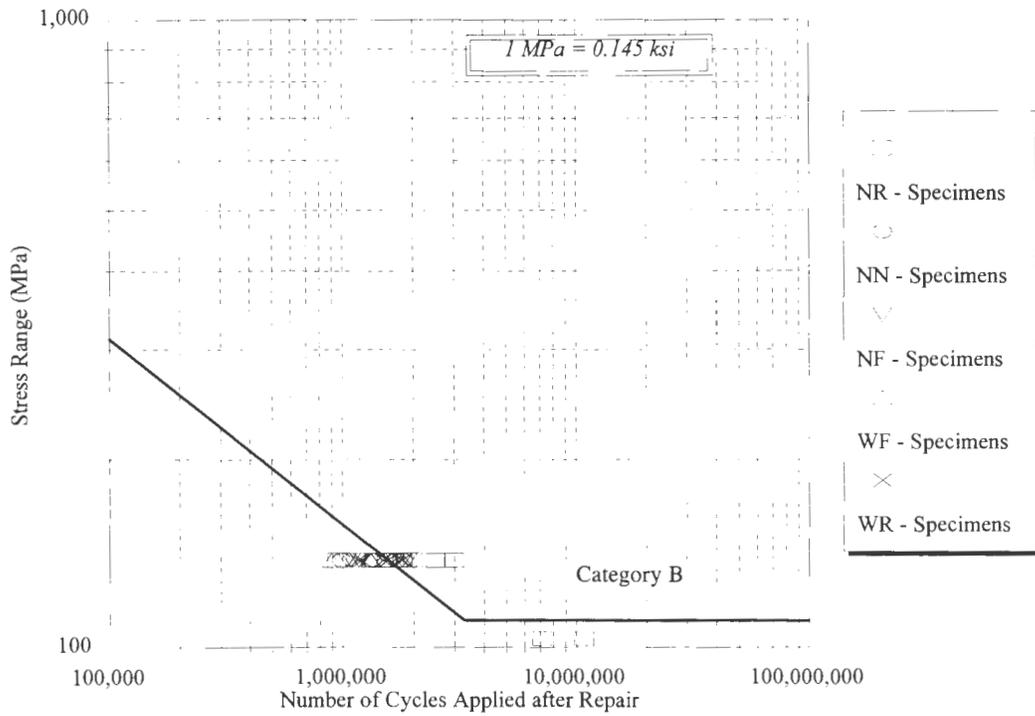
FIGURE 3 Stress range versus number of cycles applied after repair (bolted splice beams).

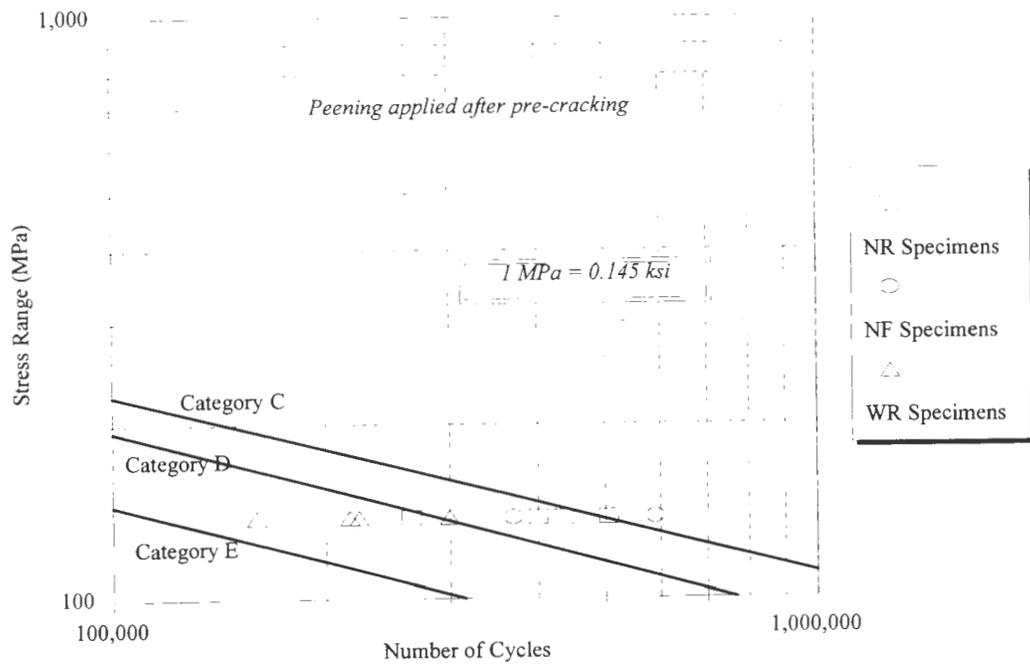
FIGURE 7 Stress range versus number of cycles applied after peening (precracked peening beams).

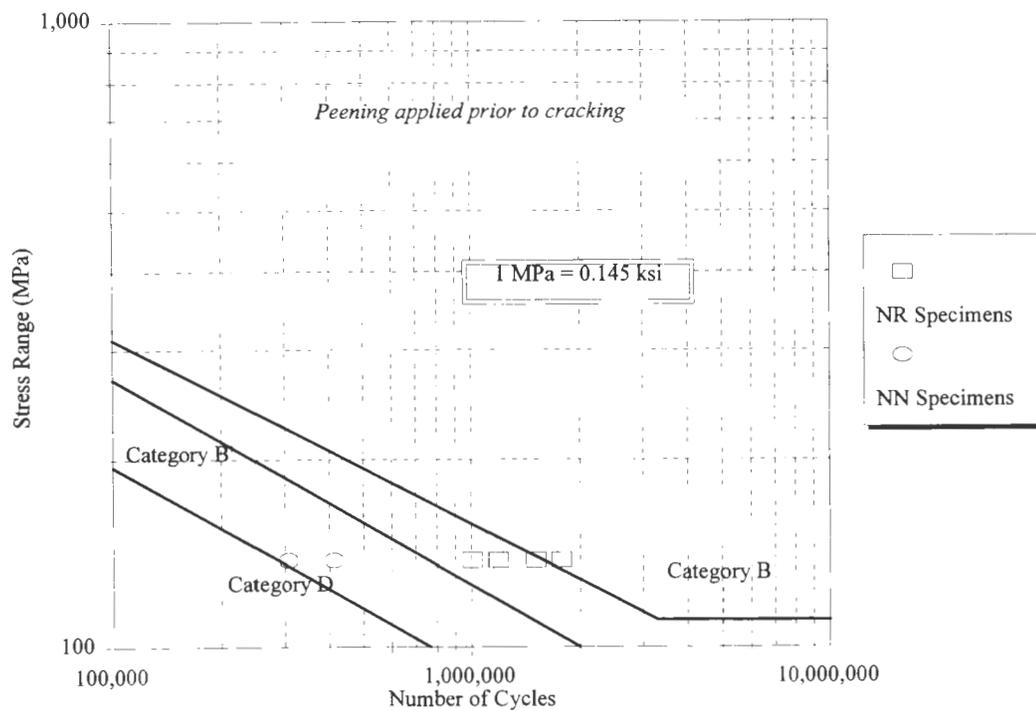
FIGURE 8 Stress range versus number of cycles applied after peening (noncracked peening beams).

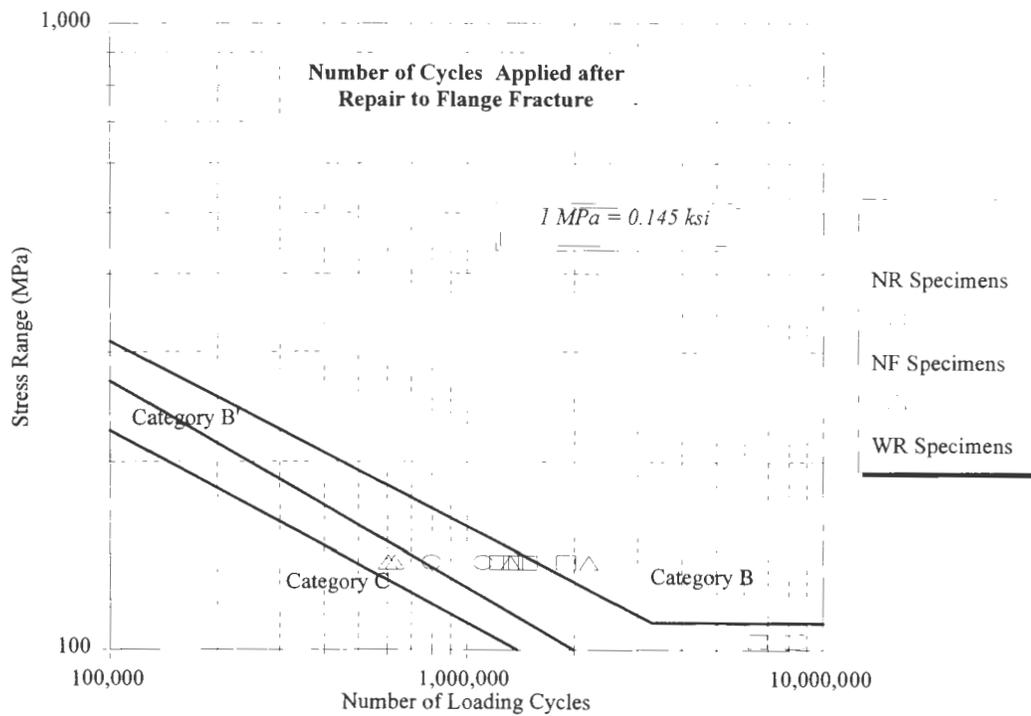
FIGURE 10 Stress range versus number of loading cycles (partial bolted splice beams).

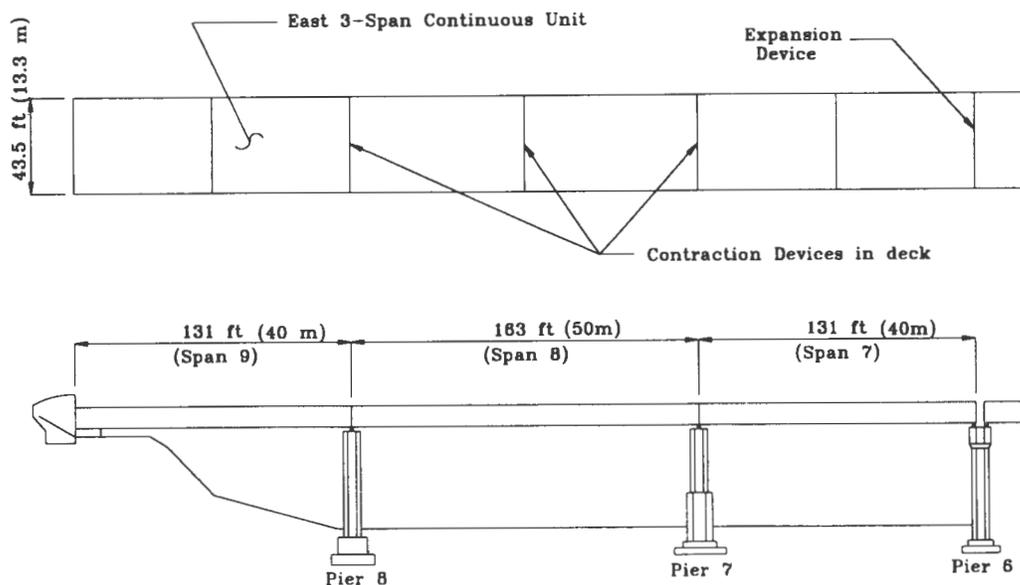
FIGURE 1 Overall plan and elevation of east three-span continuous unit of eastbound I-40 bridge.

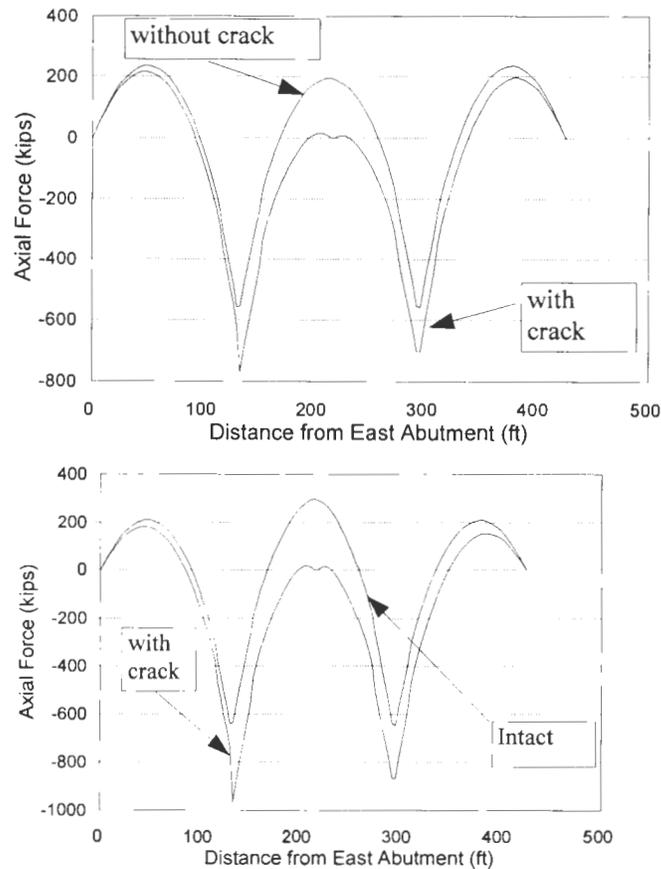
FIGURE 5 *Top:* North girder bottom flange forces; *bottom:* north girder bottom flange forces under dead load plus two HS-20 truck loadings, no impact (1 kip = 4.45 kN, 1 ft = 0.305 m).

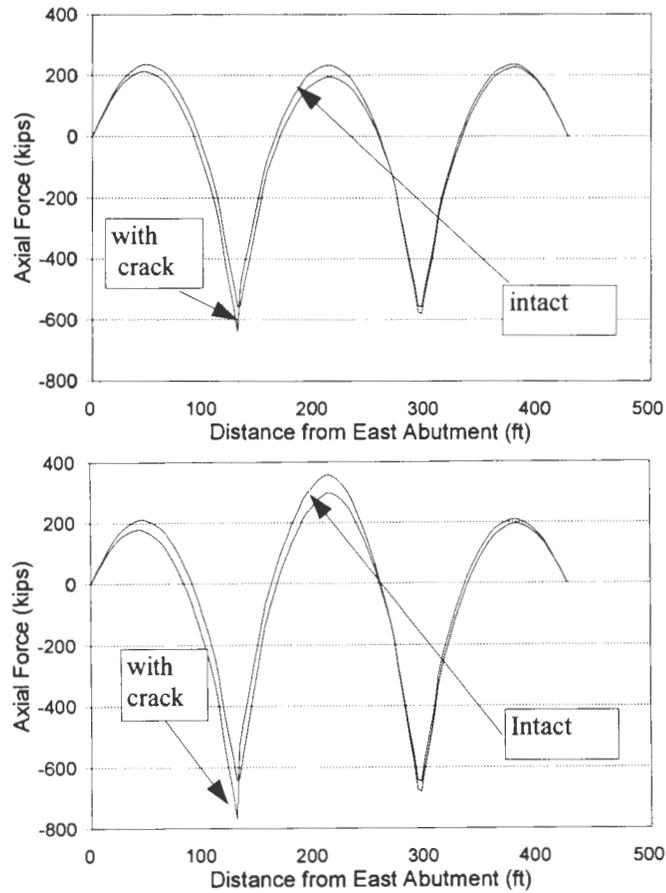
FIGURE 6 *Top*: south girder bottom flange forces under dead load; *bottom*: south girder bottom flange forces under dead load plus two HS-20 truck loadings, no impact (1 kip = 4.45 kN, 1 ft = 0.305 m).

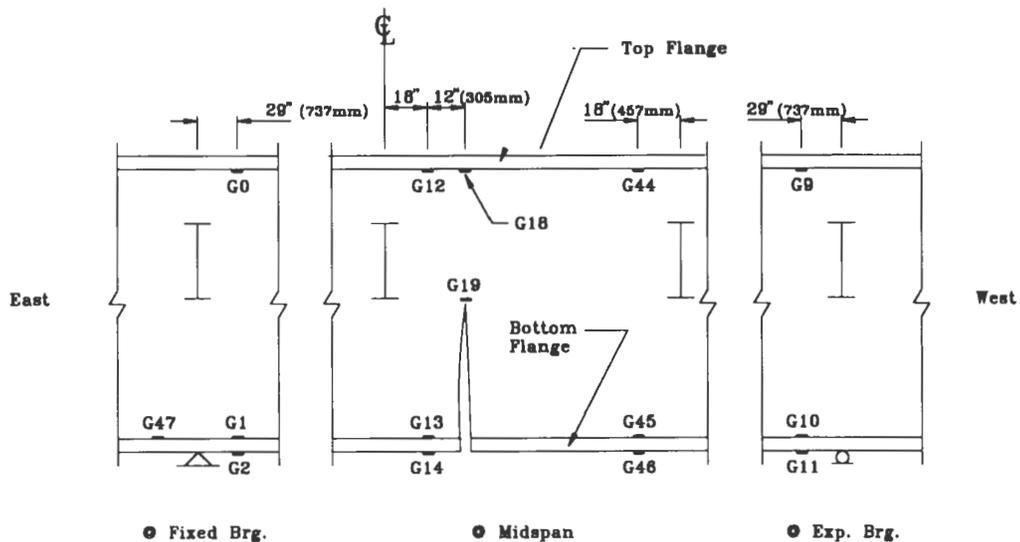
FIGURE 7 Positioning of strain gauges on north (damaged) girder (view from inside looking out).

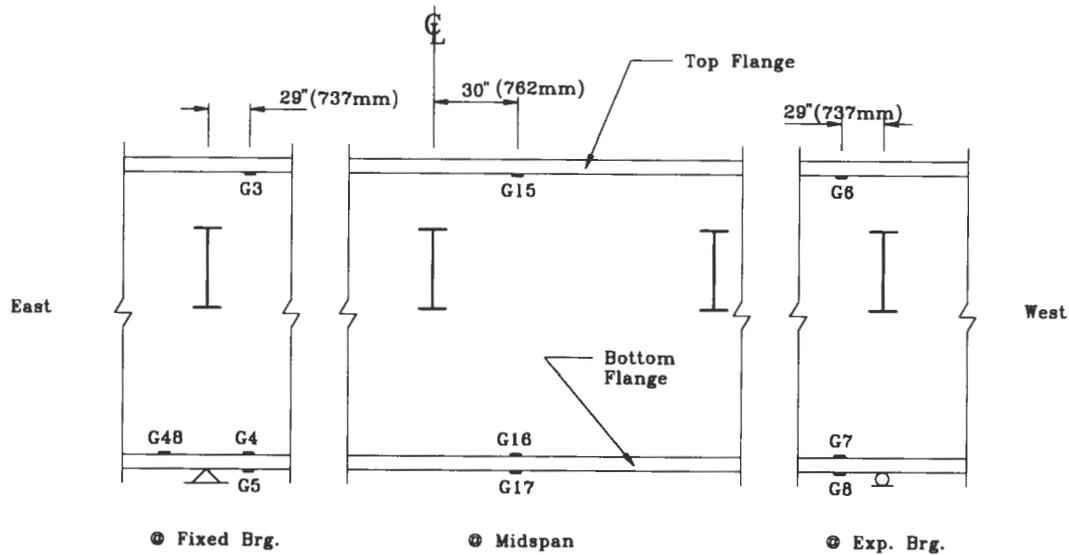
FIGURE 8 Positioning of strain gauges on south (intact) girder (view from inside).

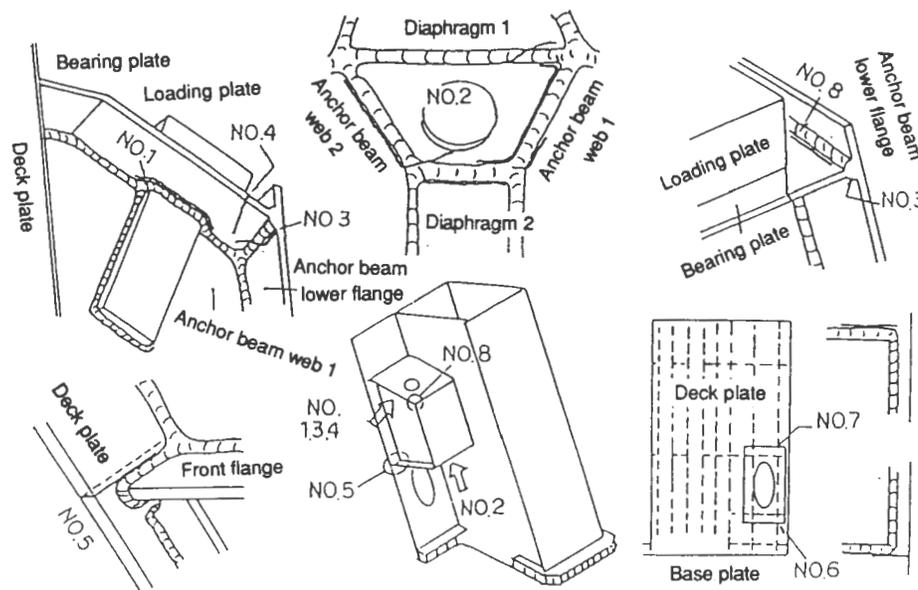
FIGURE 5 Location of cracks in beam-type anchorage.

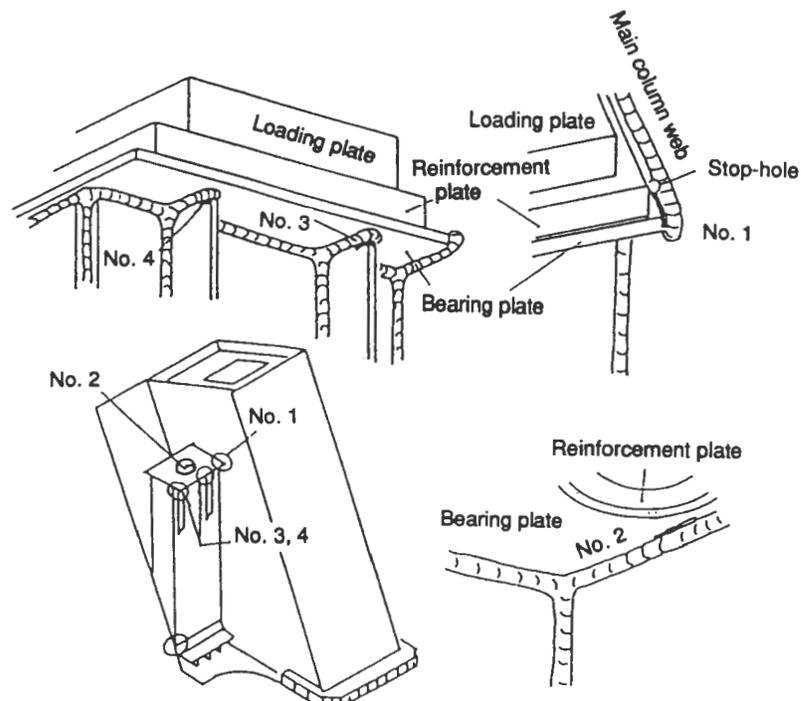
FIGURE 6 Location of cracks in column-type anchorage.

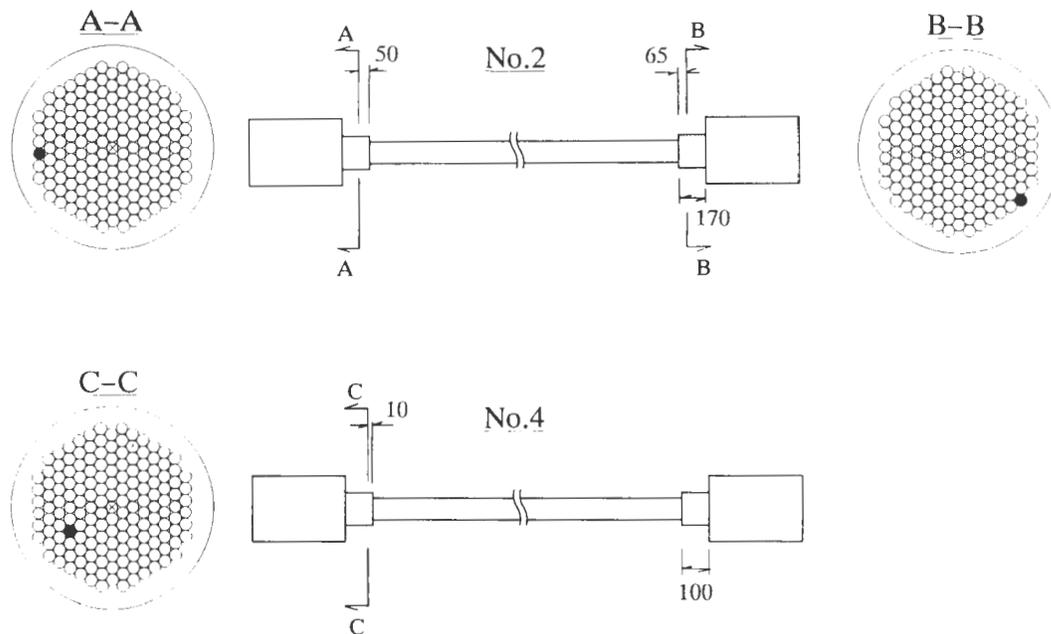
FIGURE 13 Location of wire breakage.

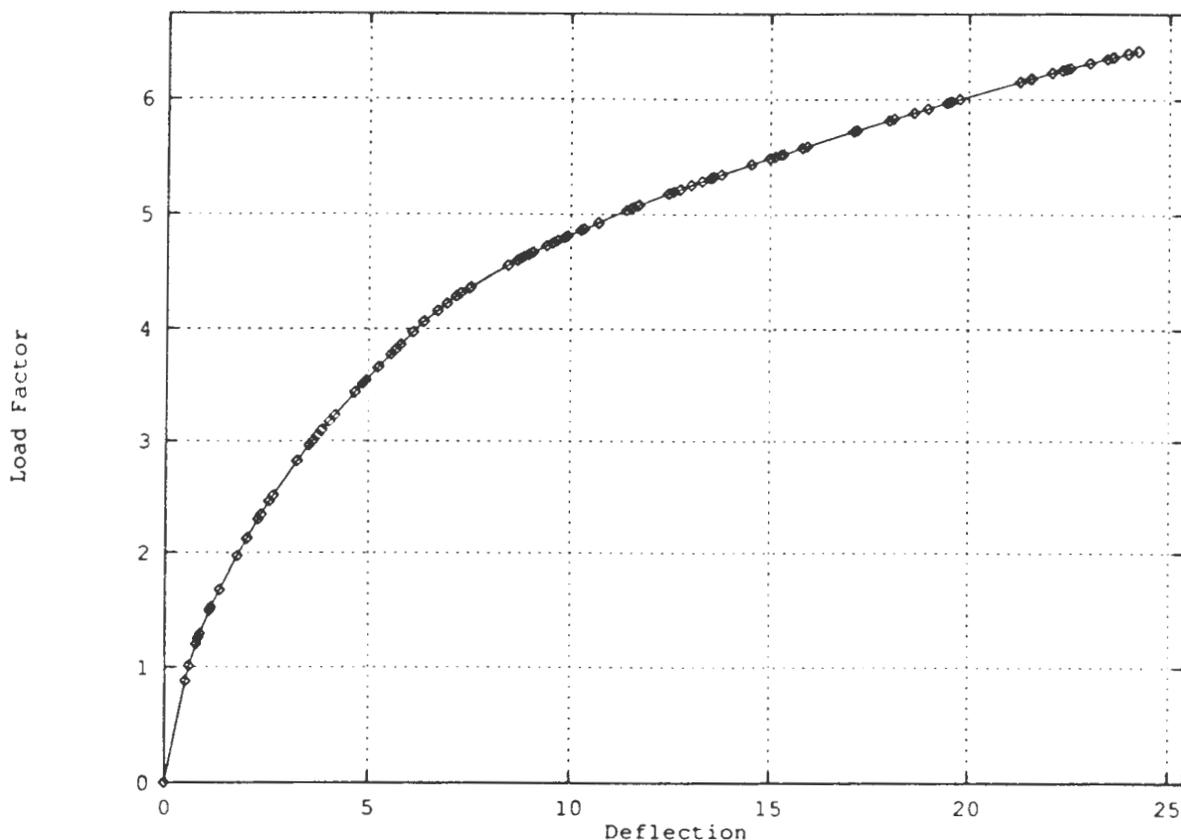
FIGURE 2 Load deflection curve for example of prestressed concrete bridge.

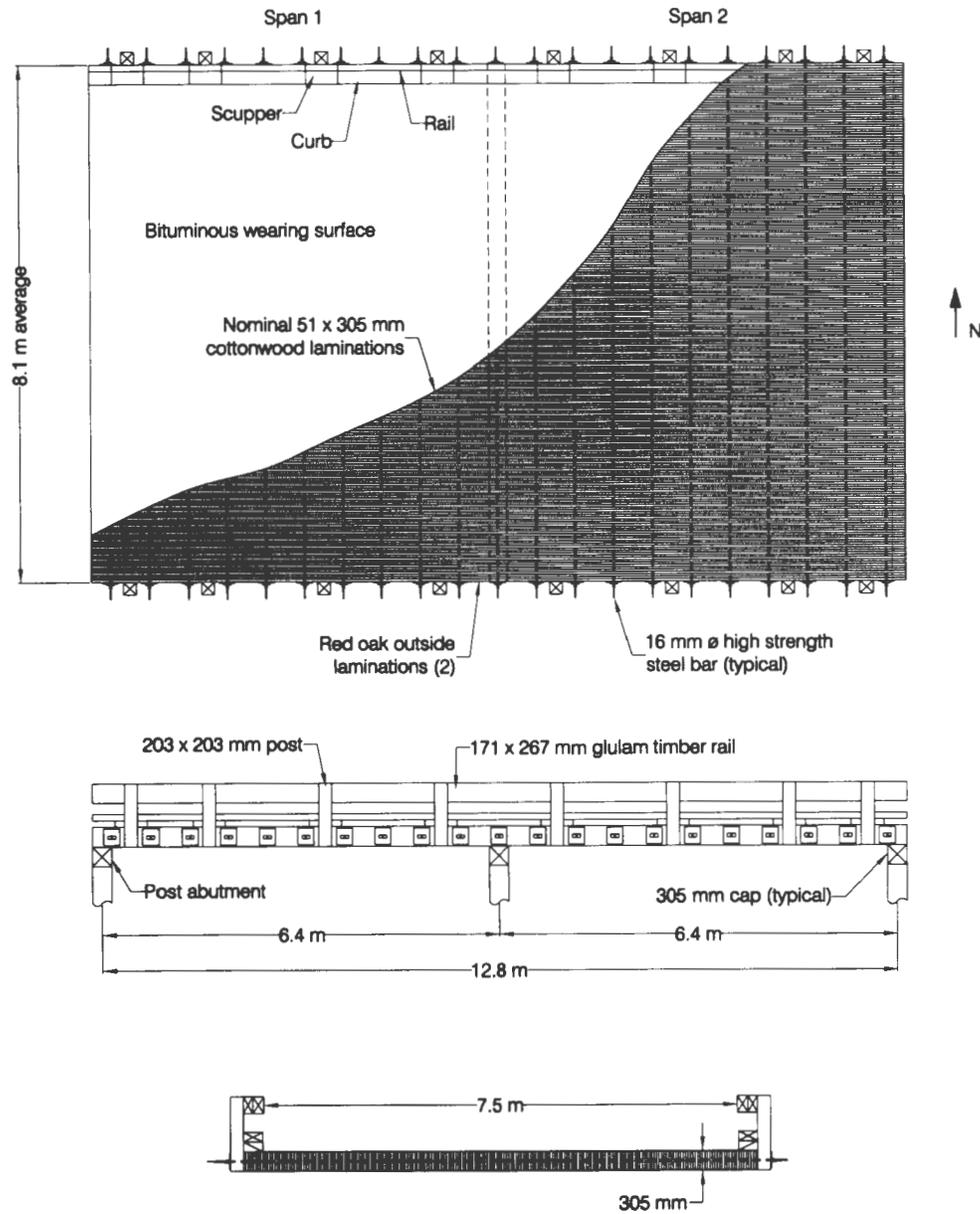
FIGURE 1 Design configuration of Cooper Creek bridge.

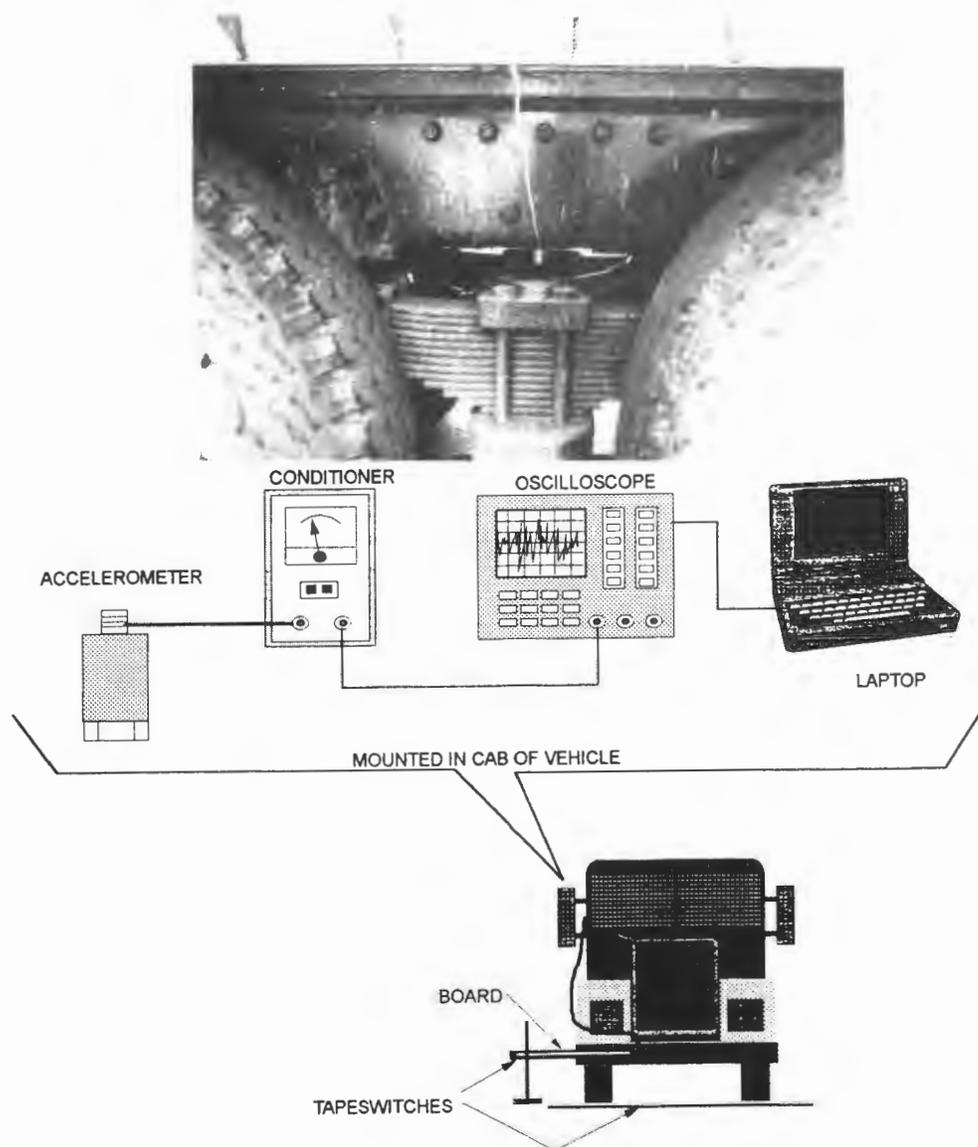
FIGURE 5 Vehicle data acquisition system: *top*, accelerometer mounted on frame; *bottom*, schematic of layout.

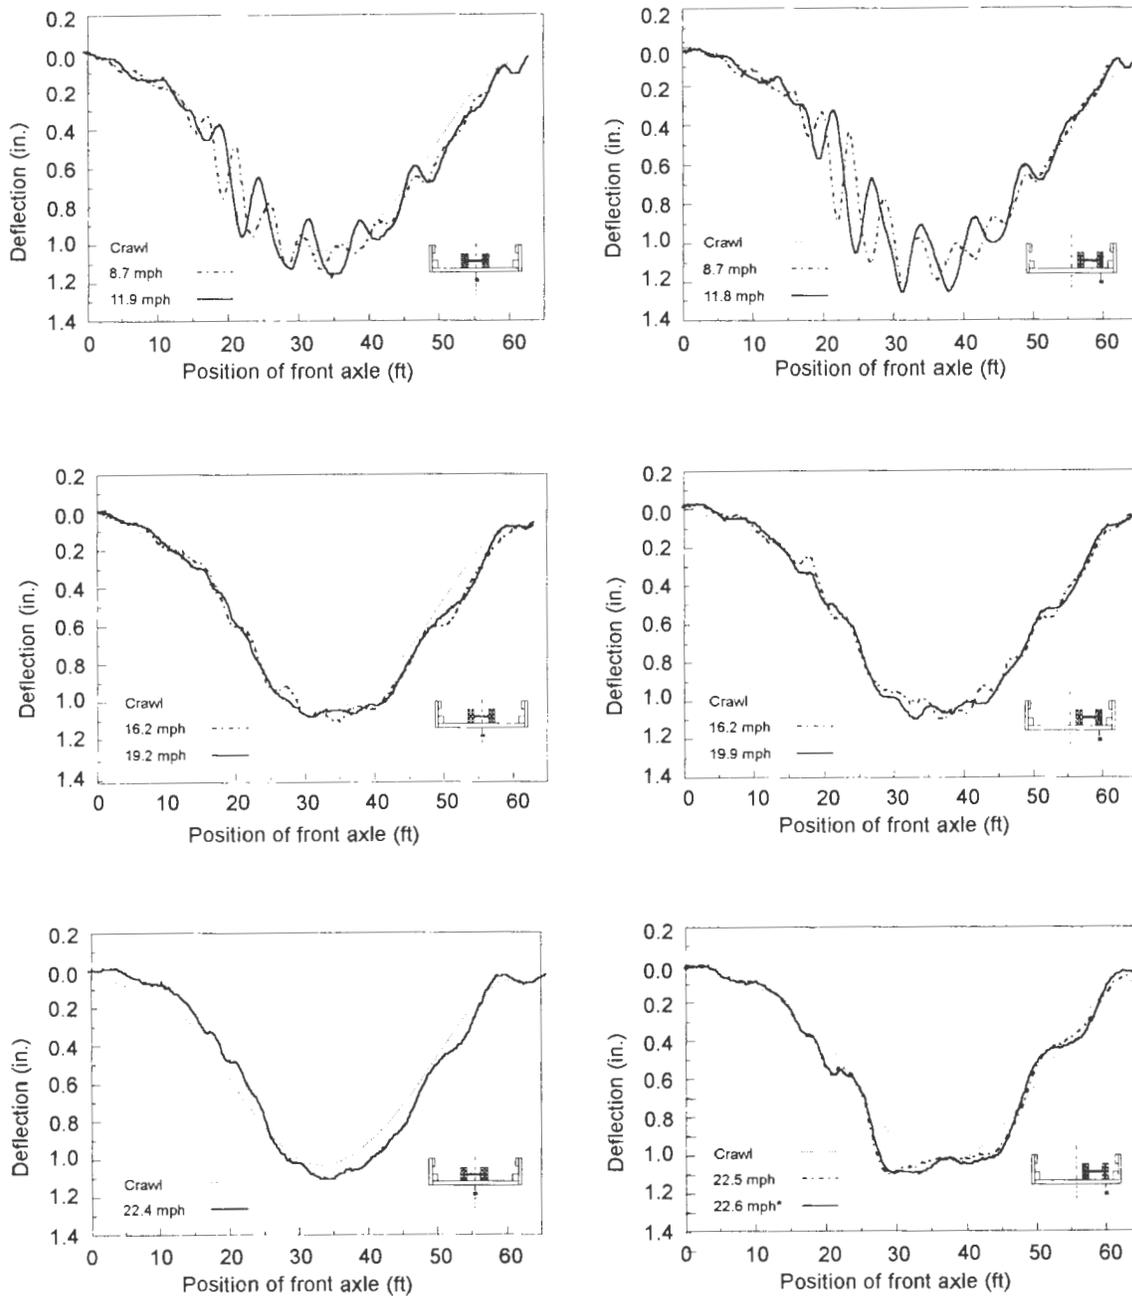
FIGURE 8 Dynamic response for Trout Road Bridge (1 in. = 25.4 mm; 1 ft = 0.3048 m).

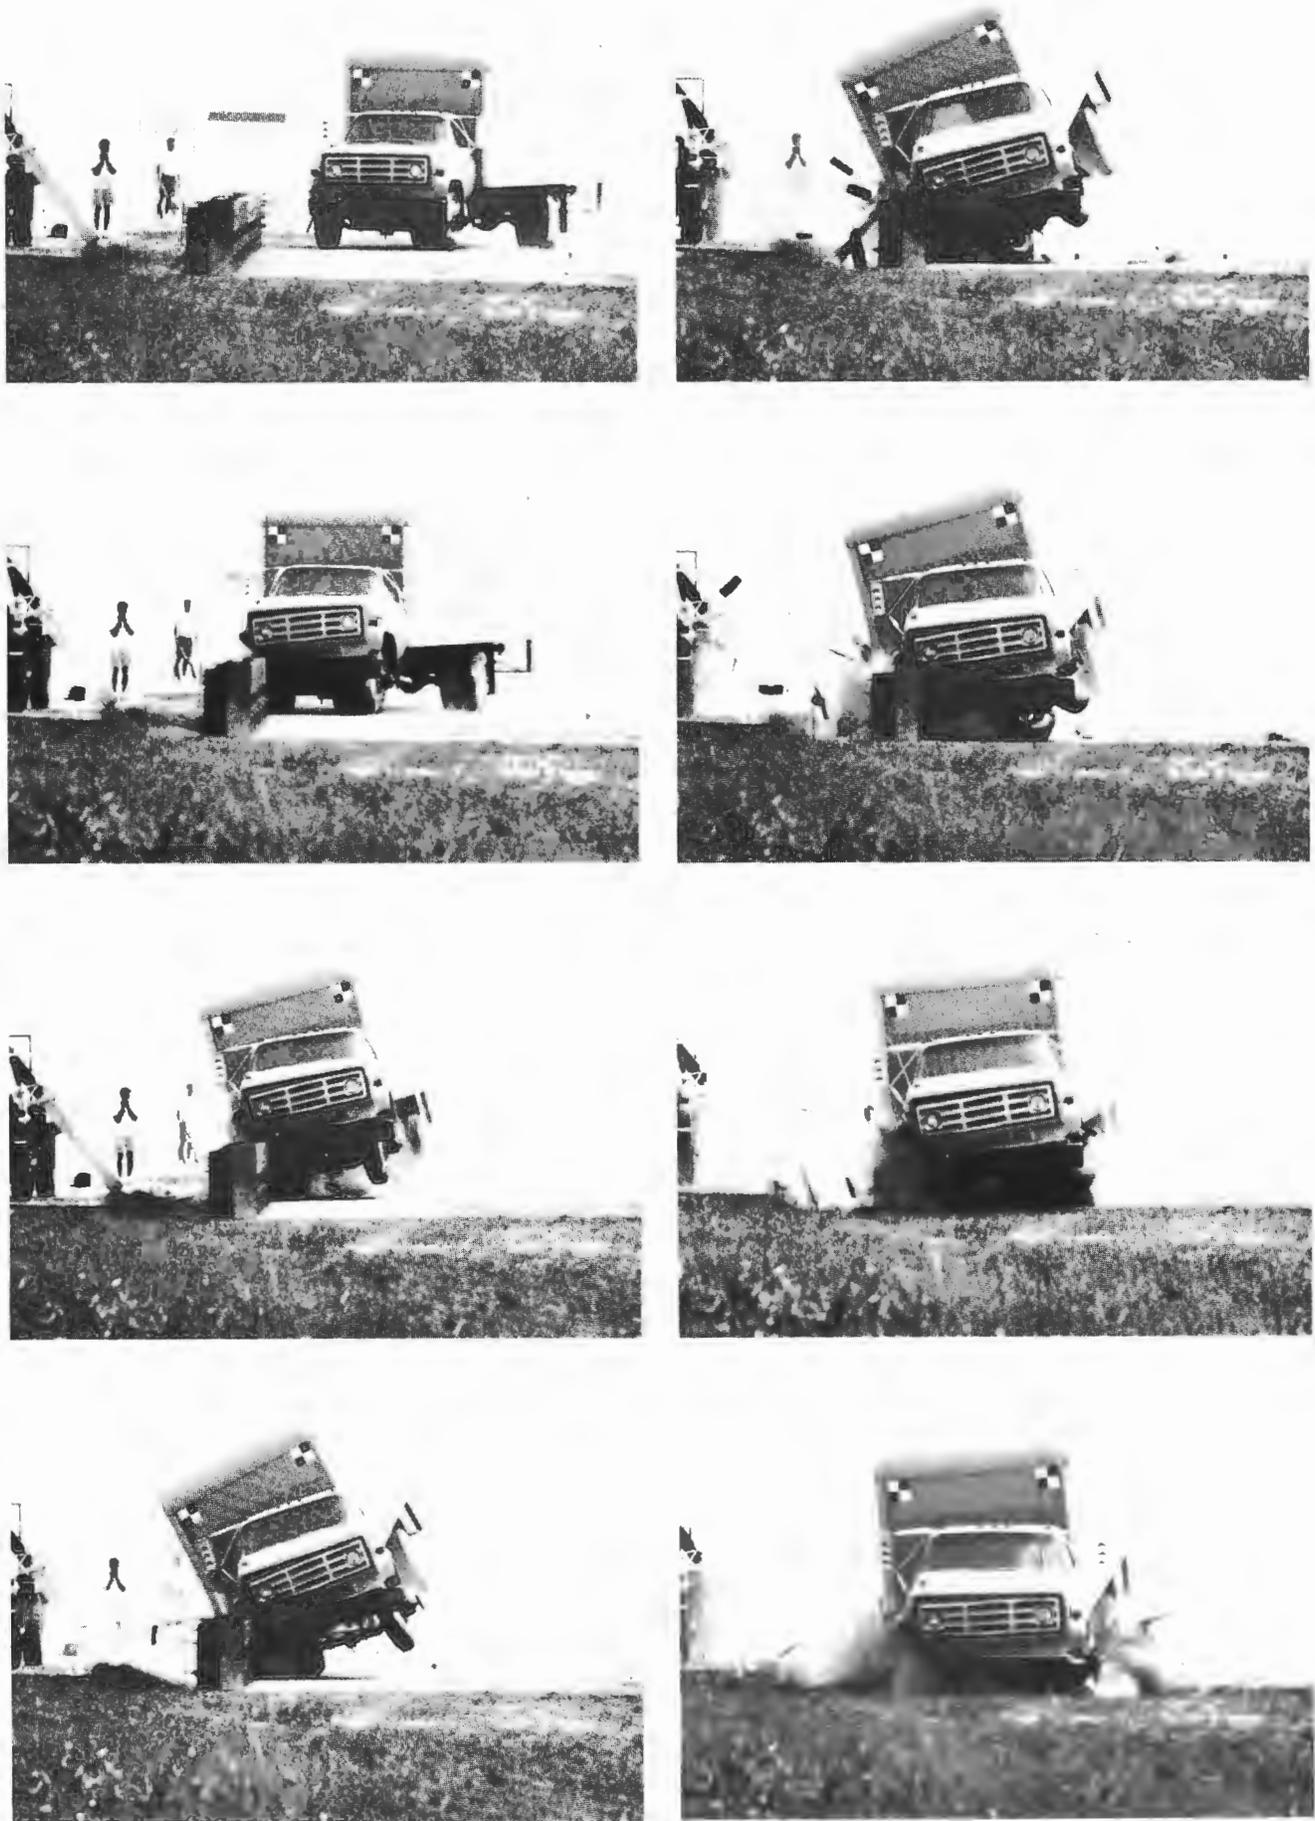
FIGURE 1 Crash-test sequence for 8172-kg (18,000-lb) truck traveling at 80.5 km/hr (50 mph), hitting railing at 15-degree angle to longitudinal railing axis.
