**BIOLOGICAL RESOURCES ASSESSMENT
FOR THE
LOS ANGELES AERIAL RAPID TRANSIT PROJECT
LOS ANGELES, CALIFORNIA**

The Los Angeles Aerial Rapid Transit Draft Environmental Impact Report

AECOM
999 Town & Country Road
Orange, CA 92868
Contact: Michael Kuehn

October 2022

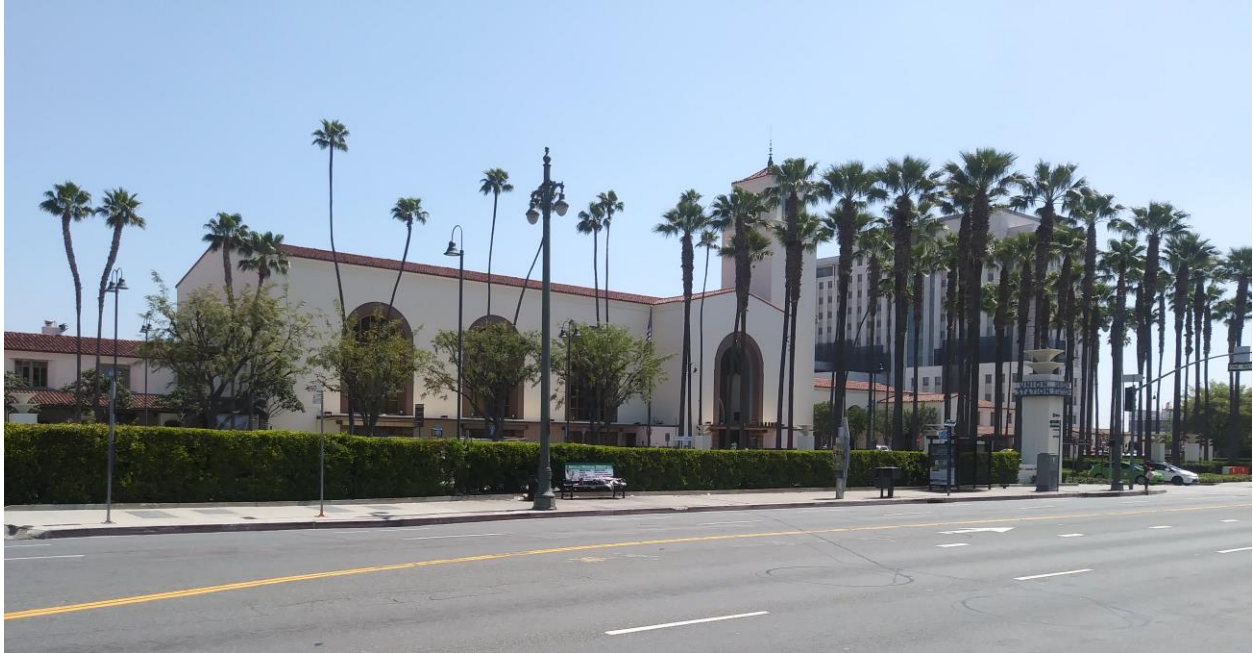
Photo 1. South-facing view of proposed location of Alameda Station over Alameda Street. Union Station with mature palm trees is in background.

Approximately 50 mature Mexican fan palm (*Washingtonia robusta*) trees occur near the entrance to Union Station (Photo 1) on the east side of Alameda Street. Ornamental vegetation occurs on the west side of Alameda Street within the Placita de Dolores, including pink trumpet trees (*Handroanthus impetiginosus*) and ornamental shrubs and vines. Small clusters or solitary street trees including pink trumpet tree, Mexican fan palm, Canary island date palm (*Phoenix canariensis*), and Moreton bay fig (*Ficus macrophylla*) occur along Alameda Street, between Union Station, north to Cesar Chavez Avenue. These street trees fall within the public ROW. The number and regulatory status of the trees occurring within the Project footprint at this site, which include pink trumpet tree and Mexican fan palm, are included in Table 2 of Appendix B.

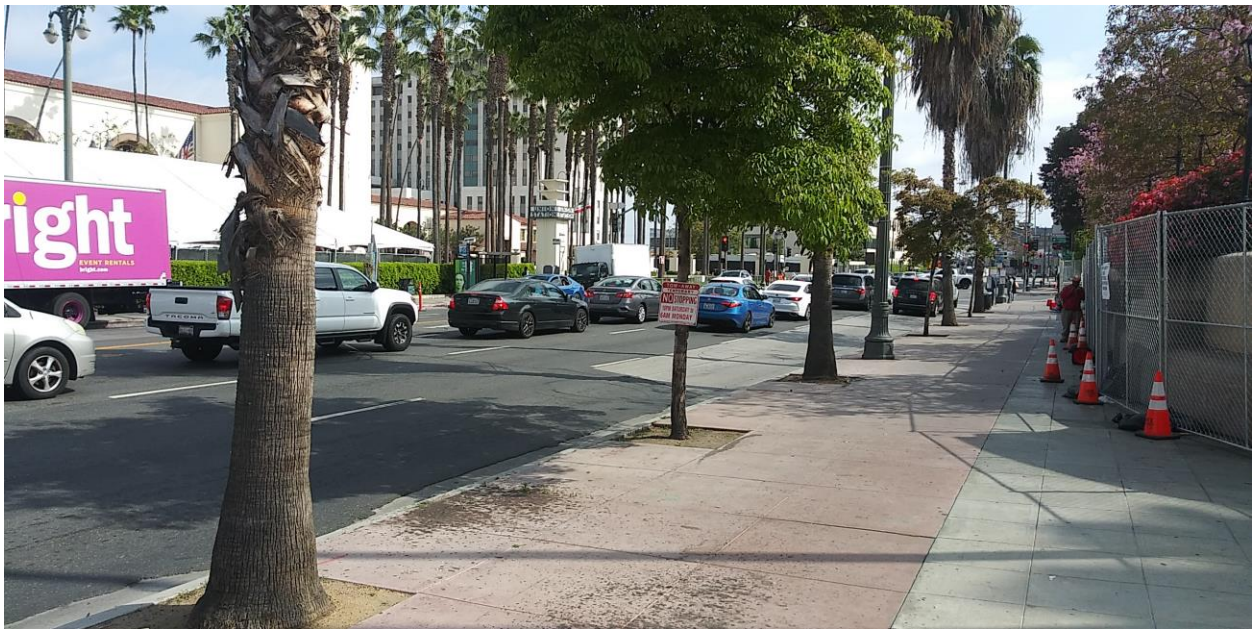
Photo 2. South-facing view of street trees along the west side of Alameda Street, with the fenced-off Placita de Dolores at right.

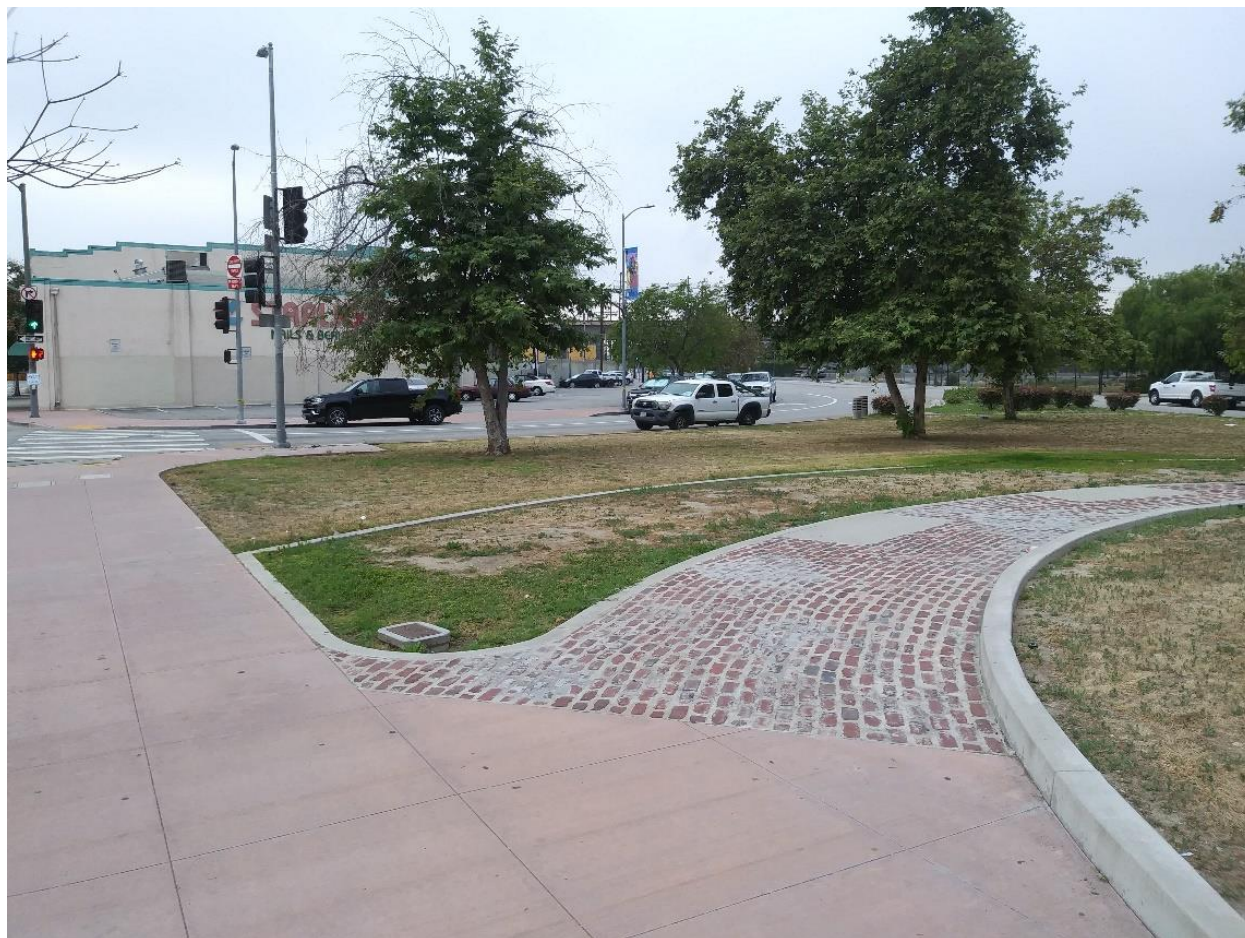
Photo 3. North-facing view of proposed location for the Alameda Tower between pavers and intersection in background. Two western sycamore trees in the northern portion of the site are pictured in the background.

Four western sycamore (*Platanus racemosa*) trees approximately 40 feet in height occur within proximity of the proposed location of this tower within the Alameda Triangle, a small City green space flanked on all sides by roadways (Photos 3-5). Two additional western sycamore and a small carrotwood tree (*Cupaniopsis anacardioides*) also occur on this site. Three pink trumpet trees occur as street trees along Alameda Street. One dead pink trumpet tree and an empty tree well also occur along Alameda Street within the public ROW. Additionally, a small blue atlas cedar (*Cedrus atlantica glauca*) tree, which is not identified in the tree report due to its small size, occurs on this site. The number and regulatory status of the trees occurring at this site are included in Table 3 of Appendix B. Most of the green space consists of lawn and paved or brick pathways, with clusters of ornamental shrubs.

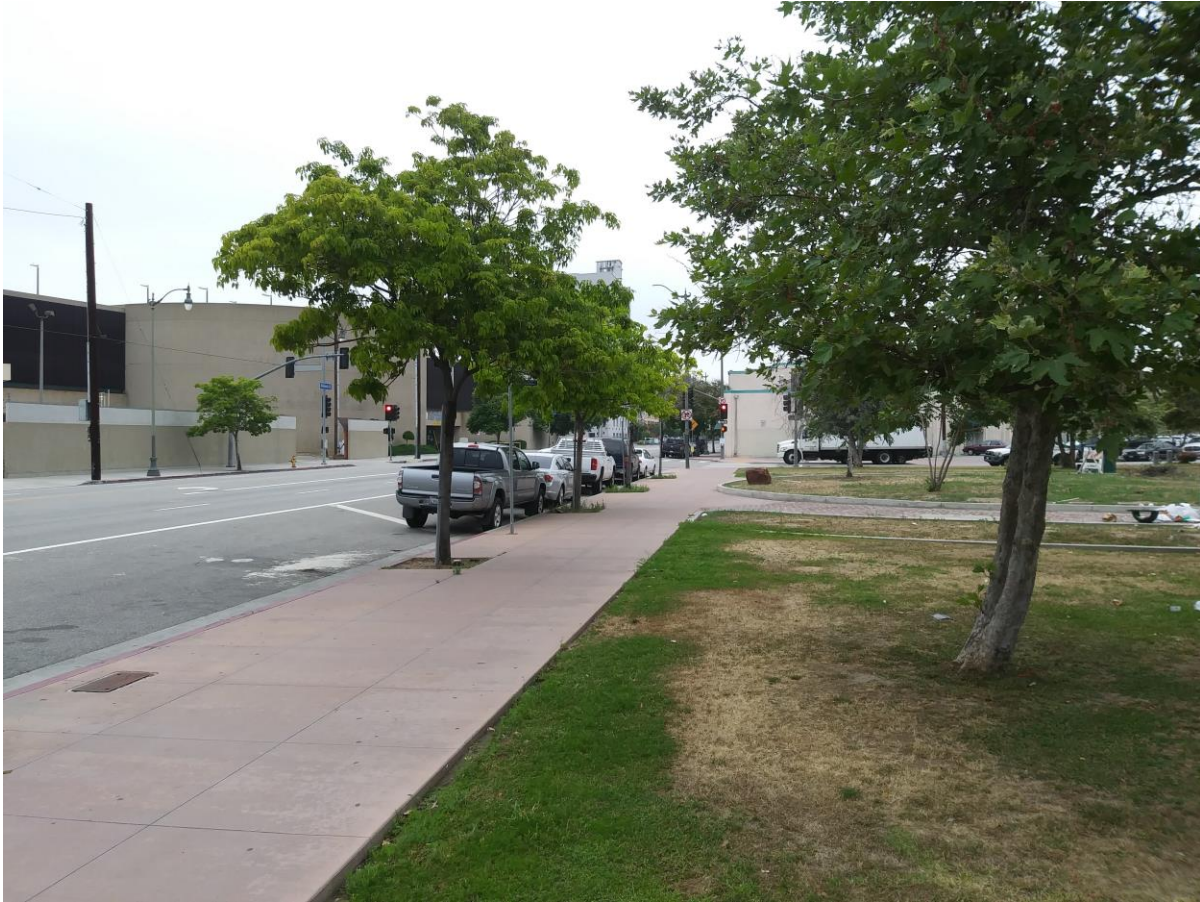
Photo 4. North-facing view of street trees along Alameda Street at left and sycamores in the southern portion of the Alameda Triangle at right.

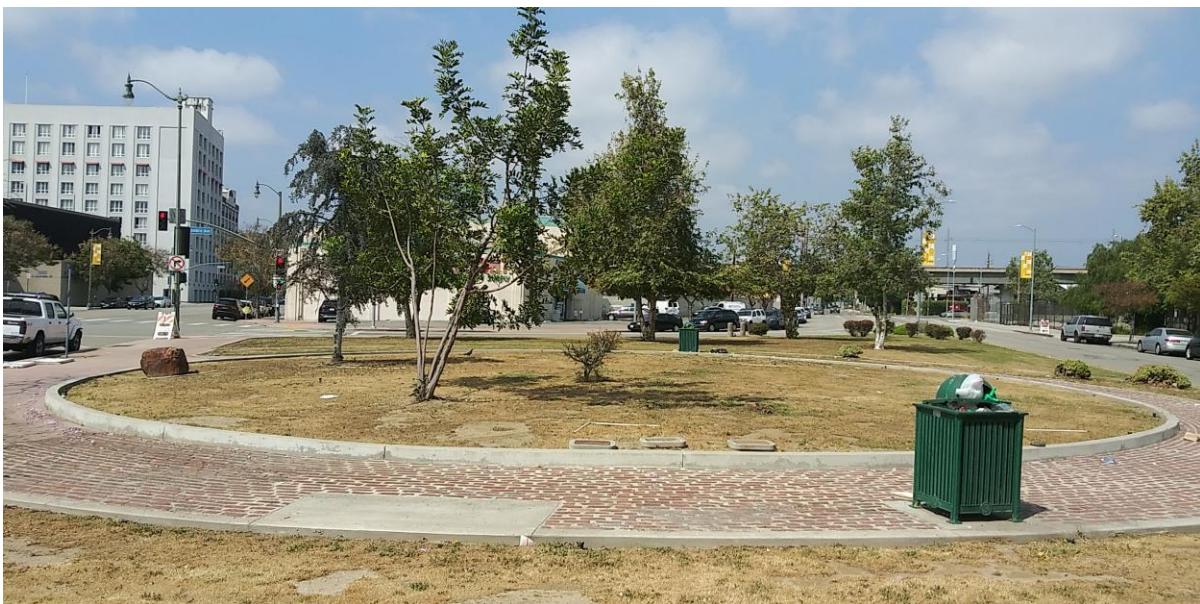
Photo 5. North-facing view across Alameda Triangle with circular path of pavers in center of site and trees occurring in background which fall within the footprint of the proposed tower.

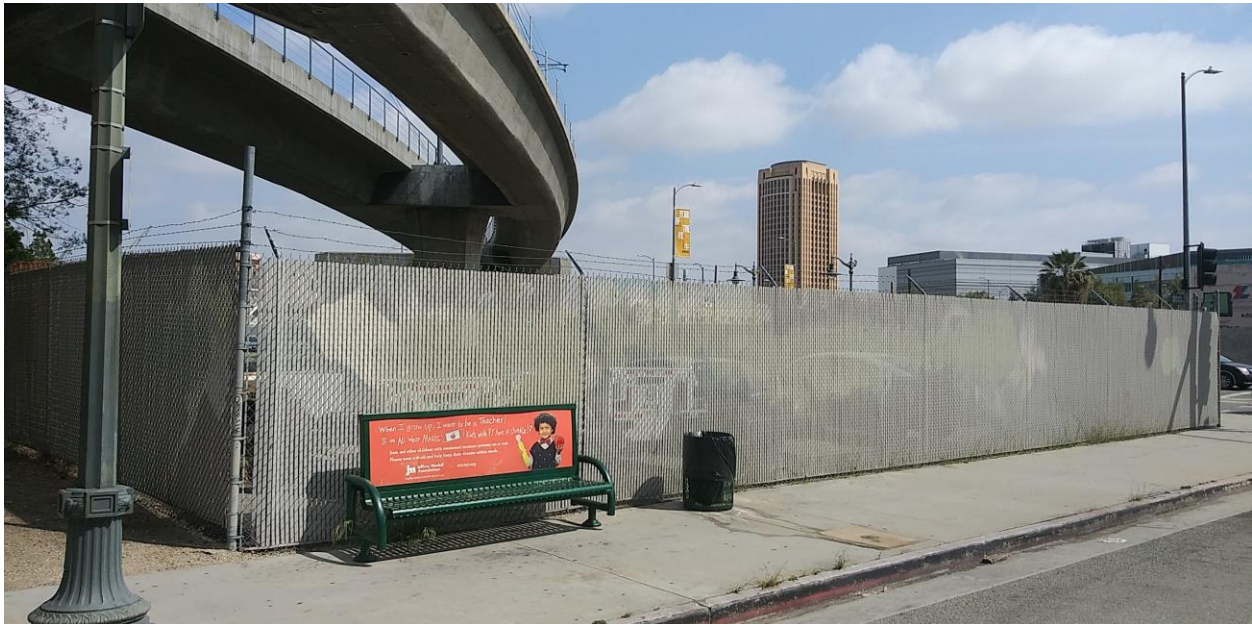
Photo 6. Southeast-facing view from Alameda Street of City-owned parcel proposed for the Alpine Tower, which would be constructed to the right of the elevated Metro L Line (Gold) structure.

The proposed Alpine Tower site coincides with a paved parking area on a City-owned parcel (Photos 6 and 7). No trees are present in the parking area and only clumps of non-native grasses and weedy herbaceous vegetation is present. Approximately three African fern pine (*Afrocarpus gracilior*) and two Mexican fan palms occur along the northern perimeter of the parcel, roughly 70 to 150 feet east-northeast of the proposed location for this tower.

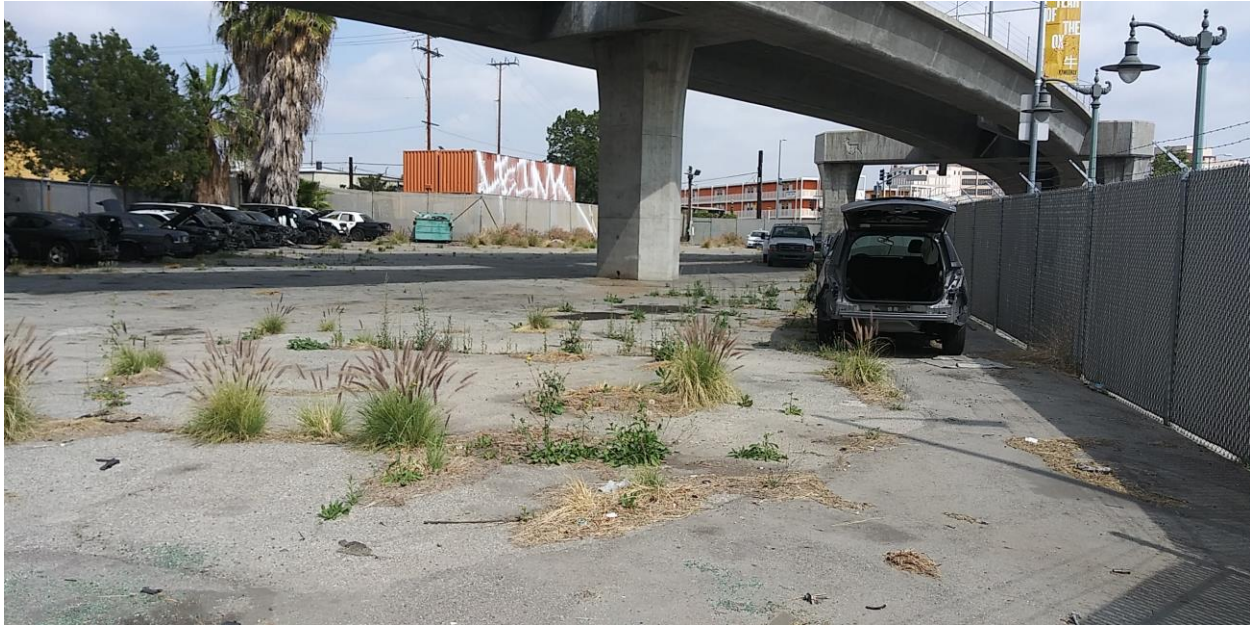
Photo 7. East-facing view of the interior of the City-owned parcel proposed for the Alpine Tower, which would be constructed in the foreground of the elevated Metro L Line (Gold) structure.

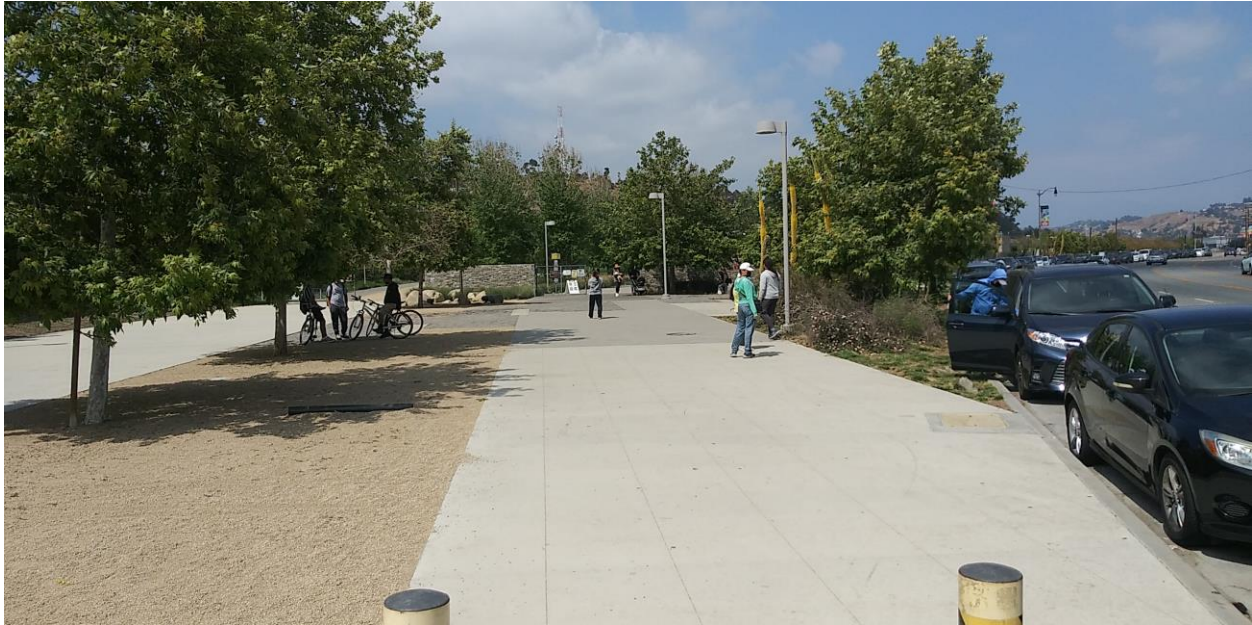
Photo 8. North-facing view of a portion of the proposed location for the Chinatown/State Park Station at the landscaped entrance to the Los Angeles State Historic Park, with Spring Street at right.

The BSA surrounding the proposed Chinatown/State Park Station consists of paved roadways, sidewalks, the elevated Metro L Line (Gold) structure, and buildings. A few Chinese flame (*Koelreuteria bipinnata*) street trees and occasional pockets of ornamental landscaping occur in the BSA outside the Los Angeles State Historic Park with landscaped plantings of native and non-native species occurring further into the Los Angeles State Historic Park.

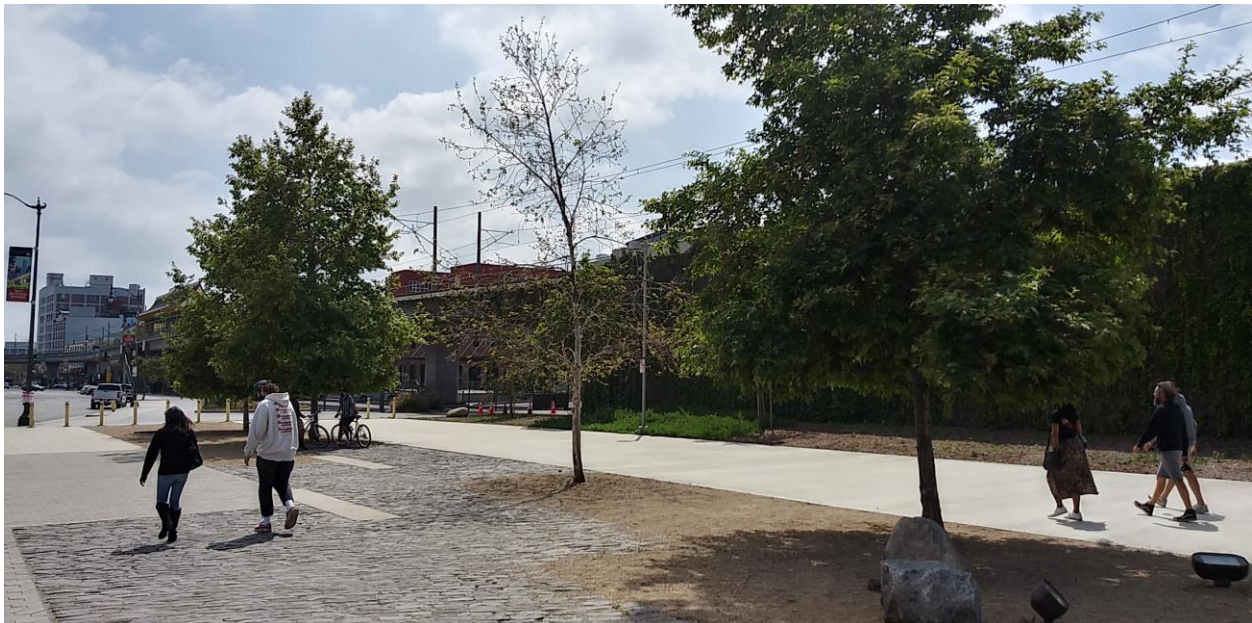
Photo 9. South-facing view of a portion of the proposed location for the Chinatown/State Park Station at the southern entrance to the Los Angeles State Historic Park.

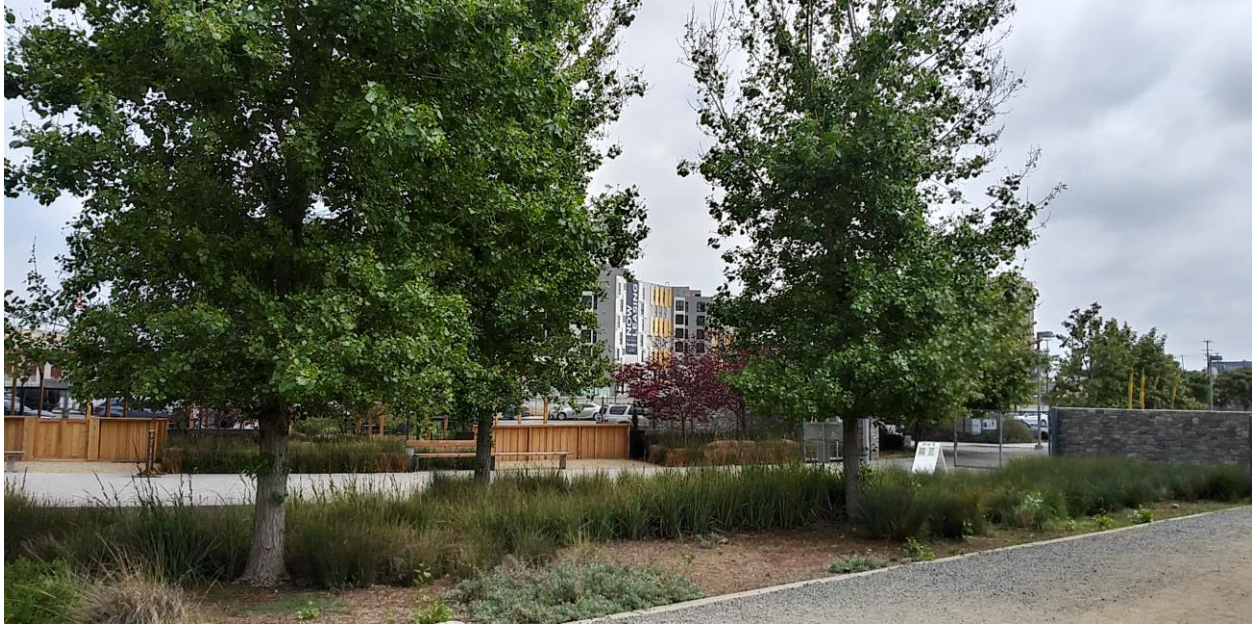
Photo 10. Southeast-facing view of a portion of the proposed location for the Chinatown/State Park Station inside the Los Angeles State Historic Park's southern entrance.

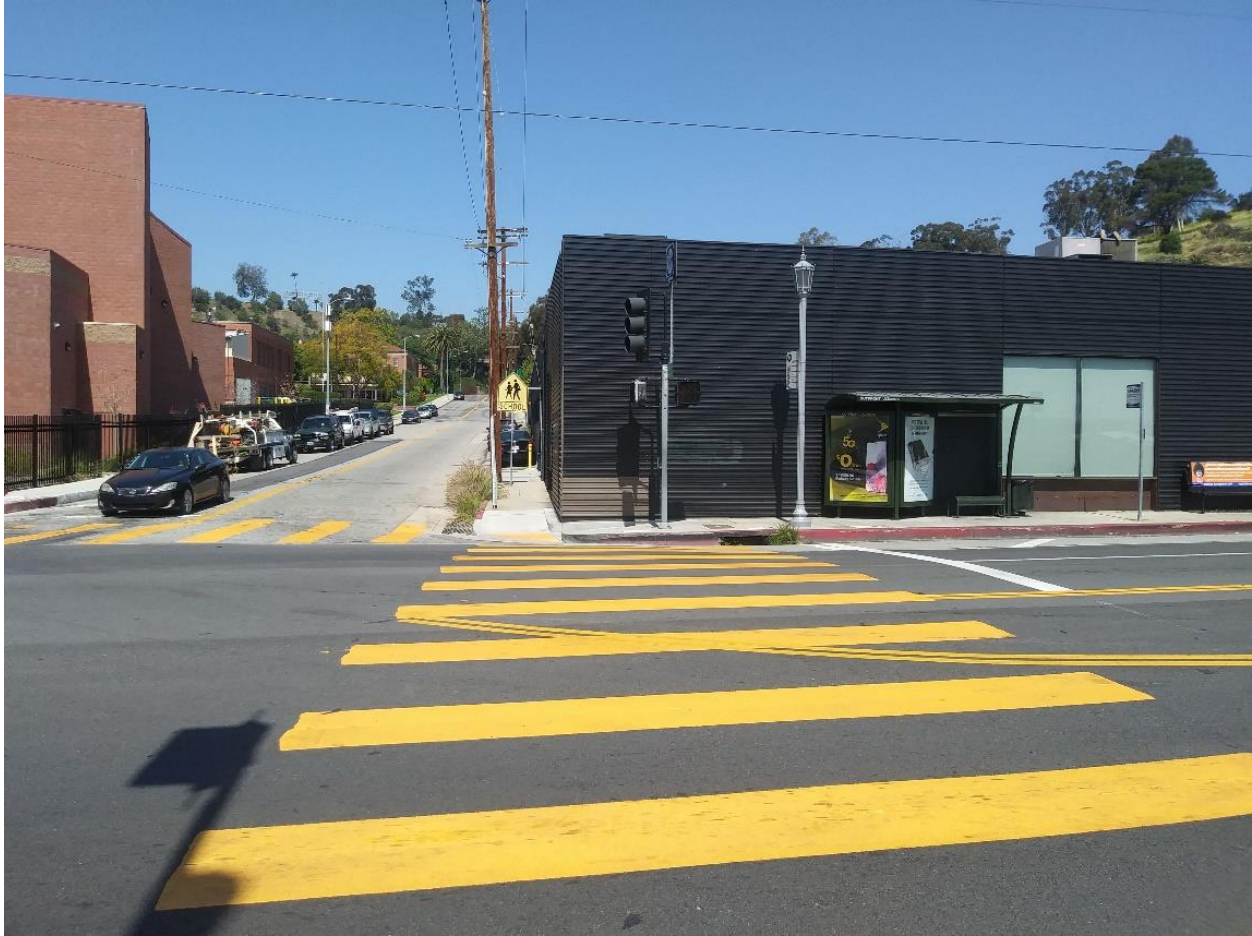
Photo 11. Northwest-facing view of proposed location for the Broadway Junction at 1201 Broadway, with North Broadway in foreground and Bishops Road at left.

The Broadway Junction site would be located at 1201 North Broadway, occurring primarily on a privately-owned parcel which includes a one-story building (Photo 11) at the intersection of North Broadway and Bishops Road, and a patio area north of the building. A few Australian willow (*Geijera parviflora*) trees (Photo 12) on the west side of North Broadway and small jacaranda trees (*Jacaranda mimosifolia*) (Photo 13) occur on the Cathedral High School property west of the private parcel. A persimmon (*Diospyros virginiana*) shrub and Marina strawberry tree (Photos 14 and 15) occur within a small courtyard at 1201 North Broadway within the proposed Broadway Junction site.

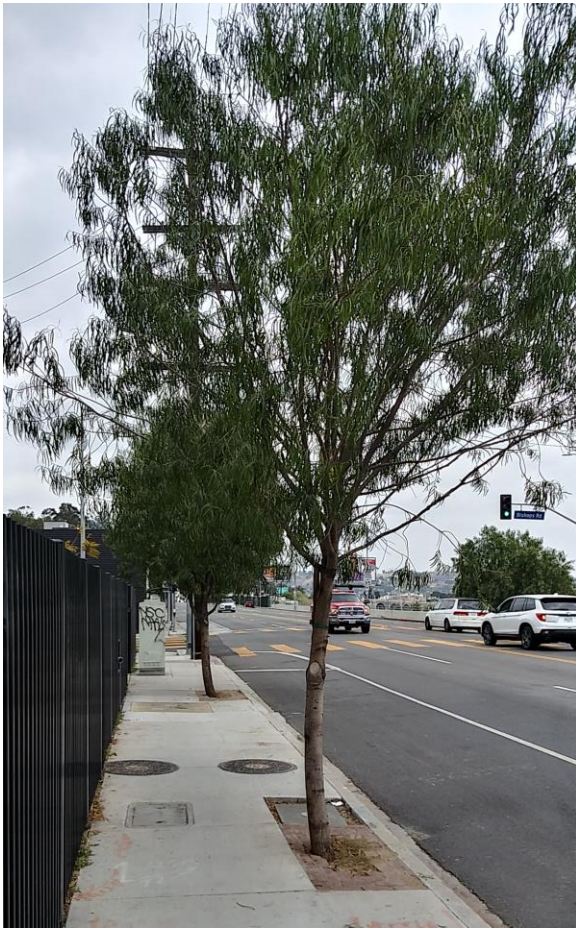
Photo 12. Northwest-facing view of street trees along North Broadway (at left) in front of Cathedral High School.

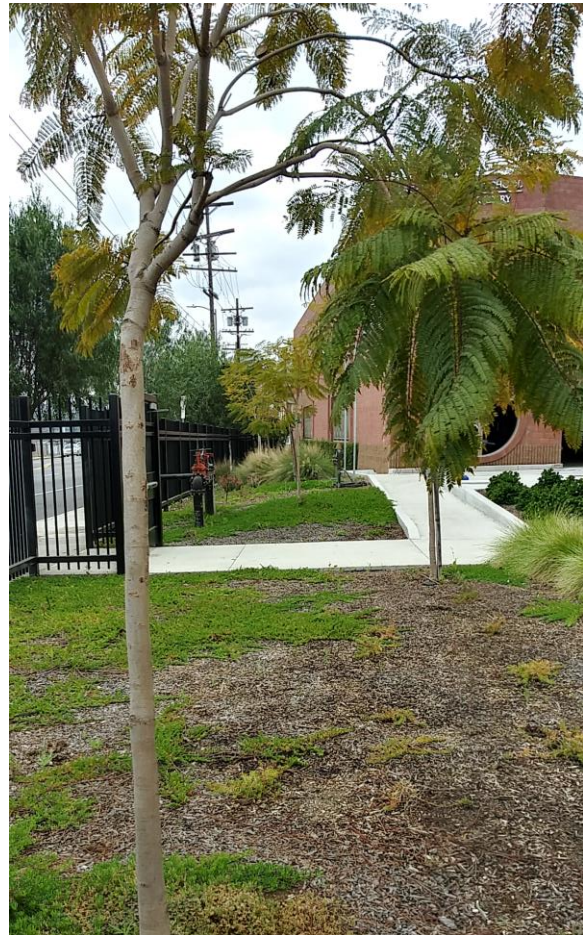
Photo 13. Southeast-facing view of small jacaranda trees on the Cathedral High School property.

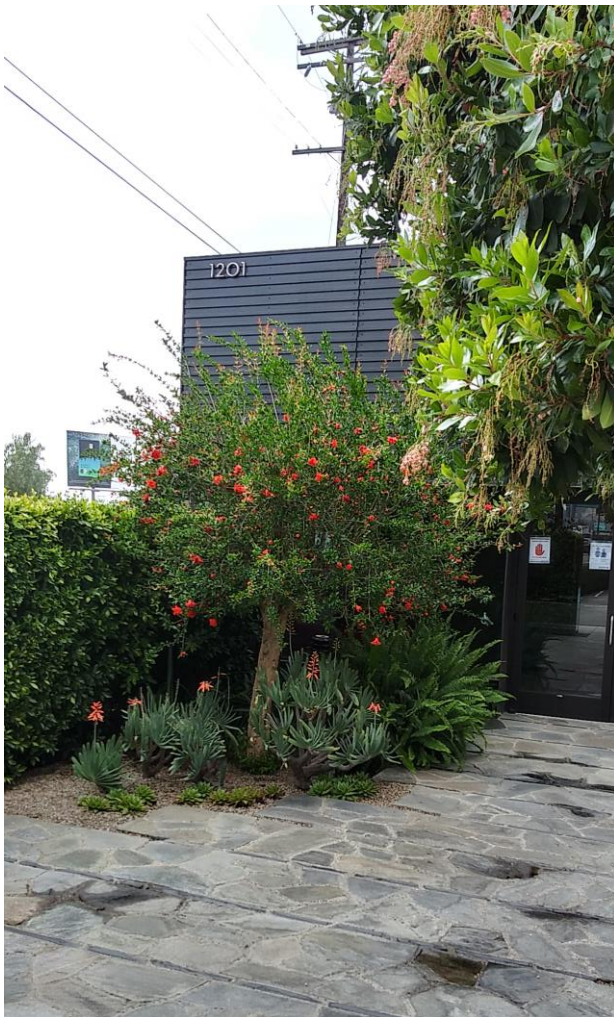
Photo 14. Persimmon tree in courtyard at 1201 North Broadway, with strawberry tree at right.

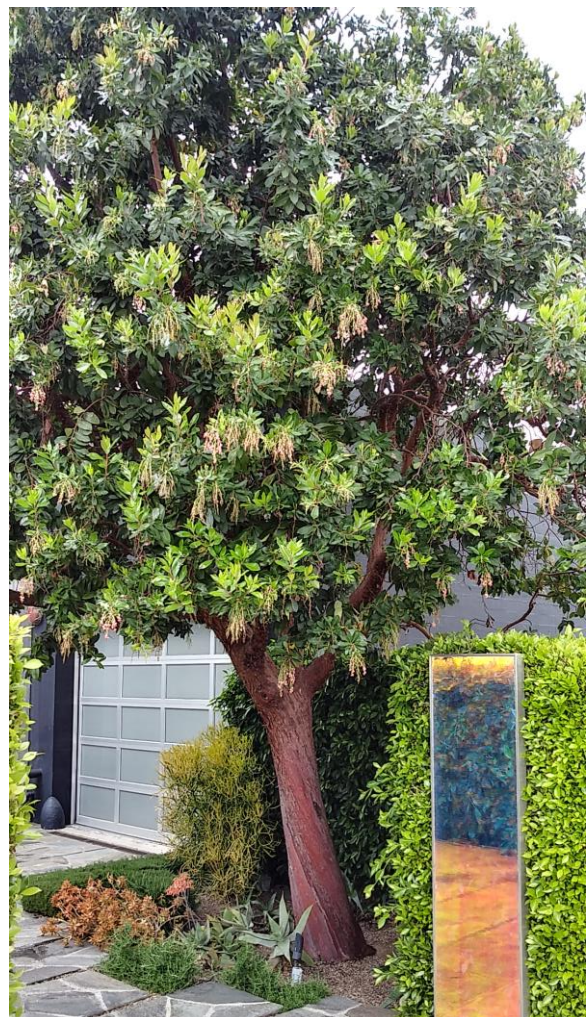
Photo 15. Strawberry tree in courtyard at 1201 North Broadway.

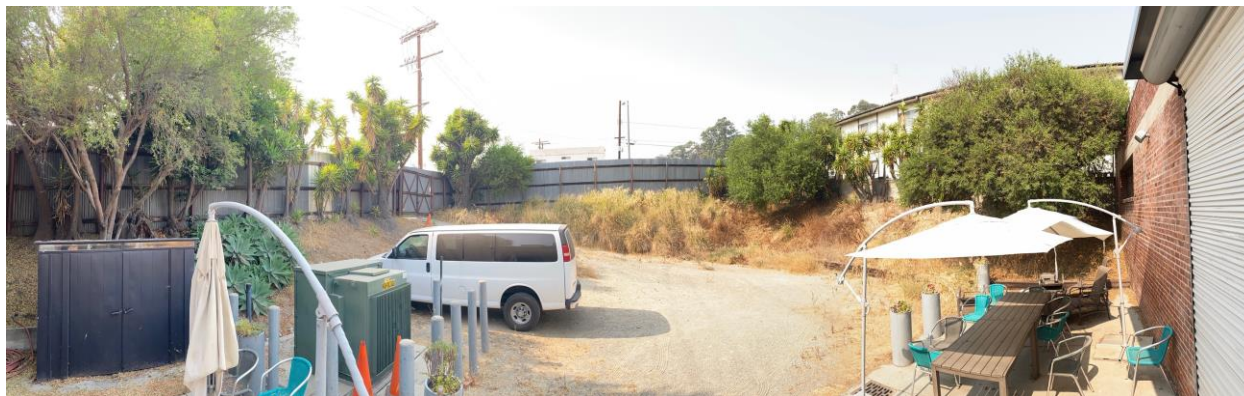
Photo 16. Northwest-facing view of the patio area at the rear of 1201 North Broadway, with low growing trees and other ornamental species present.

The outdoor patio area north of the existing 1201 North Broadway building, which coincides with the construction staging area for the proposed Broadway Junction, includes trees along a perimeter fence line, with a cover of non-native grass species and areas of gravel covering the interior of the patio area. Spanish dagger (*Yucca gloriosa*), Chilean pepper, Carolina cherry (*Prunus caoliniana*), and avocado (*Persea americana*) trees, and one Mexican elderberry shrub located in the far northwest corner of the site, occur along the perimeter fence line (Photo 16). The number and regulatory status of the trees occurring at this site are included in Table 6 of Appendix B.

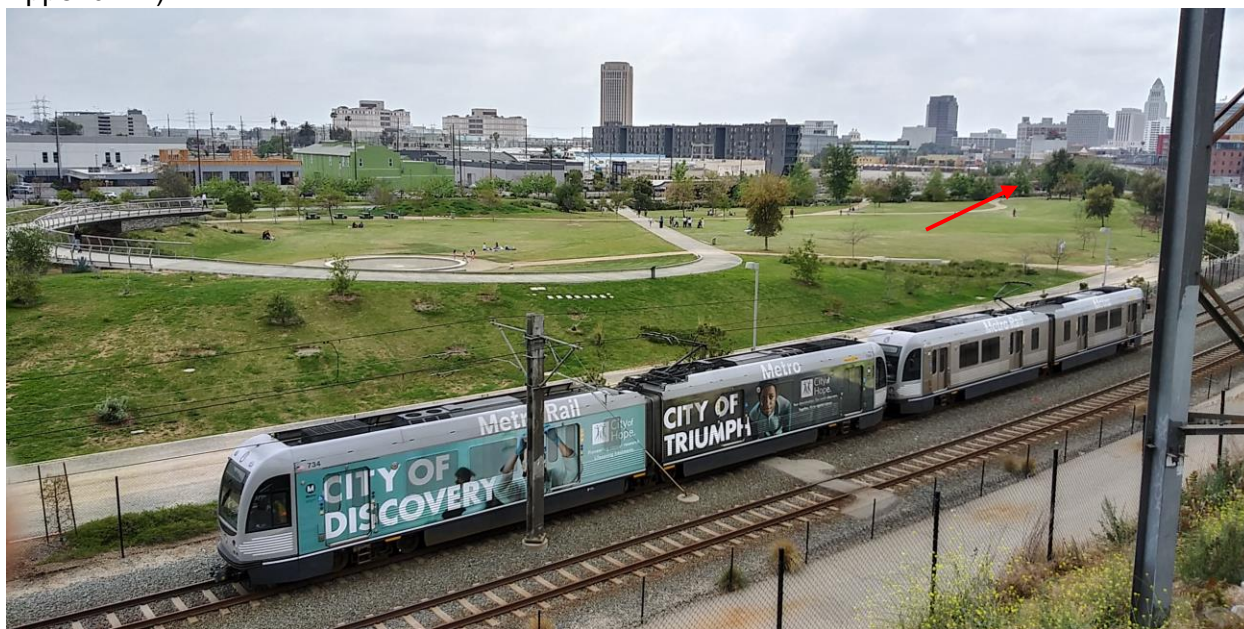
Photo 17. Southeast-facing view from North Broadway (1201 North Broadway) along the proposed alignment of the aerial gondola's route between the Broadway Junction and Chinatown/State Park Station (location shown by red arrow) over the Los Angeles State Historic Park.

Although the Los Angeles State Historic Park occurs in the BSA just east of this site, they are separated by fencing, a steep slope, and railroad tracks (Photo 17). Paved roadways, sidewalks, the Cathedral High School campus, and homes comprise the remainder of the BSA. Ornamental plantings occur on the high school campus and at homes surrounding the proposed junction site. The BSA along the alignment between this junction and the Stadium Tower includes a few homes, the high school campus, SR-110, and Stadium Way. Vegetation includes mature trees on the high school campus, between the north and south-bound lanes of SR-110, and along Stadium Way. As detailed in the Appendix B, sugar gum (*Eucalyptus caldocalyx*) and Chilean pepper trees occur along the portion of the alignment that coincides with the over SR-110 Caltrans ROW (Table 7, Appendix B).

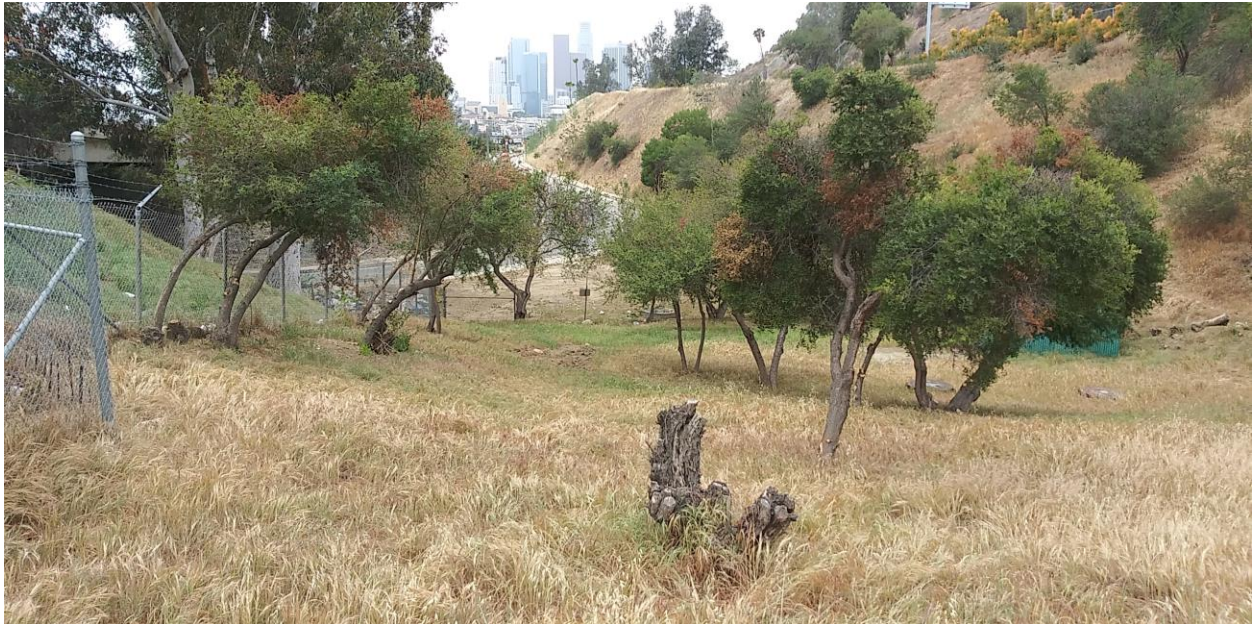
Photo 18. Southwest-facing view of proposed location for the Stadium Tower in undeveloped area between the SR-110, out of view at left, and access road to the Downtown Gate, out of view at right.

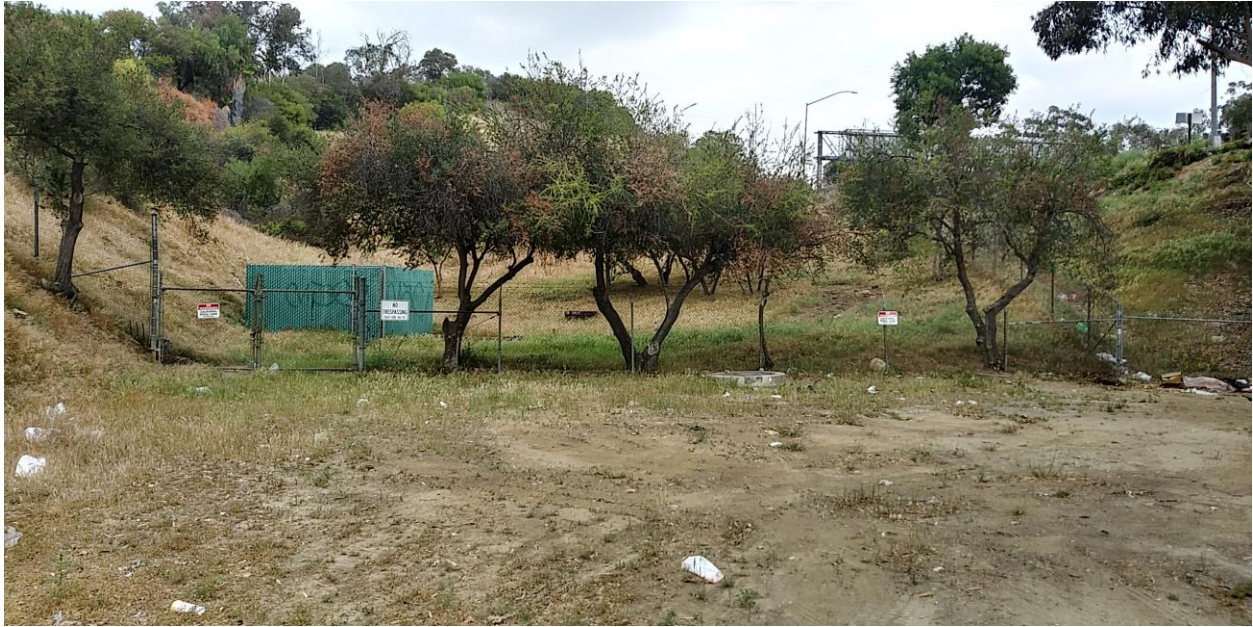
Photo 19. North-facing view from Stadium Way of proposed construction access route to the Stadium Tower site, located behind the Chilean pepper trees occurring in the middle of this photo.

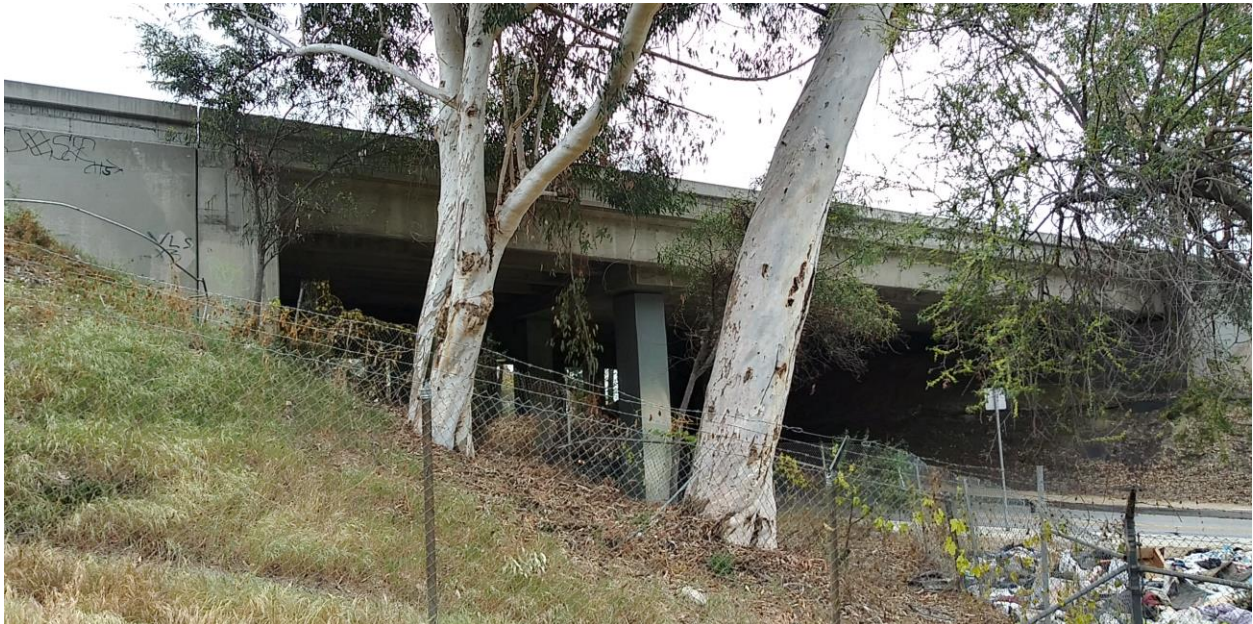
Photo 20. East-facing view of mature sugar gum trees occurring within the Caltrans ROW along the SR-110 bridge and adjacent to the proposed location for the Stadium Tower.

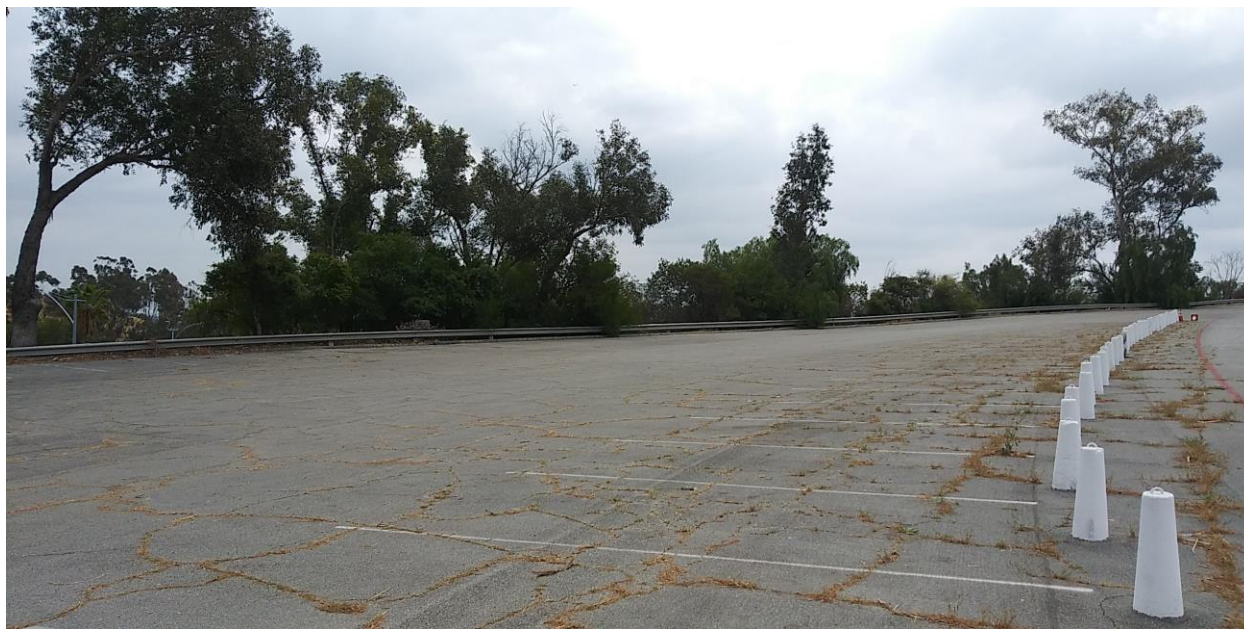
Photo 21. Southeast-facing view of proposed location for the Dodger Stadium Station in parking area. Site occurs in the paved area and roughly between tall trees at far left and right in photo.

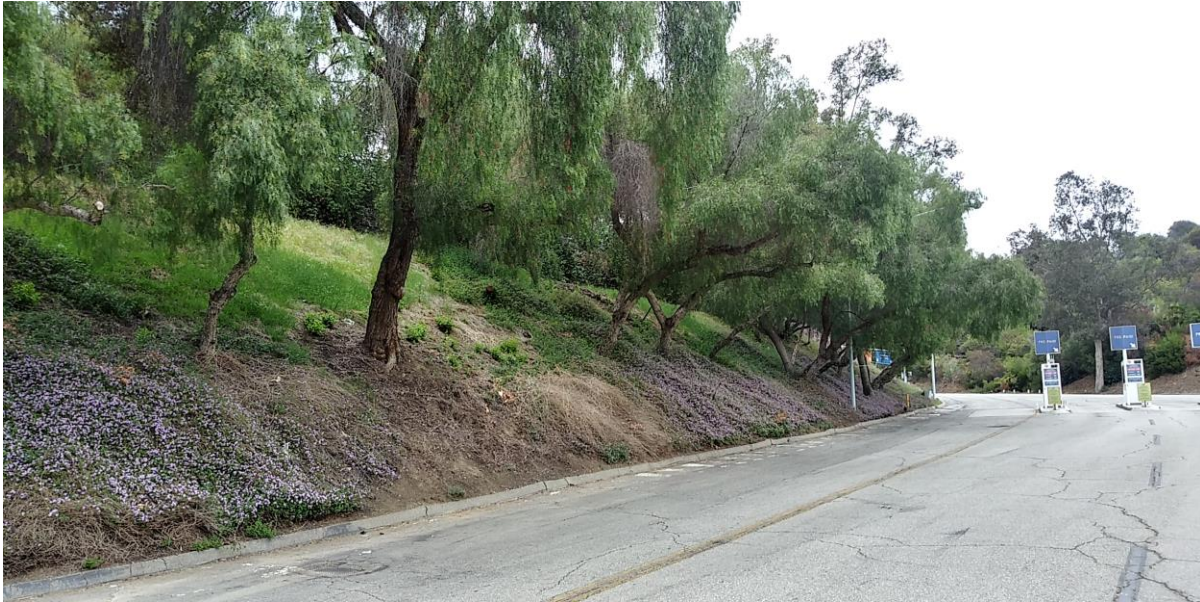
Photo 22. North-facing view of slope with Chilean pepper trees occurring between the parking area shown in Photo 20 and the Downtown Gate access road in this photo.

The proposed Dodger Stadium Station site coincides with a paved parking area that occurs approximately 700 feet east of the stadium and a screen of trees on a vegetated slope that occurs between the parking area and the Downtown Gate access road to the east (Photos 21 and 22). Sugar gum, Chilean pepper, California pepper (*Schinus molle*) and blackwood acacia trees are present. The number and regulatory status of the trees occurring at this site are included in Table 10 of Appendix B. The understory along the slope includes numerous weeping fig (*Ficus benjamina*) saplings, a few mature native lemonade berry (*Rhus integrifolia*) shrubs, and non-native grasses.

The proposed pedestrian connections from the station to Dodger Stadium and connections to Elysian Park and adjacent neighborhoods coincide with existing paved parking areas at the stadium (Photo 22). Mature eucalyptus trees surround the stadium complex and occasional Mexican fan palm trees occur in the parking lot in close proximity to proposed pedestrian connections.

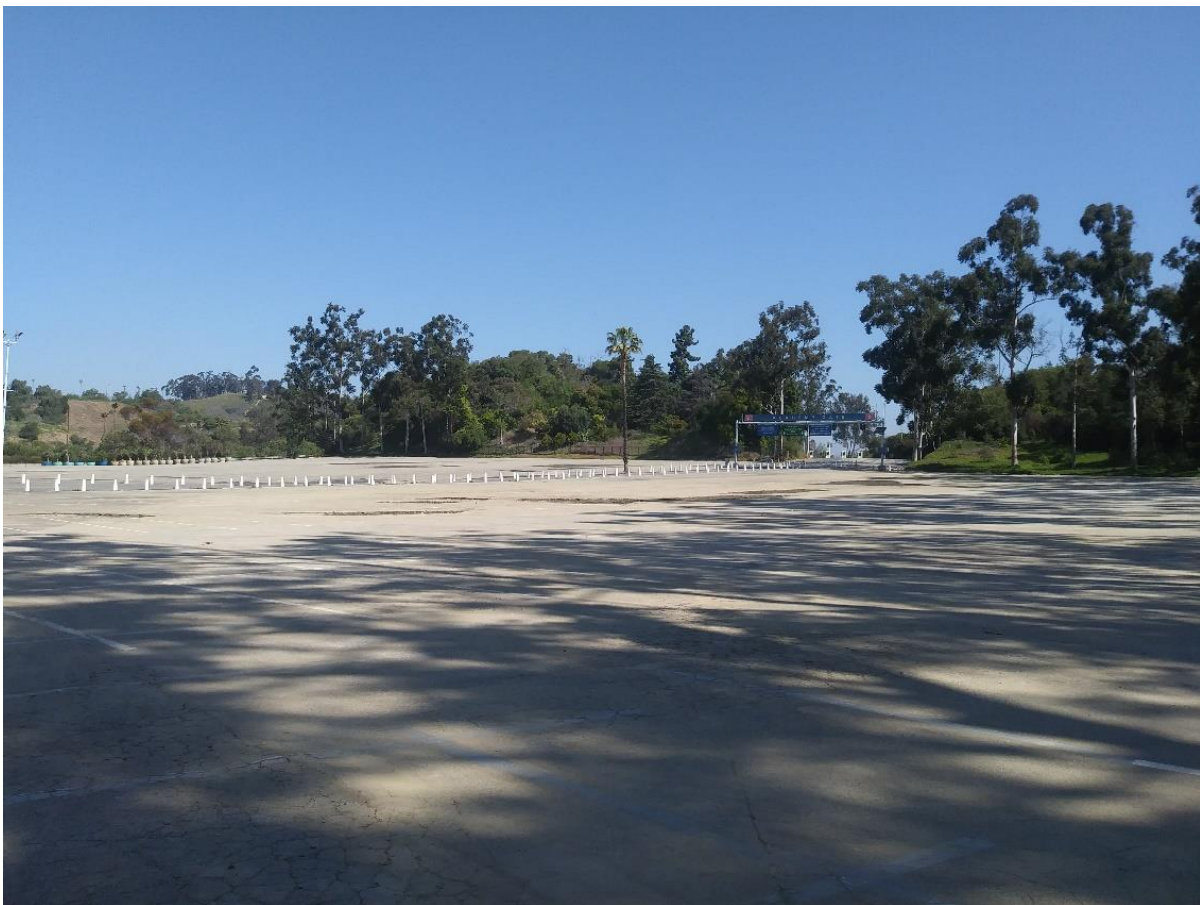
Photo 23. North-facing view of proposed pedestrian connection route through paved parking areas at the stadium, with stands of mature eucalyptus in background.
