Plastic Sheeting Replaces Stone Parapet Atop MTA Building

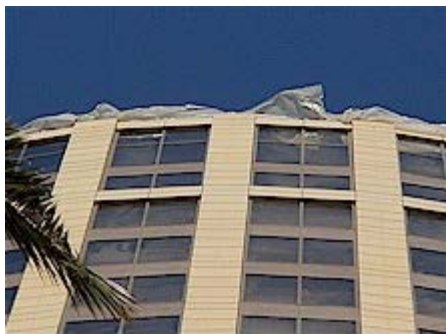
(Jan. 22) Pedestrians crossing the Transit Plaza today could see an odd sight at the top of MTA Headquarters: billowing plastic sheeting where there once was a stone parapet.

The front of the building was cordoned off last Friday, when it appeared some pieces of the 25 or so panels of stone facing were in danger of coming loose from their fastenings and falling onto the plaza.

"The stone was damaged when the fire heated it and then the cold water hit it," said Dan Colonello, General Services supervisor. "Some of the pieces were cracked almost like a jigsaw puzzle."

Colonello said much of what burned was the stucco and insulation of a wall directly behind the stone parapet.

Over the past weekend, a contractor removed the top course of stone facing from the parapet, wrapped the area in plastic for weather protection and cleaned up debris - mostly burnt insulation and wiring - from the Jan. 12 fire.
