### New Signs, Cameras Reducing Accidents, Illegal Crossings on Metro Blue Line

By BILL HEARD, Editor  
(May 9, 2001) Between July 1990 and December 2000, Metro Blue Line trains were involved in 157 accidents at 19 intersections in Los Angeles – about 15 accidents a year.

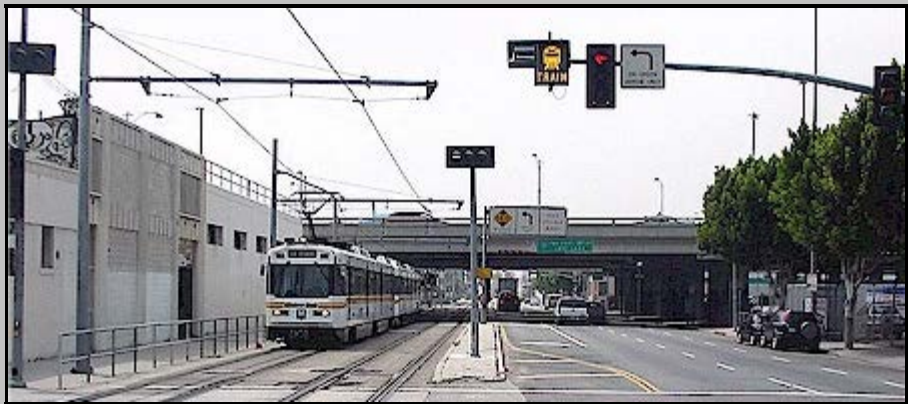
As a Metro Blue Line approaches an intersection in downtown LA, all three rail safety signs are visible in this photo. The white signal, center, is for the train operator. The fiber optic sign warns of the train's approach, while the red arrow indicates a left turn is prohibited until the train passes. PHOTO BY LUIS INZUNZA

The most noticeable feature at the 19 intersections these days is a large fiber optic sign that shows the silhouette of a train. It blinks to alert motorists when a train is approaching the intersection.

Designed as vertical, diagonal or horizontal white bars, they tell a train operator whether to proceed, slow or stop at the intersection, but are meaningless to motorists. They take the place of the red, yellow and green "T" signals that may have confused drivers.

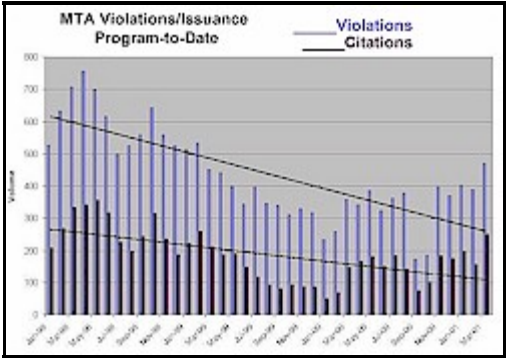
Chart shows the number of motorists violating rail crossings (top line) trending downward since January 1998. Bottom line shows that the number of citations also has declined since photo enforcement cameras were installed at Metro Blue Line rail crossings.

In 1998, the cameras recorded 7,258 violations and 3,249 citations were issued. The following year, 4,738 violations were logged and 1,789 citations issued. In 2000, there were 3,786 violations and 1,637 citations.

During the three-year period, that's 47 percent fewer violations and a 49.6 percent drop in citations for illegal rail crossings.
