Plaza Reconstruction Begins; Project May Last Into October

(July 13, 2004) Workers have begun the first phase of extensive repairs to the surface of Patsaouras Plaza, a project that is expected to last into mid-October.

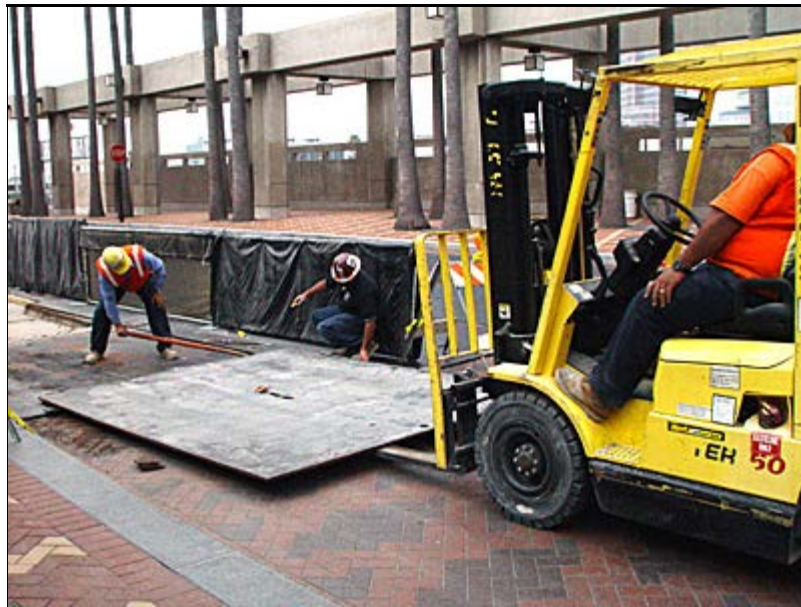
Workmen place a temporary steel plate in the busway of Patsaouras Plaza.

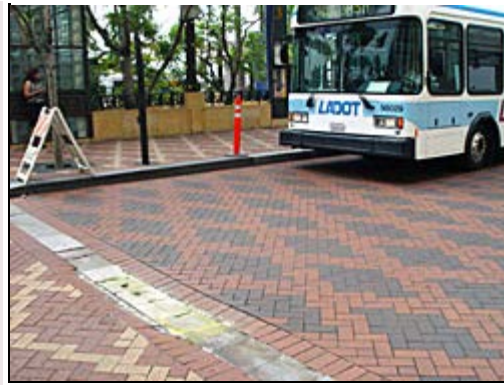
Since the Transit Plaza was opened in 1995, the constant passage of heavy buses has displaced and cracked the brick pavers in certain locations and has broken the granite blocks that define the pedestrian crosswalks.

Colored brick pavers will replace the granite slabs that have defined the pedestrian walkways on the Transit Plaza.

Workers will take care during reconstruction to duplicate the unique tri-color pattern of the brickwork that defines the pedestrian, automobile and bus areas of the roadway. They also will remove the damaged granite and replace it with colored brick to mark the pedestrian

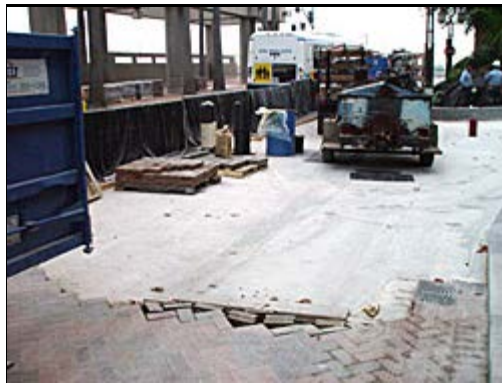
At the south turn of the busway, water seeping from the landscaped park undermined the layer of sand supporting the bricks, and the weight and movement of the buses caused them to buckle. Workmen have stripped the area of bricks in preparation for further repairs.

Workmen have stripped the paver bricks from the deck of the south end of the roadway in the first phase of repairs to the Transit Plaza.
